# Arboricultural Appraisal Report

## Subsidence Damage Investigation at:

27 Vicarage Meadow  
 Mirfield  
 WF14 9JL

CLIENT:	B Maule & Co Ltd
CLIENT REF:	20185072 / 20227573
MWA REF:	SUB230703-13606
MWA CONSULTANT:	John Graham B.Sc. Hons PhD
REPORT DATE:	26/08/2023

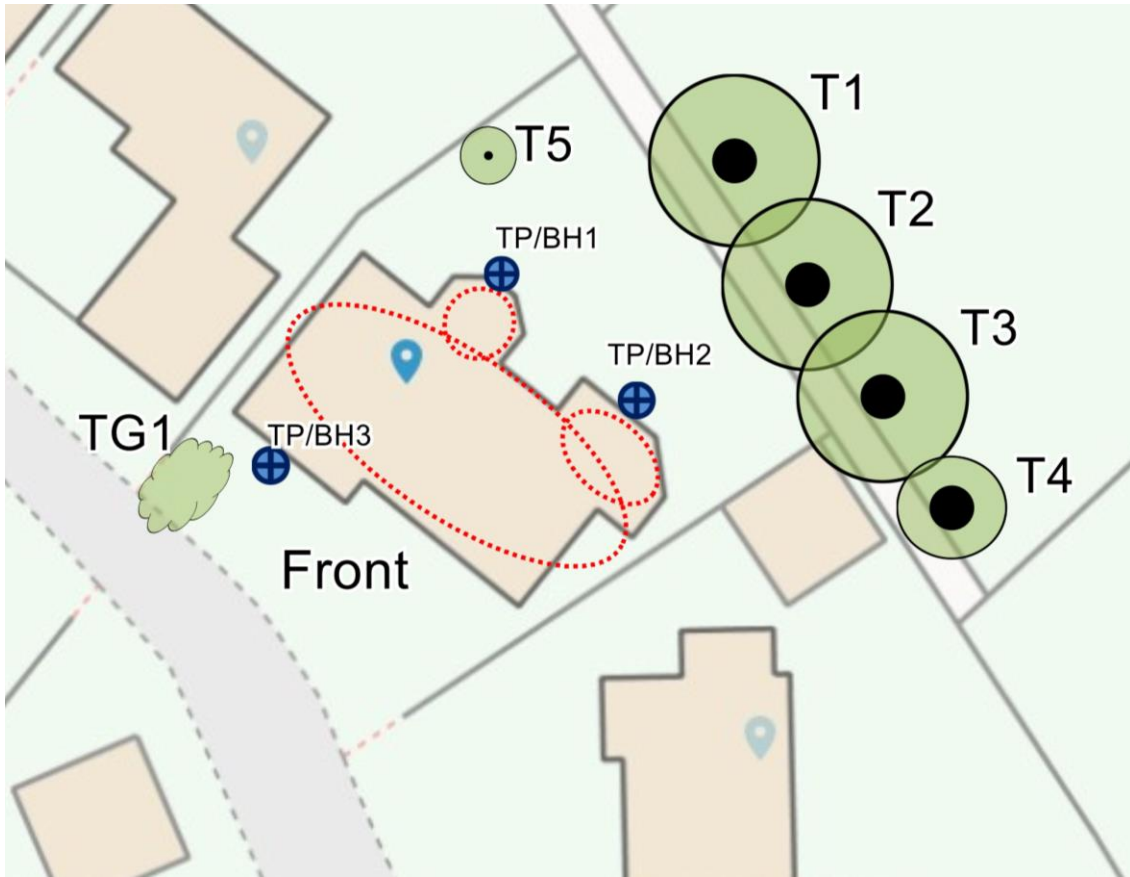
Site Plan

Approximate areas of damage

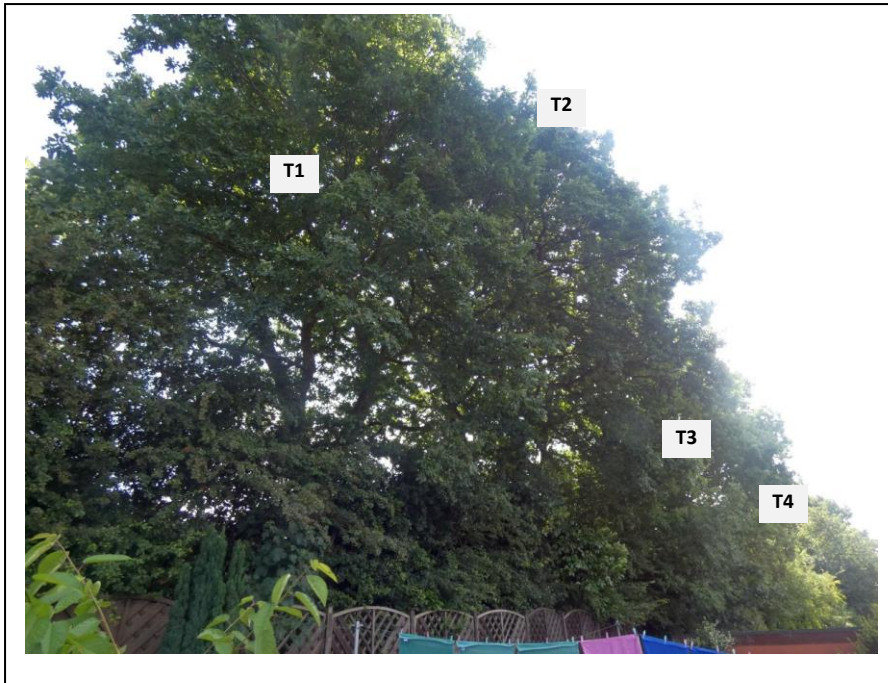
View of the rear third party trees.

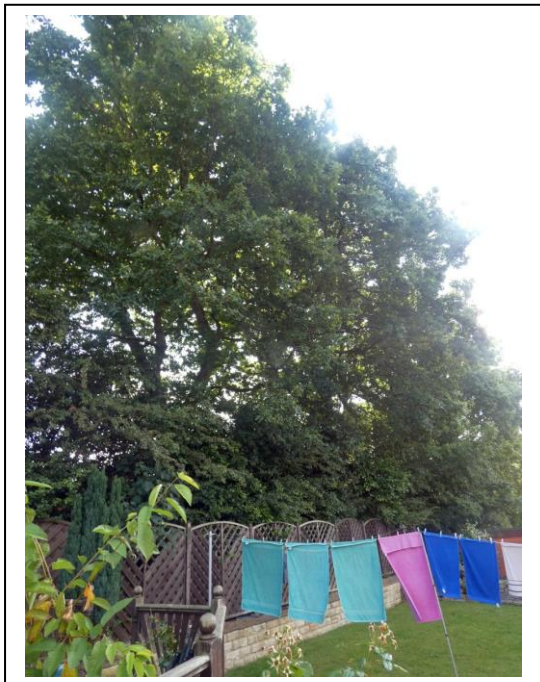
Based on the technical reports currently available, engineering opinion and our own site assessment we conclude the damage is consistent with shrinkage of the clay subsoil related to moisture abstraction by vegetation. Having considered the information currently available, it is our opinion that T1, T2, and T3 are the principal cause of or are materially contributing to the current subsidence damage.

View of T1 to T4.

If an arboricultural solution is to be implemented to mitigate the influence of the implicated trees/vegetation we recommend that T1, T2, and T3 are removed. Other vegetation recorded presents a potential future risk to building stability and management is therefore recommended.

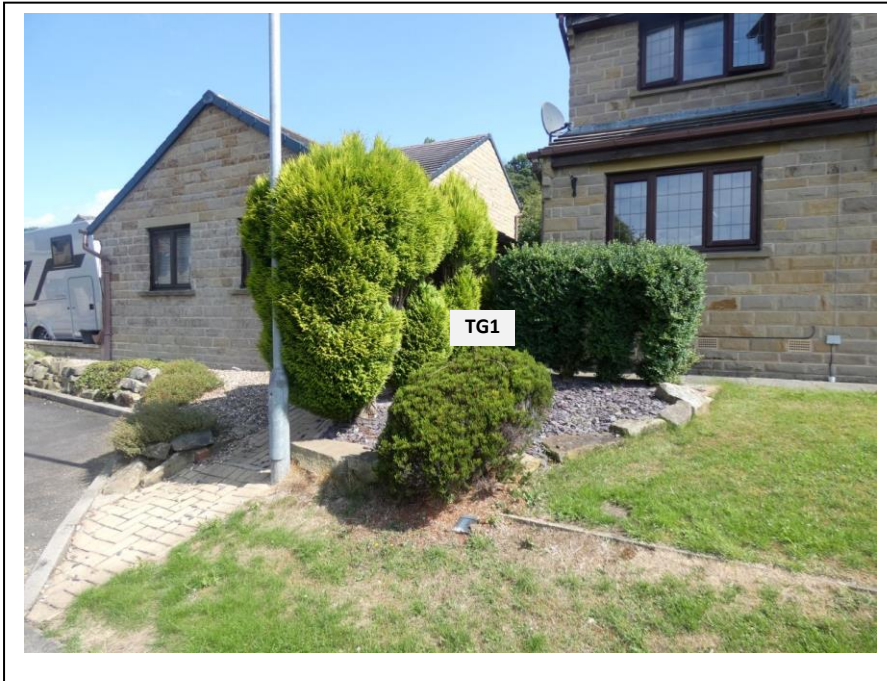
View of TG1.

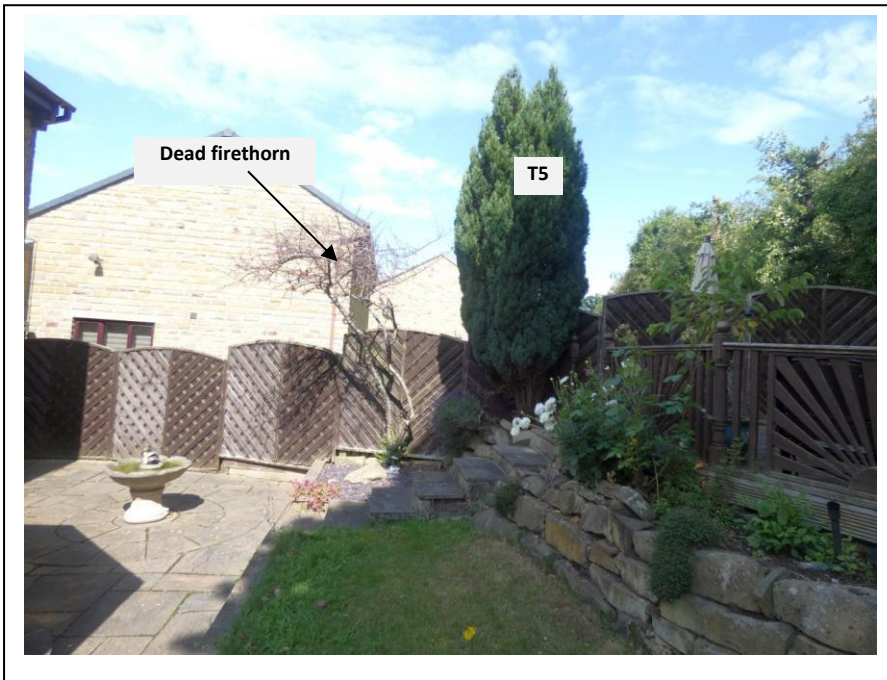
View of rear left.
