SUBSIDENCE ENGINEER'S REPORT

Client Name: LV
Reference: S2434045
Name of Insured:
Policy Number: 21871764229
Risk Address: 27 Vicarage Meadow, Mirfield, West Yorkshire, WF14 9JL

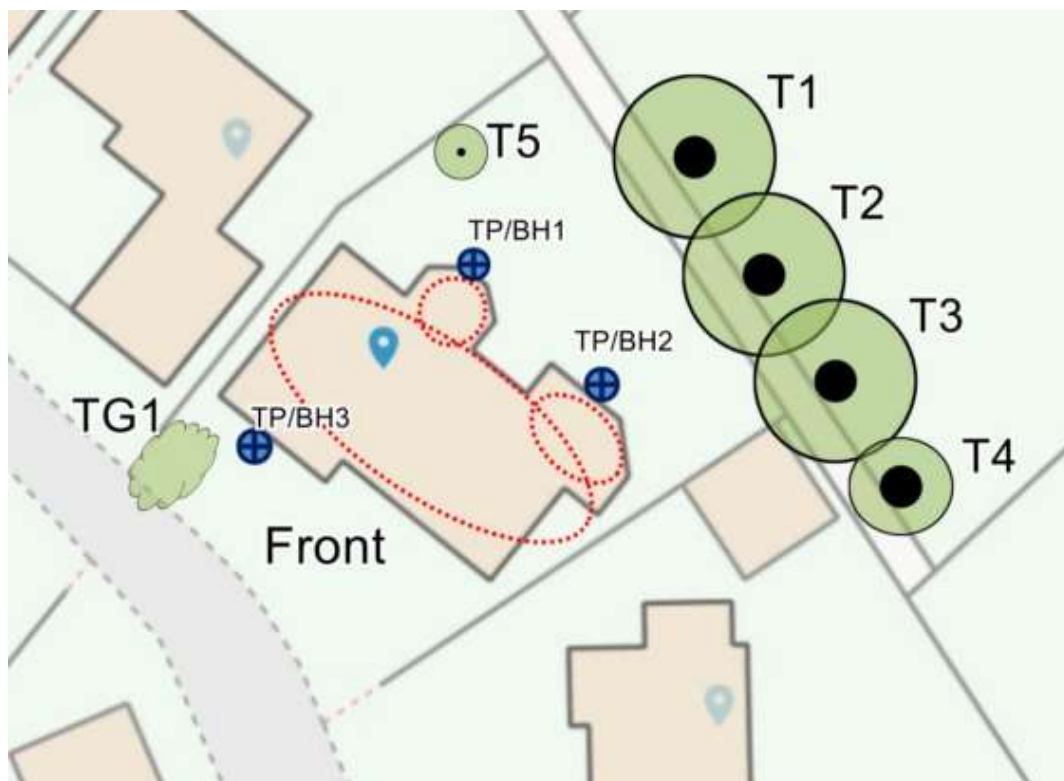
To properly assess the vegetation surrounding the property, we appointed MWA Arboriculture. The vegetation around the property is shown on the attached site plan which has been extracted from the Arboricultural Assessment Report that MWA have produced:

The vegetation which is considered most likely to be involved in this matter are T1, T2 & T3, which have been identified by MWA as Oak trees.

In most cases of subsidence, the foundations can be stabilised by removing the cause. In this case, this would involve removal of T1, T2 & T3.

It would be our recommendation to mitigate the subsidence issue by removing the implicated trees, this will then allow the soil to rehydrate and the property to stabilise. This would in turn avoid the need for costly and disruptive substructure works.

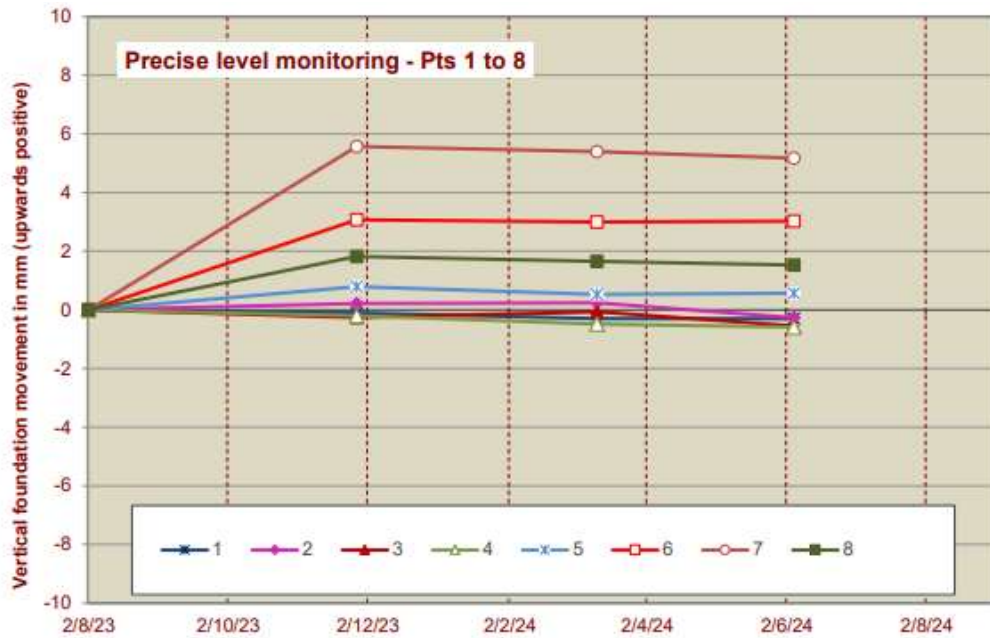
(Graph Showing the Movement of Monitoring Points 1-8)

The level monitoring to date has shown a general pattern of upward movement / closure of the cracks, which is to be expected monitoring exercise having only covered the Autumn, Winter and Spring months.
