# **TREE SURVEY RISK REPORT**

**ON BEHALF OF: Matthew Quarmby**

**SITE ADDRESS: 197 Penistone road, Kirkburton HD8  
0PH**

**DATE: 29/07/2024**

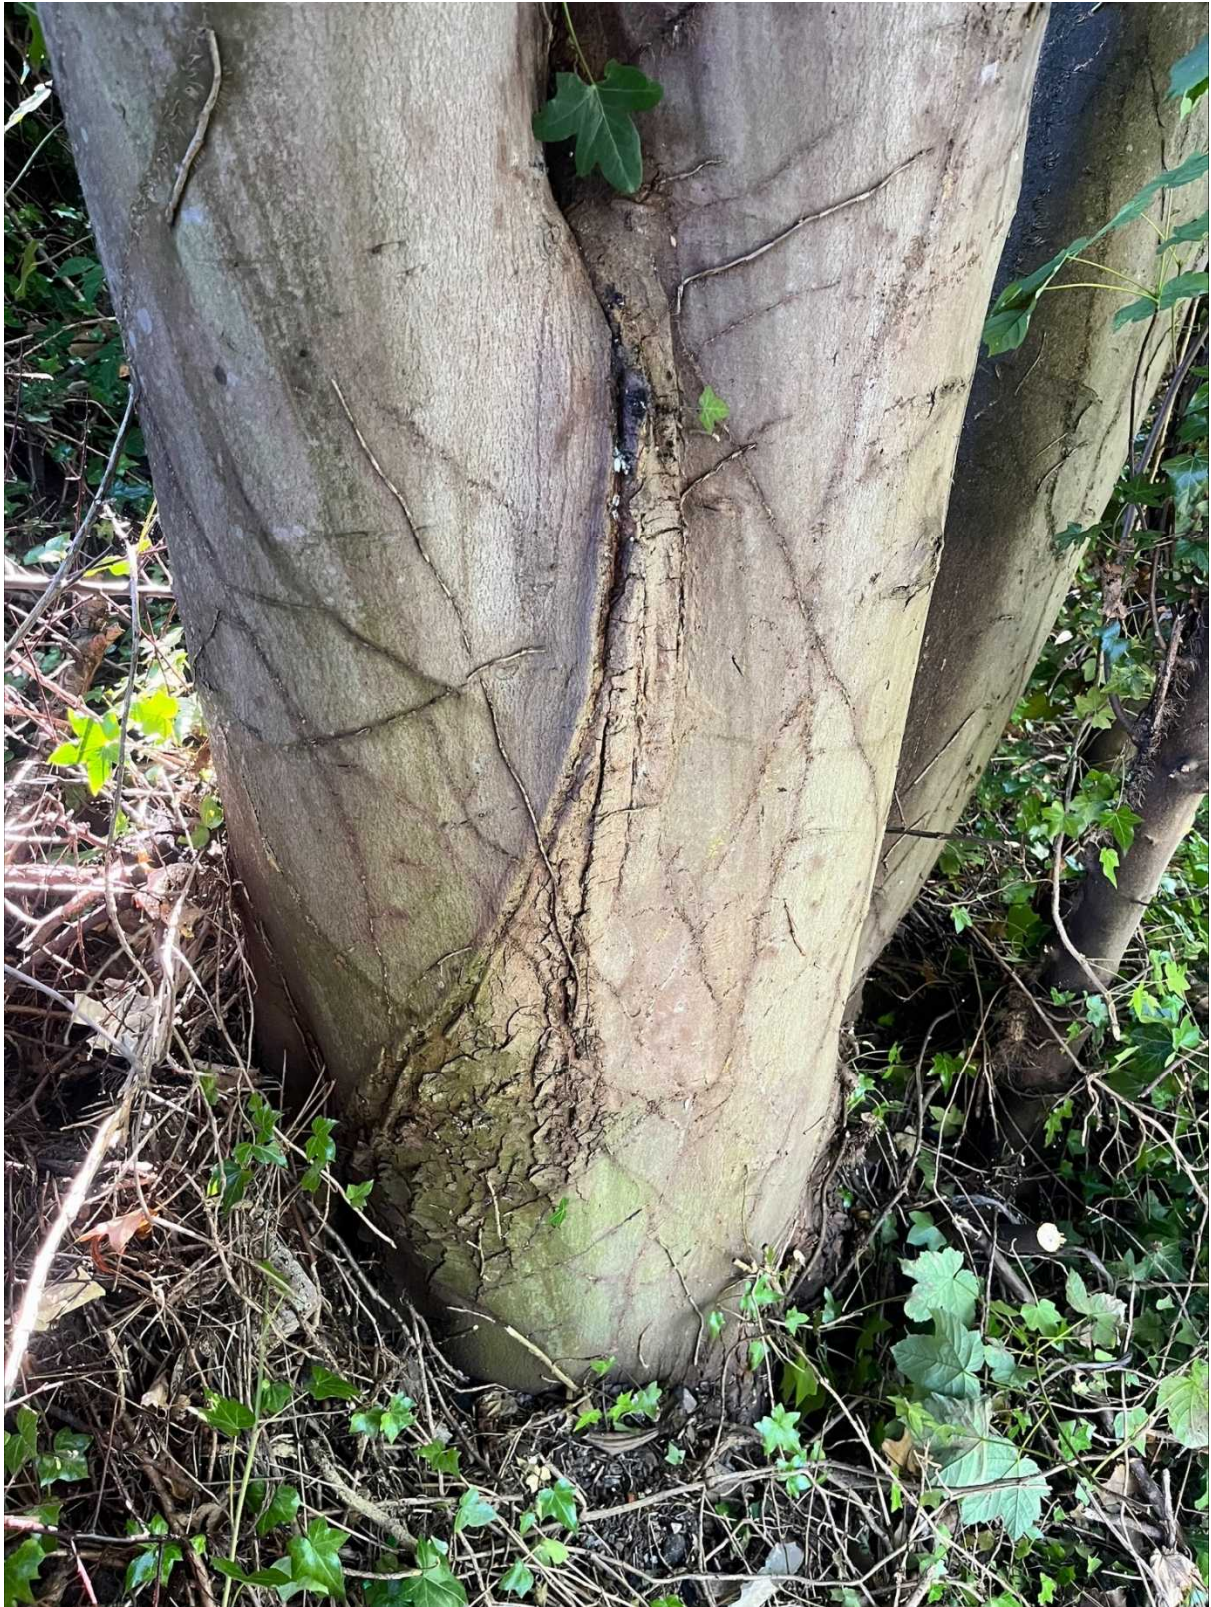
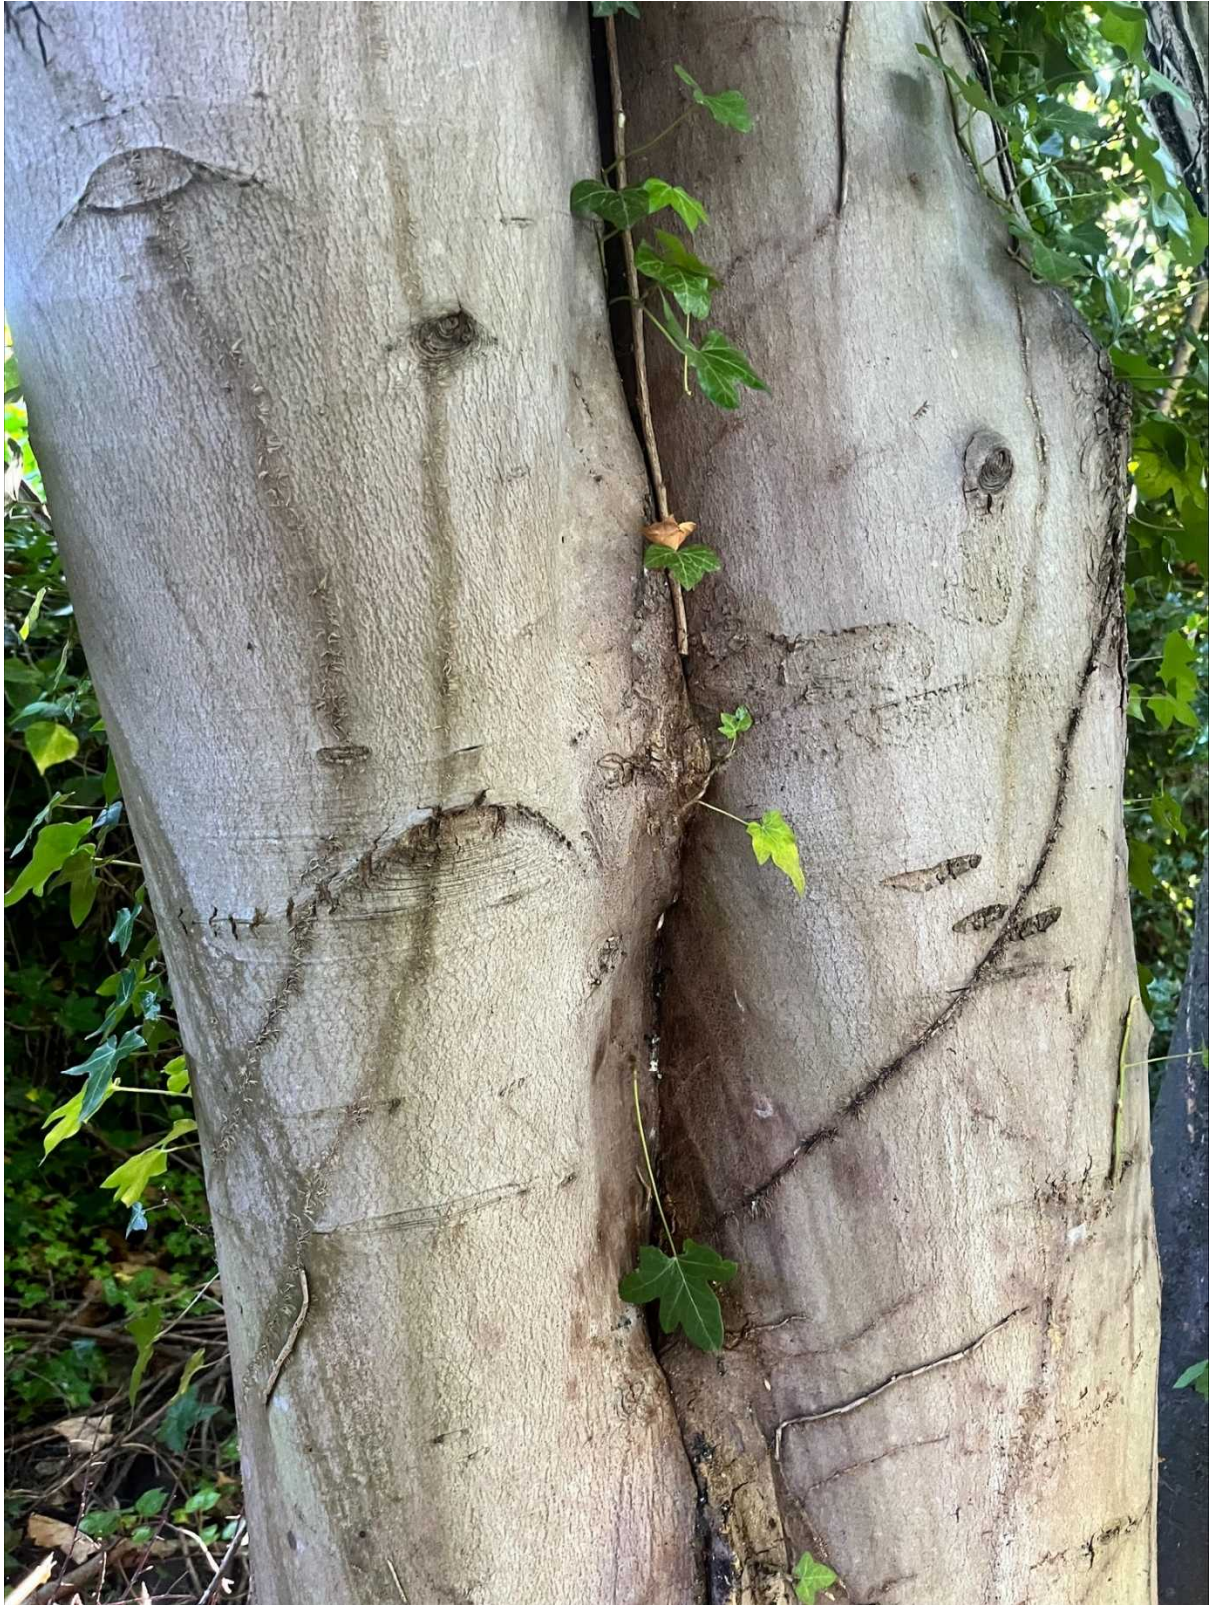
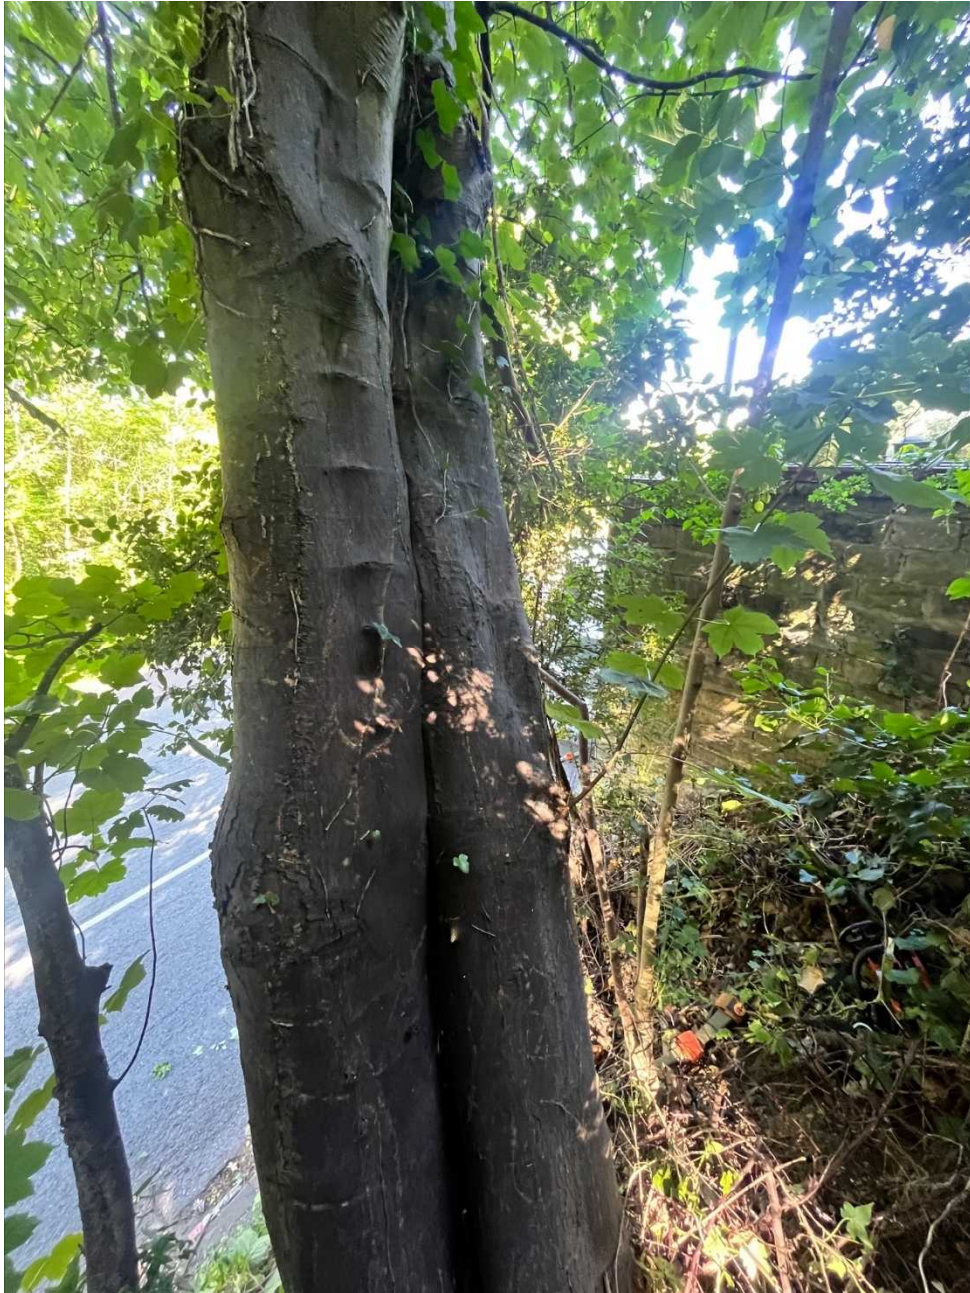
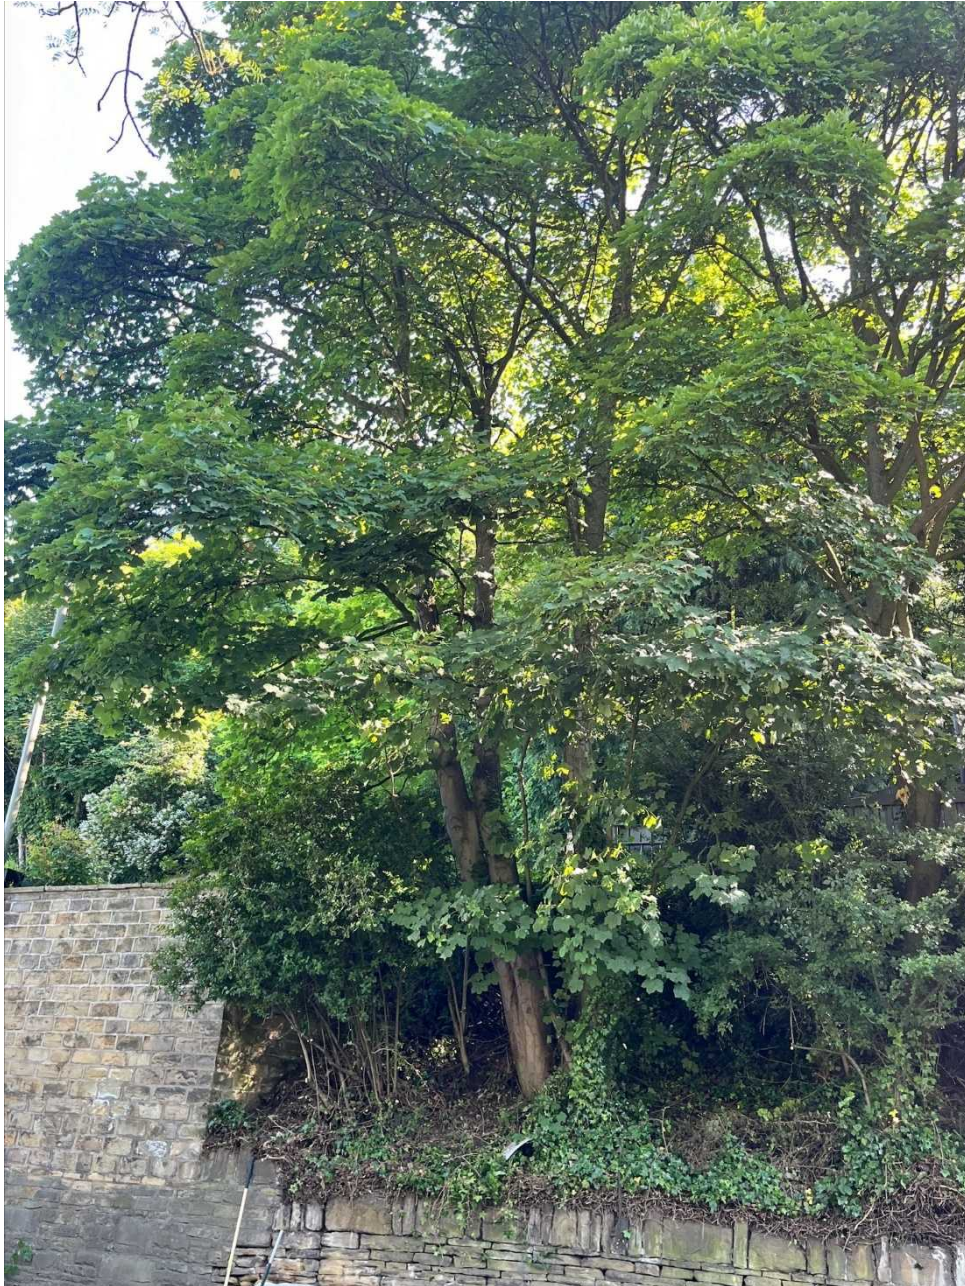
**T1 sycamore**

| Species/num | Vigor | Striking distance | Risk level | Recommended work | Time frame |
|---|---|---|---|---|---|
| T1 sycamore | good | yes | 4 | The tree is situated very close to the property and a busy main road. <b>Remove to ground level</b> | Within 3 months |

T1 large Sycamore tree stands on a steep embankment along side a busy main road and the property. The tree is multi stem split at ground level, on removal of the ivy it is evident that the stems have twisted together at the base creating a natural fail point with heavy weighting of the main road. I suggest removal of this tree to ground level due to the split stem at ground level and potential for failure in such a close proximity to a busy main road and property. Refer to pictures below.

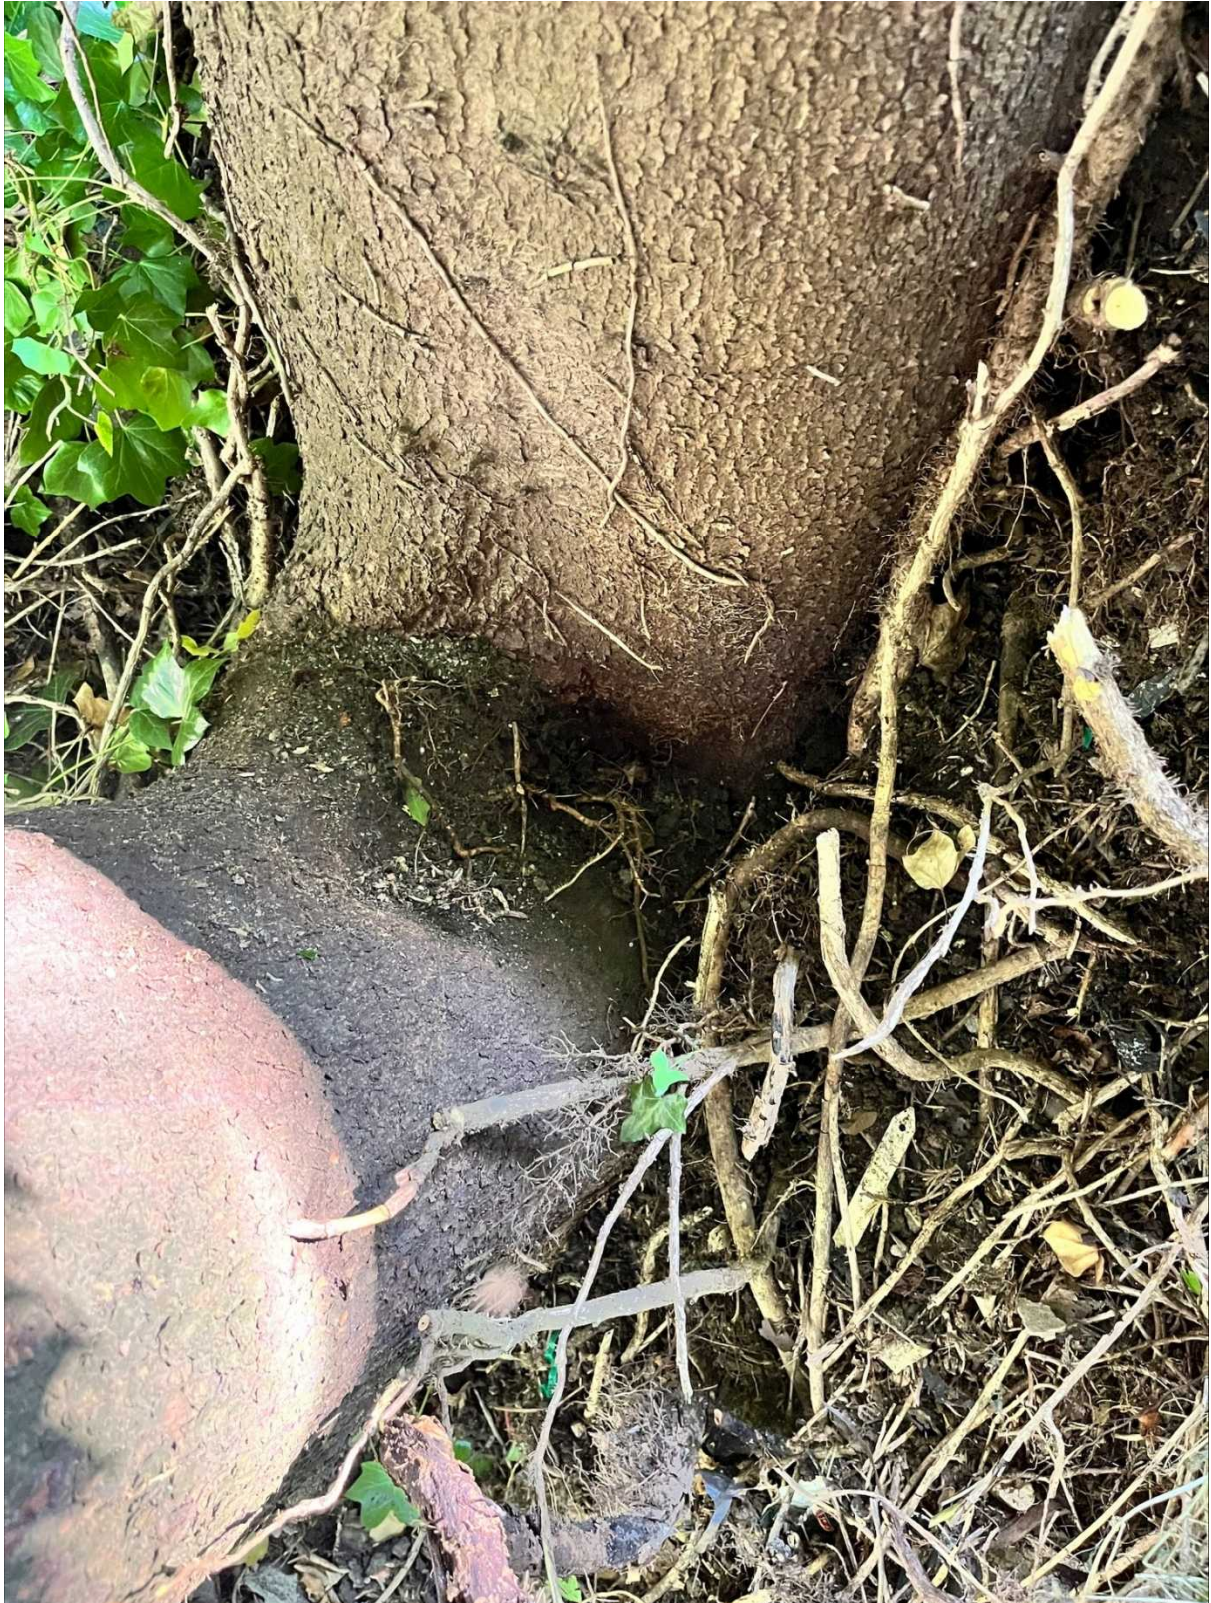
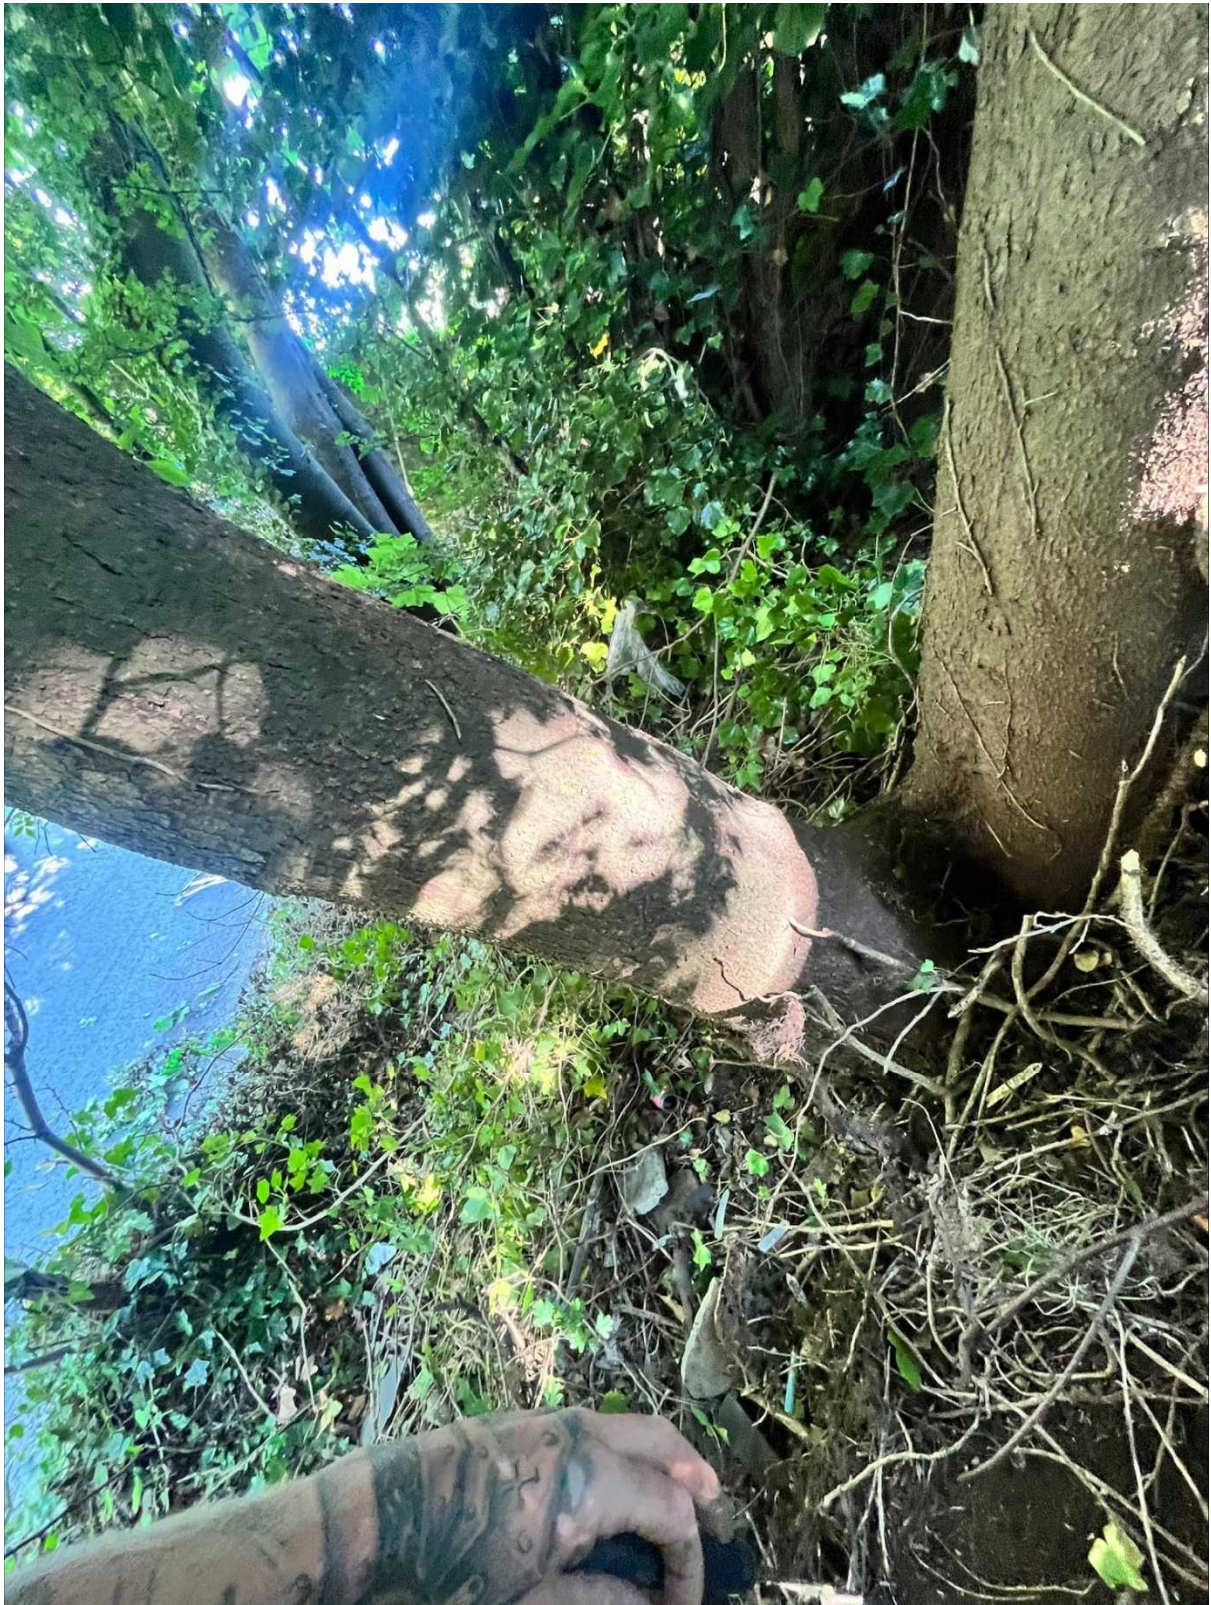
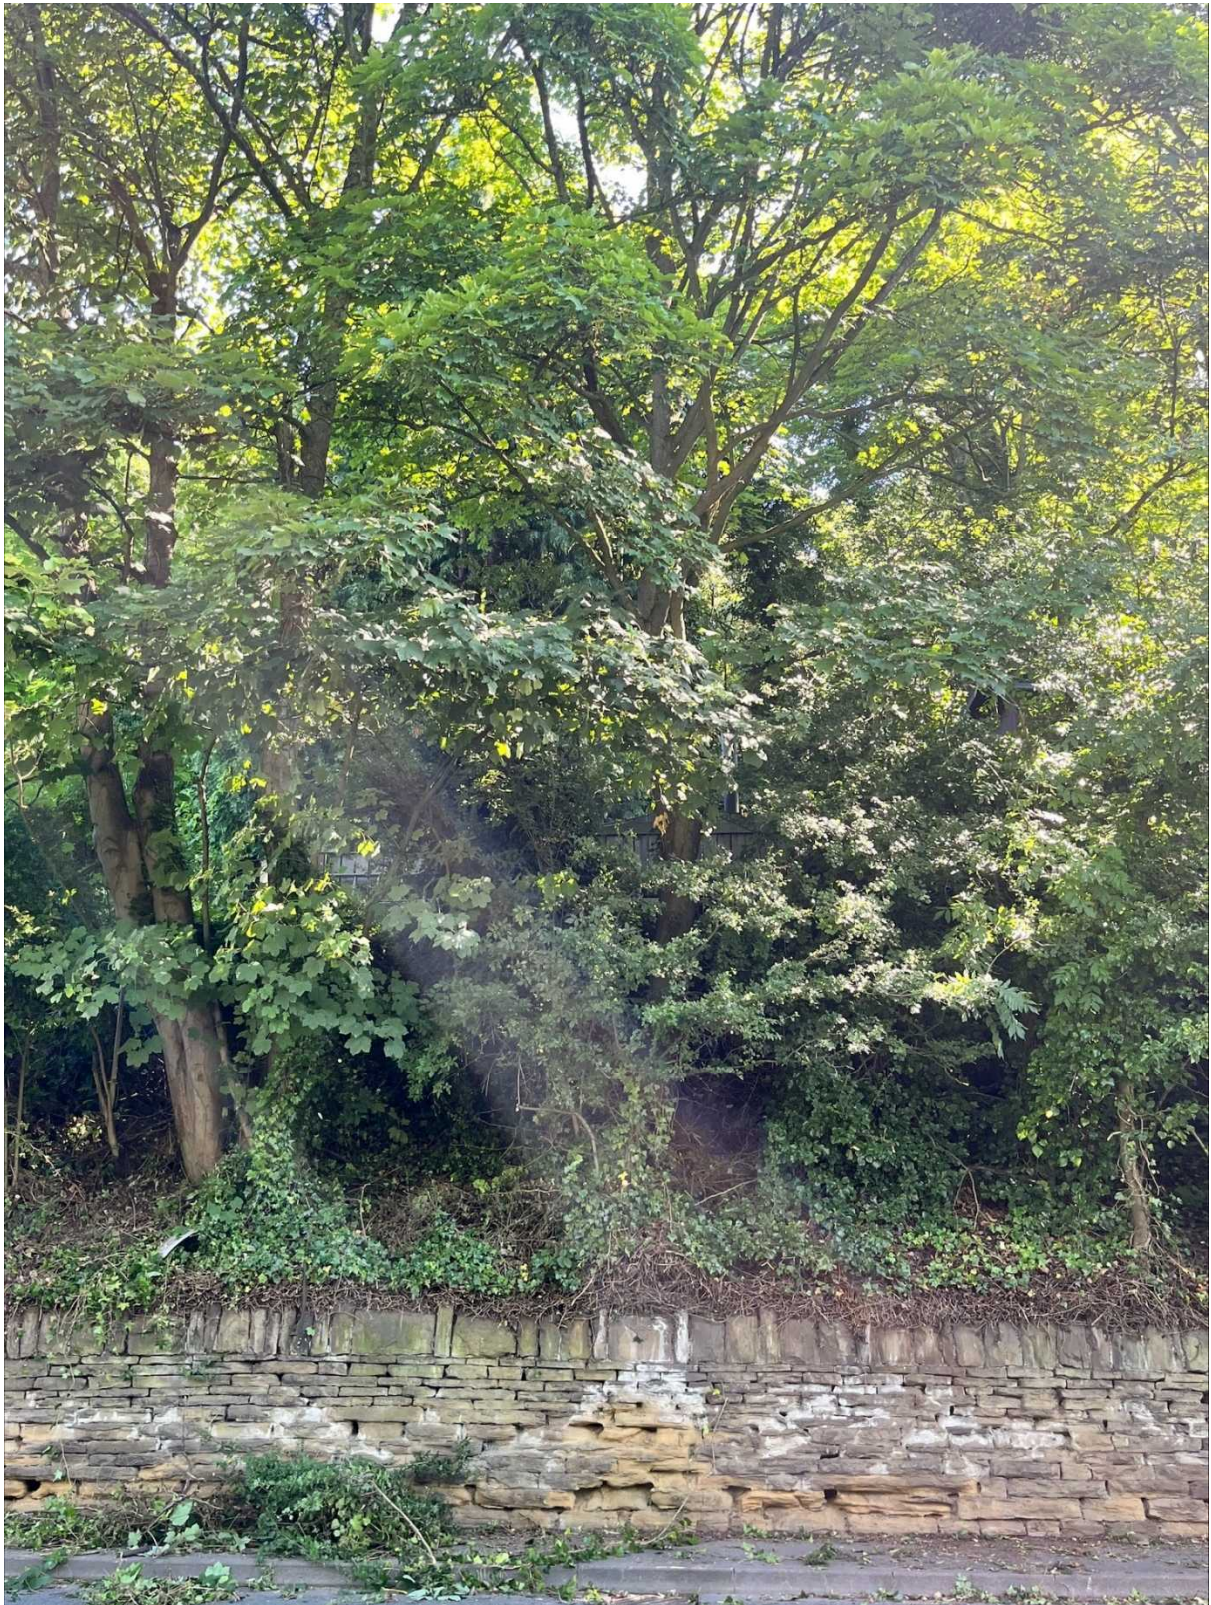
| Species/num | Vigor | Striking distance | Risk level | Recommended work | Time frame |
|---|---|---|---|---|---|
| T2 maple | good | yes | 4 | The tree is situated next to a busy main road. <b>Remove to ground level.</b> | Within 3 months |

**T2 Maple tree, this tree stands on a steep embankment over a busy main road. On removal of the ivy it is evident that the tree is multi stem at ground level and showing heavy composting on this union point cause rot. The front leader of the tree has a very heavy lean over the main carriage way. I suggest removal to ground level due to the potential of failure over a busy main road. Refer to pictures below.**

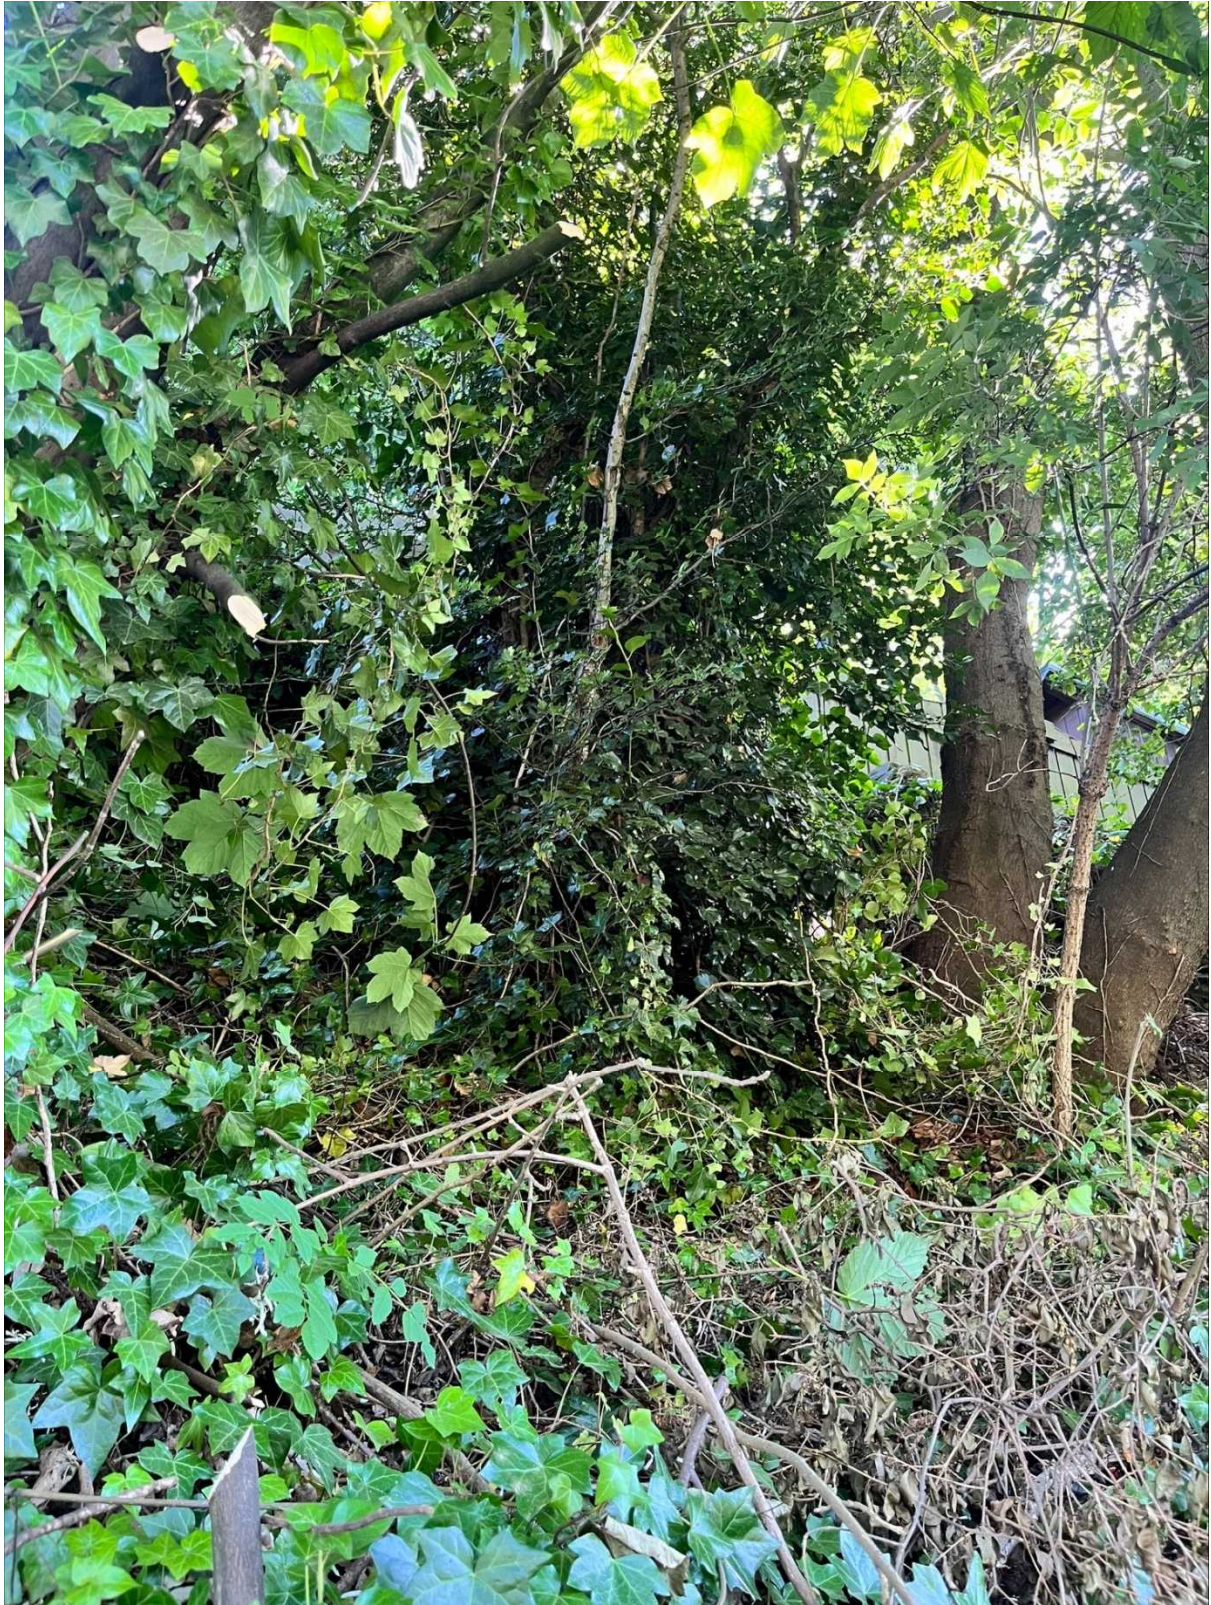
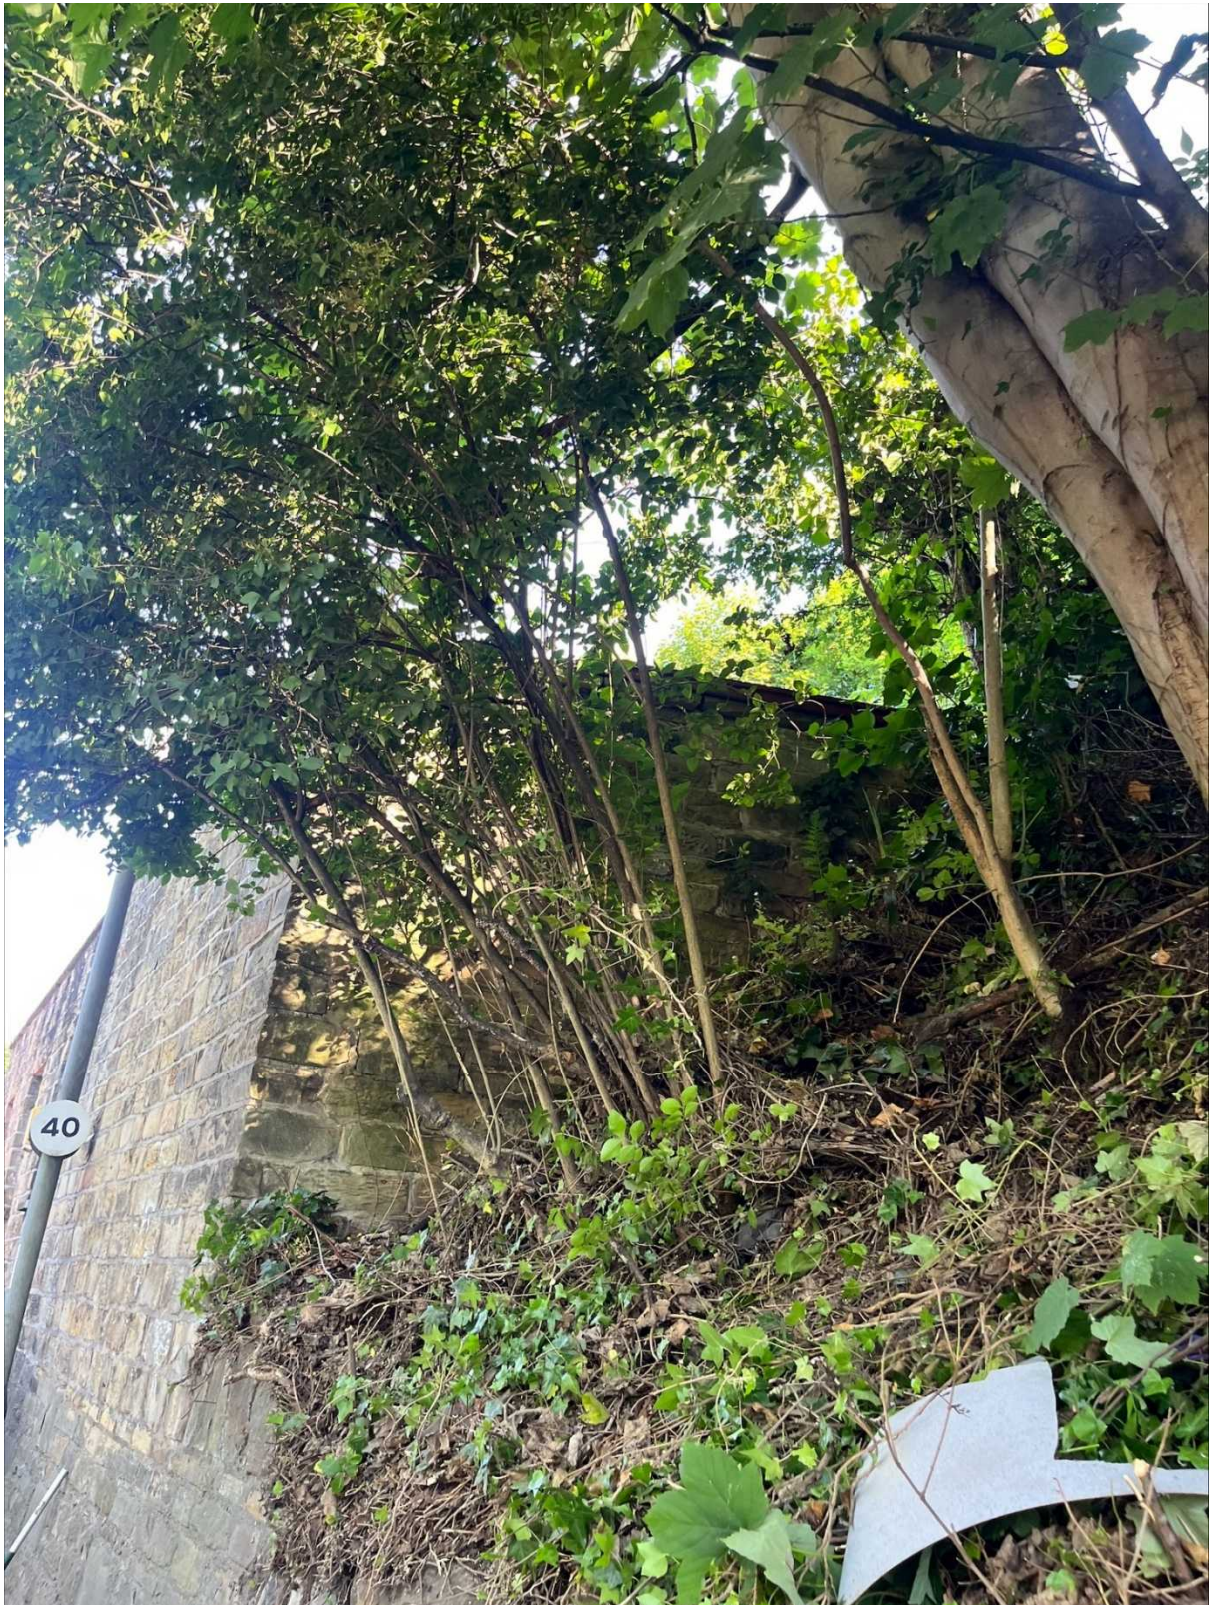
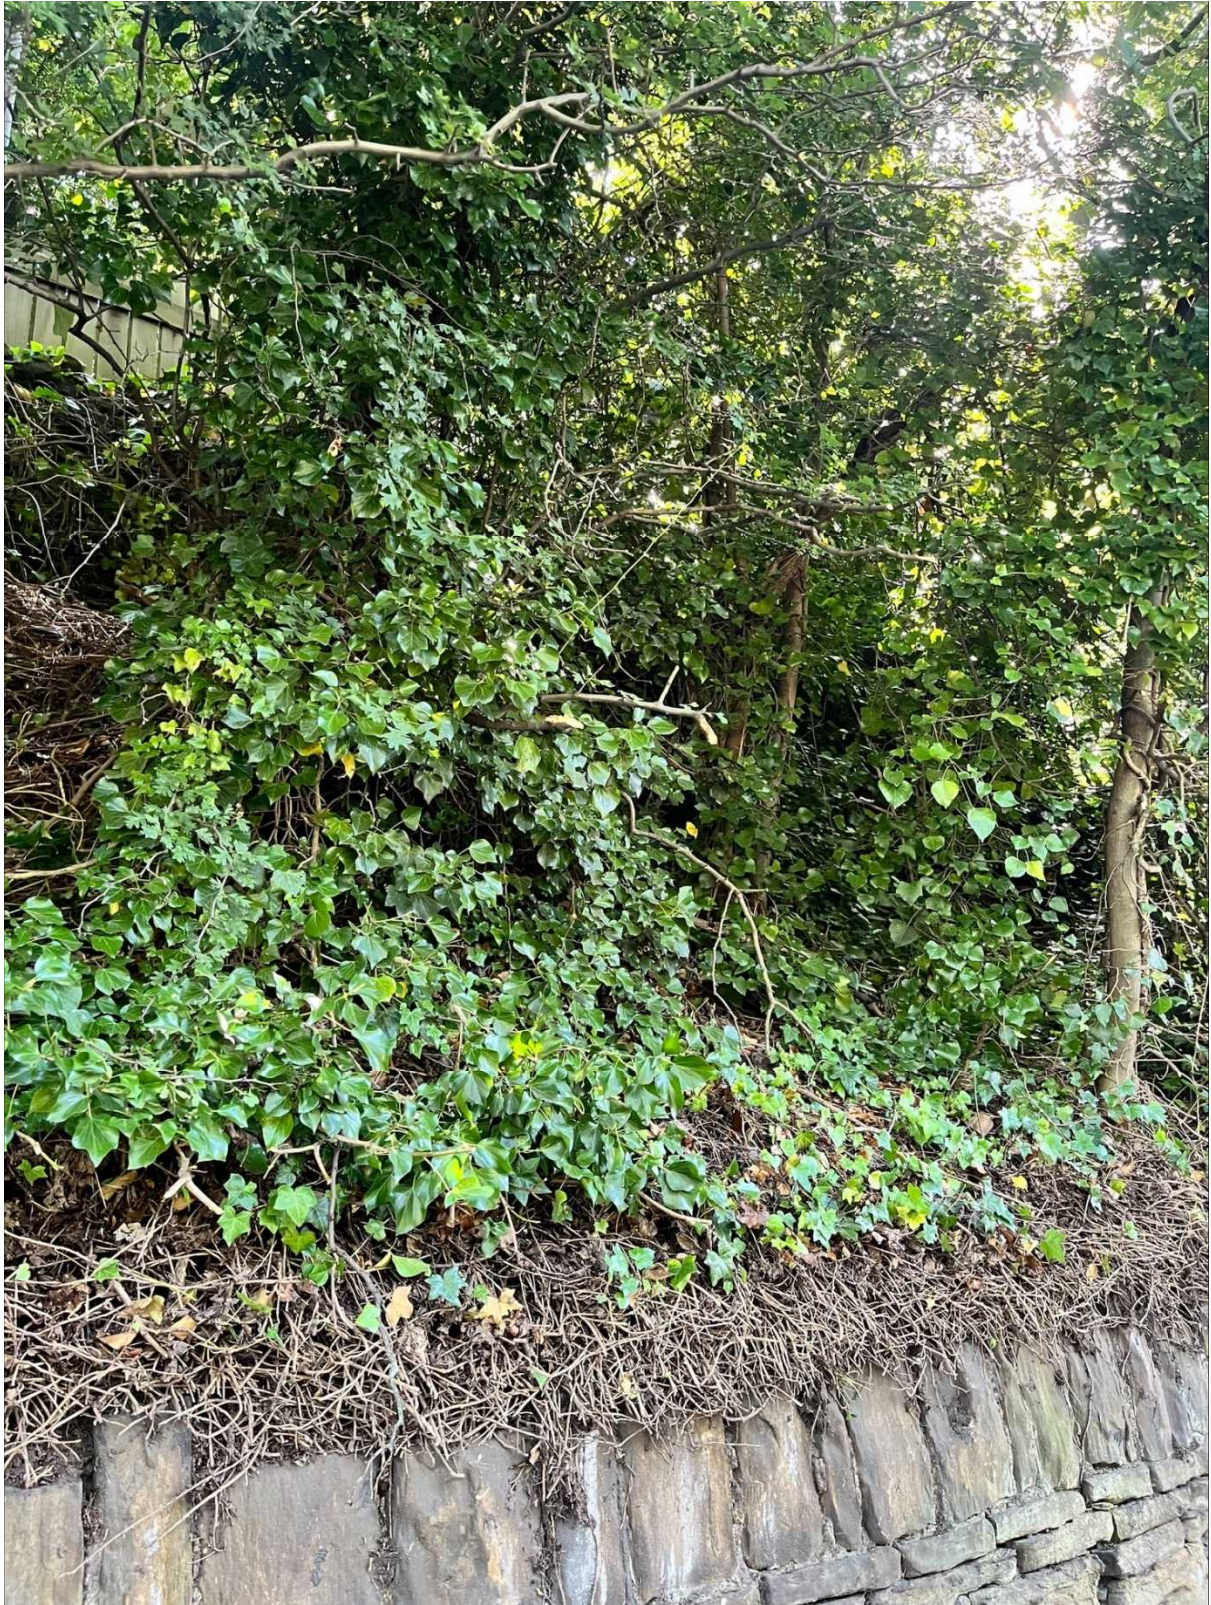
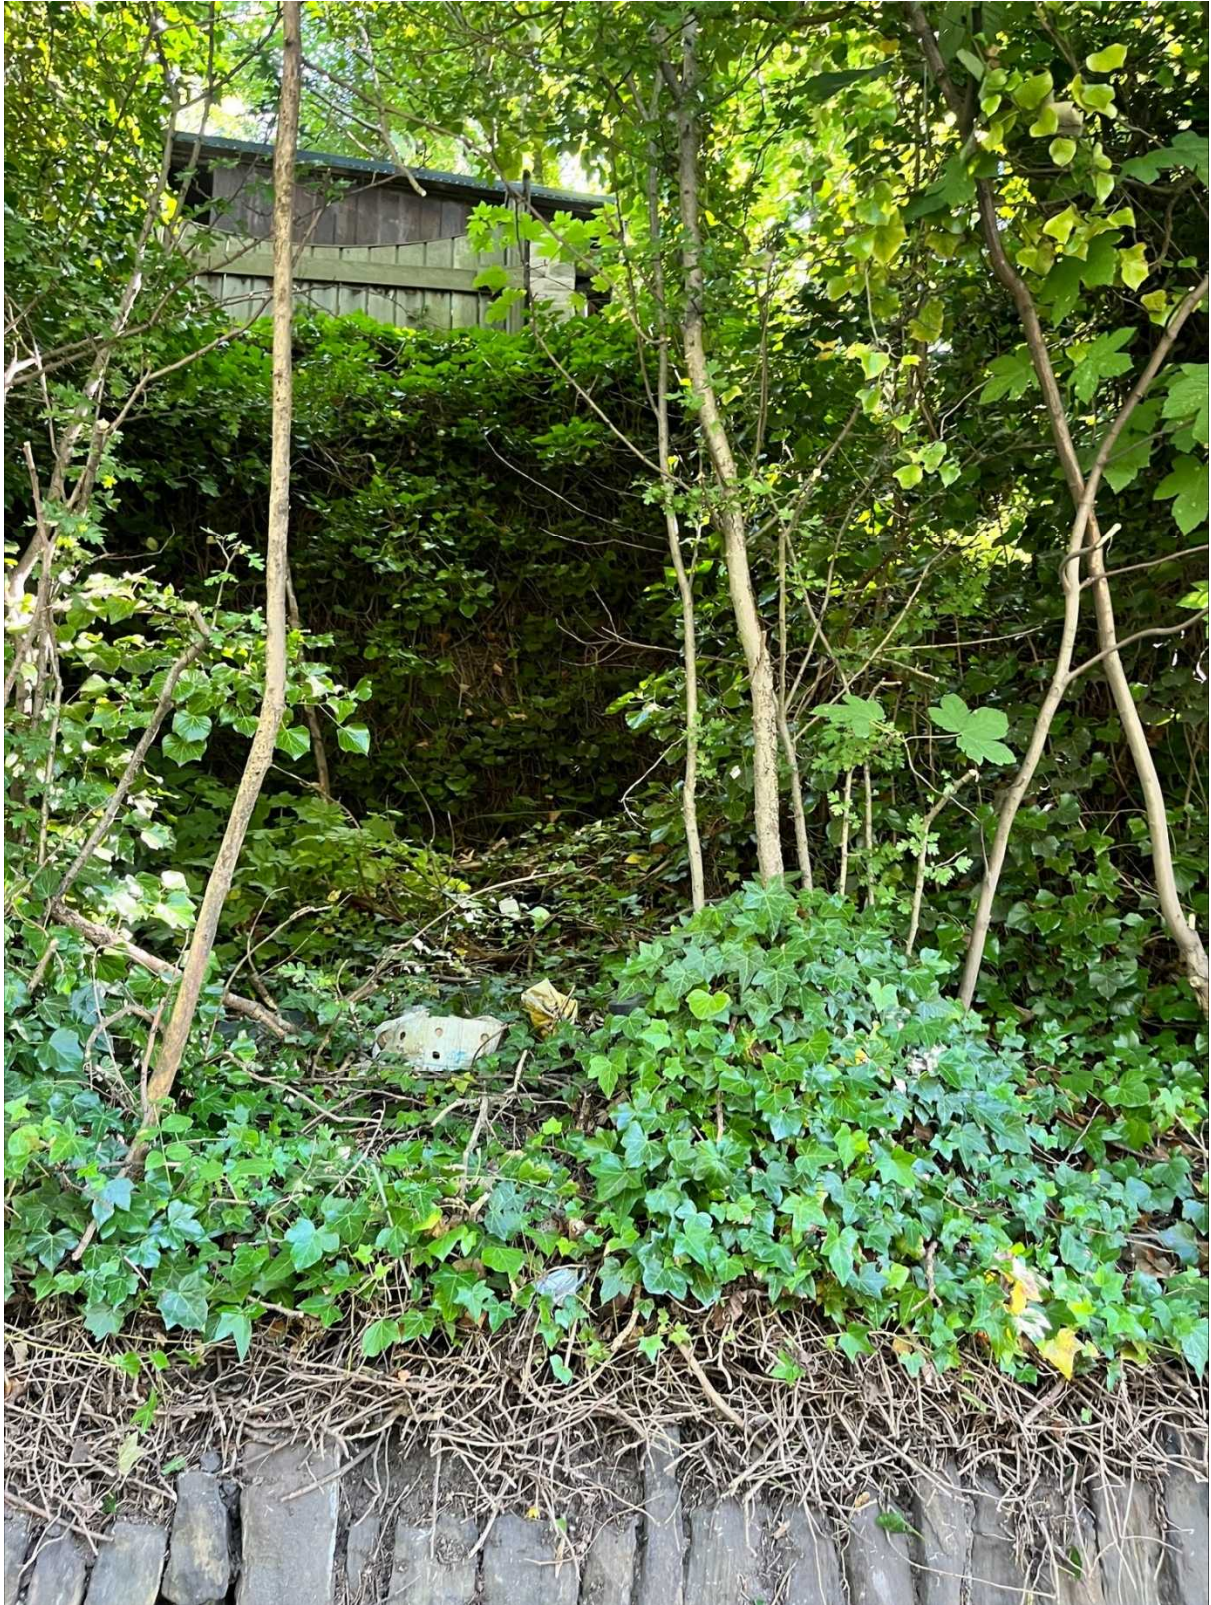
| Species/num | Vigor | Striking distance | Risk level | Recommended work | Time frame |
|---|---|---|---|---|---|
| G1 group of mixed trees and shrubs. | poor | no | 2 | Group of mixed small trees and shrubs. <b>Clear scrub completely ready for replant.</b> | N/A |

**G1 low value self set scrub, whilst removing ivy from the above trees I have noticed the embankment is majority self set low value scrub comprising of hawthorn, sycamore and shrubs. The embankment has become covered in litter from road users and pedestrians. I suggest clearing the embankment of all scrub to tidy the area up and plant more higher value hedging or flowers to create a new road green space which is more easily managed for litter etc.**
