**APPLICATION FOR TREE WORK**

<b>Tree Preservation Order Ref:</b>	<b>35/91/a1</b>
<b>Location:</b>	<b>Teasel Close, Hightown, Liversedge, WF15 8BJ</b>
<b>Applicant:</b>	<b>Phil Amess Tree &amp; Woodlands Inspector PLACE Kirklees Council</b>
<b>Date:</b>	<b>28<sup>th</sup> August 2024</b>

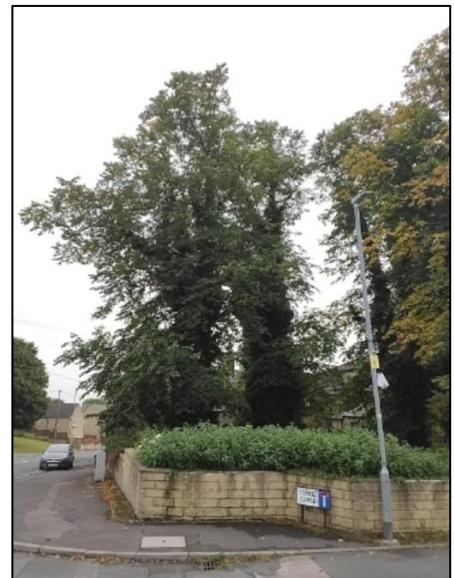
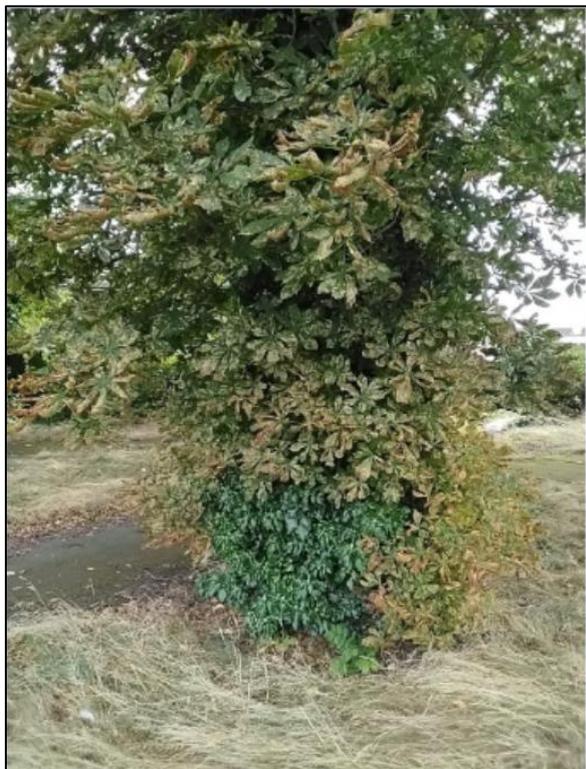
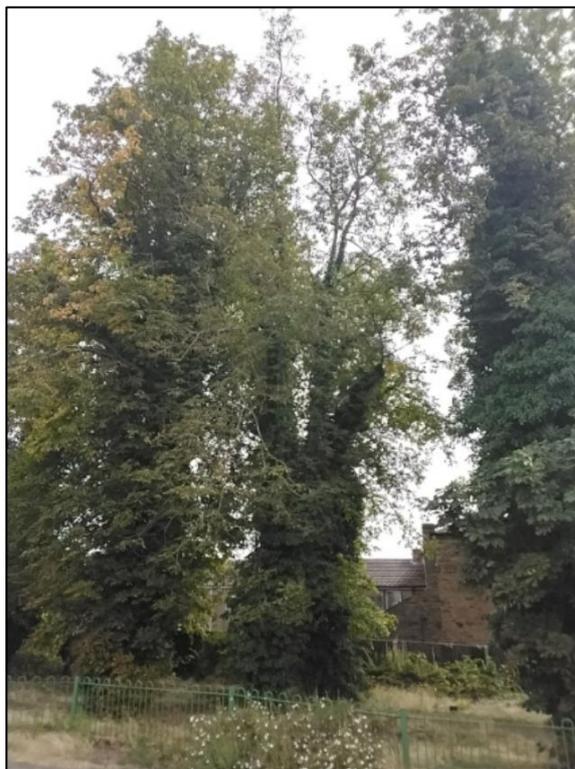
**T1-T8**

**Condition** – All trees in this group are semi-mature & stand at a similar height of approximately 14-17m with similarly sized crown spreads of approximately 5-7m. There appears to have been little to no maintenance on these trees for a number of years and they are all laden with thick ivy & epicormic growth which makes it difficult to fully assess their condition during a VTA. Generally, vigour was good across the group with the exception of 1 x Horse Chestnut (T2) which had a largely sparse crown. Both Horse Chestnuts (T1, T2) were blighted with Horse Chestnut Leaf Miner damage as is typical of this species.

**Works Proposed** – I propose to sever the ivy at base & strip to 1m of all trees in group. I also propose to carry out a crown clean of all trees to include the removal of dead/defective branches & to carry out a crown lift to approximately 4-5m to include the removal of epicormic & non-scaffold limbs. This work should enable better monitoring of the condition of the trees going forwards & should also remove growth which is impeding the footways & play area below. The work proposed should not detract from the amenity value of the trees as individuals or as part of the overall group.

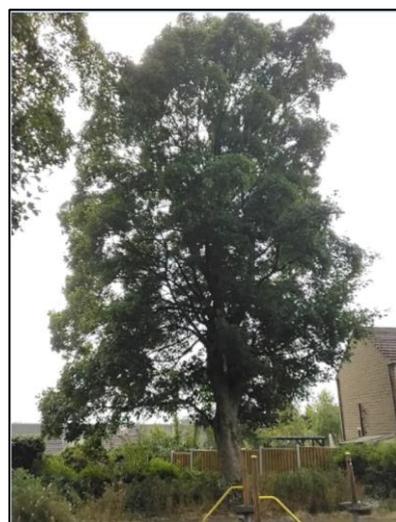
**T9**

**Condition** – This tree is in a good condition showing good signs of vigour with only small amounts of deadwood within the crown.

**Works Proposed** – I propose to carry out a crown clean to include the removal of dead/defective branches & to carry out a minor crown lift to approximately 4-5m to include the removal of the larger, lower limb as there is evidence this has been repeatedly used for rope swings. Removal of this lower branch should hopefully prevent more rope swings appearing on this tree. The work proposed should not detract from the amenity value of the trees as individuals or as part of the overall group.
