Popeley Farm, Gomersall – BARN 1 Structural inspection for planning

Description: For client and planning approval

Project: Popeley Farm
Client: Mr J. Clay
Description: Structural inspection
Date: 4th September 2023

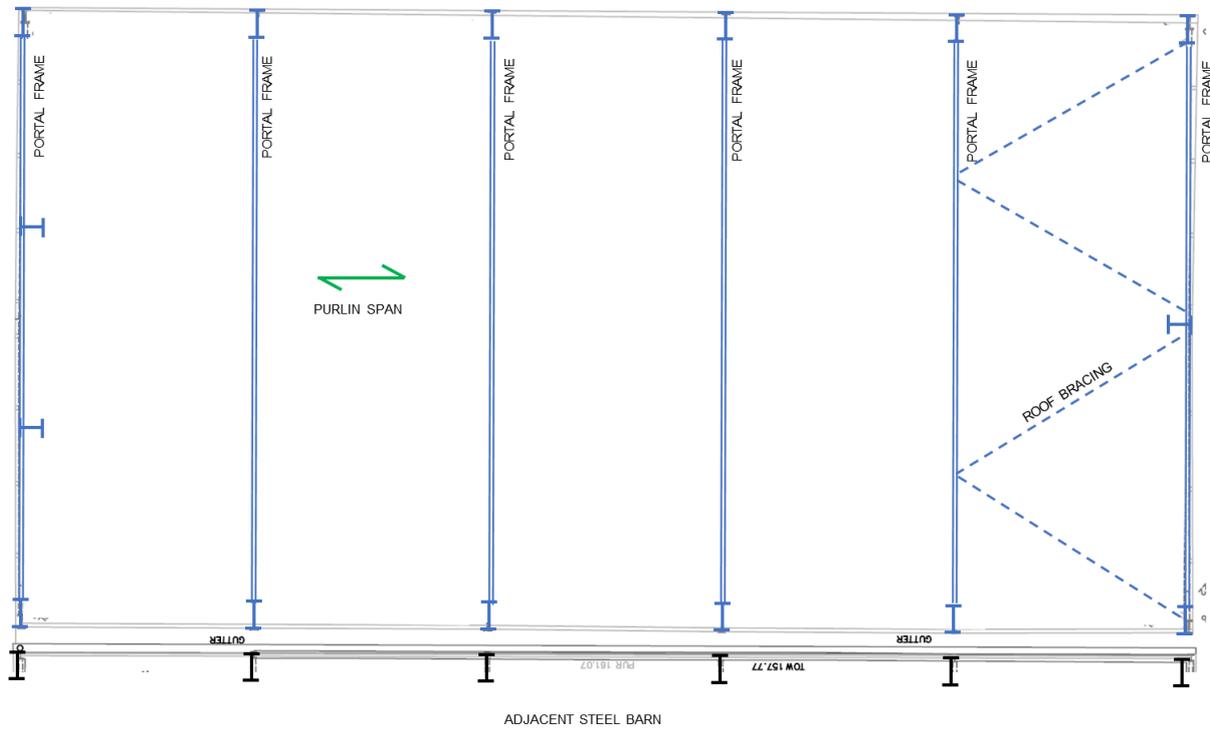
Figure 3: Barn 1 general structural arrangement (base image modified from MET Consultancy Group. original survey drawings)

The main frames have not been formally braced in the longitudinal direction. This implies that the frames are either formally built in with a significant foundation at their base to develop bending in their minor axis to transfer load to the ground, or are relying on the cladding forming a 'stressed skin' diaphragm to stiffen the walls in the longitudinal direction.

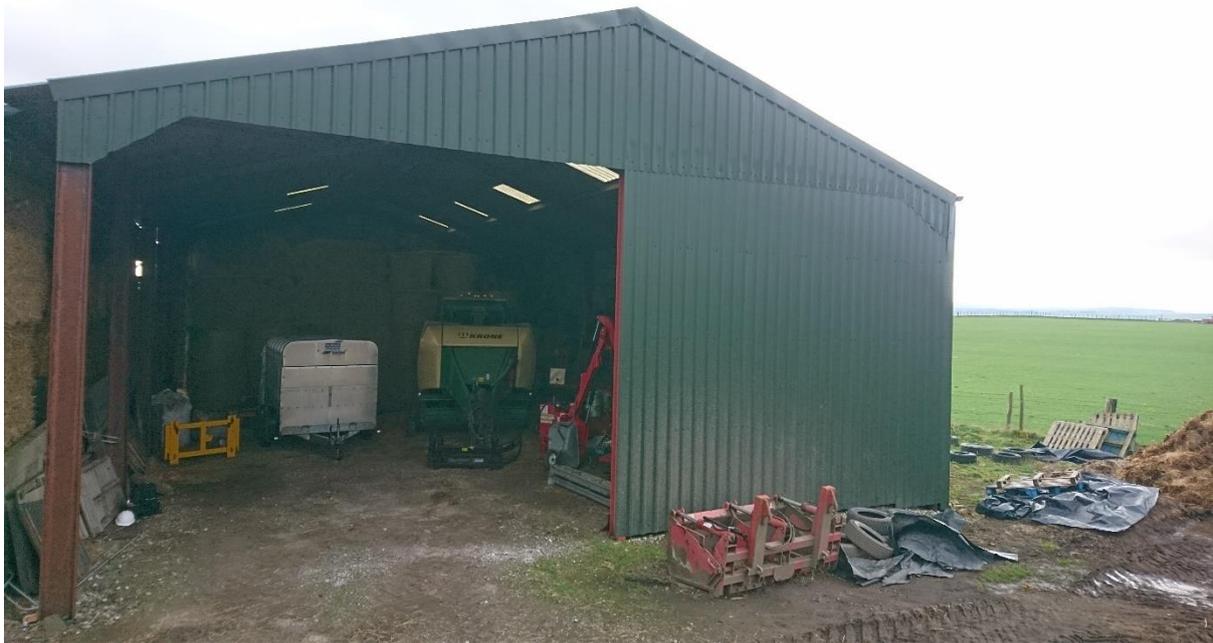
The north-western (front) gable is clad from the south-eastern side elevation to the centreline under the roof apex and the remaining half is open. The cladding here has been supported with cold rolled steel side rails in contrast to the timber provided in the remainder of the structure.

Figure 4: External view of the north-western (front) gable of Barn 1.

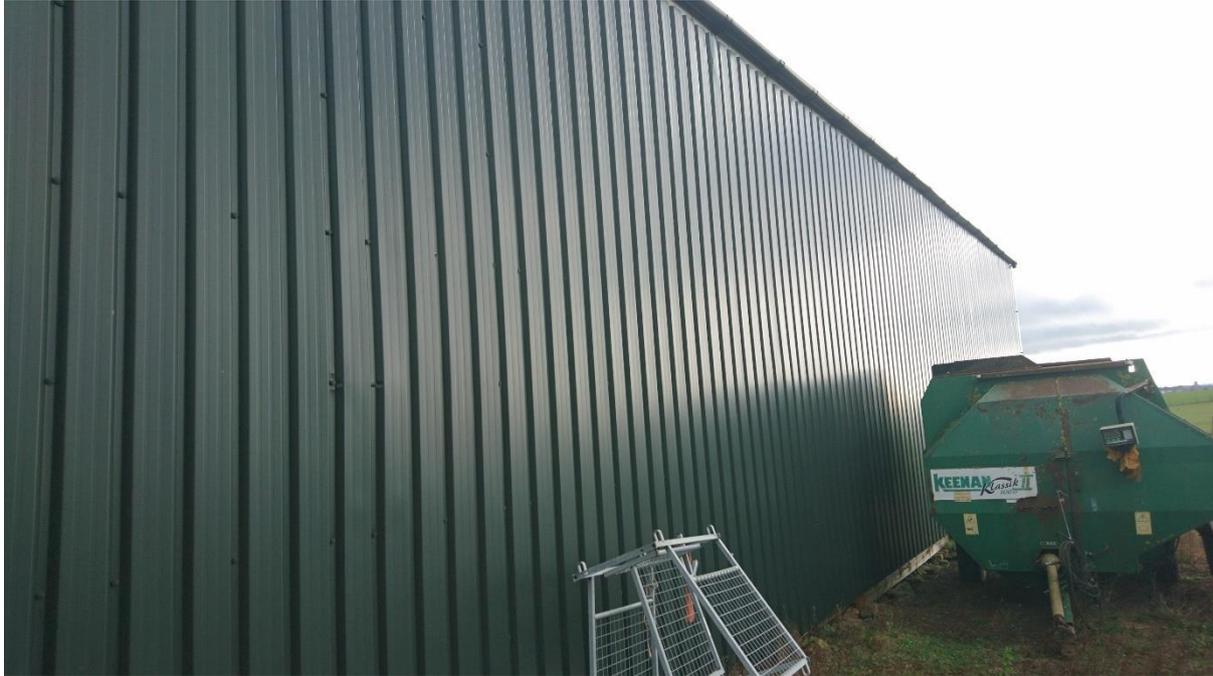
The cladding is only present on the southwestern elevation, and the north eastern elevation is open to the adjacent barn. Regardless of the design intention and construction details of the foundations

Figure 5: External view of the south-western elevation.

noted in the previous paragraph, the barn has an eccentric distribution of stiffening elements and is likely to develop rotational / torsional motions during high wind events. Bracing or other stiffening such as masonry or timber infill walls should be provided during conversion.

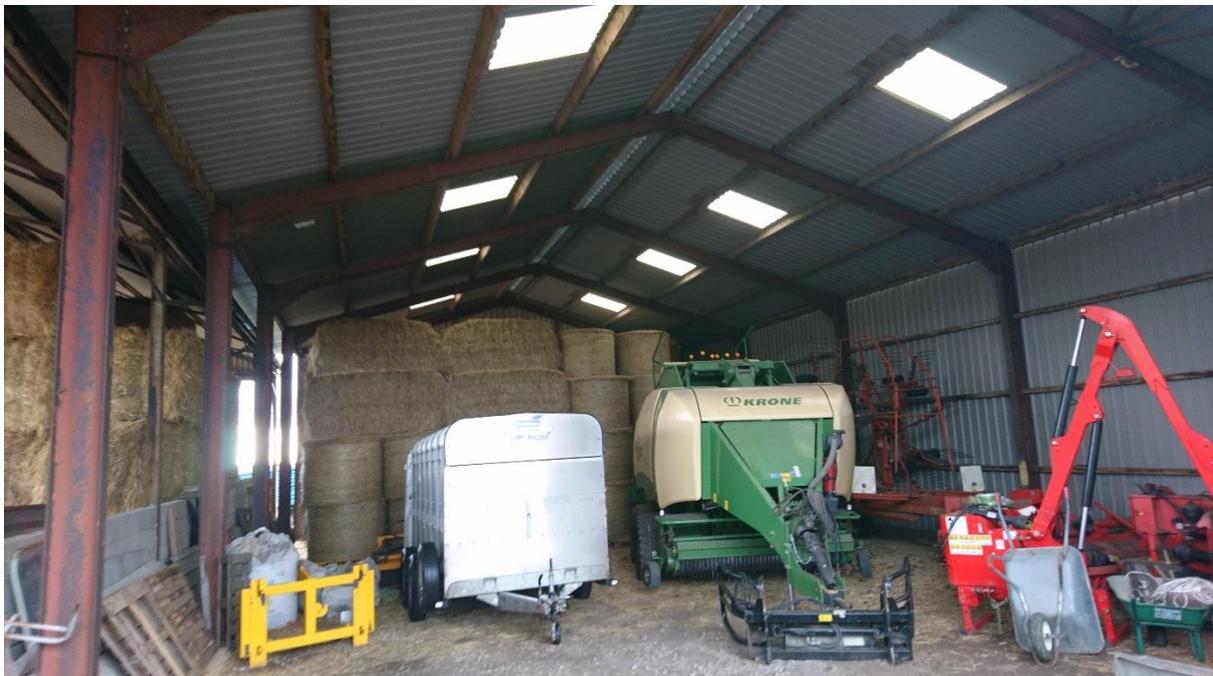
The timber purlins are in sound condition but are slender and the roof build-up should be carefully specified to avoid excessive stresses or damage to brittle internal finishes. Any timber to be retained should be inspected during works for decay and infestation by an expert.

The floor is a compacted dirt type which should clearly be upgraded to suit conversion to a dwelling.

Figure 6: Internal view of Barn1, noting the red painted steel portal frames, timber purlins, timber side rails, compacted dirt floor and an asymmetric provision of side cladding.

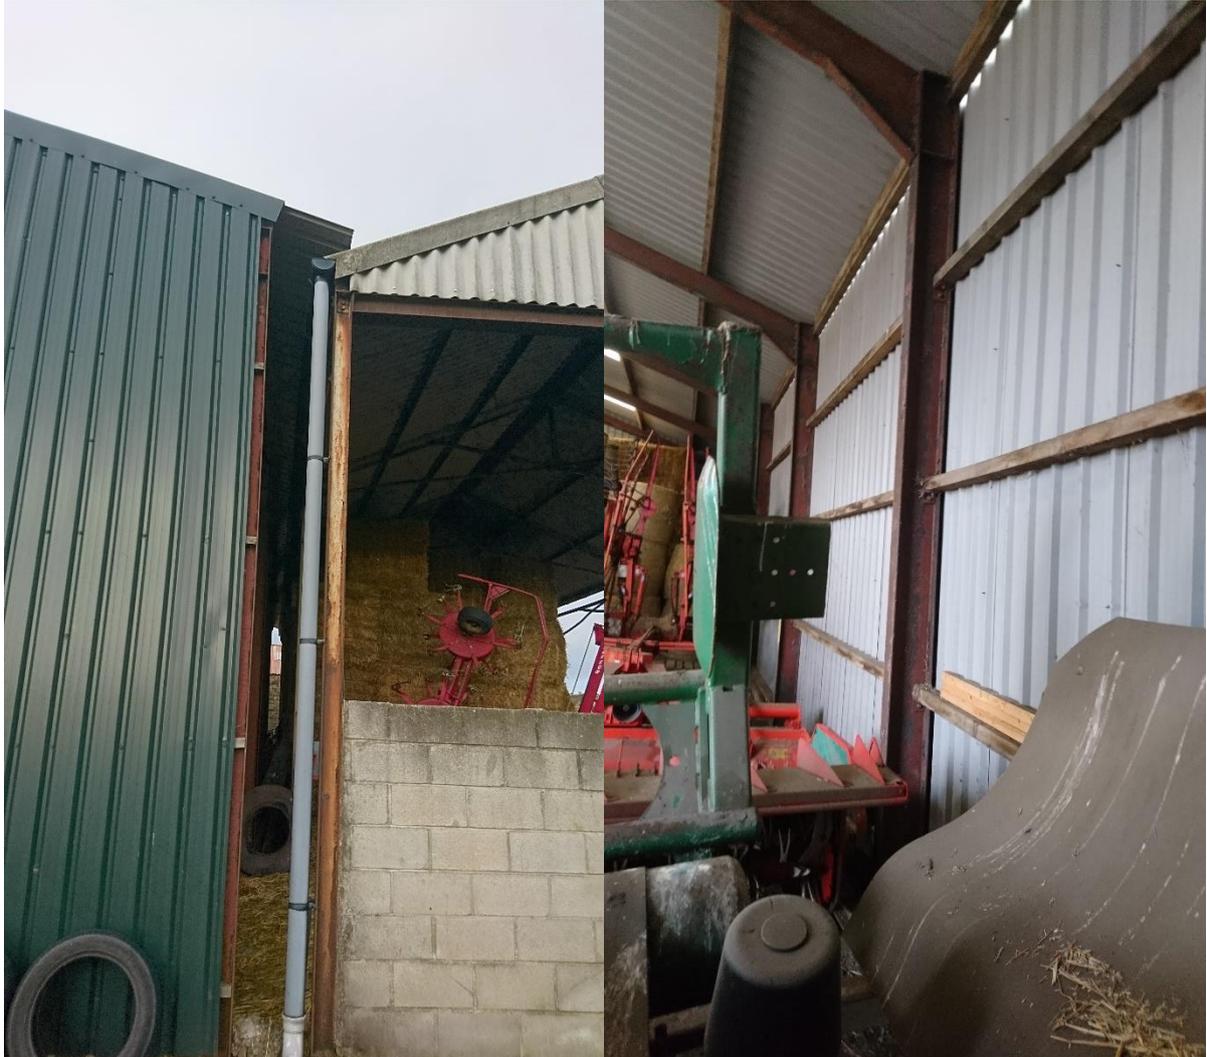
The beams have been connected at the eaves and apex with haunched moment-resisting bolted connections to develop the required portal frame behaviour.

Figure 7: Independence of Barn 1 from the adjacent barn structure (image LEFT), robust haunched eaves connections (image RIGHT).

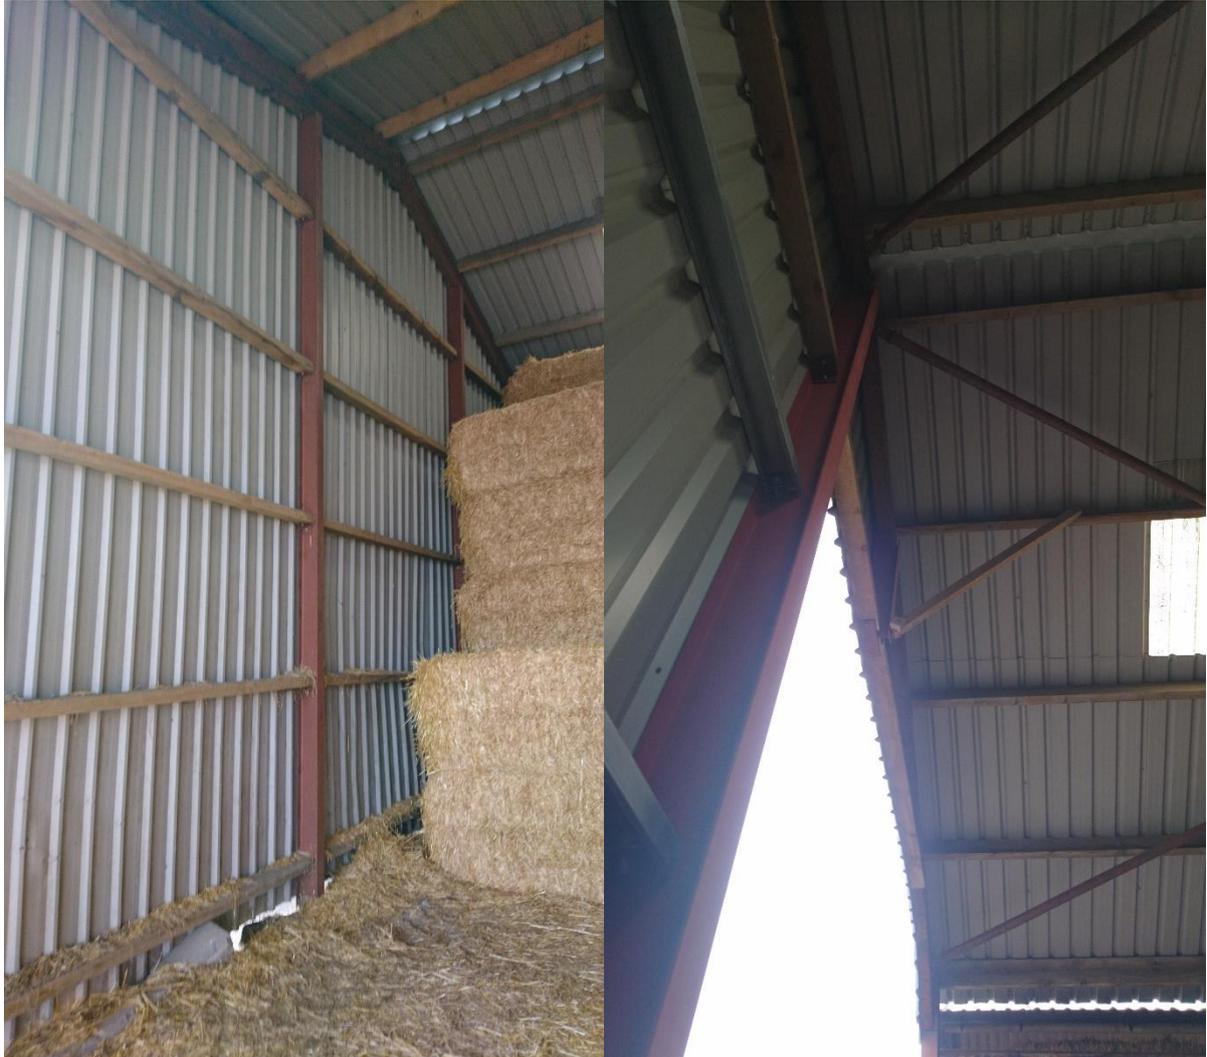
Barn 1 is a classical agricultural steel portal frame structure, formed of six portal frames formed from UB 254 x 146 x 31 beam elements. The gable frames have been provided with additional vertical members (two UB 178 x 102 x 19 at the south-eastern/rear gable and a single UB 203 x 133 x 25 at the north-western / front gable) to assist the installation of cladding. The primary steelwork has been painted with a red oxide finish and some light corrosion was observed.

Figure 8: internal view of the south-western (rear) gable framing (image LEFT) and the north-western gable framing (image RIGHT).
