Popeley Farm, Gomersall – BARN 2 Structural inspection for planning

Version: 1.0

Description: For client and planning approval.

Project: Popeley Farm
Client: Mr J. Clay
Description: Structural inspection
Date: 4th September 2023

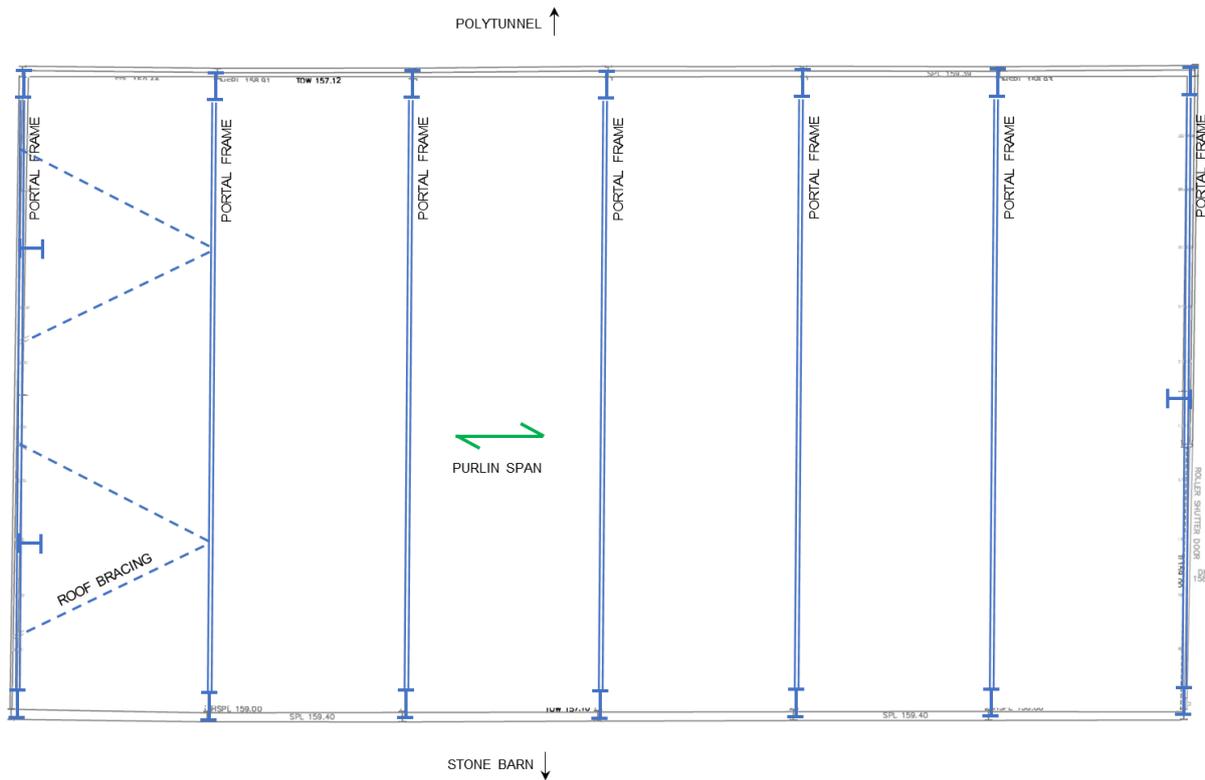
Figure 3: Barn 2 general structural arrangement (base image modified from MET Consultancy Group. original survey drawings)

Barn 2 is constructed around seven steel portal frames which are themselves composed of UB 254 x 146 x 31 columns and estimated UB 203 x 133 principal rafters of an unknown section weight. The primary steelwork has been painted with a red oxide finish and some light corrosion was observed.

Four steel rolled steel angle (RSA) braces have been provided in the roof to transfer wind loading from the gables to the main frames via the purlins and roof sheets. The main frames have not been formally braced in the longitudinal direction. Stability is provided to both side elevations by means of the concrete masonry dwarf walls which abut the webs of the steel columns (in lieu of steel bracing).

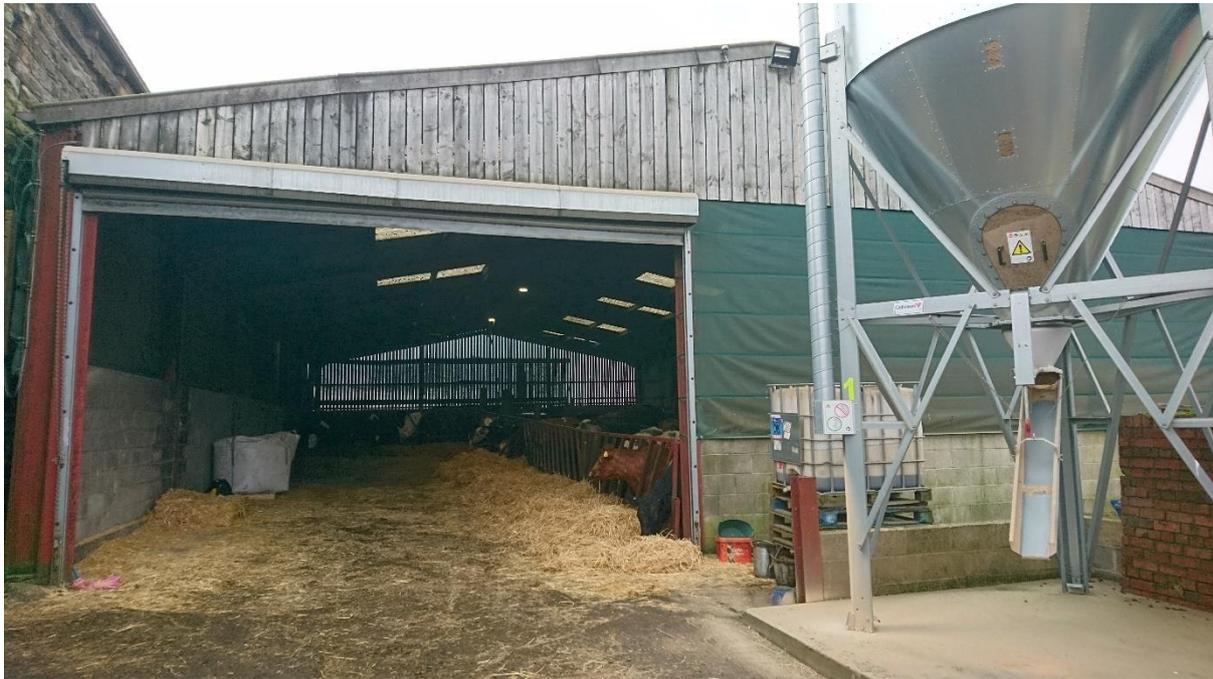
The north-eastern (front) gable features a steel column (UB 254 x 146) directly underneath the ridge which divides the gable into two halves. One half has been built with a dwarf wall in the same fashion as noted for the other walls with light mesh screening to eaves level and then timber Yorkshire boards from eaves level to the roof slope above. The other half of the gable features a large opening with steel framing for the roller shutter door.

Figure 4: External view of the north-eastern (front) elevation of barn 2.

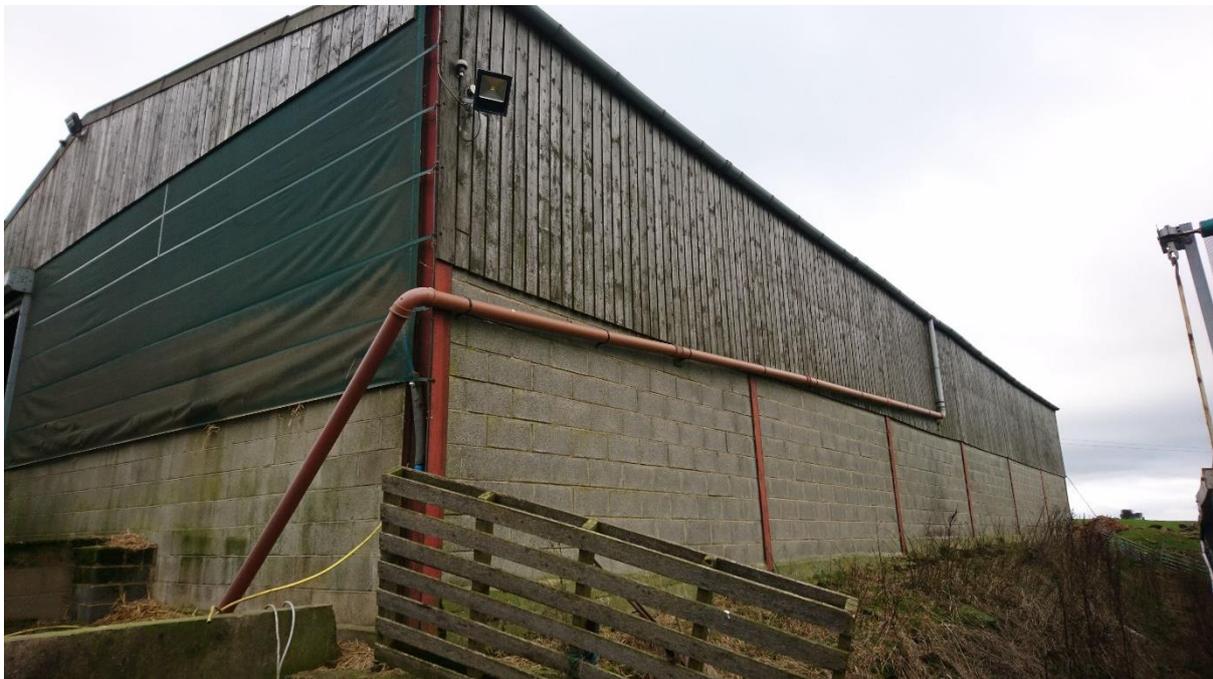
The south-western gable has been provided with two smaller (UB203 x 133) posts to support the cladding.

Figure 5: External view of the south-western elevation of barn 2.

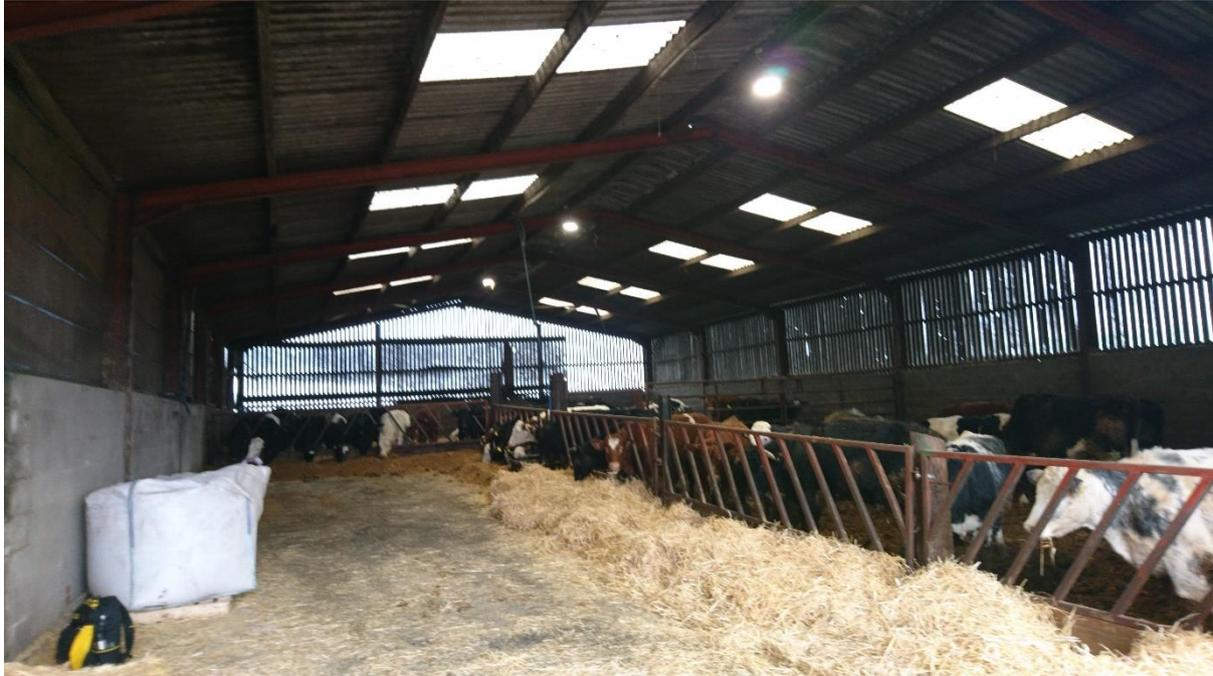
Figure 6: Typical internal view of Barn 2.

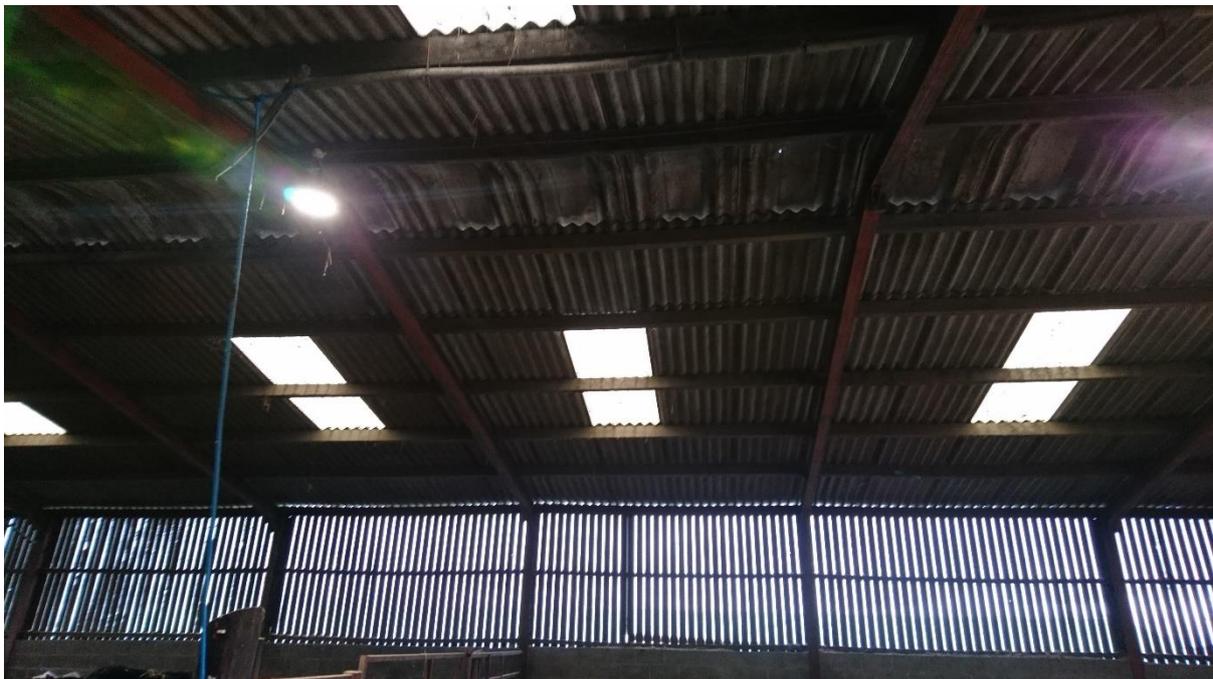
The roof over Barn 2 is a profiled cement fibre sheet system with a large proprietary ventilated ridge supported from timber purlins, which themselves bear onto the primary steel portal frames. The composition of the roof sheets is unknown and should be inspected and tested for asbestos prior to stripping works.

The timber purlins appear to be in sound condition (from distant inspection) but are slender and the roof build-up should be carefully specified to avoid excessive stresses or damage to brittle internal finishes. Any timber to be retained should be inspected during works for decay and infestation by an expert.

Figure 7: Internal view of the roof structure in barn 2

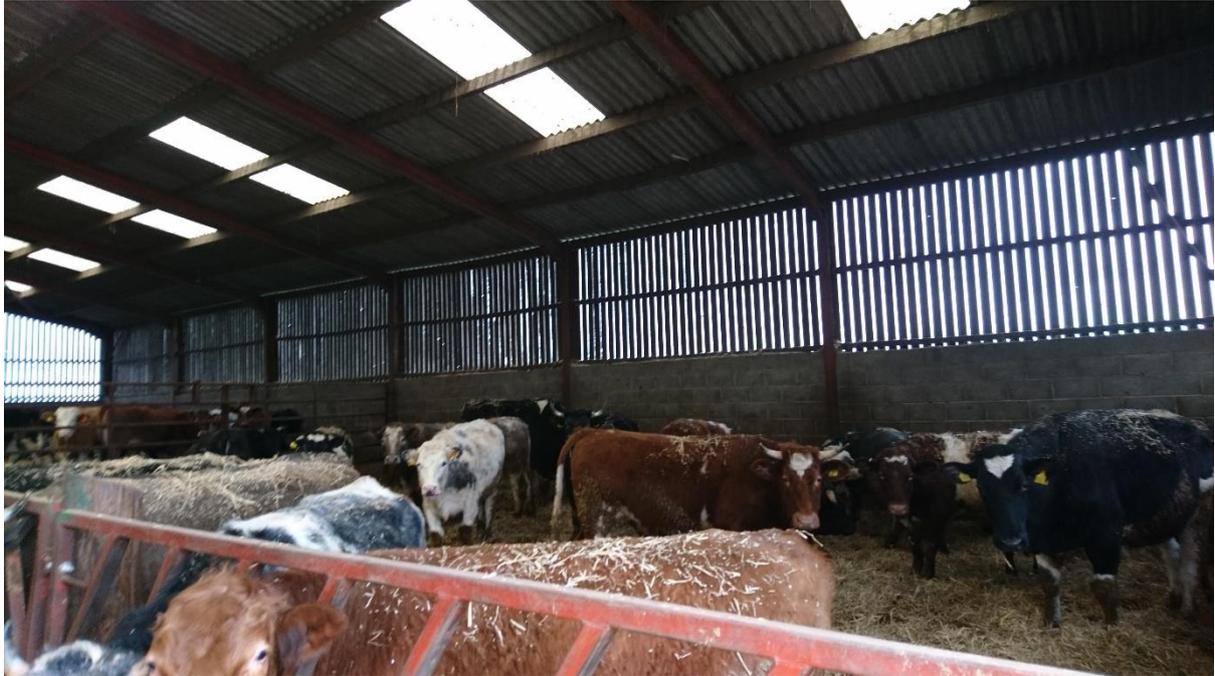
The walls have been formed in two sections, the lower dwarf walls are constructed from 215mm thick shell bedded hollow concrete blocks laid in cement mortar, and above this timber Yorkshire boarding has been provided to the roof line.

The masonry has not become cracked or otherwise distressed and therefore it can be concluded that this arrangement has provided sufficient stability to date and the addition of further material to infill the bays such that a weather tight envelope can be formed for the proposed dwelling will provide further stability.

Figure 8: Internal view of the timber Yorkshire board cladding and masonry dwarf walls in Barn 2.

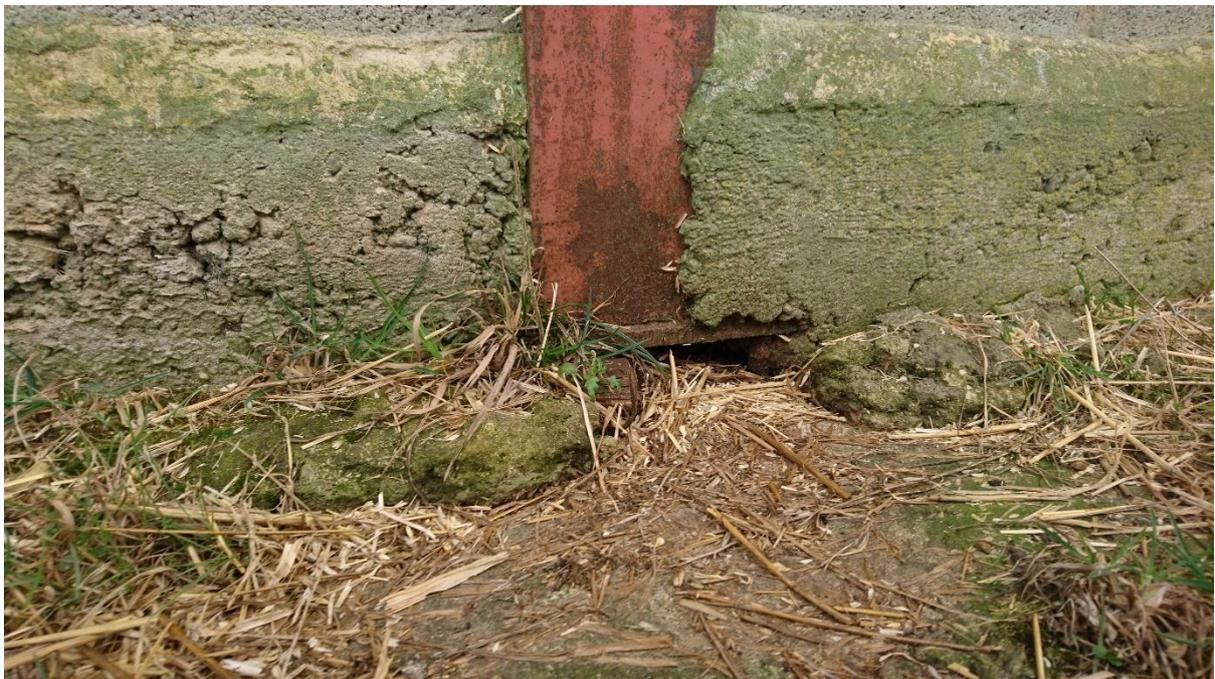
The exposed top edges of the pad foundations means that the base plate connections of the steel frames to the pads are also visible. One particular location indicates that the base plates have not been properly grouted after shimming/levelling under the column base plates and it is recommended that all base plates are grouted during works to provide an efficient transfer of load to the foundation.

Figure 9: Un-grouted base plate.

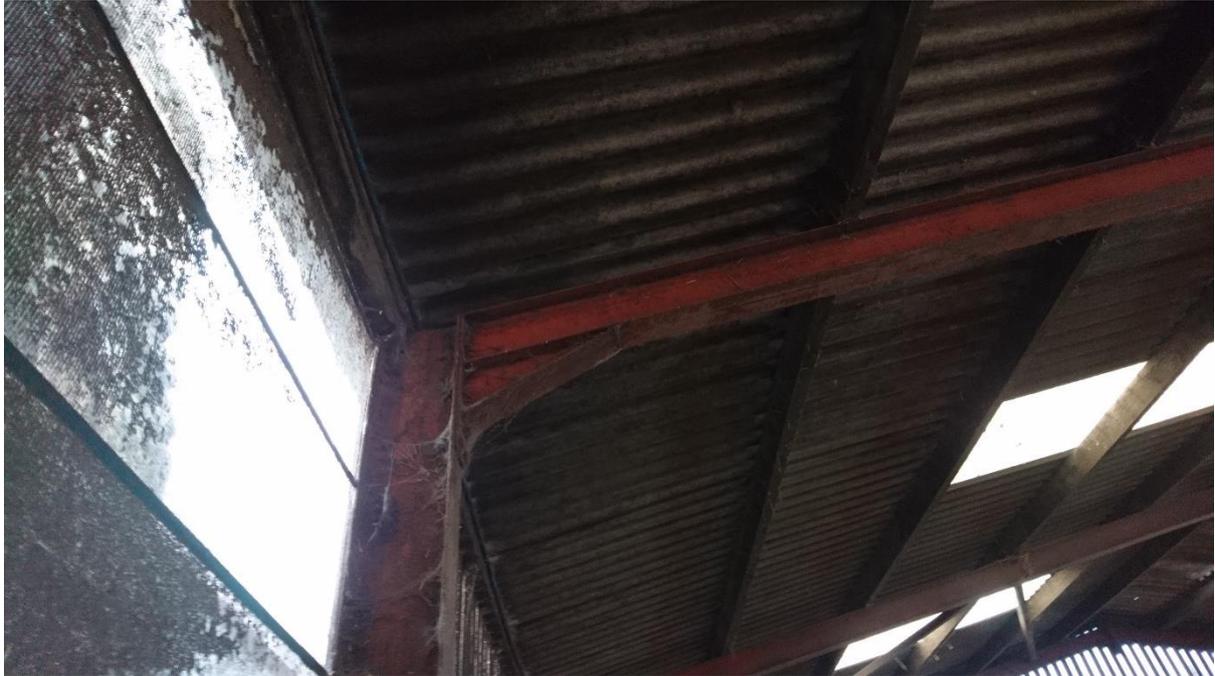
The beams have been connected at the eaves and apex with haunched moment-resisting bolted connections to develop the required portal frame behaviour.

Figure 10: Haunched eaves connection and mesh screen above the masonry dwarf wall internally on the south-eastern elevation.

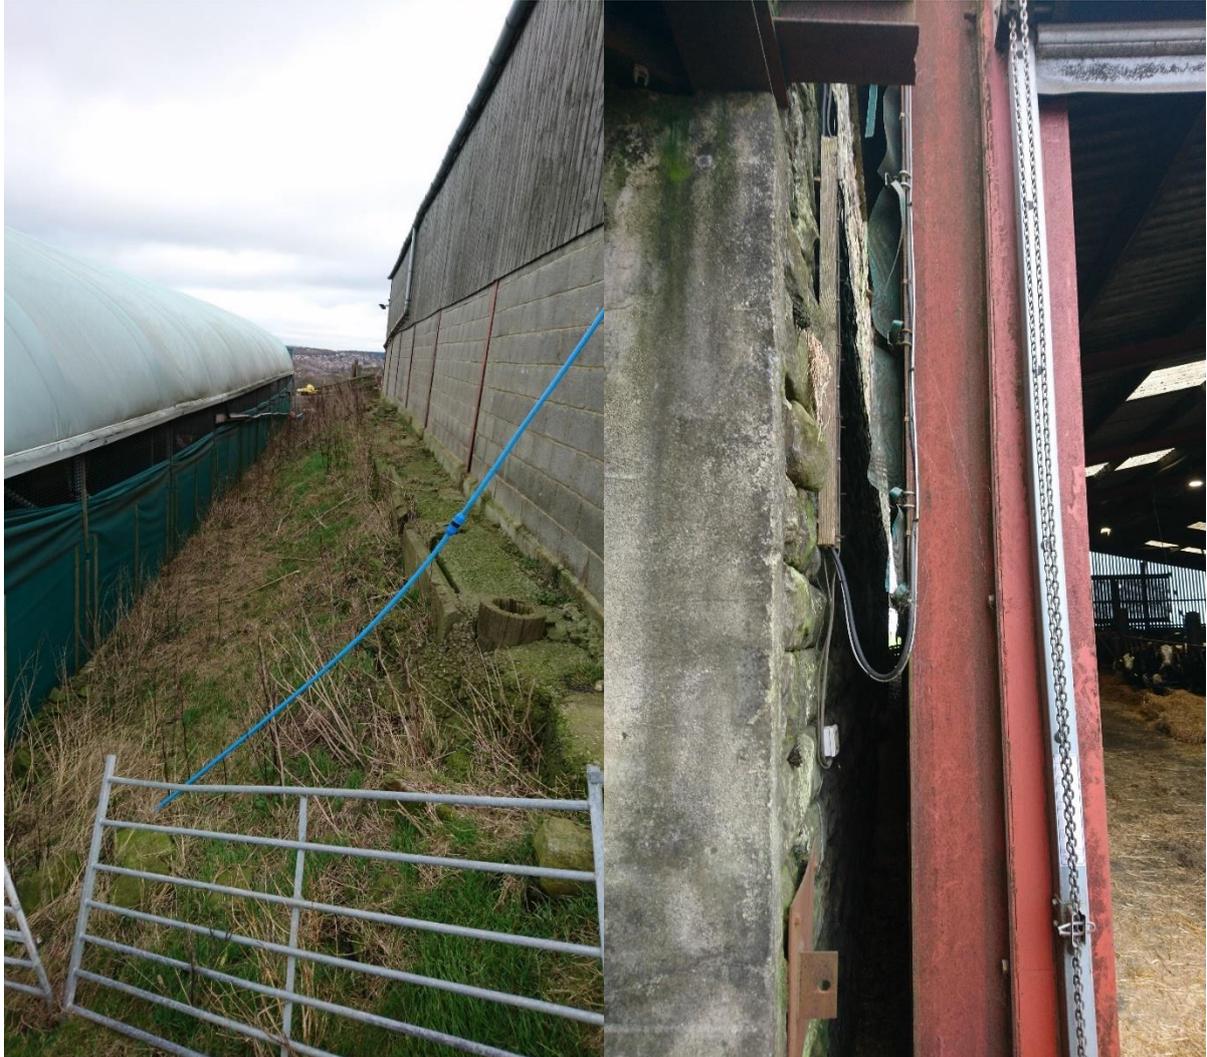
The foundations to the north-western elevation are situated close to the top of a step down in ground levels. This step down has been left as a slope. Checks on the depth and hence the long-term stability of these foundations should be made and these foundations underpinned to the base of this slope or the frames tied at their base if necessary during works to mitigate against the possibility of the foundations moving down this slope over the longer term under the outward thrust developed by the portal frame action at their base.

Figure 11: Sloping ground at a change in levels on the north-western elevation. Note the slightly larger footprint and cropped timber and steel columns of a previous structure (image LEFT), Structural independence of Barn 2 and the adjacent masonry structure (image RIGHT).

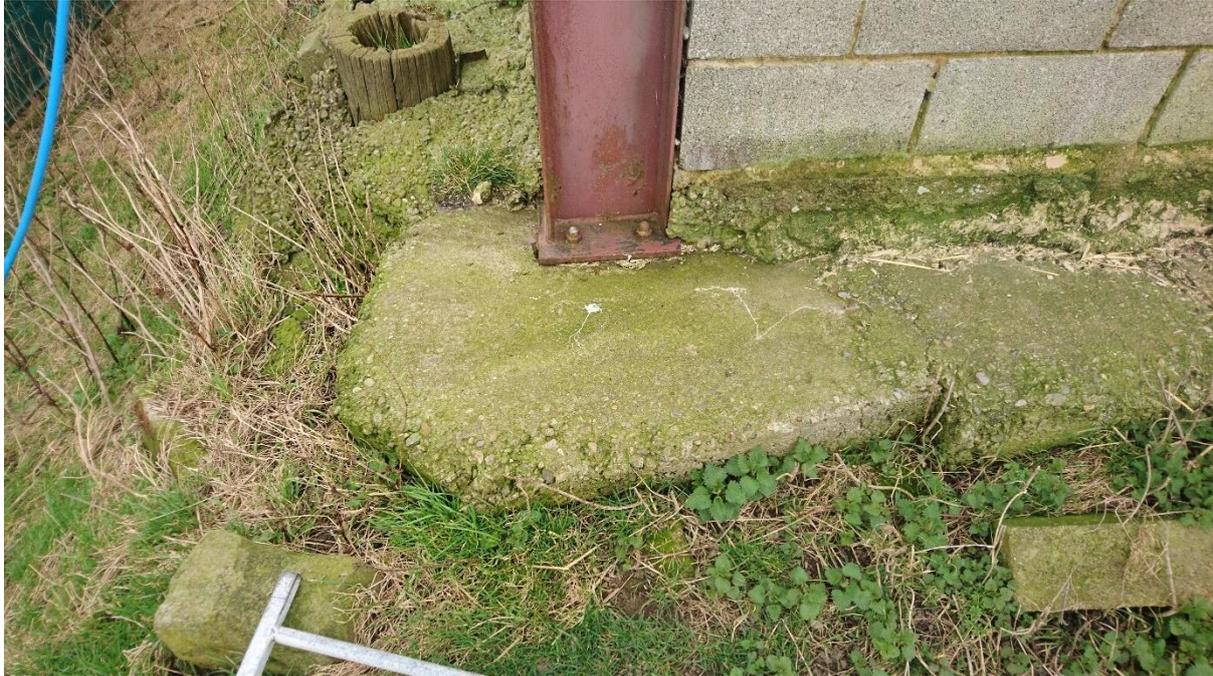
The foundations were not exposed for inspection, but some of the concrete pads are exposed and are visible. It is not immediately clear whether these concrete pads are the original provision to the barn which stood on this site previously, are purpose built or a combination of the two.

Figure 12: Exposed pad foundation at the western corner, possibly a new purpose-built provision.

The depth of these foundations is unknown and should be checked in relation to modern recommended minimums during works.

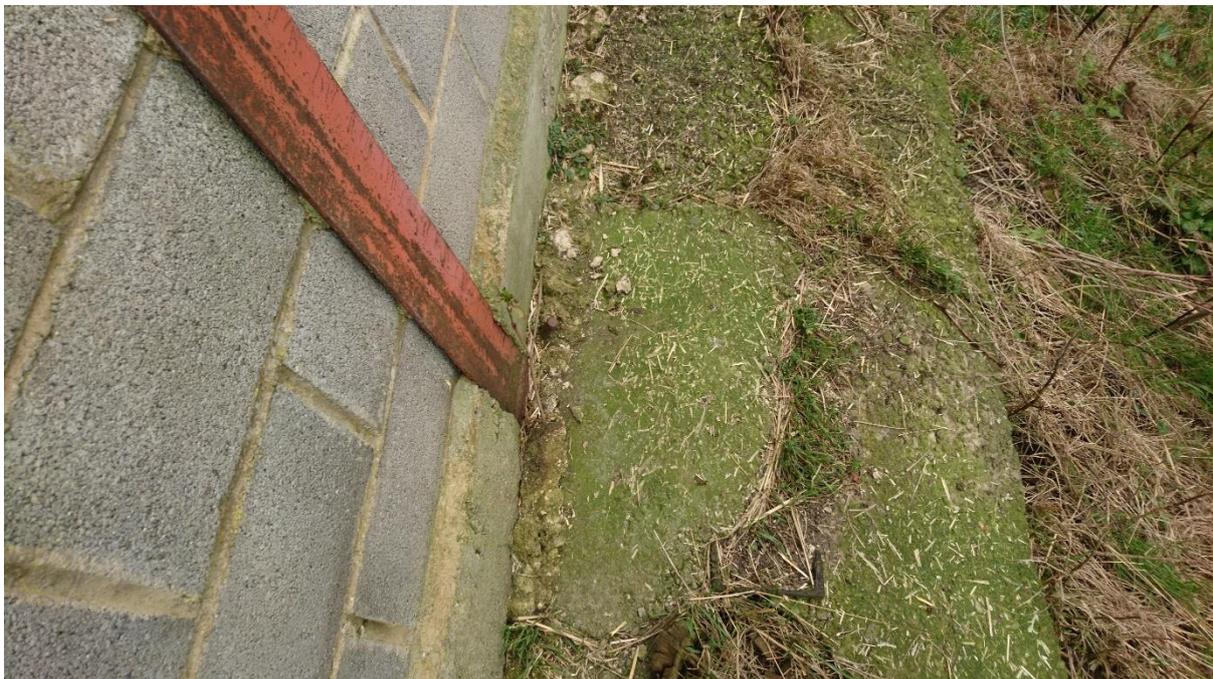
Figure 13: Exposed pad foundation at the north-western elevation, noting the cropped steel channel – possibly indicating that this pad is a reused provision.
