Tree Survey, Condition & Management Report

Oakroyd Hall
Bradford Road
Birkenshaw
West Yorkshire
BD11 2DY

ALLERTONOAKROYD

13th April 2023

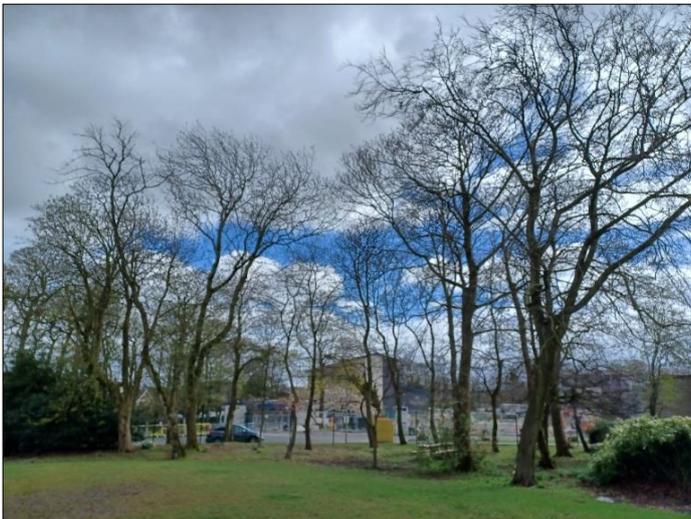
Figure 2: View from South Side of Site Towards Oakroyd Hall

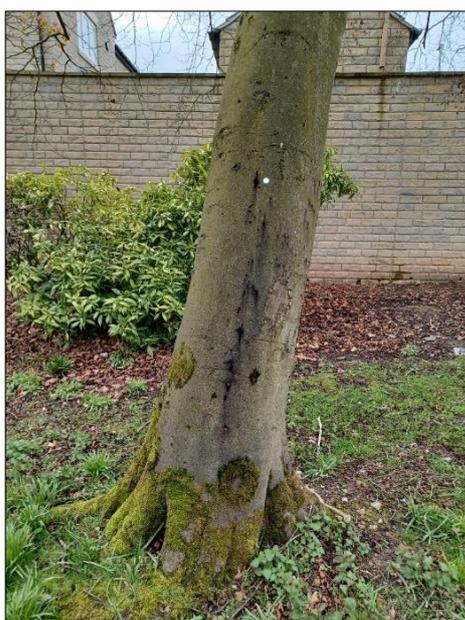
Several of the trees across the site are exhibiting signs of physiological stress, manifesting as apical die-back and “bleeds” on the stem.

This is possibly due to construction damage sustained by the trees, and / or changes in the soil and rooting environment, at the time of development.

Figure 3: Beech Showing Signs of “Bleeds” on Stem

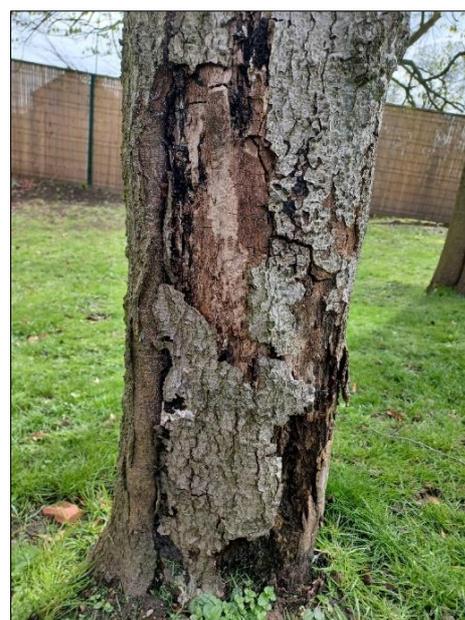
Figure 4: Brittle Cinder Fungus on Stem of Beech T15

T15	215	Beech	8	240	4	Y	Poor	· Apical die back	· Small / sparse	· Increase in soil level	· Fungus or decay · Bark wounds · <i>Kretzschmaria deusta</i> present in stem wound	· Fell · Replant Space	1 year
T17	217	Hawthorn	7	220	3	M	Fair	· Minor dead wood · Damage / wounding	· Normal	· Increase in soil level	· Multi stemmed	· Remove major dead wood	2 Years
T18	218	Beech	16	650	12	M	Fair	· Minor dead wood · Major dead wood	· Normal	· Increase in soil level	· Old pruning wounds · Stress marks · Slime flux	· Remove major dead wood	2 Years
