**1092 – 35 Church Lane  
Clayton West**

**BS 5837:2012 Arboricultural  
Report, Impact Assessment  
and Method Statement**

**October 2024**

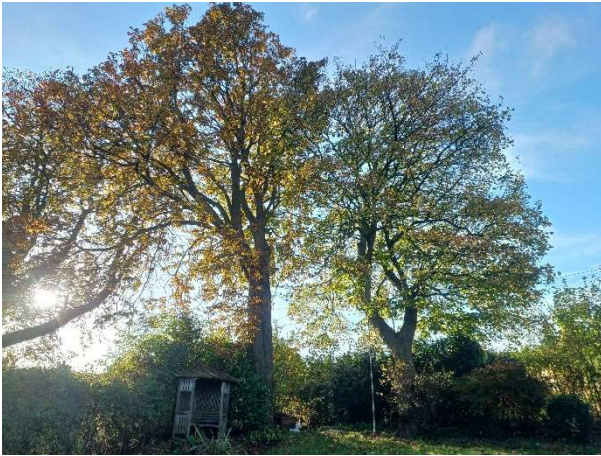
- 4.5 The survey recorded 3 individual trees, 1 tree group and 1 hedgerow.
- 4.6 The sycamore (T001) was a fine example of the species with good future prospects. The lack of human intervention in the trees' development has allowed it to grow relatively undisturbed and has not allowed for the ingress of decay or dysfunction into the tree's vascular system.

- 4.7 The horse chestnut, (T002) although large and impressive, had long helical cracking on the stem, with exposed bark in areas. Although this is normal for the species it can be a possible means of ingress for dysfunction. In addition to this, there were several large historical pruning wounds at various points on the stem.

**Photo 1:** T001 and T002 from the north

- 4.8 Due to this, irrespective of any future Site development, it would be advisable to remove significant deadwood from the crown, and for a safety assessment to be carried out for this tree by a suitably qualified and experienced arboricultural professional.

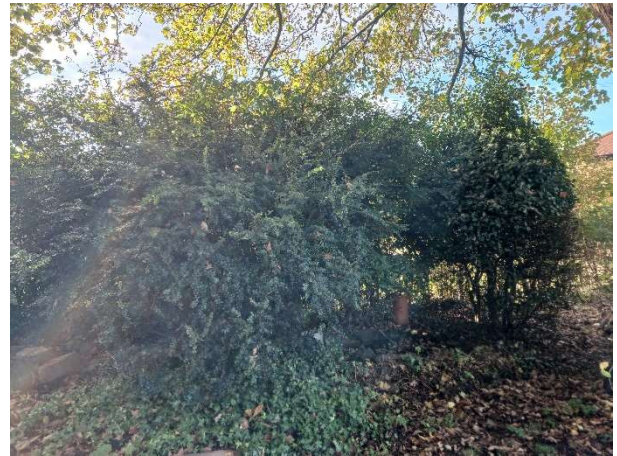
5.6 The western extent of G003 currently encroaches approximately 1.5m into the location of the new carport. This group will need to be cut back by 1.7m to allow for the construction of the carport.

**Photo 4** G003 from the east

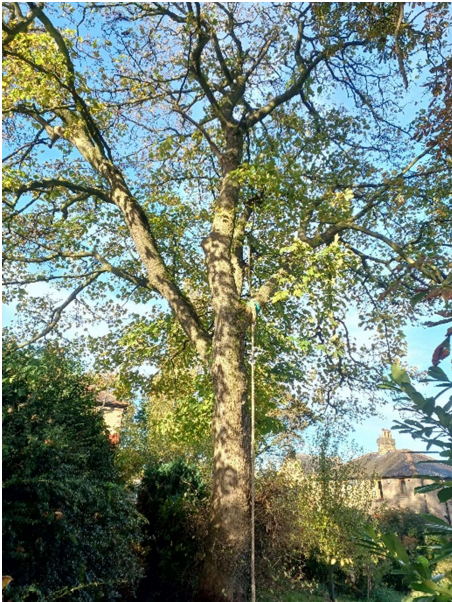
**Photo 2:** T001, from the east

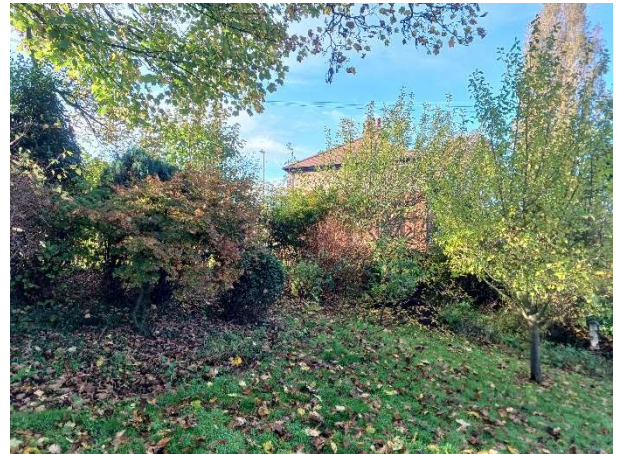
5.4 The design proposals indicate that the low value apple tree (T004), along with particularly small sections of G003 and H005, will need to be removed to facilitate the development, as they are situated in the footprint of the proposed driveway.

**Photo 5:** T004 and surrounding shrubs from the north east.

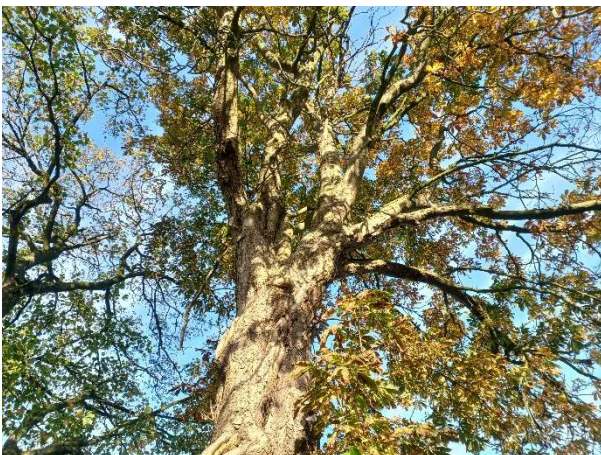
**Photo 3:** T003 from the south

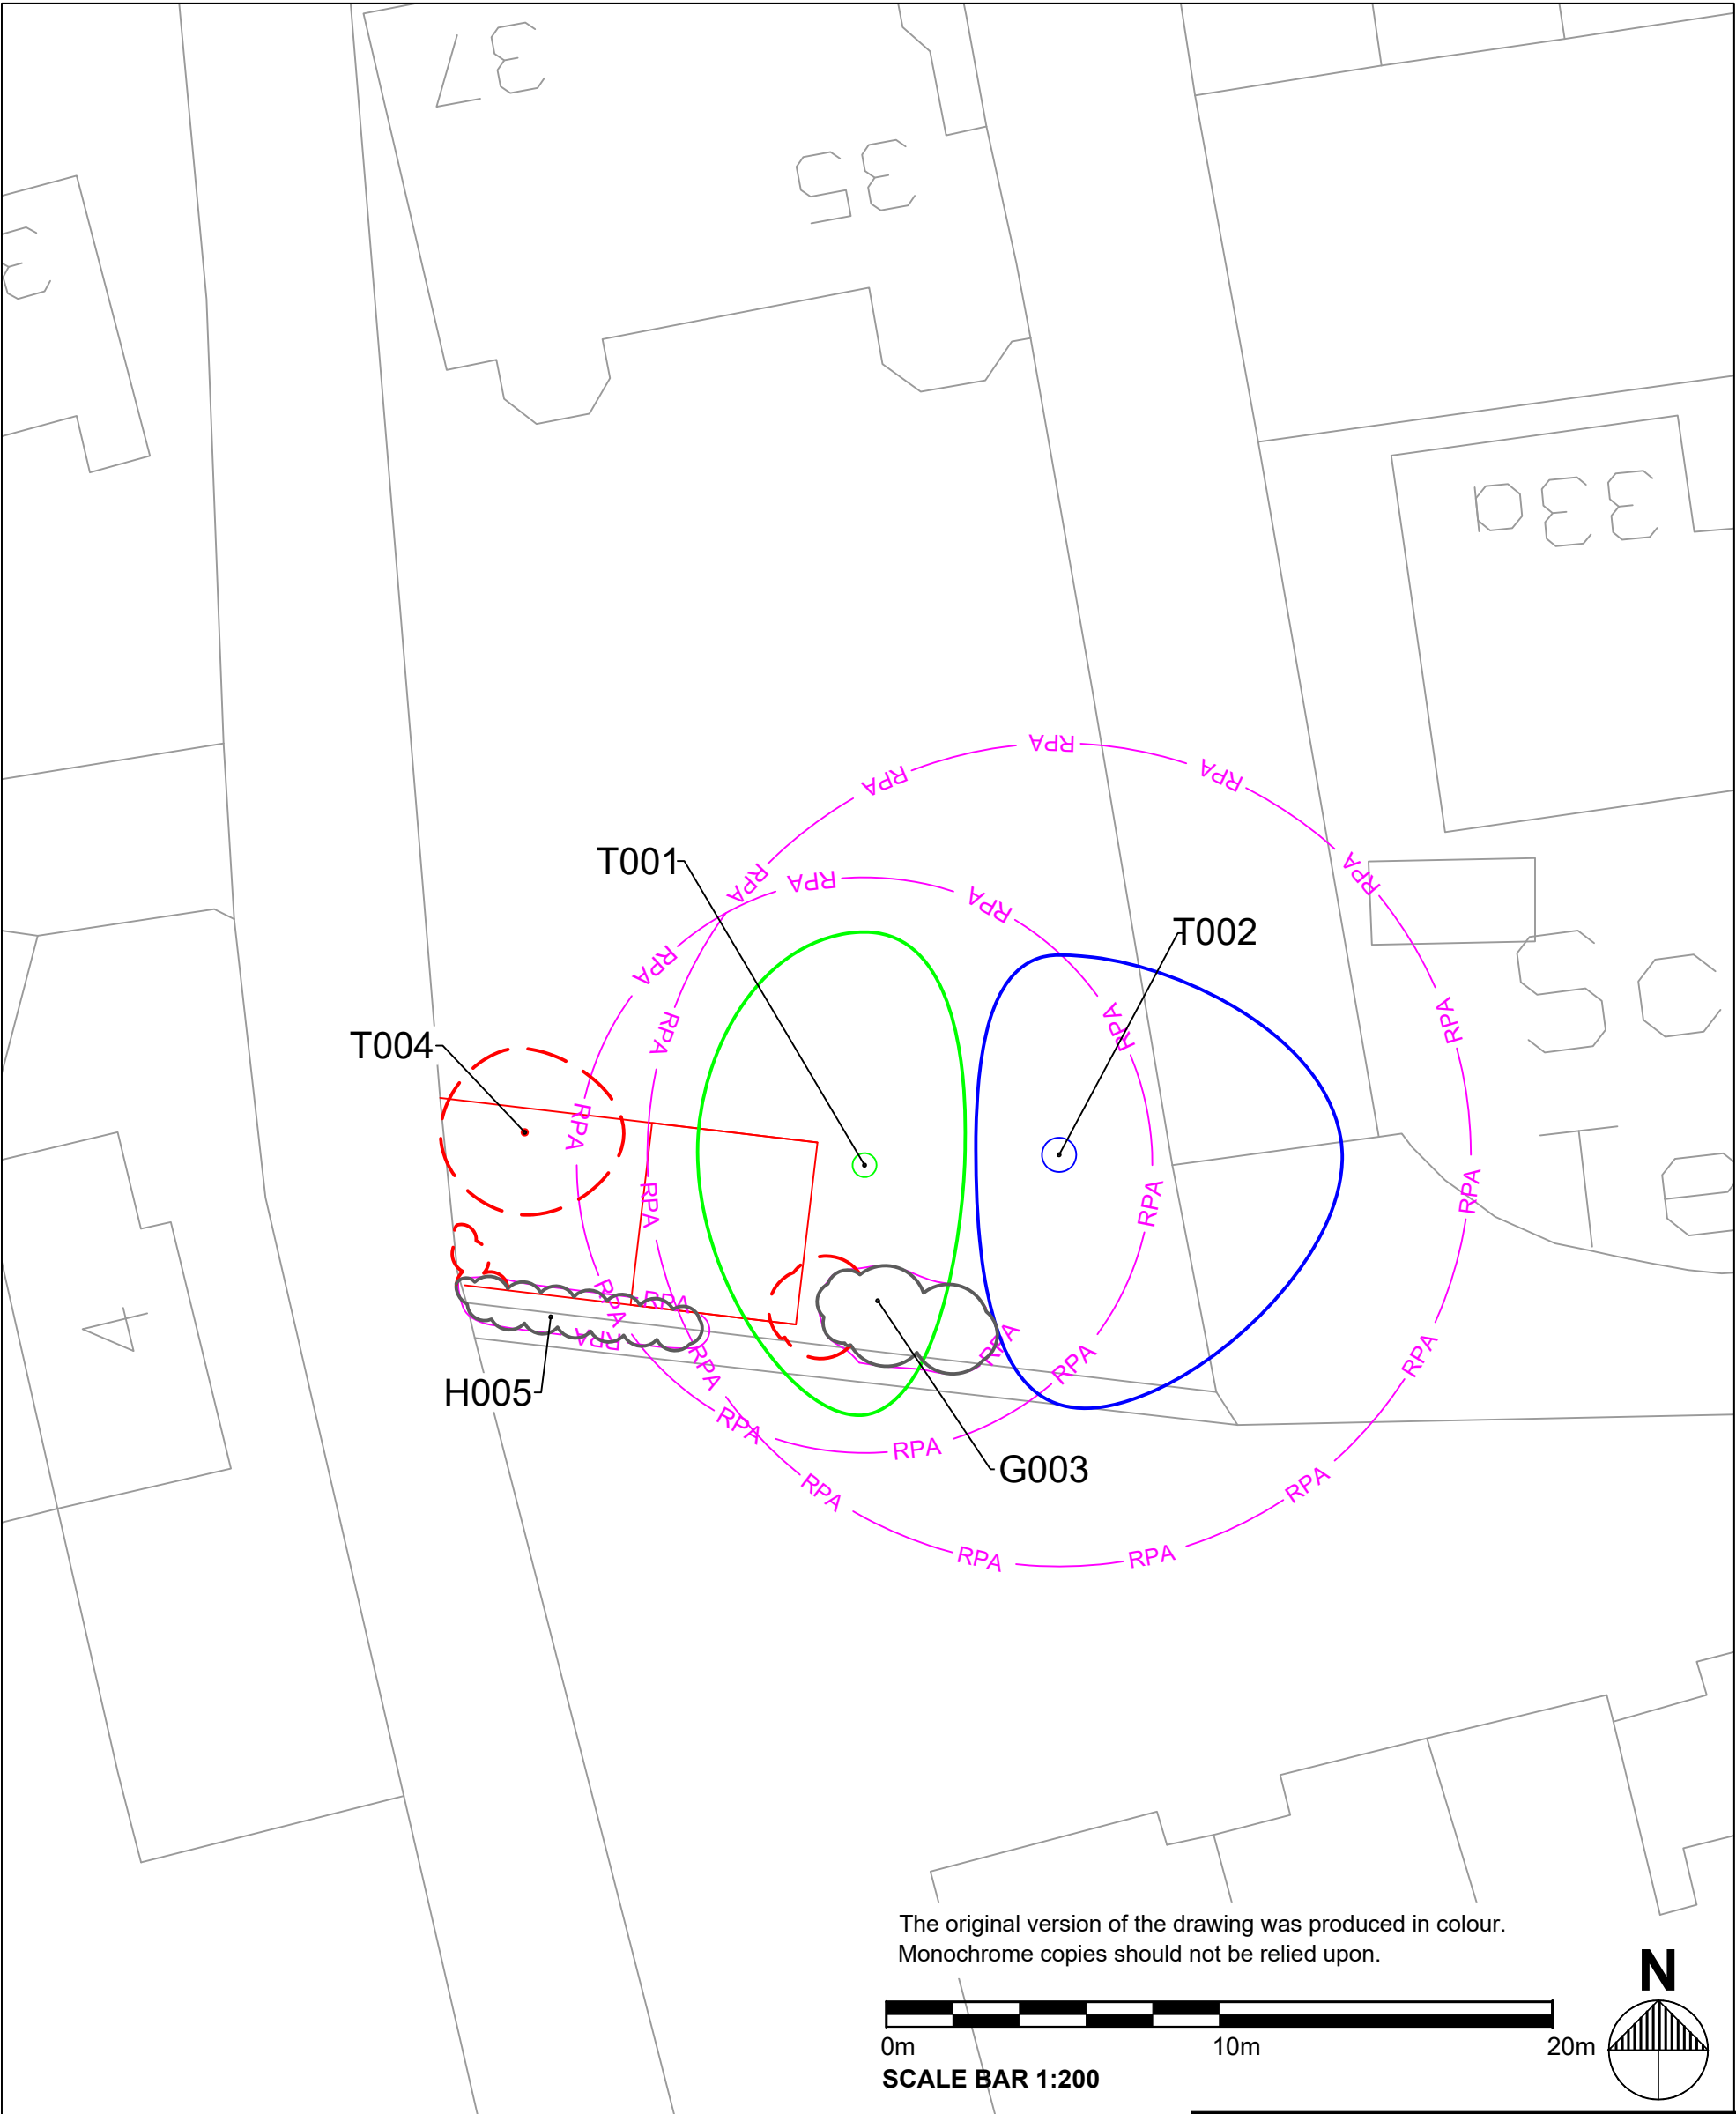
Figure 3 - Tree Impacts Plan

- 5.13 Construction of the new driveway and carport is proposed within the RPA of the retained trees T002 and T003, as shown on the Tree Impacts Plan at Appendix 3.

- 5.14 The potential impacts this may have on tree roots likely to be present in this area can be overcome through the use of specialist construction techniques such as an above ground Cellular Confinement System for the driveway and the use of screw piles to support the posts for the carport.

- 5.15 Due to the particularly close proximity of the northeastern carport post to the stem of T002, it is recommended that a trial pit is dug in this location to ensure that there are no significant roots likely to be damaged by the screw pile here. This should be carried out using hand tools only and under the supervision of the project arboriculturist.

- 5.16 If significant roots are found in this location, it may be necessary to slightly adjust the location of the car port to avoid root damage.
- 5.17 Due to the height and extent of the tree canopy in the direction of the proposed carport, there is not a significant potential for tree branches to be impacted during the construction works.
