Arboricultural Tree **Inspection Report**

RELIANCE PRECISION LTD

Rowley Mills

Date: 24th March 2024

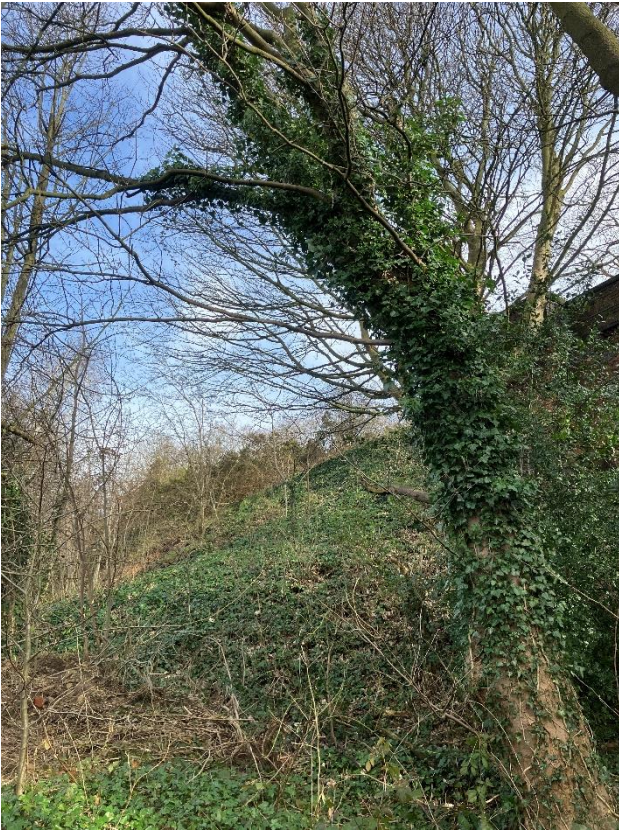
PHOTO 1 – TREE 1 – SYCAMORE

| Tree No. | SPECIES | COMMENTS | RECOMMENDATIONS | PRIORITY |
|---|---|---|--|---|
| T1 | SYCAMORE | HEAVILY LEANING TOWARDS BUILDING / IVY PRESENT (PHOTO 1) | FELL | L |

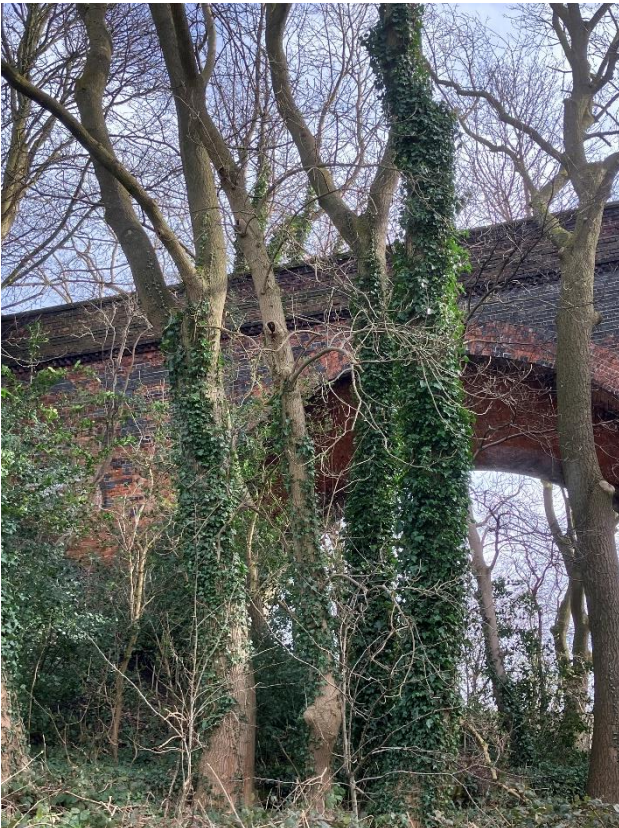
PHOTO 2 – TREE'S 2, 3, 4 & 5 – ASH

| Tree No. | SPECIES | COMMENTS | RECOMMENDATIONS | PRIORITY |
|---|---|---|--|---|
| T2 | ASH | ASH DIEBACK CATEGORY 3 (PHOTO 2) | FELL | H |
| T3 | ASH | ASH DIEBACK CATEGORY 1 / TREE SUPPRESSED (PHOTO 2) | FELL | M |
| T4 | ASH | ASH DIEBACK CATEGORY 3 (PHOTO 2) | FELL | H |
| T5 | ASH | ASH DIEBACK CATEGORY 3 (PHOTO 2) | FELL | H |

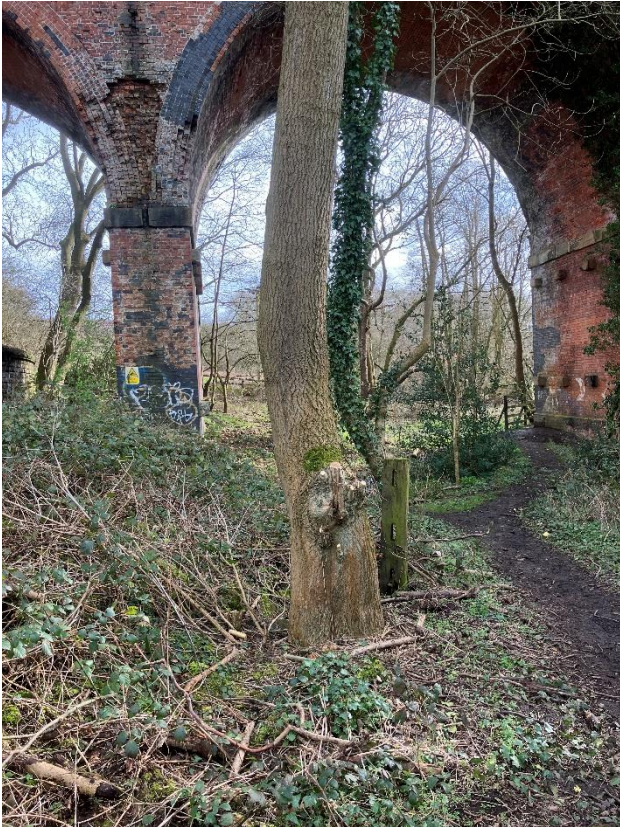
PHOTO 3 – TREE 6 – ASH

| Tree No. | SPECIES | COMMENTS | RECOMMENDATIONS | PRIORITY |
|---|---|---|--|---|
| T6 | ASH | ASH DIEBACK CATEGORY 3 (PHOTO 3) | FELL | H |

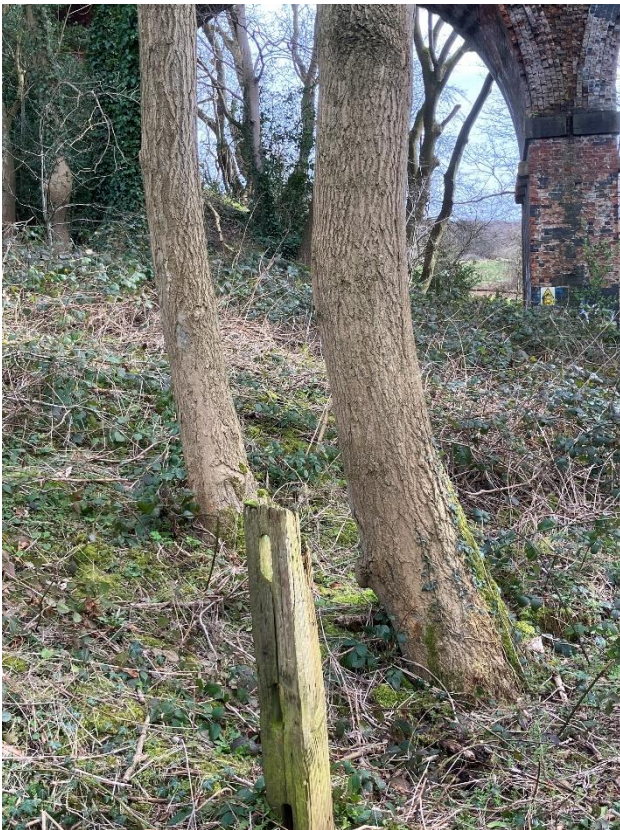
PHOTO 4 – TREE'S 7 & 8 – ASH

| Tree No. | SPECIES | COMMENTS | RECOMMENDATIONS | PRIORITY |
|---|---|---|--|---|
| T7 | ASH | ASH DIEBACK CATEGORY 3 (PHOTO 4) | FELL | H |
| T8 | ASH | ASH DIEBACK CATEGORY 3 (PHOTO 4) | FELL | H |

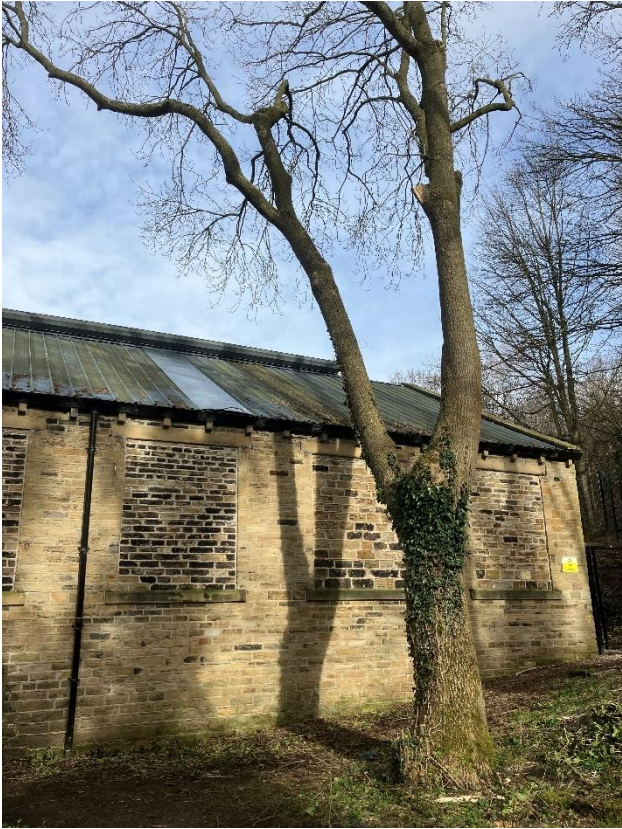
PHOTO 5 – TREE 9 – ASH

| Tree No. | SPECIES | COMMENTS | RECOMMENDATIONS | PRIORITY |
|---|---|---|--|---|
| T9 | ASH | ASH DIEBACK CATEGORY 1 (PHOTO 5) | FELL | H |

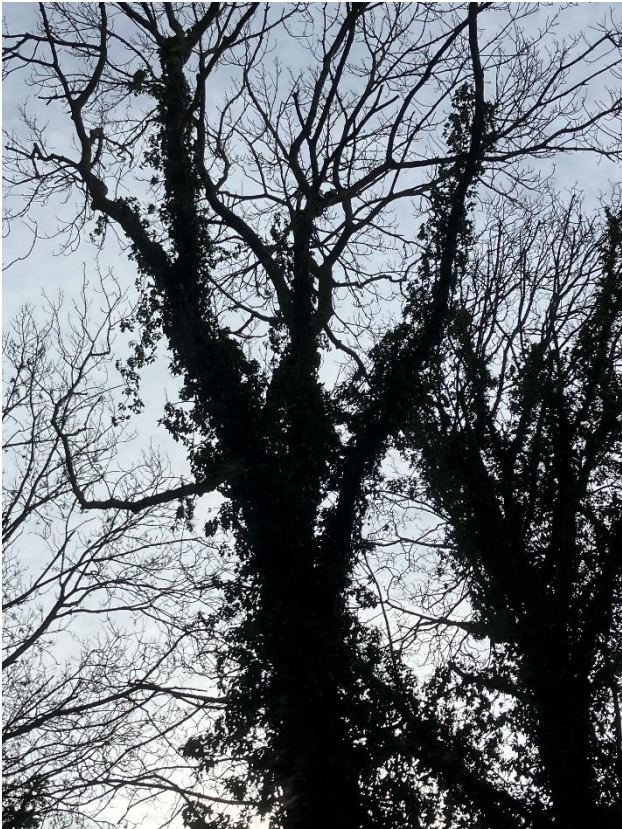
PHOTO 6 – TREE 10 - ASH

| Tree No. | SPECIES | COMMENTS | RECOMMENDATIONS | PRIORITY |
|---|---|---|--|---|
| T10 | ASH | ASH DIEBACK CATEGORY 1 (PHOTO 6) | FELL | M |

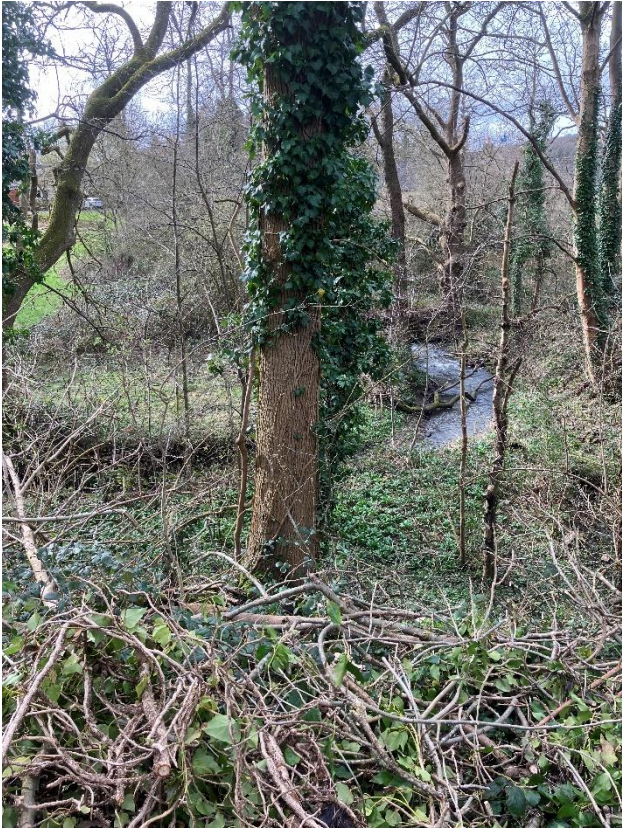
PHOTO 7 – TREE 11 – ASH

| Tree No. | SPECIES | COMMENTS | RECOMMENDATIONS | PRIORITY |
|---|---|---|--|---|
| T11 | ASH | ASH DIEBACK CATEGORY 2 (PHOTO 7) | FELL | M |

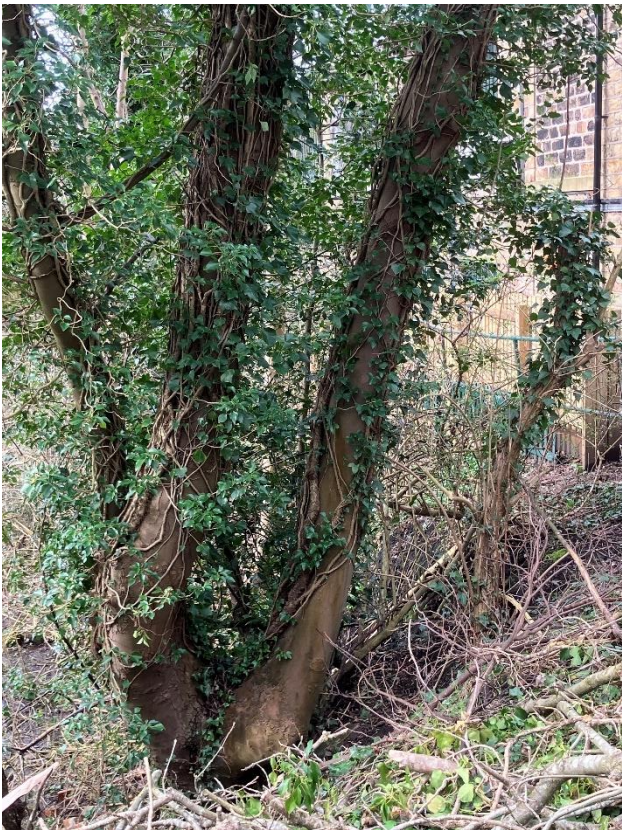
PHOTO 8 – TREE 12 – SYCAMORE

| Tree No. | SPECIES | COMMENTS | RECOMMENDATIONS | PRIORITY |
|---|---|---|--|---|
| T12 | SYCAMORE | MULTI STEMMED / LEANING TOWARDS BUILDING / IVY PRESENT (PHOTOS 8 & 9) | FELL | M |

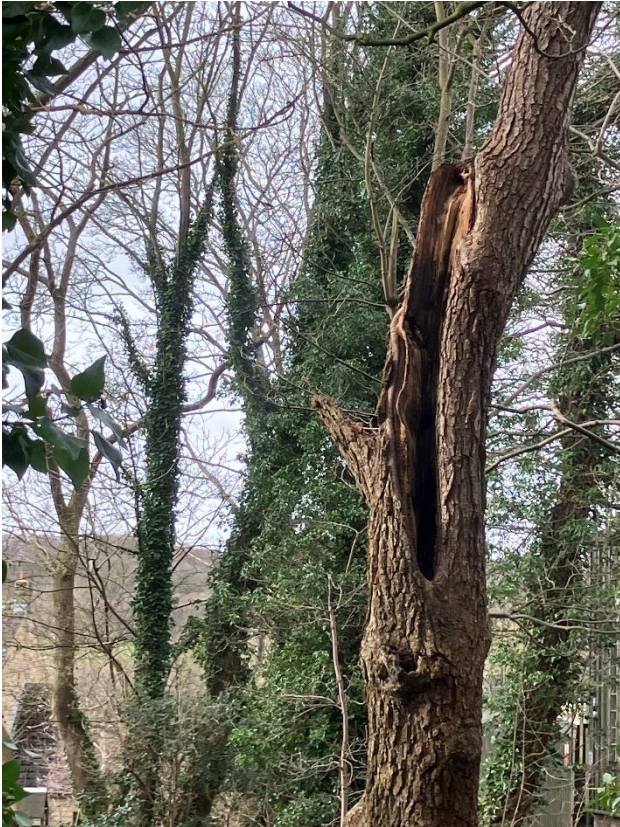
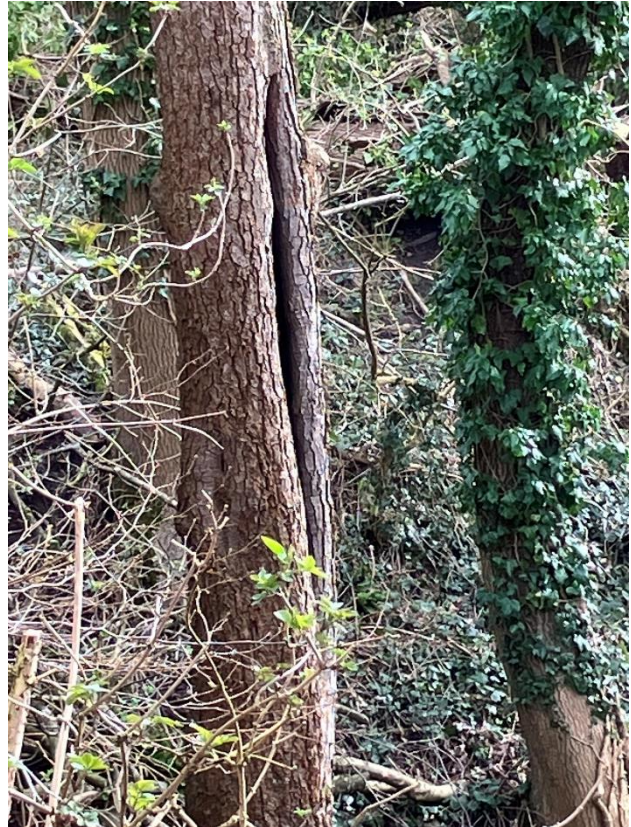
PHOTO' 9 & 10 – TREE 13 – ALDER

| Tree No. | SPECIES | COMMENTS | RECOMMENDATIONS | PRIORITY |
|---|---|---|--|---|
| T13 | ALDER | MAJOR CAVITIES IN TRUNK (PHOTOS 10 & 11) | FELL | H |

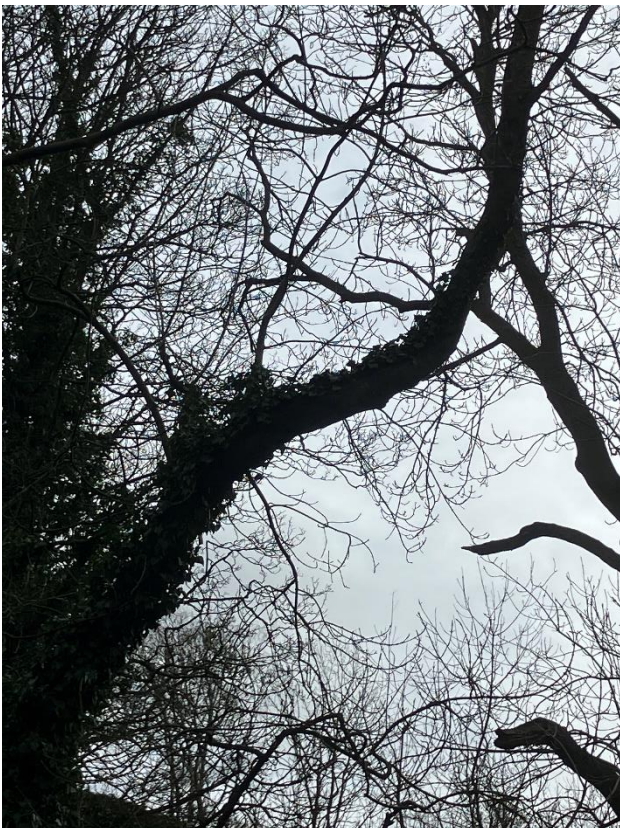
PHOTO 11 – TREE 14 - ASH

| Tree No. | SPECIES | COMMENTS | RECOMMENDATIONS | PRIORITY |
|---|---|---|--|---|
| T14 | ASH | ASH DIEBACK CATEGORY 1 (PHOTO 12) | FELL | L |

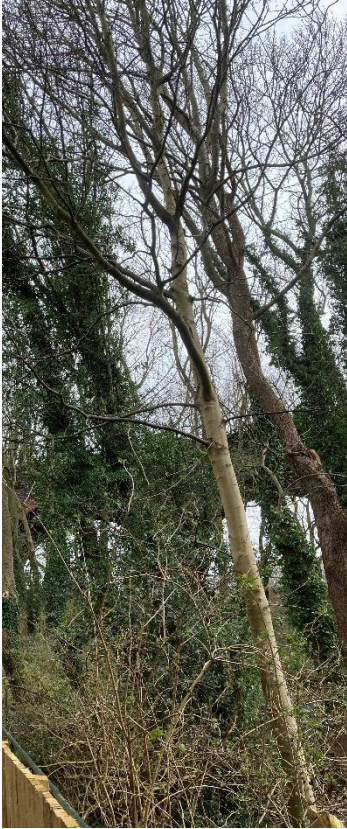
PHOTO 12 – TREE 15 – SYCAMORE

| Tree No. | SPECIES | COMMENTS | RECOMMENDATIONS | PRIORITY |
|---|---|---|--|---|
| T15 | SYCAMORE | YOUNG TREE / CLOSE TO BUILDING (PHOTO 13) | FELL | L |

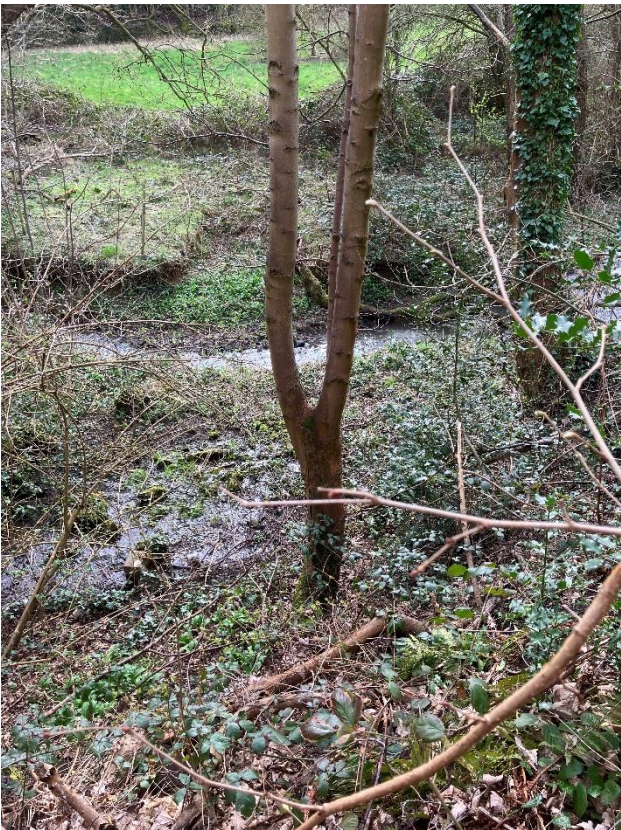
PHOTO 13 – TREE 16 - SYCAMORE

| Tree No. | SPECIES | COMMENTS | RECOMMENDATIONS | PRIORITY |
|---|---|---|--|---|
| T16 | SYCAMORE | YOUNG TREE / CLOSE TO BUILDING (PHOTO 14) | FELL | L |

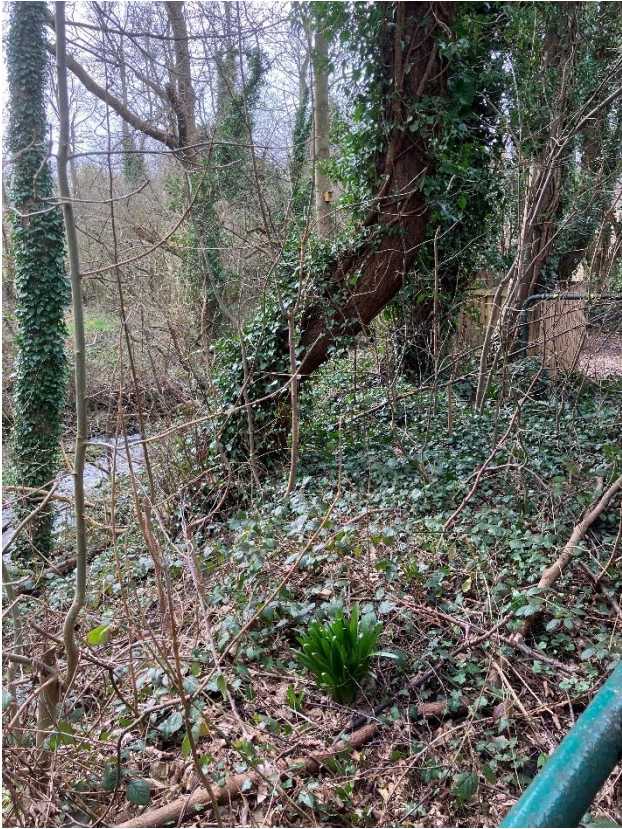
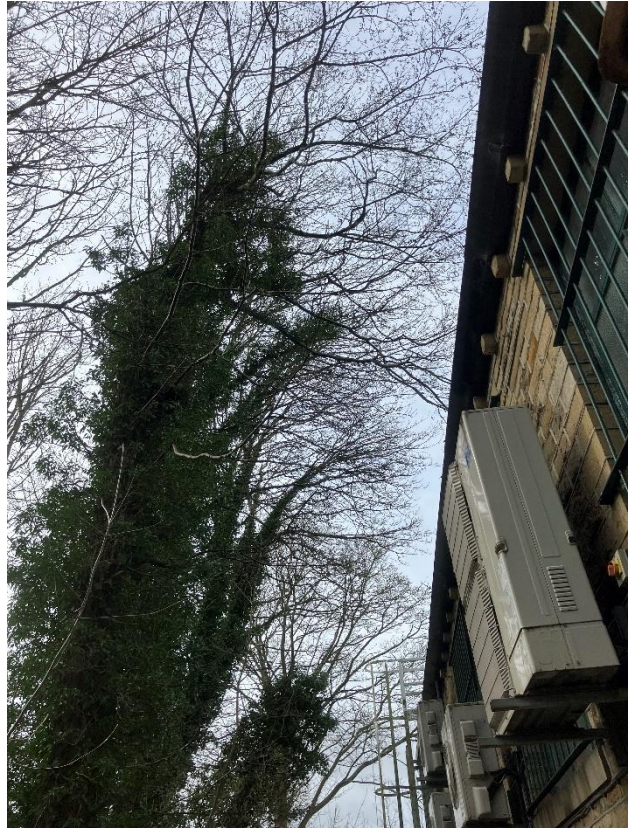
PHOTO'S 14 & 15 – TREE 17 – ALDER

| Tree No. | SPECIES | COMMENTS | RECOMMENDATIONS | PRIORITY |
|---|---|---|--|---|
| T17 | ALDER | BAD FORM / NEAR BUILDING AND ELECTRICAL BOXES (PHOTOS 15 & 16) | FELL | L |

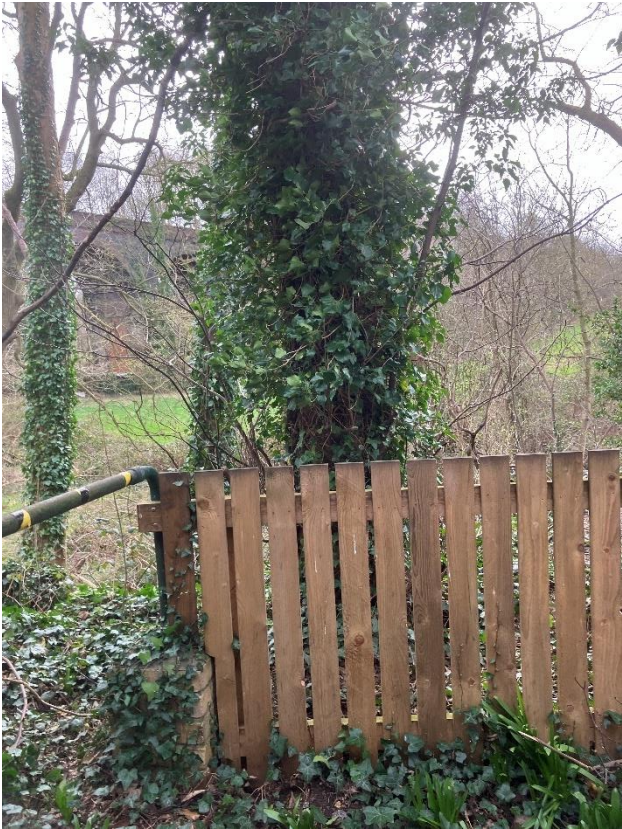
PHOTO 16 – TREE 18 - SYCAMORE

| Tree No. | SPECIES | COMMENTS | RECOMMENDATIONS | PRIORITY |
|---|---|---|--|---|
| T18 | SYCAMORE | LOW BRANCHES / IVY PRESENT (PHOTO 17) | CROWN LIFT AWAY FROM BUILDING / REMOVE IVY UPTO 2 METERS | L |

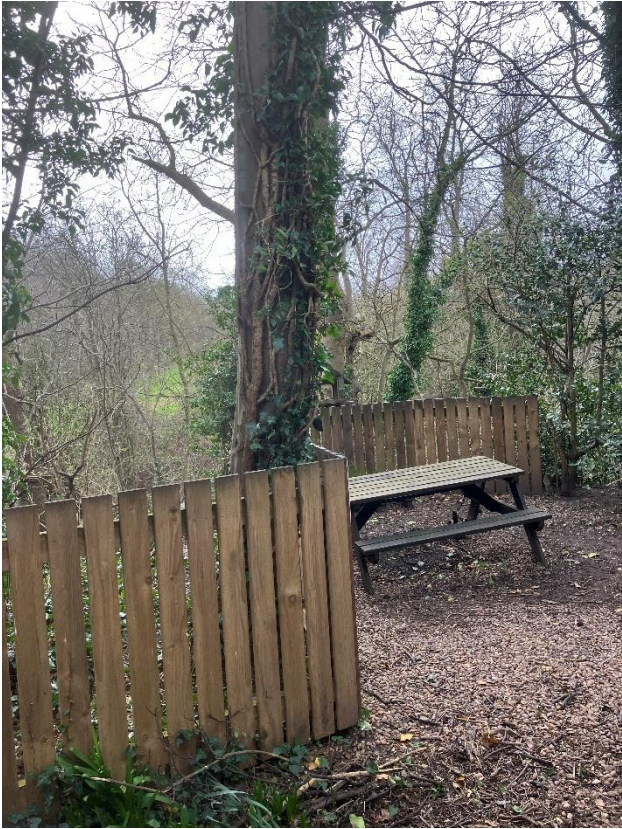
PHOTO 17 – TREE 19 – SYCAMORE

| Tree No. | SPECIES | COMMENTS | RECOMMENDATIONS | PRIORITY |
|---|---|---|--|---|
| T19 | SYCAMORE | LOW BRANCHES / IVY PRESENT (PHOTO 18) | CROWN LIFT AWAY FROM BUILDING / REMOVE IVY UPTO 2 METERS | L |

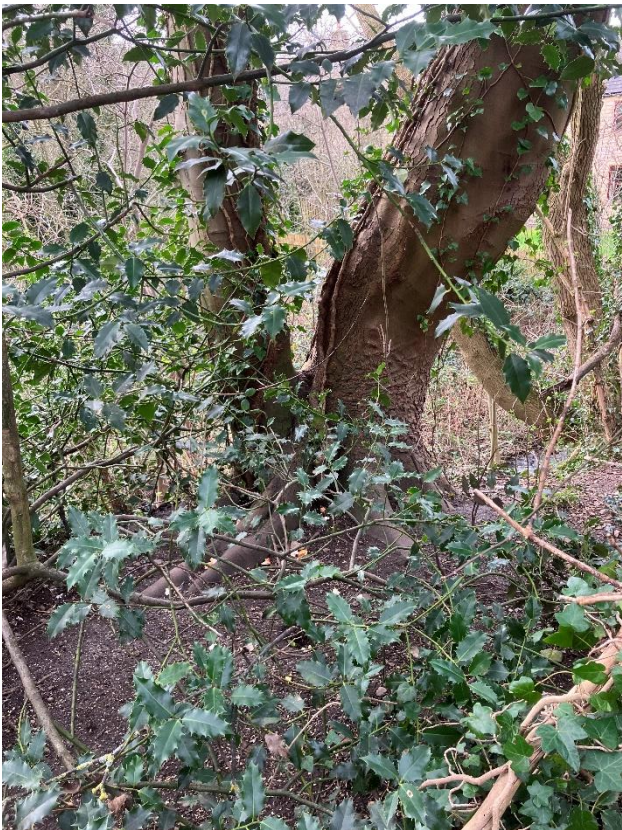
PHOTO 18 – TREE 20 – SYCAMORE

| Tree No. | SPECIES | COMMENTS | RECOMMENDATIONS | PRIORITY |
|---|---|---|--|---|
| T20 | SYCAMORE | MULTI STEMMED / IVY PRESENT (PHOTO 19) | REMOVE IVY UPTO 2 METERS | L |

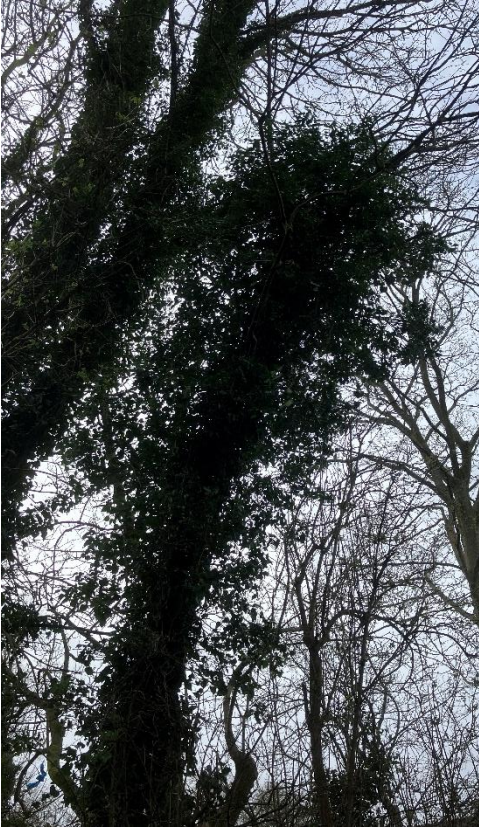
PHOTO 19 – TREE 21 – SYCAMORE

| Tree No. | SPECIES | COMMENTS | RECOMMENDATIONS | PRIORITY |
|---|---|---|--|---|
| T21 | SYCAMORE | YOUNG SUPPRESSED TREE (PHOTO 20) | FELL | M |

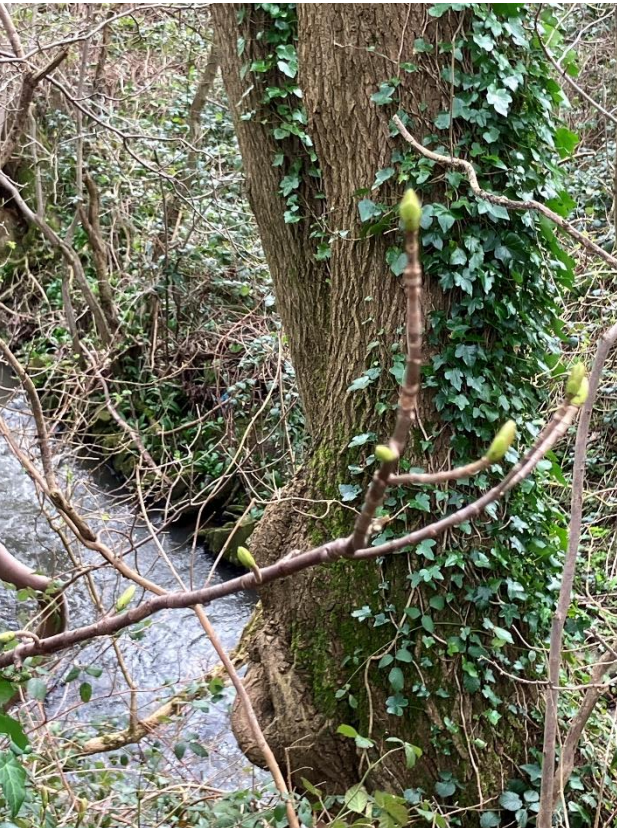
PHOTO 20 – TREE 22 - ASH

| Tree No. | SPECIES | COMMENTS | RECOMMENDATIONS | PRIORITY |
|---|---|---|--|---|
| T22 | ASH | ASH DIEBACK CATEGORY 1 / LOW TARGET AREA PHOTO 21) | REMOVE DEADWOOD | L |

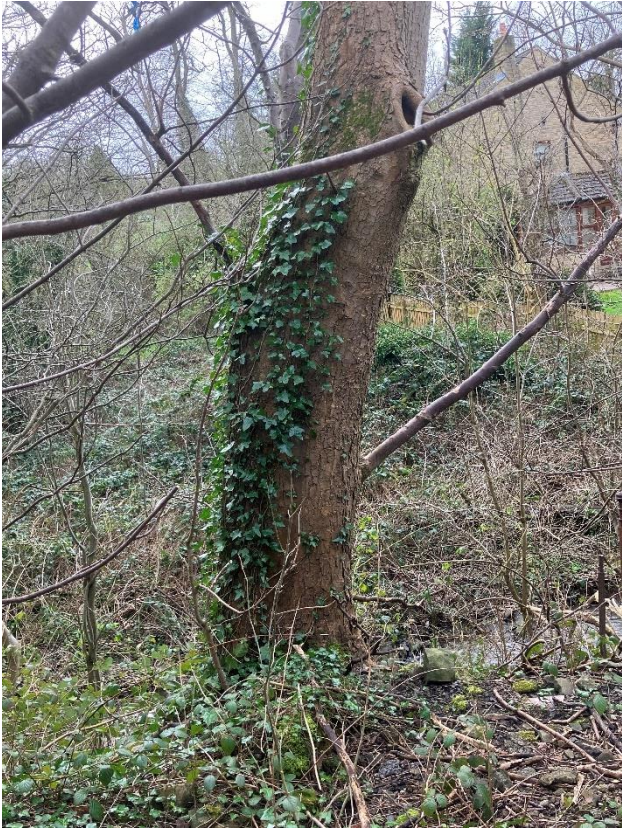
PHOTO 21 – TREE 23 – SYCAMORE

| Tree No. | SPECIES | COMMENTS | RECOMMENDATIONS | PRIORITY |
|---|---|---|--|---|
| T23 | SYCAMORE | LOW BRANCHES OVER BUILDING (PHOTO 22) | CROWN LIFT AWAY FROM BUILDING | M |
