Cumberworth C.E First School

Heritage Statement

For the Replacement of External  
Windows

1<sup>st</sup> November 2024

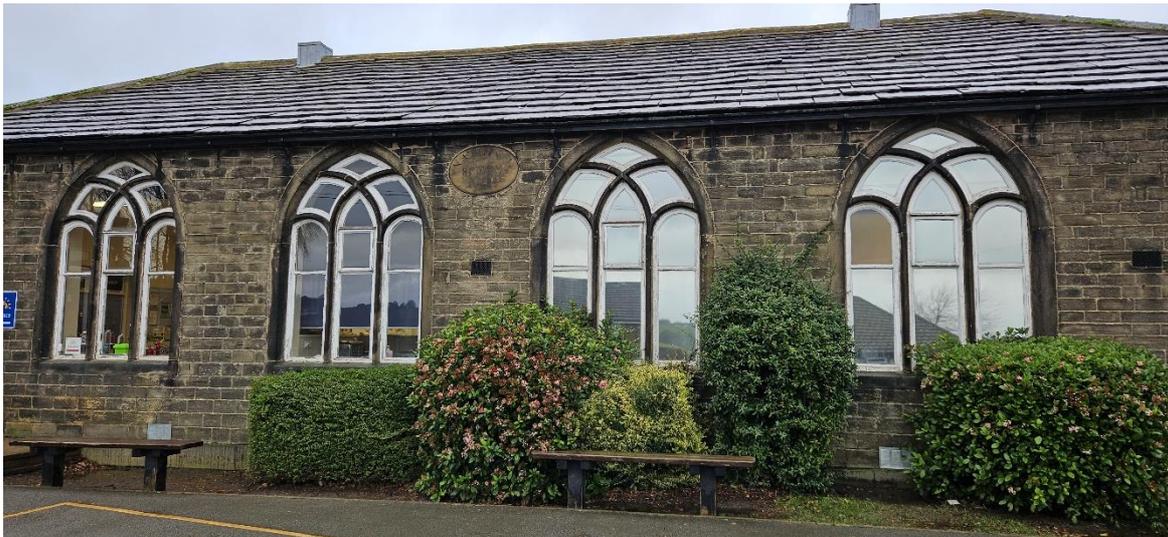
**Photo 1:** Gothic arched windows to front elevation of school, to which the works relate.

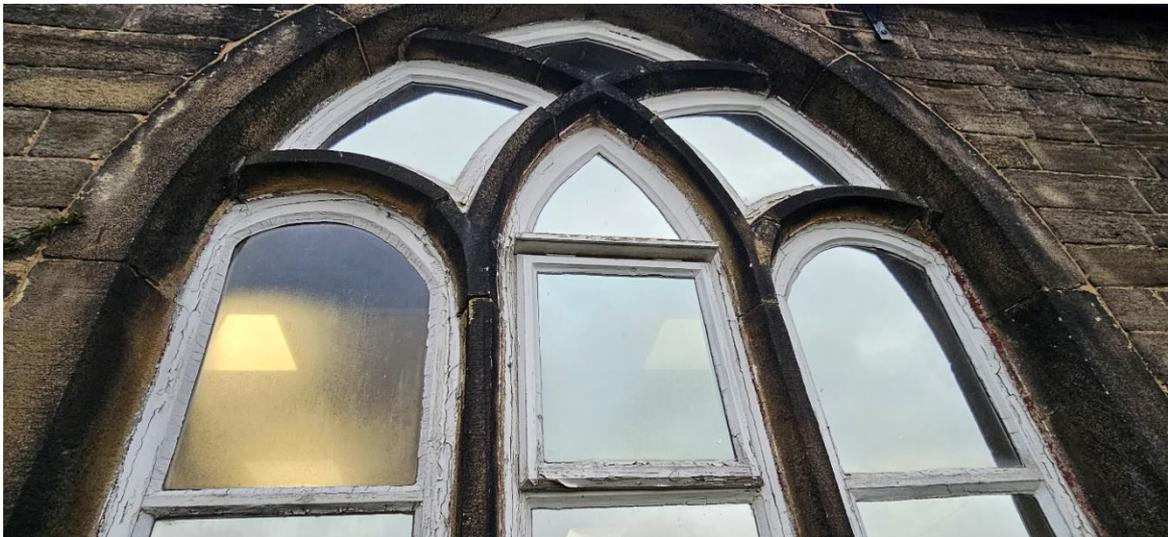
**Photo 2:** Typical detail of arched window, showing stonework and rotten timber framed single glazed windows.

- 4.6 The windows will be replaced with new, purpose-made hot-dip galvanised, polyester powder-coated steel frames, complete with double-glazed units to suit to all window openings, including the tracery elements above.

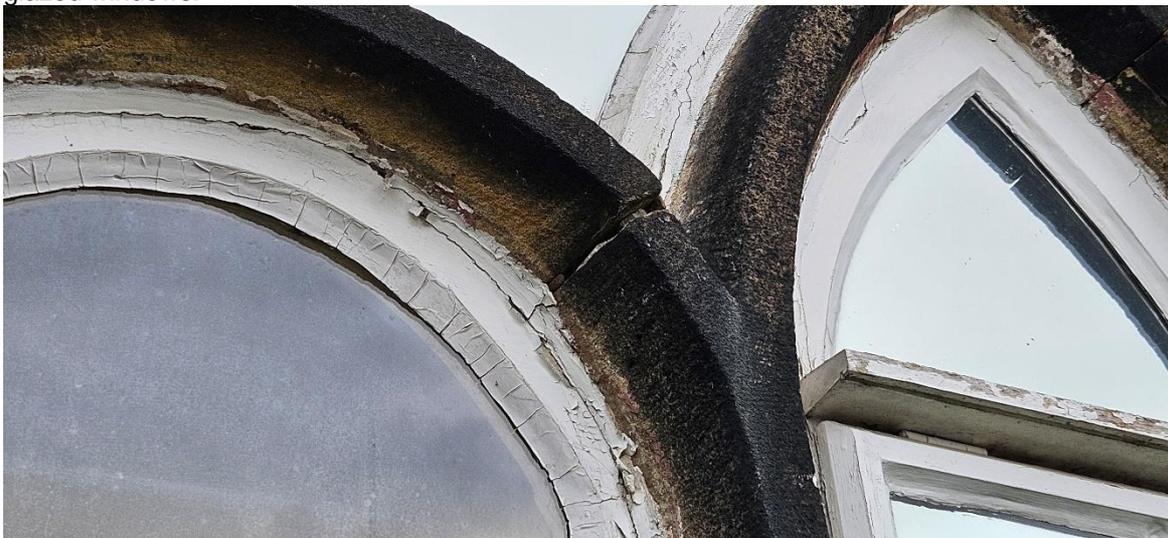
**Photo 3:** Movement evident to tracery with displacement noted between stone sections.

- 4.8 No cleaning of the internal stonework will be undertaken.
- 4.9 Defective sections of stone tracery will be replaced by a skilled stone mason, in strict accordance with the conservation officer's approval.

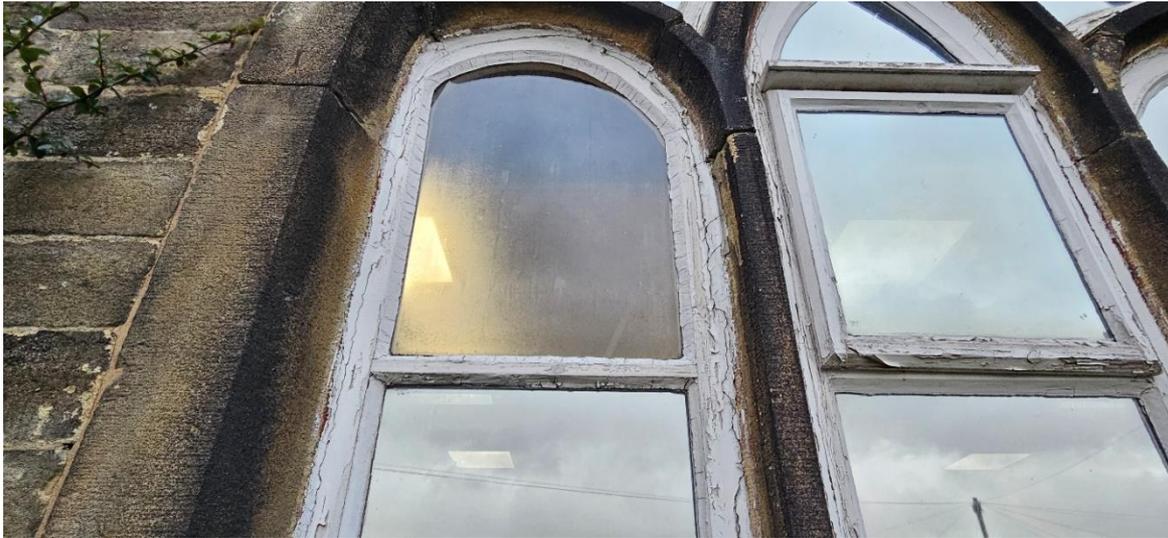
**Photo 4:** General view showing poor condition of timber framed windows inset in between stone arches.

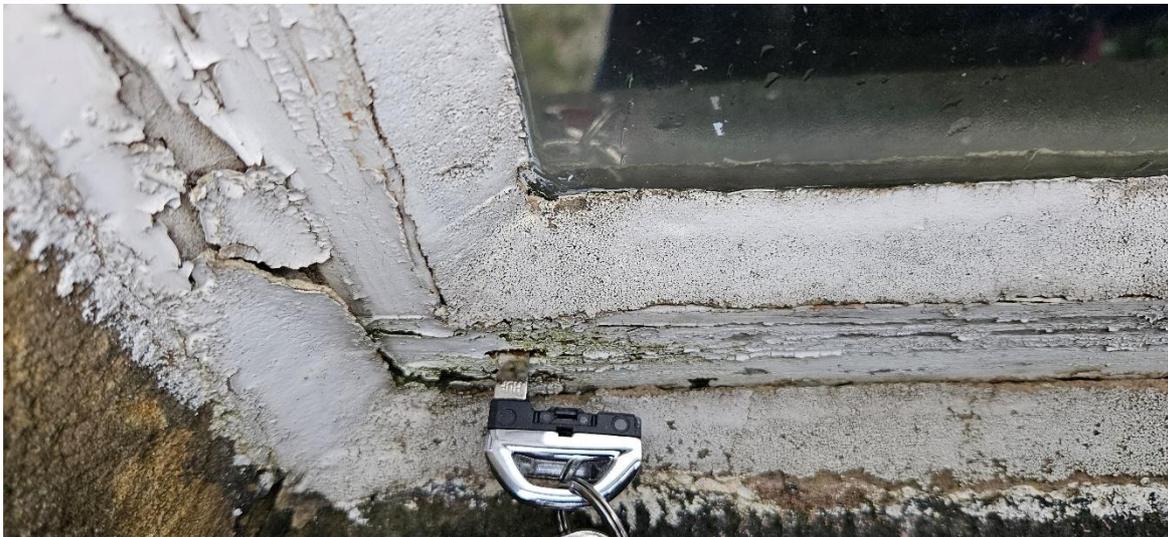
**Photo 5:** Rotten timber window frames with car key easily pushed into soft and saturated timber.

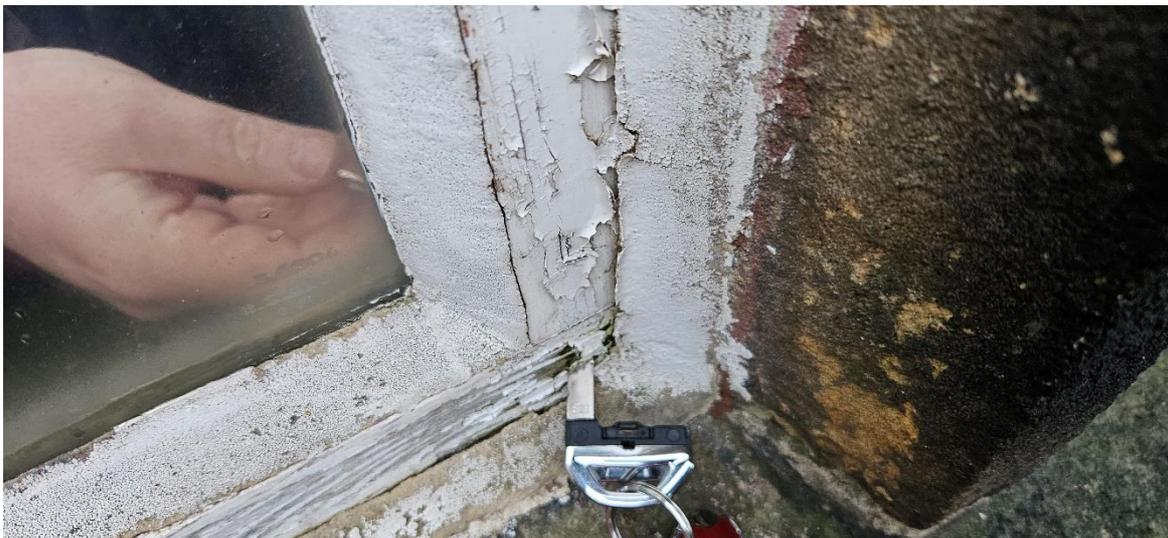
**Photo 6:** Further example of deteriorated and rotten timber framed windows.

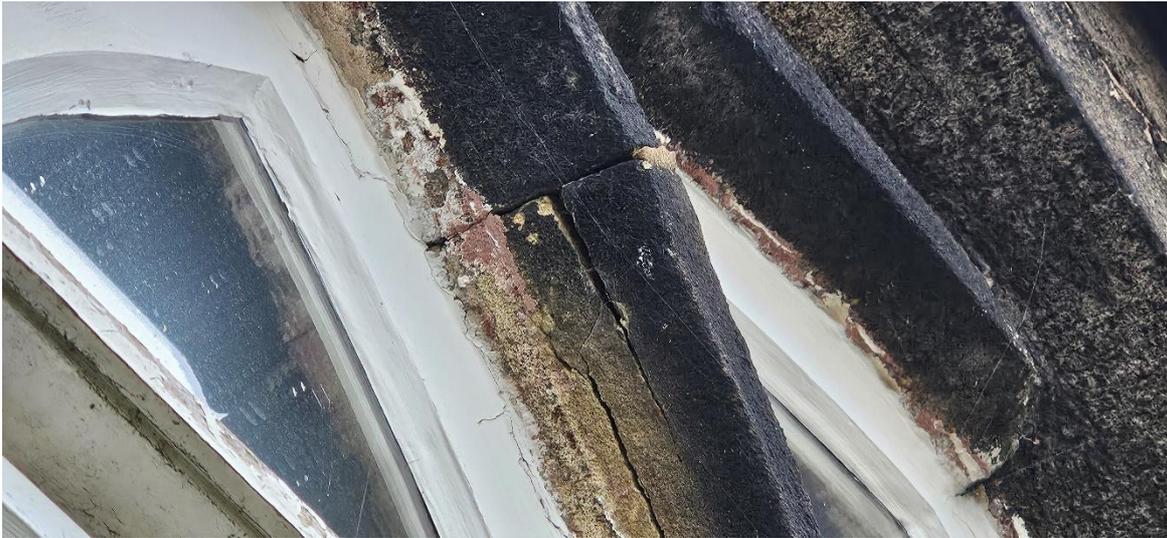
**Photo 7:** Stonework deterioration with splits and cracks in sections of stone arch.

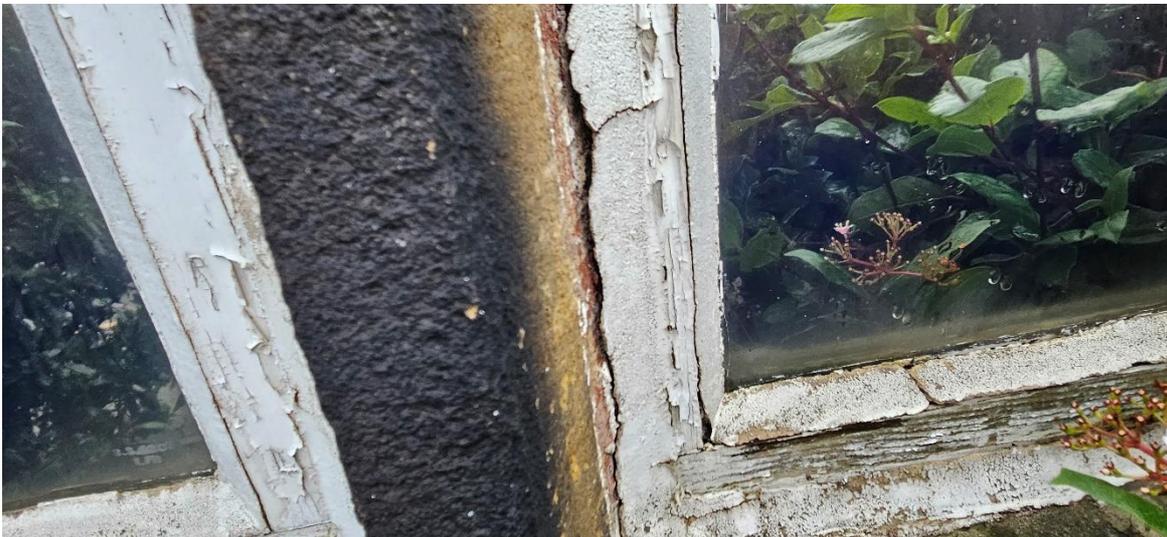
**Photo 8:** Putty infill and mortar repairs are cracked and lifting allowing moisture to penetrate into building.

- 4.10 It is also anticipated that areas of pointing to the tracery and surround stonework may need to be carefully removed and repointed in a lime-based mortar. The specific areas will be agreed upon on-site with the conservation officer.

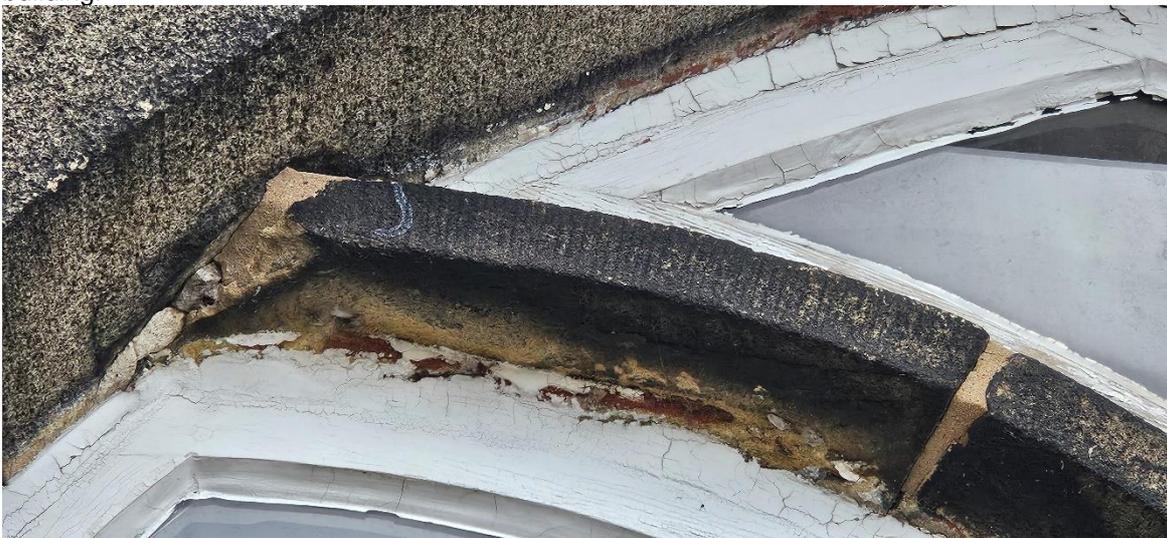
**Photo 9:** Example of previous pointing repairs to fill gaps between sections of stone arch.

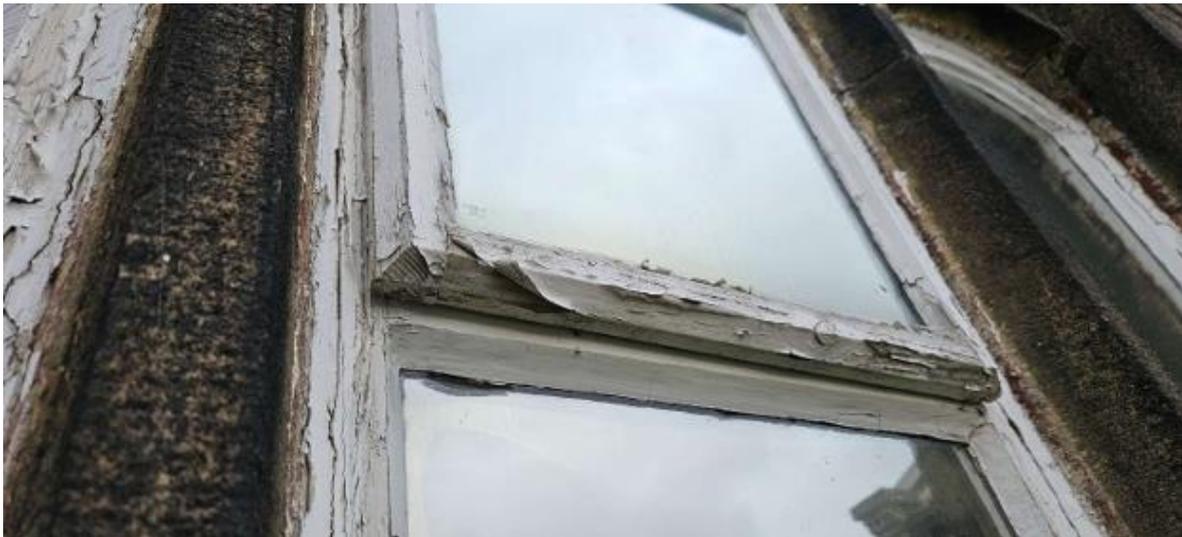
**Photo 10:** Window opener with gaps where frame has twisted / warped.

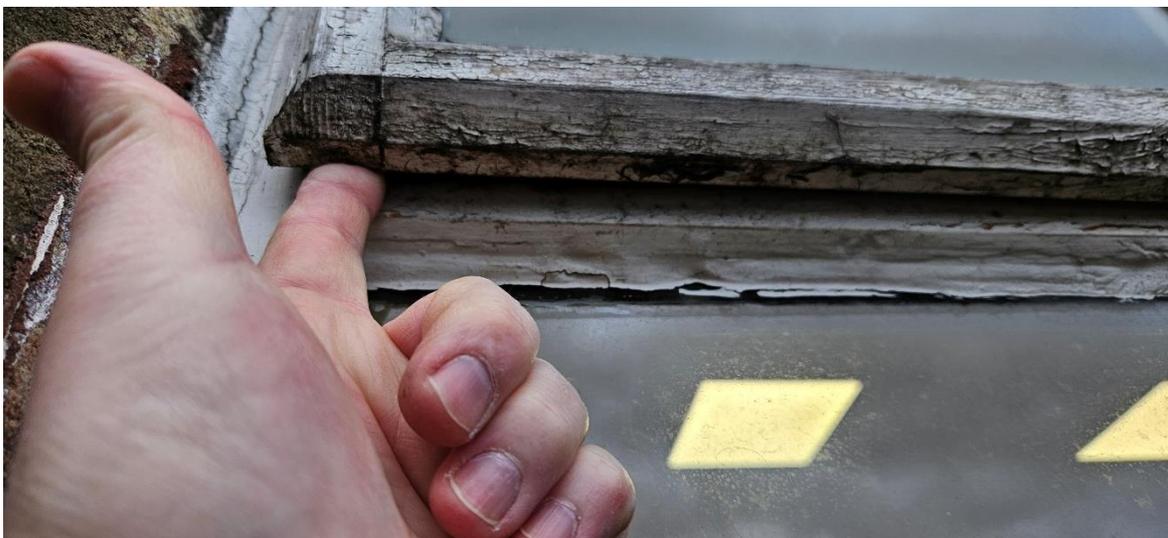
**Photo 11:** Extent of gap between frame and opener demonstrated with finger used for scale reference point.

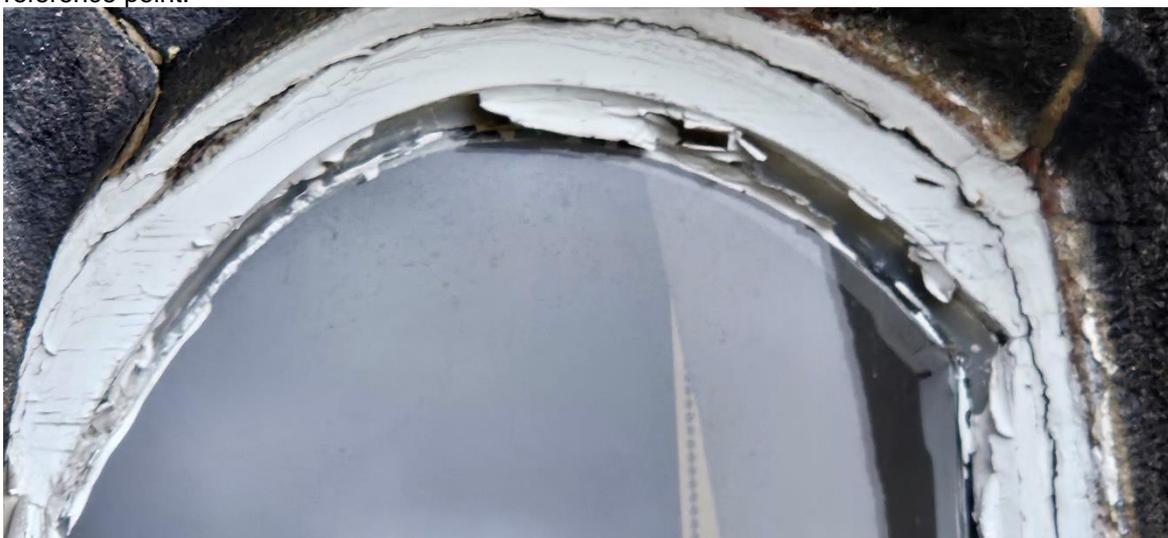
**Photo 12:** Gaps opening up between top of window frame and seal also evident is missing sections of glazing putty exposing edge of glazing pane.

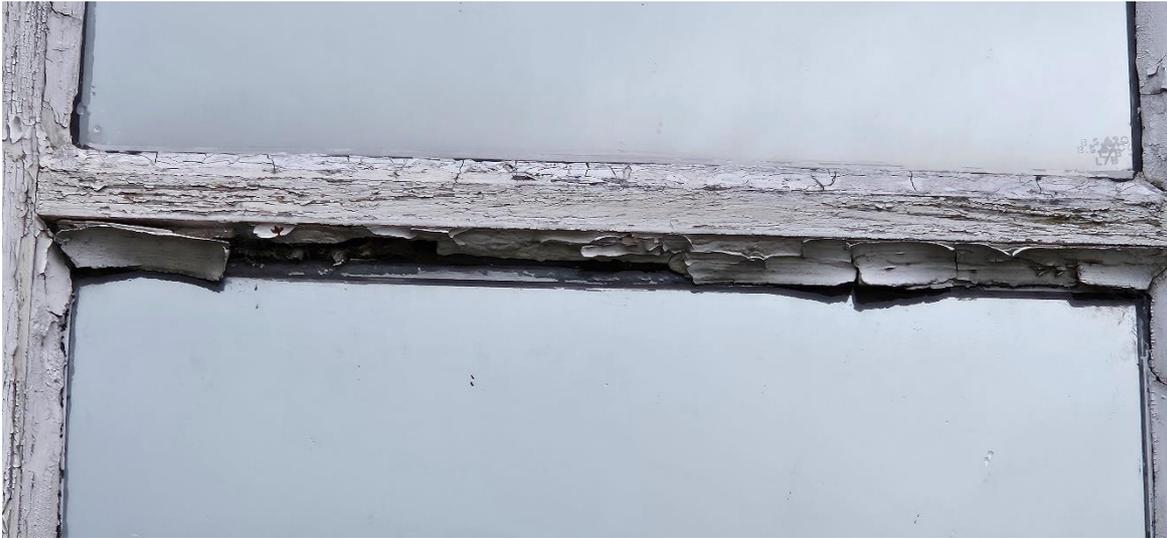
**Photo 13:** Worn and deteriorated timber glazing bead and missing glazing putty which holds glass in place.

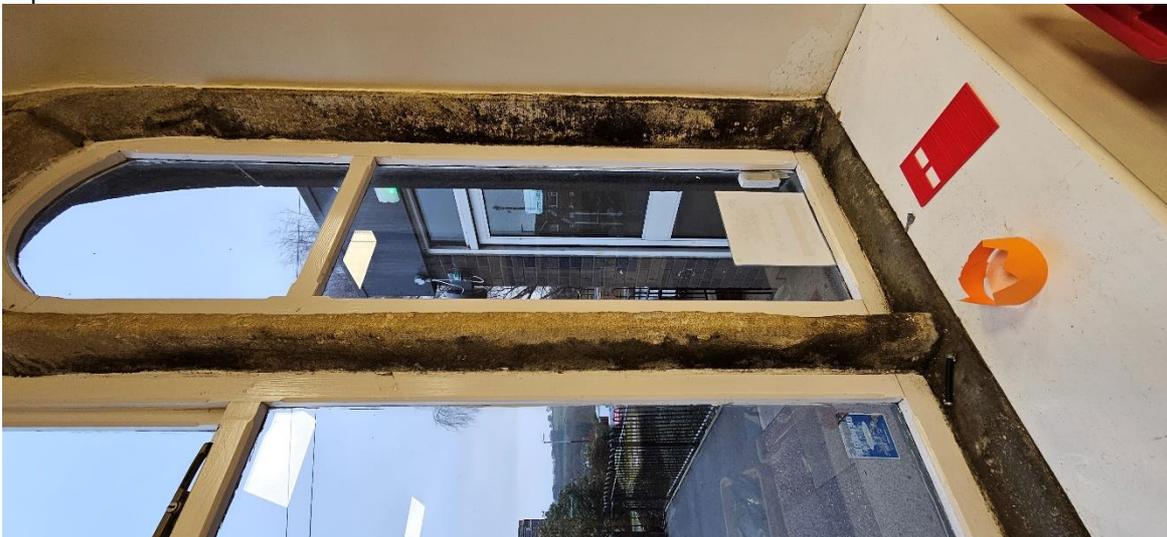
**Photo 14:** Internal view of window showing black mould, moisture staining and wear to stonework.

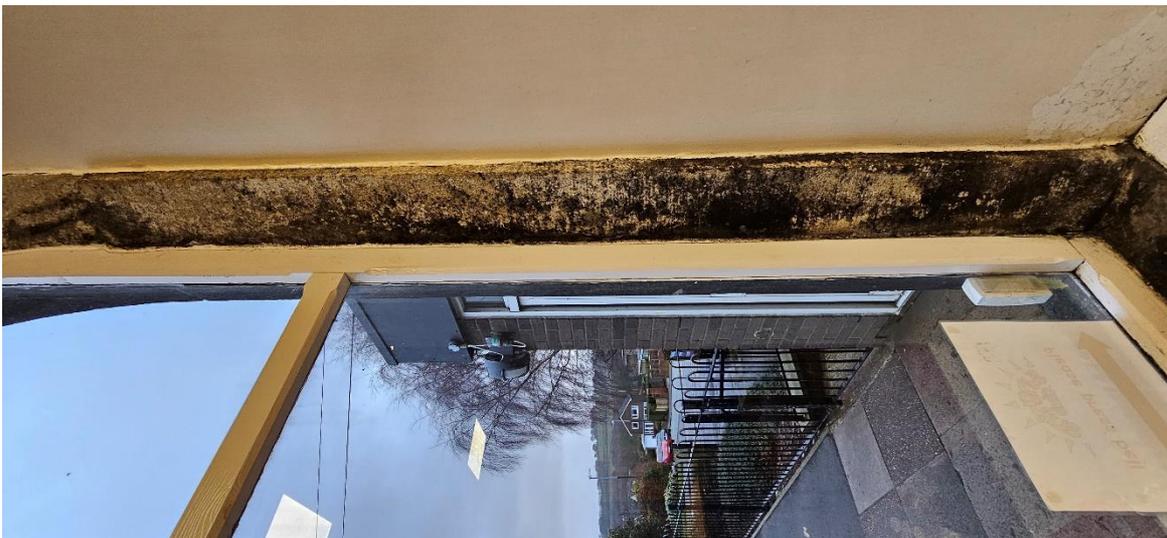
**Photo 15:** Uneven finish of stone and timber frame following contours of stone.

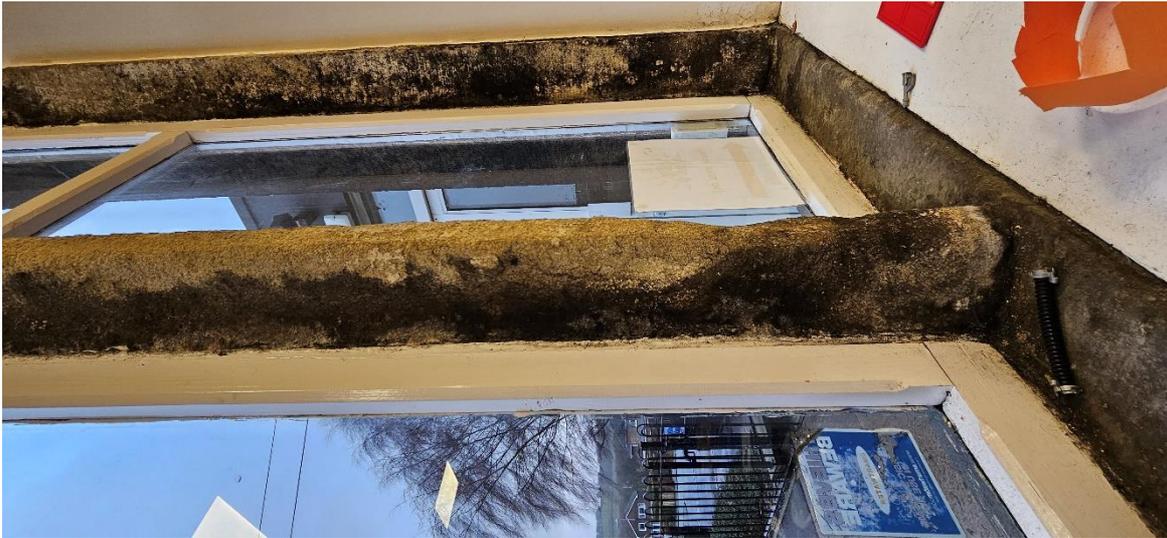
**Photo 16:** Further example of wear and staining to internal stonework from penetrative damp and condensation.

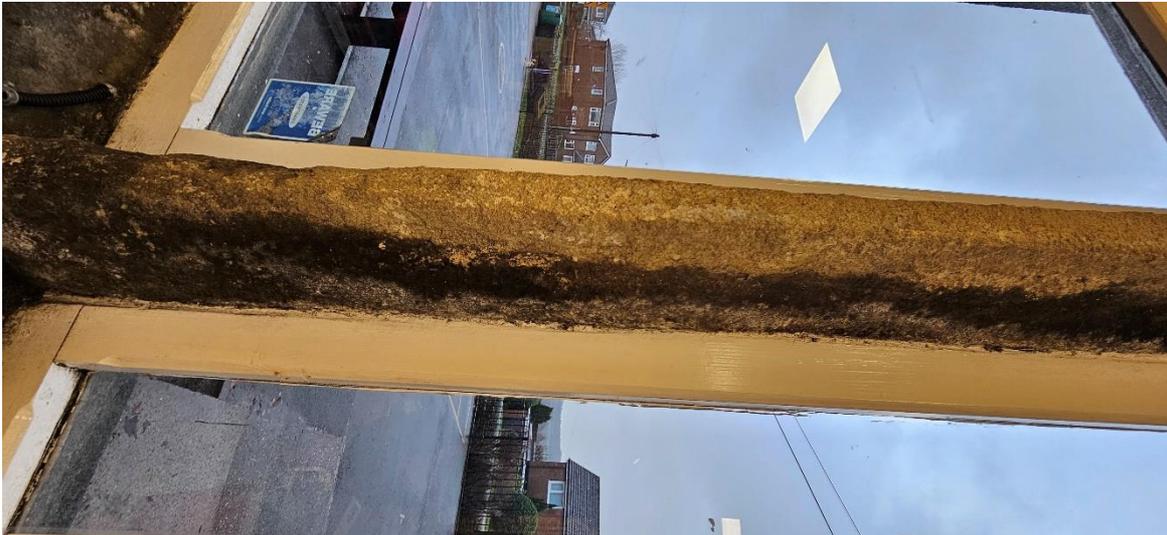
**Photo 17:** Further example of worn stonework.

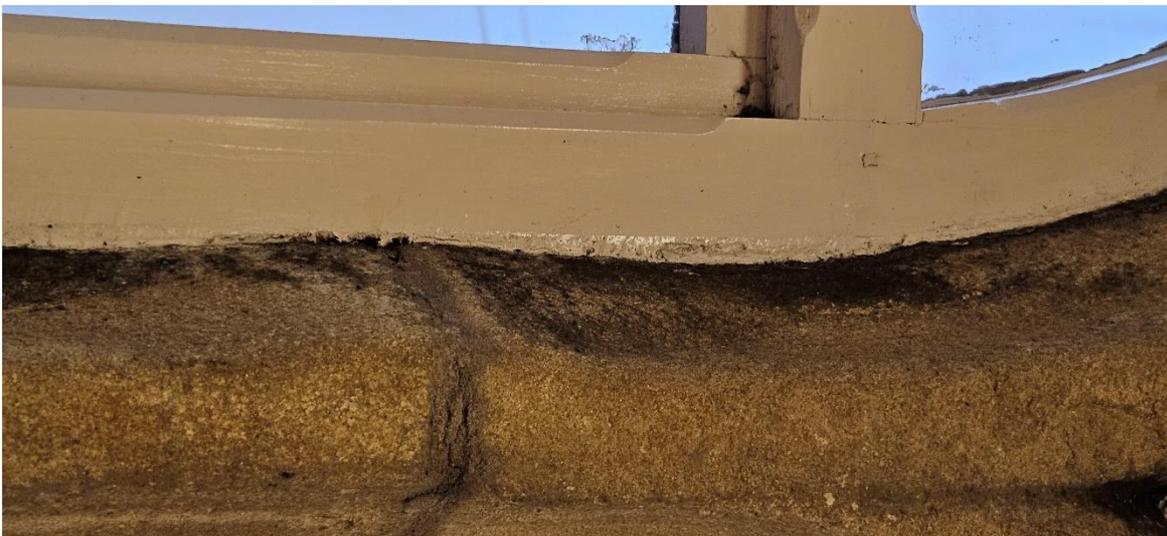
**Photo 18:** Further example of uneven edges to stonework and how gaps between the timber frame and stonework have been filled.

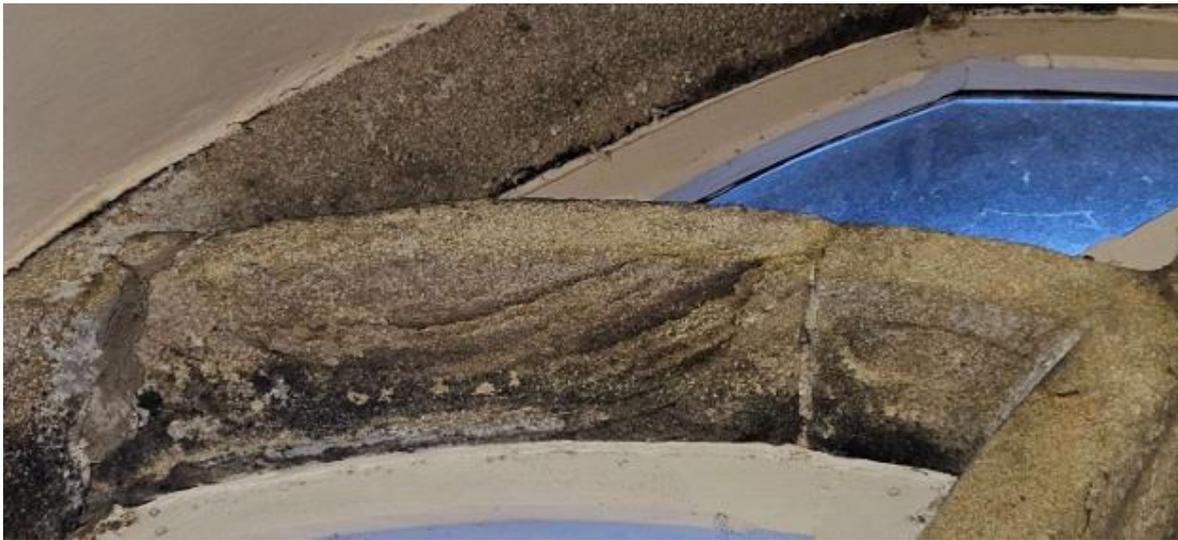
**Photo 19:** Worn and previously pointed sections evident to stonework internally.

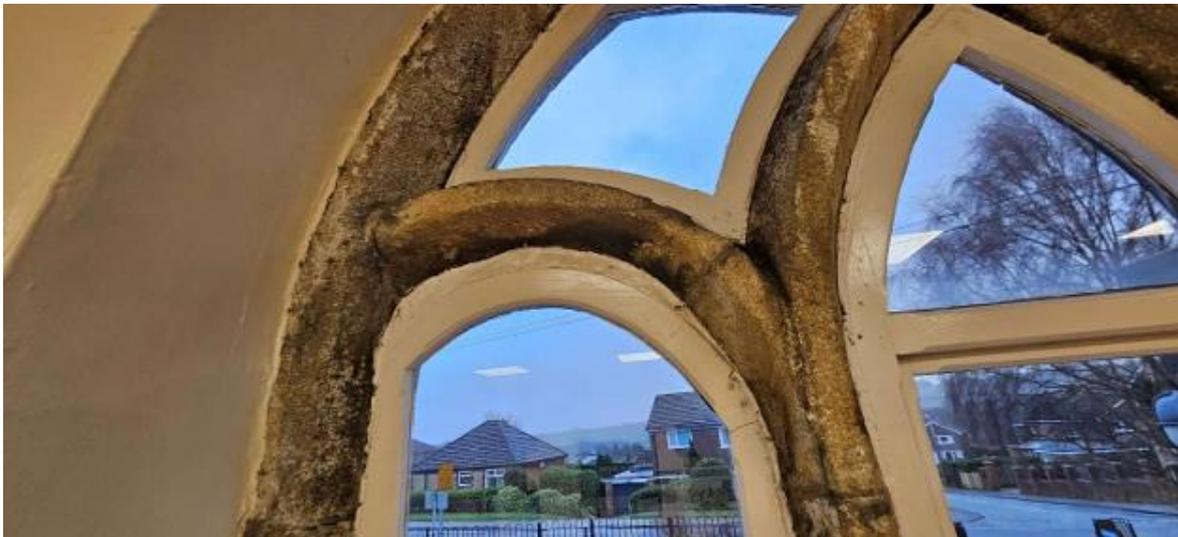
**Photo 20:** Excessive gaps between timber frames and stonework to previous installation evident.

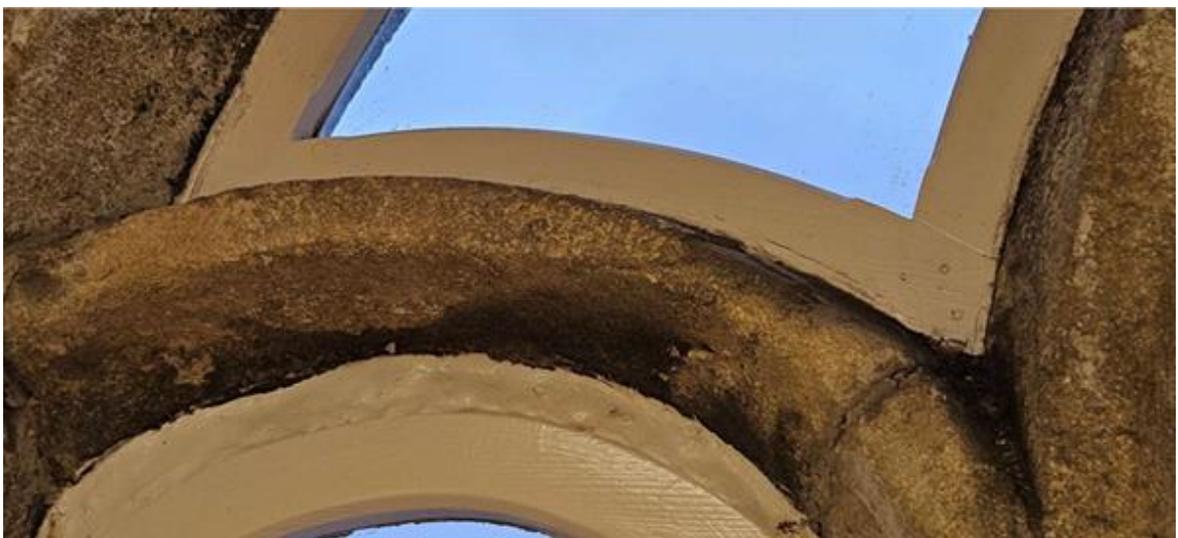
**Photo 21:** Close up view of previous view above.
