Healey Lane, Batley

Stage 1 Road Safety Audit

STAGE 1 ROAD SAFETY AUDIT

Ref: 25-117-001.02

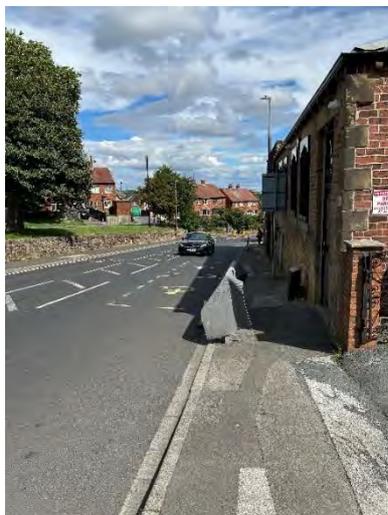
Risk of collisions between vehicles waiting to turn right into the access from Healey Lane and vehicles travelling westbound.

Drivers attempting to turn right into the access are likely to enter the existing central hatching area and will have to wait for gaps in the oncoming traffic on Healey Lane. Drivers of oncoming vehicles including larger vehicles such as buses currently travelling westbound around the bend encroach into the central hatching area as illustrated in Images No.1 and 2. If a vehicle is waiting to turn right there is an increased risk of head on type collision or rear end shunt type collision if the oncoming vehicle brakes suddenly to avoid a collision.

The presence of parked cars in the existing 2 no. disabled parking bays on Healey Lane will exacerbate the risks. In the event that there are vehicles waiting to turn right into the site, vehicles including larger vehicles may not be able to safely pass parked cars and vehicles waiting to turn into the site, leading to an increased risk of queuing vehicles across the existing pedestrian crossing facility and site access.

Photograph 1 -Vehicle entering hatched central reserve

Provide measures to ensure vehicles travelling westbound do not have to use the central hatching area when travelling around the bend or along the site frontage. Remove the on street disabled parking bays and implement 'no waiting at any time' restrictions on Healey Lane along the site frontage.

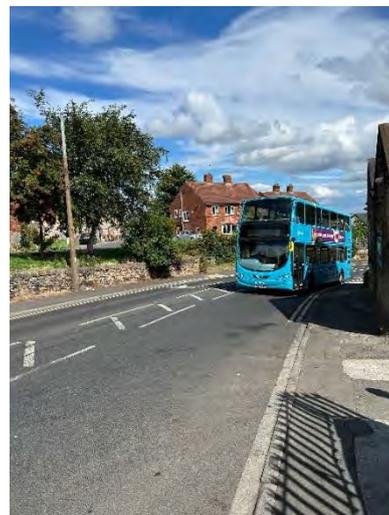
Photograph 2-Larger Vehicle entering hatched central reserve

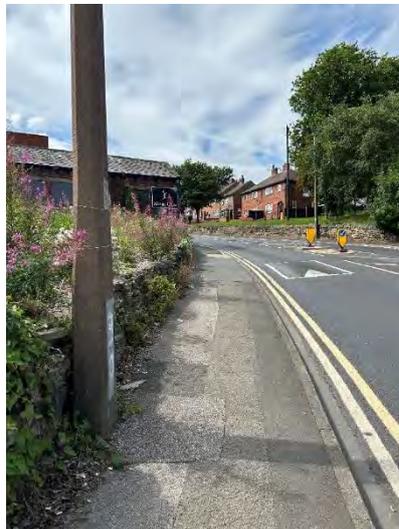
Existing street lighting reduces the effective footway width close to the building entrance.

The existing street lighting column shown in Photograph No.3 reduces the effective width available to pedestrians and during busy periods to pass safely pedestrians may need to step into the carriageway of Healey Lane to pass each other, leading to an increased risk of collisions between pedestrians and vehicles.

Photograph 3 -Existing Lighting Column

Relocate street lighting column.
