## PRE-CONDITION SURVEY ON BEHALF OF OWENS DEVELOPMENTS LTD

| <b>Works Location</b> | Bierley Marsh, East Bierley, West Yorkshire |
| <b>Date of inspection</b> | 2 <sup>nd</sup> October 2024 |

MCB Highway Solutions have been commissioned by Owens Developments Ltd to undertake a pre-condition survey along Bierley Marsh, East Bierley. The purpose of the survey is to identify any defects within the existing highway prior to the commencement of the residential development.

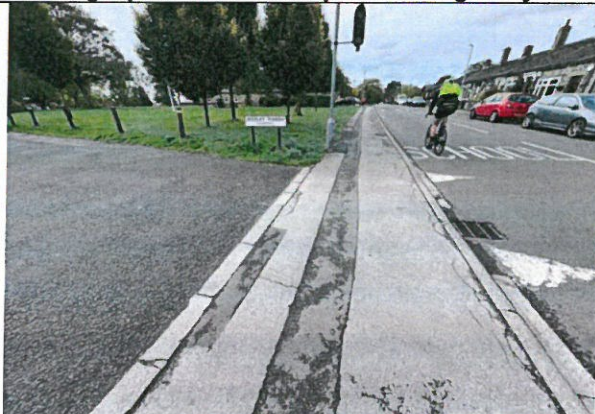
Chainage 0 – Scarring / reinstatements in footway. Cracks in several delineation kerbs to rear of footway

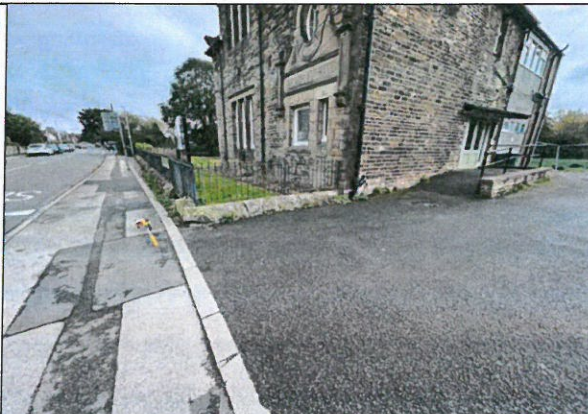
Chainage 0 – Scarring / reinstatements in footway

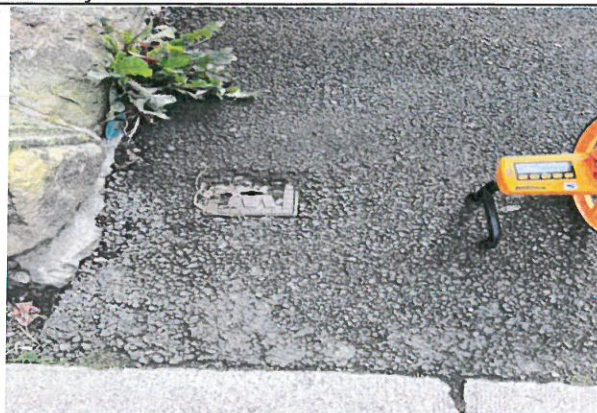
Chainage 0.5 – Water stop valve to left hand side – good condition

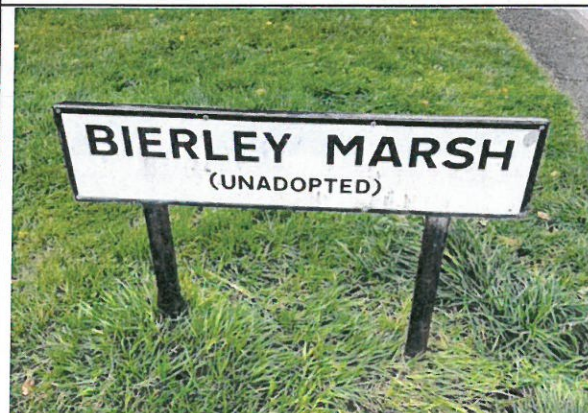
Chainage 1 – Street name plate, good condition and structurally sound

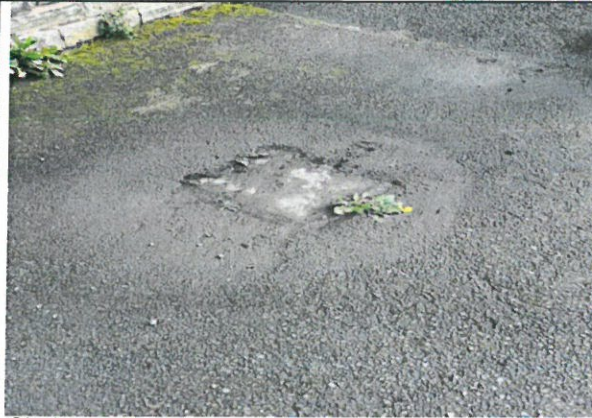
Chainage 5.3 – Inspection chamber to left hand side – good condition

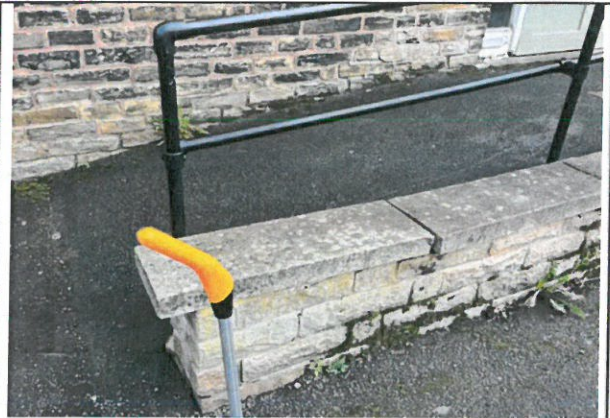
Chainage 7 – Start of pedestrian ramp. Slight crack in wall, first two coping stones loose, handrail in good condition

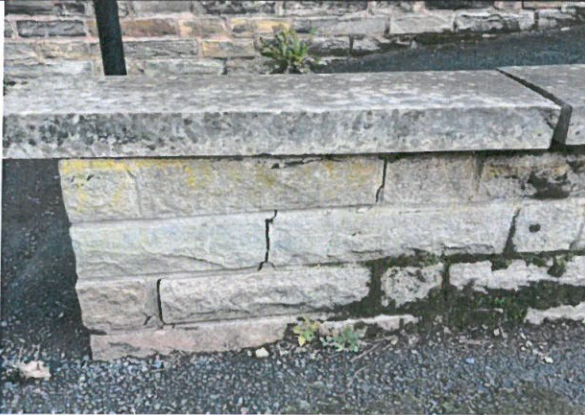
Chainage 7 – Start of pedestrian ramp. Slight crack in wall

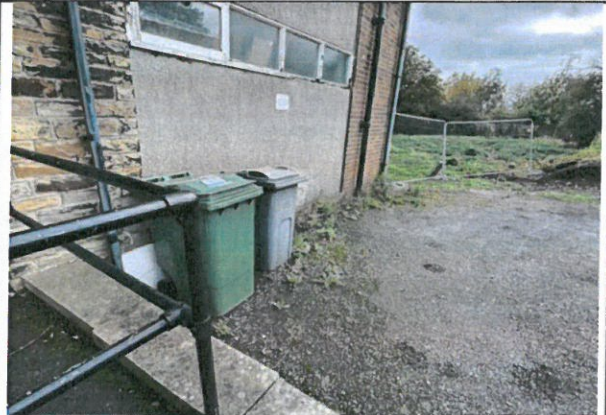
Chainage 13.2 – End of ramp. Start of unsealed surface on left hand side

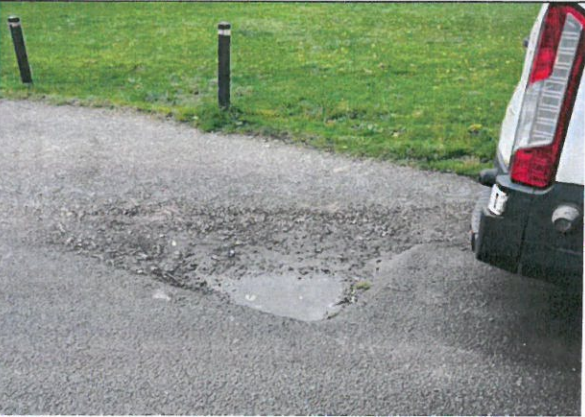
Chainage 21.5 – Start of unsealed surface on right hand side

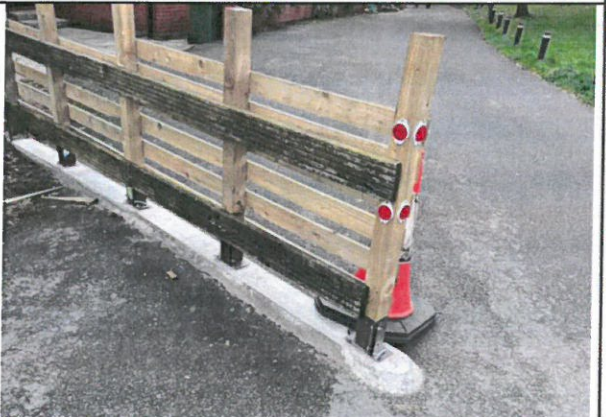
Chainage 33.6 – Start of post and rail fence on left hand side – no obvious defects

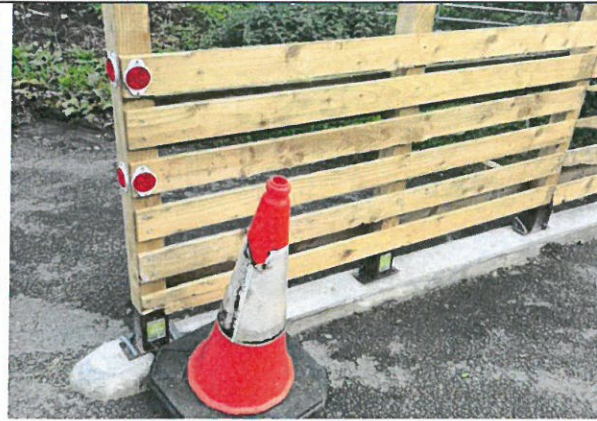
Chainage 33.6 – Start of post and rail fence on left hand side – no obvious defects

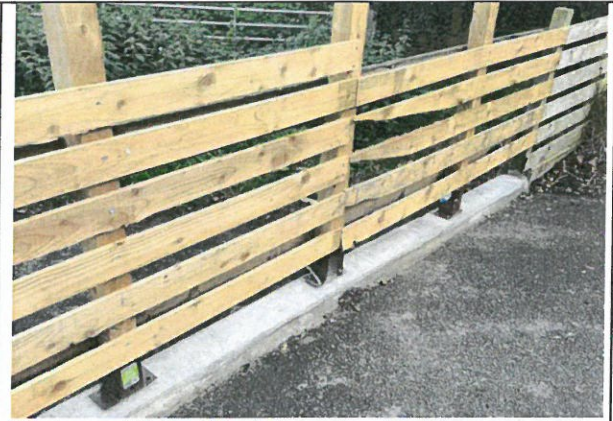
Chainage 33.6 – Start of post and rail fence on left hand side – no obvious defects

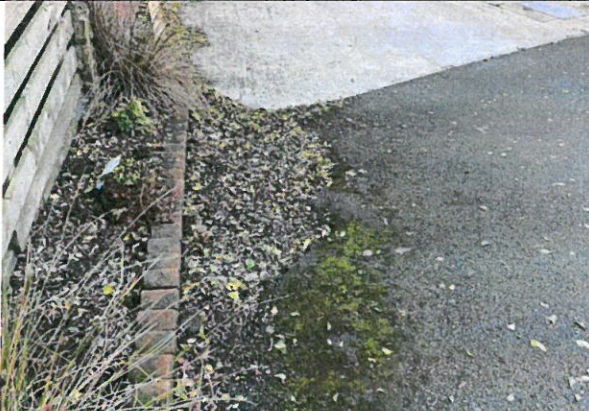
Chainage 37.6 – Start of access to 'Thornfield'. Area of surface course de-bonding adjacent to driveway

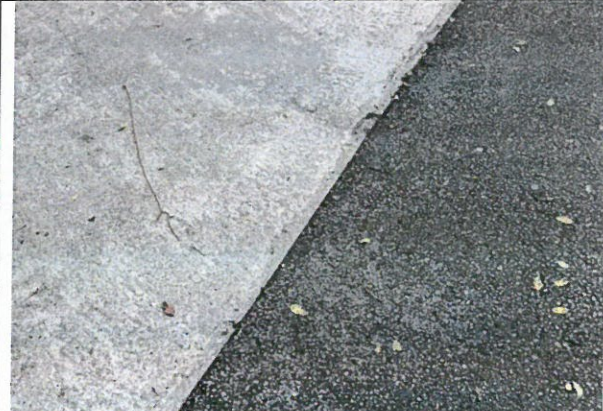
Chainage 37.6 to 42.8 – No defects in driveway

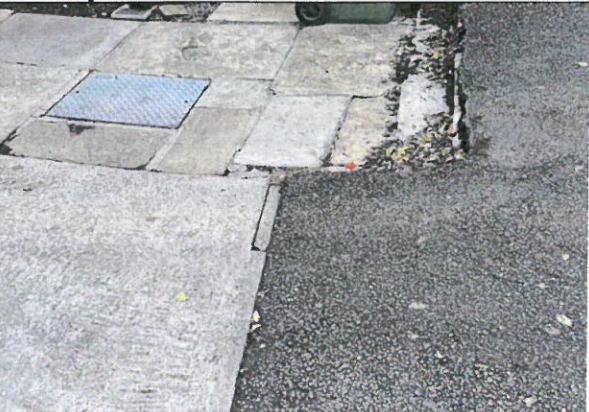
Chainage 37.6 to 42.8 – No defects in driveway

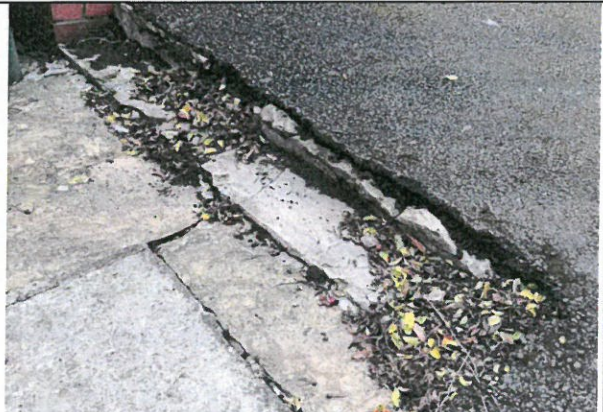
Chainage 42.8 to 44.6 – Slight collapse at back of carriageway adjacent to 'Thornfield'

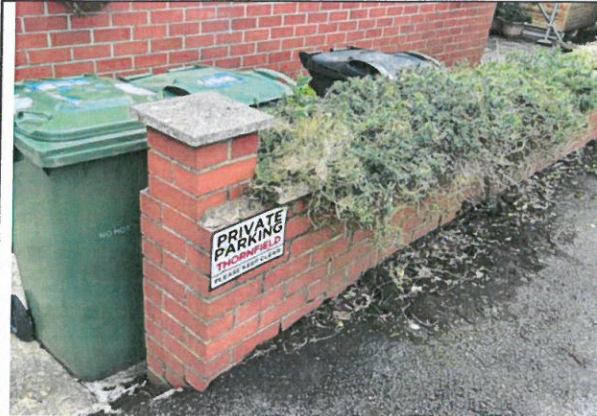
Chainage 44.5 to 55 – Property boundary wall – good condition

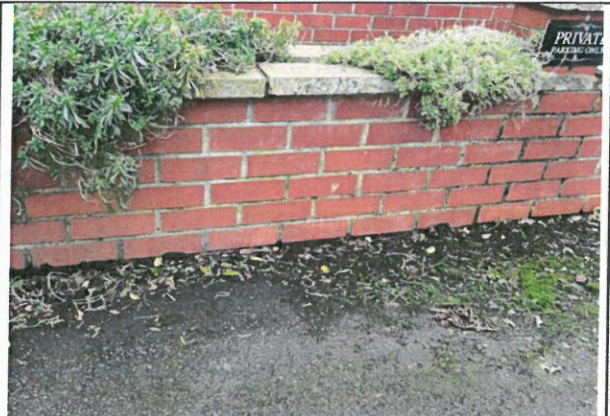
Chainage 44.5 to 55 – Property boundary wall – good condition

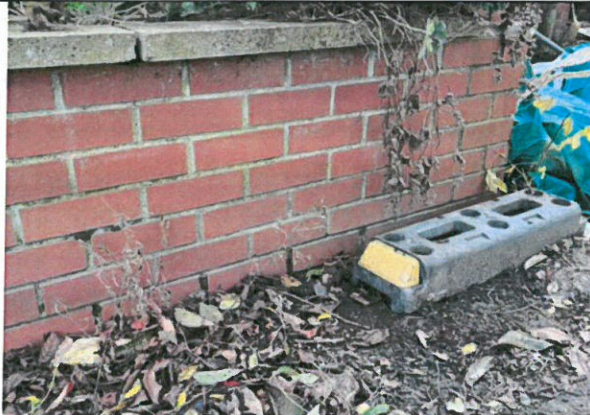
Chainage 44.5 to 55 – Property boundary wall – good condition

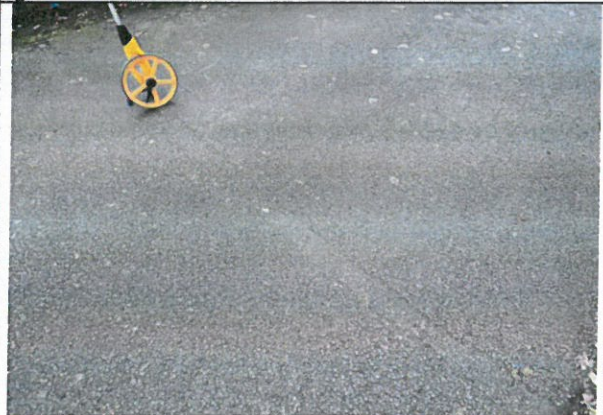
Chainage 49.6 – Scar across full width of carriageway

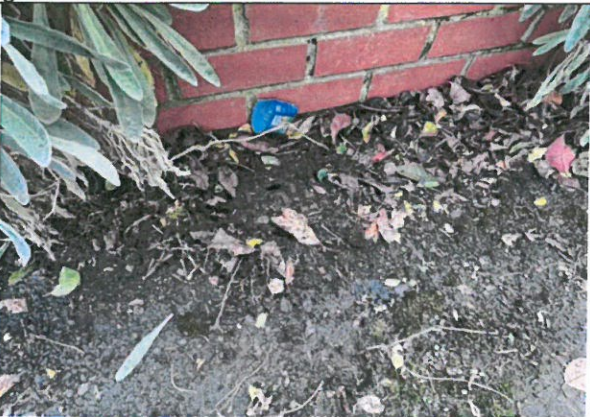
Chainage 49.6 – Small inspection chamber adjacent to boundary wall

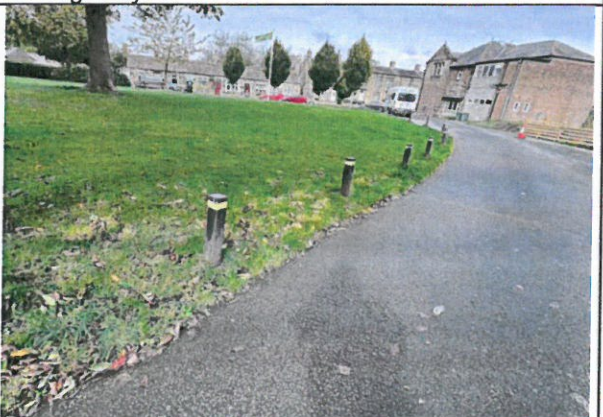
Chainage 3 to 55 – 20no bollards in verge adjacent to access road. All in good condition and structurally sound
