# Contaminated Land Phase One Desk Study for proposed residential dwelling on land at Red Doles Lane, Leeds Road, Huddersfield, HD2 1YF.

Prepared for

ADP Architecture Design,  
The Old Police Station,  
16 Bridge Lane,  
Holmfirth,  
HD9 7AN.

October 2024

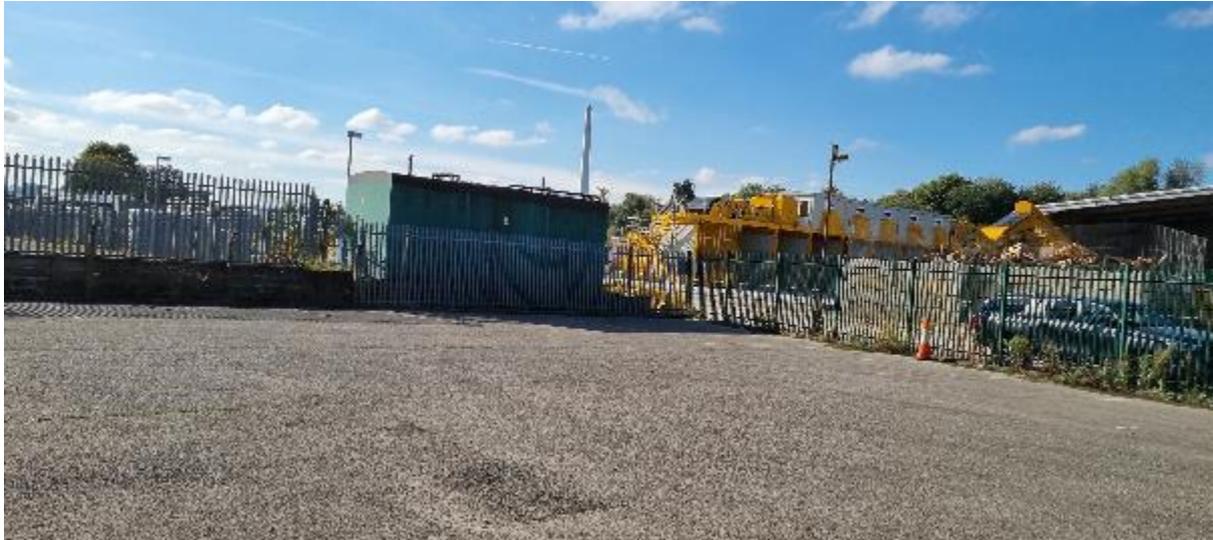
Southwest corner of the yard

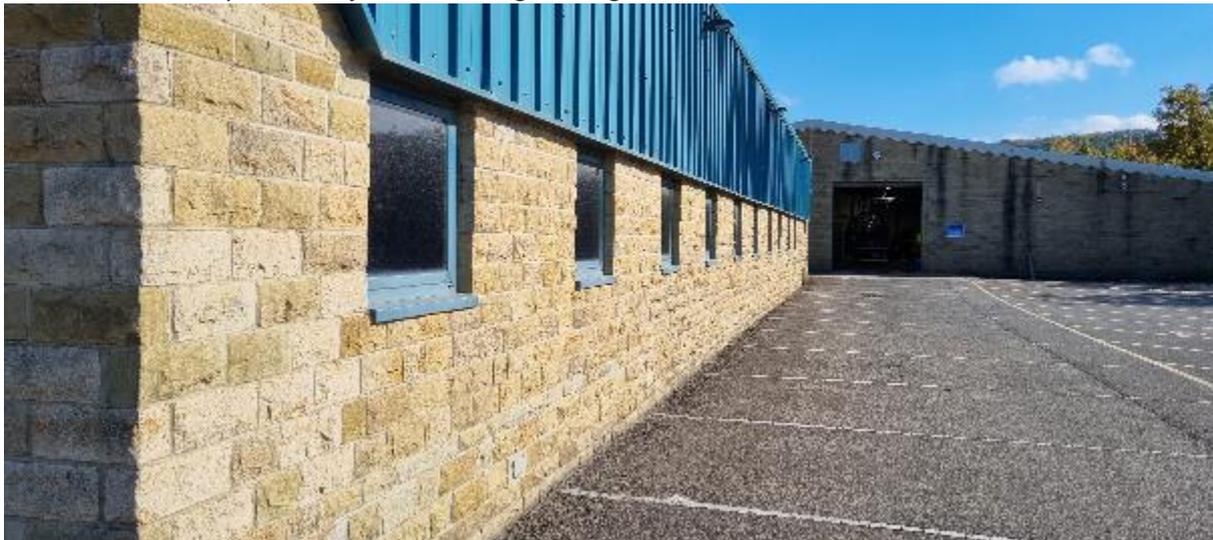
Northern boundary of the adjacent building looking east

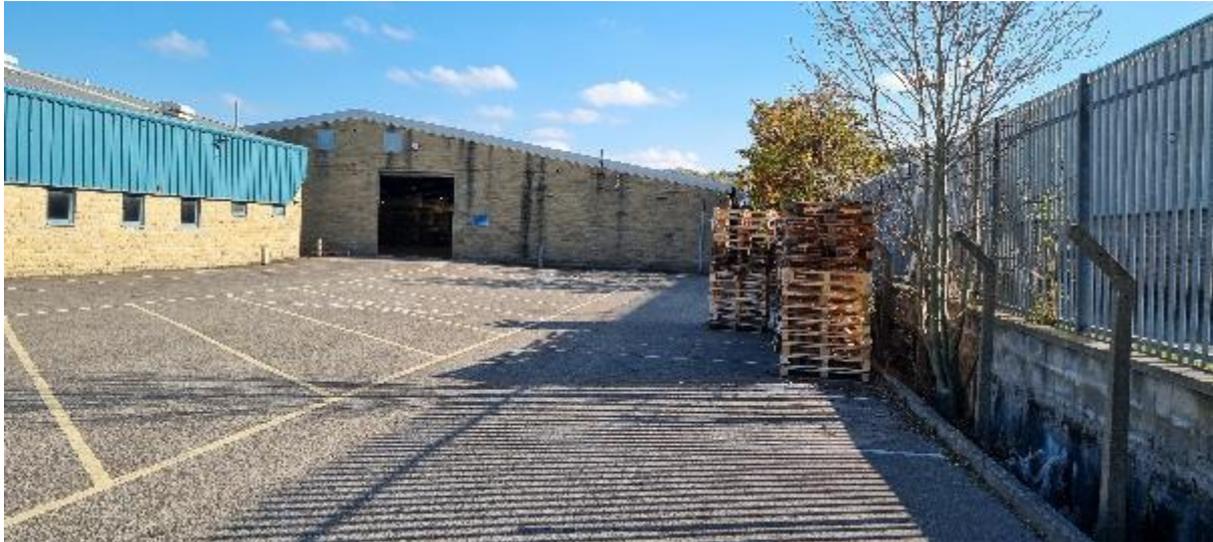
Southwest corner looking to northeast corner across the site

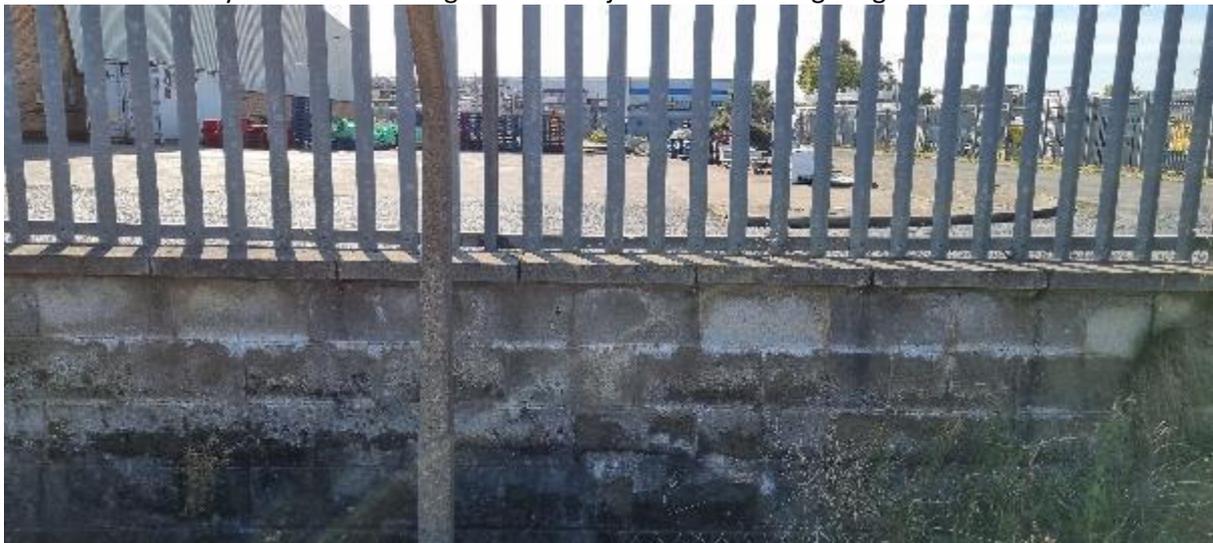
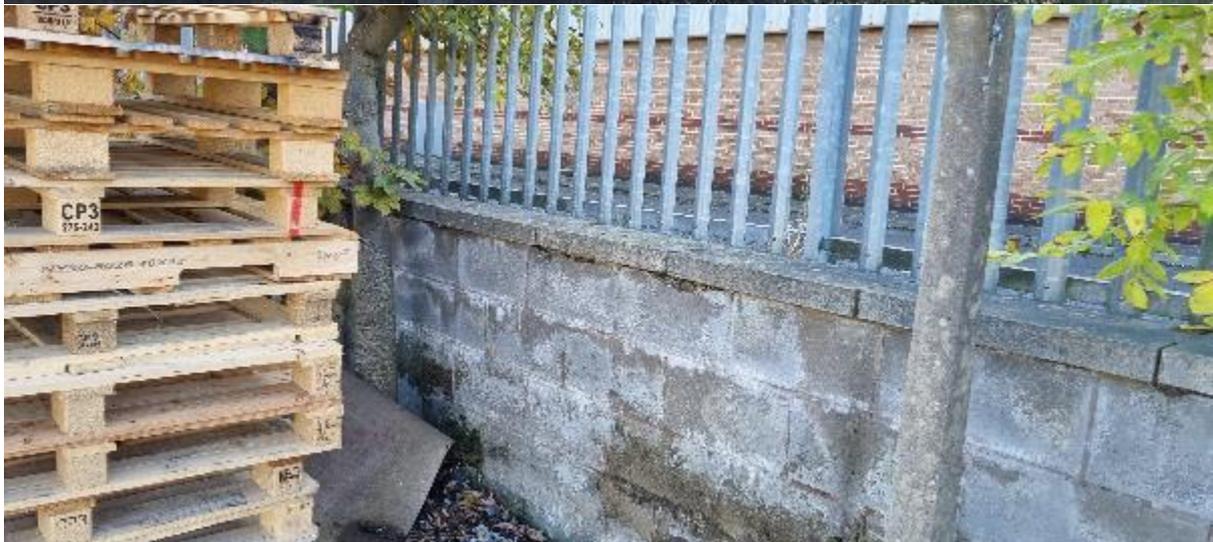
The site has been lifted and levelled during its construction as can be seen to the edge of the apron. Although the adjacent site is slightly higher.

Southern boundary of the site looking across at adjacent site and higher ground level

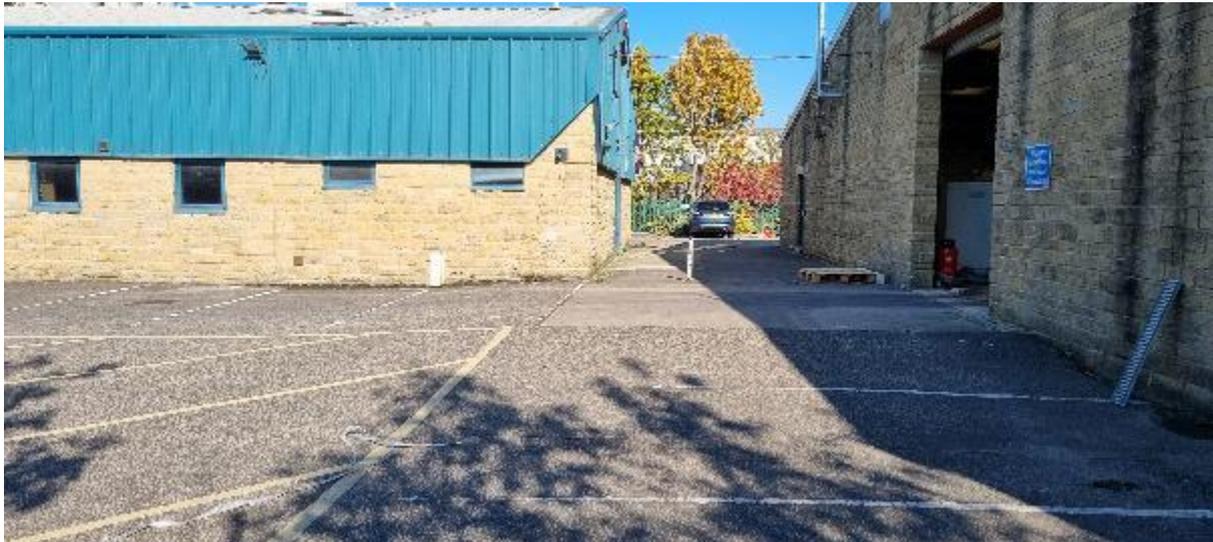
eastern boundary looking north

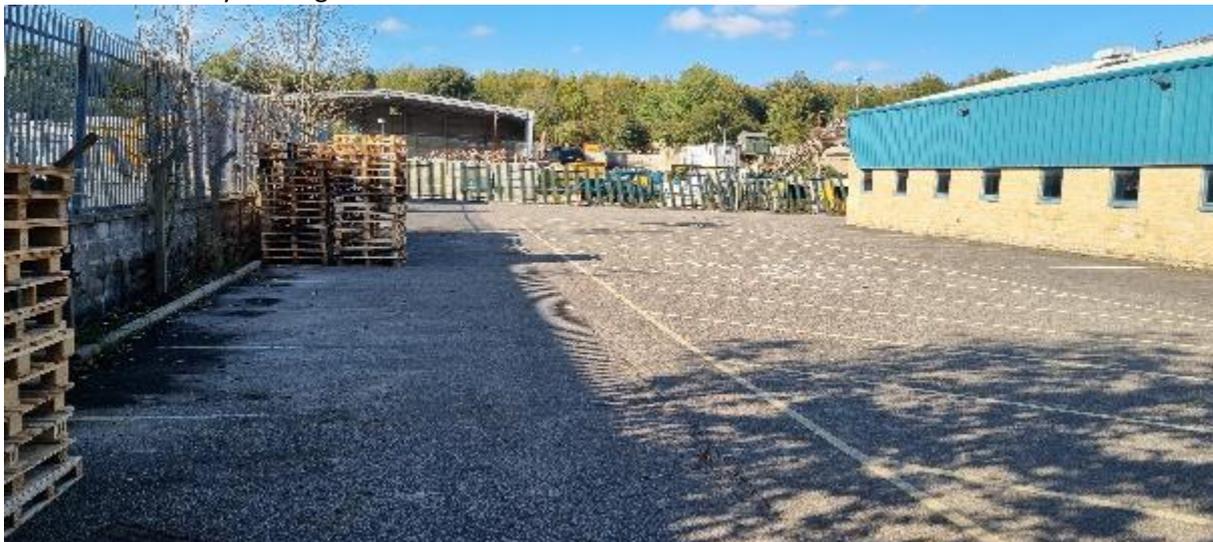
southern boundary looking west.

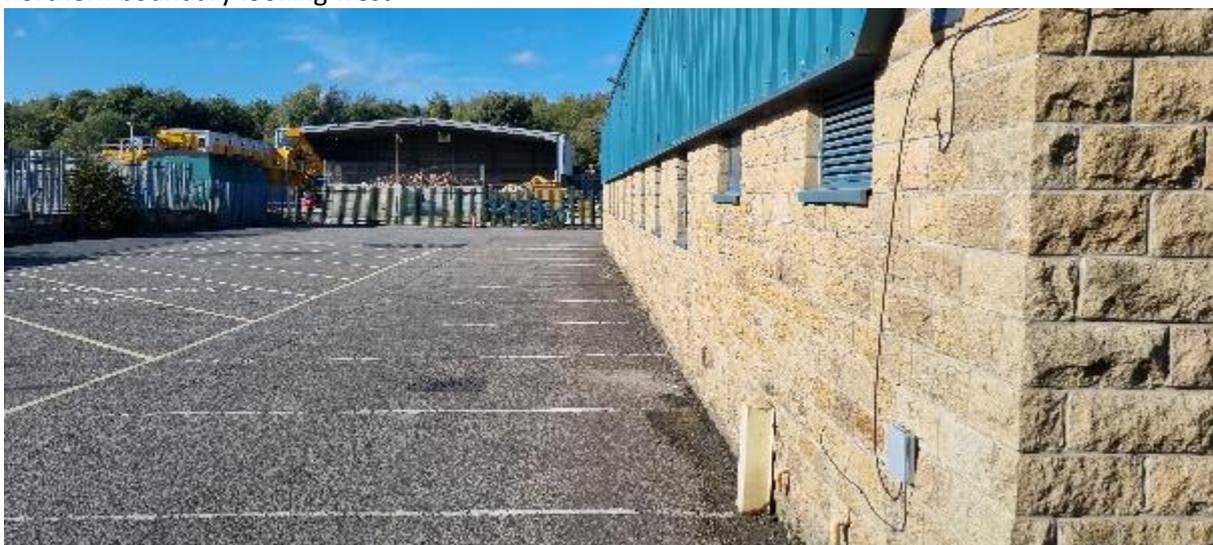
northern boundary looking west

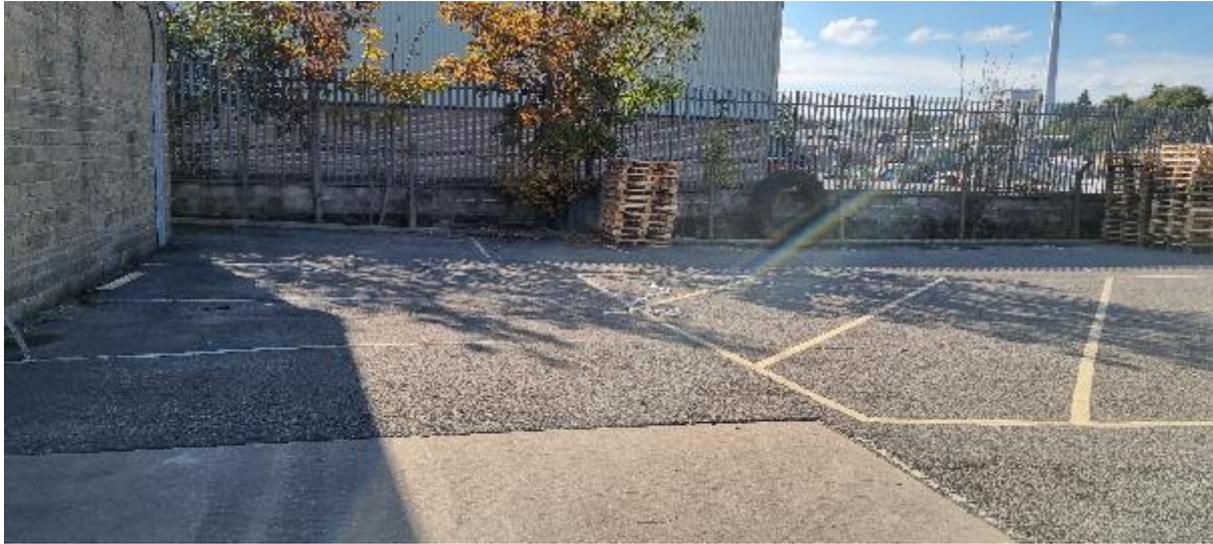
eastern boundary looking south
