Arboricultural Impact Assessment

WC-335.1a

Shelley Community Football Club

Report type:	Arboricultural Impact Assessment
Report reference:	WC-335.1
Revision:	a
Client:	The Leslie Sports Foundation
Site address	Shelley Community Football Club, Storthes Hall Park, off Storthes Hall Lane, Kirkburton, Huddersfield HD8 0WA
Grid reference:	SE 18331 12232
Report prepared by:	Jack Delaney MICFor MArborA
Date:	28 th November 2024

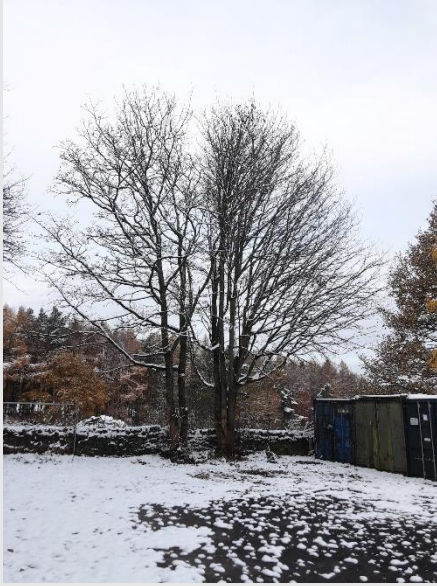
Plate 1: T001 (right) & T002 (left)

- 4.1.1. The development proposals will necessitate the removal of T001.
- 4.1.2. T001 is positioned within 1 m of the site of the proposed modular building, and therefore would significantly overhang the structure. Significant facilitation pruning would be required to T001 to enable construction, whilst branch encroachment, leaf drop, and honeydew (a sugar-rich sticky liquid, secreted by aphids and other insects), are likely to be the source of long term and ongoing nuisance.
- 4.1.3. T001 is a category C tree of low-quality only, and therefore in accordance with *BS 5837: 2012*, should not be considered a constraint to the proposed development.

Tree Ref:	Species	Age	SULE	Ht.	DBH	CS				CC	Comments	PC	SC	BS 5837: 2012 Category	Recommendations
						N	E	S	W						
T001	Sycamore (<i>Acer pseudoplatanus</i>)	SM	40-80	16	520	6.5	6.5	6.5	3.5	2.5	Bifurcates at 1 m into three co-dominant stems; unions are acute and are potentially included, though with multiple crossing branches higher in the crown providing natural bracing. Multiple pruning wounds and branch stubs on main stems from 1-3 m, sustained from historic crown lifting works. Historic fire damage to north aspect of main stems, with some minor decay to the exposed ripewood apparent.	F	PD	C1	Remove tree
T002	Sycamore (<i>Acer pseudoplatanus</i>)	SM	20-40	15	340 280	7	2	6	5.5	3	Bifurcates at ground level into two co-dominant stems. Multiple pruning wounds and branch stubs on main stems from 1-3 m, sustained from historic crown lifting works. Historic fire damage to north	F	PD	C1	No works recommended

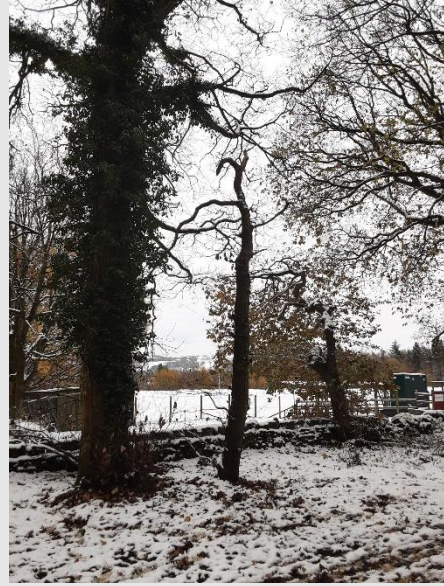
Plate 2: T003, T004, & T005 (left to right)

Tree Ref:	Species	Age	SULE	Ht.	DBH	CS				CC	Comments	PC	SC	BS 5837: 2012 Category	Recommendations
						N	E	S	W						
											aspect of main stems, with some minor decay to the exposed ripewood apparent.				
T003	Sycamore (<i>Acer pseudoplatanus</i>)	M	40-80	24	760	7	11	7.5	6	3	Dense ivy <i>Hedera helix</i> established on main stem and structural branches, which obscures tree features and potential defects, though upper portion of crown appears of fair vitality and vigour with no indication of physiological dysfunction.	F	F	B2	No works recommended
T004	Sessile oak (<i>Quercus petraea</i>)	SM	5-10	6	310	2	3	1	1	1.5	Moribund tree.	P	PD	U	No works recommended
T005	Sessile oak (<i>Quercus petraea</i>)	SM	20-40	7	420	3	6	3	1	2	Suppressed by the adjacent trees, with asymmetrical crown spread in result. First order branch extending east at 2.5 m has historically been removed, with significant residual pruning wound left in result.	F	PD	C2	No works recommended

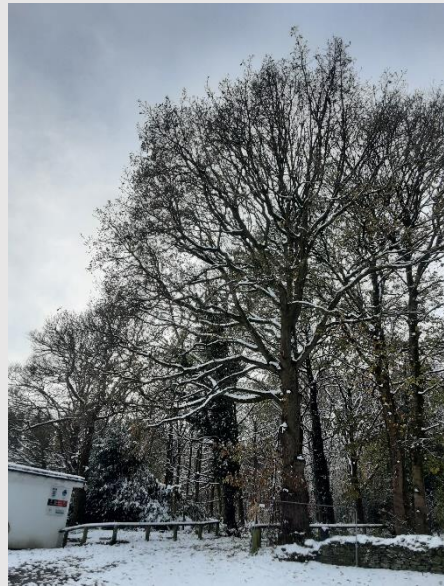
Plate 4: T006

T006	Sessile oak (<i>Quercus petraea</i>)	M	80 +	22	990	9.5	9	11	5	3.5	Asymmetrical form due to proximity with adjacent trees. Multiple pruning wounds and branch stubs on main stems from 1-3 m, sustained from historic crown lifting works. Minor deadwood < 100 mm in diameter scattered throughout the crown	F	F	A2	No works recommended
T007	Sycamore (<i>Acer pseudoplatanus</i>)	EM	40-80	24	530	6	7	2.5	3	2	Asymmetrical form due to proximity with adjacent trees.	G	F	B2	No works recommended
T008	Sycamore (<i>Acer pseudoplatanus</i>)	M	40-80	24	1020	4.5	6	9	9.5	4	Asymmetrical form due to proximity with adjacent trees. Bifurcates at 1 m into two co-dominant stems; union is acute and is potentially included. Minor deadwood < 100 mm in diameter scattered throughout the crown	F	F	B2	No works recommended
T009	Sycamore (<i>Acer pseudoplatanus</i>)	SM	40-80	15	430	1.5	5	6	4	8	Dense ivy <i>Hedera helix</i> established on main stem and structural branches, which obscures tree features and potential defects, though upper portion of crown appears of fair vitality and vigour with no indication of physiological dysfunction.	F	F	B2	No works recommended

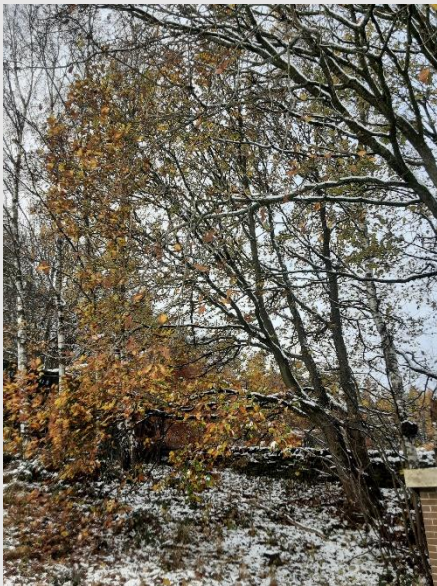
Plate 7: T010

Tree Ref:	Species	Age	SULE	Ht.	DBH	CS				CC	Comments	PC	SC	BS 5837: 2012 Category	Recommendations
						N	E	S	W						
T010	Sessile oak (<i>Quercus petraea</i>)	EM	40-80	16	420 410	9	2	8	8.5	0.5	Bifurcates at 0.5 m into two co-dominant stems; union appears structurally optimised. Asymmetrical form due to proximity with adjacent trees. Minor deadwood < 100 mm in diameter scattered throughout the crown	F	F	B1	No works recommended

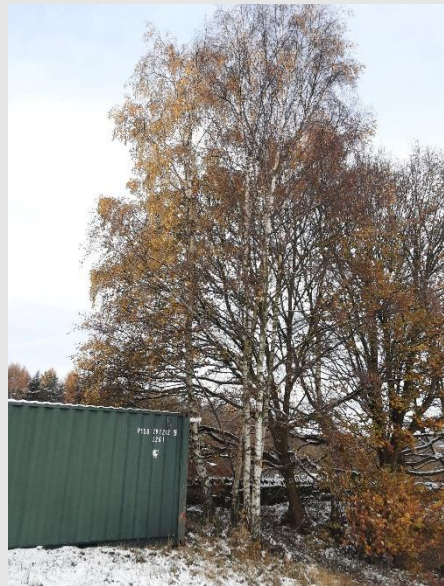
Plate 8: G001

Group Ref:	Species Composition	Age	SULE	Mx. Ht.	Mx. DBH	Approx. No. of Stems	CC	Comments	V	SC	BS 5837:2012 Category	Recommendations
G001	Silver birch (<i>Betula pendula</i>) Sessile oak (<i>Quercus petraea</i>)	Y SM	40-80	15	260	6	3	Group containing six young and semi-mature trees, to east of existing containers. Trees display elongated forms due to density of group, with poor height to DBH ratios.	G	F	C1	No works recommended
