NOVEMBER 10, 2024

**BARNFIELD, BECKETT ROAD,  
DEWSBURY WF13 2LS**

TREE SURVEY AND RECOMMENDED WORKS

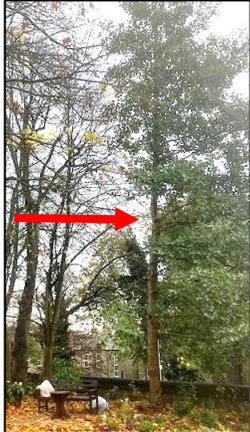
12m	260mm	G	S/M	Tree in good condition with no apparent defects. Lower branches extend over the road.	Raise crown to 2 metres by removing lower branches.
T2	Horse Chestnut <i>Aesculus hippocastanum</i>

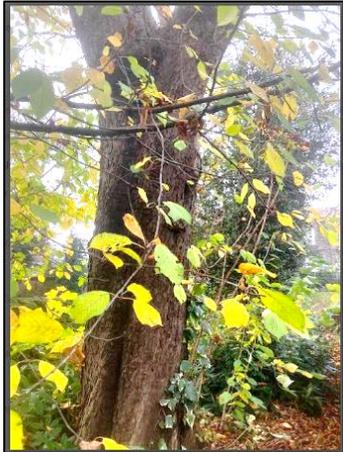
16m	800mm	G	M	A large mature tree in good condition with no apparent defects. It is trifurcated at 3 metres with a well-balanced crown.	No work required at present.

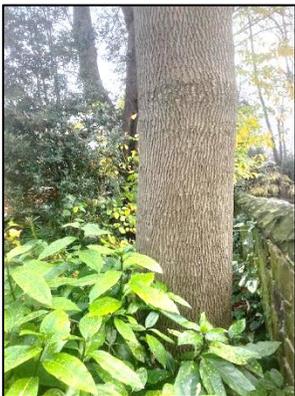
13m	570mm	G	S/M	A large single-stemmed mature tree in good health with no apparent defects.	<b>No work required.</b>
T4	Norway Maple <i>Acer platanoides</i>

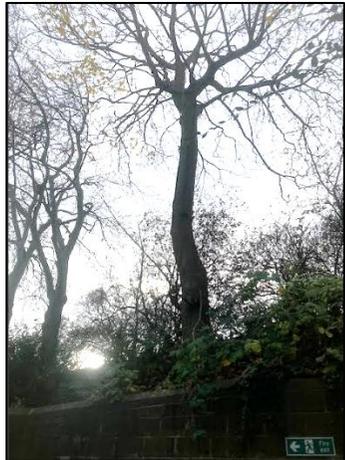
16m	560mm	G	M	A mature tree in good condition with a well-balanced crown and no apparent defects.	<b>No work required.</b>

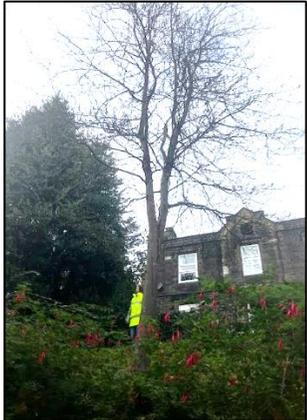
10m	280mm	D	S/M	Tree in severe decline with decay and cracks evident.	<b>Remove.</b>
T6	Holly <i>Ilex aquifolium</i>

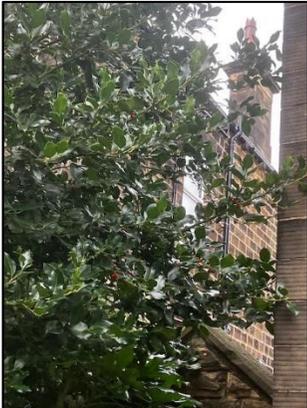
6m	150mm x2	G	M	A dual-stemmed tree in good condition with no apparent defects.	<b>Prune back branches by 1 metre extending towards the building.</b>

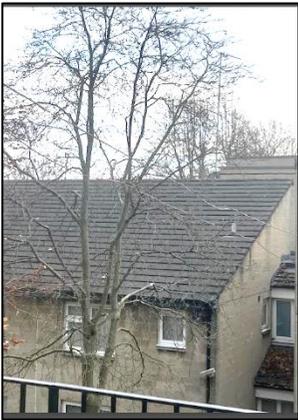
7m	250mm	G	S/M	Tree in good health with no apparent defects. Branches are conflicting with a cable.	<b>Prune back branches to clear the cable.</b>
T8	Beech <i>Fagus sylvatica</i>

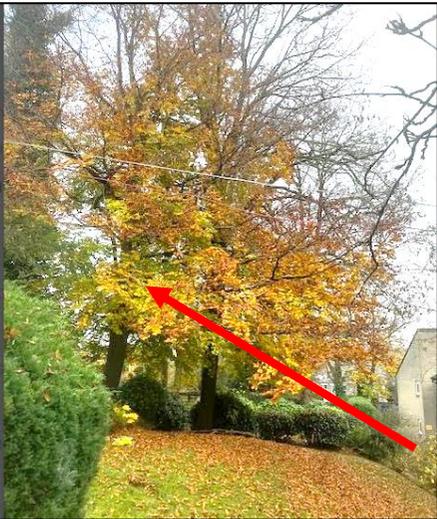
15m	500mm	G	M	A mature tree in good health with a well-balanced crown and no apparent defects.	<b>Prune branches conflicting with ash tree and prune back lower branches by 2 to 3 metres to allow more light into the garden.</b>

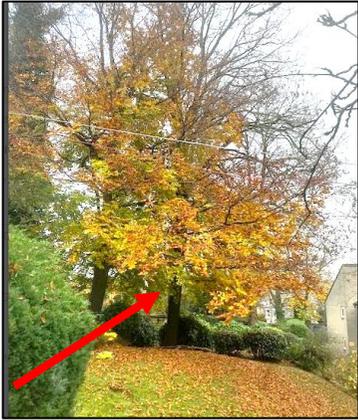
16m	550mm	G	M	Tree in good health with no apparent defects. It has an asymmetrical crown due to its close proximity to the beech (T8).	<b>No work required.</b>
T10	Whitebeam <i>Sorbus aria</i>

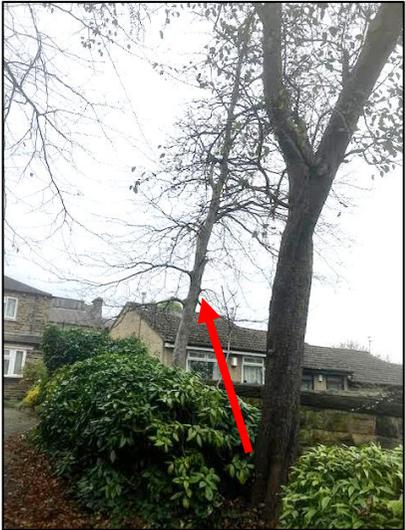
8m	270mm	G	S/M	A semi-mature tree in good health with a well-balanced crown and no apparent defects.	<b>No work required.</b>

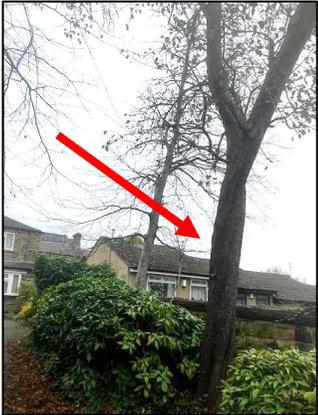
11m	500mm	G	M	Tree in good health with no apparent defects. It has a well-balanced crown.	<b>No work required.</b>
T12	Lime <i>Tilia x europaea</i>

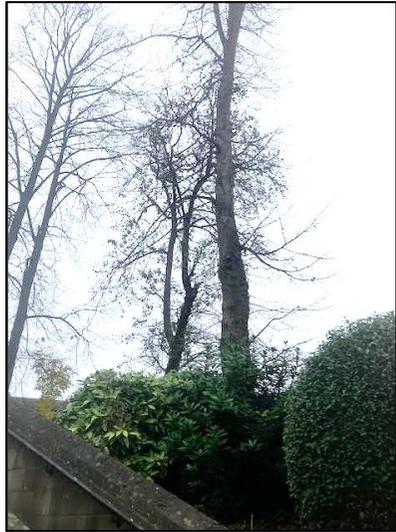
13m	600mm	G	M	A mature tree in good health with a well-balanced crown and no apparent defects.	<b>No work required.</b>

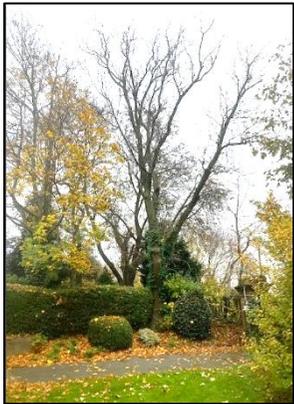
12m	700mm	G	S/M	Tree in good health with no apparent defects. The trunk is covered in ivy which is obstructing a clear visual assessment.	<b>Remove ivy from base to 2 metres.</b>
T14	Sycamore <i>Acer pseudoplatanus</i>

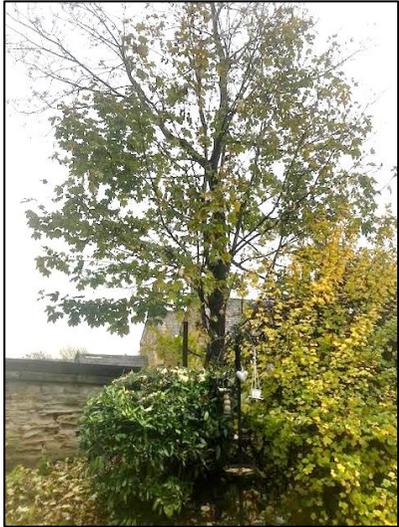
7m	270mm	G	S/M	A semi-mature tree in good health with a well-balanced crown and no apparent defects.	<b>No work required.</b>

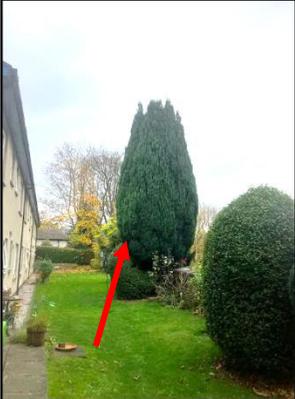
6m	500mm	G	S/M	Tree in good health with no apparent defects.	Trim periodically to maintain size and shape.
T16	Rowan <i>Sorbus aucuparia</i>

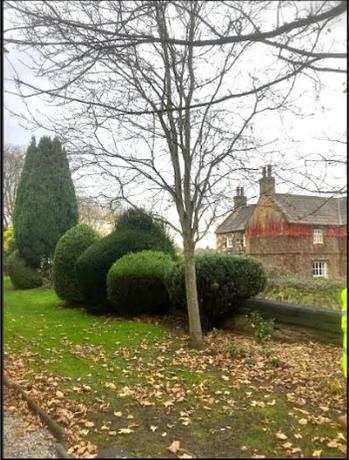
8m	190mm	G	Y	A young tree in good health with a well-balanced crown and no apparent defects.	No work required.

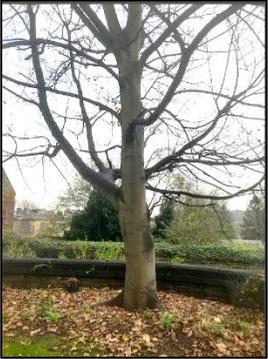
10m	520mm	G	M	Tree in good health with no apparent defects. It has a wide extensive broad crown.	Raise the canopy over the road by 2 metres and prune back branches extending towards the building by 2 metres.
T18	Sycamore <i>Acer pseudoplatanus</i>

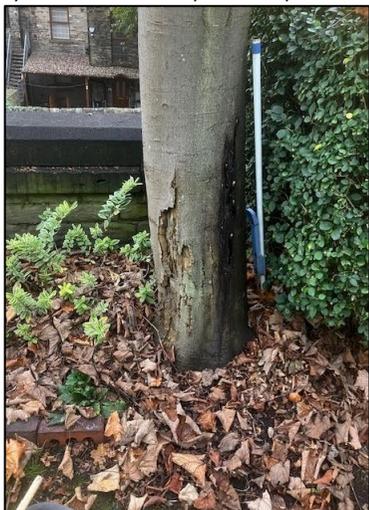
7m	340mm	P	S/M	Tree in poor health with evidence of significant decay.	Remove.

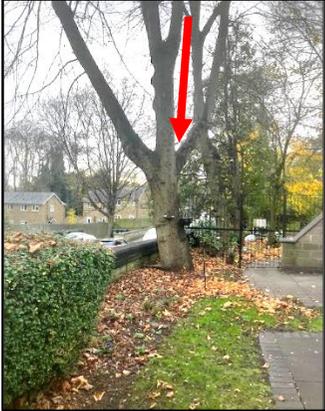
7m	250mm	G	S/M	A mature tree in moderate health. There is some decay evident in the lower section of a primary limb.	A crown reduction to previous pruning points (appx 3 metres). Monitor decay.

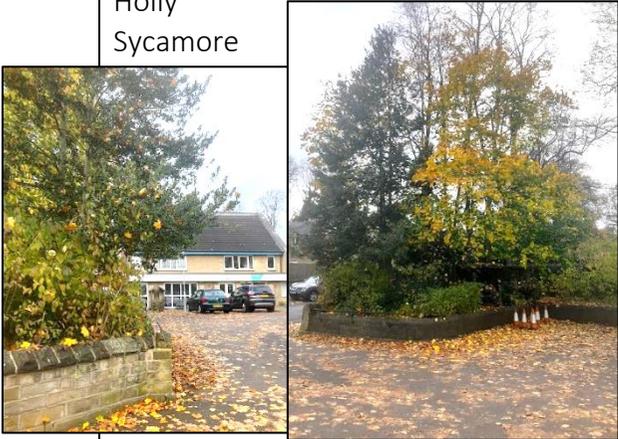
12m	280mm	G	S/M	A young group of trees located adjacent to the front boundary. Branches over parking spaces are starting to obstruct vehicular access.	Prune back branches obstructing access and over parking spaces by approximately 2 metres.
G2	Hawthorn Lime

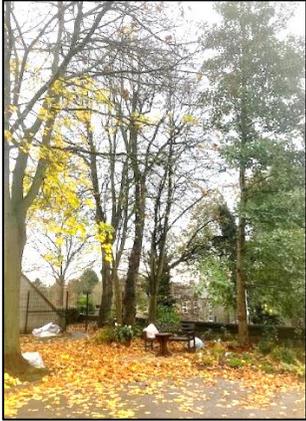
16m	400mm	G		One hawthorn and two lime trees in good condition. The limes have imbalanced crowns with branches extending towards the road.	Prune back lower limb of smaller lime to help to redress balance.

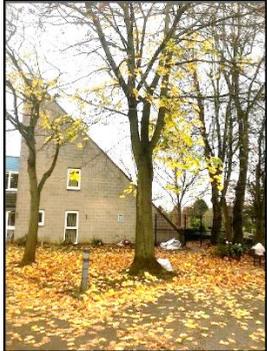
11m	350mm	G	S/M	Two single-stemmed trees in good condition. Branches are extending over the parking area and towards the building.	Prune back branches extending over parking area and towards the building by approximately 3 metres.
G4	Holly Sycamore

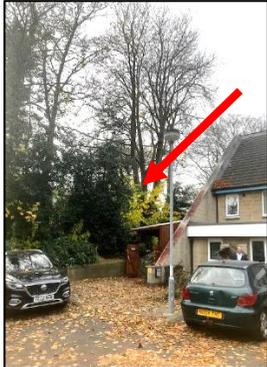
16m	450mm	G	S/M	Linear group of trees in good condition. Ivy prevents a clear visual inspection.	Remove ivy from base to 2 metres. Raise crown holly tree crown to clear fence and gateway by 1 metre.

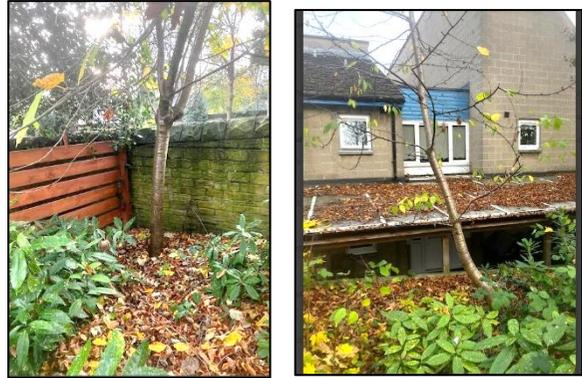
4m	100mm	G	Y	A group of trees located adjacent to boundary. One of the cherry trees a has a significant lean towards the building.	<b>Remove leaning cherry tree.</b>
G6	Whitebeam <i>Sorbus aria</i>

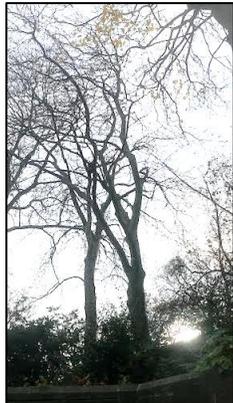
11m	360mm	G	M	A pair of sorbus trees with single stems, in very good condition.	<b>No work required at present.</b>

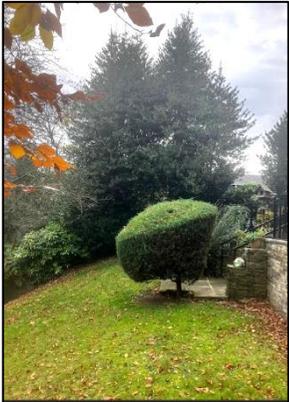
12m	300mm	G	S/M	Two trees located on the boundary. They are oversized for the location	<b>Prune/trim to maintain size and shape.</b>
G8	Laburnum Magnolia

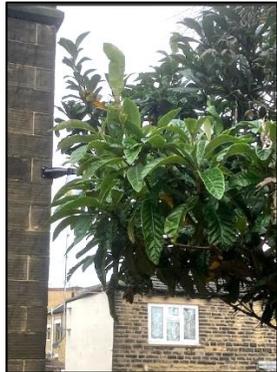
4m	150mm	G	Y	Three young trees/shrubs in good condition with branches extending towards the building.	<b>Prune back branches by 1 metre to clear building.</b>

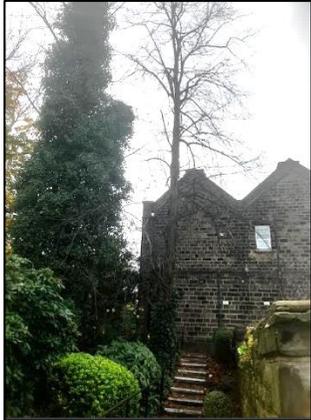
17m	400mm	G	M	Two tall mature trees in good condition with no apparent defects. One tree is clad in ivy preventing a clear assessment.	<b>Remove ivy from base to 2 metres.</b>
