SA 21603 209 Scar Lane, Milnsbridge

ARBORICULTURAL SURVEY REPORT | BS 5837:2012

January 2025

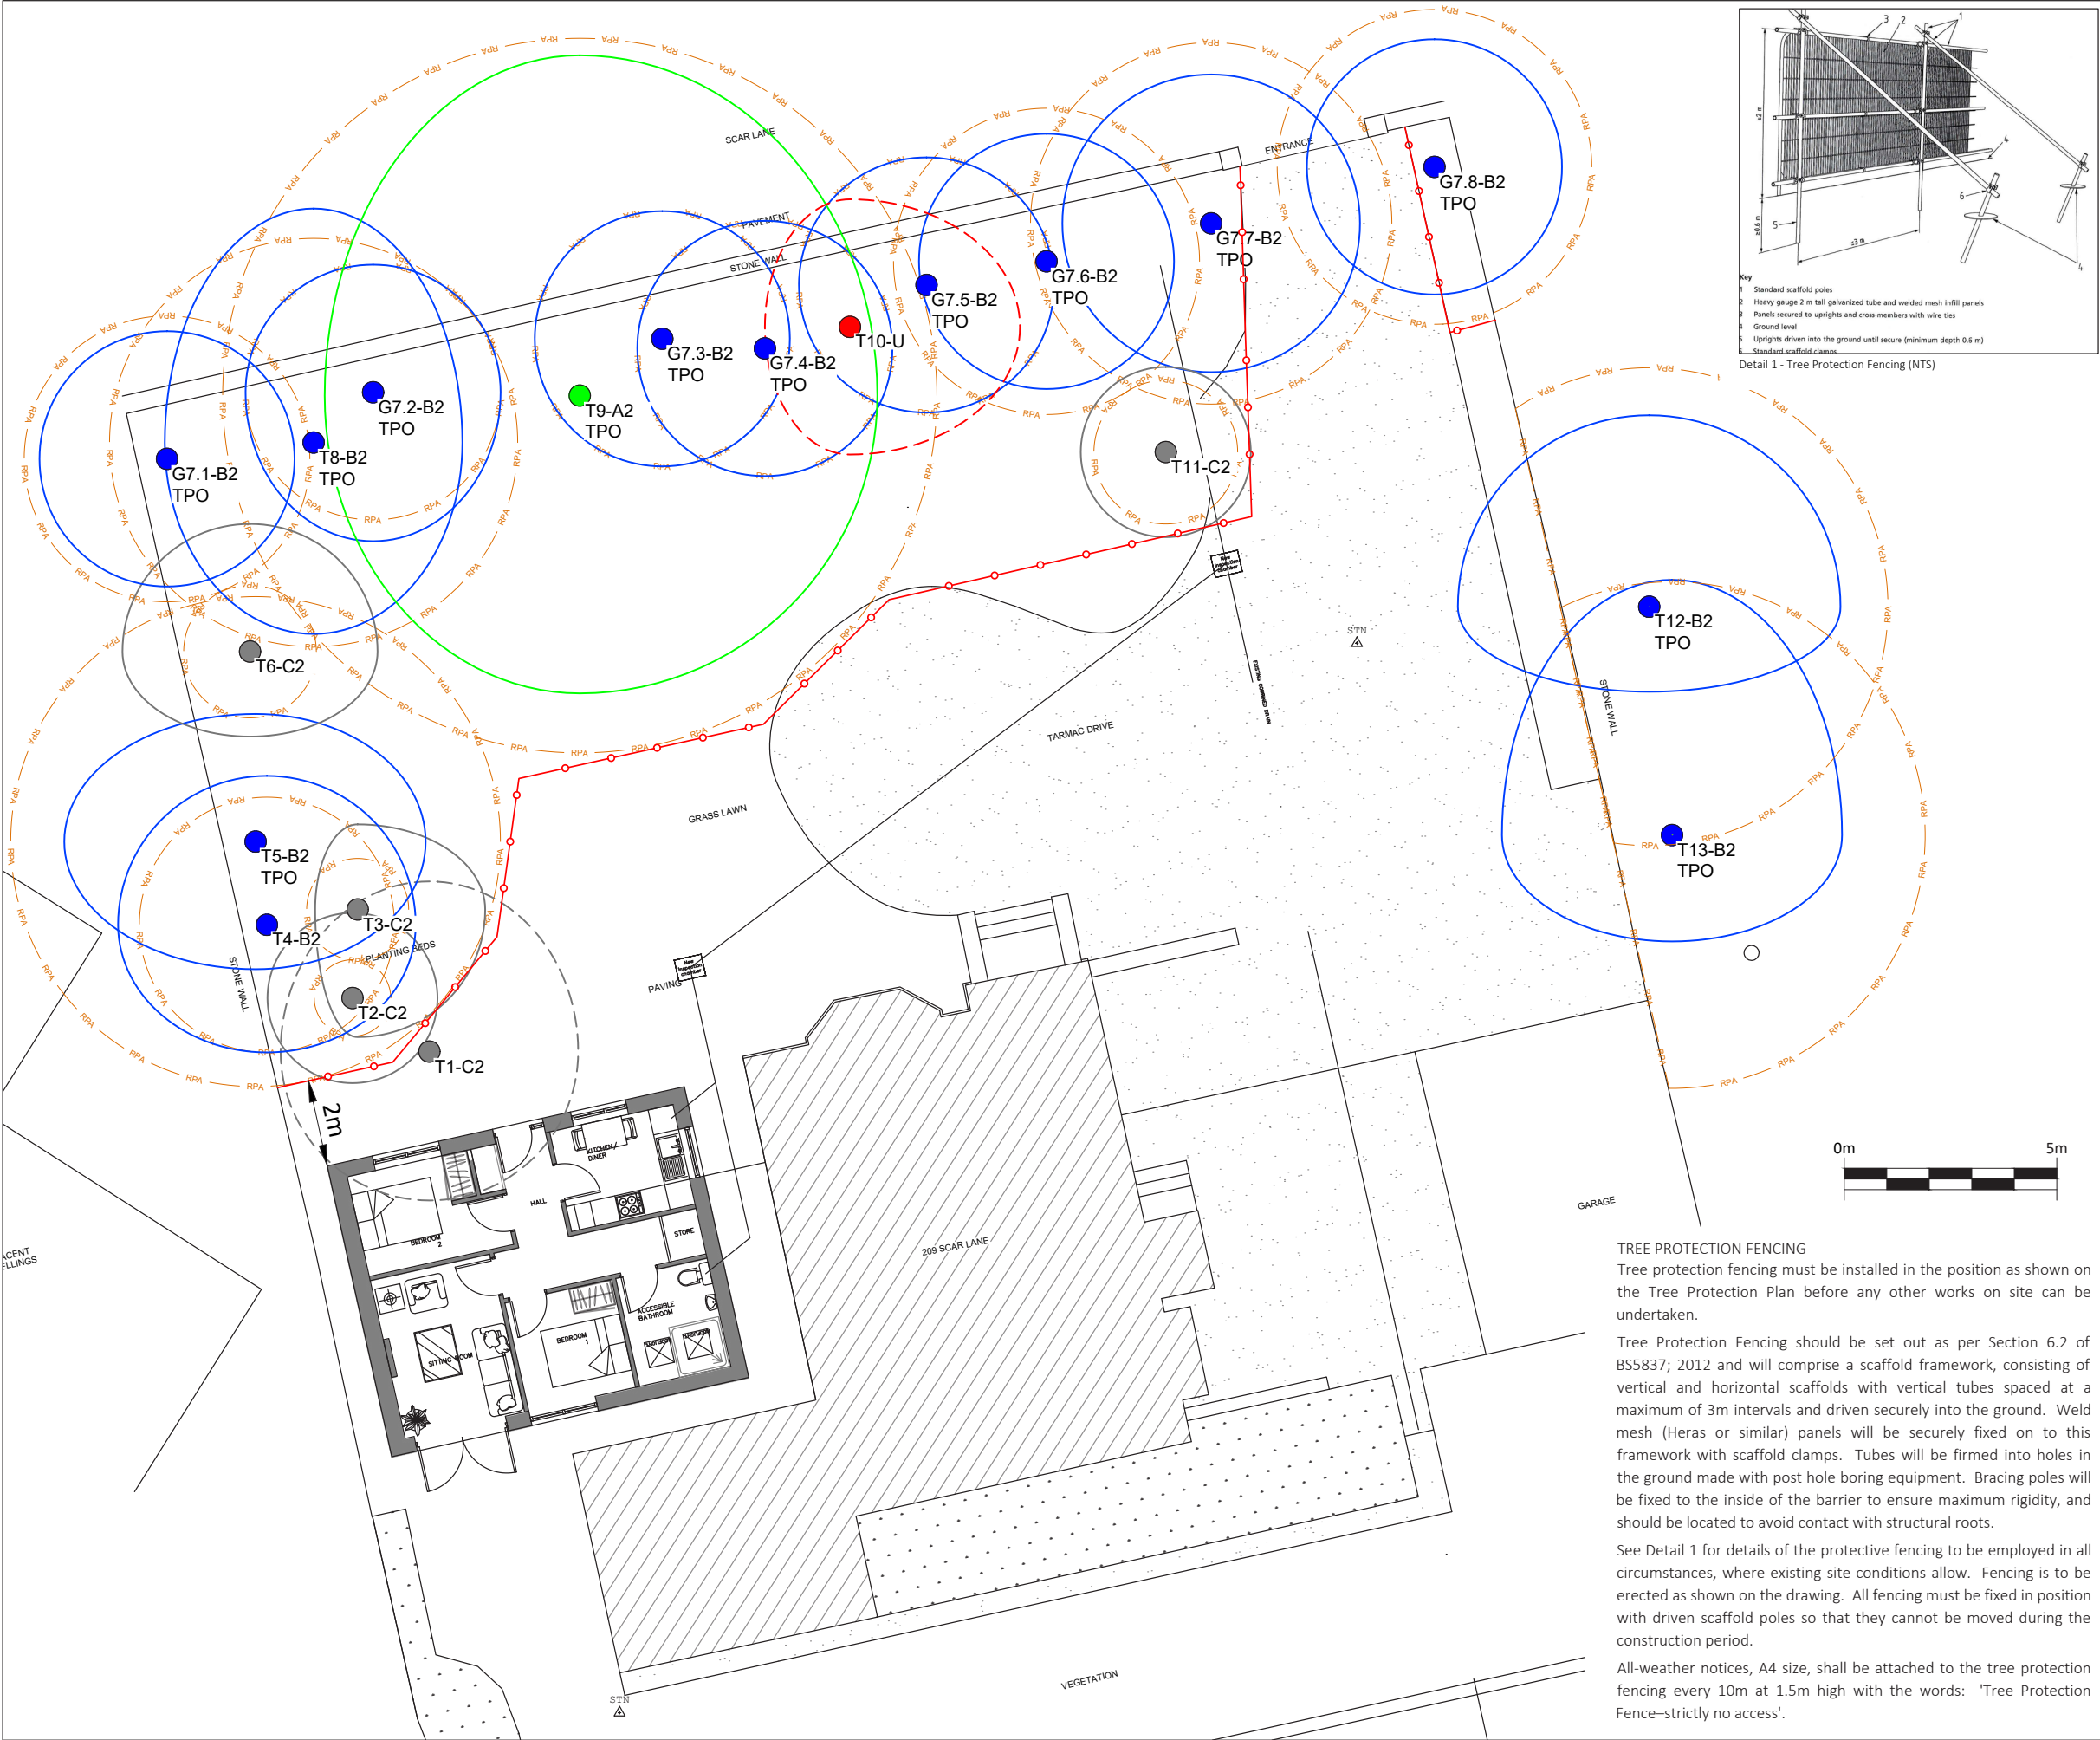
**ARBORICULTURAL IMPACT ASSESSMENT PLAN**

- 5.2.1 The proposed building will be 2m from the edge of the Root Protection Area (RPA) of the nearest TPO tree T5. The proposed drainage and inspection chambers will be located outside the RPA. The recommended location of tree protection fencing is indicated on drawing SA 21603 AIA01 (Appendix C).

- 5.7.1 The proposed building could be constructed without any impacts to the TPO trees on the north and western boundary. The RPA of all TPO trees on site can be fully protected whilst allowing sufficient clearance and space for construction.

See Detail 1 for details of the protective fencing to be employed in all circumstances, where existing site conditions allow. Fencing is to be erected as shown on the drawing. All fencing must be fixed in position with driven scaffold poles so that they cannot be moved during the construction period.
