Issue date: 28/10/2024

Monitoring visit **7** of **7**

## Monitoring Plus Report

| Address | Field House, Wood Street<br>Skelmanthorpe, Huddersfield<br>West Yorkshire<br><br>HD8 9BN | Principal area of damage | to be advised | Installed | 14/08/2023 |

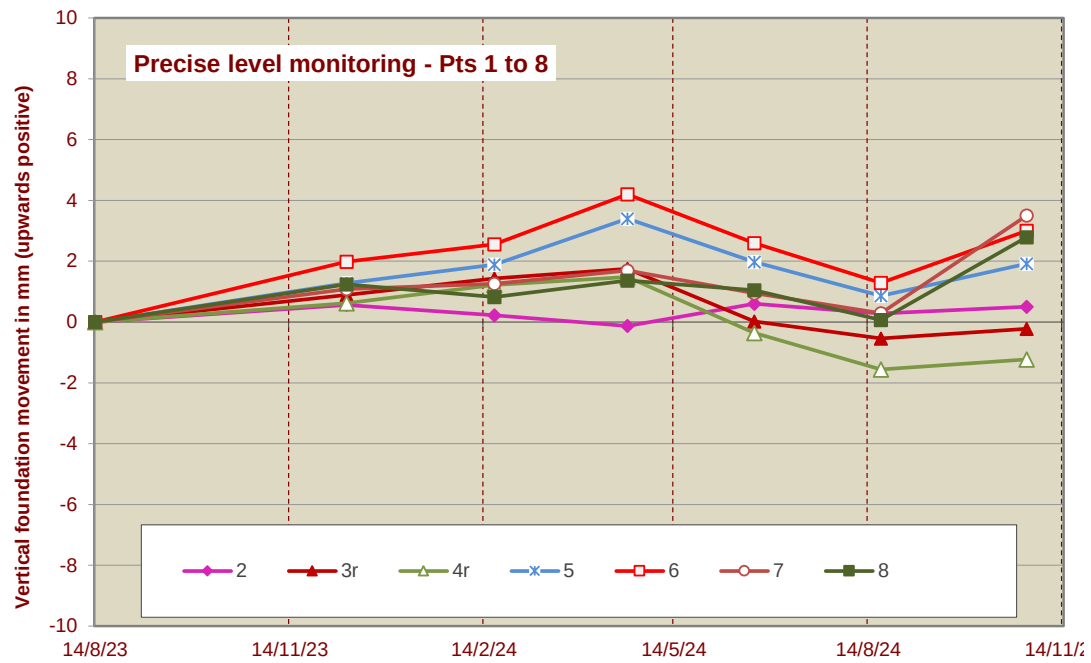
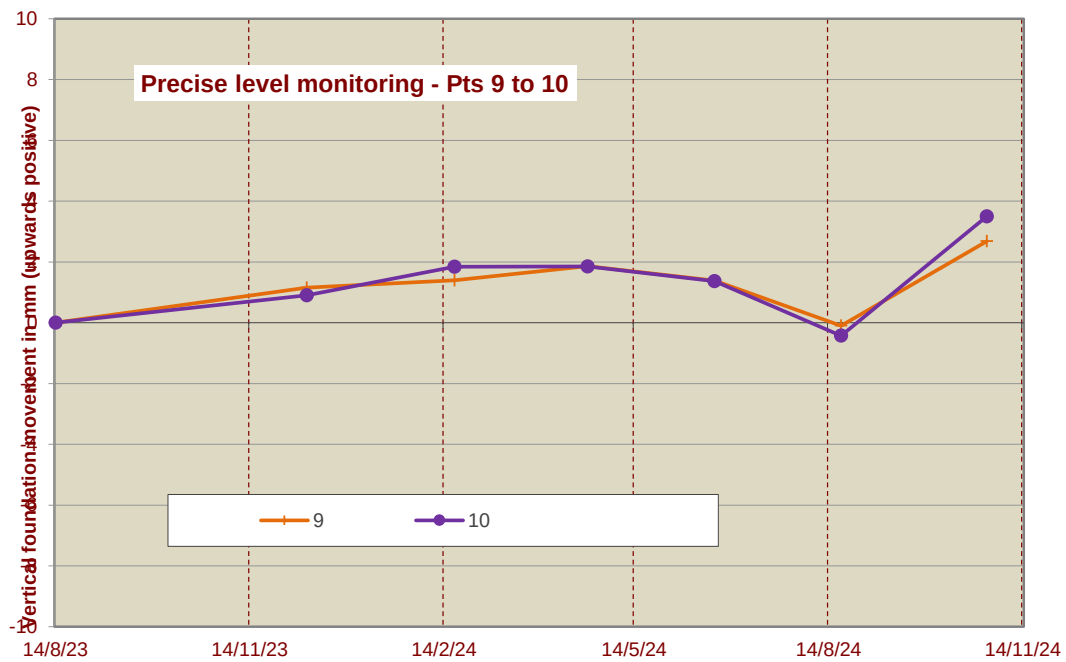
## Precise level monitoring related to Point 1

| Max move 4.2 mm | no feedback for this visit | | | | |
| Focal area Pts 4r, 5, 6, 7, 8, 9, 10, | | | | | |
