Engineers Report

Risk Address Field House
Wood Street
Skelmanthorpe
Huddersfield
West Yorkshire
HS8 9BN

Claim Reference 084665694
Policyholder Mr G Harper

Date Notified 26 September 2022
Date Instructed 26 September 2022
Report Date 30 November 2022

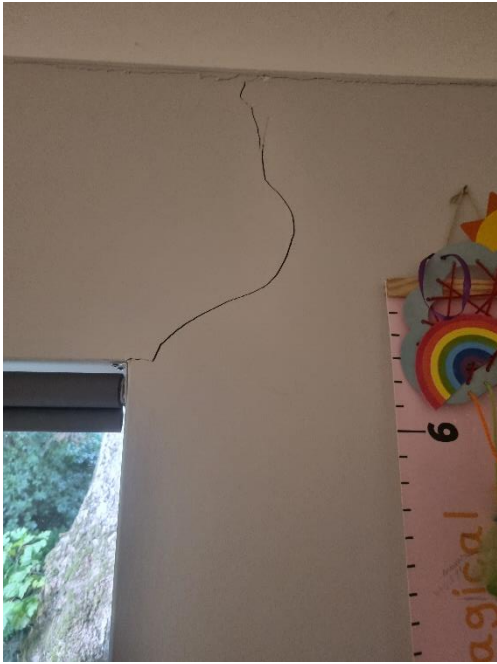
There is a diagonal 1-2mm crack to the front wall at high level, above the left-hand side of the front window. There is a 1mm crack at the junction of the front wall and the ceiling. There is a predominantly vertical 1-2mm crack to the front wall, beneath the front window board.

Diagonal cracking to front wall of front left-hand bedroom

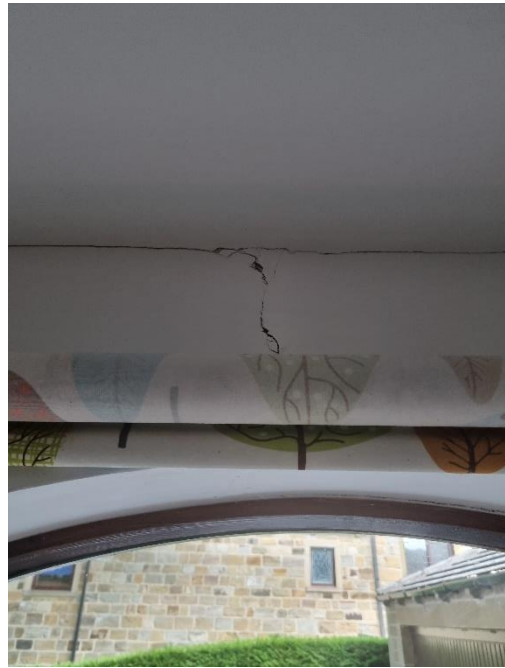
Vertical cracking to front wall of front left-hand bedroom

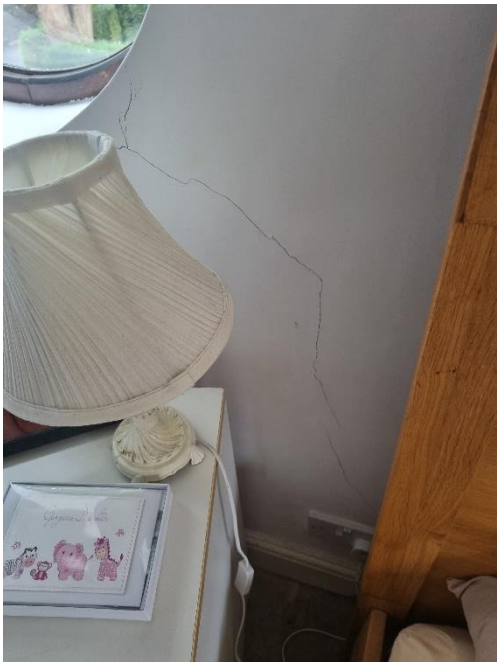
There is a diagonal 1-2mm crack to the rear of the left-hand wall at low level, underneath the left-hand circular window.

Diagonal cracking to left-hand wall of rear left-hand bedroom

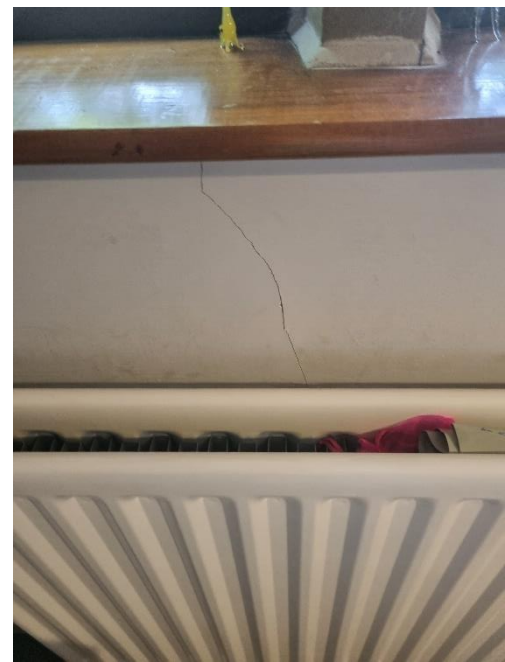
There is a predominantly vertical 1-2mm crack to the front wall, beneath the front window board.

Vertical cracking to front wall of front left-hand bedroom

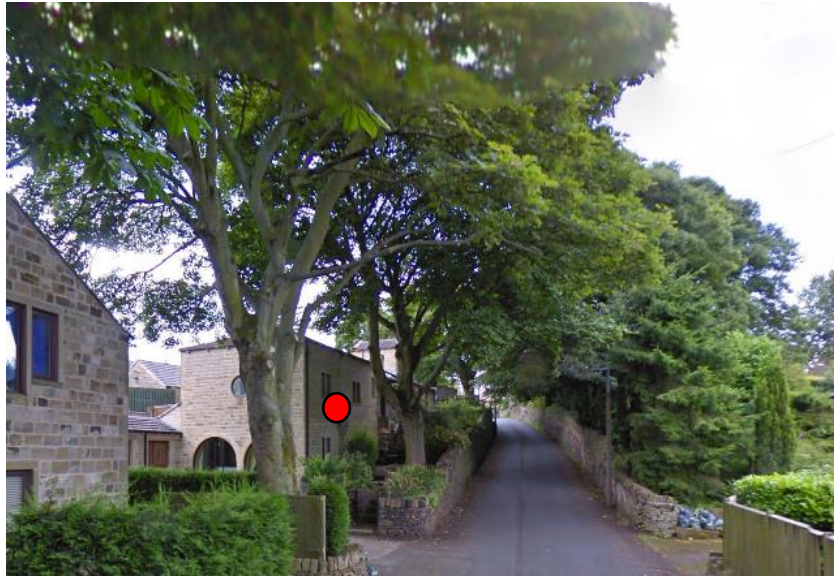
Previous photograph to show significance of Sycamore within the front garden

We note there is a significant Sycamore tree within the front garden, and there could be a possibility that roots from this vegetation has caused the clay sub-strata underneath the foundation of the property to shrink, and as such, cause localised subsidence movement to occur. In addition to this, we note the especially dry summer, and the increase in subsidence claims throughout the country. We need to therefore investigate this aspect further.

It should be noted however, that it is both likely that the Sycamore pre-dates the property's construction date, and, the Sycamore is on a higher level than the building, therefore the chance for roots getting underneath the foundation to cause potential shrinkage would be more difficult. We do need to investigate this further, though.

A trial pit and borehole will be undertaken to confirm the depth of the property's foundation, as well as assessing the content and condition of the sub-soil beneath the foundation, to both the front and rear elevations. This will also provide a good indicator as to whether the ground has been affected by an external influence, and allowed some slight downward movement of the foundation.
