SF3282 Cliff Hill, Denby Dale

ARBORICULTURAL SURVEY REPORT | BS 5837:2012

Revision B - October 2023

SMEEDEN FOREMAN

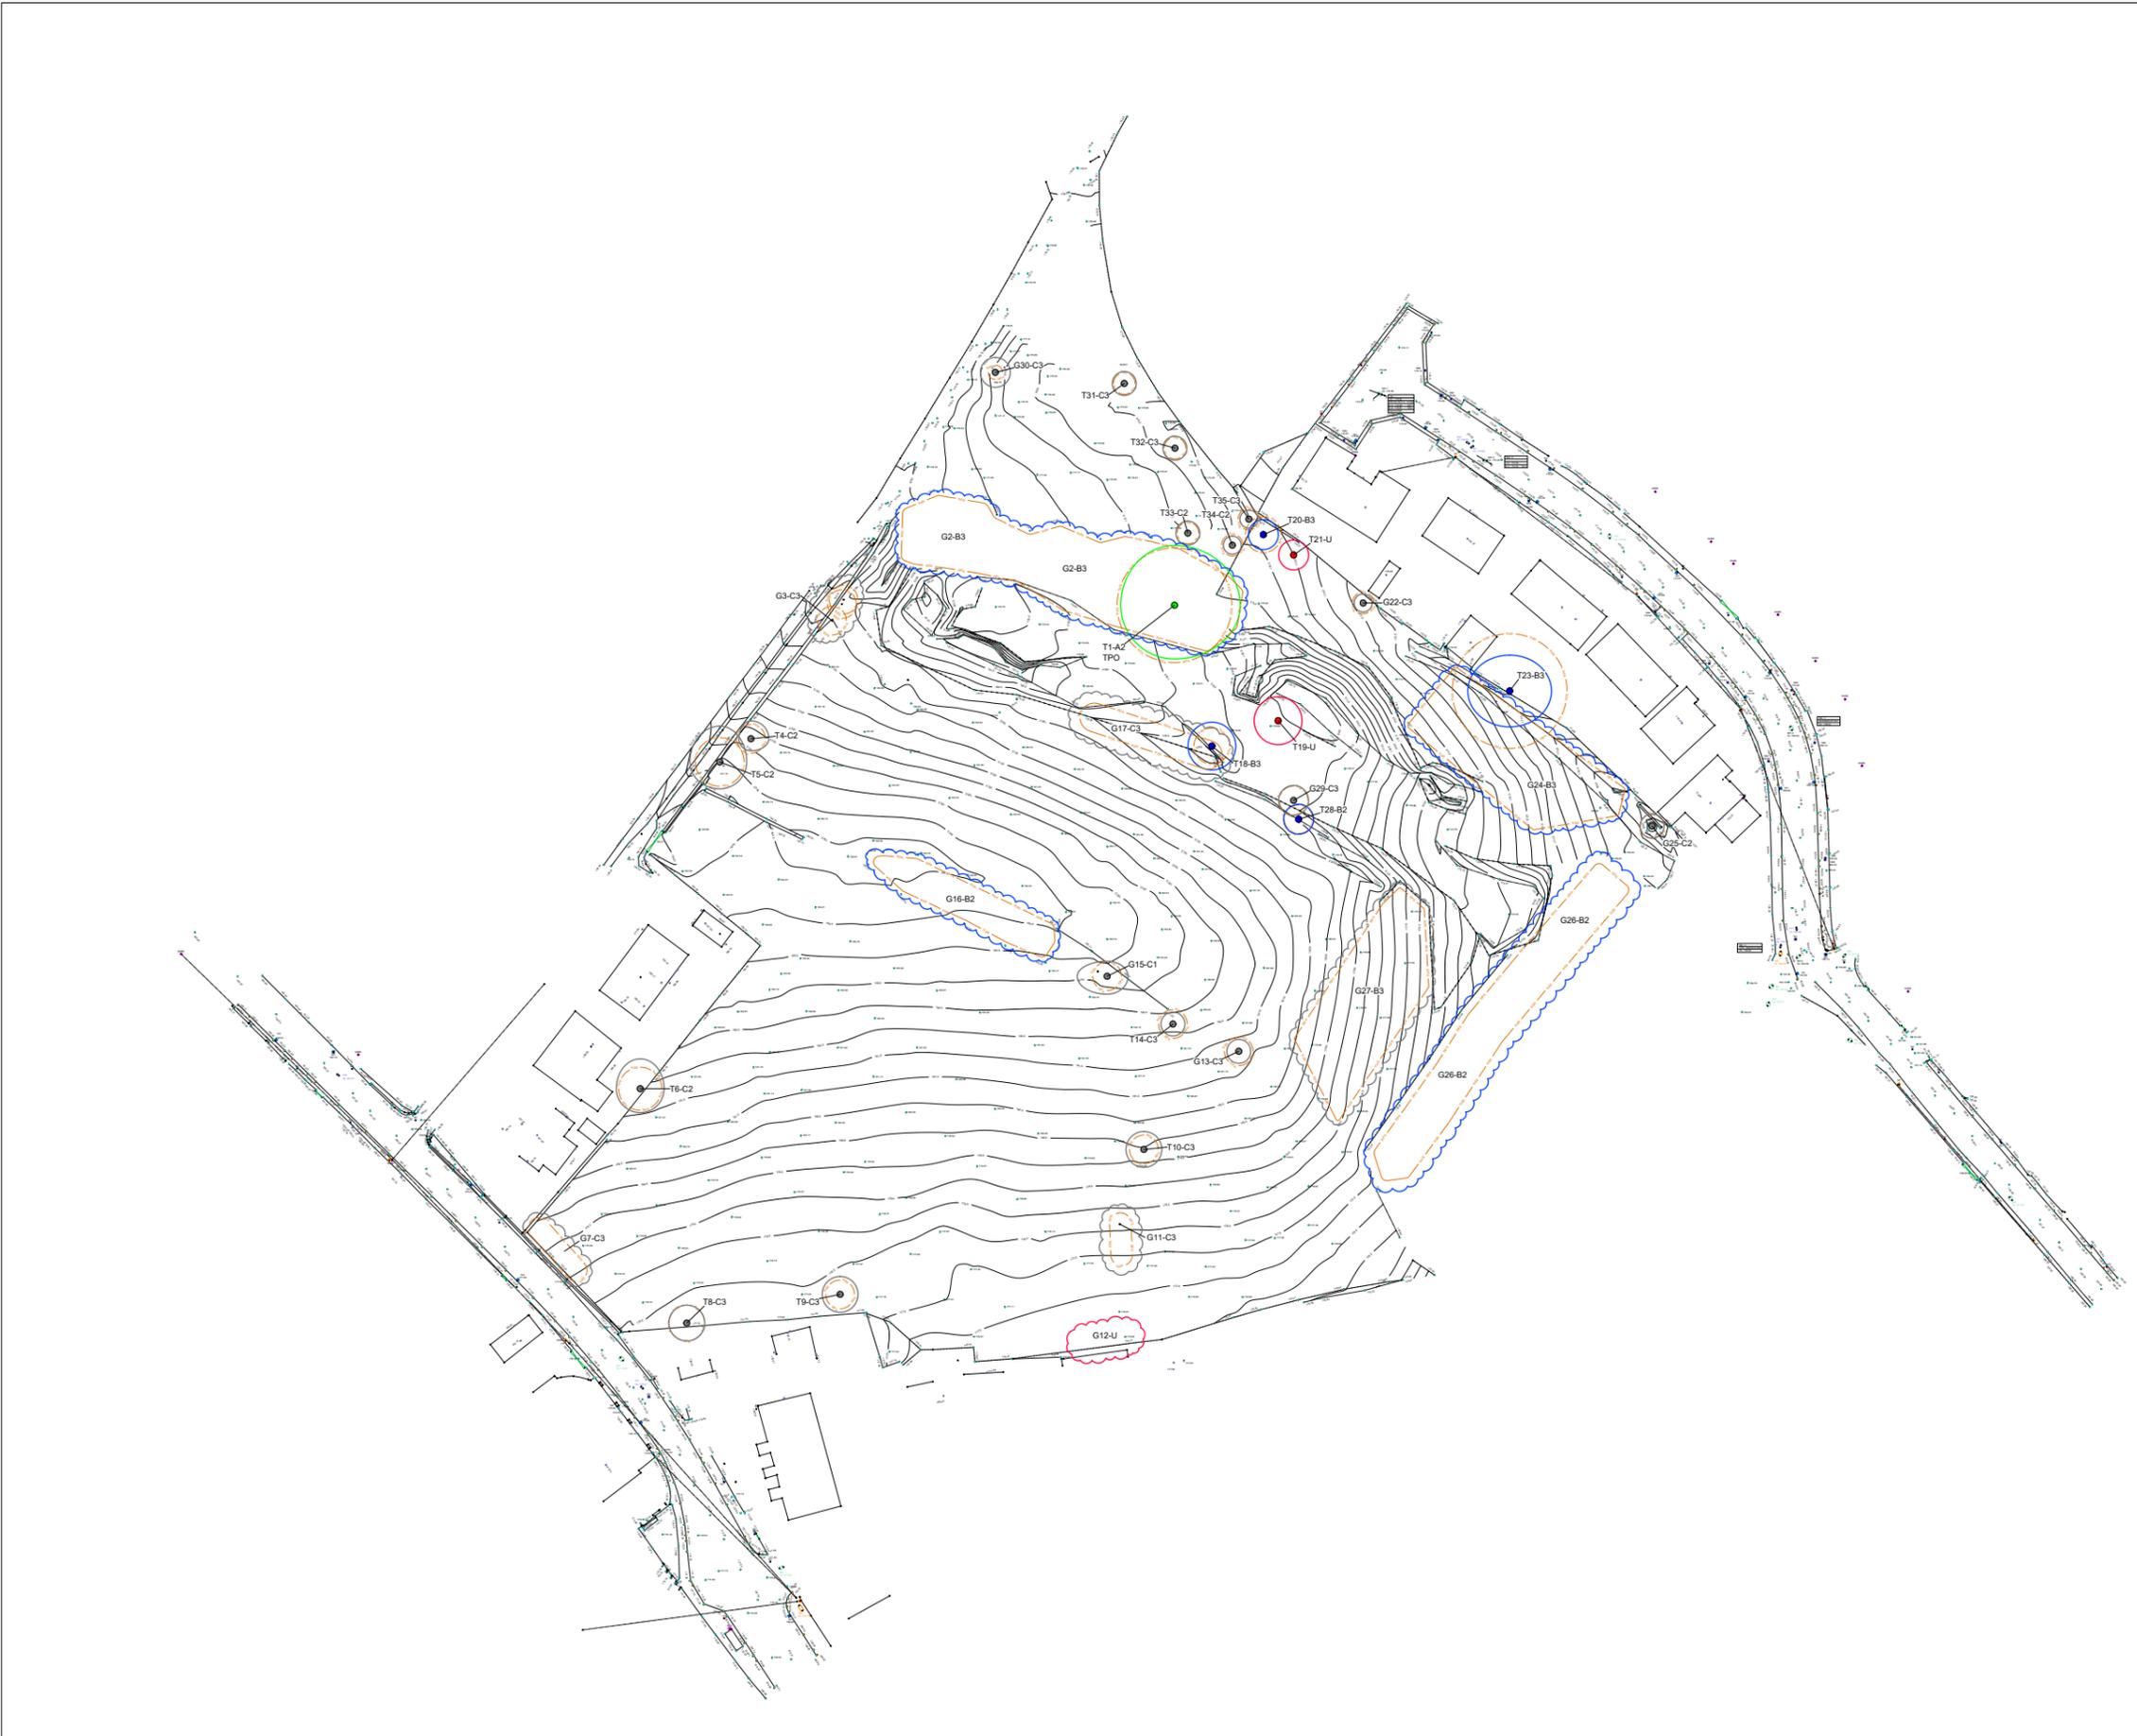
SF3282 TS01 Tree Survey Plan

Tree No. (Tag)	Species	Top Height (crown height) m	Branch Spread (m)				Stem Dia. (mm)	Age Class	Water Demand	Condition	Comments	ERC (years)	Recommendations	Category
			N	E	S	W								
T1 TPO	Quercus robur (Common Oak)	12(2)	10	11	9	9	800	M	H	Good	Broken branches in crown. Limited access. South lower 4 branches broken due to machinery, approx. 3m from stem.	40+	Remove soil to previous level. Prune broken branches back to natural junctions.	A1
G2	Fraxinus excelsior (Ash), Elder (Sambucus nigra), Ilex aquifolium (Holly), Prunus padus (Bird Cherry), Crataegus monogyna (Hawthorn)	8(0)	3	3	3	3	200	SM	H	Fair	Broken branches in crown. Overgrown hedgerow. Damage to south side branches. Soil heaped up to lower branches.	40+	Clear soil to previous level.	B3
G3	Fraxinus excelsior (Ash), Ilex aquifolium (Holly), Crataegus monogyna (Hawthorn)	7.5(0)	4	4	3	4	200	M	H	Fair	Multiple stems at ground level. Soil heaped up to lower branches.	40+	Clear soil to previous level.	C3

T5	Quercus robur (Common Oak)	6(2)	6	4.5	4.5	5	340	SM	H	Poor	Poor shape & form. Epicormics on stem. Broken branches in crown. Major deadwood in crown. Barb-wire enveloped in stem. Fracture of lower south branch.	20+	Remove remaining wire. Prune fractured branch to natural growth point.	C2
T4	Crataegus monogyna (Hawthorn)	4(0)	3	3	2	2	200	M	H	Fair	Unbalanced crown shape.	40+	NWR	C2

T19	Fraxinus excelsior (Ash)	11(2)	4	4	4	4	600	EM	M	Poor	Poor shape & form. Major bark wounding on stem. Stem divides below 1.5m. Included bark with compression fork. Recent bark damage on south side. Broken branches to south side. Base of tree obscured by piled up soil.	<10	Fell	U

- 3.1.1 Tree T1 (oak- category A) is a mature tree located in the north of the site. The tree is protected by a Tree Preservation Order. The tree is of high amenity value, with an attractive crown shape and is highly visible from the wider surrounding area. Some recent site activity has resulted in earth being moved onto the Root Protection Area (RPA) of T1, and some broken branches in the lower south side of the canopy. Despite the recent ground work, the tree appears to be in good physiological condition with no current sign of any dieback in the canopy. To maintain the health and long term retention of the tree we would recommend that the soil is cleared to the previous existing ground level and compaction damage remediated. The broken branches should be pruned back to natural junctions.

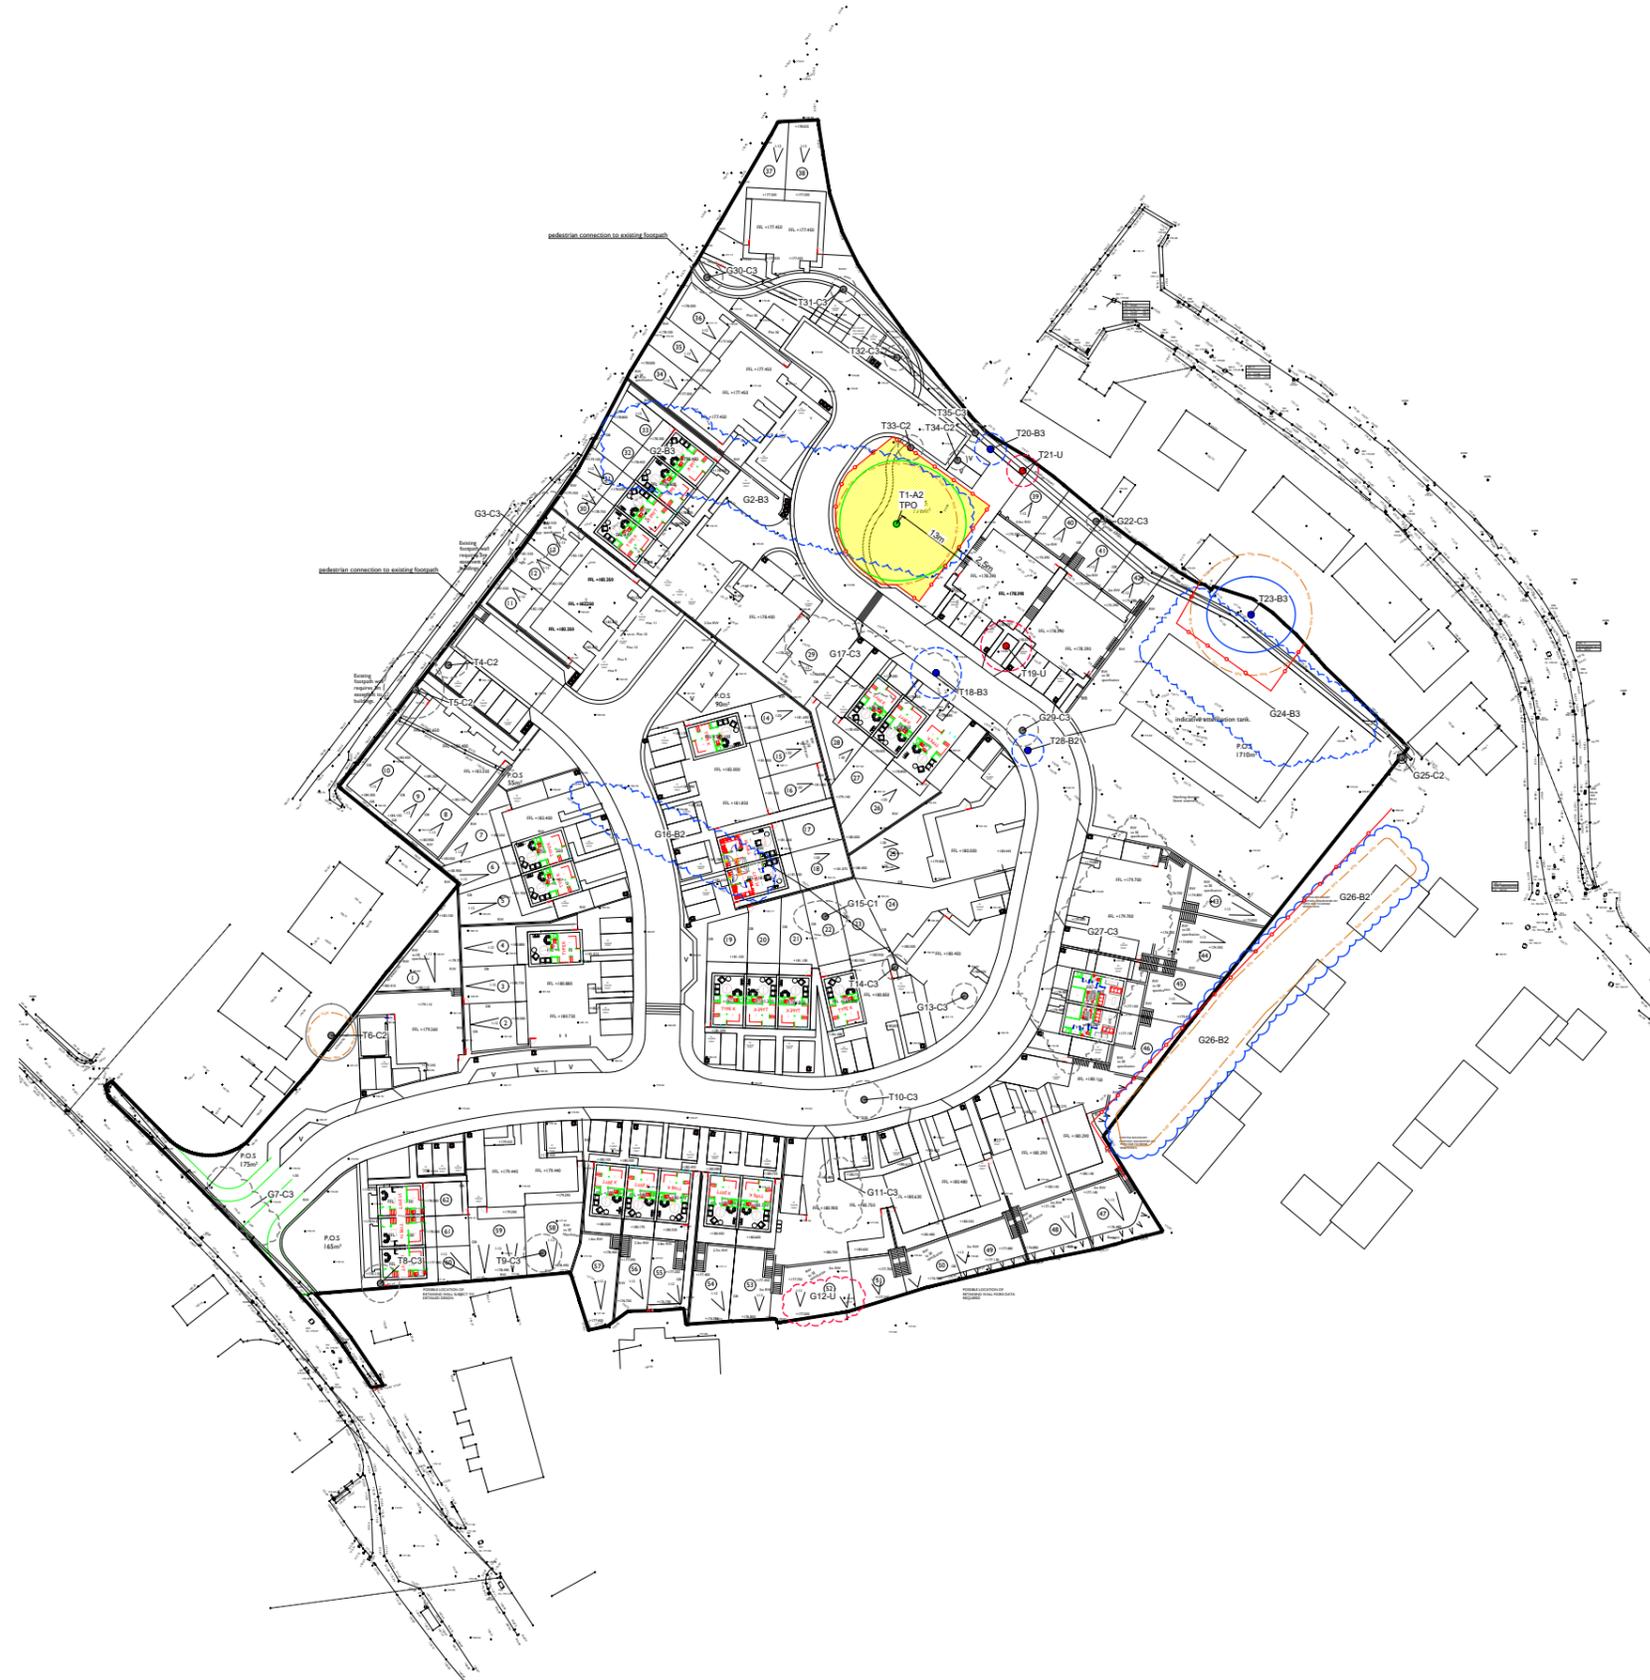
The scheme has been designed to retain tree T1 which is subject to a TPO. It was noted that previous site activity has resulted in earth being piled up in the Root Protection Area (RPA) of T1. The new levels of the earthworks are shown in the topographical survey. To maintain the health and long term retention of the tree, it is proposed to clear the excess soil and reinstatement the original ground level. Compaction damage in the RPA will be remediated. The construction of the proposed road is planned to follow the original site levels, therefore it can be constructed without a change in level at the boundary of the RPA.

**IMPACT OF PROPOSED POS FOOTPATH IN RPA.** The RPA of T1 is 290m<sup>2</sup>. The proposed footpath will cover 20m<sup>2</sup> of the total RPA. This represents an impact of 7% of the total RPA. This is well within the tolerance set out in BS5837, which recommends new hard surfacing should not exceed 20% of the RPA.

Tree No.	Species	Proposed Works	Category
T19	Ash	Removal	U
T21	Elder	Removal	U

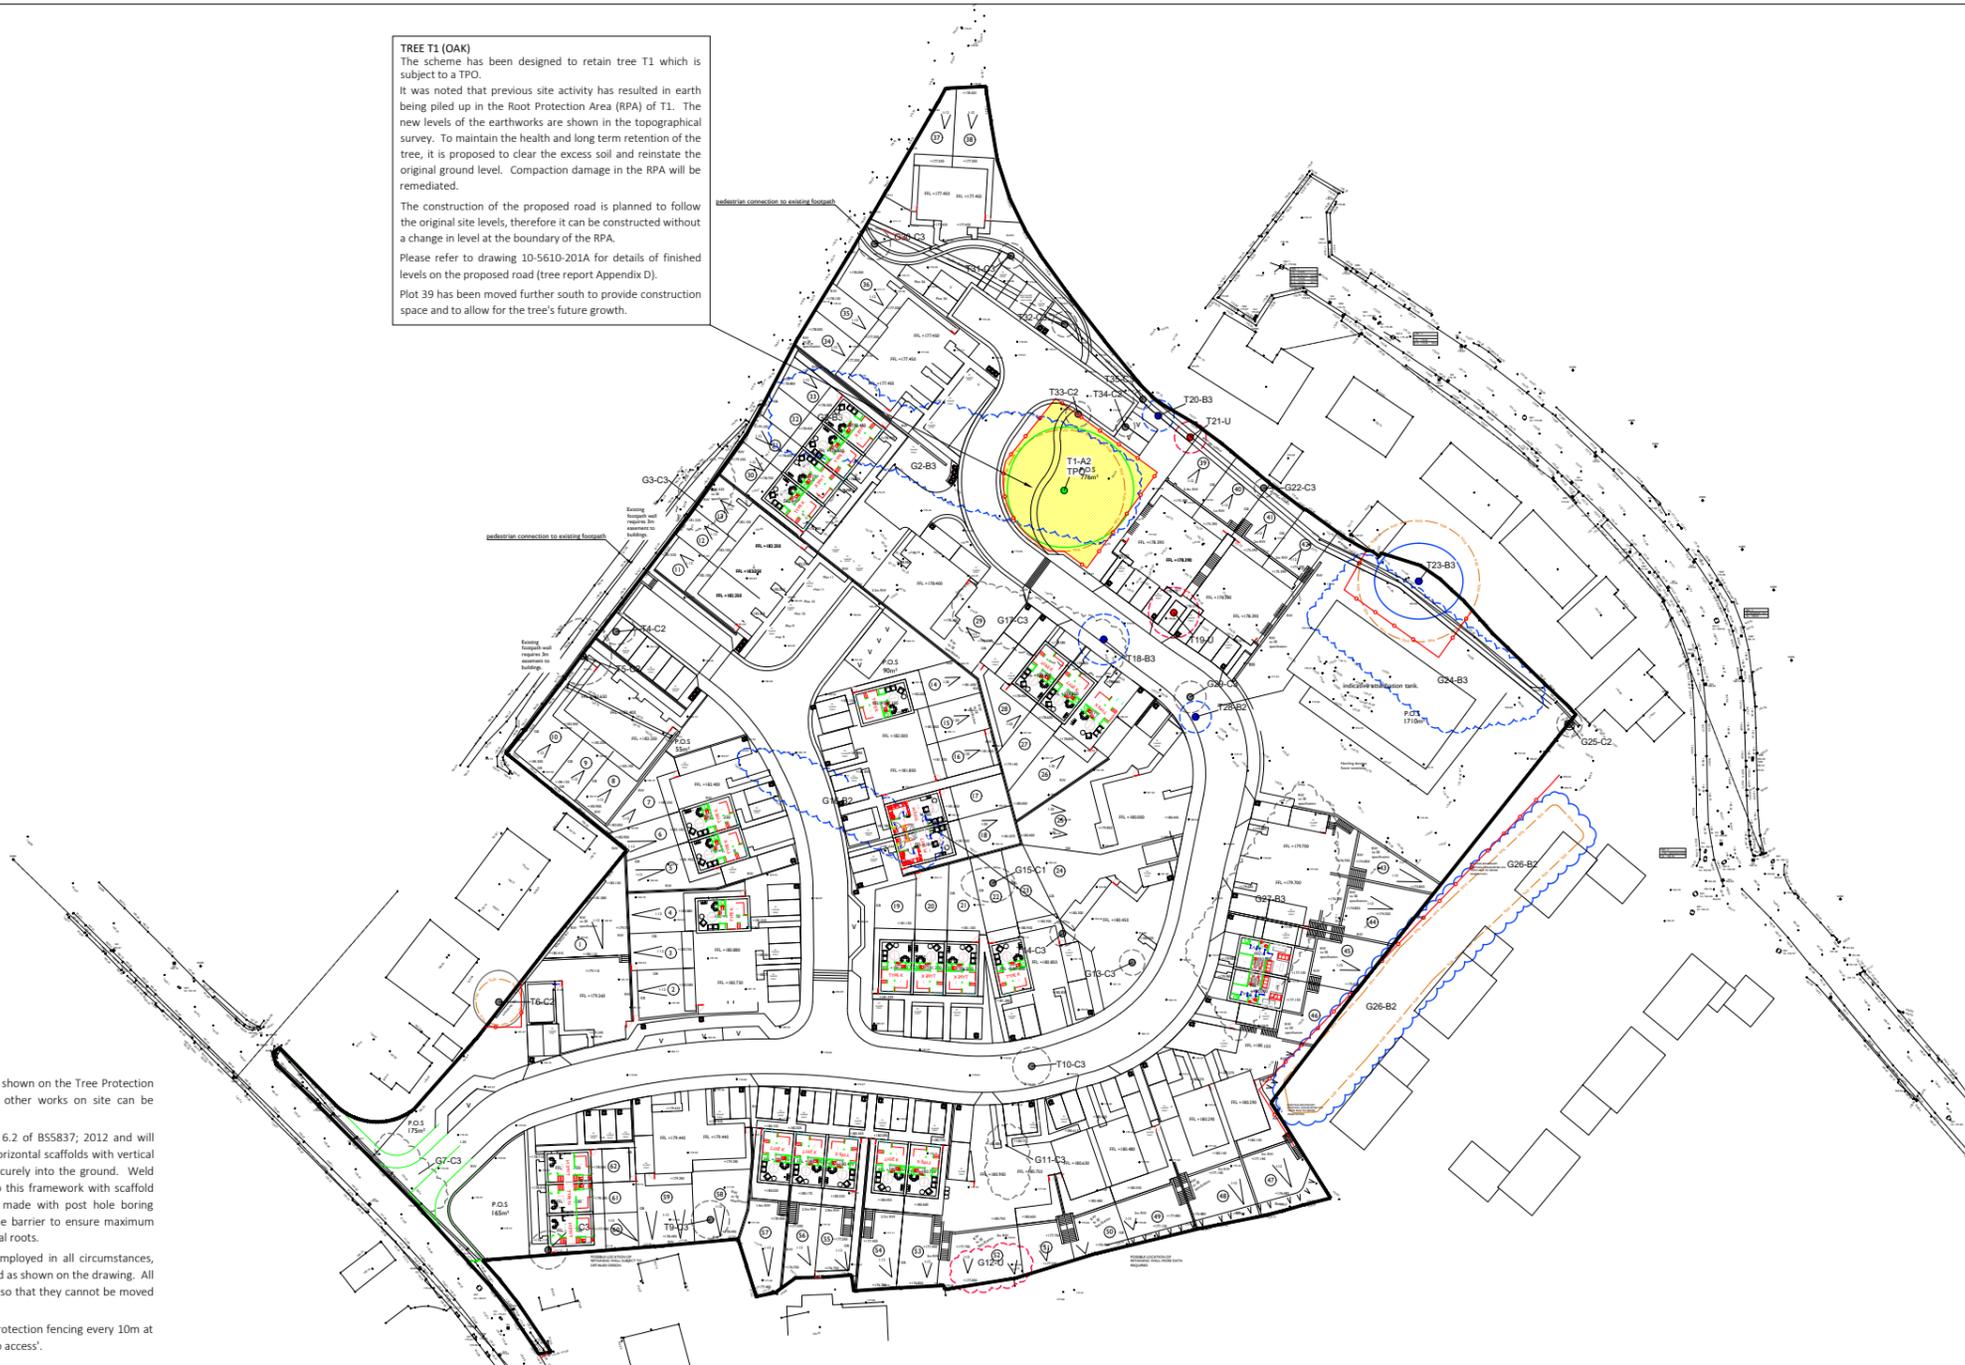
SF3282 TPP01 Tree Protection Plan and Method Statement

**TREE T1 (OAK)**  
 The scheme has been designed to retain tree T1 which is subject to a TPO.  
 It was noted that previous site activity has resulted in earth being piled up in the Root Protection Area (RPA) of T1. The new levels of the earthworks are shown in the topographical survey. To maintain the health and long term retention of the tree, it is proposed to clear the excess soil and reinstate the original ground level. Compaction damage in the RPA will be remediated.  
 The construction of the proposed road is planned to follow the original site levels, therefore it can be constructed without a change in level at the boundary of the RPA.  
 Please refer to drawing 10-5610-201A for details of finished levels on the proposed road (tree report Appendix D).  
 Plot 39 has been moved further south to provide construction space and to allow for the tree's future growth.

See Detail 1 for details of the protective fencing to be employed in all circumstances, where existing site conditions allow. Fencing is to be erected as shown on the drawing. All fencing must be fixed in position with driven scaffold poles so that they cannot be moved during the construction period.

Deeper soil compaction to be alleviated using an air lance to inject compressed air, creating fissures and aerating the soil.
