# Tree Hazard Survey

at  
23 Oldroyd Way  
Dewsbury

Arboricultural Hazard Survey at:  
23 OLDROYD ROAD, DEWSBURY

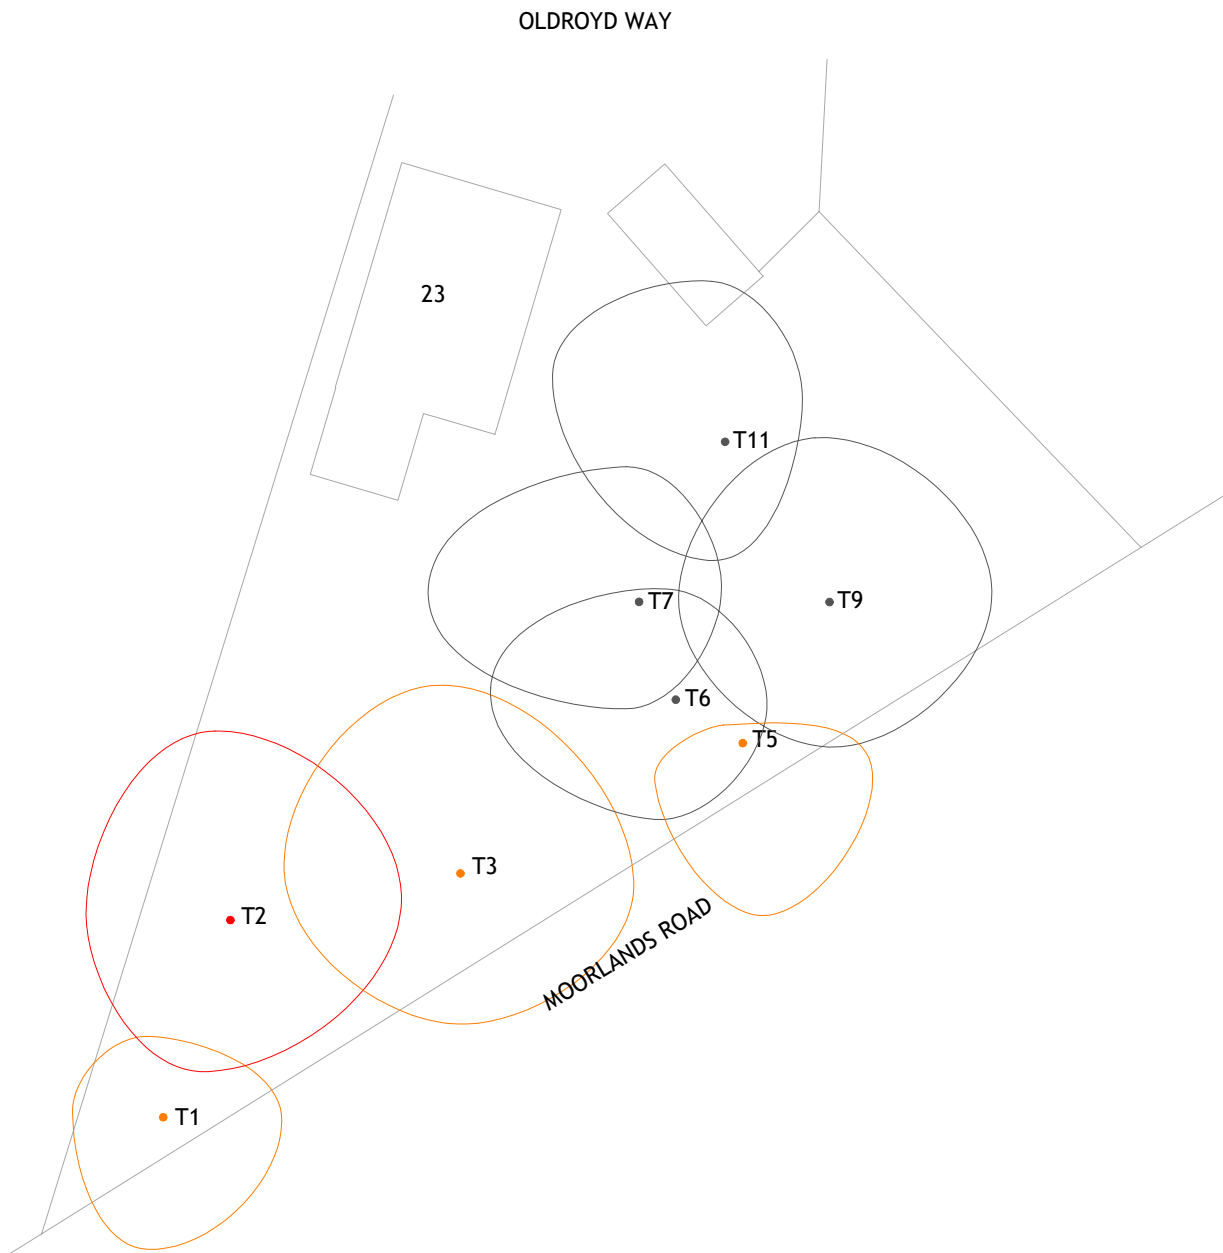
This survey covers those trees as shown on the attached plans at 23 Oldroyd Way, Dewsbury

Category 1 works (shown as red on the plan) are those which are urgent and should be dealt with as soon as is reasonably practicable.

Category 2 works (shown as orange on the plan) should also be considered as important and should also be done as soon as is reasonably practicable, but these works could be done after category 1 works where resources are limited. A maximum of 3 months from the date of survey is suggested.

Category 3 works (shown as green on the plan) are not urgent, but there is the possibility that observed defects may become more significant in the future. These trees should be monitored for signs of deterioration. It is sometimes cost effective to include these works as part of an ongoing arboricultural management plan.

Category 4 works (shown as gray on the plan) are areas with no significantly elevated risks. These areas either contain no trees, the trees are so small as to present no foreseeable risk of harm from striking injury, or the trees show no apparent defects.
