3rd February 2025

Ref: GUK-0225-01

10-12 Windmill Hill Lane, Emley Moor, Huddersfield, HD8 9TA

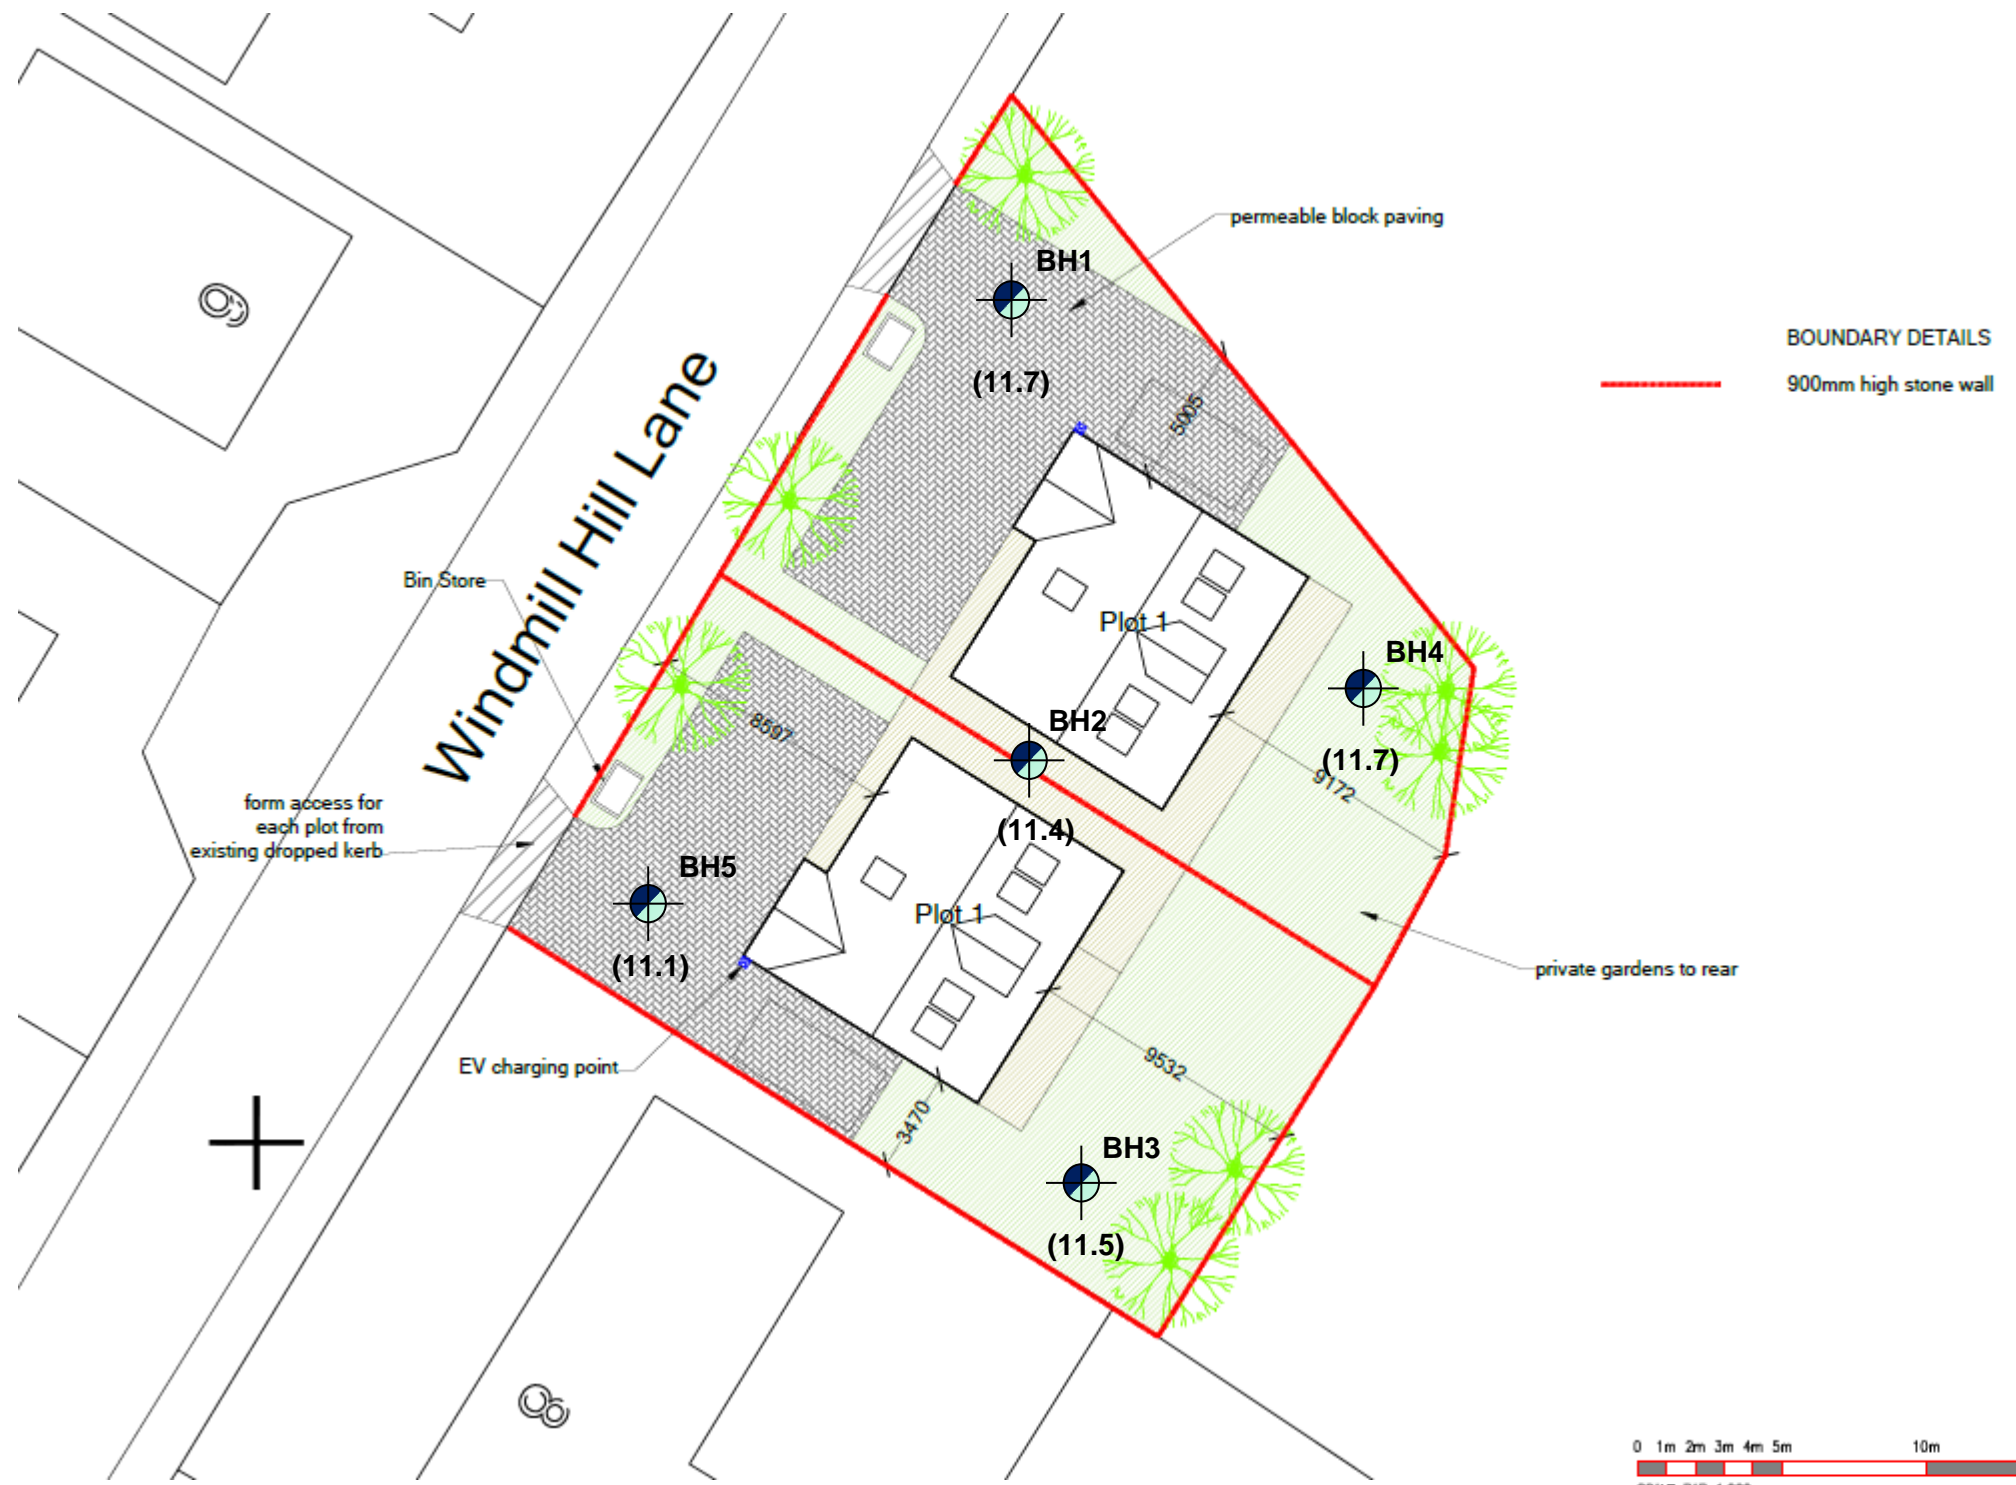
Borehole Position	Borehole Terminal Depth (m)	Depth to Top of Coal Mining Feature (m)	Depth to Base of Coal Mining Feature (m)	Thickness of Coal Mining Feature (m)	Comment
BH1	30.00	11.70	11.90	0.20	Thin intact coal in all instances. Intact bedrock soils to terminal depths. No recorded working. No indicated loss of flushing medium.
BH2	15.00	11.40	11.60	0.20	
BH3	30.00	11.50	11.70	0.20	
BH4	15.00	11.70	11.90	0.20	
BH5	30.00	11.10	11.30	0.20

The only coal to be encountered was 0.20m thick, with this being recorded from between c.11.00-12.00m bgl. It was stated by D&G that the recorded coal thickness would not be economic, and as such working in it would not be expected. Overall, the findings of the investigation were consistent and D&G indicated that it would be reasonable to conclude that the Site is not at risk of subsidence issues due to shallow mining and that further works are not required over and above normal advice from a structural engineer with regards to foundation design.

D&G rotary openhole borehole position (depth to coal).
