## Addendum Engineer's Report

| <b>Risk Address</b> | <b>5 Westfield Court</b> |
| <b>360 Reference</b> | <b>DLG-SN-22-005272</b> |
| <b>Addendum Report Date</b> | <b>08.01.2025</b> |

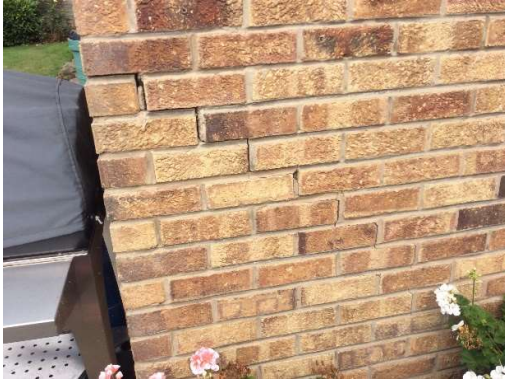
External cracking at rear left corner

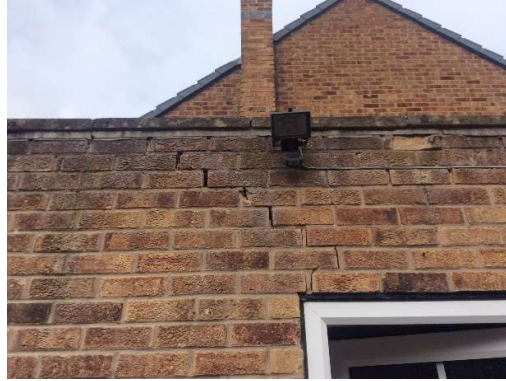
External cracking to LHS of property

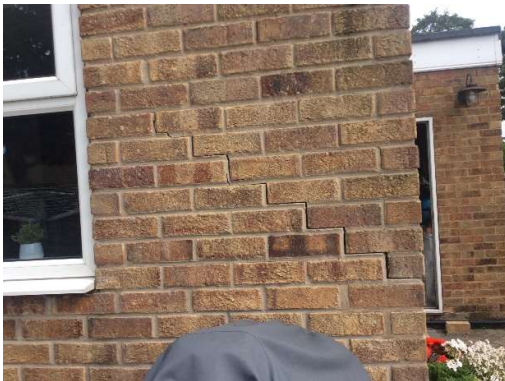
External cracking to rear elevation

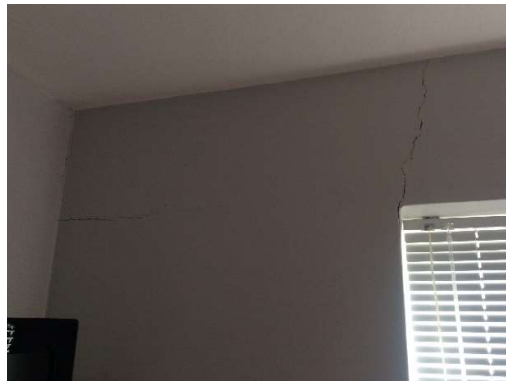
Internal cracking to rear left bedroom

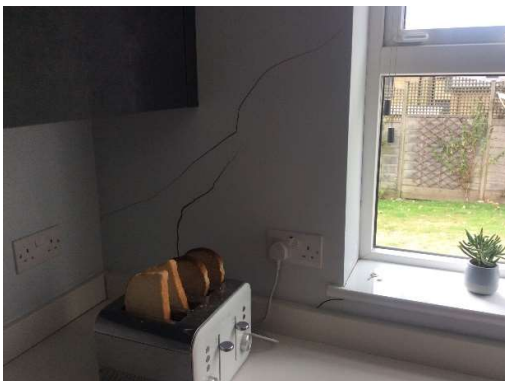
Cracking to rear left corner of kitchen

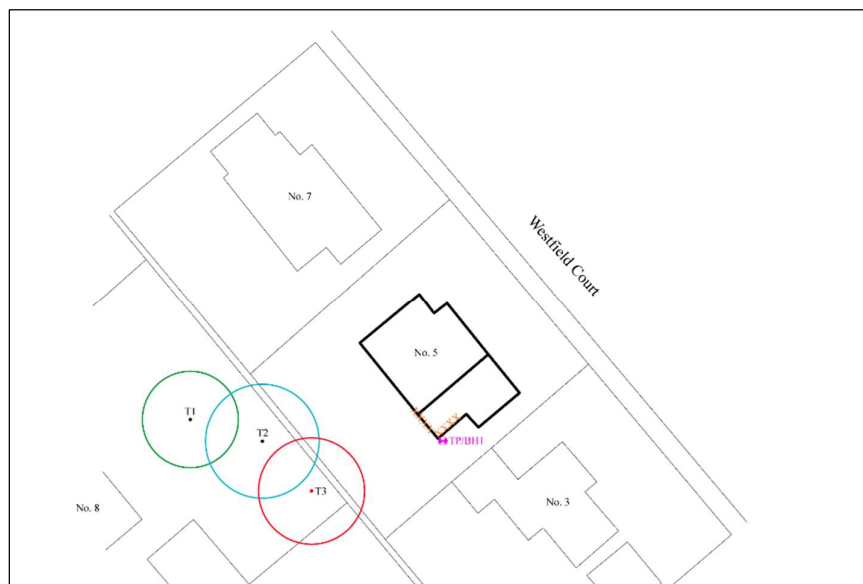
In summary, they recommended the removal of the closest Sycamore tree (T3 – 20 metres tall and 12.7 metres away). The other trees (T1 Sycamore – 17 metres tall and 17 metres away and T2 Oak – 17 metres tall and 13.8 metres away) were recommended to be maintained. All trees are subject to a Tree Preservation Order.

After consultation with the neighbouring owner and the Local Authority, the Preservation Order was lifted and the Sycamore T3 was removed in March 2024.

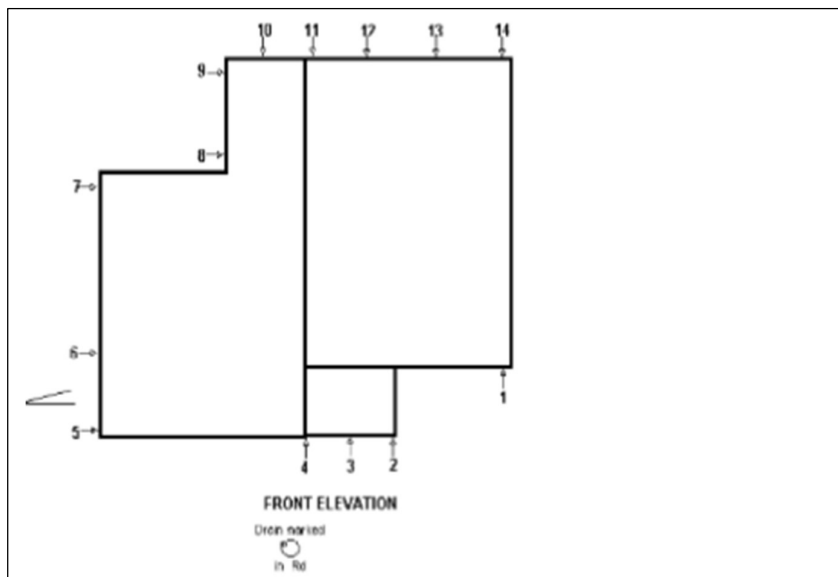
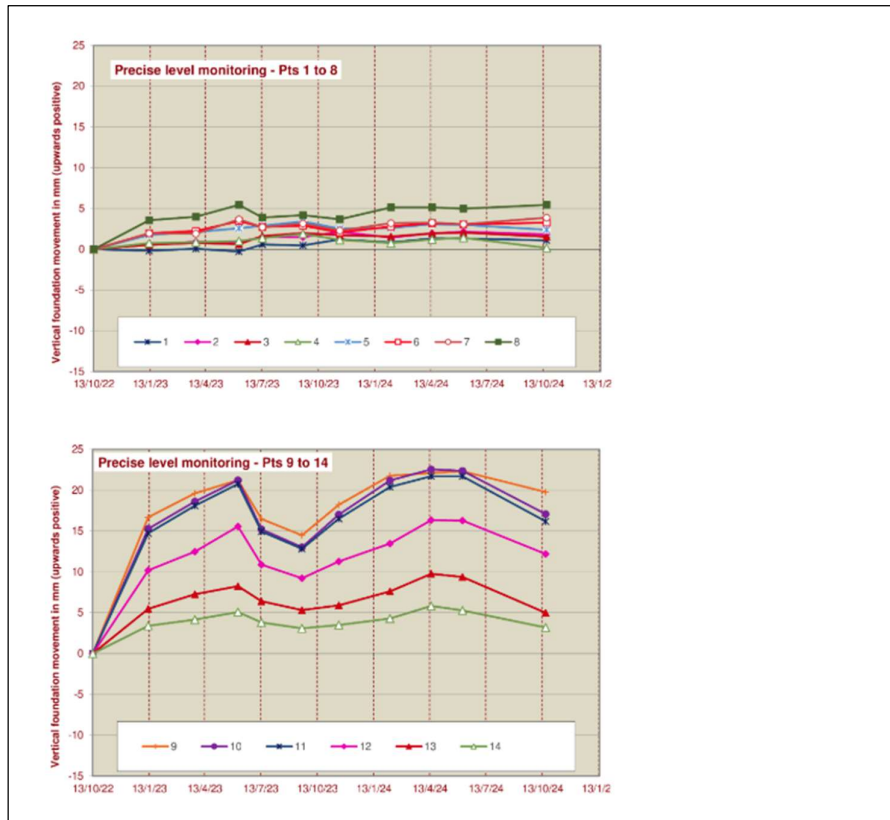
In summary, the rear of the property has shown a clear pattern of seasonal movement. Upward movement / recovery of 20mm occurred as the clay rehydrated over the winter and spring of 2022 / 2023 however, this was reversed over the summer and autumn of 2023 as the clay shrank again, with 8mm of downward movement occurring. Further rehydration and recovery occurred over the winter and spring of 2023 / 2024, back to a similar level to the previous year. With the Sycamore T3 being removed in March 2024, it was expected that the foundations would stabilise however, this has not occurred, with further downward movement of around 5mm occurring by October 2024 (with further movement still likely before rehydration commences).
