Arboricultural Safety Assessment

WC-323.1b

Hollybank School, Far Common Road,
Mirfield WF14 0DQ

Report type:	Arboricultural Safety Assessment
Report reference:	WC-323.1
Revision:	b
Client:	Hollybank Trust
Site address	Hollybank School, Far Common Road, Mirfield WF14 0DQ
OS Grid reference:	SE 19069 21809
Report prepared by:	Jack Delaney MICFor MArborA
Date:	27 th December 2024

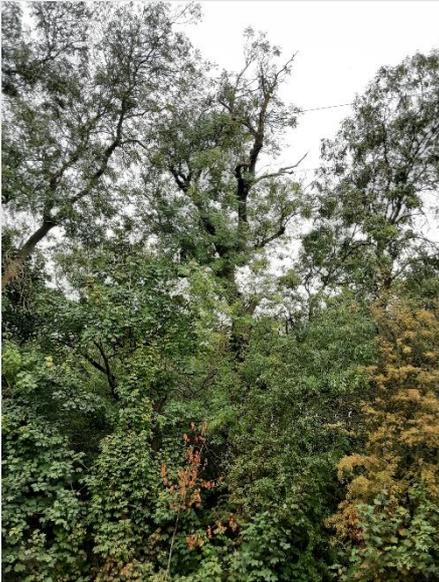
Plate 3: T004

T004	Common ash (<i>Fraxinus excelsior</i>)	M	10-20	21	7	85	P	Situated outside of site boundaries. Extensive crown tip dieback, with deadwood > 100 mm throughout the crown. Multiple branch cavities on main stem and structural branches which provide good ecological value.	Main stem/root plate failure	Powerlines	P3	P	100 %	6	< 1/1M (BA)	Remove tree (retain as 7 m standing stem)	Low
T005	Common ash (<i>Fraxinus excelsior</i>)	EM	20-40	23	7	59	F	<i>Inonotus hispidus</i> fructifications at 7 m, at base of primary branch extending north. Minor deadwood < 100 mm in diameter scattered throughout the crown.	Defective primary branch	Footpath	H3	2	100 %	3	1/100 K	Remove primary branch extending north at 6 m	High

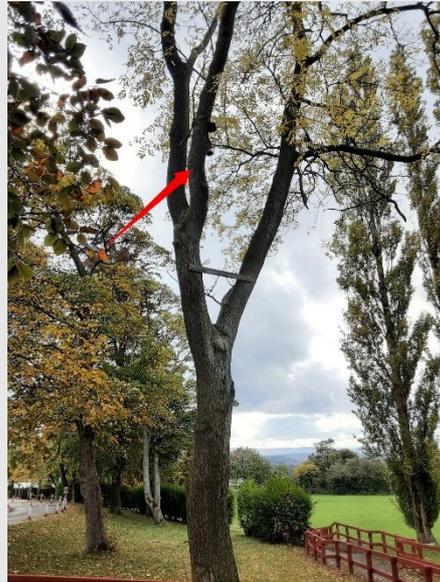
- 3.6.1.** T005 is a mature common ash which displays *Inonotus hispidus* fructifications at approximately 7 m, at the base of a primary branch extending north. *I. hispidus* is the most frequent decay fungus found on ash, and can destroy both lignin and cellulose at equal rates in a simultaneous white-rot. Since *I. hispidus* can weaken wood at an early stage of decay, its presence indicates that failure of the affected branch could be imminent (Lonsdale, 2015). T005 was therefore deemed to present a RoH of 1/100,000.

Plate 4: *Inonotus hispidus* fructifications on T005

- 4.1.2.** To remove the RoH posed by T006, T010, T011, T013, and G019, it is recommended that these trees are removed.
- 4.1.3.** To reduce the RoH posed by T005, it is recommended that a compromised branch displaying *I. hispidus* fructifications - extending north at approximately 7 m - is removed.

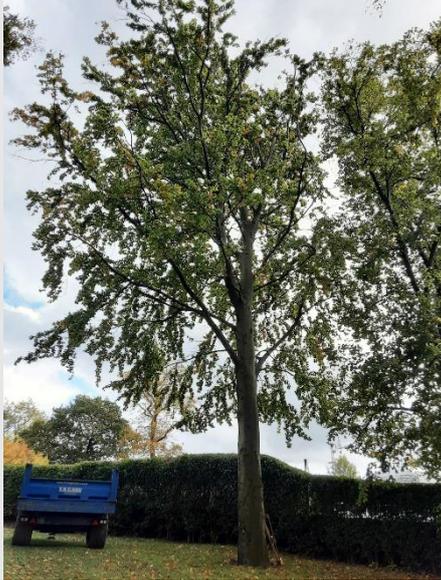
Plate 5: T006

- 3.5.1.** T006 is an early-mature European beech, which displayed *Meripilus giganteus* fructifications around the base of the main stem during a previous inspection of the tree which was carried out in 2023. *M. giganteus* fructifications were absent at the time of the current survey, though symptoms of the disease were apparent, such as thinning of foliage and deadwood around the extremities of the crown. *M. giganteus* can cause a white-rot to the principal roots of a colonised tree, though with a white-rot in the early stages of decay. Decayed wood becomes brittle and liable to fracture, and therefore careful and regular investigation is required if colonised trees are to be retained (Watson and Green, 2011). Resistance micro-drilling test results (Refer to **Appendix 3**) indicate that there are substantial areas of decay in the root collar and principal roots of T006, and the tree was therefore deemed to present a RoH of 1/400.

Tree Ref: T006	Level/Aspect of Stem: 20 cm below ground level/North	Comments: Results indicate needle entering bark/wood to a depth of 3 cm; functional sapwood/ripenwood from 3-15 cm; early-stage decayed ripewood from 15-28 cm; then functional ripewood from 27-38 cm.
Date: 20.12.2024	Drill Depth: 38 cm	
Resistograph Reading		Indicative drill cross-section

Tree Ref: T006	Level/Aspect of Stem: 20 cm below ground level/South	Comments: Results indicate needle entering bark/wood to a depth of 3 cm; functional sapwood/ripenwood from 3-8 cm, with a section of heavily lignified 'barrier zone' wood at 8 cm; then heavily decayed ripewood from 8-38 cm.
Date: 20.12.2024	Drill Depth: 38 cm	
Resistograph Reading		Indicative drill cross-section
		<p>38 cm Resistograph drill bit</p> <p>Main stem of T006 (68 cm diameter)</p> <p>----- Needle entering bark/wood ----- Functional wood ----- Heavily Decayed wood</p>

Tree Ref: T006	Level/Aspect of Stem: 20 cm below ground level/West	Comments: Results indicate needle entering bark/wood to a depth of 1 cm; functional sapwood/ripenwood from 1-15 cm; then heavily decayed ripewood from 15-38 cm.
Date: 20.12.2024	Drill Depth: 38 cm	
Resistograph Reading		Indicative drill cross-section

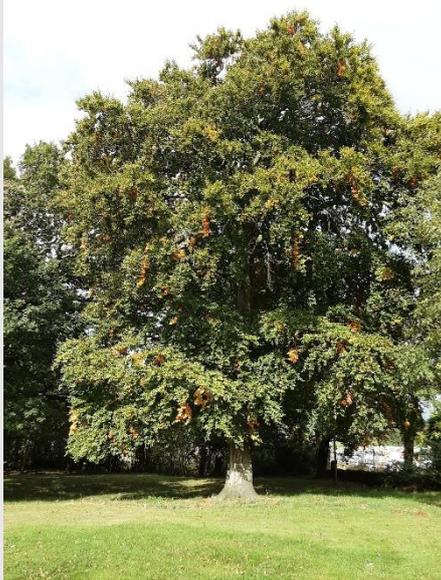
Plate 7: T008

T008	Common beech (<i>Fagus sylvatica</i>)	M	40-80	26	10	89	G	Historical mechanical damage to base of main stem on south aspect, approx. 150 x 100 cm, with some visible decay to the exposed ripewood apparent, though with extensive reactionary growth forming around margins of defect.	Main stem/root plate failure	Fall Ln.	H3	1	100 %	6	< 1/1M (BA)	No works recommended	N/A
T009	Flowering cherry (<i>Prunus serrulata</i>)	SM	20-40	7	3	30	G	Some minor mechanical damage apparent to surface roots.	Main stem/root plate failure	Footpath	H2	2	100 %	7	< 1/1M (BA)	No works recommended	N/A
T010	Goat willow (<i>Salix caprea</i>)	EM	5-10	9	4	61	P	Extensive crown tip dieback, with bark necrosis on main stem and first order branches to 3 m. Honey fungus <i>Armillaria mellea</i> rhizomorphs apparent.	Main stem/root plate failure	Footpath	H3	1	100 %	4	1/400 K	Remove tree and plant replacement trees	Moderate

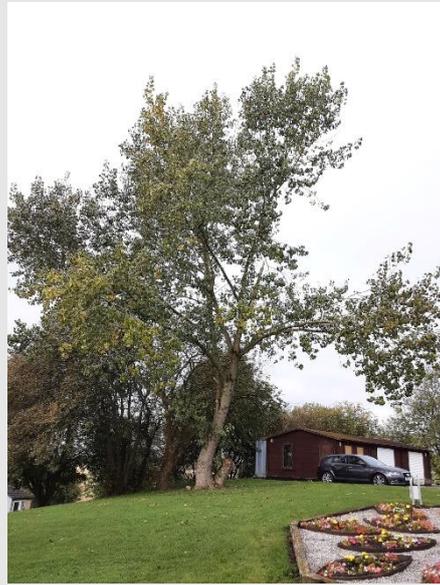
Plate 10: T011

- 3.6.3.** T011 is a mature hybrid-black poplar which displays multiple tear-out wounds throughout the crown from the recent failure of second order branches. The remaining tree is now anticipated to be susceptible to further branch failures, due to changes in windloading of the crown. T011 was therefore deemed to present a RoH of 1/100,000.

Tree Ref:	Species	A	SULE	H	CS	DBH	V	Comments	Area of Tree Risk Assessed	Target Description	QTRA Factors					Management	Priority Category
											Target Type /Zone	Size	Mass	POF	RoH		
T011	Black hybrid poplar (<i>Populus x canadensis</i>)	EM	10-20	22	9	67	F	Bifurcates at ground level into two co-dominant stems, though one stem has historically been removed. Multiple second order branch tear-out wounds throughout the crown, with remaining tree now susceptible to further branch failure due to changes in windloading.	Further failure of second order branches	Main drive	H2	2	100 %	4	1/100 K	Remove tree and plant replacement trees	Moderate
T012	Wild cherry (<i>Prunus avium</i>)	SM	10-20	10	4	31	G	Bifurcates at 1.5 m into two co-dominant stems; union appears included with slight lateral broadening of parent stem directly beneath the point of bifurcation. Branches extending east encroach upon adjacent building	Included branch union	Footpath	H3	3	100 %	5	< 1/1M (BA)	Remove tree and replant replacement trees	Low

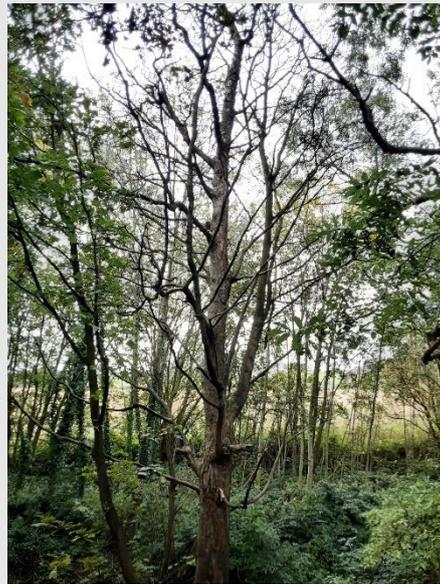
Plate 12: T013

T013	Sycamore (<i>Acer pseudoplatanus</i>)	D	< 5	20	5	51	D	Moribund tree	Main stem/root plate failure	Woodland	V1	1	100 %	4	1/4K	Remove tree (retain as 10 m standing stem for ecological value) and plant replacement trees	High
T014	Sessile oak (<i>Quercus petraea</i>)	EM	40-80	19	8	62	F	Hanging branch > 100 mm in diameter suspended in east aspect of crown at 16 m.	Hanging branch	Amenity grassland	H4	3	100 %	2	1/500 K	Remove hanging branch at 16 m in east aspect of the crown	High
T015	Common ash (<i>Fraxinus excelsior</i>)	SM	5-10	11	3	27	P	Displays advanced symptoms of Chalara ash dieback <i>Hymenoscyphus fraxineus</i> , with deadwood > 100 mm in diameter throughout the crown.	Main stem/root plate failure	Fall Ln.	V1	2	100 %	6	1/1M	RoH is ALARP Remove tree and plant replacement trees	Low

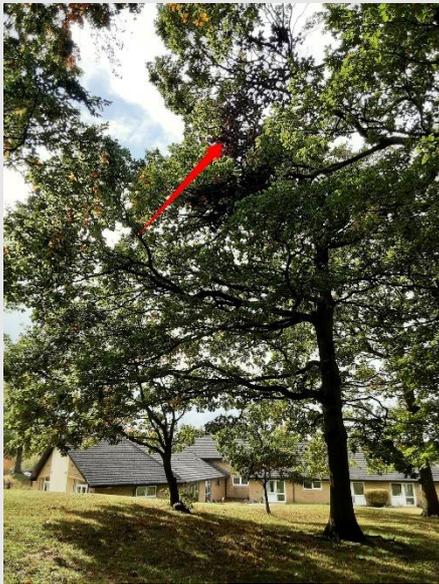
Plate 13: Hanging branch in T014

- 4.1.4.** To reduce the RoH posed by T014, it is recommended that a hanging branch which is suspended at 16 m in the east aspect of the crown is removed.

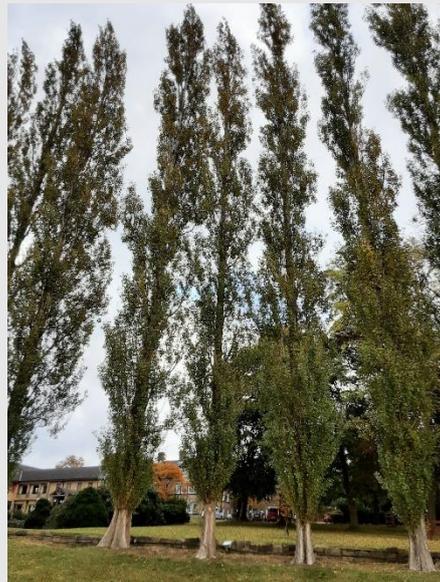
- 3.6.7.** T017, T018, and T019 are all early-mature Lombardy poplar which display cavity openings at bases of main stems, which are anticipated to extend upwards as decay columns. Pronounced reactionary root buttressing was also apparent on T017, T018, and T019. T017 and T018 were therefore deemed to present a RoH of 1/1,000,000, and T019 was determined to present a RoH of 1/400,000.

Plate 16: T017, T018, & T019 (centre, right to left)

T017	<ul style="list-style-type: none"> Remove trees and plant replacement trees, or carry out further decay testing on main stems 	
T018		
T019		
G007	<ul style="list-style-type: none"> Remove deadwood < 50 mm in diameter 	
G011		
T003	<ul style="list-style-type: none"> Remove tree (retain as 7 m standing stem for ecological value) 	Low
T004		
T007	<ul style="list-style-type: none"> Remove deadwood < 50 mm in diameter 	
T012	<ul style="list-style-type: none"> Remove tree and plant replacement trees 	
T015	<ul style="list-style-type: none"> Remove tree and plant replacement trees 	Low
T020	<ul style="list-style-type: none"> Remove deadwood > 50 mm in diameter 	
T021	<ul style="list-style-type: none"> Remove deadwood > 50 mm in diameter Remove hanging branch at 5 m in south aspect of the crown

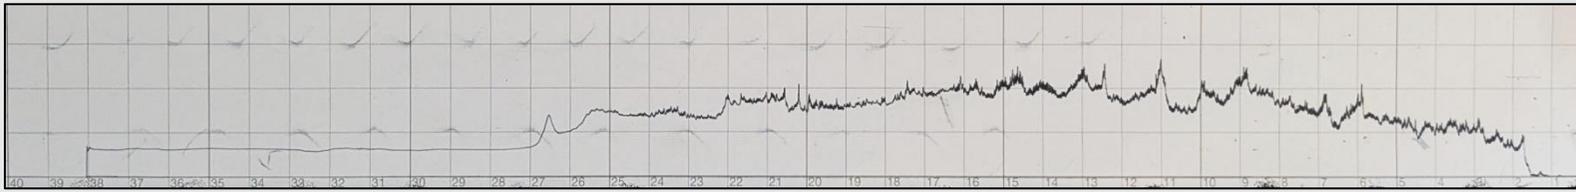
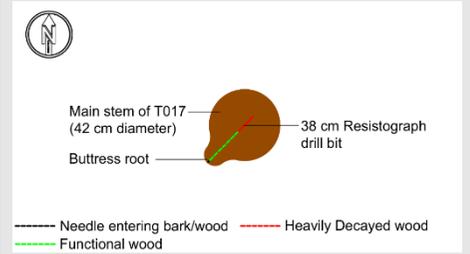
Tree Ref: T017	Level/Aspect of Stem: 30 cm above ground level (through buttress root)/South-west	Comments: Results indicate needle entering bark/wood to a depth of 2 cm; functional sapwood/ripenwood from 2-28 cm; then heavily decayed ripewood from 28-38 cm.
Date: 20.12.2024	Drill Depth: 38 cm

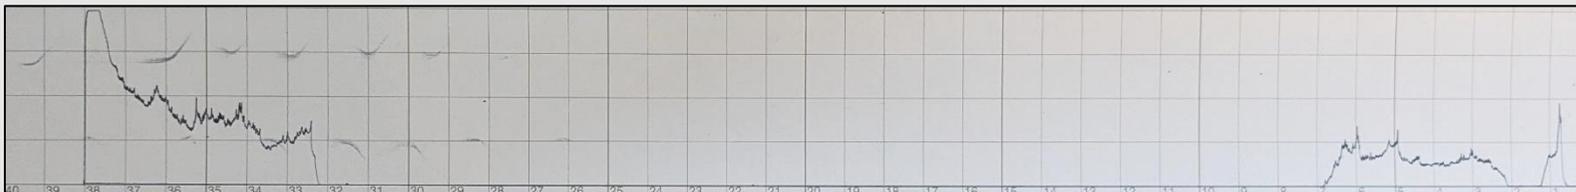
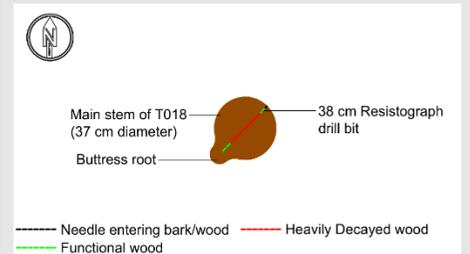
Test 7

Tree Ref: T018	Level/Aspect of Stem: 30 cm above ground level/North-east	Comments: Results indicate needle entering bark/wood to a depth of 2 cm; functional sapwood/ripenwood from 2-7 cm; heavily decayed ripewood from 7-32 cm; then functional and heavily lignified ripewood from 32-38 cm.
Date: 20.12.2024	Drill Depth: 38 cm

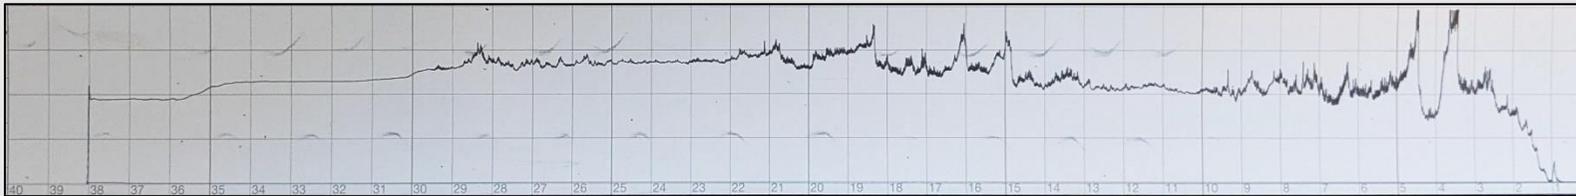
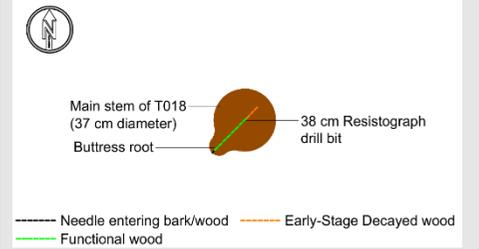
Test 8

Tree Ref: T018	Level/Aspect of Stem: 30 cm above ground level (through buttress root)/South-west	Comments: Results indicate needle entering bark/wood to a depth of 2 cm; functional and heavily lignified sapwood/ripewood from 2-29 cm; then early-stage decayed ripewood from 29-38 cm.
Date: 20.12.2024	Drill Depth: 38 cm

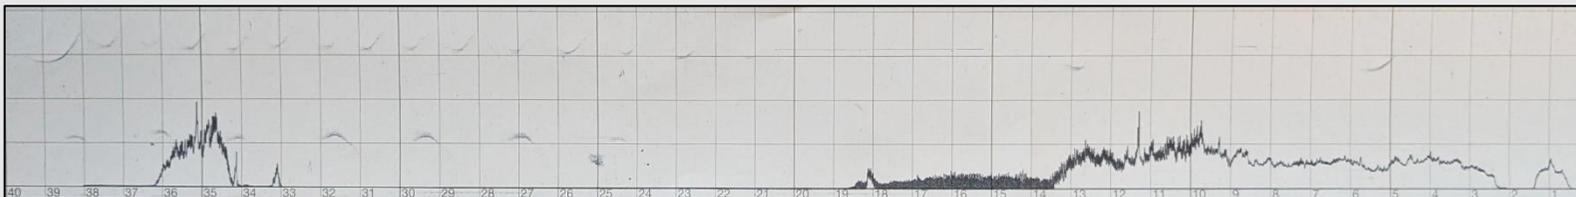
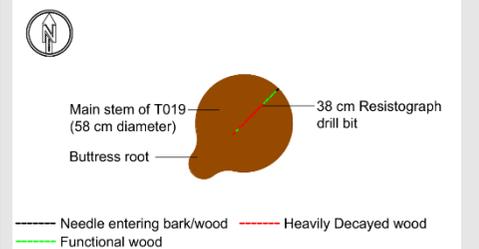
Test 9

Tree Ref: T019	Level/Aspect of Stem: 30 cm above ground level/North-east	Comments: Results indicate needle entering bark/wood to a depth of 3 cm; then functional sapwood/ripewood from 3-13 cm; heavily decayed ripewood from 13-34 cm; functional ripewood from 34-36 cm; then heavily decayed ripewood from 36-38 cm.
Date: 20.12.2024	Drill Depth: 38 cm
