Fenay Hall

Structural Engineers Review of Existing Chimney Stacks

23_453_SR_01 rev A

October 2024

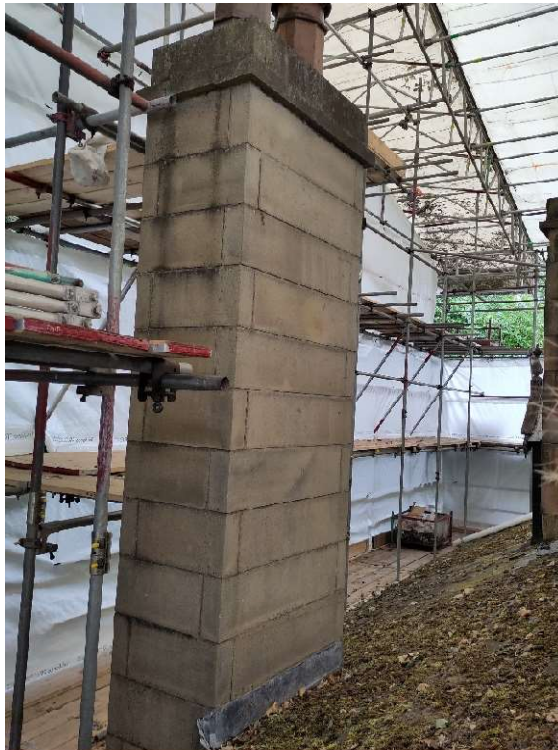
Photo 1 – Stack S1 from South

Stack S1 appears to have been reconstructed relatively recently using new ashlar stonework. However, there is some evidence of movement in the stones to the top three ashlar courses of the stack where perpendicular joints have opened up. This is particularly evident viewing from the South (refer photo 2)

Carefully dismantle the top section of chimney stack, to remove the top 3 courses which appear to have experienced movement. Rebuild from this level, providing stainless steel ties with stainless steel dowels drilled and resin anchored into horizontal face of ashlar stone block to provide tie across the perpend joint

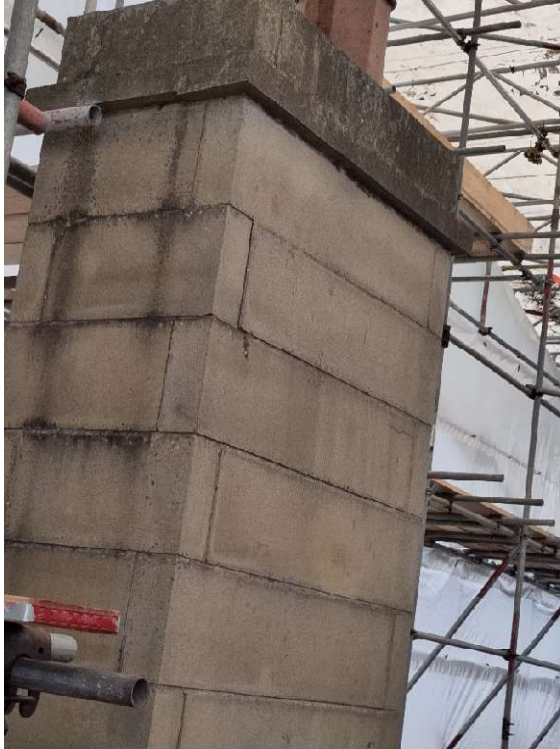
Photo 2 – Stack S1 from South, open joints to head of stack

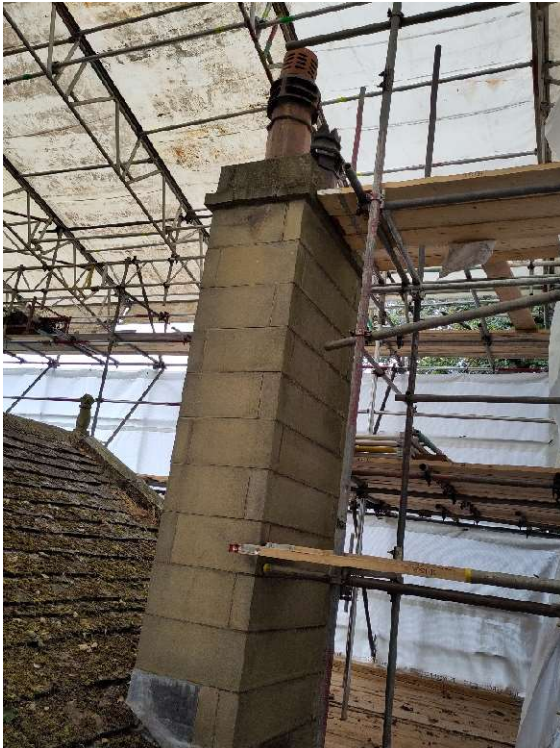
Photo 3 – Stack S1 from North, open joint to top course

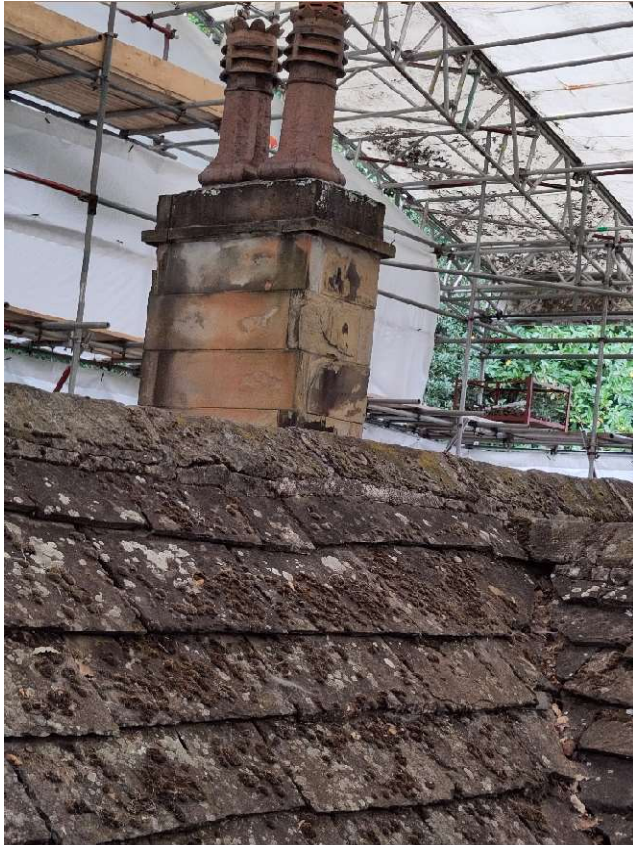
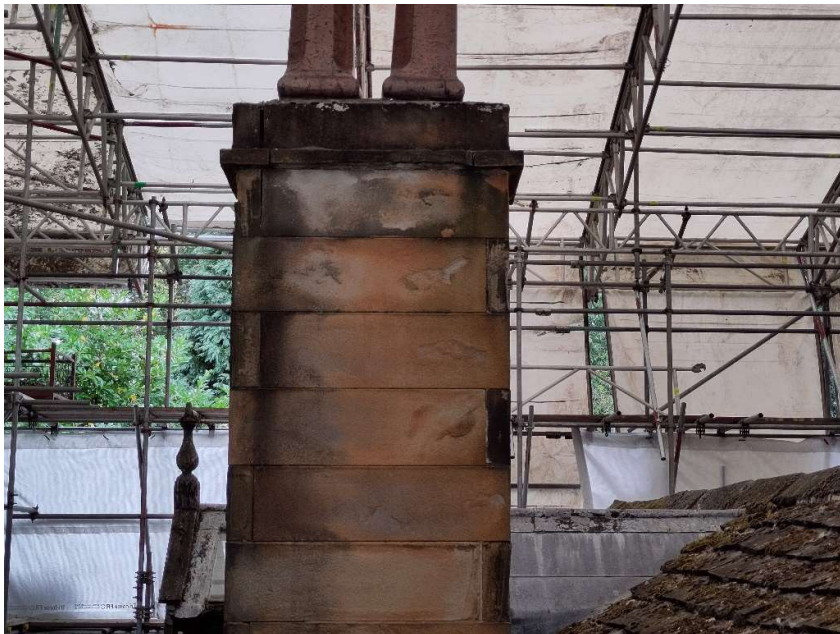
The ashlar stonework to Stack S2 is heavily weathered, particularly to the top 2 courses, where faces of the stonework are spalling, which can clearly be seen to the top course to the South West corner (Photo 5 and 6). An open joint can be clearly seen in the perpend joint to the capping above the string course to the West elevation (Photo 7)

Photo 5 – Stack S2 from South East

Photo 6 – Stack S2 from South

Carefully dismantle the top section of chimney stack, to remove the top 2 courses (below the string level) which are particularly heavy weathered. Rebuild from this level, providing replacement ashlar stone to match existing to replace the heavily weathered and spalling stones. Incorporate stainless steel ties with stainless steel dowels drilled and resin anchored into horizontal face of ashlar stone block to provide tie across the perpend joint to new sections of stone.

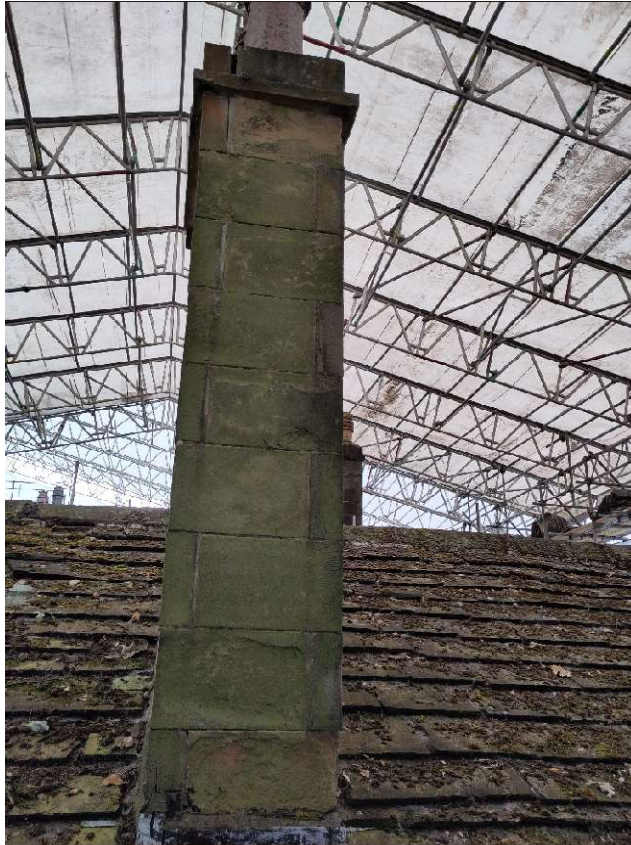
Photo 7 – Stack S2 from West

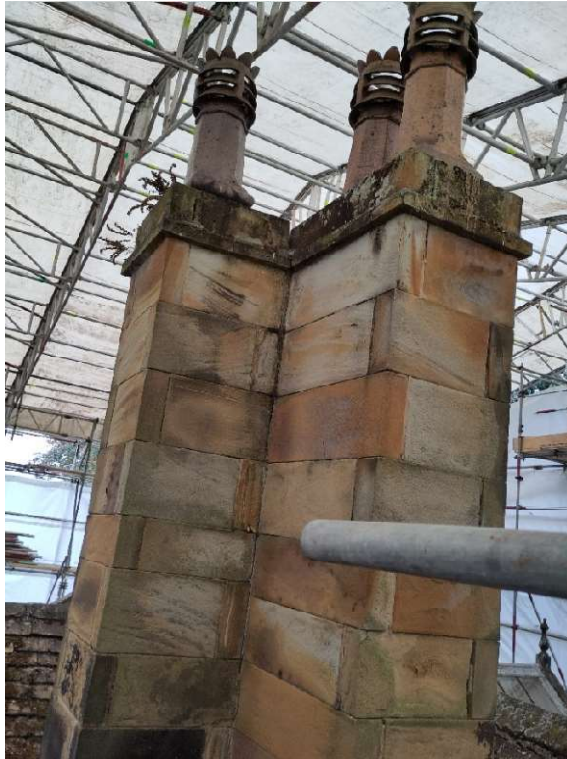
Photo 8 – Stack S3 from North (Top Section)

The ashlar stonework to Stack S3 is heavily weathered throughout, with stones delaminating, spalling and damaged. There has been lateral movement to the West section of the stack, and the straight joint between the two sections of stack is opening up over the top two courses of stack (Photo 12)

Due to the extent of heavy weathering and delamination of ashlar stone, it is considered necessary to carefully dismantle the existing stack over its full height to allow for replacement of the damaged sections of stonework. The stack should be carefully rebuilt, incorporating replacement section of ashlar stone to replace the heavily weathered, delaminating, and damaged units. Incorporate stainless steel ties with stainless steel dowels drilled and resin anchored into horizontal face of ashlar stone block to provide tie across the perpendicular joint to new sections of stone.

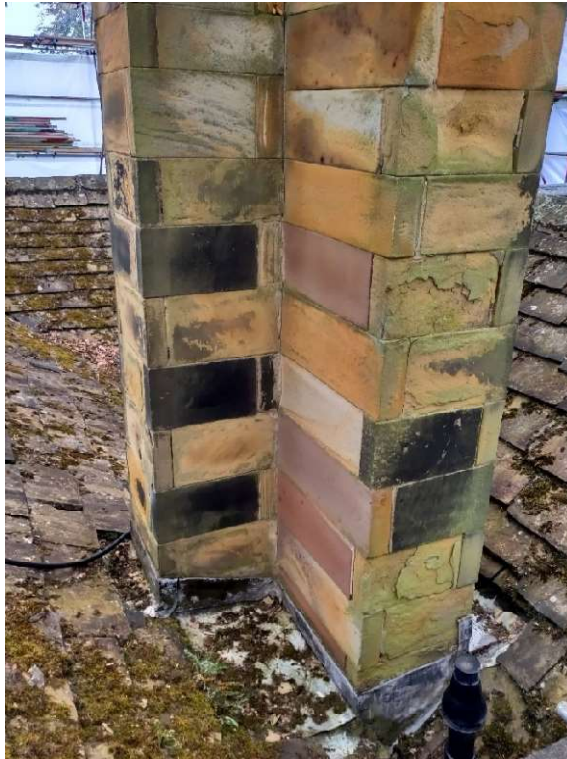
Photo 9 – Stack S3 from North (Base section) – Note heavy weathering and delamination of stonework

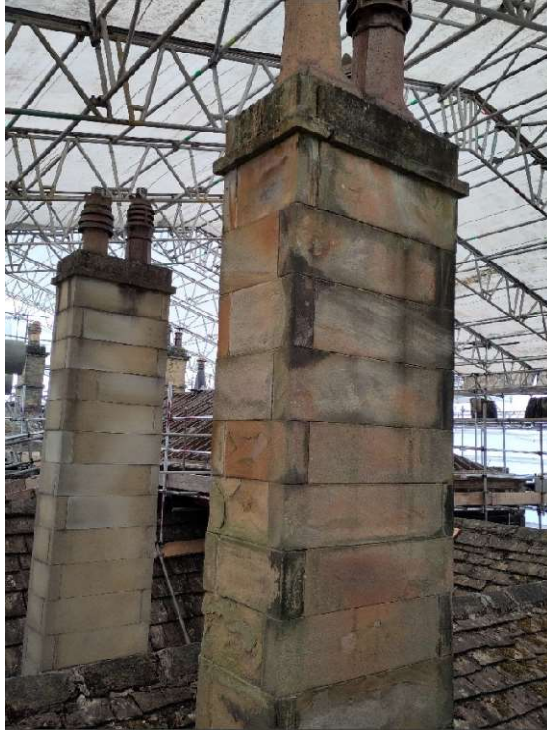
Photo 10 – Stack S3 from West (Top Section) Heavy Weathering and delamination of stones.

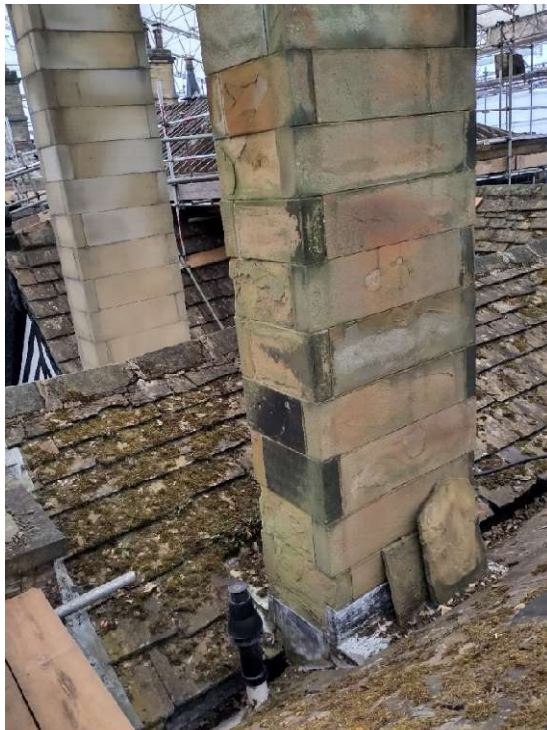
Photo 11 – Stack S3 from West (Base Section) Heavy Weathering and delamination of stones.

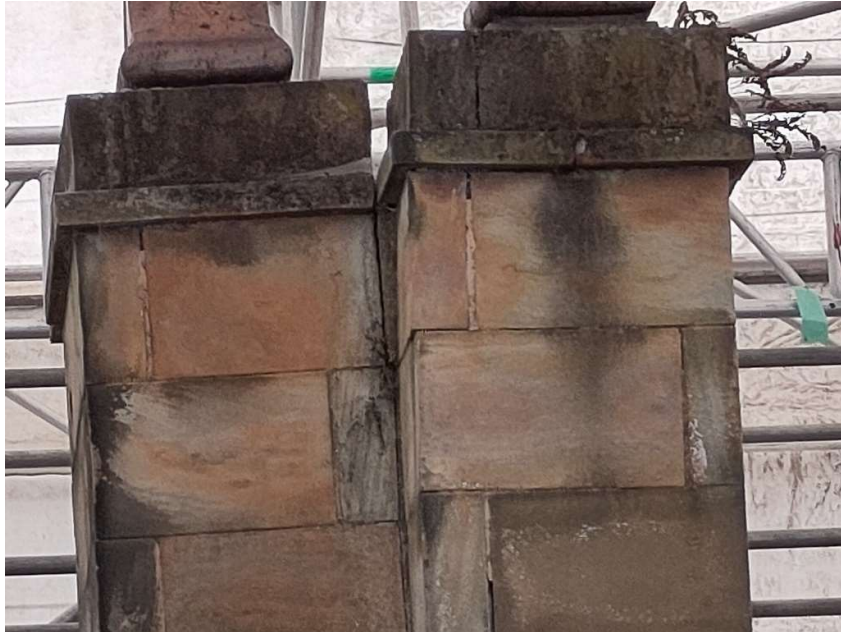
Photo 12 – Stack S3 from South, Top Section. Lean of West section of stack and sections of stack parting from one another.

Stack S3 is particularly high and slender and inherently vulnerable to lateral movement and associated instability. To help mitigate risk of future movement and instability of the rebuilt stack with associated health and safety risk and ongoing maintenance liability, it is recommended that consideration is given to reducing the height of the stack to match Stacks S1 and S2, subject to necessary listed building consent.

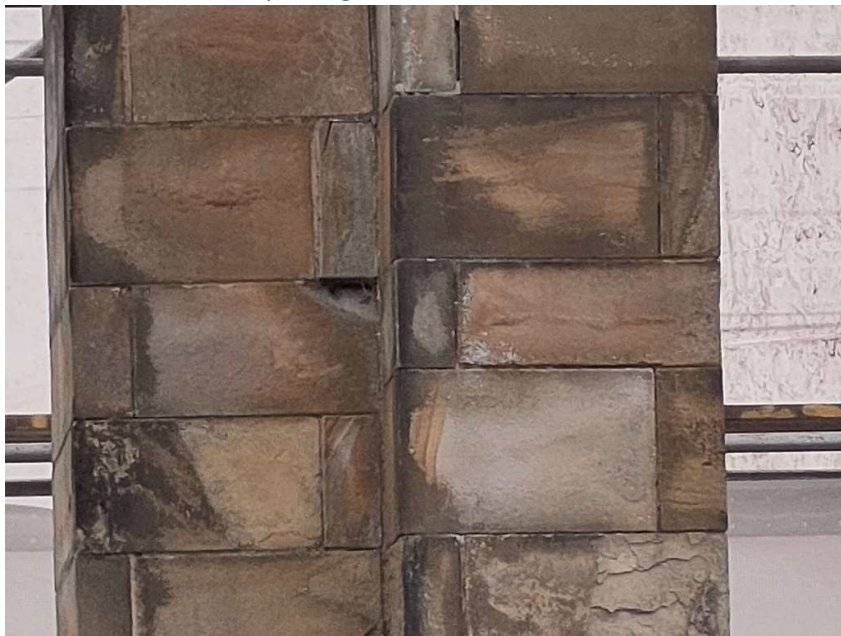
Photo 13 – Stack S3 from South, Mid Section. Heavy weathering, delamination and damage to stones.

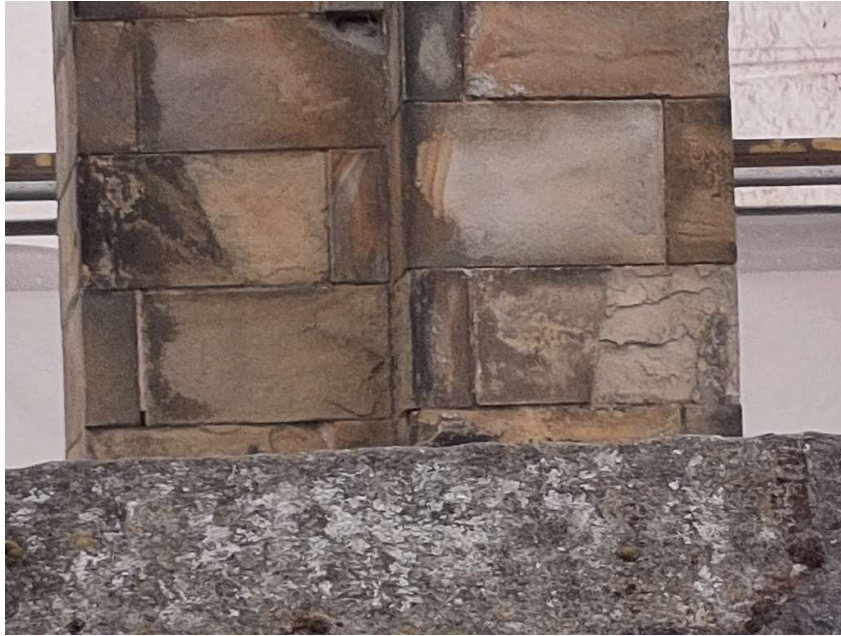
Photo 14 – Stack S3 from South, Lower Section. Heavy weathering, delamination and damage to stones.

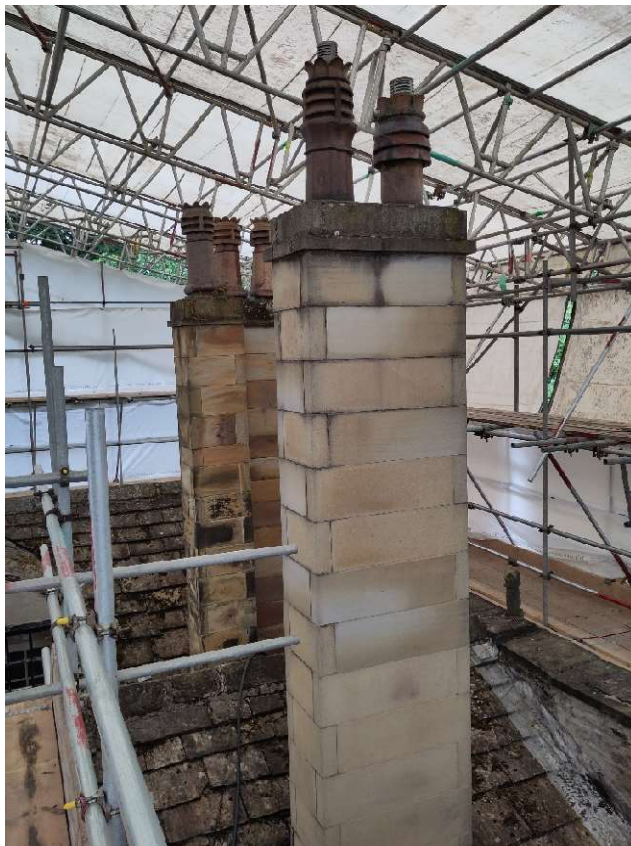
Photo 15 – Stack S4, from East, top section

Stack S4 appears to have been reconstructed relatively recently using new ashlar stonework. There is some evidence of minor opening up of perpendicular joints in the ashlar stonework throughout.

Repointing of the stack is considered necessary to mitigate risk of the minor opening and movement in existing joints becoming more significant through freeze/thaw action. It is recommended that direct access to the corbelling brickwork to the base of the stack is provided, to allow for careful removal of the existing render and to allow for further inspection of the existing brickwork supporting the stack.

Stack S4 is particularly high and slender and inherently vulnerable to lateral movement and associated instability. To help mitigate risk of future movement and instability of the (relatively recently reconstructed) stack with associated health and safety risk and ongoing maintenance liability, it is recommended that consideration is given to reducing the height of the stack to match Stacks S1 and S2, subject to necessary listed building consent.

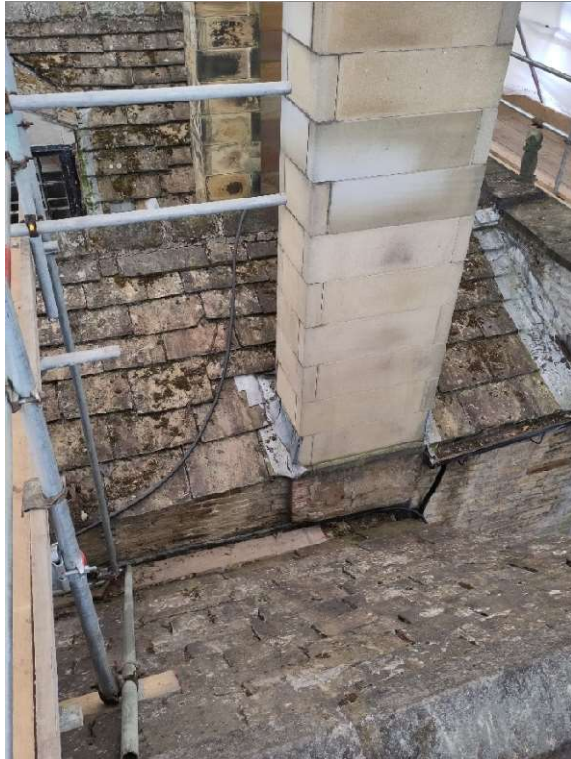
The stack is built off render covered brickwork, corbelling from the main external wall line (Photo 16). The render is locally spalling away to expose the brickwork. Direct access was not possible at the time of our survey to inspect the condition of the corbelling brickwork.

Photo 16 – Stack S4, from East, base section – Note rendered brick corbelling at base

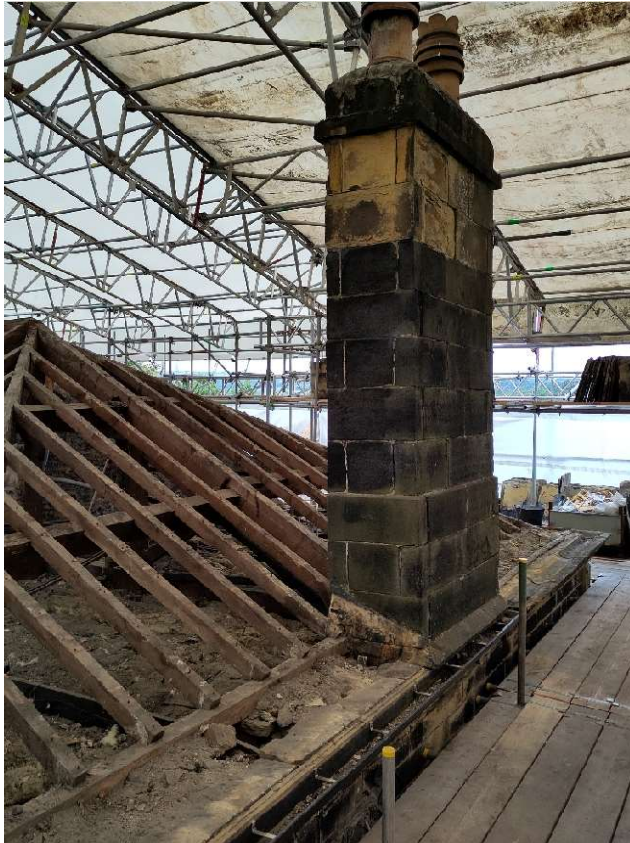
The top 2 courses of ashlar stonework (below the string course) are particularly highly weathered and delaminating. Joints to ashlar stonework are heavily weathered and washed out, leaving open joints. Brickwork to the inside face, immediately below the line of the original flashing, has completely perished.

Photo 20 – Stack S5 from North West, highly weathered and delaminating stone to top courses.

The completely perished brickwork to the inner face of stack (below the line of the original flashing) requires removal and replacement with new to maintain long term stability of the stack. To allow for the safe removal and replacement of this low level brickwork, taking into consideration the general condition of the stack with open and washed out joints, it will be necessary to carefully dismantle the stack. From our initial visual inspection, it should be possible to retain existing ashlar stone masonry for re-use in rebuilding the stack, with the exception of the top two courses below string course, where heavily weathered and delaminating units will require replacement. The stack should be rebuilt to match existing..

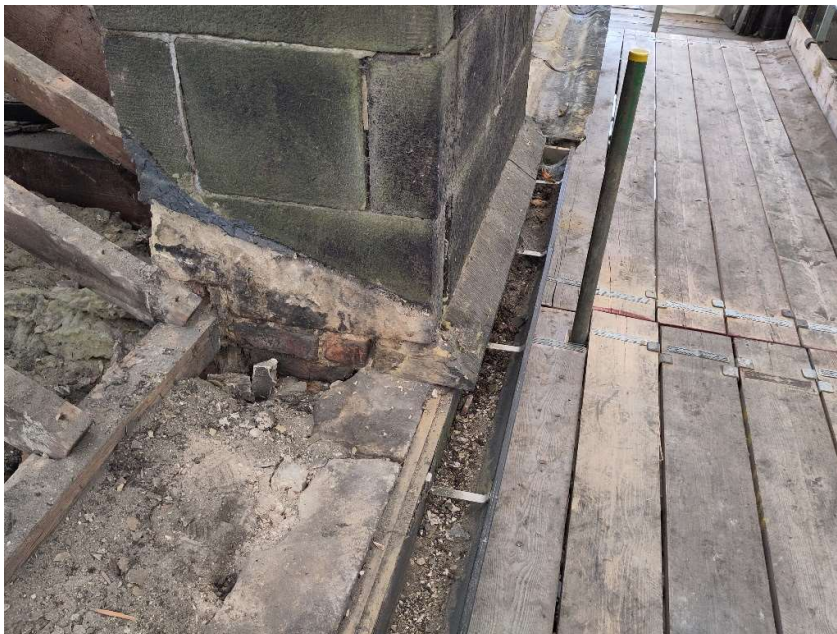
Photo 21 – Stack S5, from North West, base, highly weathered and open joints.

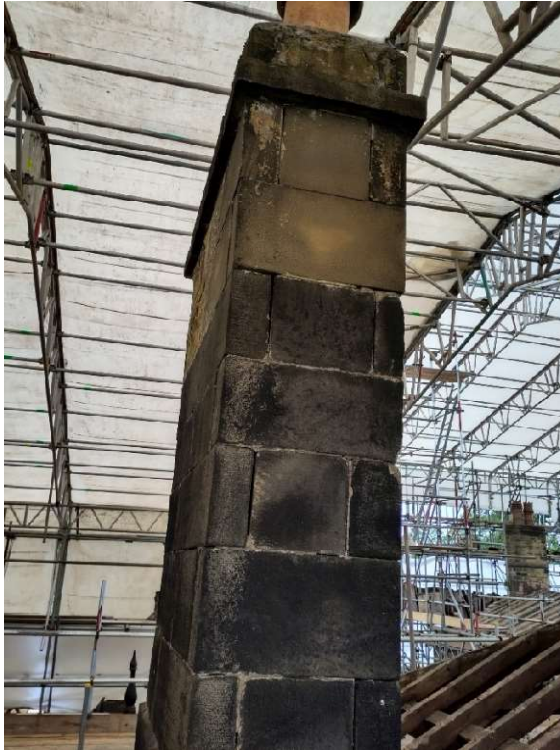
Photo 22 – Stack S5 from South, high level, highly weathered and open joints.

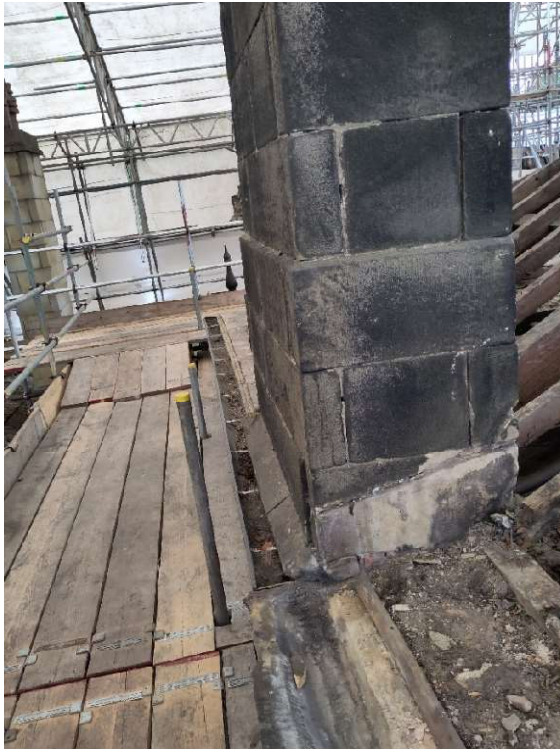
Photo 23 - Stack S5 from South, low level, highly weathered and open joints.

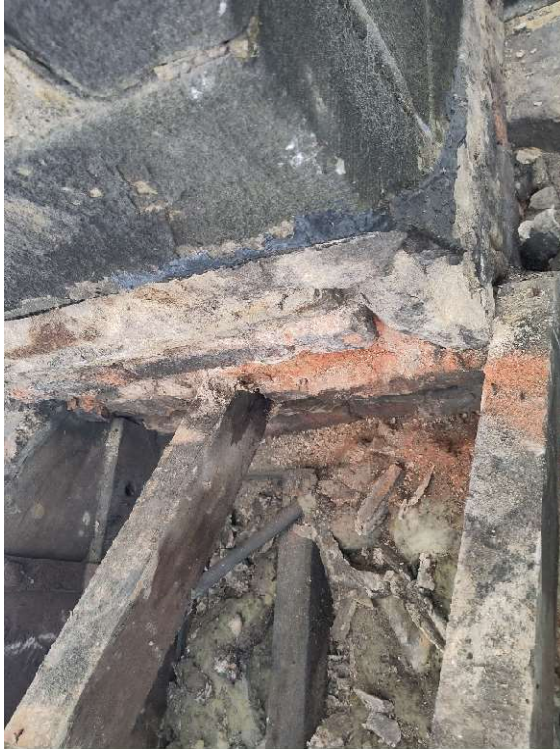
Photo 23a – Stack S5 from East. Brickwork to inner face (below original flashing line) has completely perished.

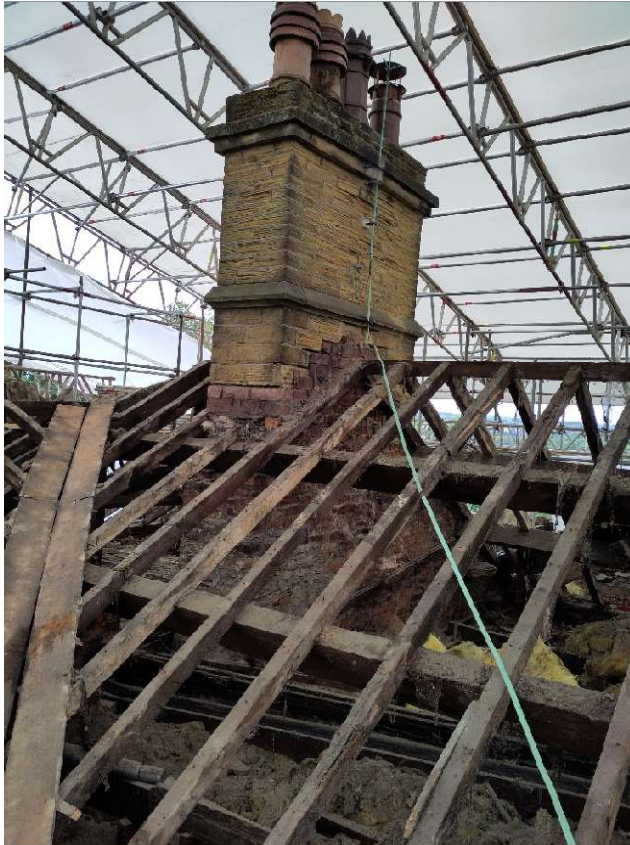
Stonework above the lower string course is heavily weathered to both the East and West elevations. The East elevation is particularly heavily weathered.

Photo 24 – Stack S6 from West. Heavily weathered stonework above lower string course

The chimney stack needs to be carefully dismantled down to the level of the lower string course. The stack should be rebuilt, using replacement stone to replace the heavily weathered stone units.

Repointing of the full stack will be necessary following rebuilding above the lower string course.

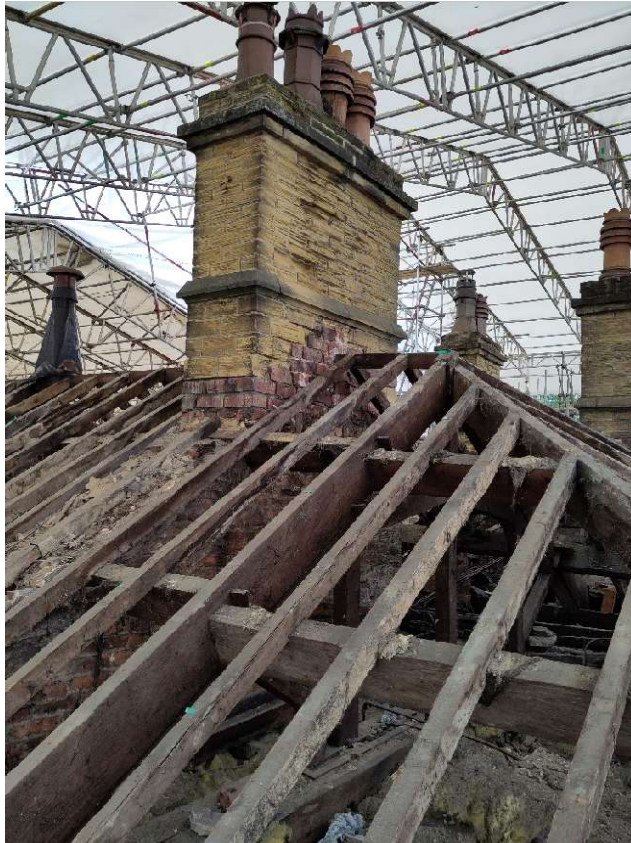
Photo 25 – Stack S6 from South East. Very heavily weathered stonework above lower string course.

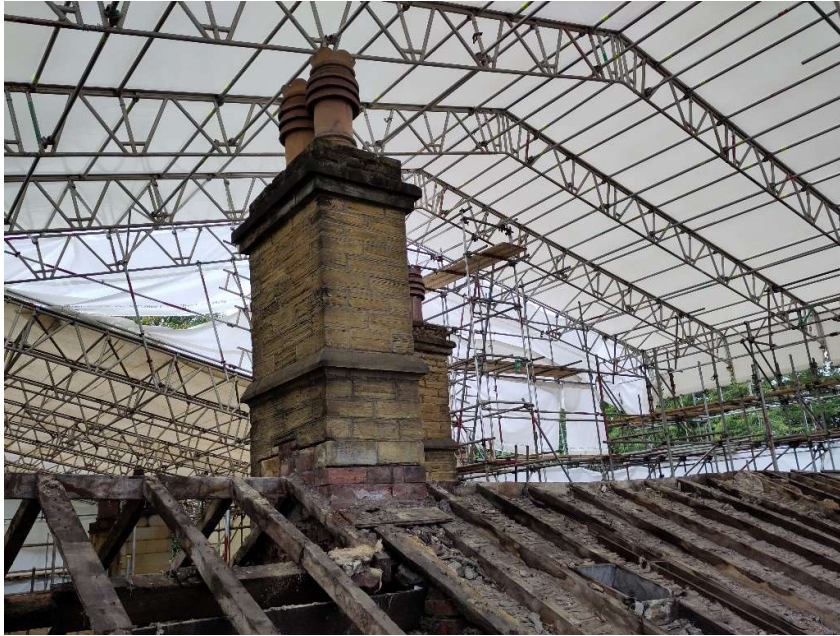
Photo 26 – Stack S7 from East

Masonry to the capping above the upper string course appears to be highly weathered. There is some weathering to the pointing, but otherwise the stack appears to be in good overall structural condition.

Masonry above the upper string course will require carefully removing and rebuilding, replacing any highly weathered stones with new. Following local rebuilding works, the stack will require repointing throughout.

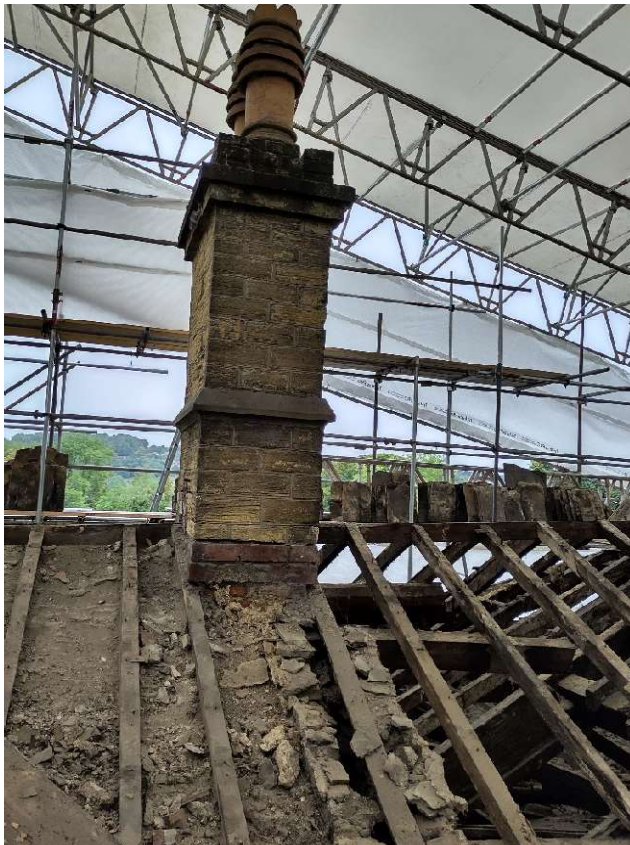
Photo 27 – Stack S7 from West. Note heavy weathering to masonry above upper string course.

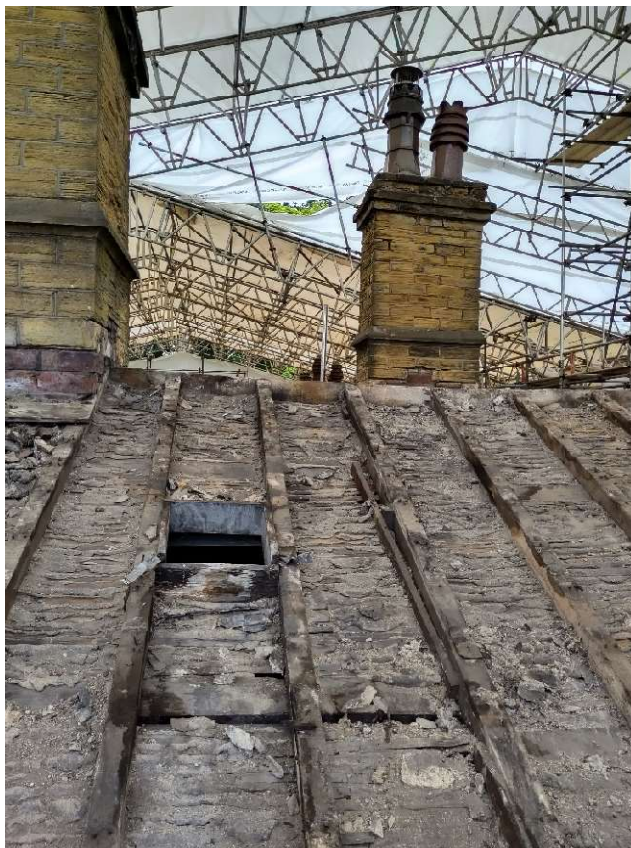
Masonry above the lower string course is heavily weathered. The stack is built off a render covered brick flue wall built into the stone gable wall. A small area of render has locally failed to expose the existing brickwork, but otherwise the render prevented direct inspection of the existing brickwork to assess its structural condition. Stonework to towards the verge of the gable peak has become loose.

Photo 28 – Stack S8 from East. Weathered stonework above lower string course.

Masonry above the upper string course will require carefully removing and rebuilding, replacing any highly weathered stones with new. Following local rebuilding works, the stack will require repointing throughout. The loose masonry towards the verge of the gable wall requires carefully removing and resetting.

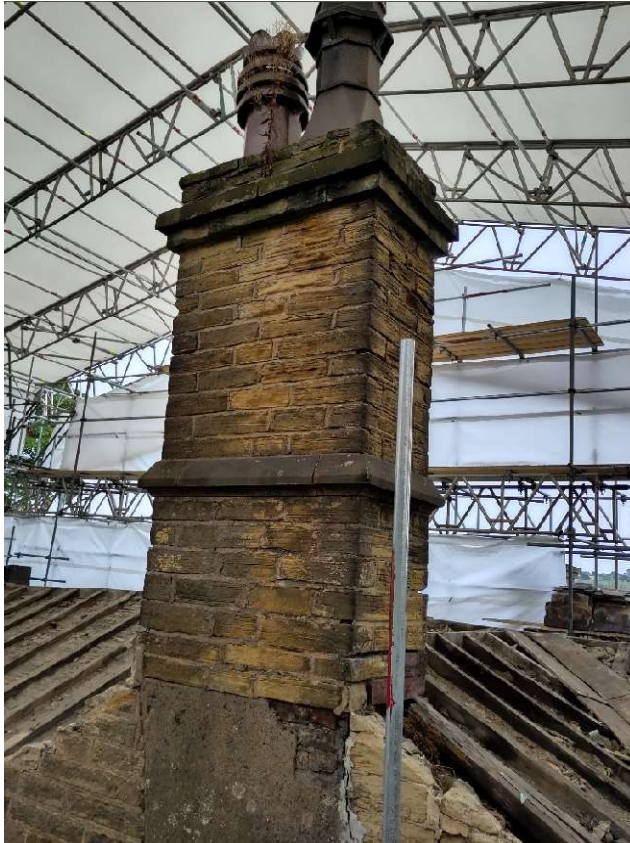
Photo 29 – Stack S8 from West. Heavily weathered stonework above lower string course. Loose masonry to verge of gable wall and rendered brickwork flue wall within gable.

The render to the brickwork flue wall should be carefully removed to allow for further assessment of the structural condition of the brick flue wall. We understand that new render has been specified by the Architect – the condition of the exposed brickwork should be assessed, and any necessary repairs carried out prior to the new render being applied.

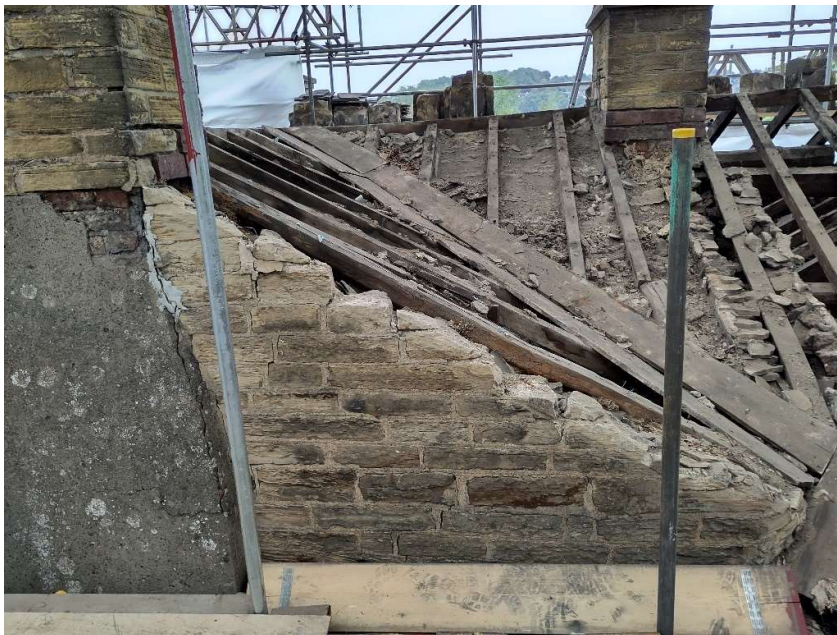
Photo 30 – Loose masonry to verge of gable peak

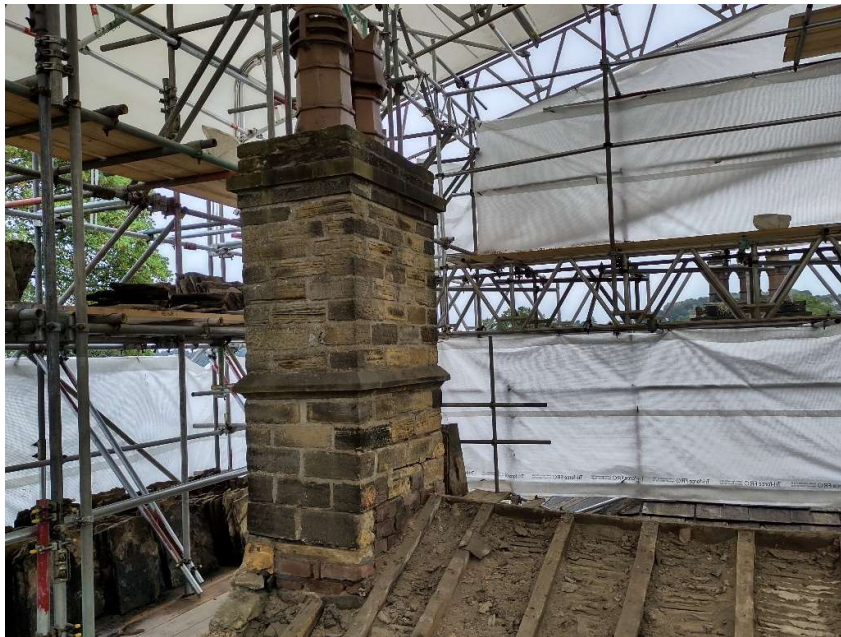
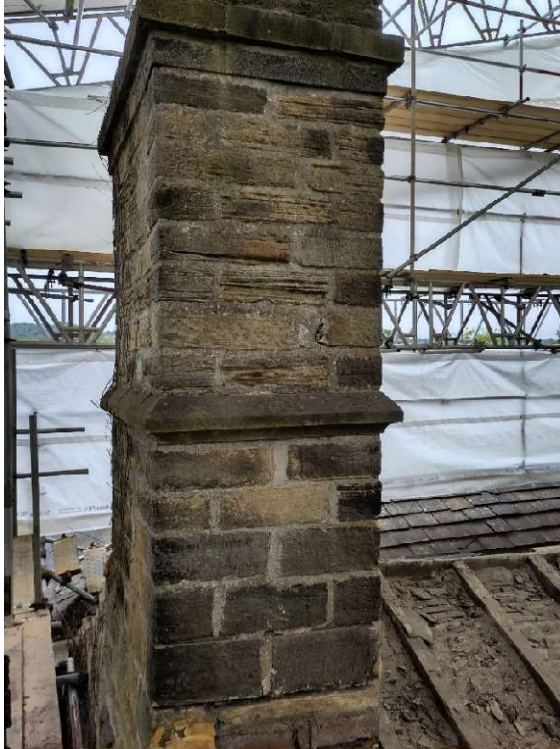
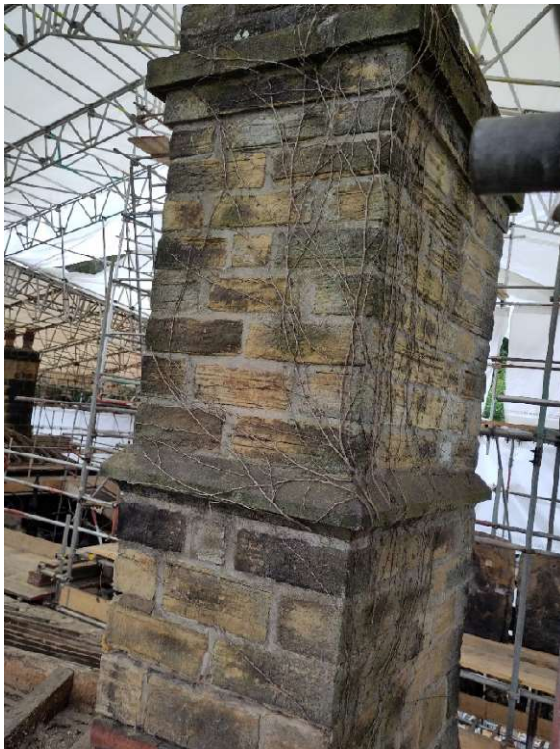
Stack S9 is in reasonably good overall structural condition with just local weathering of pointing and stonework.

Stack S9 appears to be in reasonably good condition, and only local repointing and assessing/replacing haunching is considered necessary. However, the stack is located directly above, and relies on the support of, the stone arch above the window opening to the gable wall at attic floor level. The stone arch members are heavily weathered and eroded and require replacement. To allow for the safe removal and rebuilding of the stone arch, it will be necessary to carefully dismantle the existing chimney stack and stonework immediately around the arch. The stack should be rebuilt to match existing, replacing any stones that are found to be heavily weathered or damaged during rebuilding works.

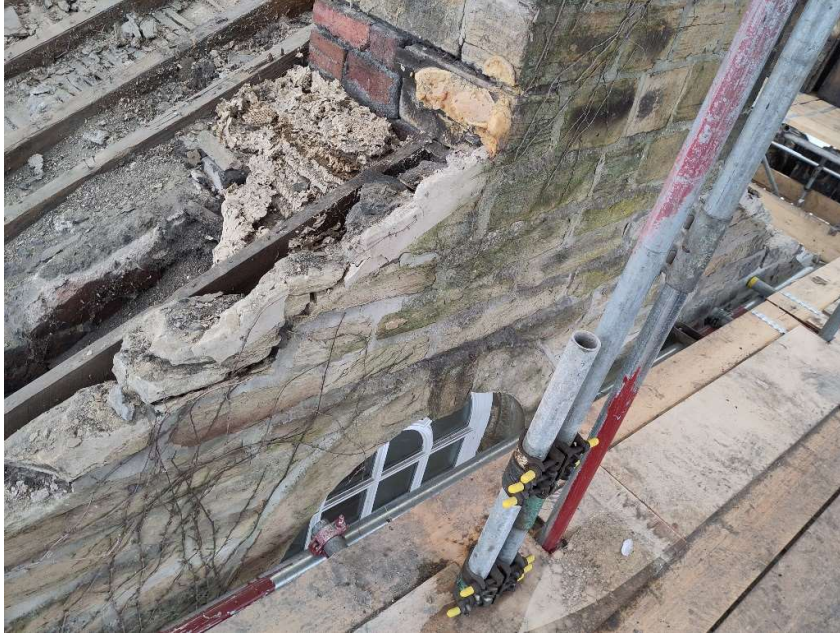
Photo 39 - Stack S9 above stone arch scheduled for removal/replacement
