HOLY INNOCENTS CHURCH, THORNHILL LEES

DEWSBURY, WEST YORKSHIRE

SPIRE STABILITY

4th August 2021

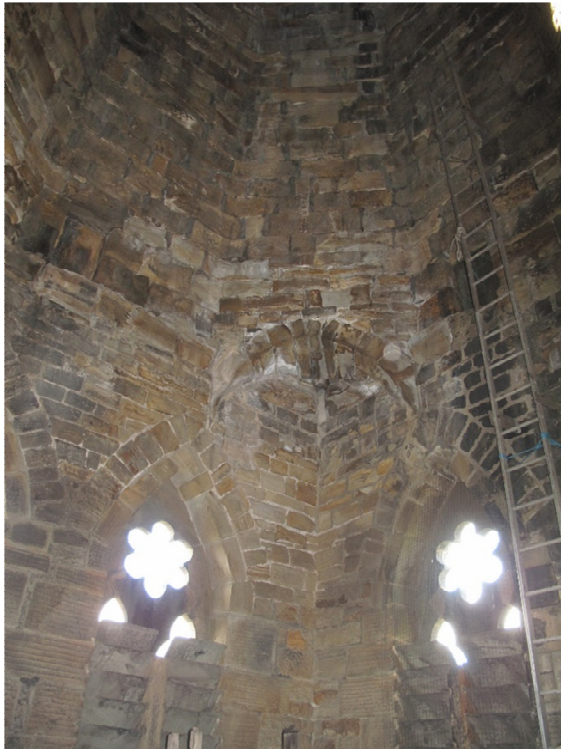
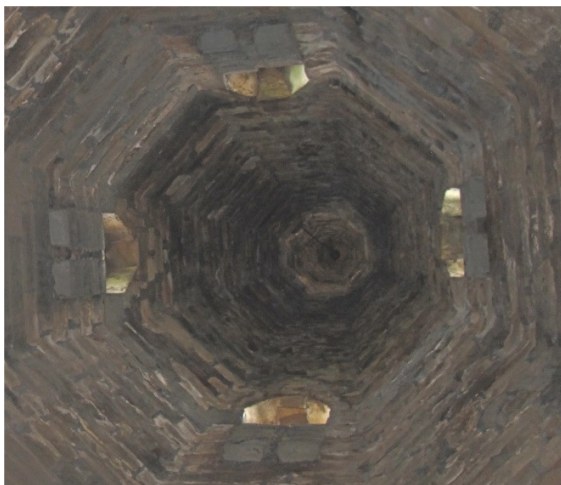
TRANSITION FROM SQUARE TO
OCTAGONAL FORM

The spire springs from 1 metre thick walls surrounding the 4.5 metre square by 5.2 m high bell chamber. The broaching that facilitates the change from a square to an octagonal form takes place using an arch form to each corner, as can be seen in the adjacent photograph.

The ladder, on the east wall, seen in the photograph gives access to the parapet ledge at spire base level but is not safe to use.

The internal masonry is faced up to the head of the lower lucarnes. The upper courses consisting of a single stone thickness are rough-hewn.

The masonry in the transitional zone was sound despite some erosion to the facings. The metre thick walls give substantial robustness at this level. There are no signs of disruption from corroding embedding ferrous ties. The form of the transition suggest use of such devices would not have been considered necessary.

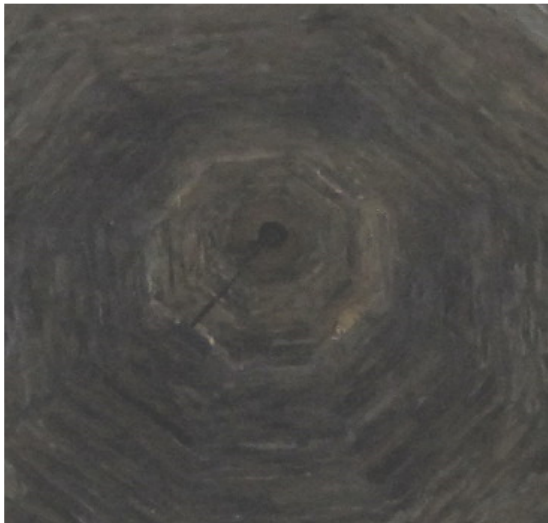
LIGHT PENETRATION AT CROSS
TREE LEVEL

The adjacent photograph of the apex interior has been trimmed from a general shot taken from bell-chamber floor level. There are two important features shown. One is the restraint rod extending down from the finial and the other is the band of light at upper lucarne level where the cross-trees appear to have been located.

The presence of these high level openings helps the masonry to be seen as well as the absence of the cross tree structure that restrained the finial. The band of light appears to be on a ring of finer stone similar to that at the lower level. The masonry above this level is likely to have been that which was found to be unstable.

Externally, the spire shows no signs of deviation from the overall geometry such as bursting, twisting or distortions to the faces. The structure is most vulnerable at lucarne level where erosion is much more likely due to weather penetration. Internally there is a band of higher quality fine grained sandstone stretchers at crown springing level, which has effectively formed a strong ring to resist bursting.

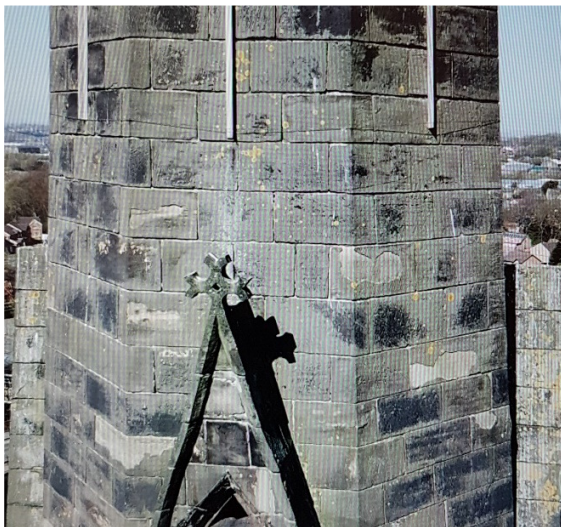
ABSTRACT FROM DRONE PHOTO SE
FACE

Externally, on the adjacent drone photo, a change in the stone thickness can be detected above the finial level. It is probable that the true thickness of the outer leaf shows below the change but that squint or external angle stones have been used above that level.

The photograph above also shows where the restraint angles and circumferential wires start. The purpose of this intervention is not reliably known but can be speculated upon.

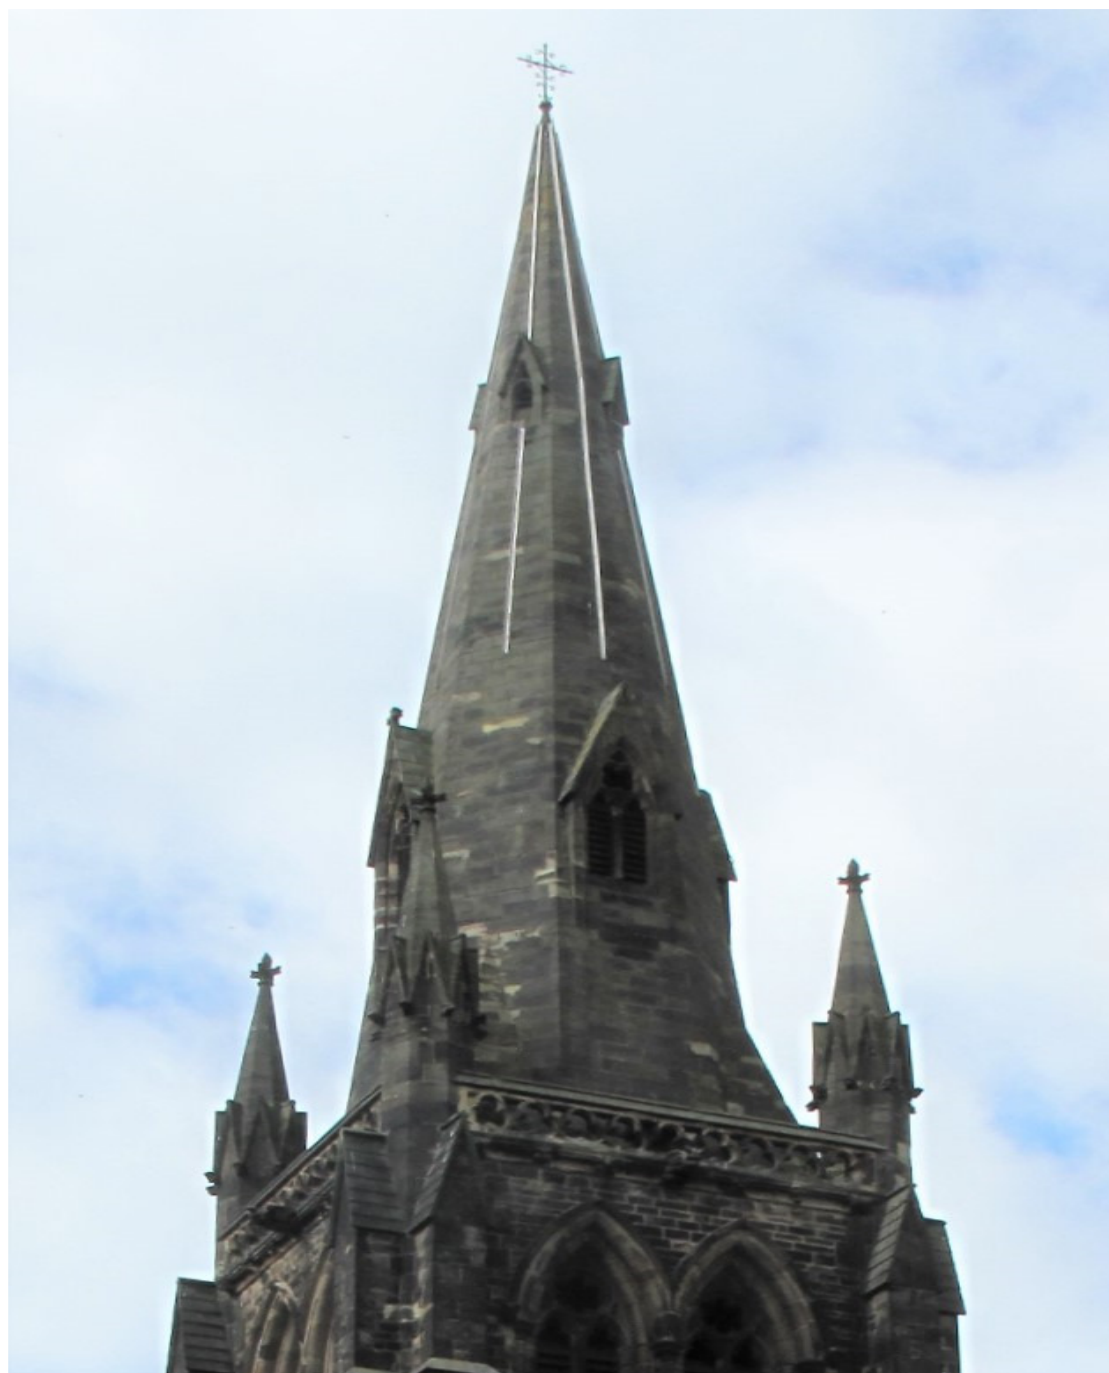
VIEW FROM THE SOUTH-EAST

The drone photographs taken by Taylor Hastwell Steeplejacks in April this year have been used for this part of the report without reproducing them. Essentially, they enlarge upon the view on the last page taken on 14th July.

The cross, finely crafted in copper-work is set into a cast iron capping, which is pitted by erosion. Bolt heads are visible that are clamps for the square stem of the cross near the top and the restraint that extends down internally. It is probable that the top eight courses are single stones that relied on the internal rod for restraint.

It is most likely the galvanised steel angles were introduced to restrain these topmost courses. It is likely the anchorage cross-tree corroded away some considerable time ago due to exposure to the weather sweeping through the upper lucarnes. There is no explanation for the internal rod not being vertical, but as it remains suspended its role in resisting lateral displacement of the upper courses remains effective, as a dowel.

The galvanised steel angles have been fixed by 16mm diameter stainless steel rods chemically bonded into the masonry with what appeared to be nuts vulnerable to corrosion causing staining. A sample had been left on the bell-chamber floor, which if typical, indicated a minimum embedded length of 200 mm, which might be confirmation of a 9" (225mm) stone thickness.

Light-gauge wire girdles have been installed at half metre intervals, some threaded beneath the angles. At the very top, the wire was threaded through alternate angles, ringed round the top stone. It is noted that the Steeplejack commented the temporary work was probably done in the early 2000s by steeplejacks.

Galvanising in exposed locations has a limited life expectancy due to the gradual loss of zinc. The later stages of effectiveness are characterised by discolouration, which was apparent on these sections. After two decades, corrosion could be expected to ensue.

The lime mortar joints to the whole of the spire were very thin and lightly eroded back from the stone facings. The ashlar faces were in remarkably good condition with loss of face showing in isolated places only at lower levels. The critical upper level surfaces remained very sound as far as could be seen on the drone photographs and with binoculars from the ground.

The long-term solution would be to reinstate the internal restraint assembly, which would obviate the need for the external temporary intervention.
