GeoShield Verification Report 1

PROJECT REFERENCE: GEO104995

PROJECT: Reservoir Street

Apartment Block - Perimeter DPC & Infills

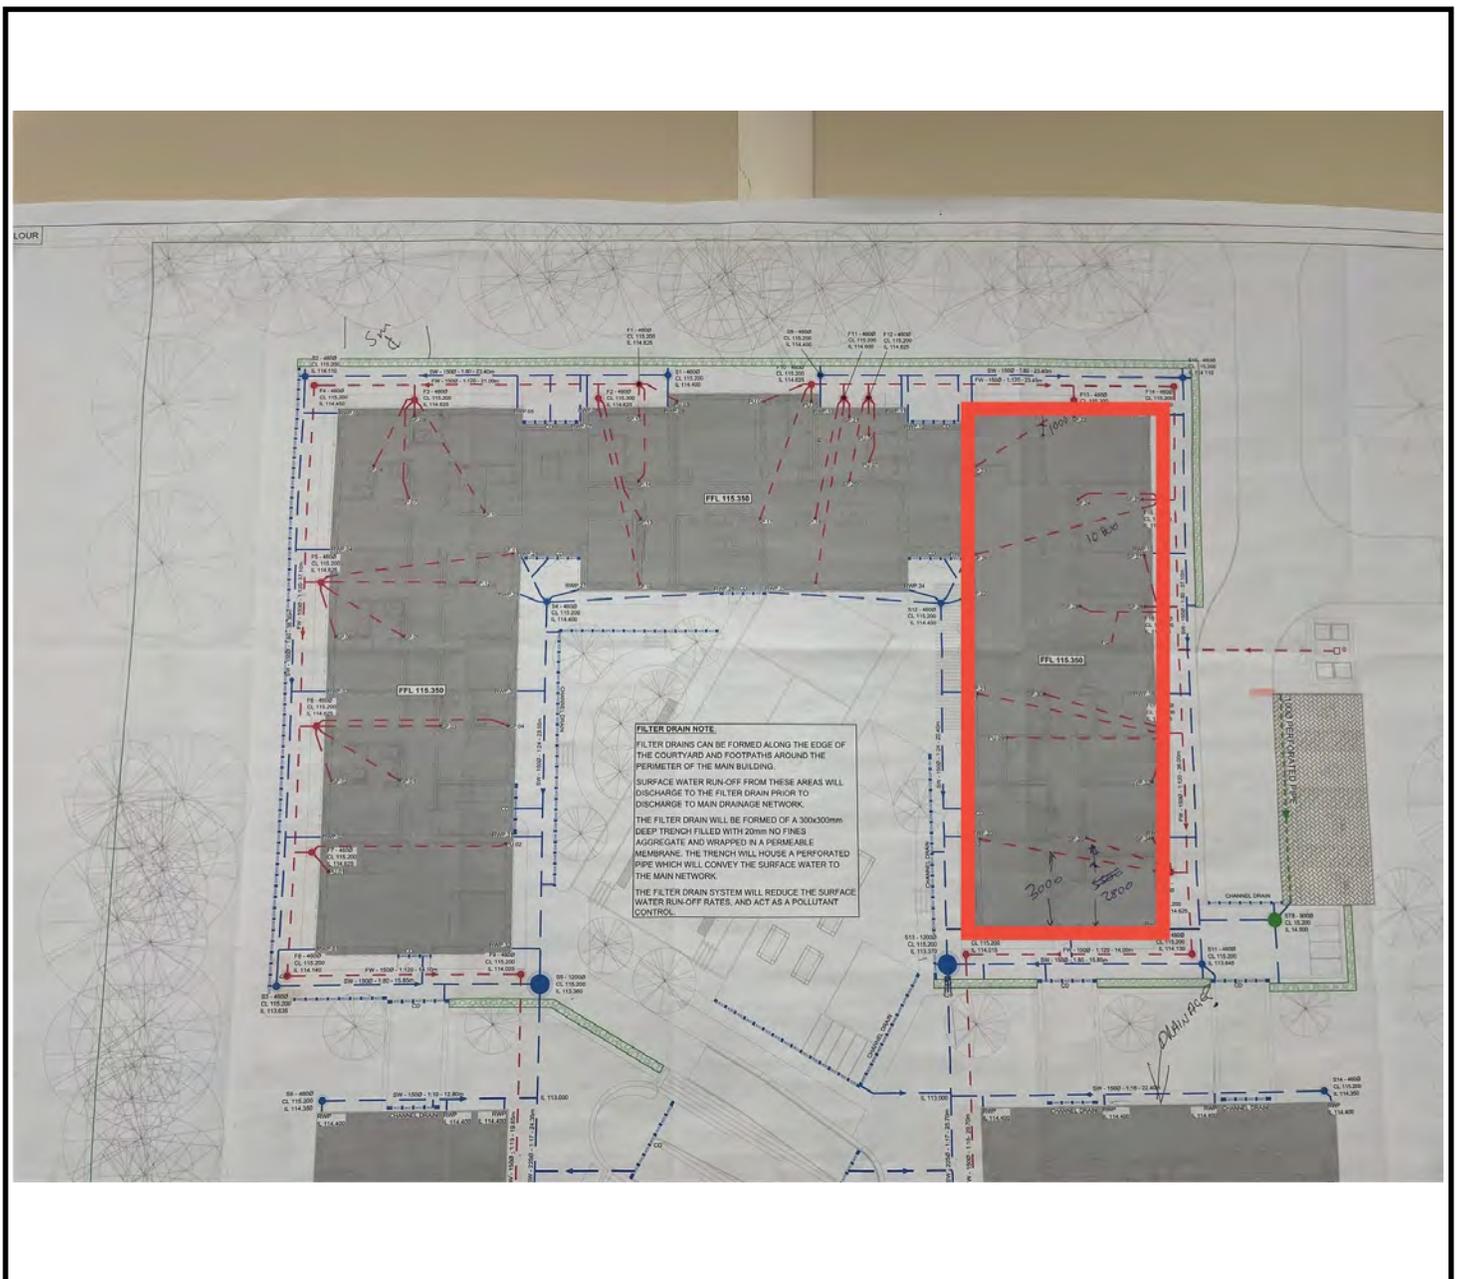
Verification Layout

The photograph above shows a plan layout of the site. The area highlighted in red shows the section of Apartment Block where the verification inspection took place on site today.

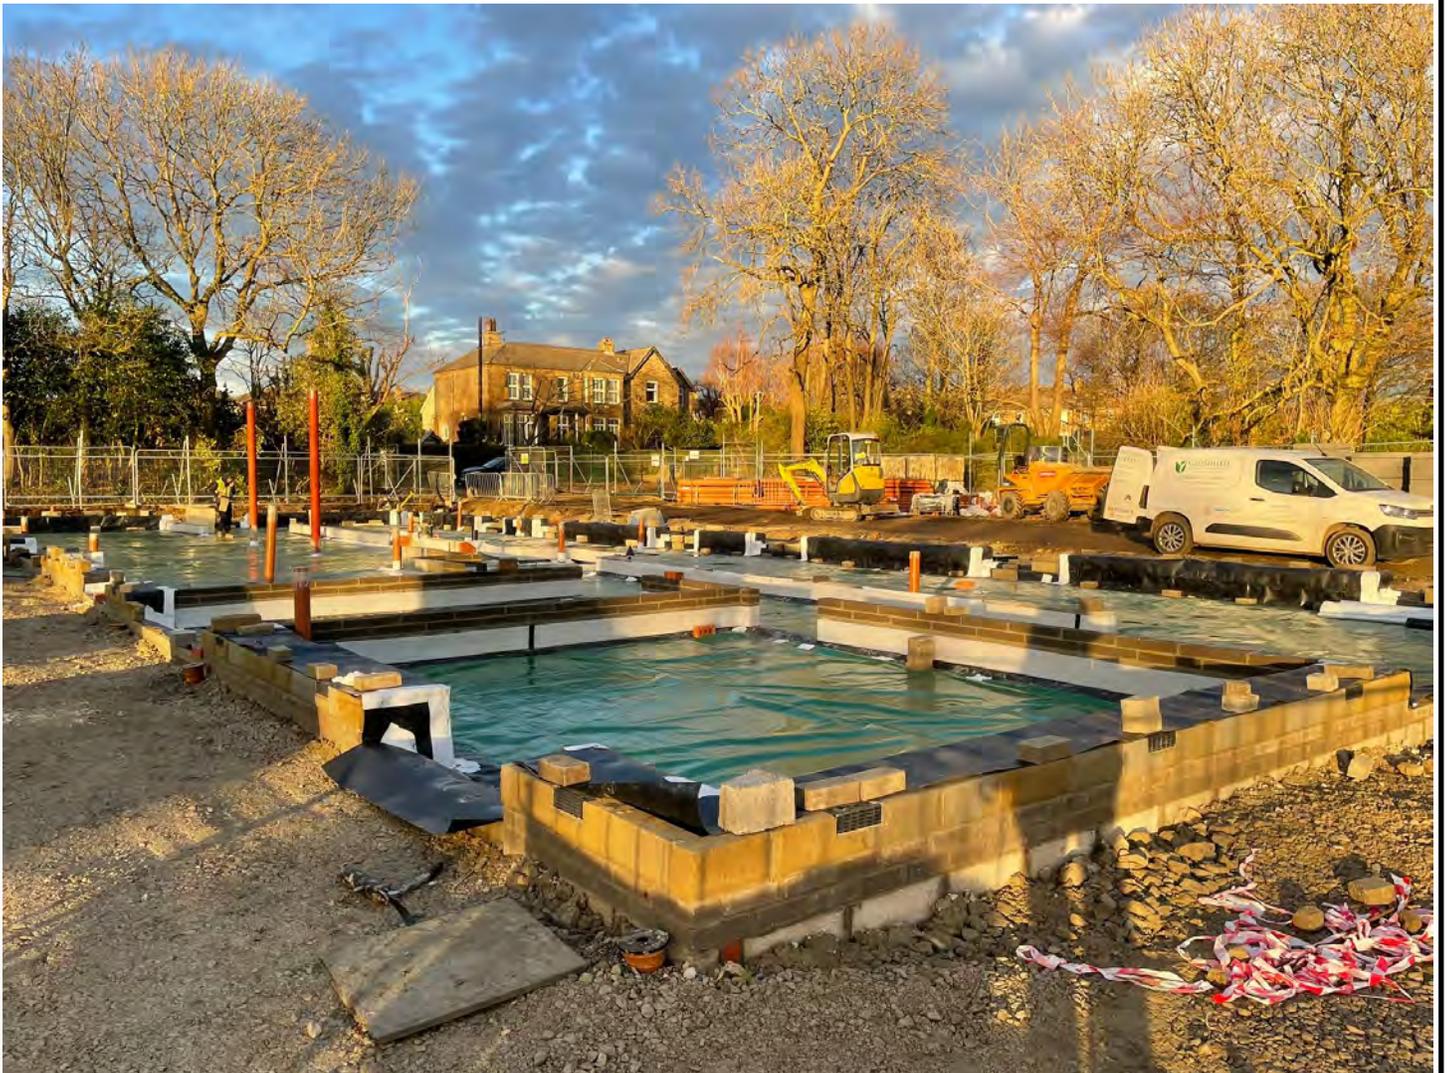
The photograph above displays an overview of the area where today's verification inspection took place on site.

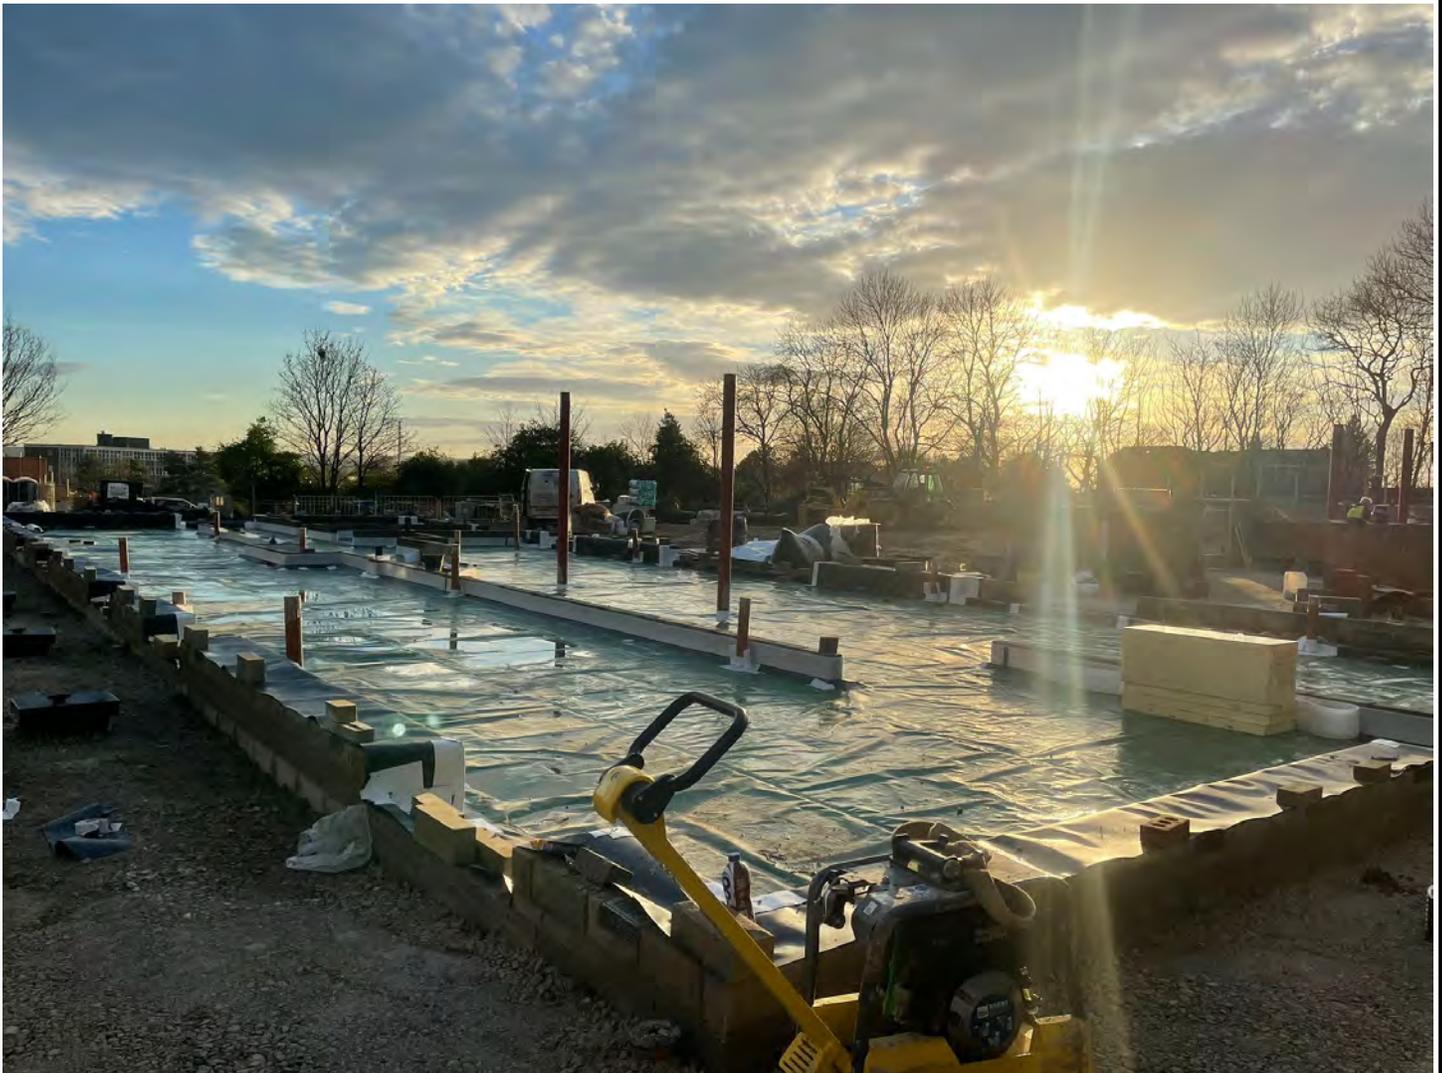
The photograph above displays an overview of the area where today's verification inspection took place on site.

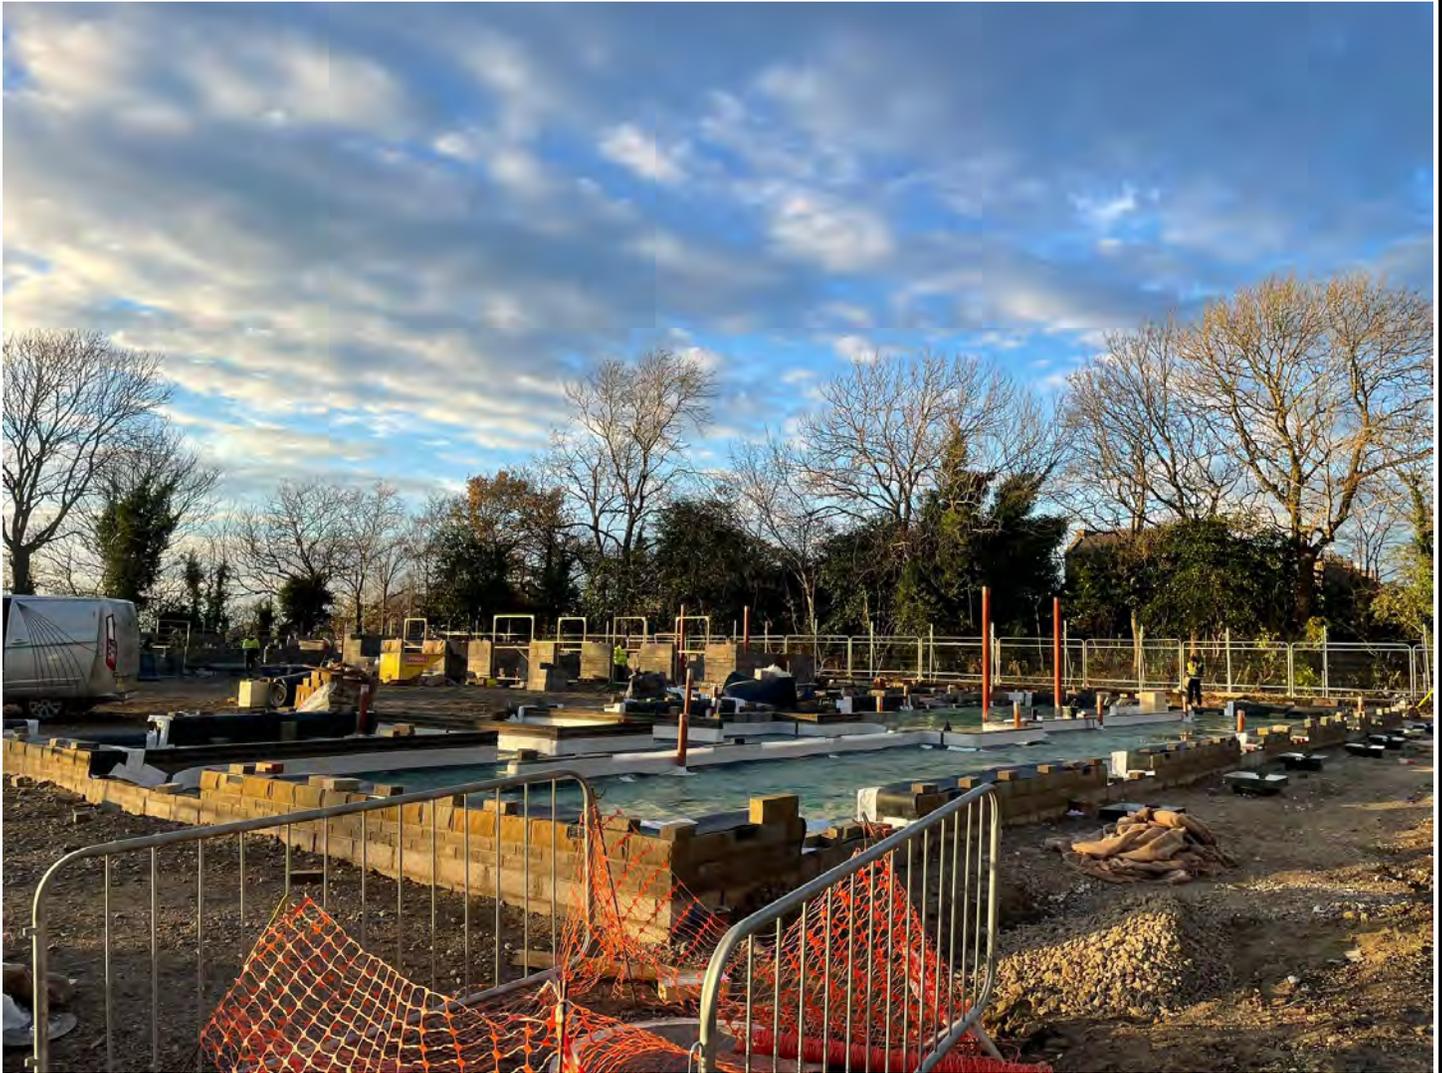
The photograph above displays an overview of the area where today's verification inspection took place on site.

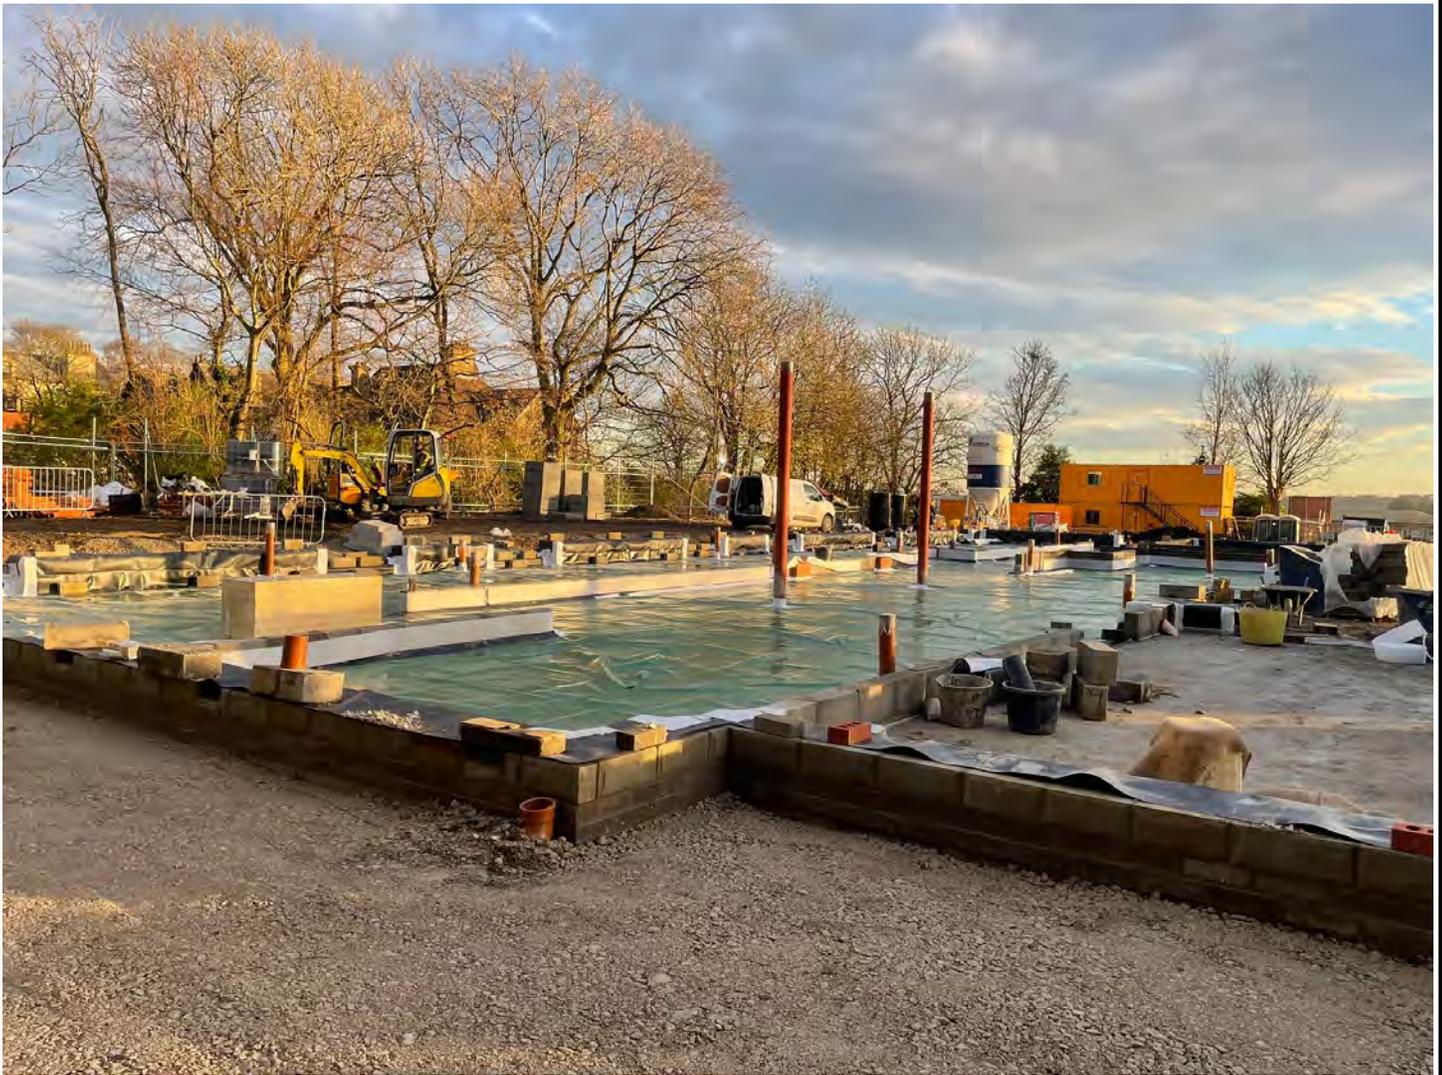
The photograph above displays an overview of the area where today's verification inspection took place on site.

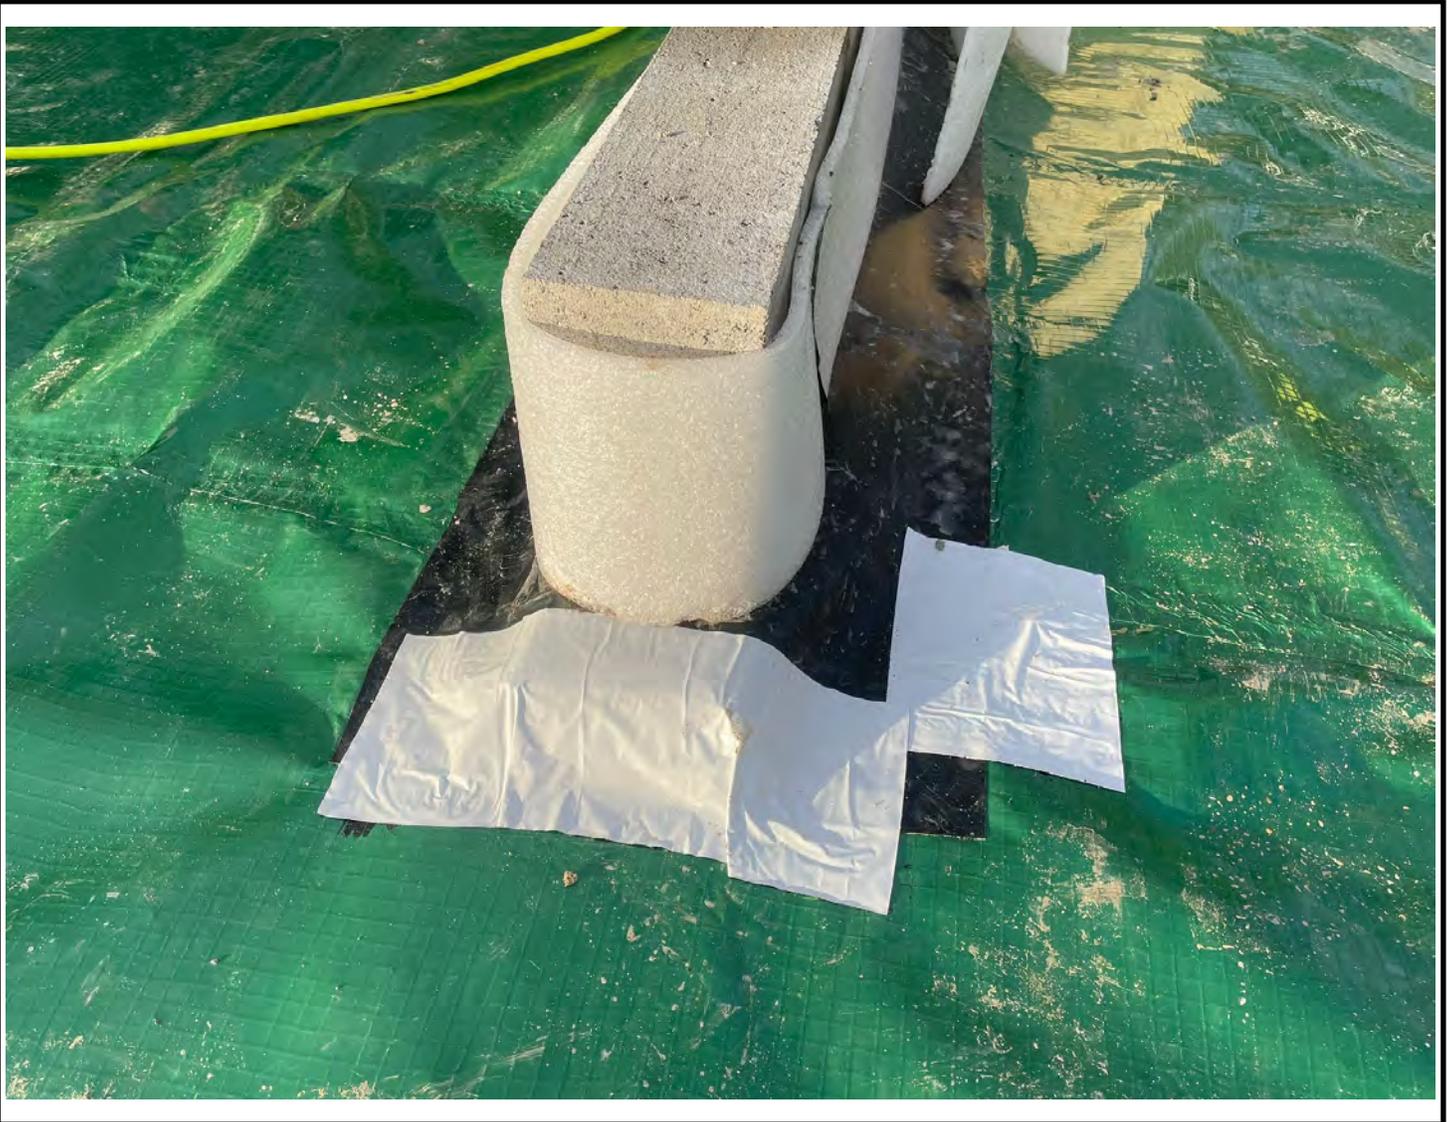
Verification could not be carried out upon any of the internal party walls due the brickwork being built on top of the Cordek DPC, which was installed by the main contractors prior to this visit.

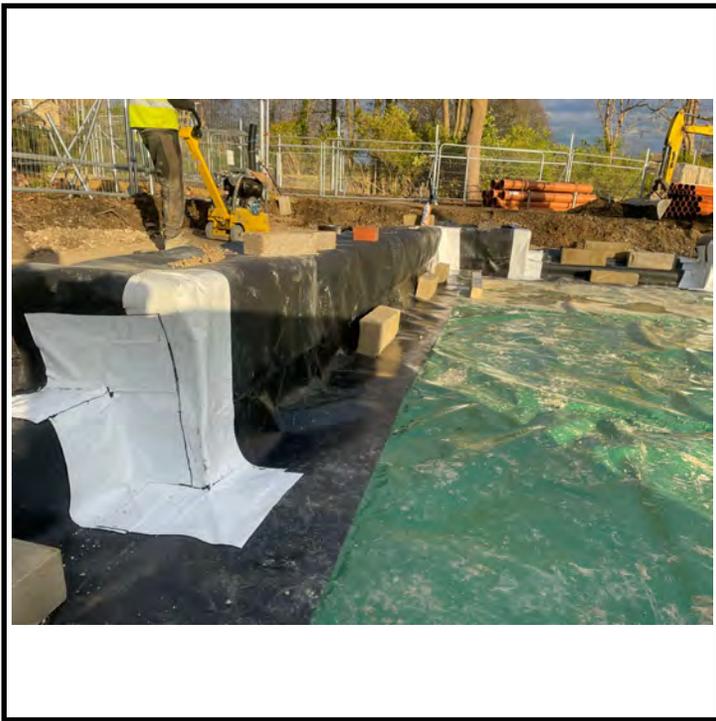
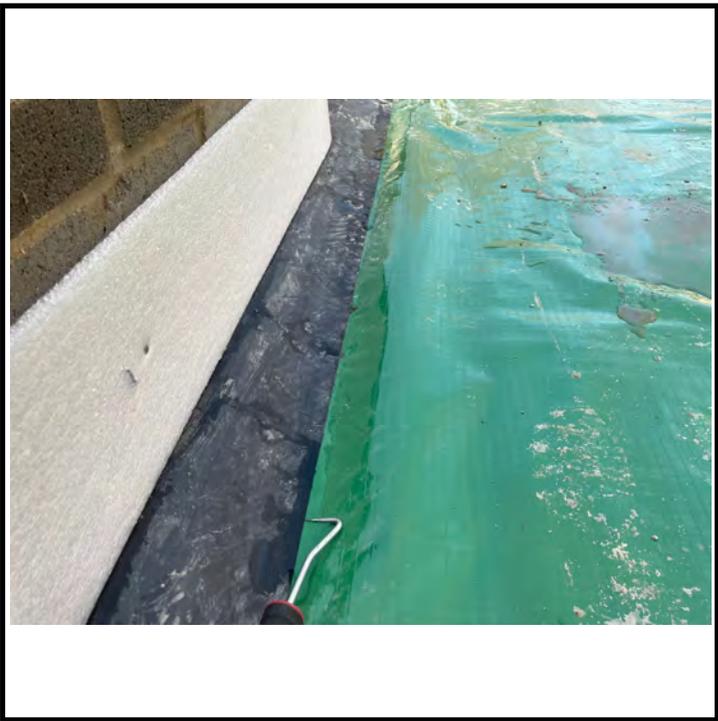
Installation of Cordek GRDPC & Cordek Tri-Gas Membrane

NOTES:
A line out to the perimeter of Cordek GRDPC and an infill installation of Cordek Tri-Gas Membrane has been carried out within a section of the Apartment Block. The installation has been carried out upon a block and beam sub floor ventilated void. The Cordek GRDPC has been taken up and over all external cavity walls. The

NOTES:
Cordek Tri-Gas Membrane has been infilled across the entirety of the area, lapping onto the Cordek GRDPC installed around the perimeter. All overlaps between the adjacent sheets of Cordek GRDPC & Cordek Tri-Gas Membrane have been overlapped a minimum of 80mm and welded using a hot air leister and a silicone

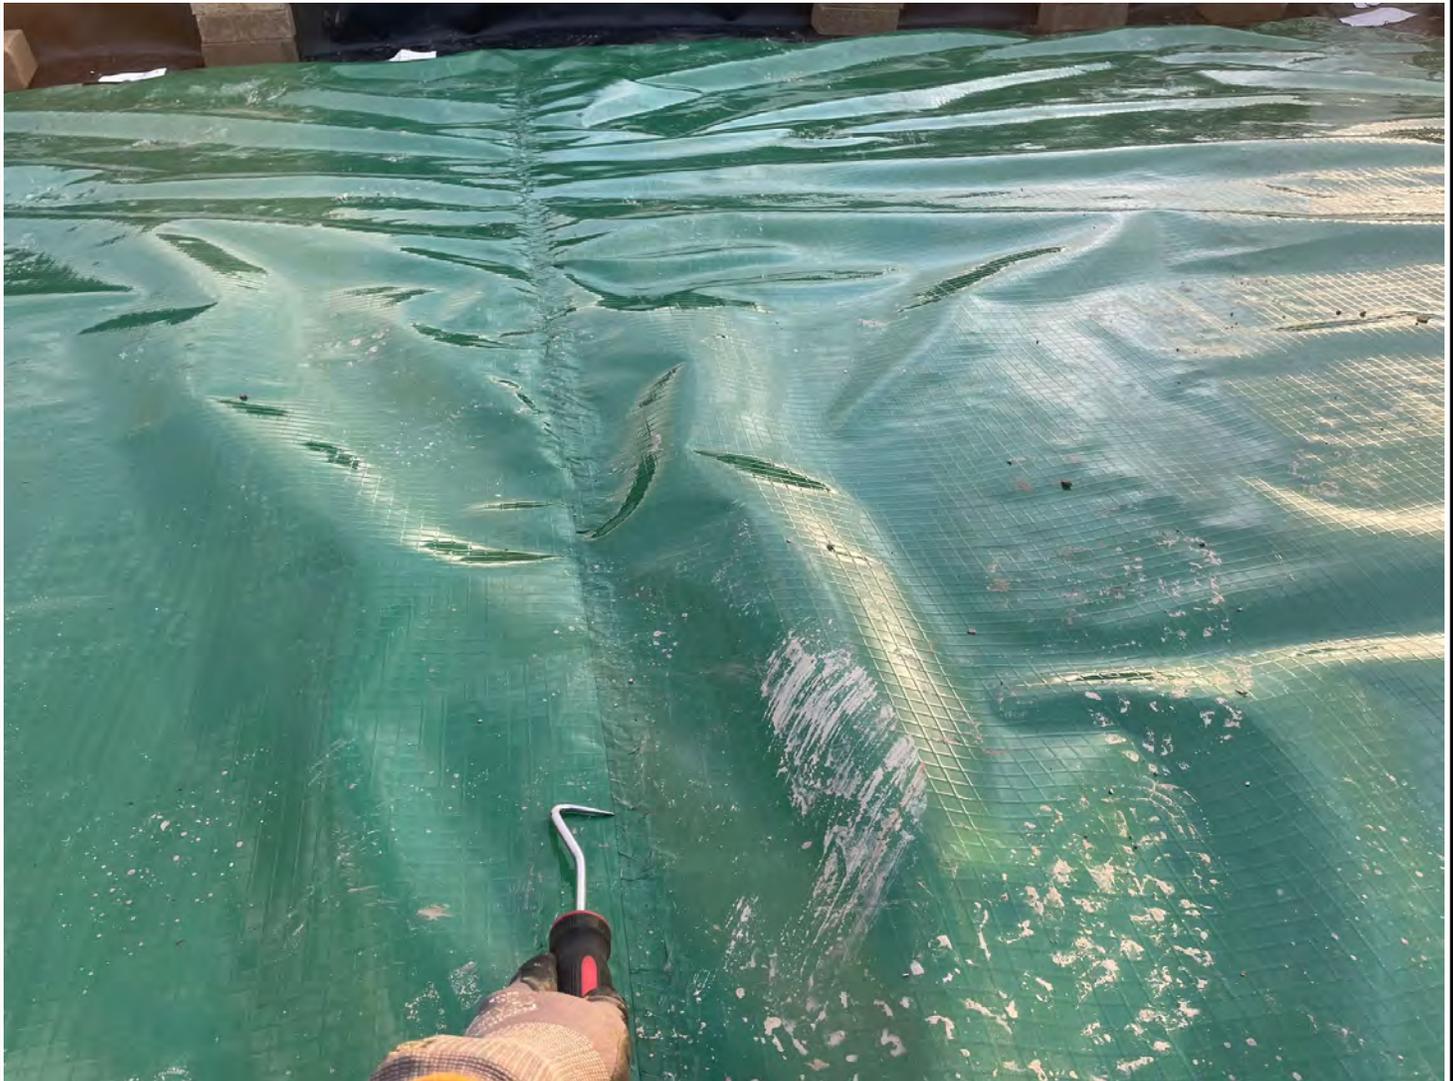
roller with adequate pressure applied to ensure continuous welds are achieved throughout. Thorough visual inspections, supported by mechanical point stress testing and non destructive air lance integrity testing were conducted upon all overlaps. One misweld was identified, which was successfully remediated in the presence of GeoShield.

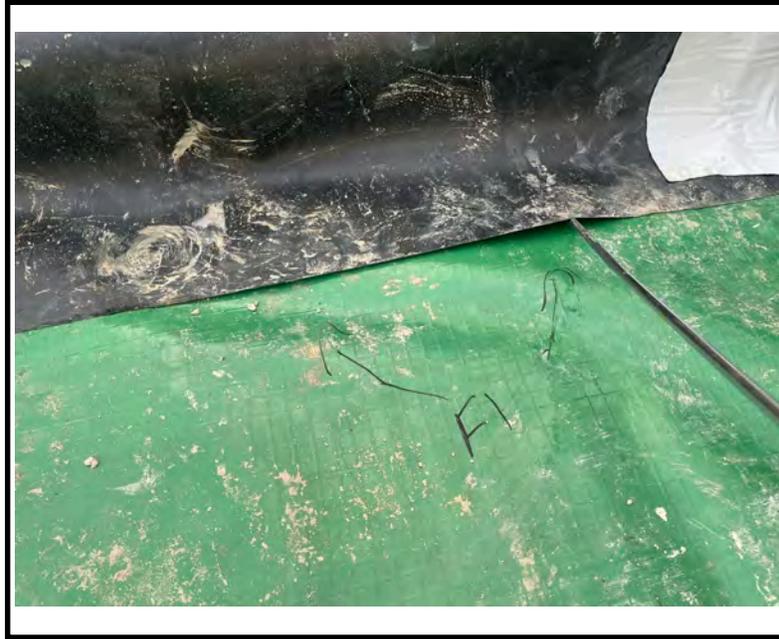
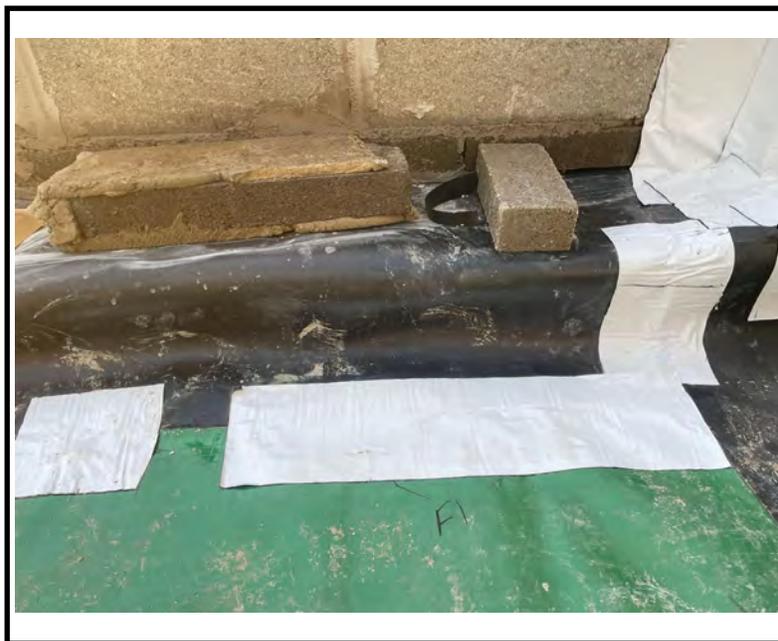
Fault Identified & Remediated

As mentioned, one misweld was identified during the testing procedures conducted upon all lap joints. The fault was highlighted for ease of identification and remediated on site in the presence of GeoShield. The dedicated applicators from PAGeo Contracting Ltd opted

to remediate the misweld using strips of Cordek GRSAM, heat and firm rolled pressure were applied to ensure the Cordek GRSAM had fully bonded. Further testing of the remedial works identified no faults or defects.

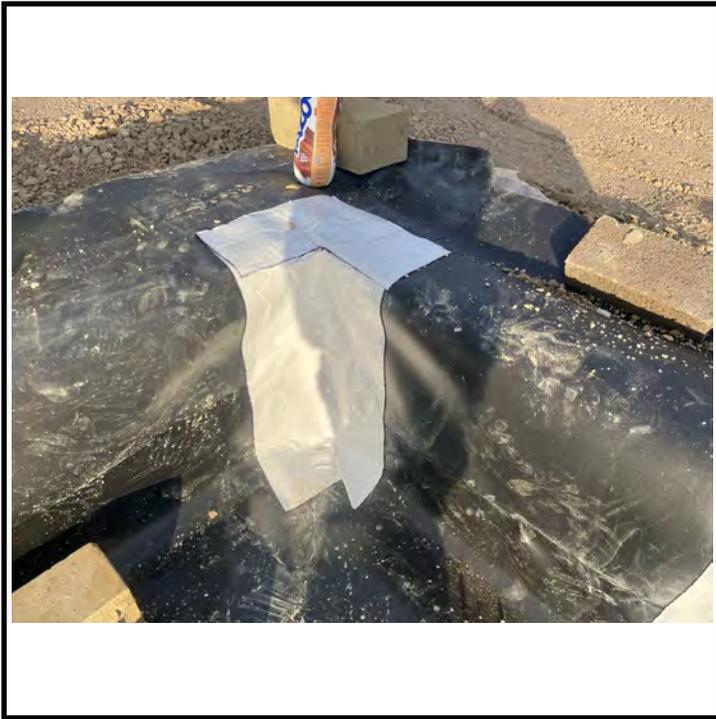
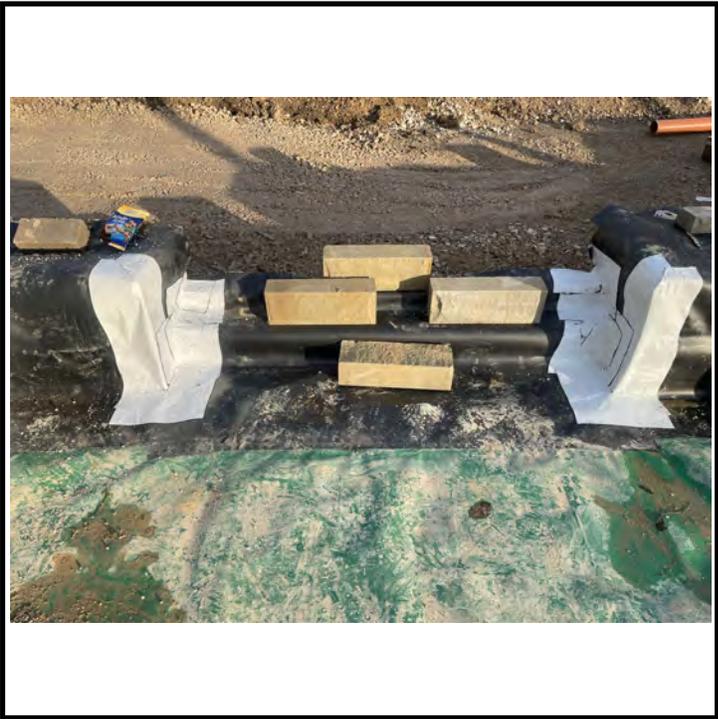
Corners & Thresholds

NOTES:
A number of corners and thresholds throughout the referenced area have also been sealed as per manufacturer's specifications and design guidelines. This has been achieved using Cordek GRSAM. Where the Cordek GRDPC has been cut to minimise voided areas and gaps across the footprint of the area, each corner and

NOTES:
threshold junction has been reinforced by heating strips of Cordek GRSAM and placing into position around each corner and threshold, onto the Cordek GRDPC. Firm rolled pressure is applied with a silicone roller to aid in the adhesion, ensuring the Cordek GRSAM has fully bonded.

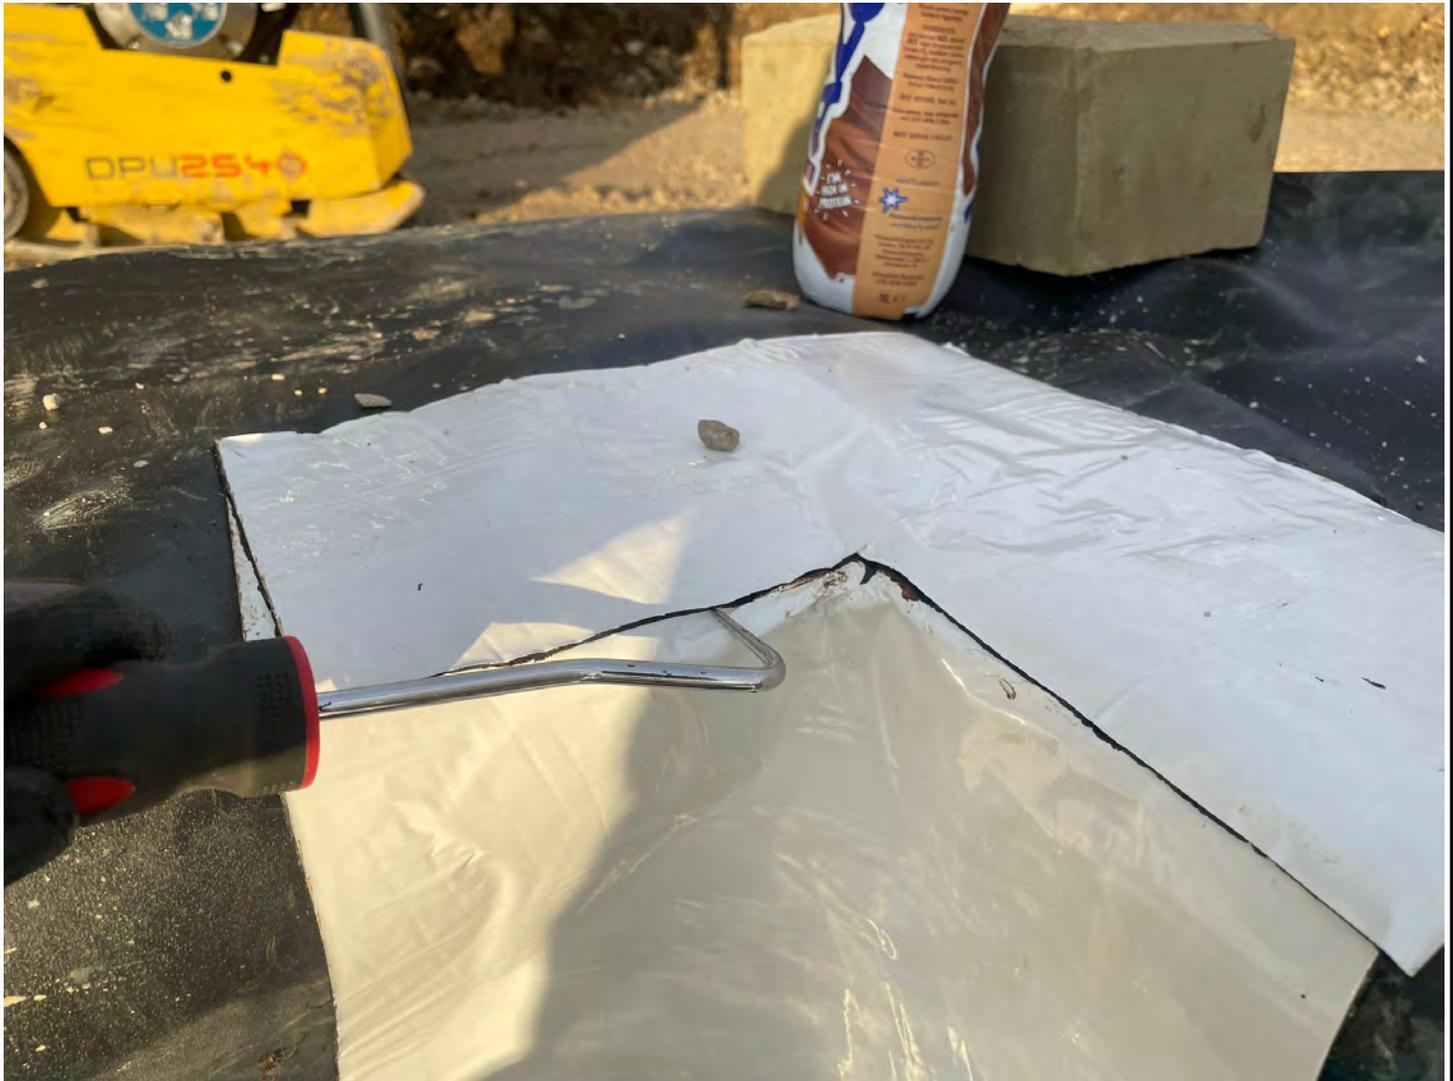
A probe was run along all edges of the Cordek GRSAM within the corner & threshold detailing to validate that a continuous gas resistant seal had been achieved throughout. No faults or defects were identified during the testing of the corners and thresholds. Tested and verified in accordance with CIRIA 735.

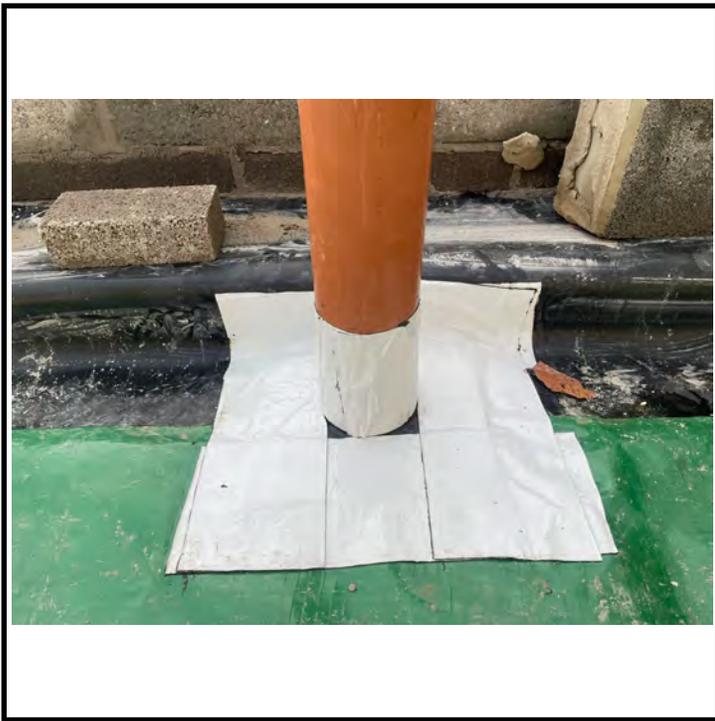
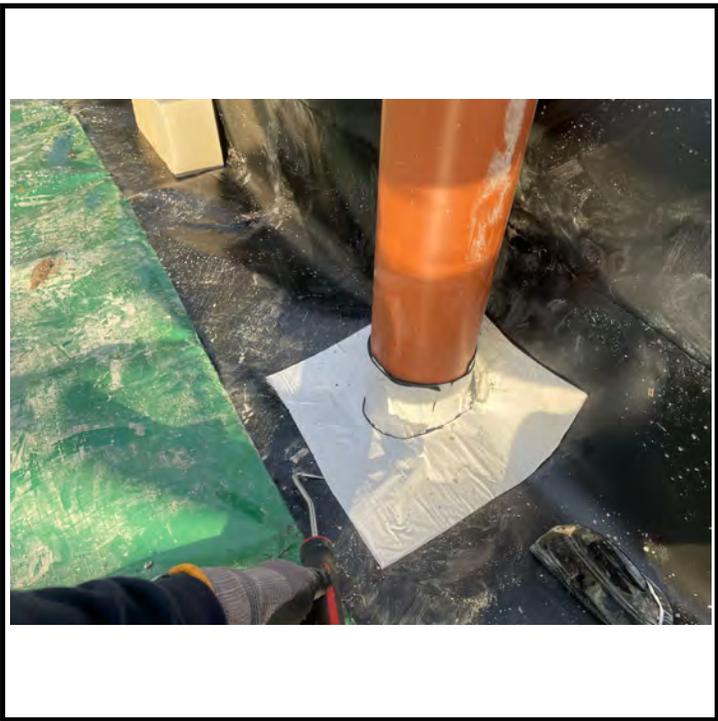
Pipe Penetrations

NOTES:
Throughout the installation of the Cordek GRDPC & Cordek Tri-Gas Membrane to the referenced area, there were a number of pipe penetrations that required sealing. The pipe penetrations have again been sealed using Cordek GRSAM. The installers have first cut the Cordek GRDPC/Cordek Tri-Gas Membrane tight

NOTES:
around the base of each pipe penetration to minimise voided areas. Next, patches of Cordek GRSAM are intricately placed around the base of the pipe penetration in a petal formation, onto the Cordek GRDPC/Cordek Tri-Gas Membrane, as shown in the photographs above.

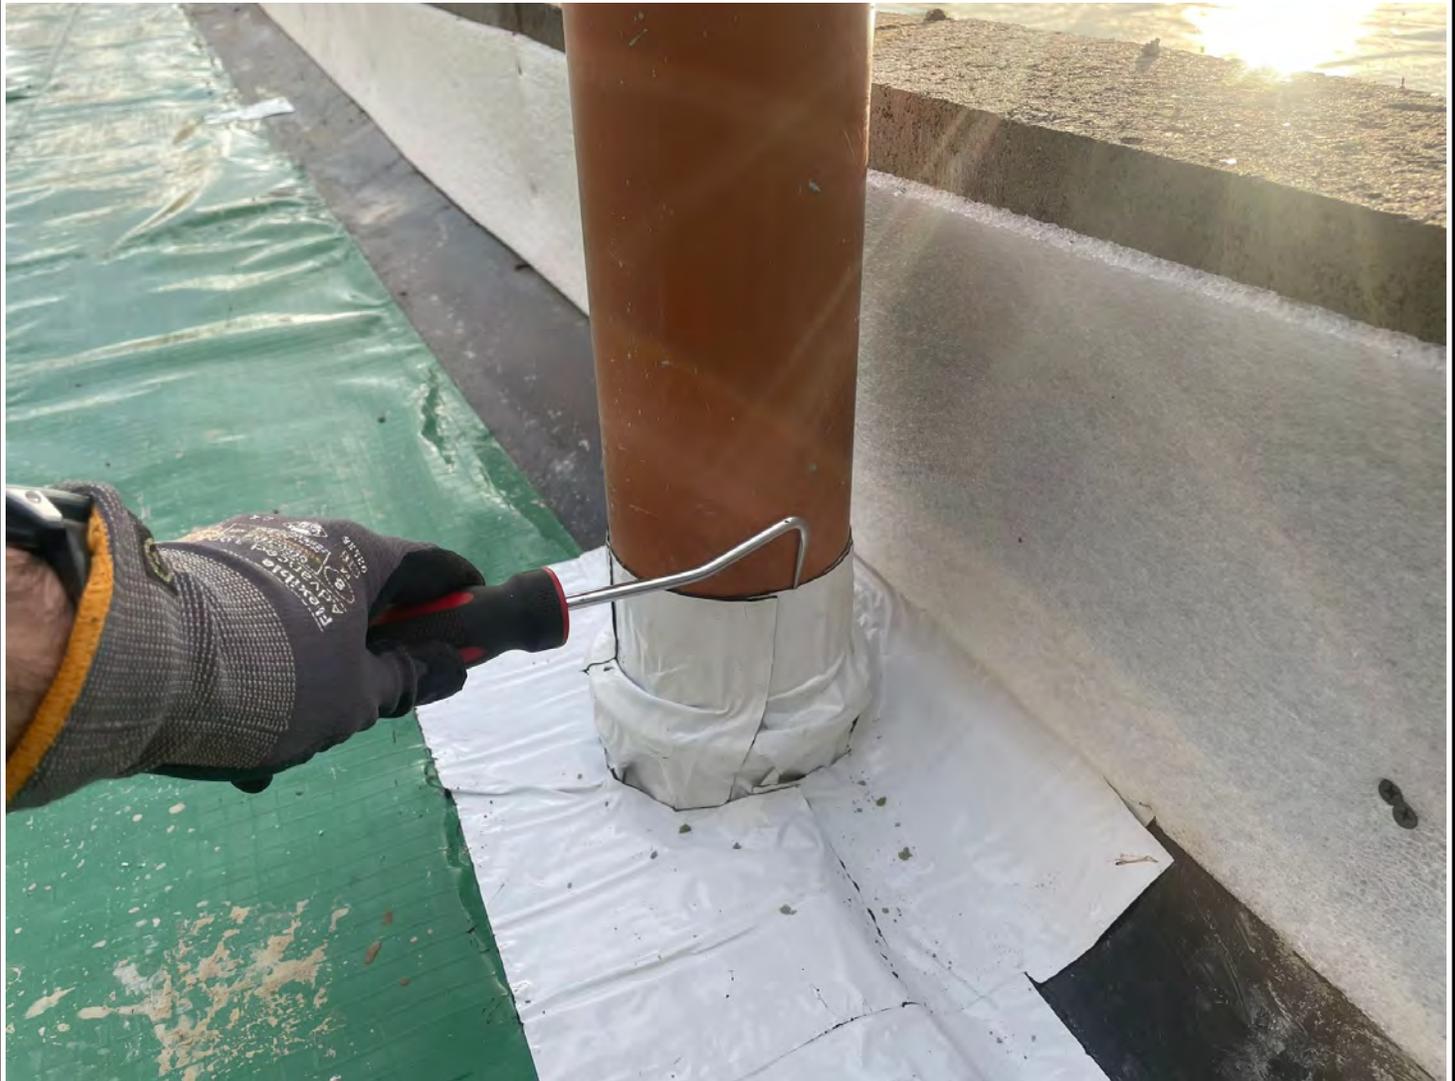
Heat and rolled pressure is applied to activate the bitumen backing, creating a secure bond between the pipe penetration and the return onto the Cordek GRDPC/Cordek Ti-Gas Membrane. Visual inspections, supported by mechanical point stress testing conducted upon all sealed pipe penetrations identified no faults or defects. A complete adhesion has been achieved throughout.

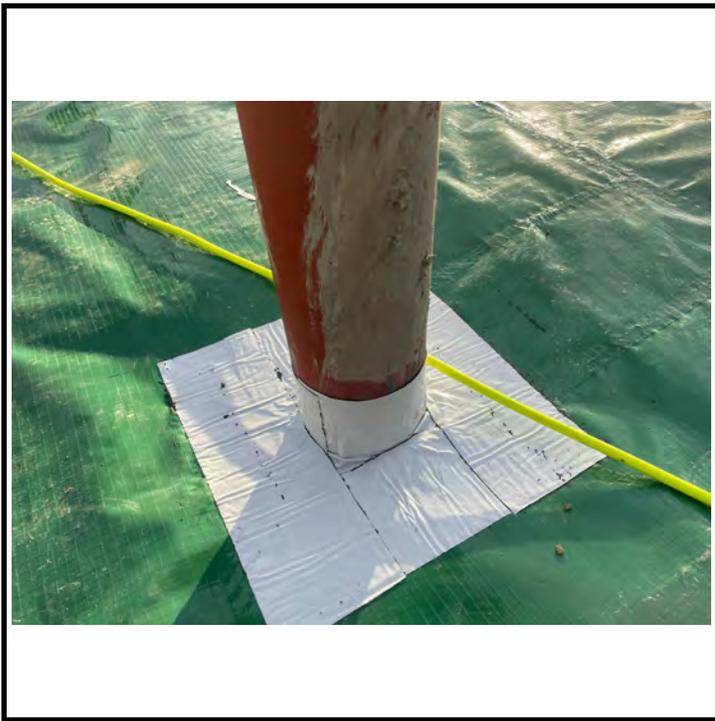
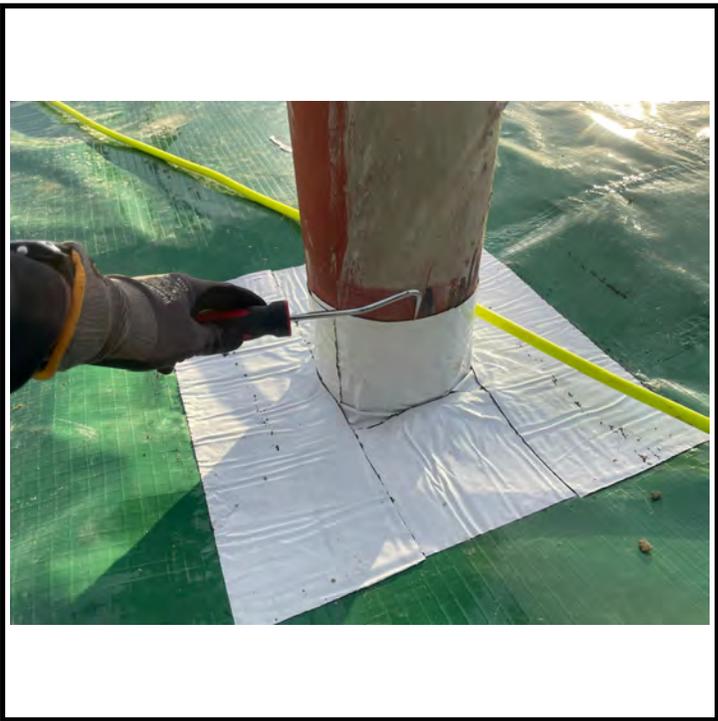
Stanchion Detailing

NOTES:
A number of stanchions also required detailing throughout the installation of the Cordek GRDPC/Cordek Ti-Gas Membrane. These too, have been sealed using Cordek GRSAM in accordance with manufacturer's specifications and guidelines. This has been achieved by cutting the Cordek GRDPC/Cordek Ti-Gas

NOTES:
Membrane tightly around the base of each individual stanchion. Strips of Cordek GRSAM are cut and formed around each stanchion, creating a tight seal. A top hat formation is then created using further strips of Cordek GRSAM to reinforce the robust seal. A gas torch was used to heat the backing of the Cordek GRSAM to

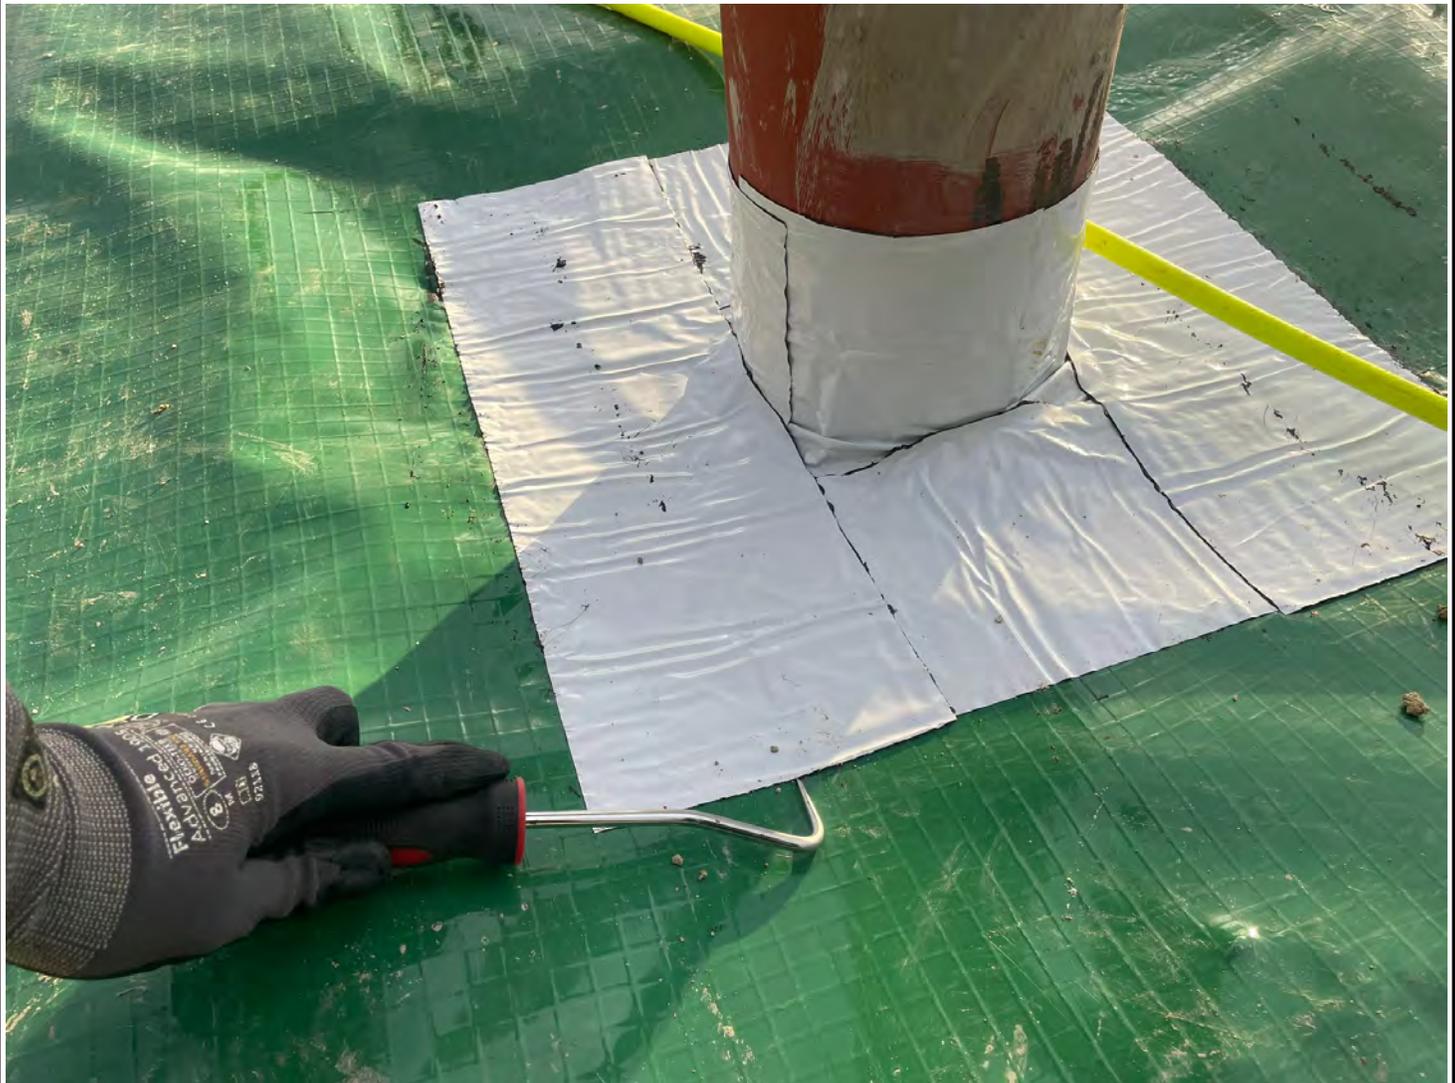
aid in the adhesion and to ensure a correct bond was achieved. Thorough visual inspections, supported by mechanical point stress testing conducted upon all sealed stanchions identified no faults or defects.

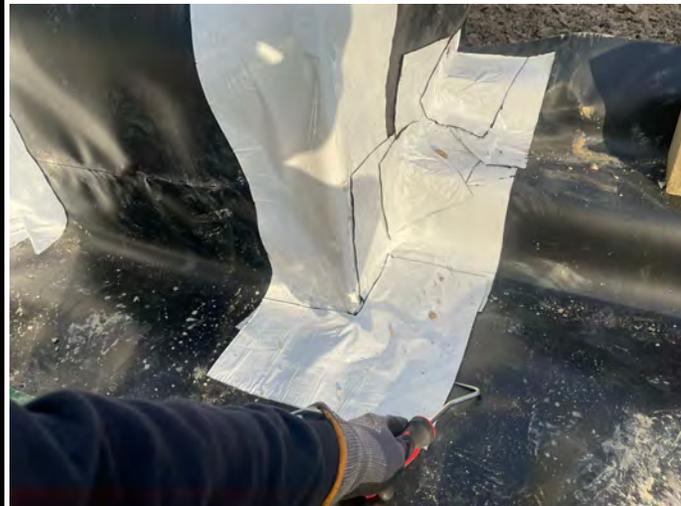
A mechanical point stress test being conducted upon a sealed corner.

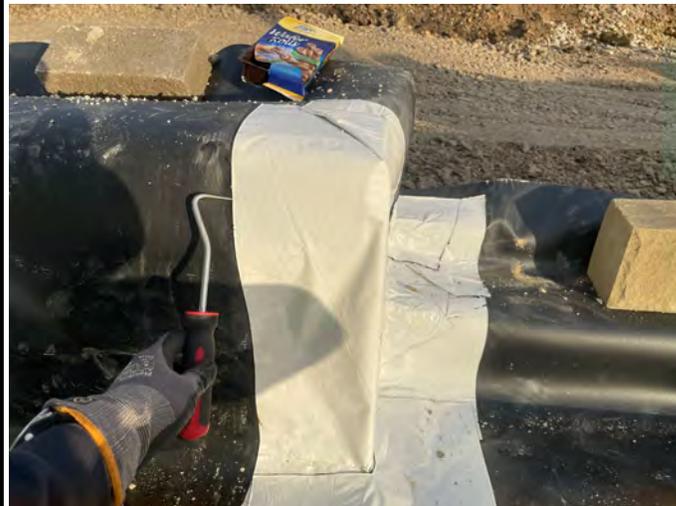
A mechanical point stress test being conducted upon a sealed corner.
