GeoShield Verification Report 1

PROJECT REFERENCE: GEO104995

PROJECT: Reservoir Street

Apartment Block - Perimeter DPC & Infills

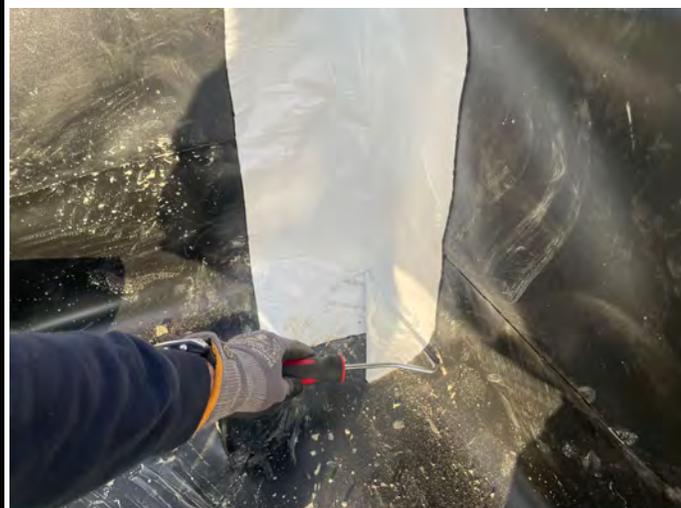
A mechanical point stress test being conducted upon a sealed corner.

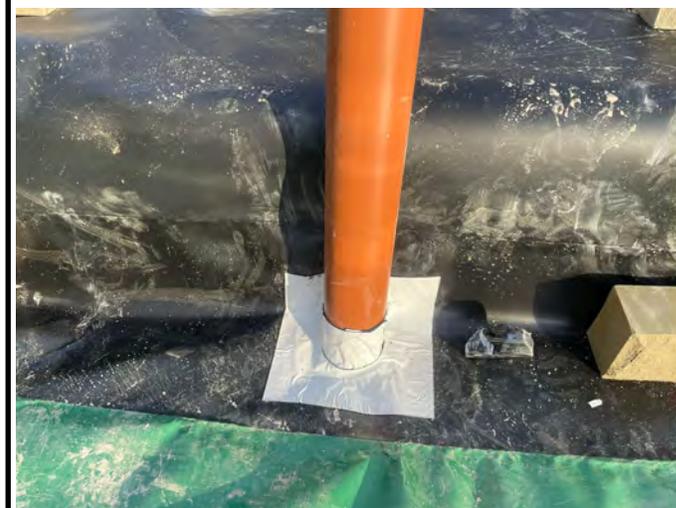
A successfully sealed pipe penetration.

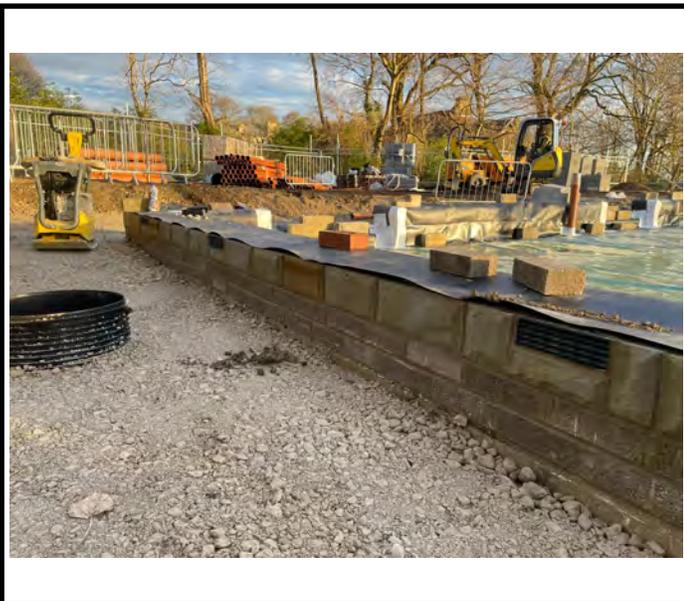
Air bricks installed throughout the perimeter of the apartment block.

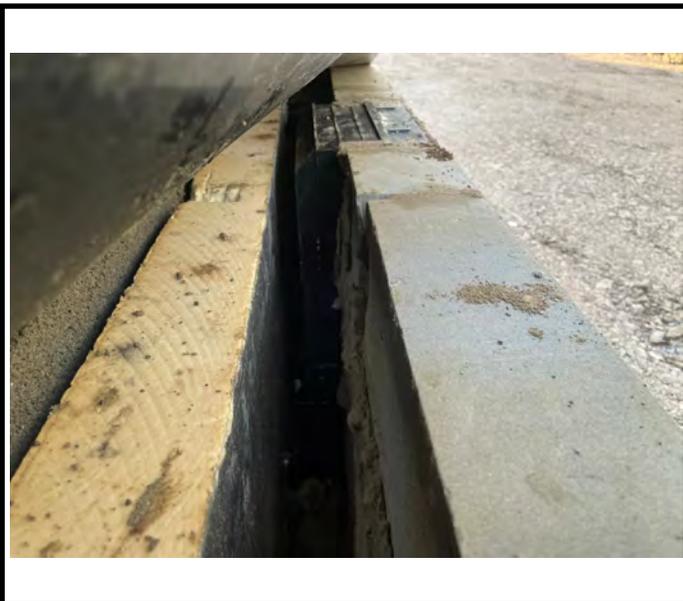
Periscope vents installed throughout the perimeter of the apartment block.

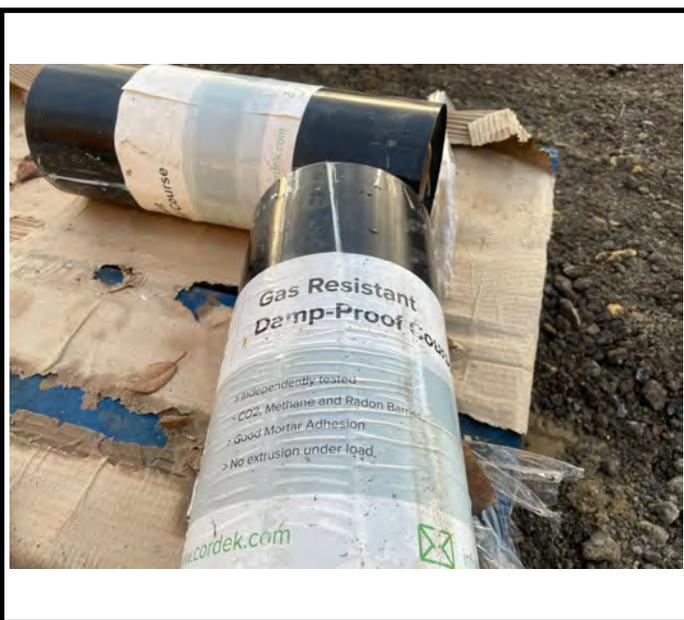
Evidence of the material used throughout the perimeter install.

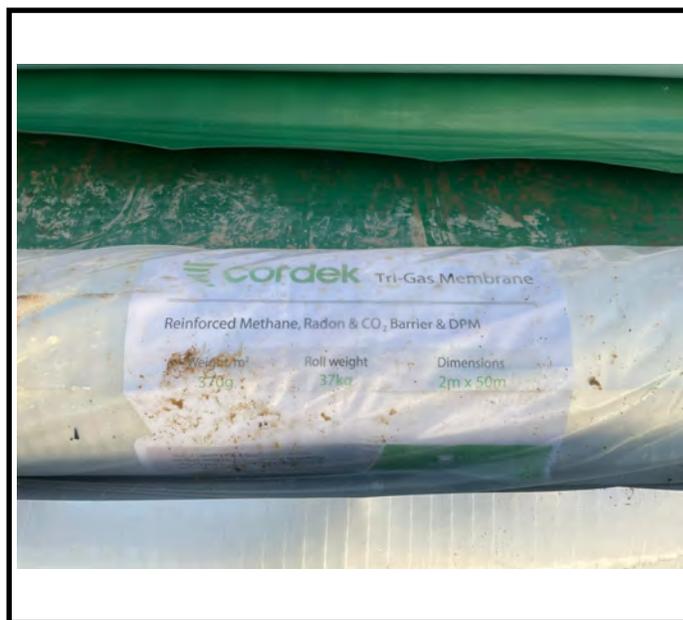
Evidence of the gas barrier used throughout the infill install.

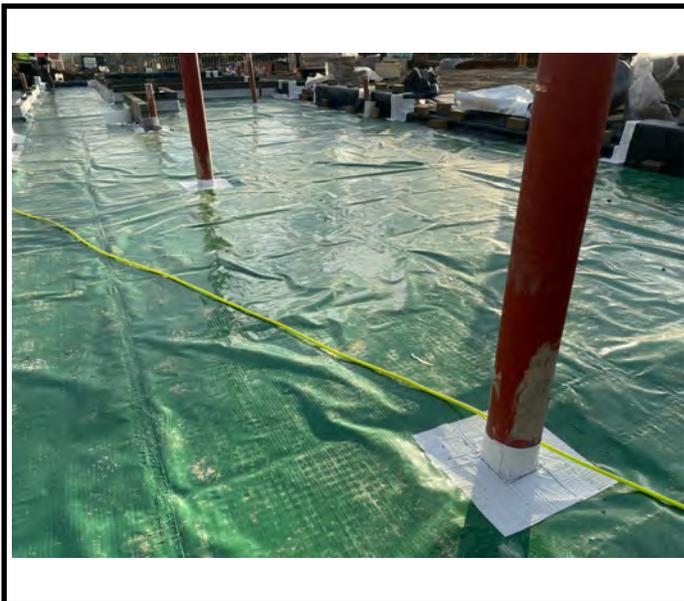
Successfully detailed stanchions.

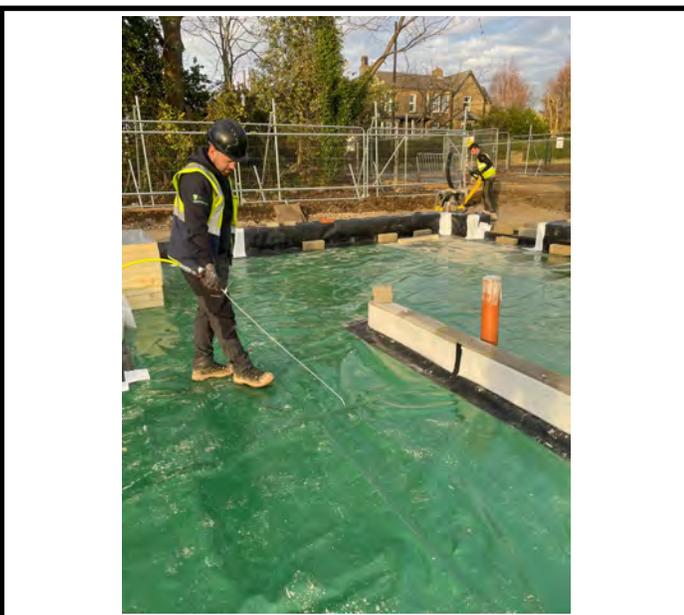
A non destructive air lance integrity test being conducted upon a sealed overlap of the Cordek Tri-Gas Membrane.

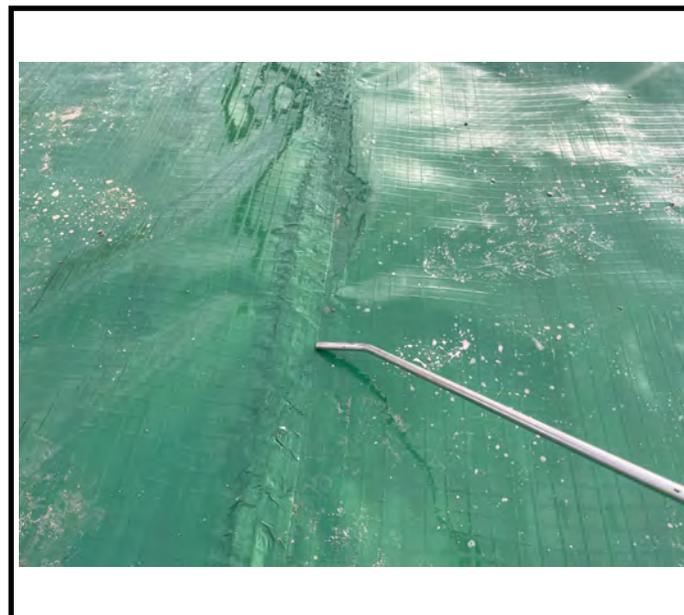
A non destructive air lance integrity test being conducted upon a sealed overlap of the Cordek Tri-Gas Membrane.

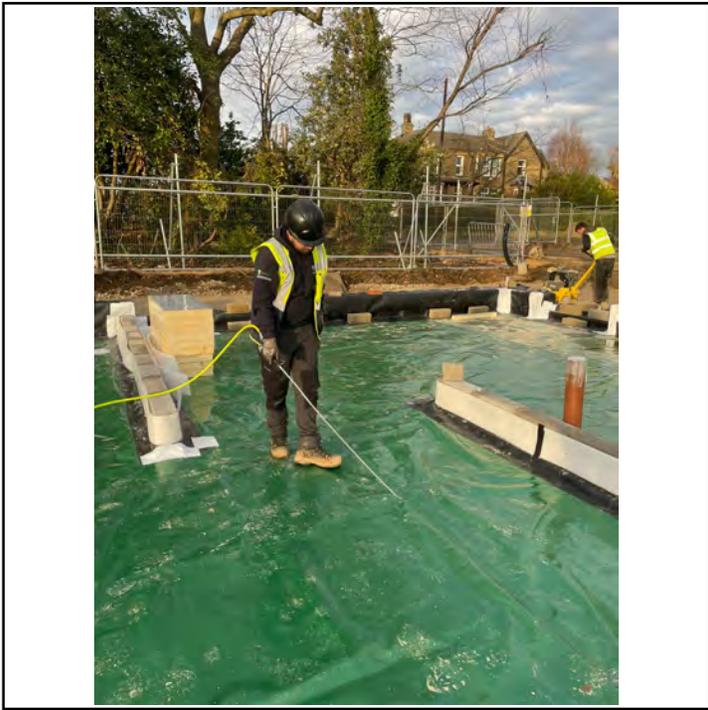
Air lance test on a lap joint.

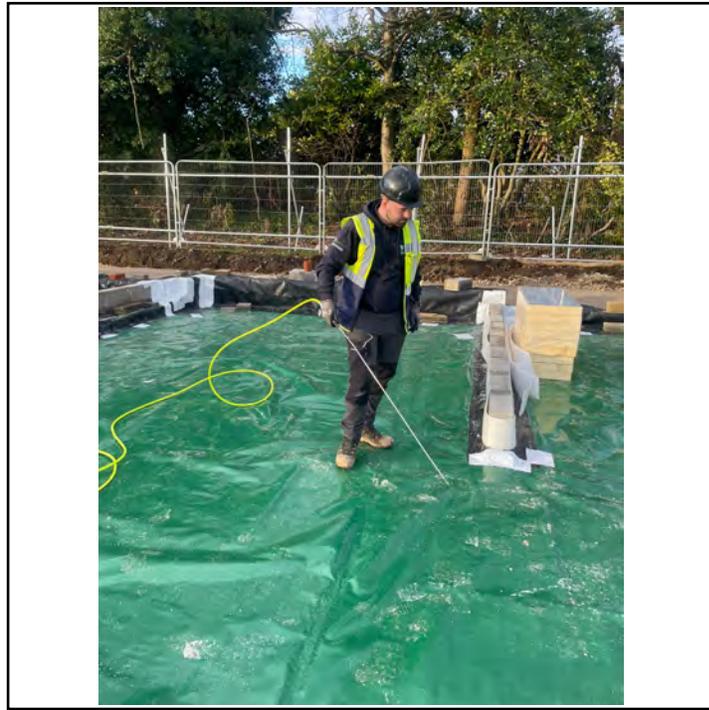
Air lance test on a lap joint.

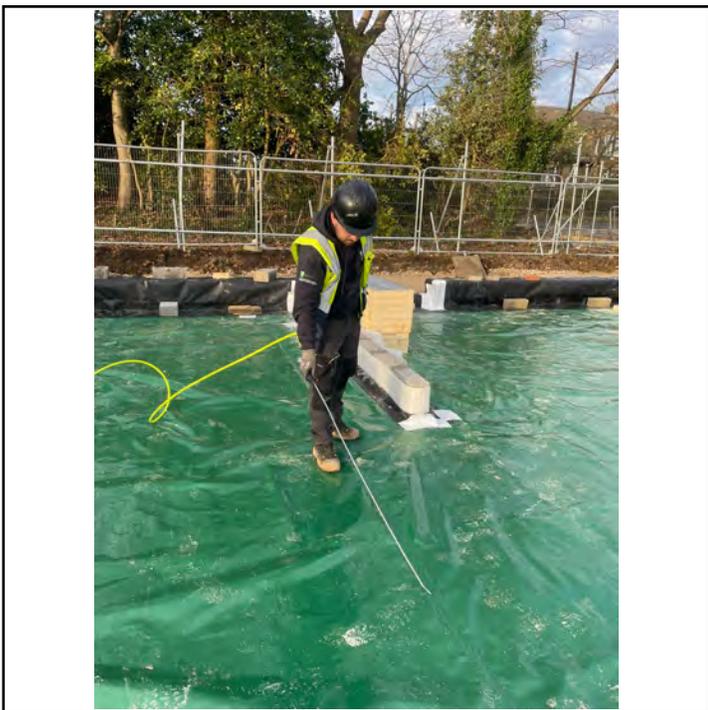
Air lance test on a lap joint.
