## REFURBISHMENT & DEMOLITION ASBESTOS SURVEY

Gomersall Hall  
Oxford Rd  
Gomersal  
BD19 4AT

**Survey Ref:** S17535

**Survey Date:** 19 & 20 October 2023

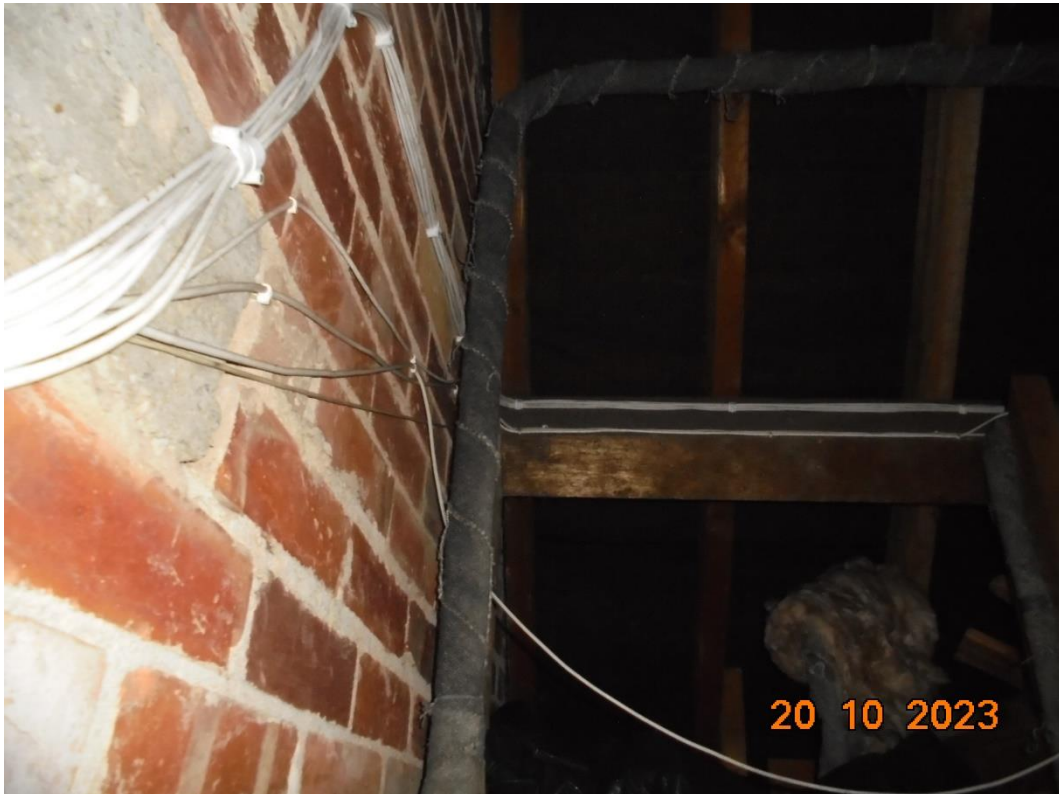
Location	Product Type	Extent	Accessibility	Condition
Rope pipe insulation, runs under floorboards on first floor	Rope pipe insulation	Unmeasured	Medium	Good
	Surface Treatment	Asbestos Type	Sample No.	Sampled/ Presumed/ Strongly Presumed
	Unsealed	<b>Chrysotile</b>	001	Sampled

<b>Material Assessment Score &amp; Action</b>	<b>8 – Medium Risk</b> Remove using licensed contractors.
---	--

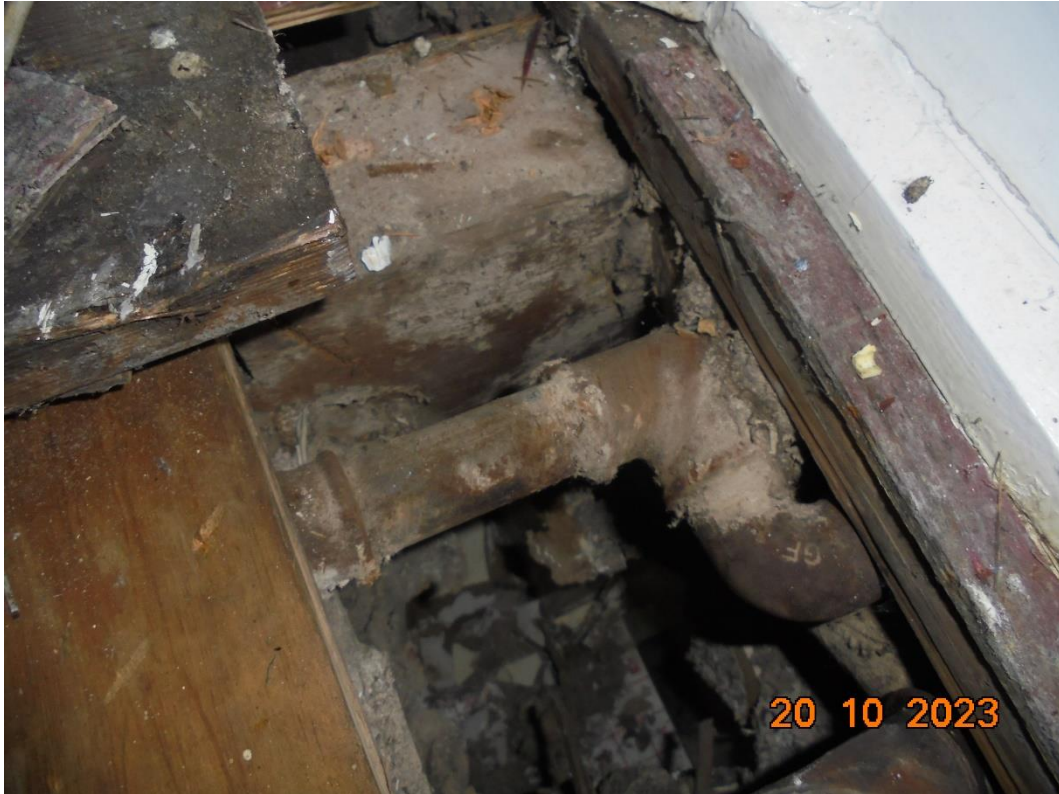
Location	Product Type	Extent	Accessibility	Condition
First floor, Room B, pipe joint below floorboards. This is within the ceiling void above room 5.	Minor residue	Unmeasured	Difficult	Poor
	Surface Treatment	Asbestos Type	Sample No.	Sampled/ Presumed/ Strongly Presumed
	Unsealed	<b>Amosite &amp; Chrysotile</b>	003	Sampled

<b>Material Assessment Score &amp; Action</b>	<b>11 – High Risk</b> Remove using licensed contractors.
---	---

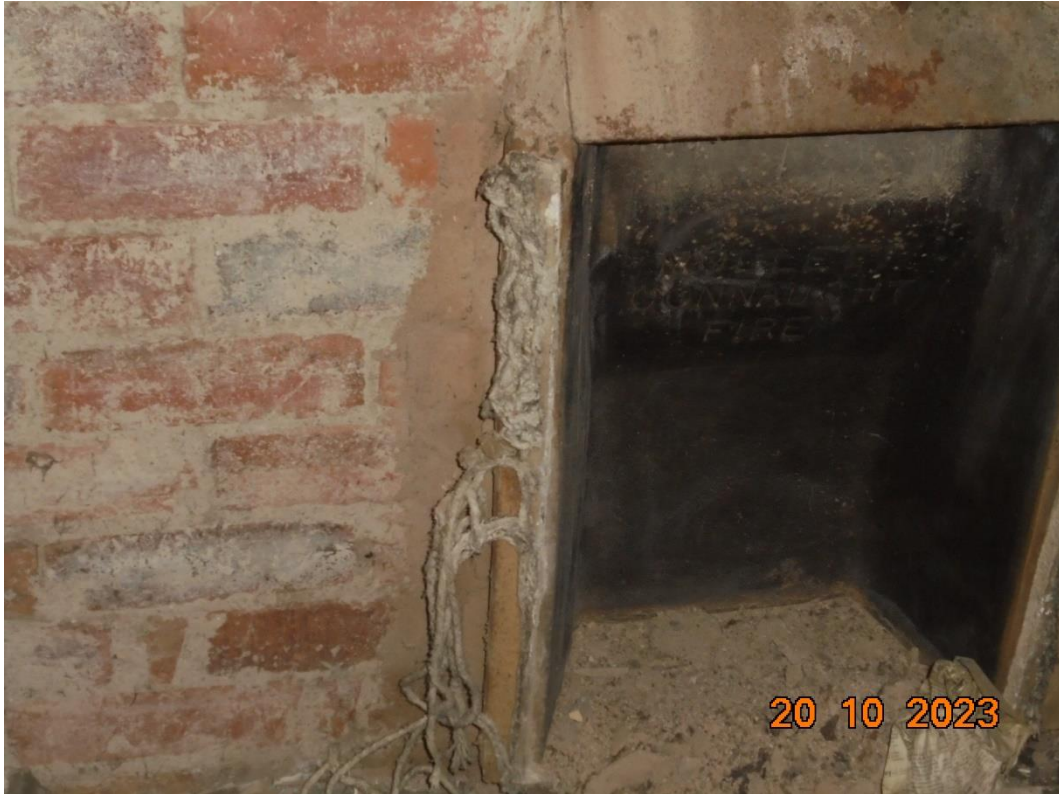
Location	Product Type	Extent	Accessibility	Condition
First Floor, Room E, Fireplace	Rope	Approximately 5 Linear Meters	Easy	Poor
	Surface Treatment	Asbestos Type	Sample No.	Sampled/ Presumed/ Strongly Presumed
	Unsealed	<b>Chrysotile</b>	004	Sampled

<b>Material Assessment Score &amp; Action</b>	<p><b>8 – Medium Risk</b></p> <p>Removal by suitably trained operatives wearing appropriate PPE, prior to refurbishment/demolition.</p>
---	---

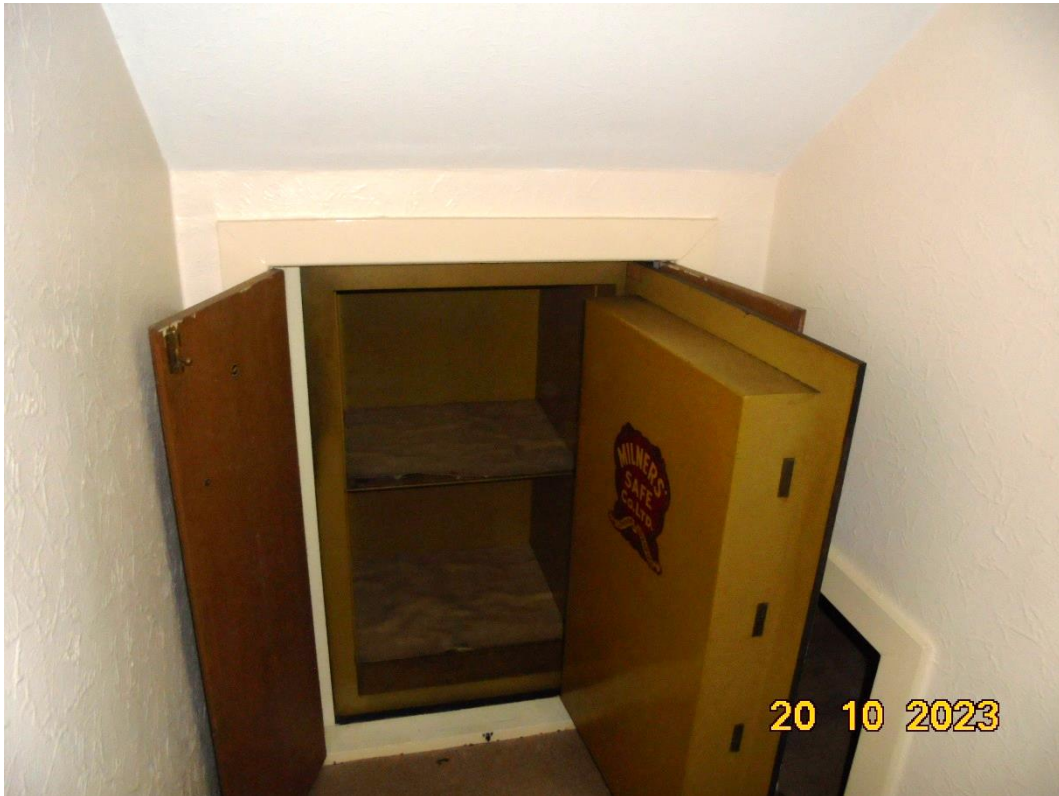
Location	Product Type	Extent	Accessibility	Condition
Ground Floor, under the stairs	Safe	1 Unit	N.A	Unknown
Possible AIB lining	Surface Treatment	Asbestos Type	Sample No.	Sampled/ Presumed/ Strongly Presumed
	Sealed within unit	<b>Presumed – Crocidolite</b>	N/A	Strongly Presumed

<b>Material Assessment Score &amp; Action</b>	<p><b>8 – Medium Risk</b></p> <p>Removal by suitably trained operatives wearing appropriate PPE, prior to refurbishment/demolition.</p>
---	---

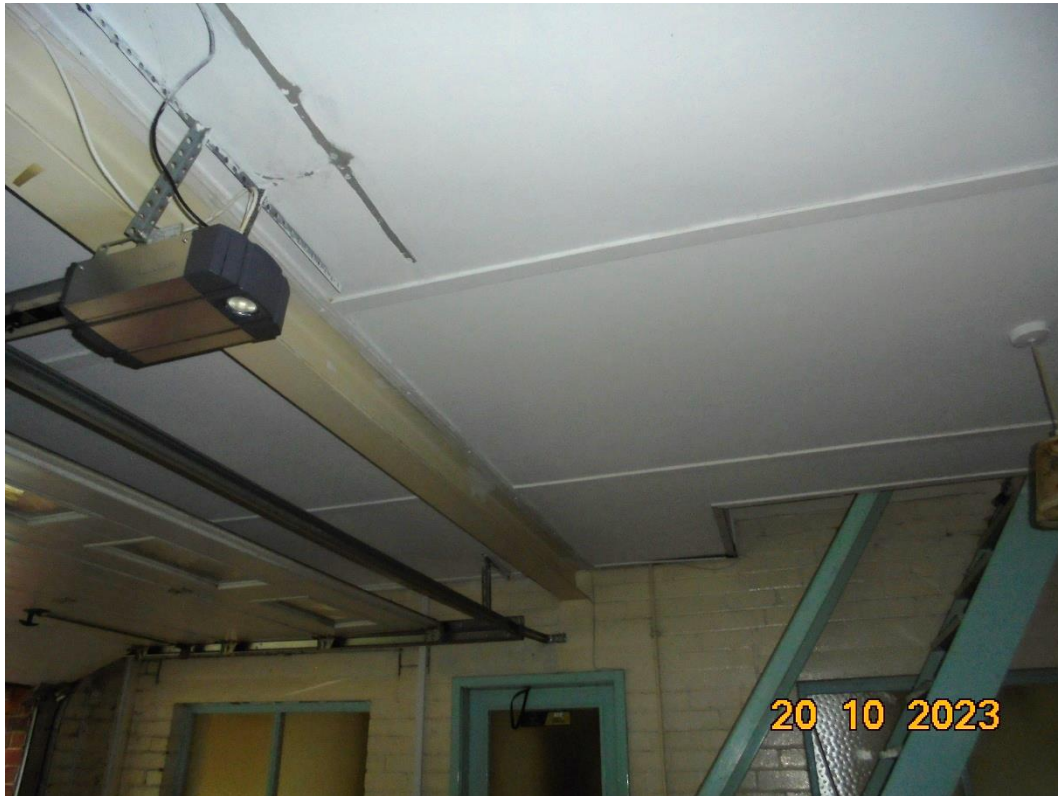
006 – Chrysotile & crocidolite	Asbestos Insulation Board - AIB	Ground Floor, Room 4, garage ceiling & top of stairs to first floor.	Approximately 34 mtr <sup>2</sup>	Remove using licensed contractors.
007 – Chrysotile & crocidolite	Asbestos Insulation Board - AIB	Ground Floor, Room 5, AIB stuck to underside of joists & debris	Approximately 6 mtr <sup>2</sup>	Remove using licensed contractors.
008 – Chrysotile	Rope pipe insulation	Ground Floor, rope pipe insulation to garage	Approximately 2 mtr <sup>2</sup>	Remove using licensed contractors.
Strongly Presumed – Crocidolite	Cement	Outbuilding, store roof	Approximately 45 mtr <sup>2</sup>	Removal by suitably trained operatives wearing appropriate PPE, prior to refurbishment/demolition.

Location	Product Type	Extent	Accessibility	Condition
Ground Floor, Room 4 & garage ceiling & top of stairs to first floor.	Asbestos Insulation Board	Approximately 34 mtr <sup>2</sup>	Medium	Good
	Surface Treatment	Asbestos Type	Sample No.	Sampled/ Presumed/ Strongly Presumed
	Sealed	<b>Chrysotile &amp; Crocidolite</b>	006	Sampled

<b>Material Assessment Score &amp; Action</b>	<b>7 – Medium Risk</b> Remove using licensed contractors.
---	--

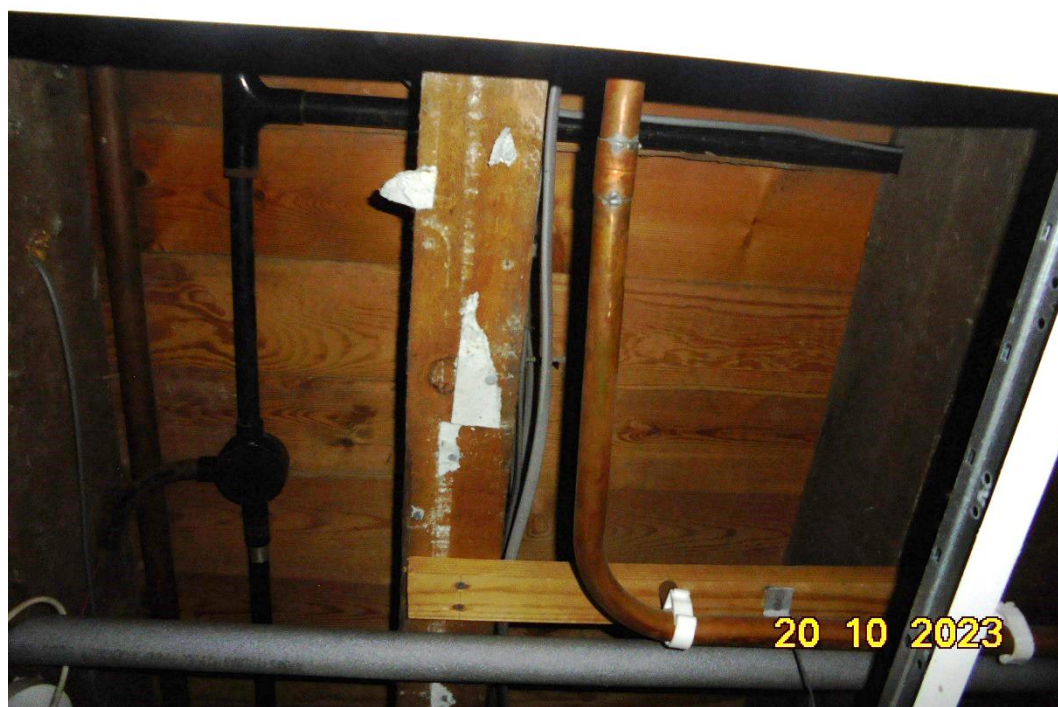
Location	Product Type	Extent	Accessibility	Condition
Ground Floor, Room 5 AIB stuck to underside of joists & debris	Asbestos Insulation Board	Approximately 6 mtr <sup>2</sup>	Medium	Very Poor
	Surface Treatment	Asbestos Type	Sample No.	Sampled/ Presumed/ Strongly Presumed
	Unsealed	<b>Chrysotile &amp; Crocidolite</b>	007	Sampled

<b>Material Assessment Score &amp; Action</b>	<b>10 – High Risk</b> Remove using licensed contractors.
---	---

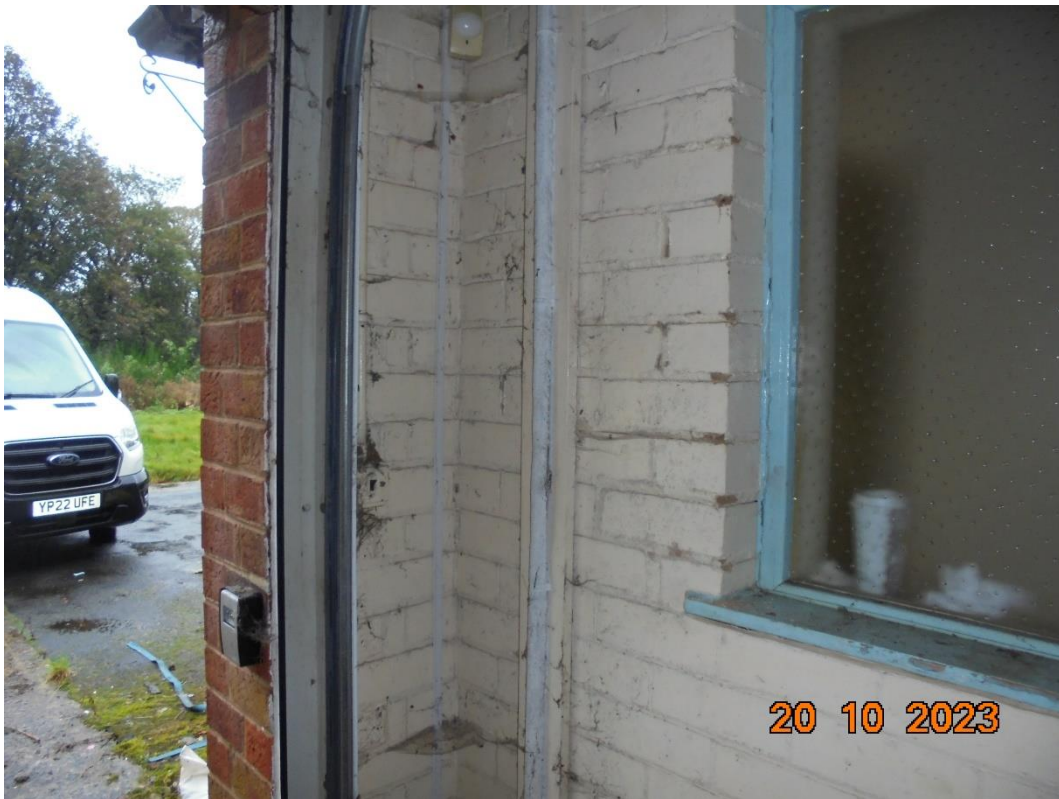
Location	Product Type	Extent	Accessibility	Condition
Ground Floor, paint-sealed rope pipe insulation in garage	Rope pipe insulation	Approximately 2 Linear Meters	Medium	Good
	Surface Treatment	Asbestos Type	Sample No.	Sampled/ Presumed/ Strongly Presumed
	Unsealed	<b>Chrysotile</b>	008	Sampled

<b>Material Assessment Score &amp; Action</b>	<b>8 – Medium Risk</b> Remove using licensed contractors.
---	--

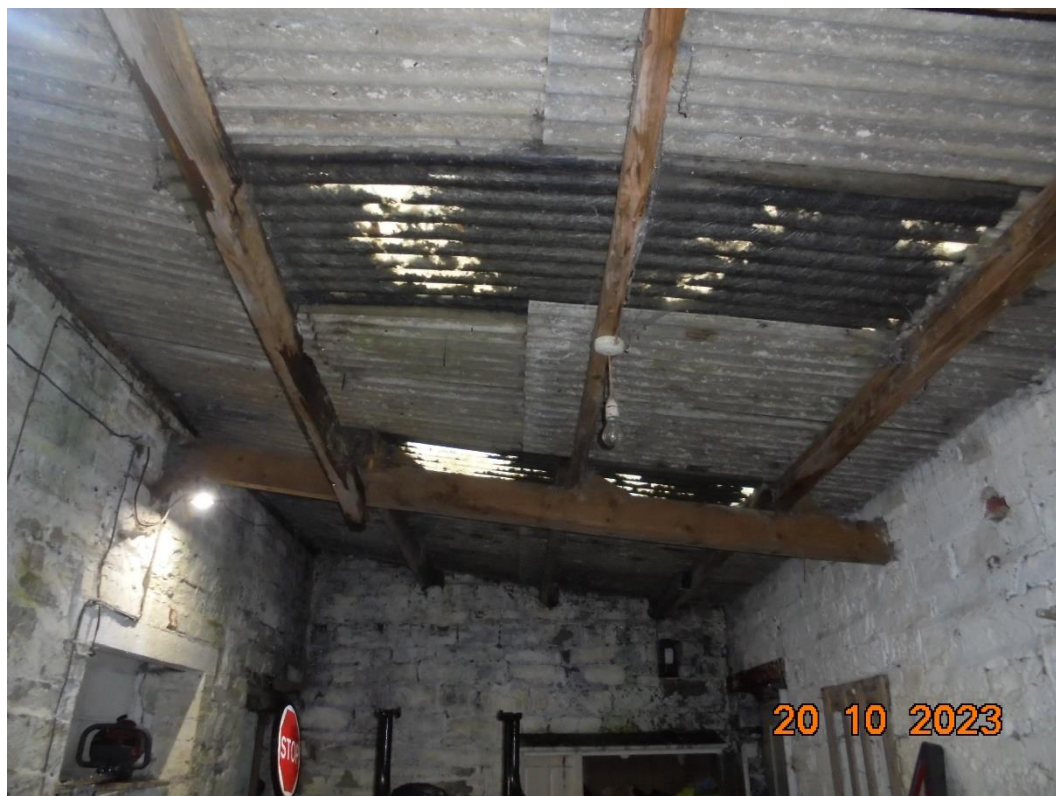
Location	Product Type	Extent	Accessibility	Condition
Outbuilding, store roof	Cement	Approximately 45 mtr <sup>2</sup>	Difficult	Poor
	Surface Treatment	Asbestos Type	Sample No.	Sampled/ Presumed/ Strongly Presumed
	Unsealed	<b>Presumed – Crocidolite</b>	N/A	Strongly Presumed

<b>Material Assessment Score &amp; Action</b>	<p><b>8 – Medium Risk</b></p> <p>Removal by suitably trained operatives wearing appropriate PPE, prior to refurbishment/demolition.</p>
---	---

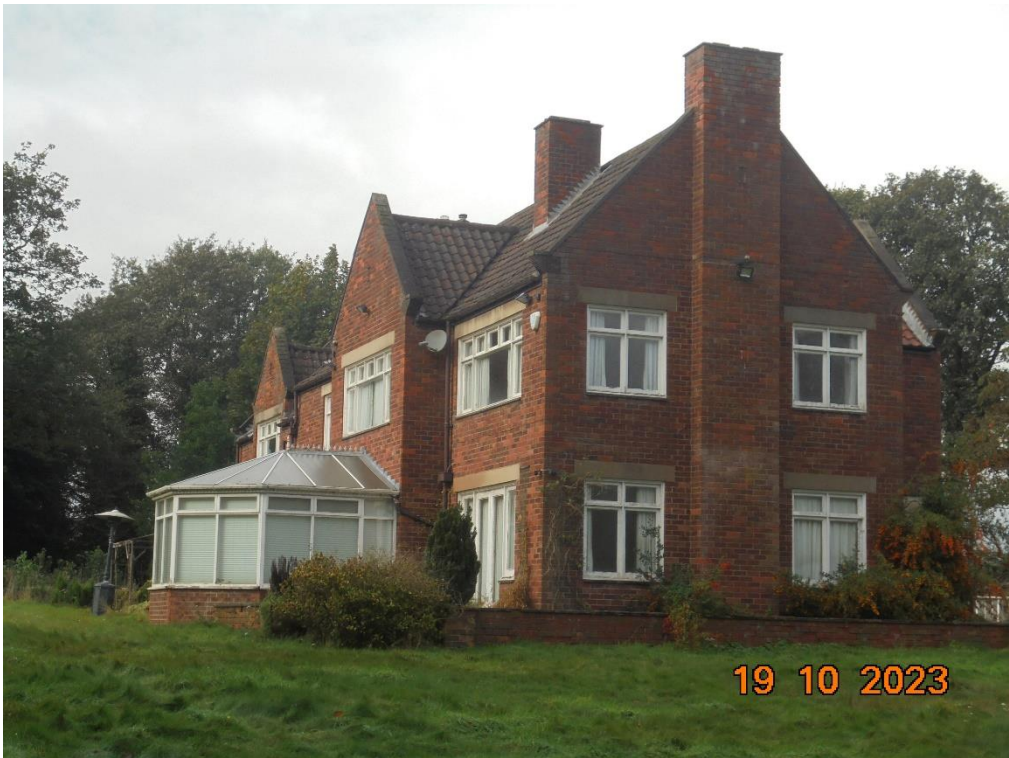
Location	Product Type	Extent	Accessibility	Condition
Outside of building	-	-	-	-
	Surface Treatment	Asbestos Type	Sample No.	Sampled/ Presumed/ Strongly Presumed
	-	No asbestos detected	N/A	-

<b>Material Assessment Score &amp; Action</b>	<b>No asbestos containing materials detected in this area.</b>
---	--

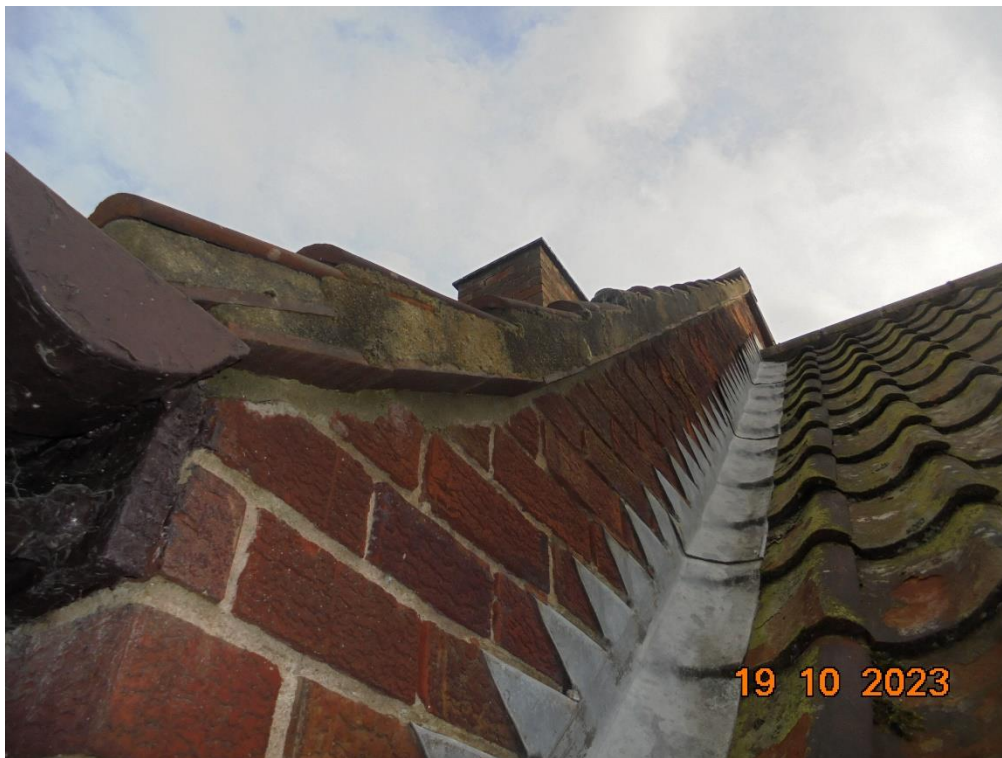
Location	Product Type	Extent	Accessibility	Condition
High level Undercloaking	-	-	-	-
	Surface Treatment	Asbestos Type	Sample No.	Sampled/ Presumed/ Strongly Presumed
	-	No asbestos detected	N/A	-

<b>Material Assessment Score &amp; Action</b>	<b>No asbestos containing materials detected in this area.</b>
---	--

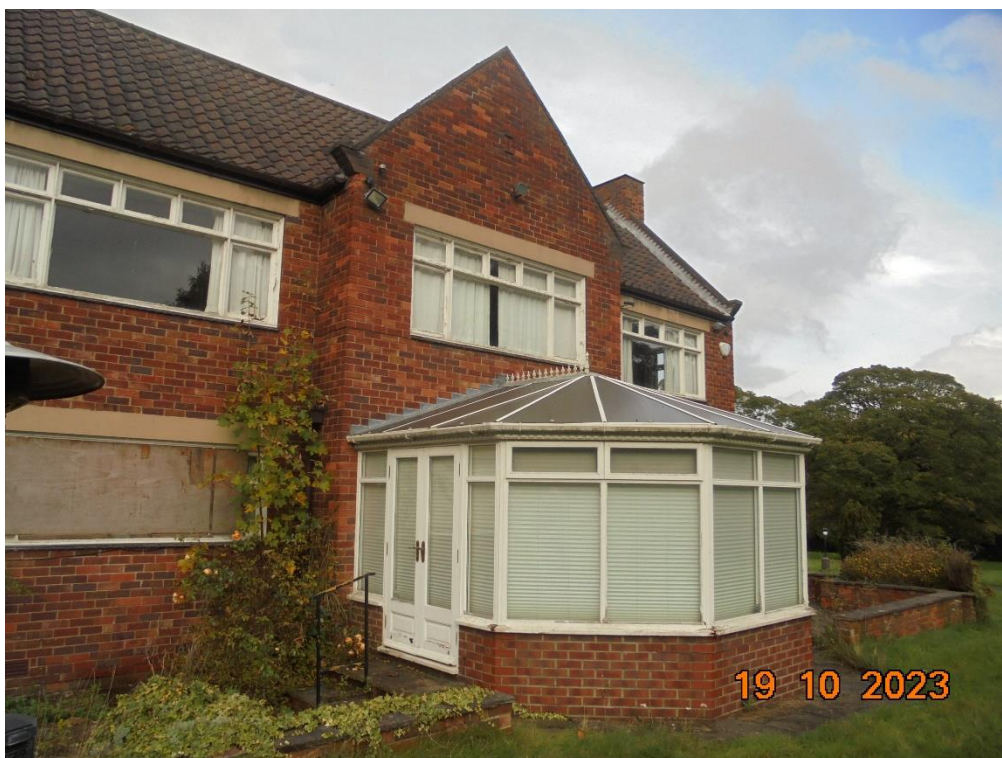
Location	Product Type	Extent	Accessibility	Condition
Rear of property, cast gutters	-	-	-	-
	Surface Treatment	Asbestos Type	Sample No.	Sampled/ Presumed/ Strongly Presumed
	-	No asbestos detected	N/A	-

<b>Material Assessment Score &amp; Action</b>	<b>No asbestos containing materials detected in this area.</b>
---	--

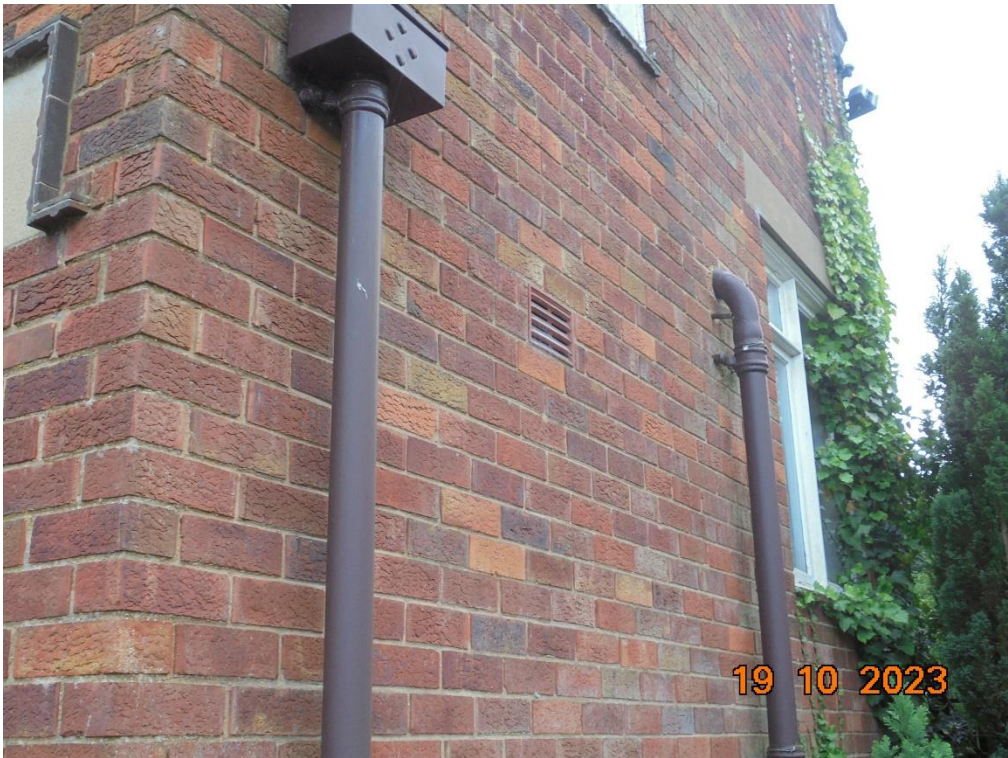
Location	Product Type	Extent	Accessibility	Condition
Cast downpipes	-	-	-	-
	Surface Treatment	Asbestos Type	Sample No.	Sampled/ Presumed/ Strongly Presumed
	-	No asbestos detected	N/A	-

<b>Material Assessment Score &amp; Action</b>	<b>No asbestos containing materials detected in this area.</b>
---	--

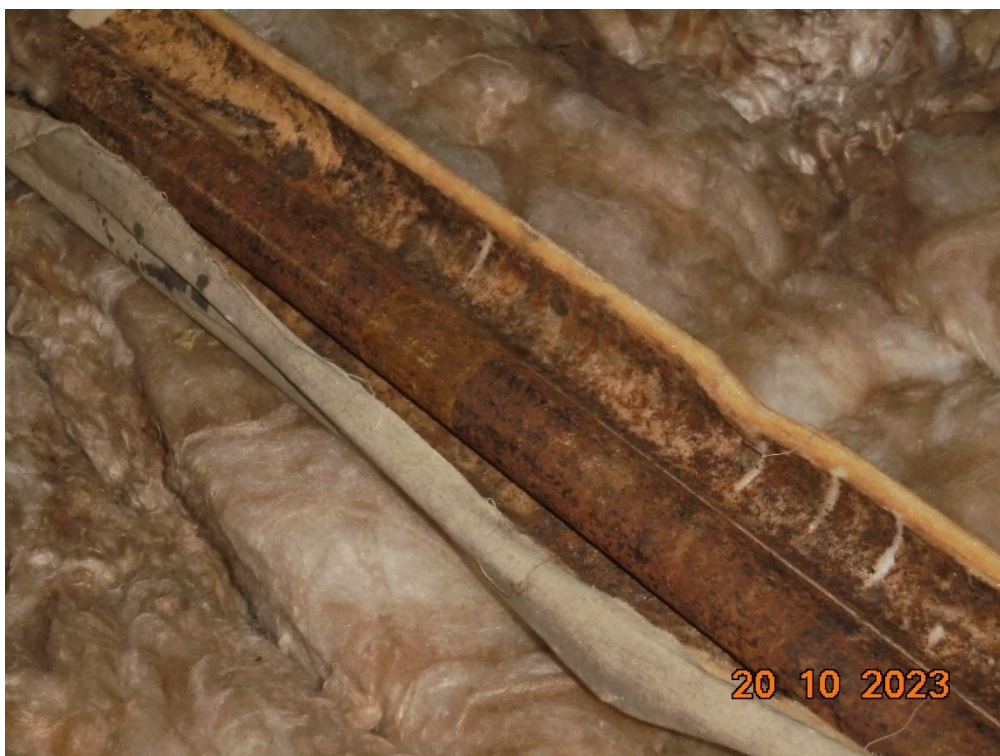
Location	Product Type	Extent	Accessibility	Condition
Loft space, lagging on pipes	-	-	-	-
	Surface Treatment	Asbestos Type	Sample No.	Sampled/ Presumed/ Strongly Presumed
	-	No asbestos detected	N/A	-

<b>Material Assessment Score &amp; Action</b>	<b>No asbestos containing materials detected in this area.</b>
---	--

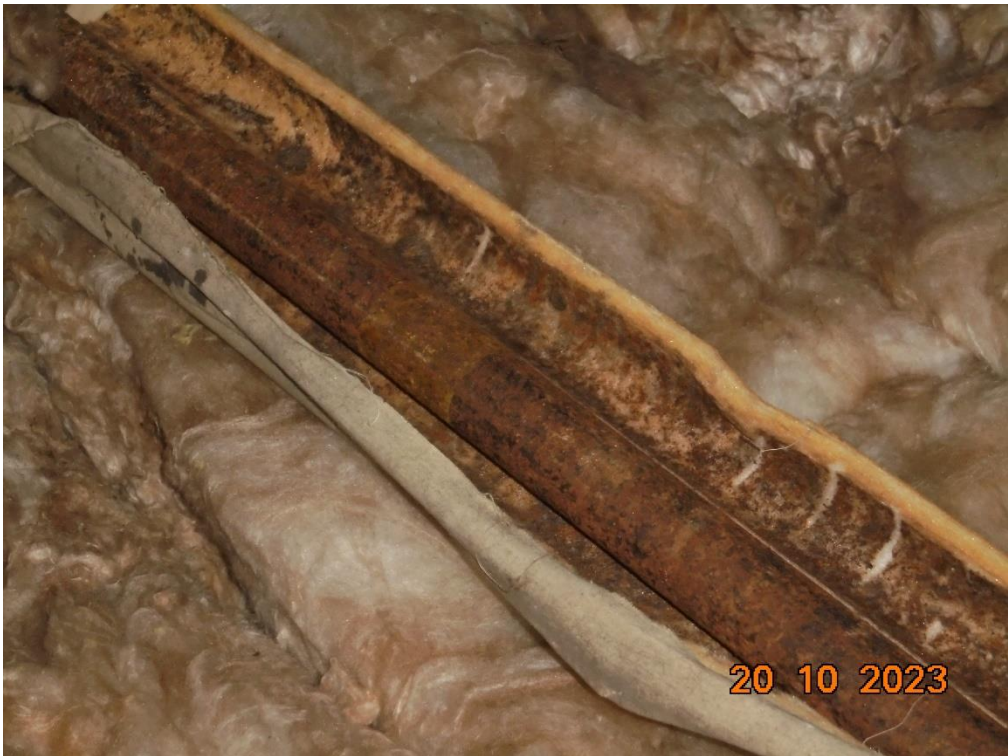
Location	Product Type	Extent	Accessibility	Condition
Loft space, above garage	-	-	-	-
	Surface Treatment	Asbestos Type	Sample No.	Sampled/ Presumed/ Strongly Presumed
	-	No asbestos detected	N/A	-

<b>Material Assessment Score &amp; Action</b>	<b>No asbestos containing materials detected in this area.</b>
---	--

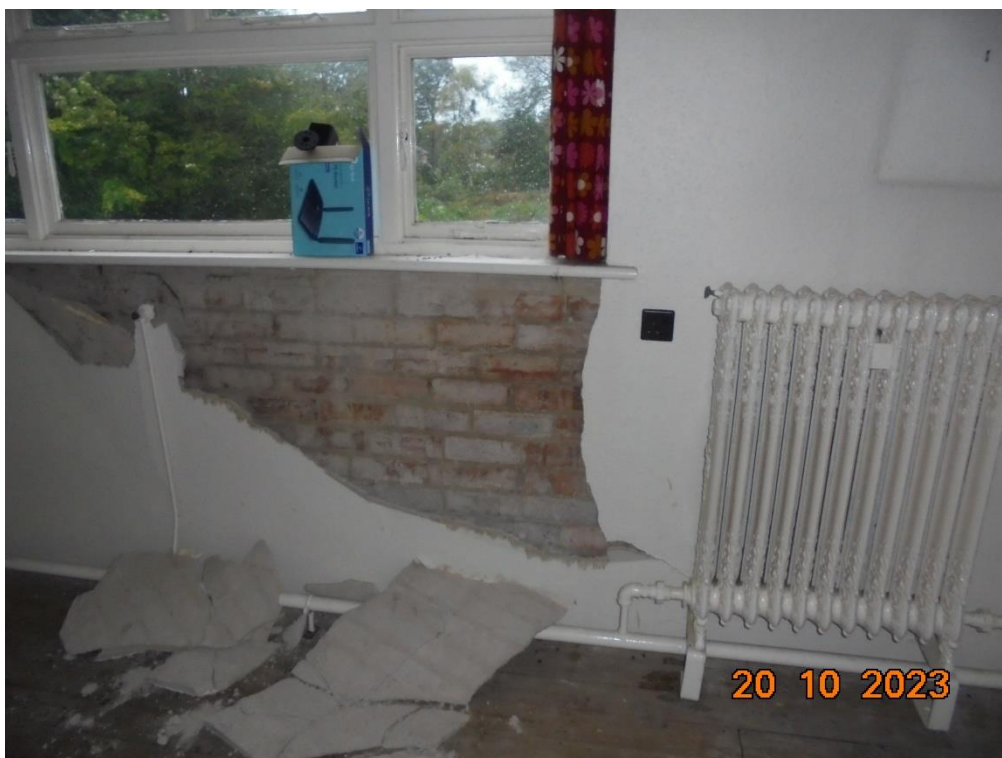
Location	Product Type	Extent	Accessibility	Condition
First floor, Room A, wall	-	-	-	-
	Surface Treatment	Asbestos Type	Sample No.	Sampled/ Presumed/ Strongly Presumed
	-	No asbestos detected	N/A	-

<b>Material Assessment Score &amp; Action</b>	<b>No asbestos containing materials detected in this area.</b>
---	--

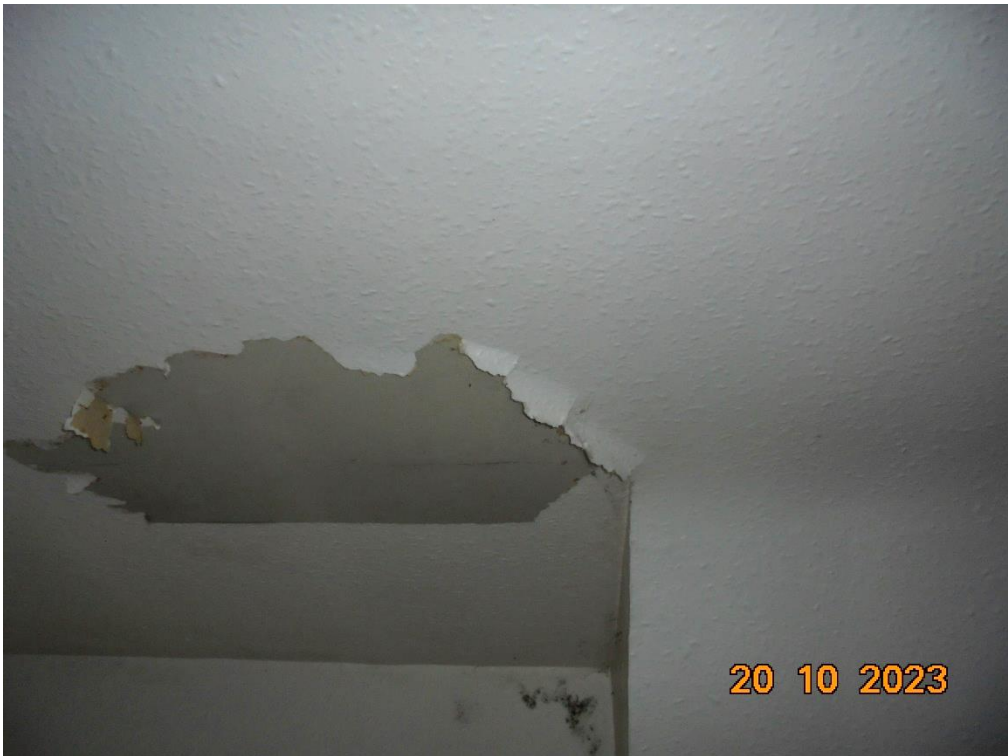
Location	Product Type	Extent	Accessibility	Condition
First Floor, Room A, Ceiling	-	-	-	-
	Surface Treatment	Asbestos Type	Sample No.	Sampled/ Presumed/ Strongly Presumed
	-	No asbestos detected	N/A	-

<b>Material Assessment Score &amp; Action</b>	<b>No asbestos containing materials detected in this area.</b>
---	--

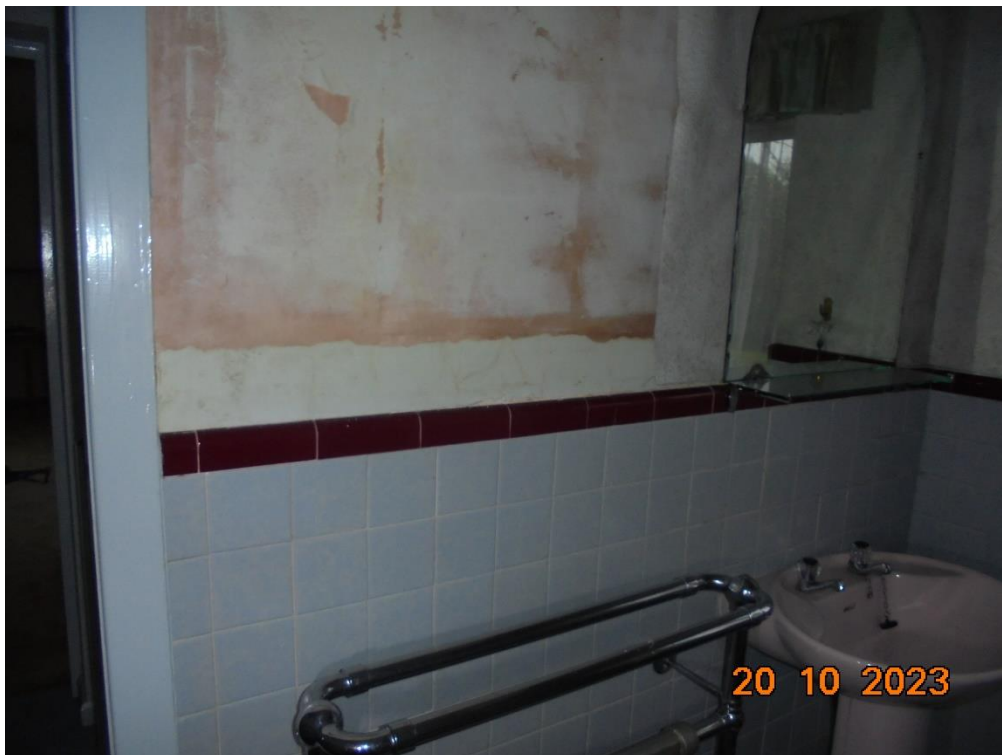
Location	Product Type	Extent	Accessibility	Condition
First Floor, Room B	-	-	-	-
	Surface Treatment	Asbestos Type	Sample No.	Sampled/ Presumed/ Strongly Presumed
	-	No asbestos detected	N/A	-

<b>Material Assessment Score &amp; Action</b>	<b>No asbestos containing materials detected in this area.</b>
---	--

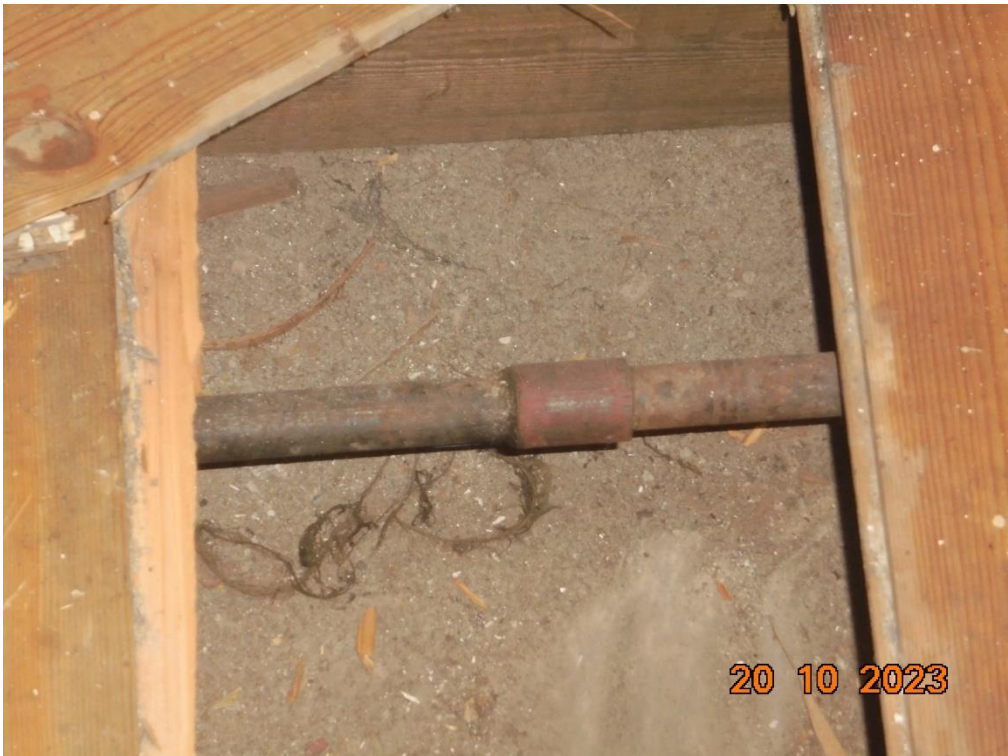
Location	Product Type	Extent	Accessibility	Condition
First Floor, Room E, pipes below floorboards	-	-	-	-
	Surface Treatment	Asbestos Type	Sample No.	Sampled/ Presumed/ Strongly Presumed
	-	No asbestos detected	N/A	-

<b>Material Assessment Score &amp; Action</b>	<b>No asbestos containing materials detected in this area.</b>
---	--

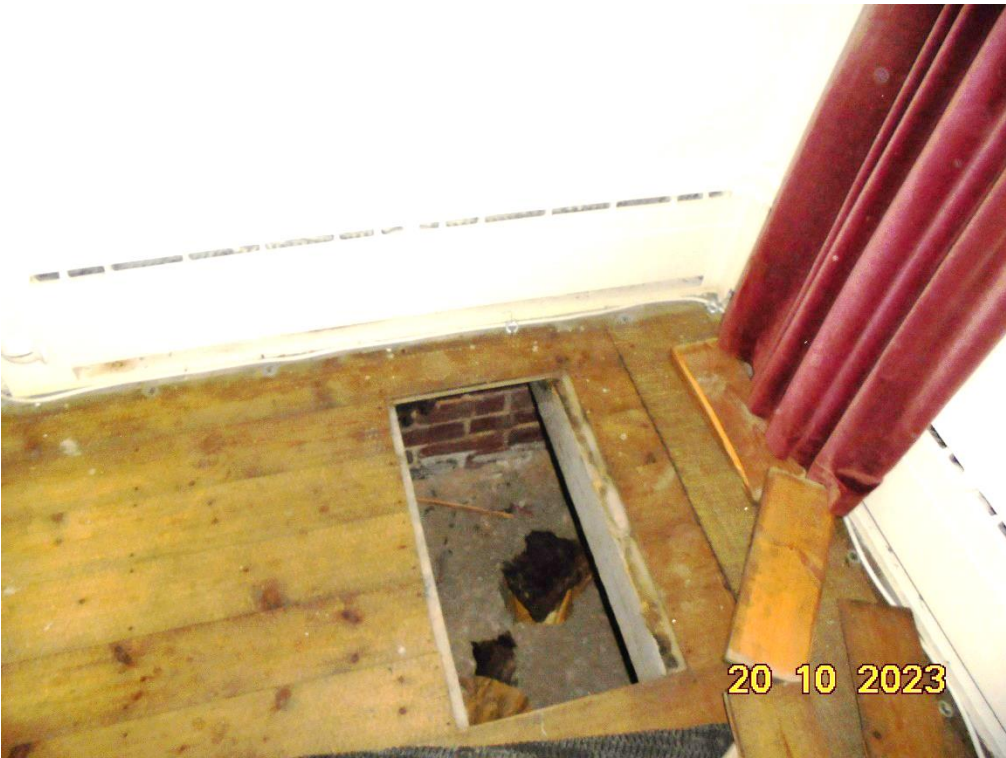
Location	Product Type	Extent	Accessibility	Condition
Ground Floor, Room 1, under floorboards.	-	-	-	-
	Surface Treatment	Asbestos Type	Sample No.	Sampled/ Presumed/ Strongly Presumed
	-	No asbestos detected	N/A	-

<b>Material Assessment Score &amp; Action</b>	<b>No asbestos containing materials detected in this area.</b>
---	--

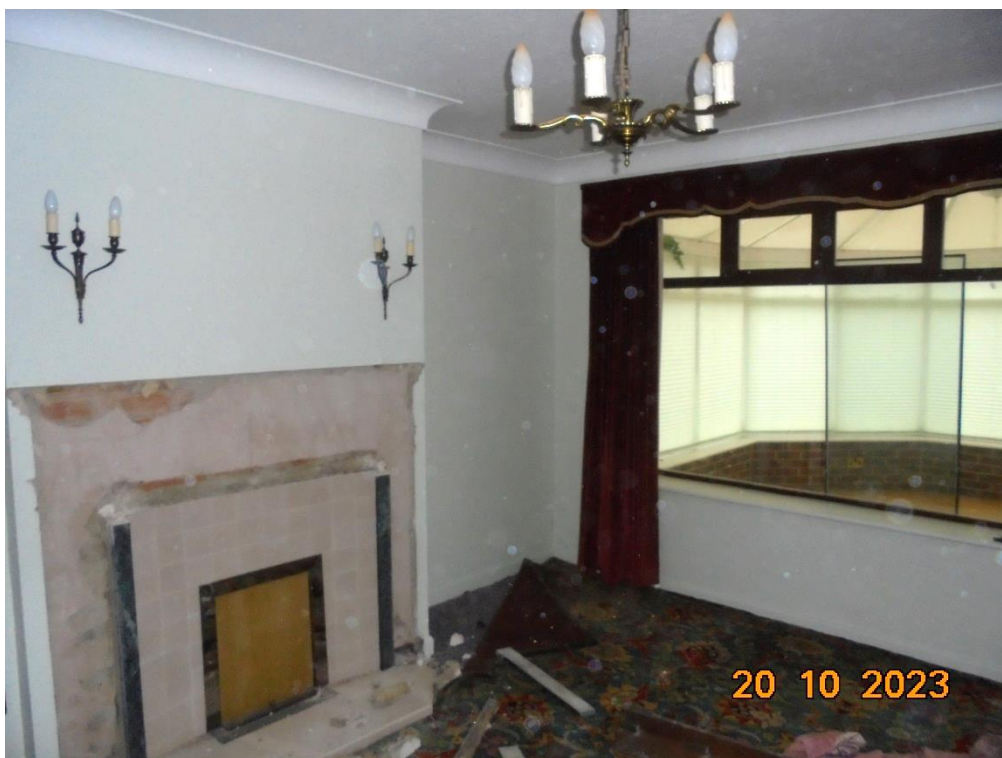
Location	Product Type	Extent	Accessibility	Condition
Ground Floor, Room 2	-	-	-	-
	Surface Treatment	Asbestos Type	Sample No.	Sampled/ Presumed/ Strongly Presumed
	-	No asbestos detected	N/A	-

<b>Material Assessment Score &amp; Action</b>	<b>No asbestos containing materials detected in this area.</b>
---	--

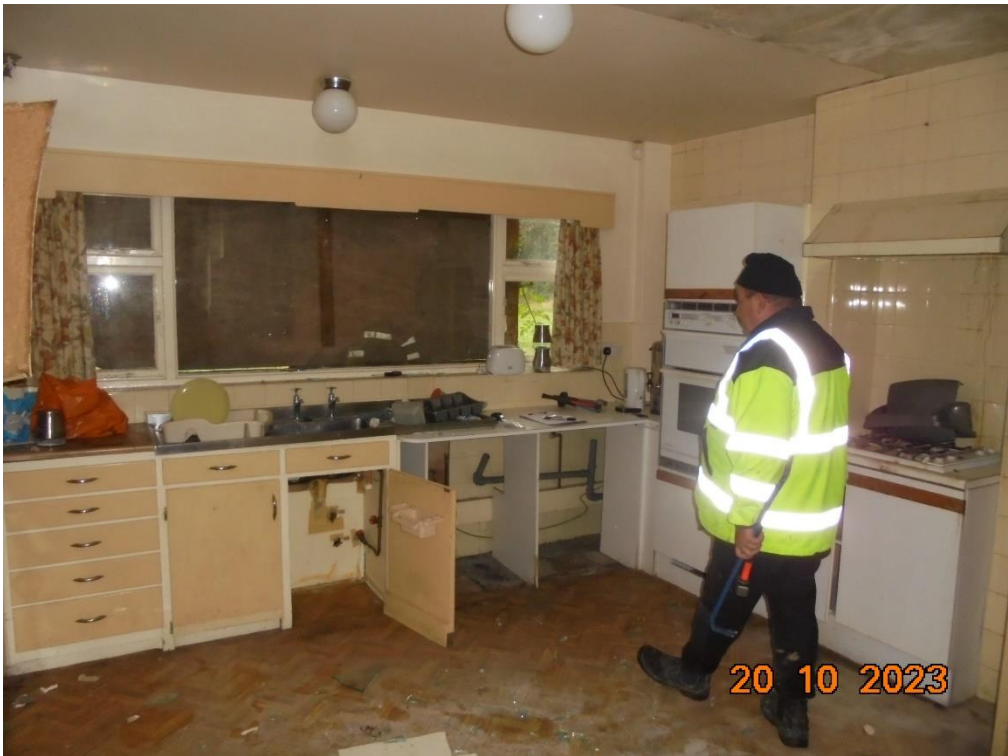
Location	Product Type	Extent	Accessibility	Condition
Ground Floor, Room 3	-	-	-	-
	Surface Treatment	Asbestos Type	Sample No.	Sampled/ Presumed/ Strongly Presumed
	-	No asbestos detected	N/A	-

<b>Material Assessment Score &amp; Action</b>	<b>No asbestos containing materials detected in this area.</b>
---	--

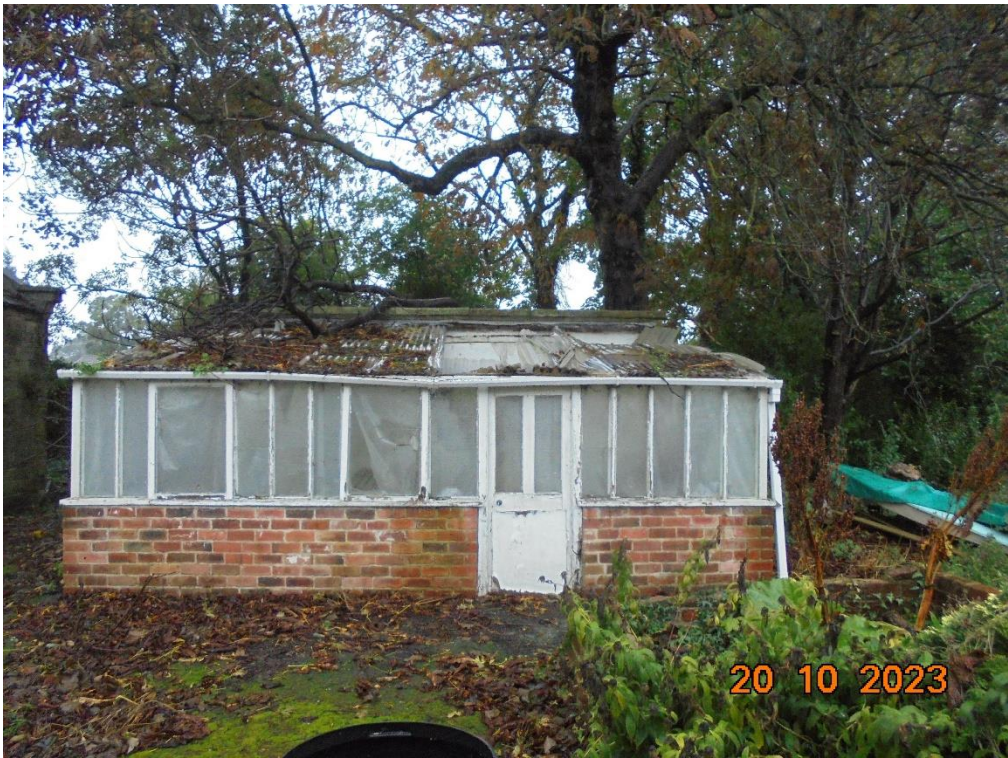
Location	Product Type	Extent	Accessibility	Condition
Outbuilding, Greenhouse	-	-	-	-
	Surface Treatment	Asbestos Type	Sample No.	Sampled/ Presumed/ Strongly Presumed
	-	No asbestos detected	N/A	-

<b>Material Assessment Score &amp; Action</b>	<b>No asbestos containing materials detected in this area.</b>
---	--

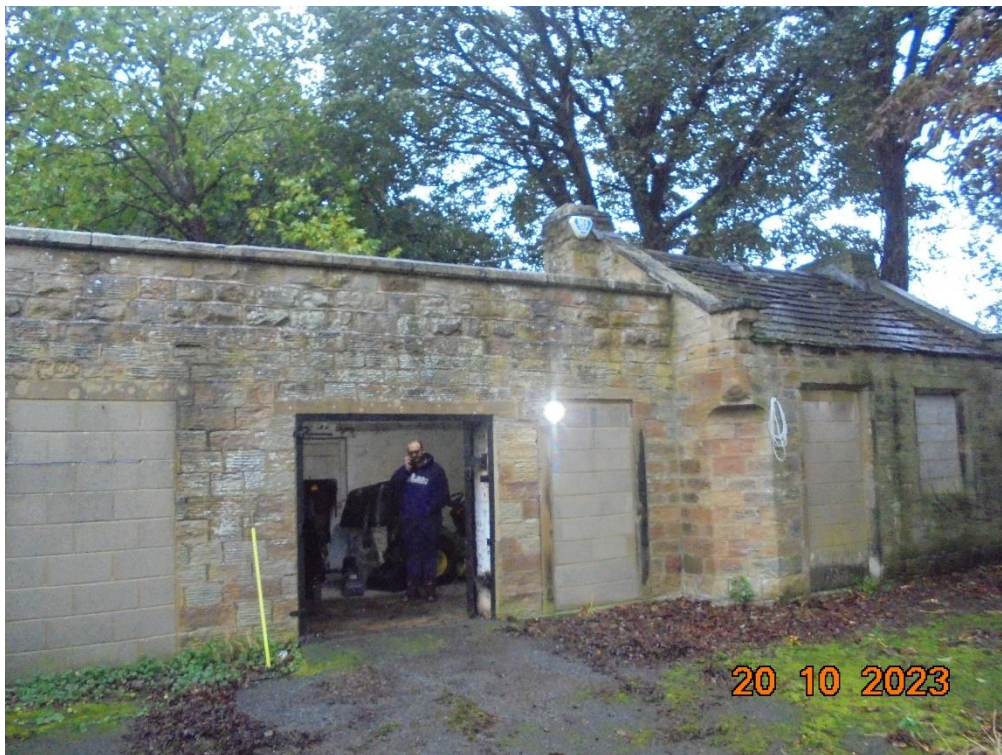
Location	Product Type	Extent	Accessibility	Condition
Outbuilding, store	-	-	-	-
	Surface Treatment	Asbestos Type	Sample No.	Sampled/ Presumed/ Strongly Presumed
	-	No asbestos detected	N/A	-

<b>Material Assessment Score &amp; Action</b>	<b>No asbestos containing materials detected in this area.</b>
---	--

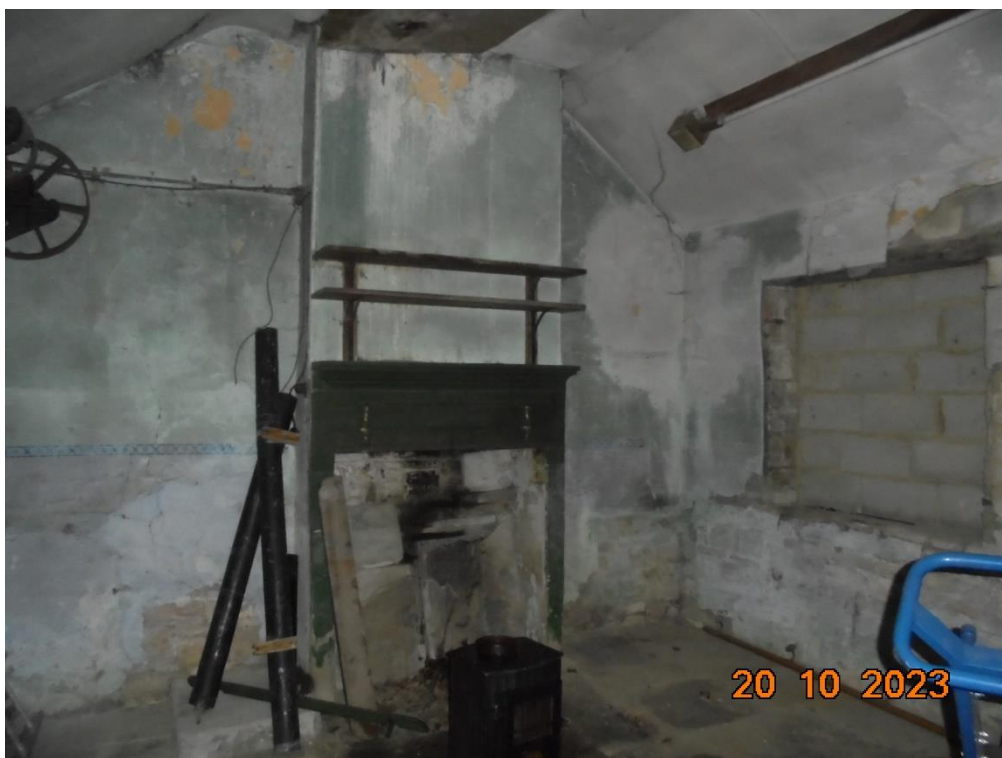
Location	Product Type	Extent	Accessibility	Condition
Outbuilding, Store	-	-	-	-
	Surface Treatment	Asbestos Type	Sample No.	Sampled/ Presumed/ Strongly Presumed
	-	No asbestos detected	N/A	-

<b>Material Assessment Score &amp; Action</b>	<b>No asbestos containing materials detected in this area.</b>
---	--
