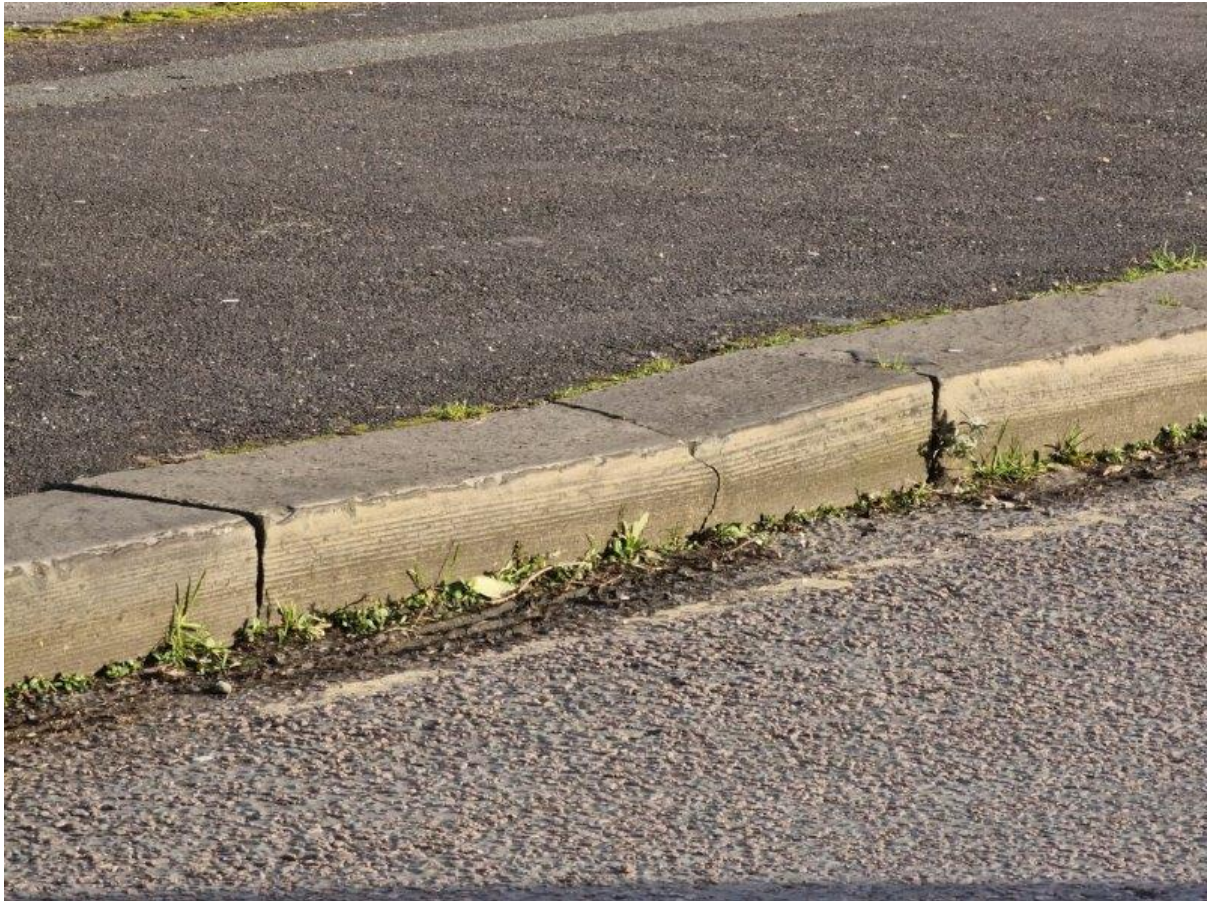
37m from Corner of Broadway and Back Union Street, Looking east along Broadway.

Broken/sunken kerb a 37m

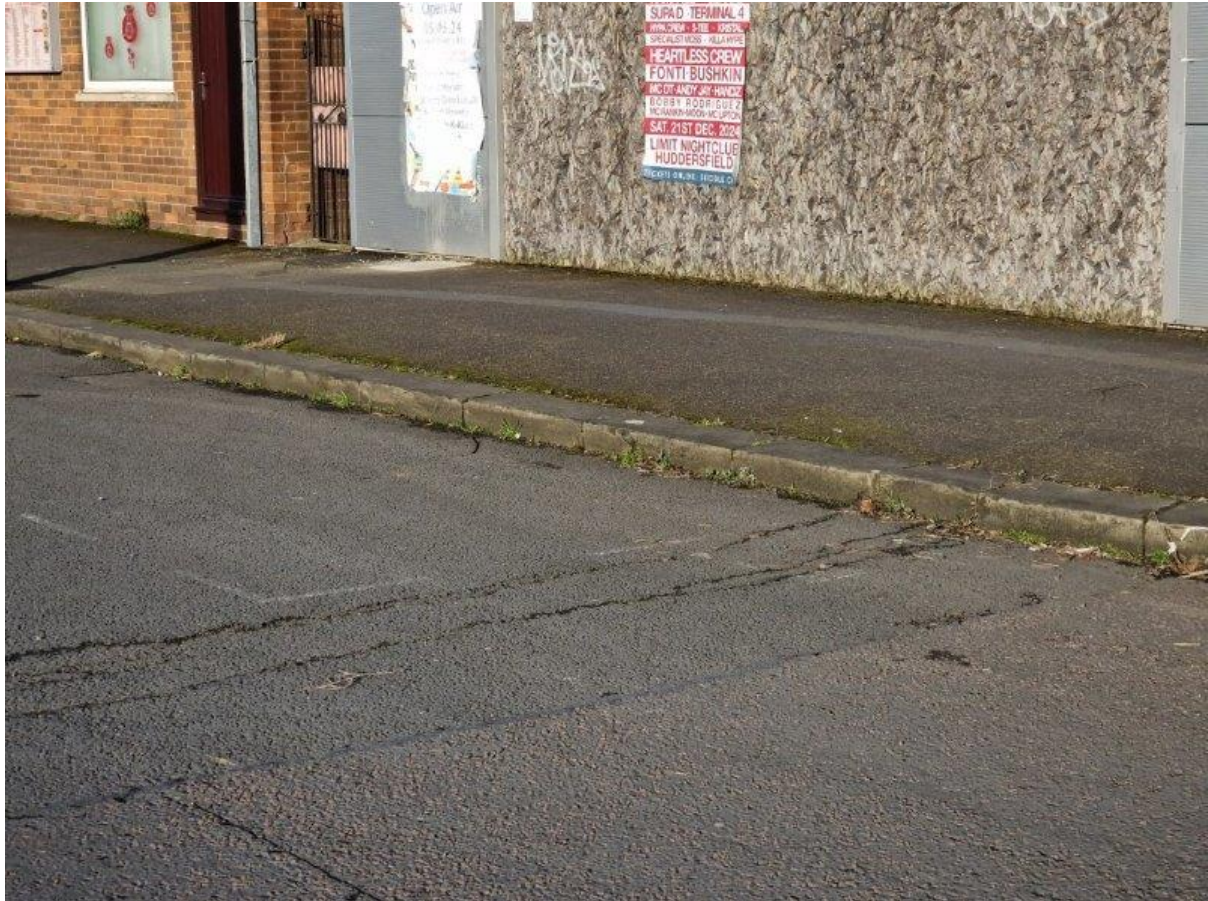
50m from Corner of Broadway and Back Union Street, Looking north along Broadway.

Stone kerbs showing signs of wear and displacement. Large scar on Broadway the whole width of the road.

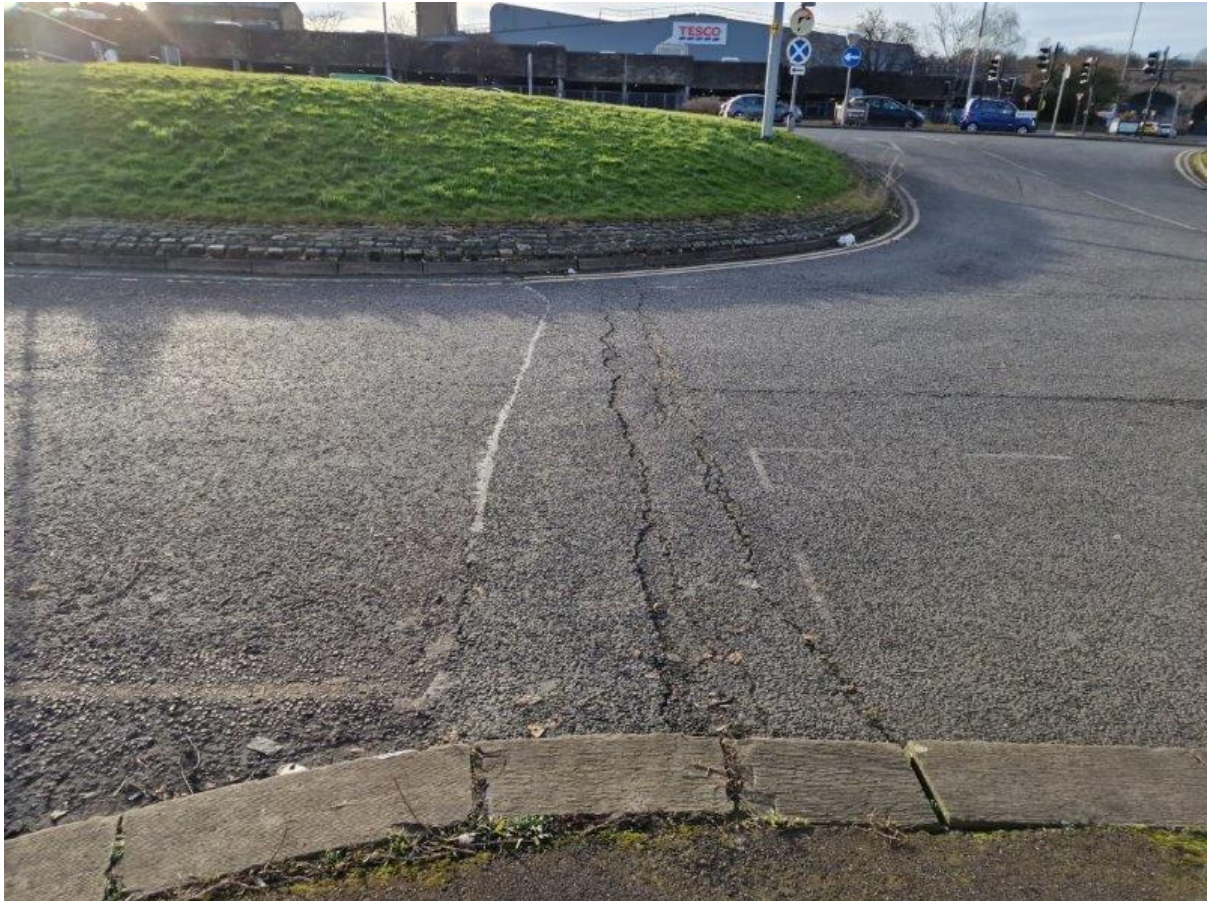
50m from Corner of Broadway and Back Union Street, Looking west Broadway.

Stone kerbs showing signs of wear and displacement. Large scar on Broadway the whole width of the road.

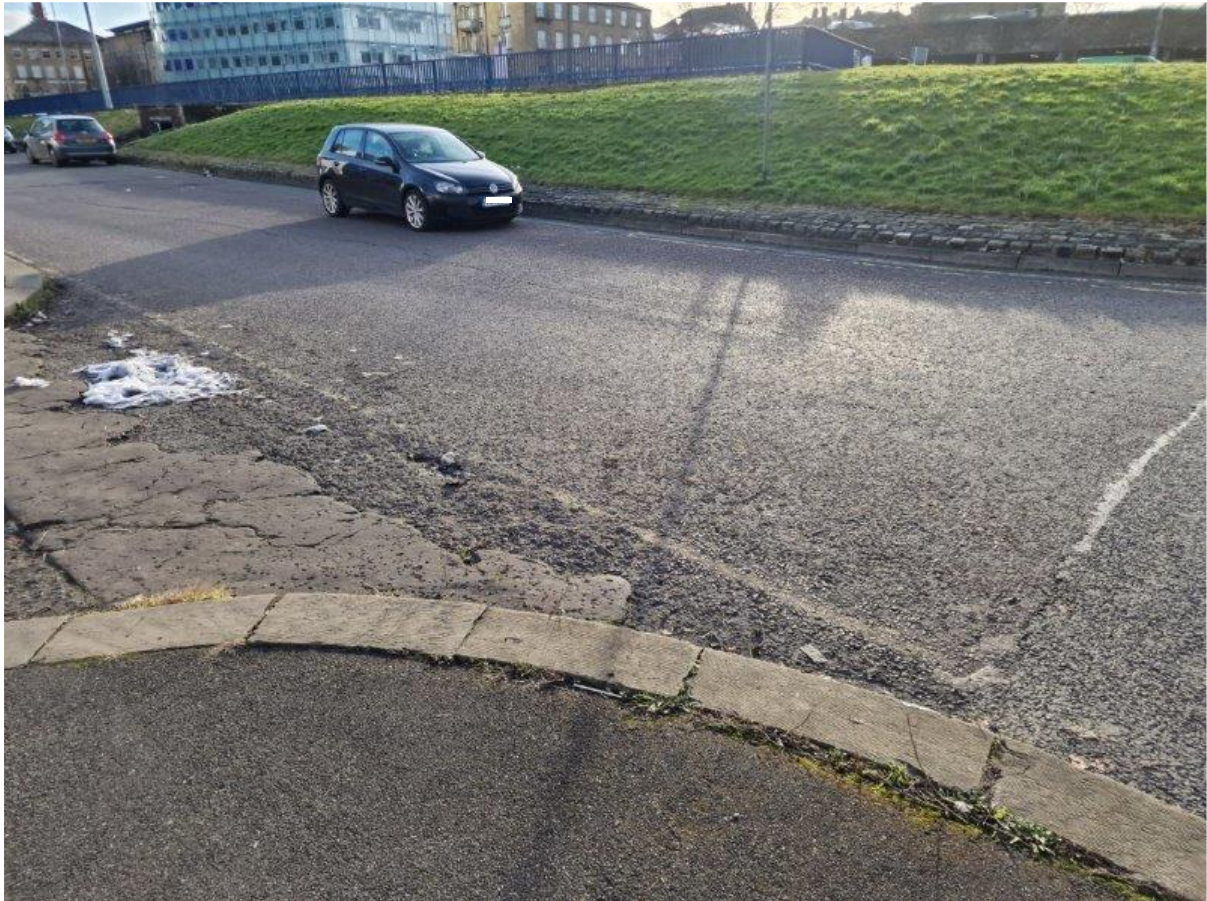
50m from Corner of Broadway and Back Union Street, Looking south along Broadway.

Poor kerb condition and Bell mouth tarmac condition poor.

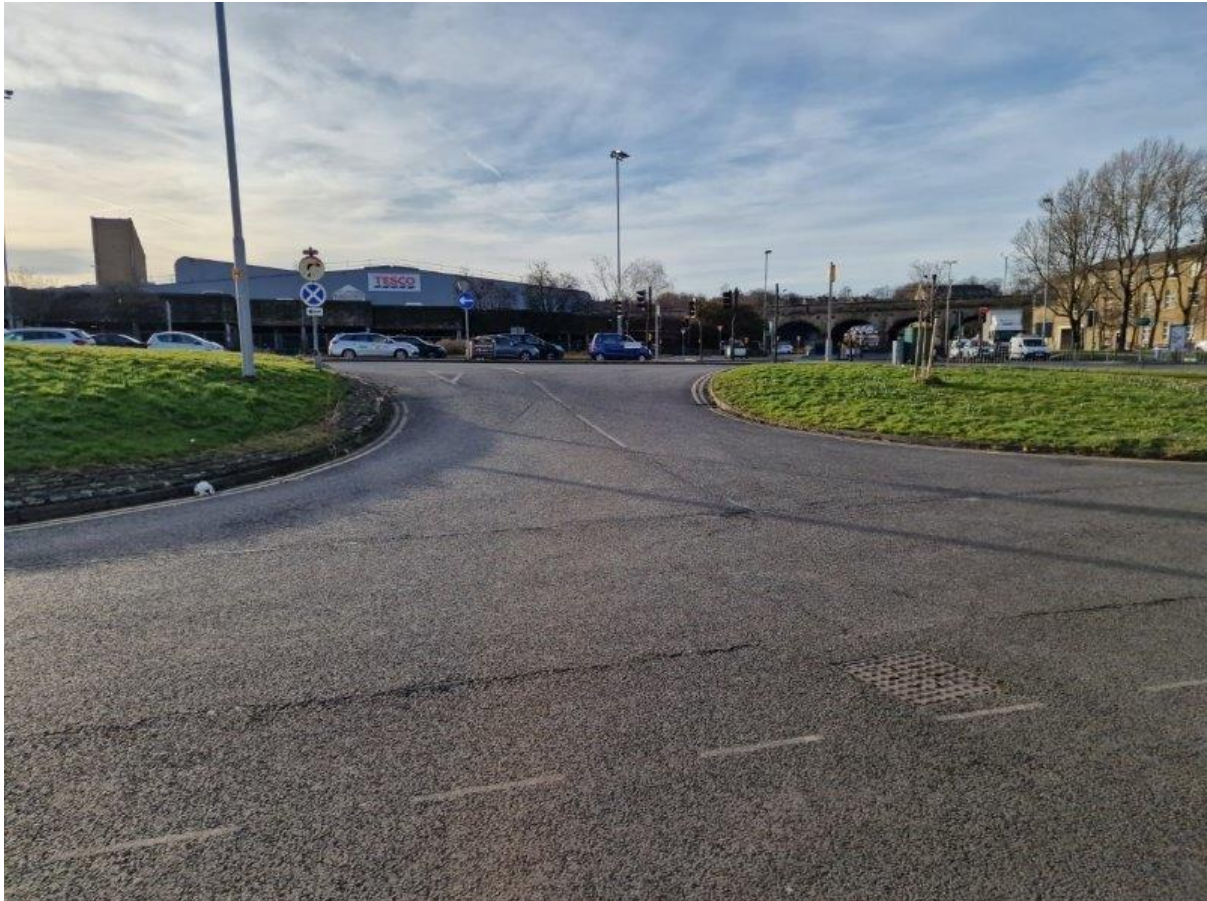
55m from Corner of Broadway and Back Union Street, Looking west along Broadway.

Tarmac generally in good condition with minor surface scarring along day joints.

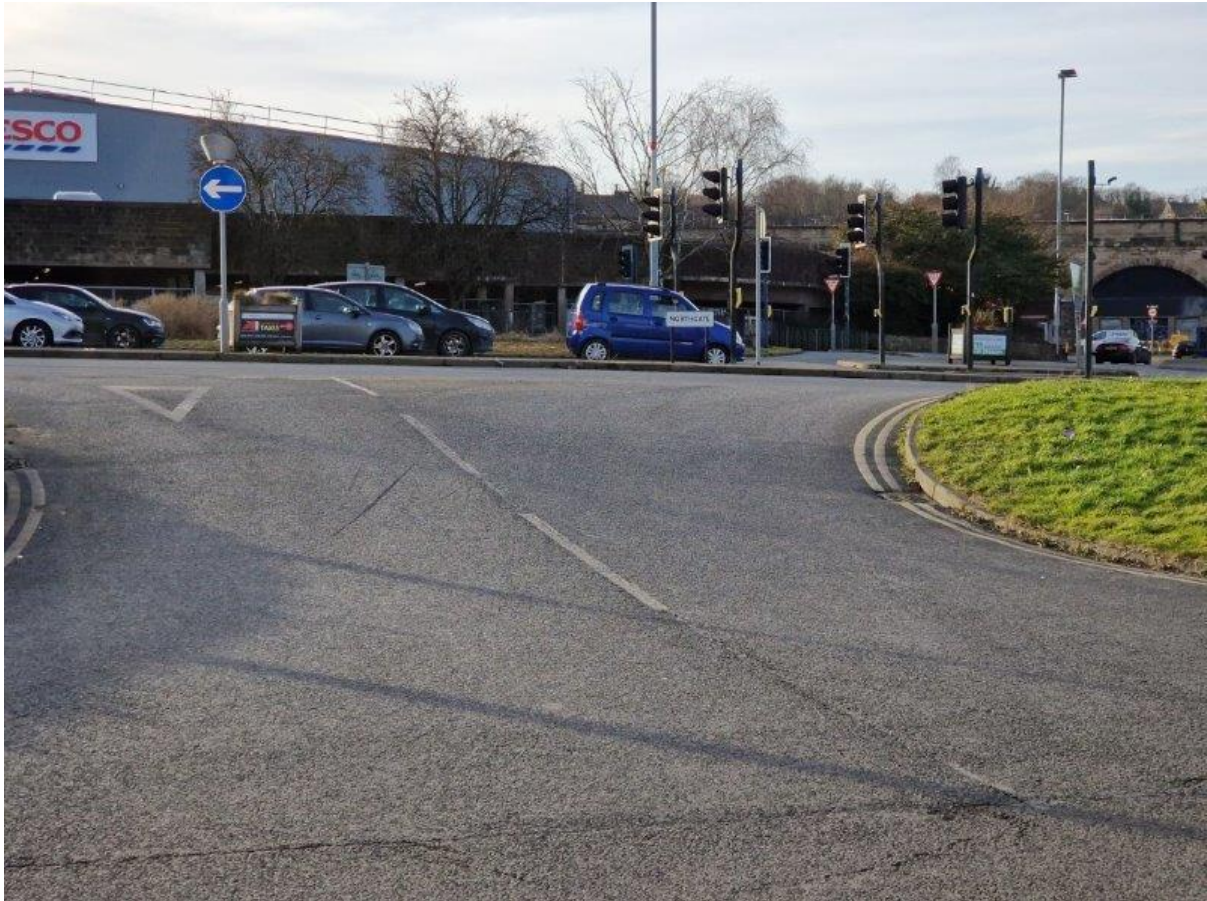
55m from Corner of Broadway and Back Union Street, Looking west along Broadway.

Scarring on entrance to Broadway due to steep incline and vehicles catching the road. White lining fading.

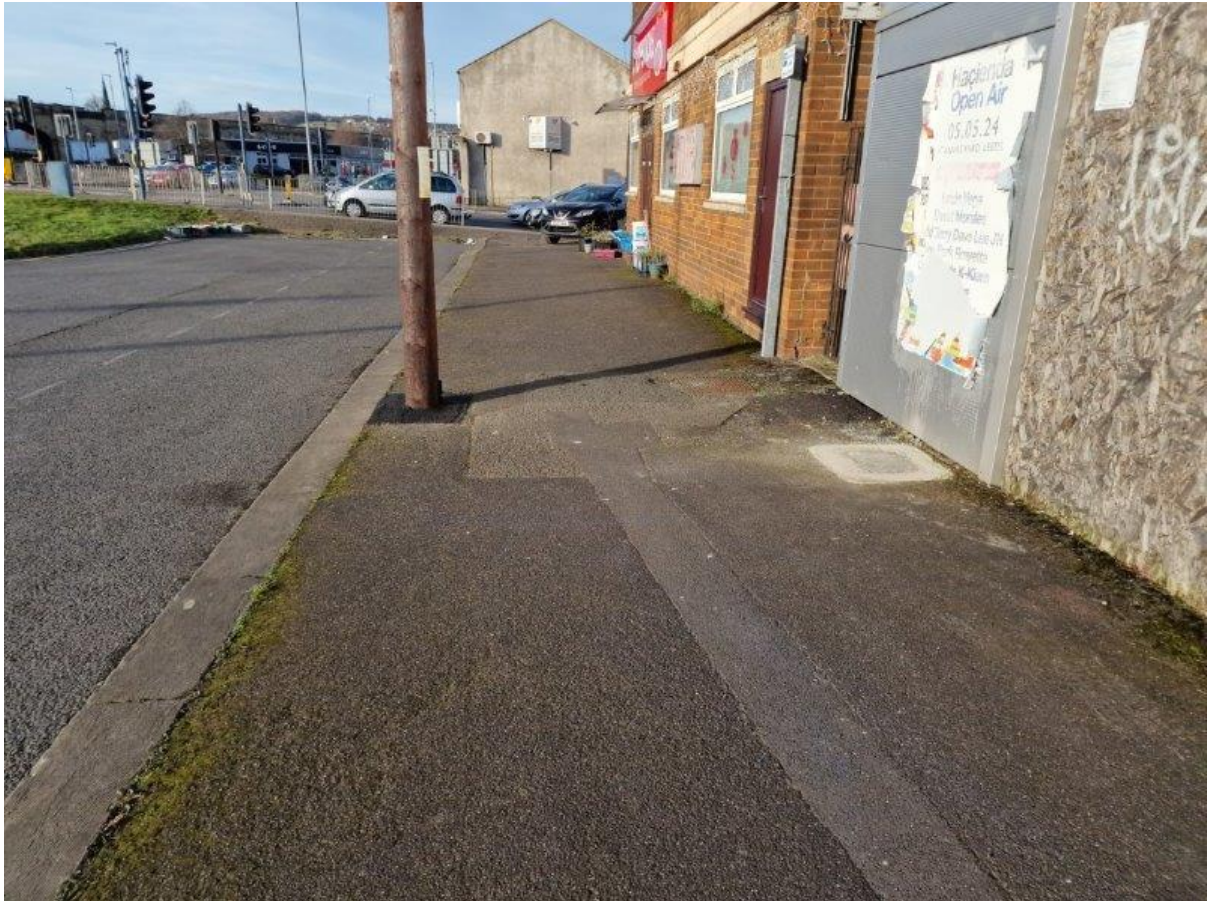
55m from Corner of Broadway and Back Union Street, Looking north along Broadway.

Patching to tarmac from previous utilities works. Vegetation growth along both edges.

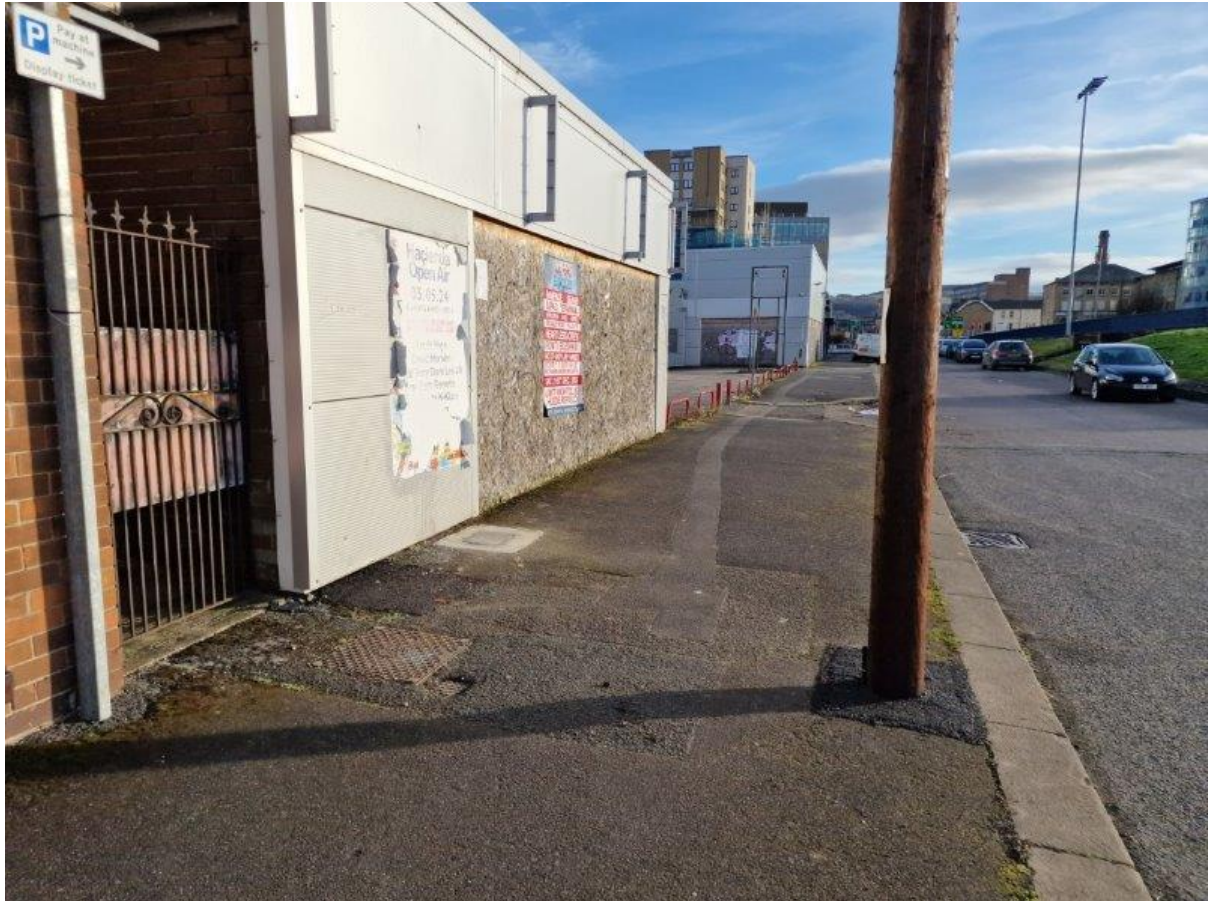
65m from Corner of Broadway and Back Union Street, Looking south along Broadway.

Patching to tarmac from previous utilities works. Vegetation growth along both edges.

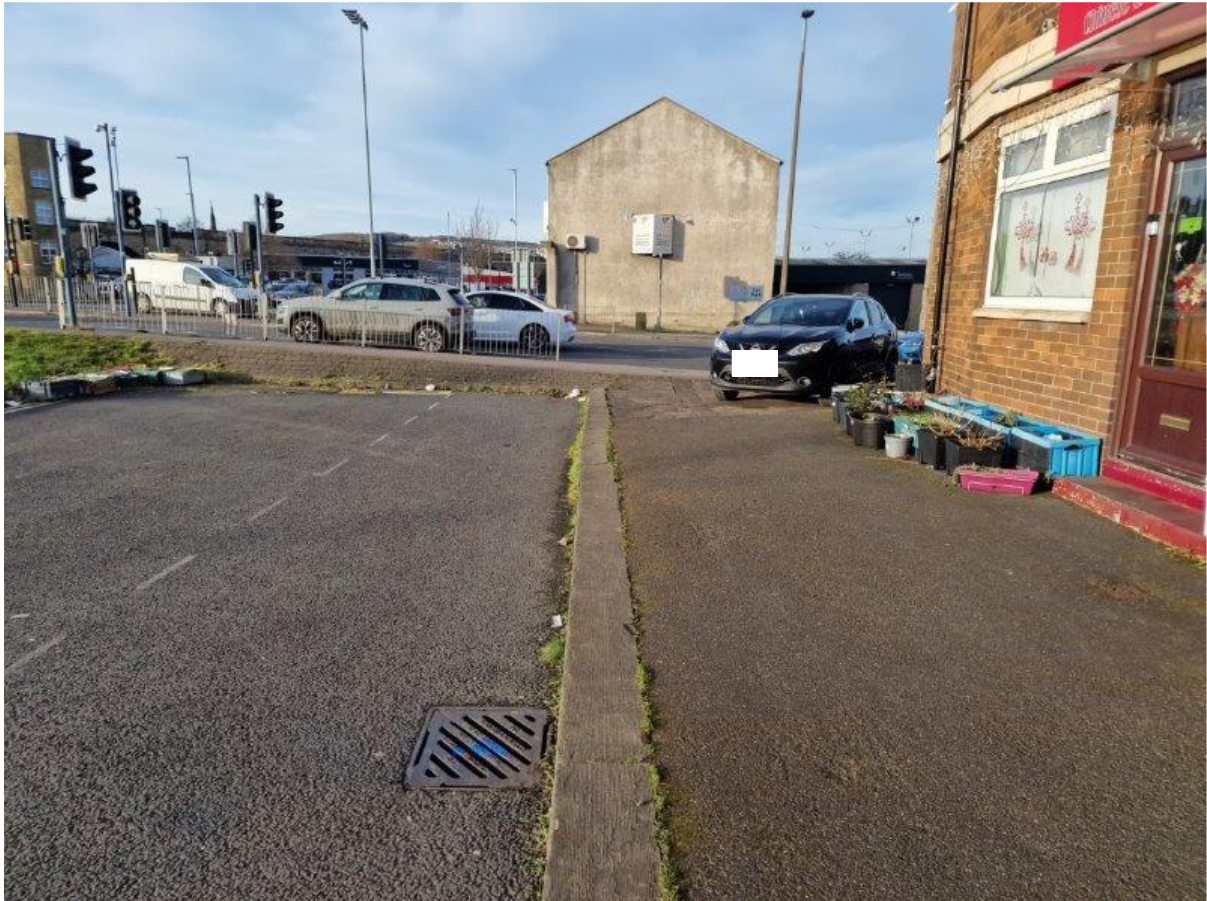
65m from Corner of Broadway and Back Union Street, Looking north along Broadway.

Kerbs showing displacement and vegetation growth on path edges and highway.

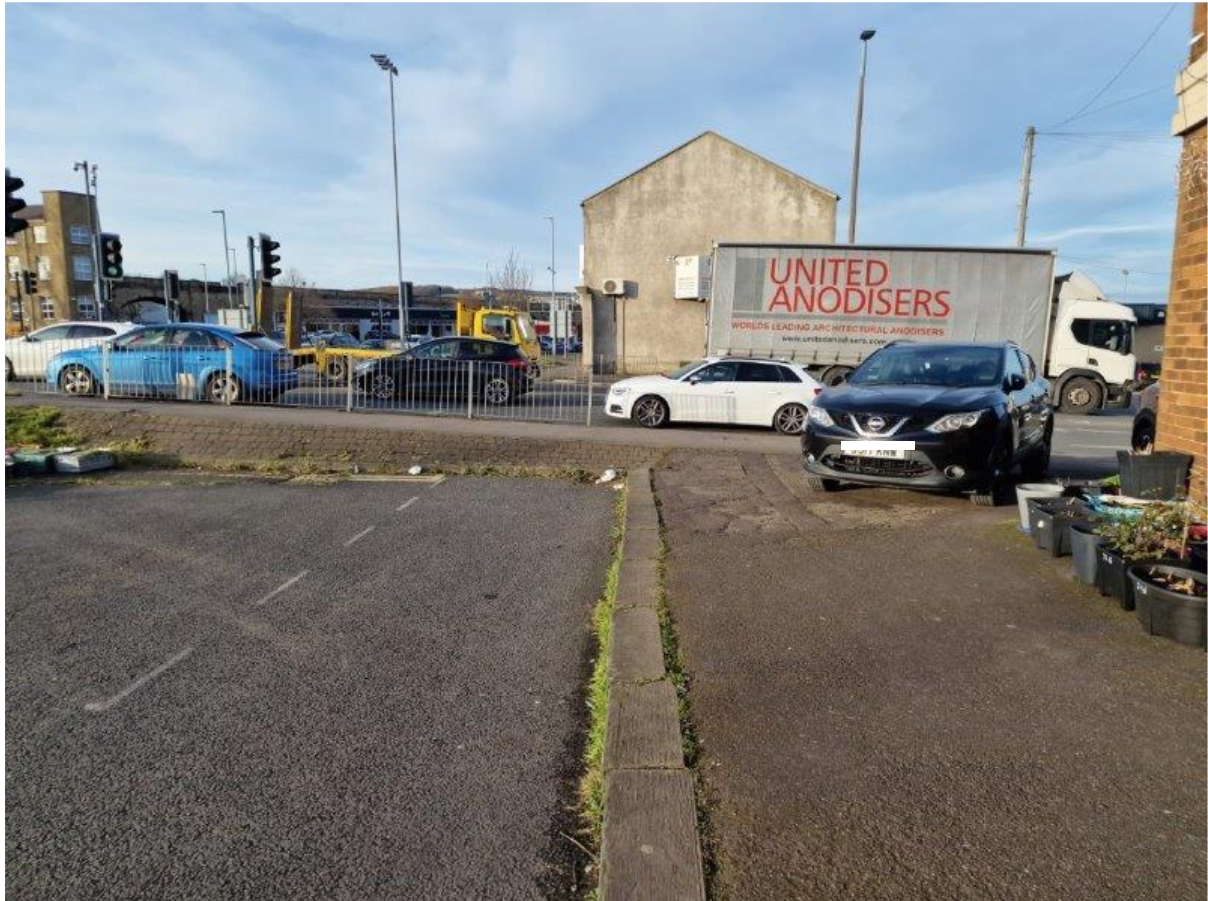
75m from Corner of Broadway and Back Union Street, Looking south along Broadway.

Kerbs showing displacement and vegetation growth on path edges and highway. Footpath in poor condition to corner of property, possibly from vehicle parking there.

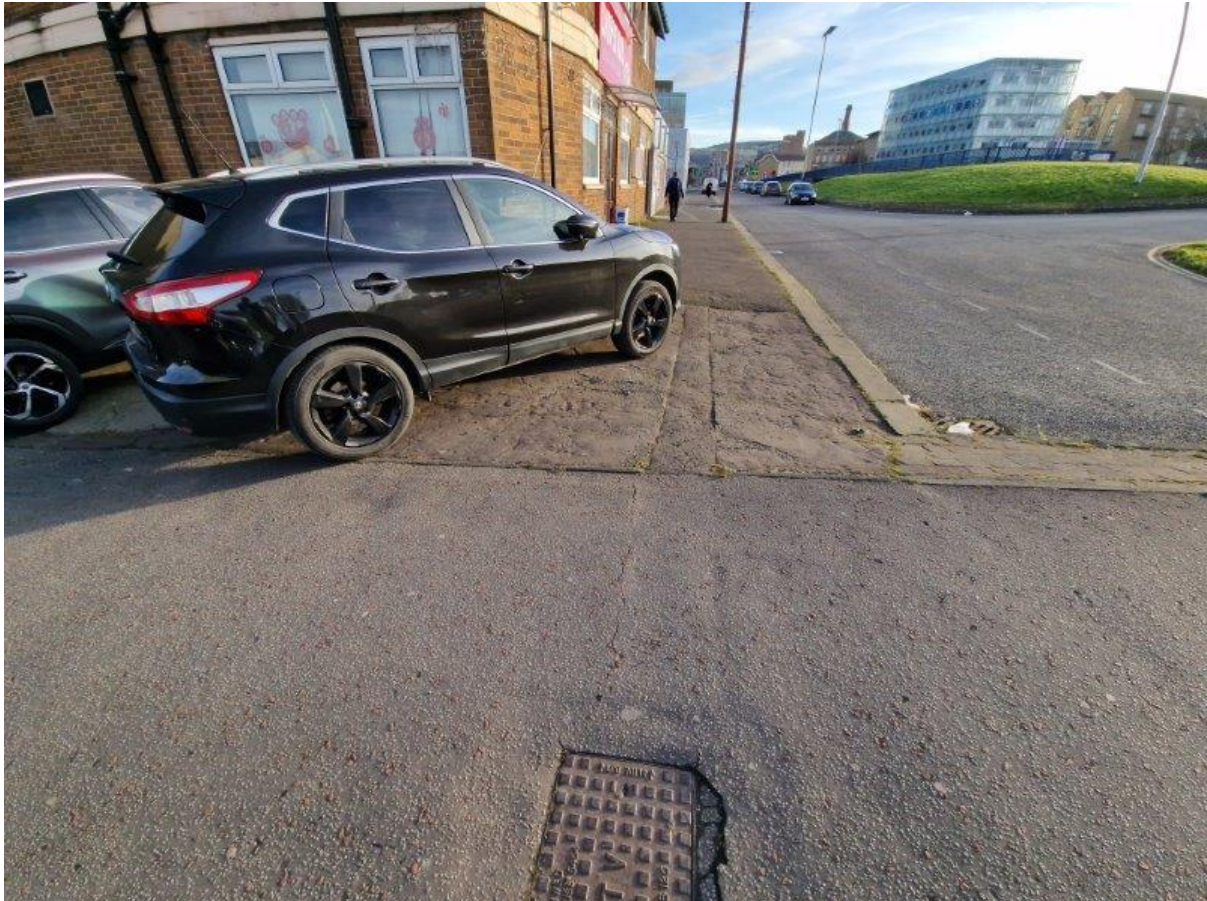
North end of Broadway

Footpath showing signs of wear and scarring from Utilities works.

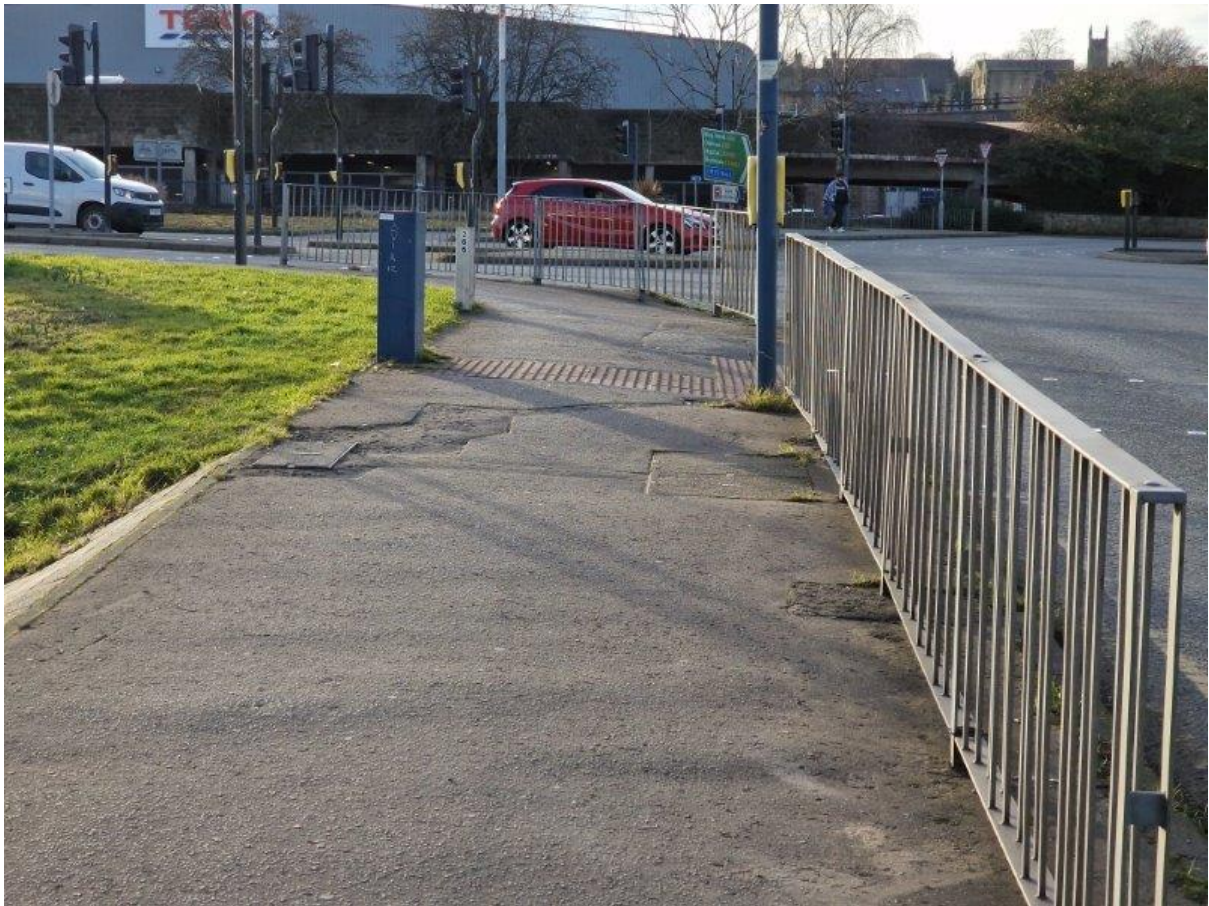
## North end of Broadway

Footpath showing signs of wear and scarring from Utilities works.

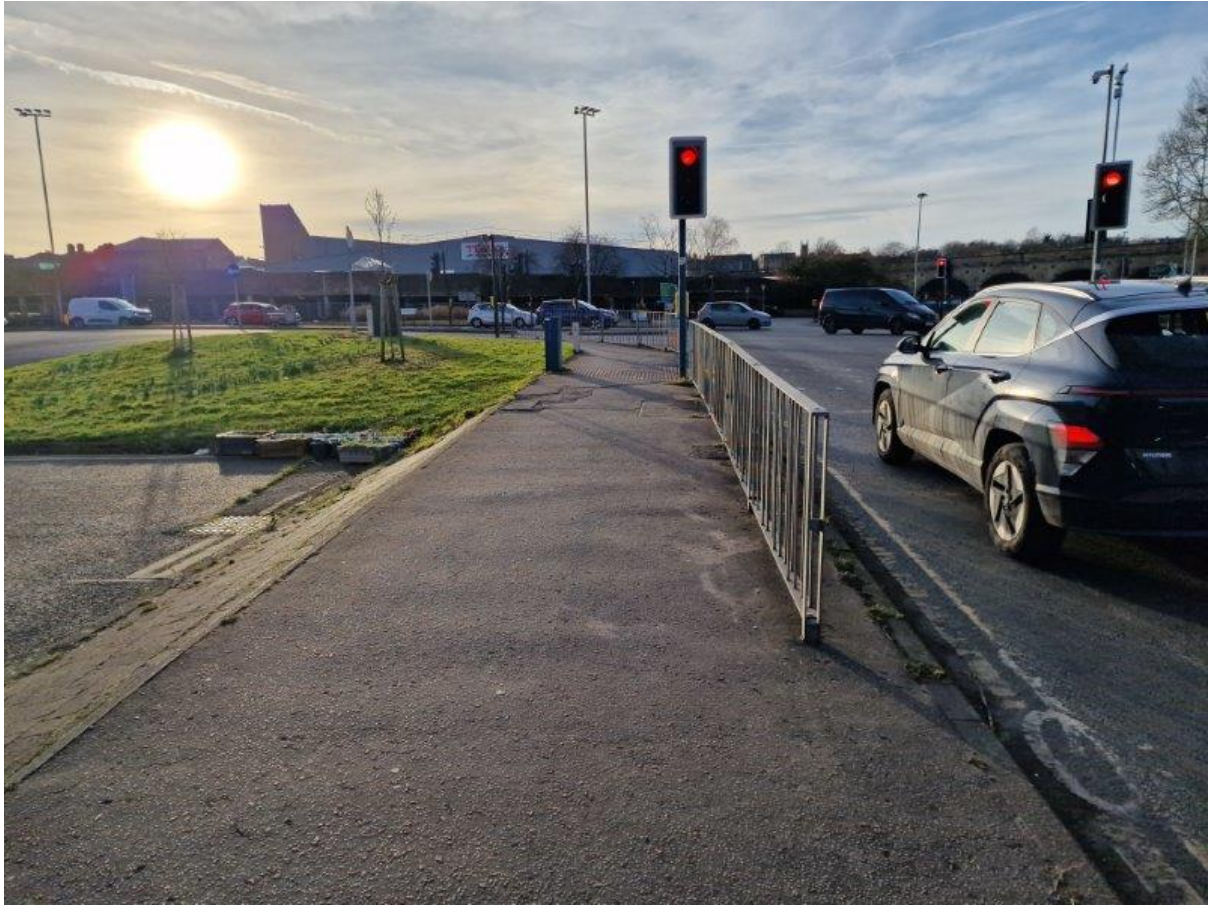
North end of Broadway

Footpath showing signs of wear and scarring from Utilities works.

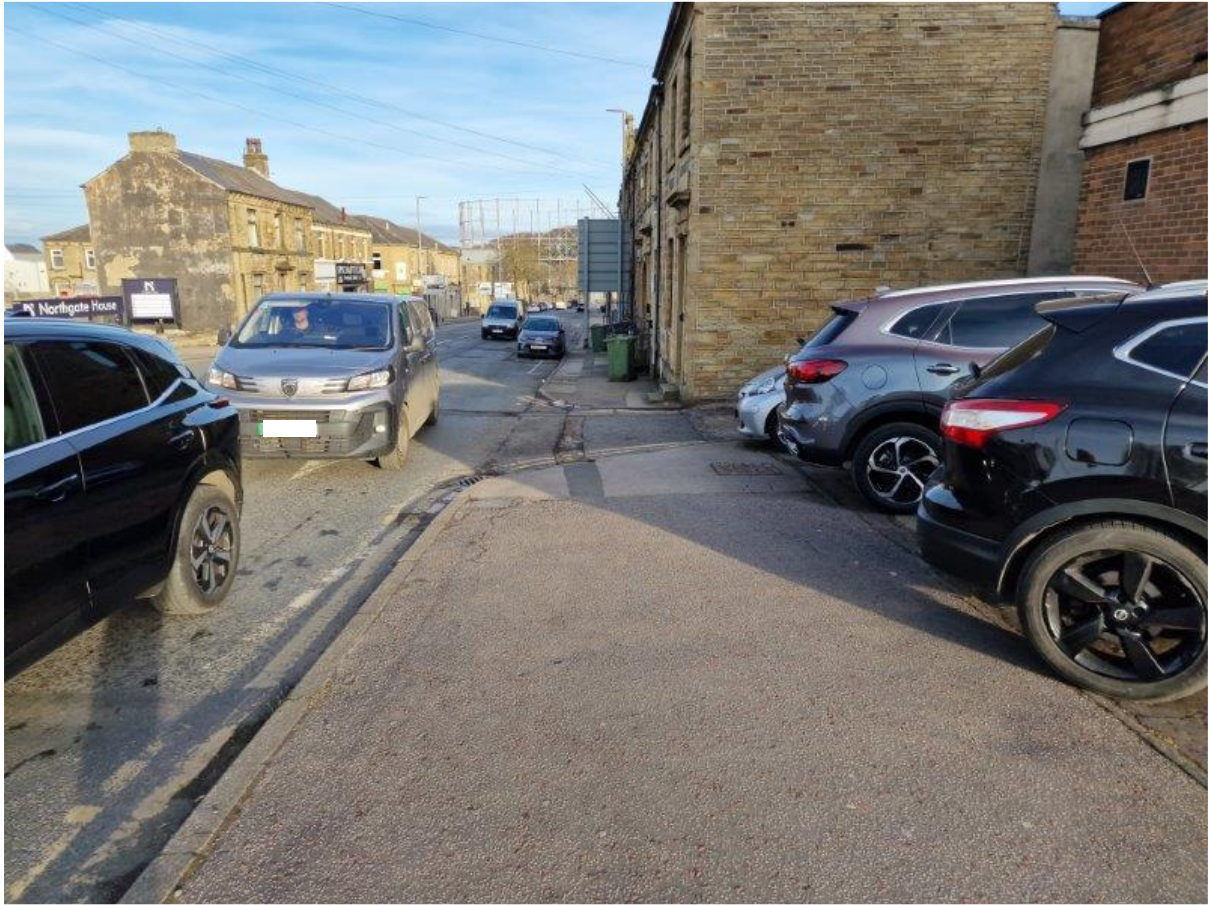
North end of Broadway

Footpath showing signs of wear and scarring from Utilities works.

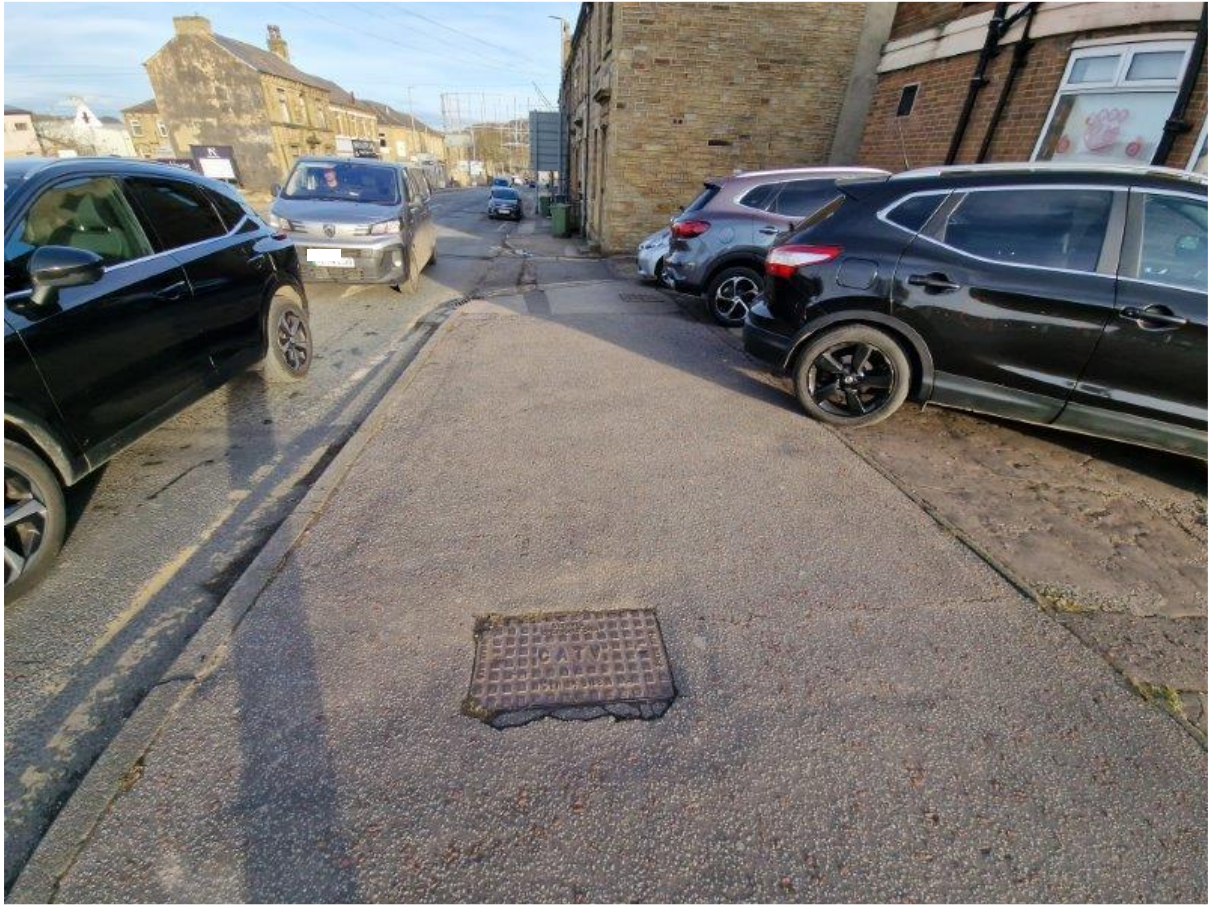
North end of Broadway

Footpath showing signs of wear and scarring from Utilities works.

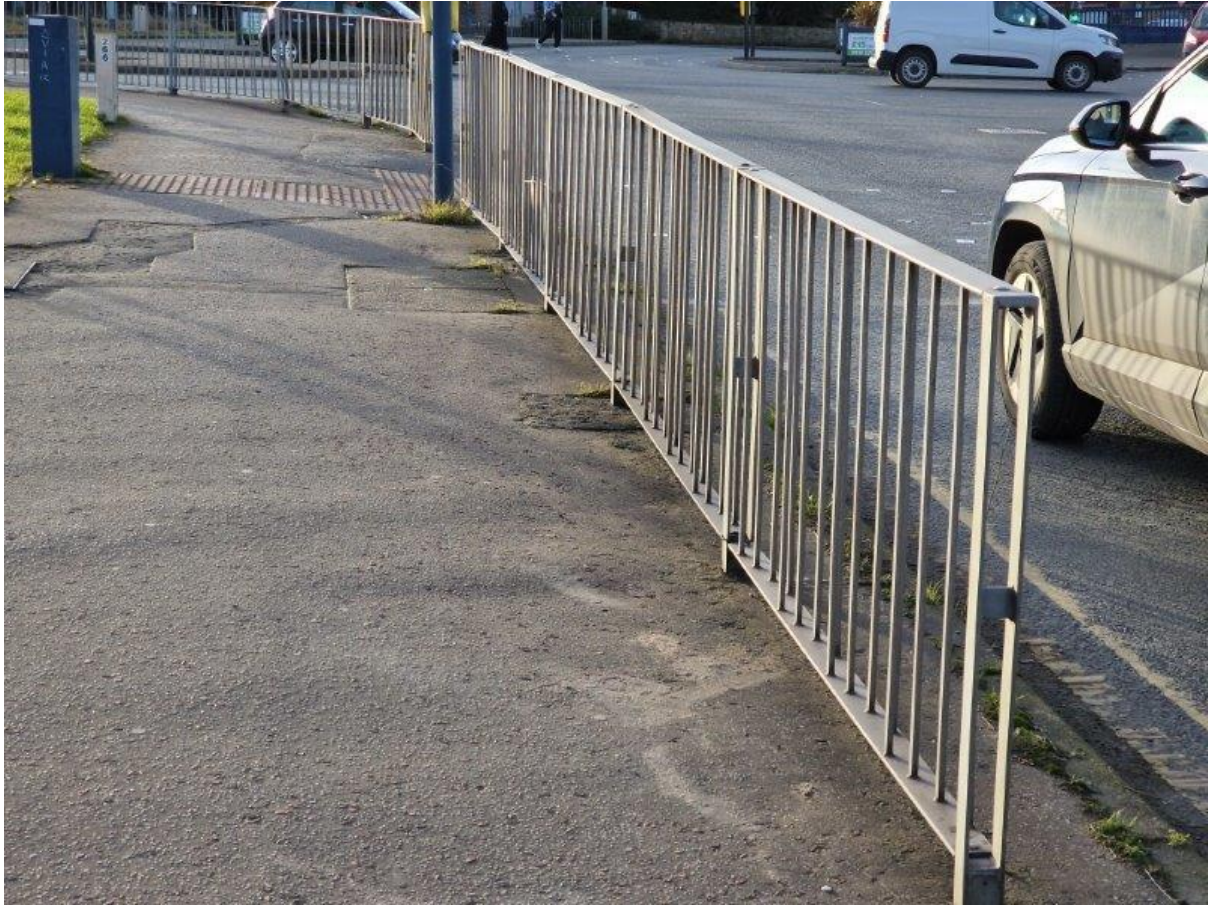
North end of Broadway

Footpath showing signs of wear and scarring from Utilities works.

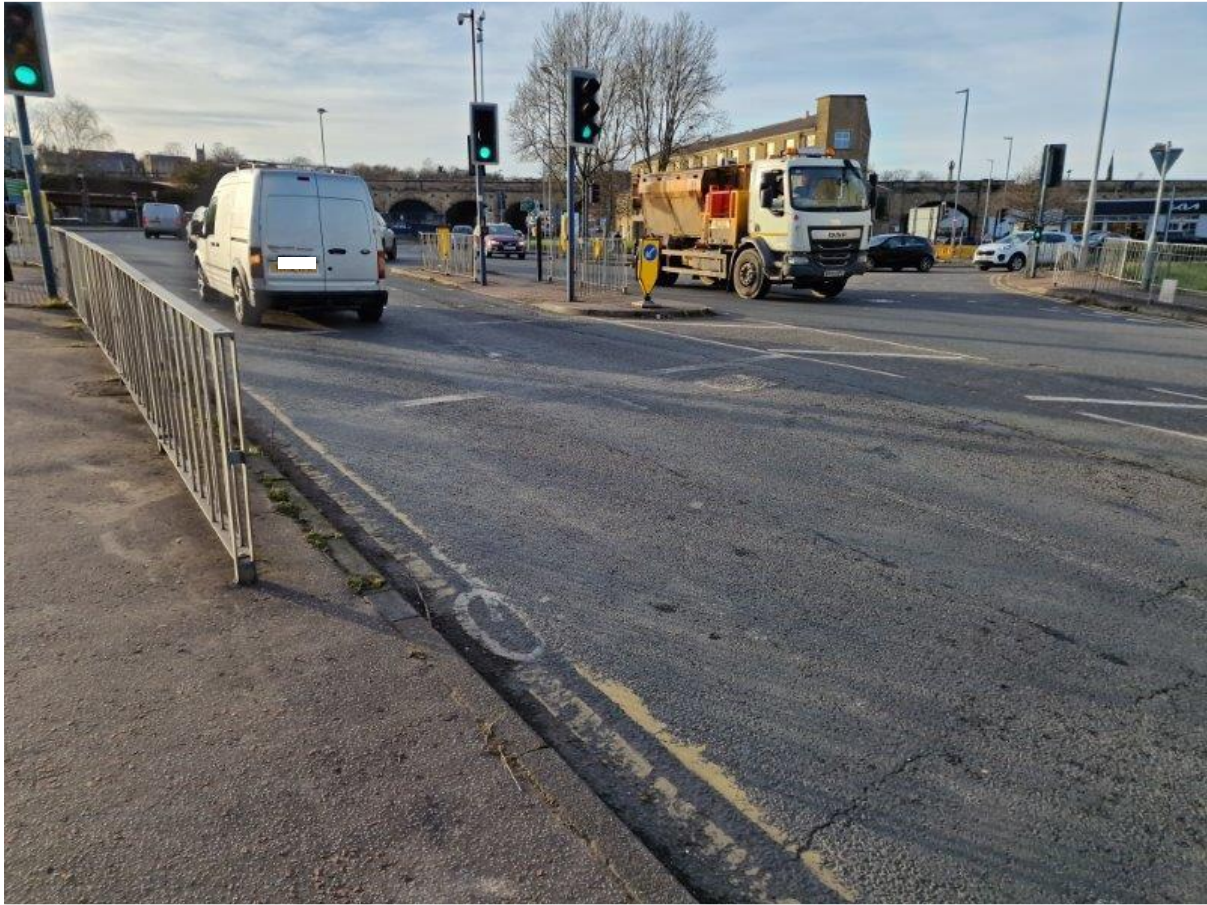
Lower Fitzwilliam Street/ Southgate junction (west side at the lights)

Yellow line marking faded. White lining faded general scarring and cracking to tarmac surface.

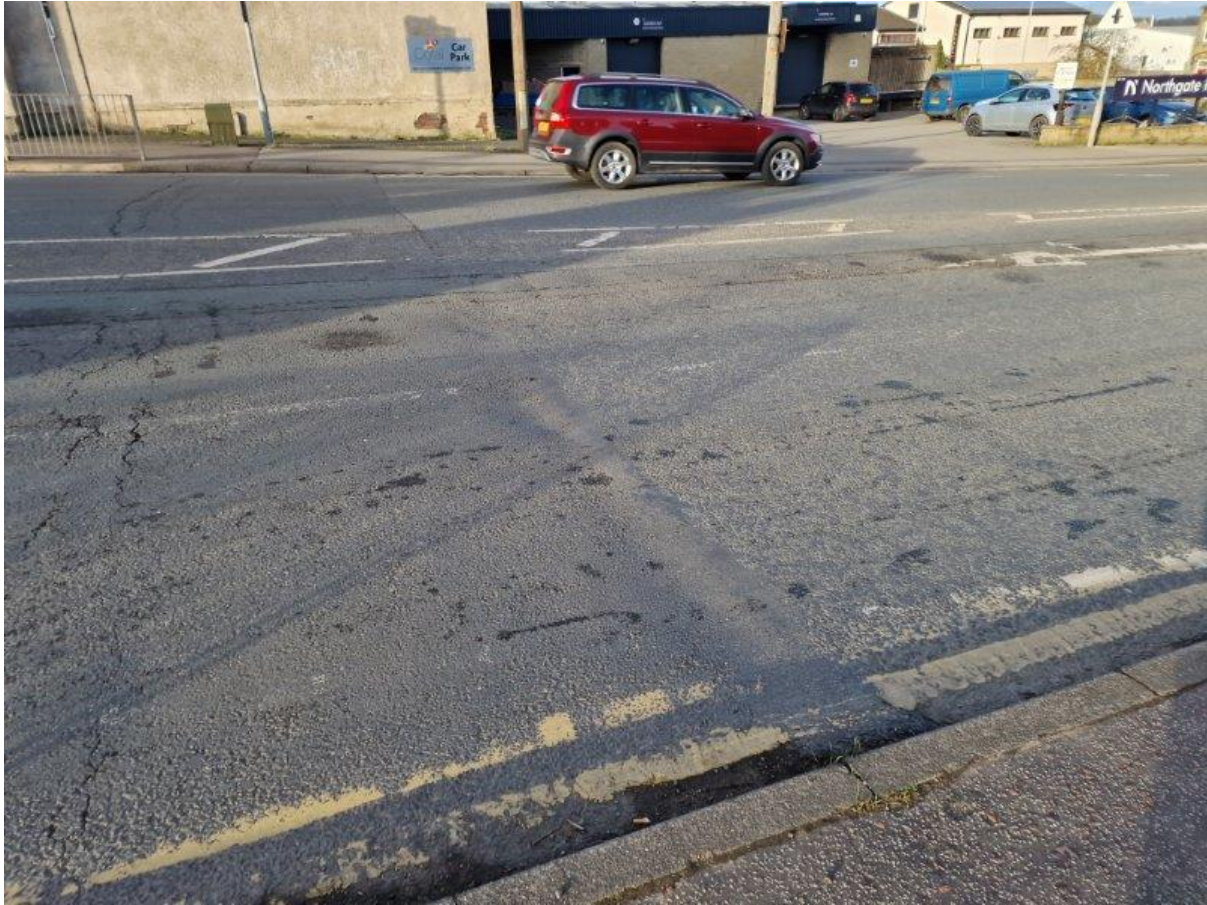
Lower Fitzwilliam Street/ Southgate junction (west side at the lights)

Yellow line marking faded. White lining faded general scarring and cracking to tarmac surface.  
Surface settlement visible across carriageway.

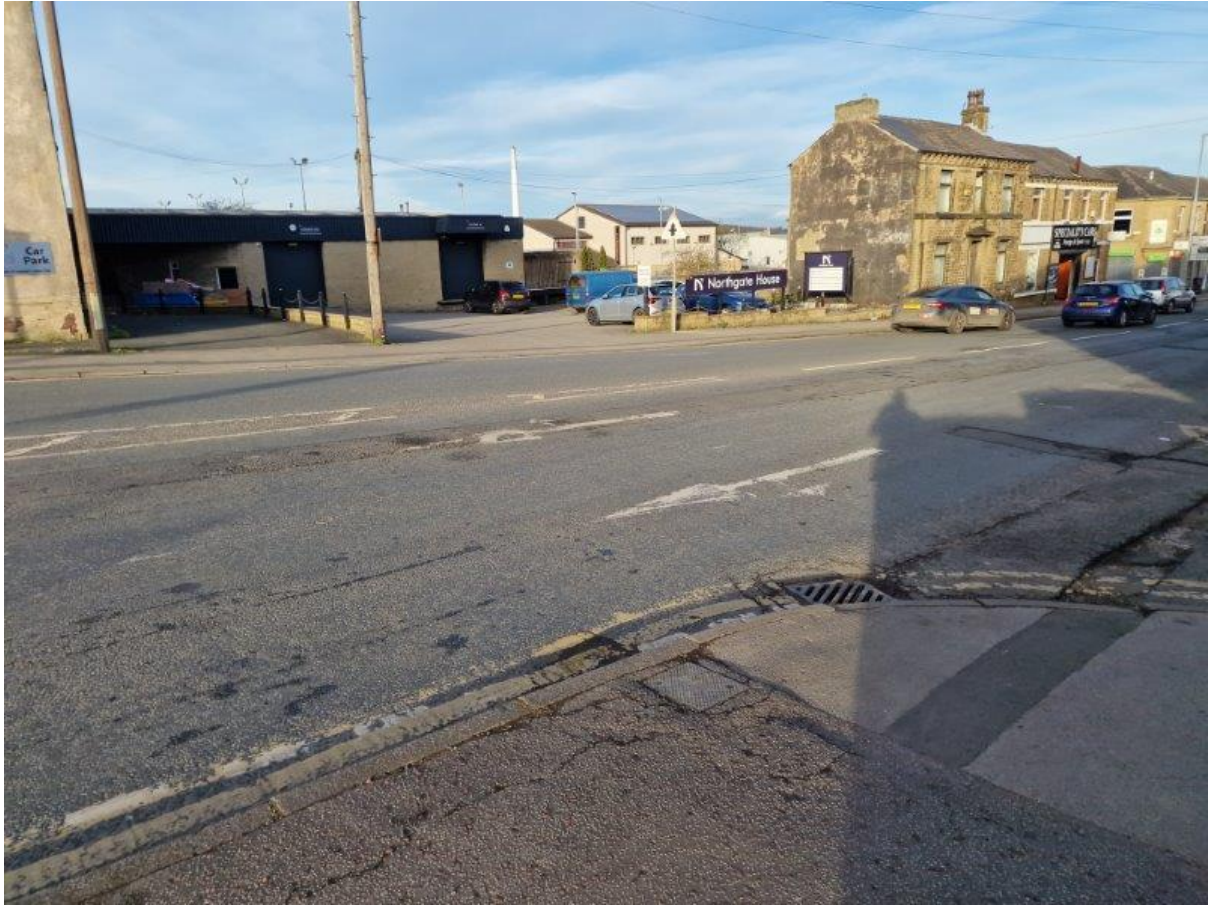
Lower Fitzwilliam Street/ Southgate junction (west side at the lights)

Yellow line marking faded. White lining faded general scarring and cracking to tarmac surface.

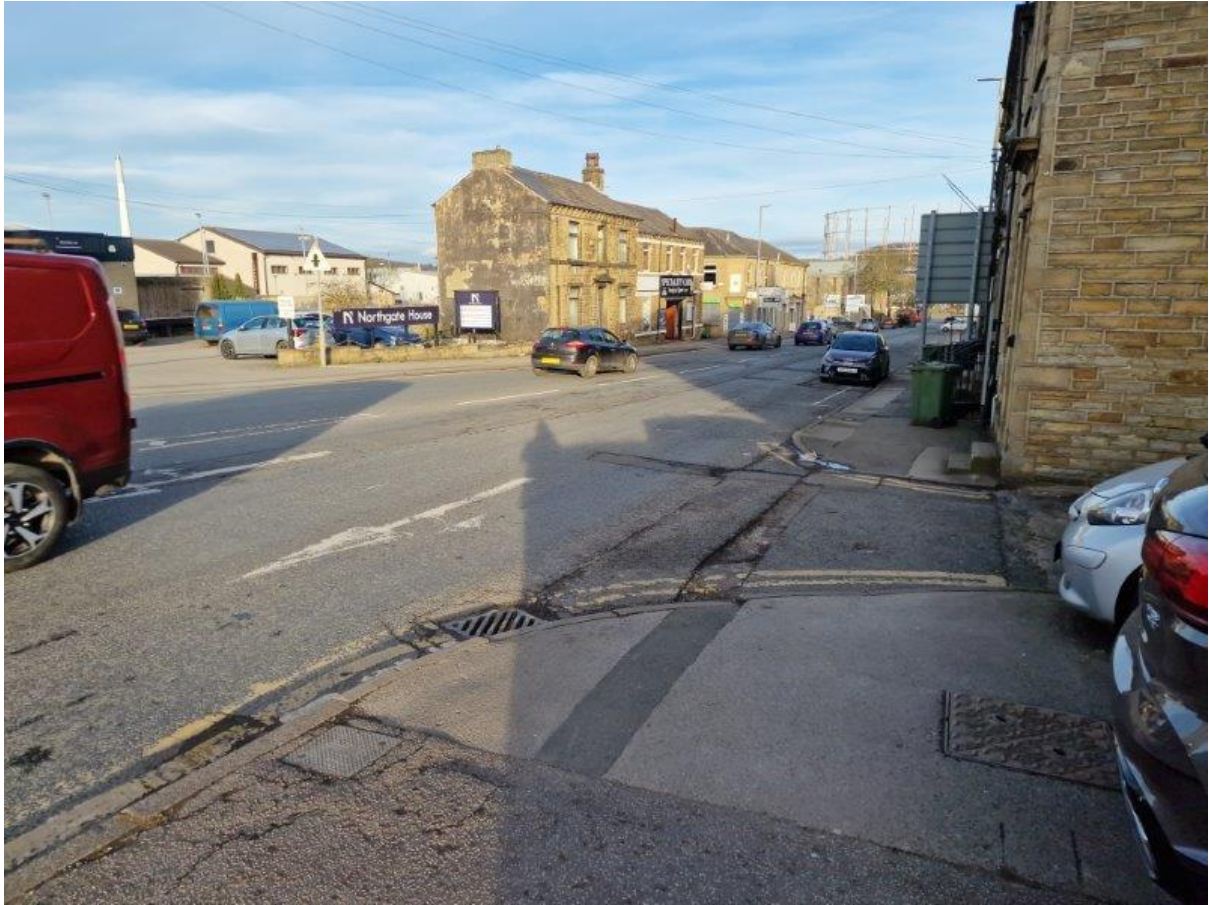
Lower Fitzwilliam Street/ Southgate junction (west side at the lights)

Yellow line marking faded. White lining faded general scarring and cracking to tarmac surface.
