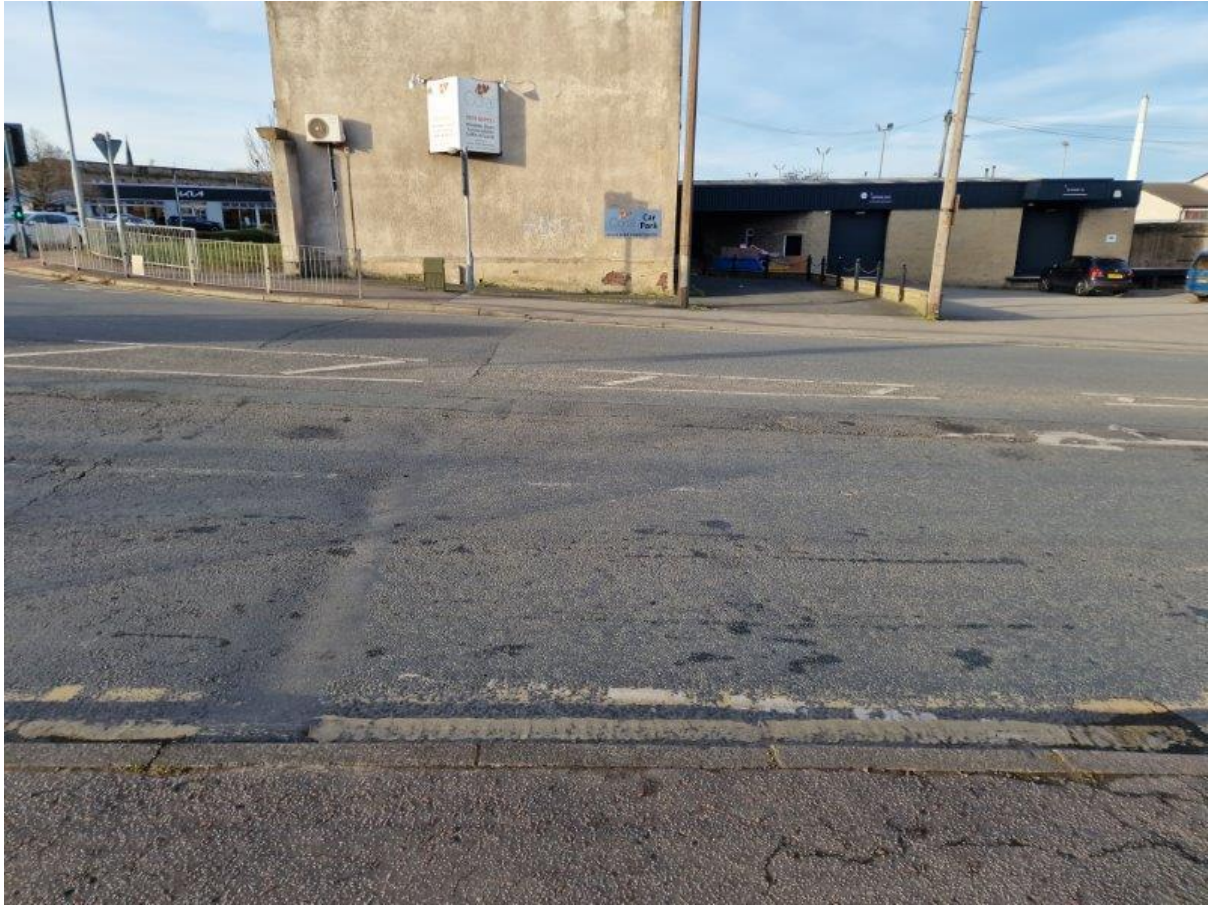
Lower Fitzwilliam Street/ Southgate junction (west side at the lights)

Yellow line marking faded. White lining faded general scarring and cracking to tarmac surface.  
Surface settlement visible across carriageway.

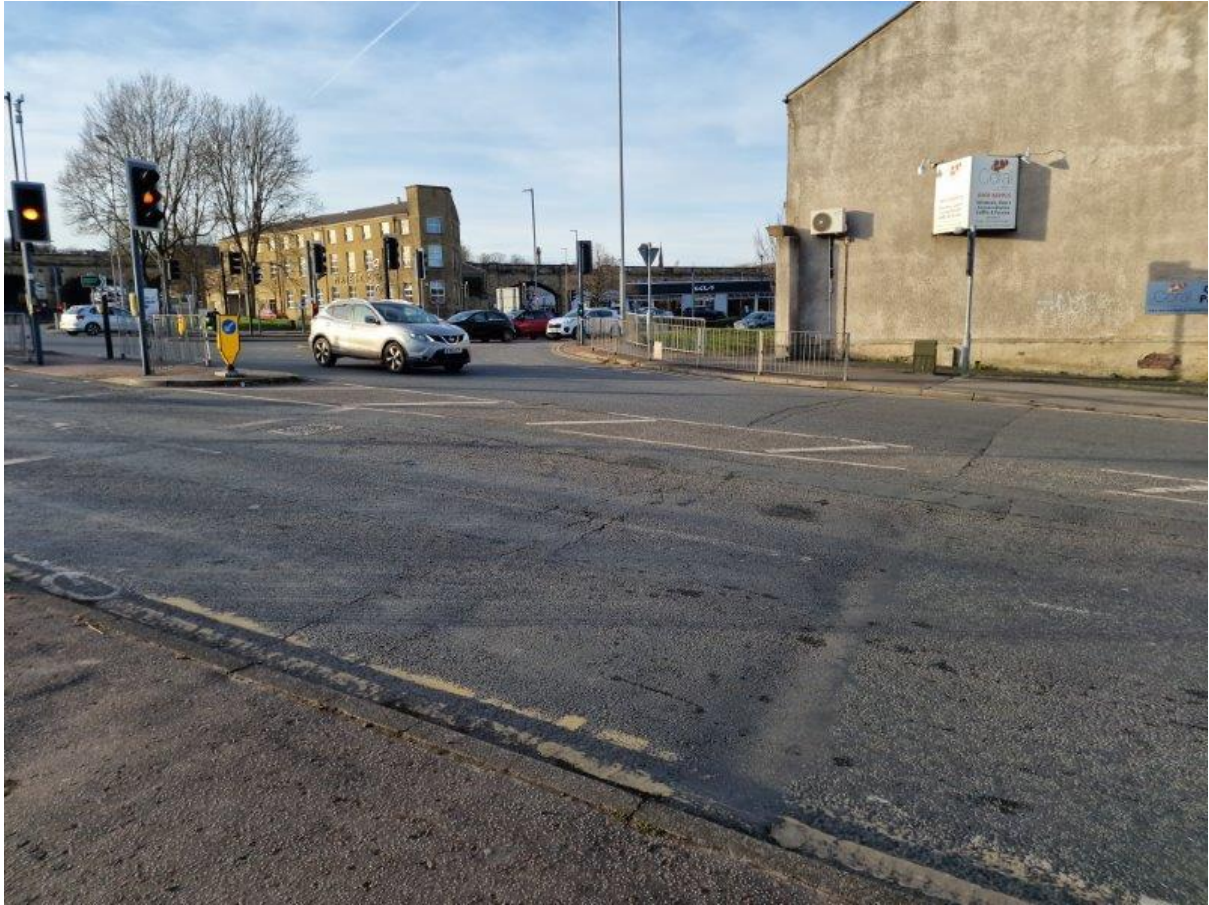
Lower Fitzwilliam Street/ Southgate junction (west side at the lights)

Yellow line and cyclist box marking faded. White lining faded general scarring and cracking to tarmac surface. Surface settlement visible across carriageway.

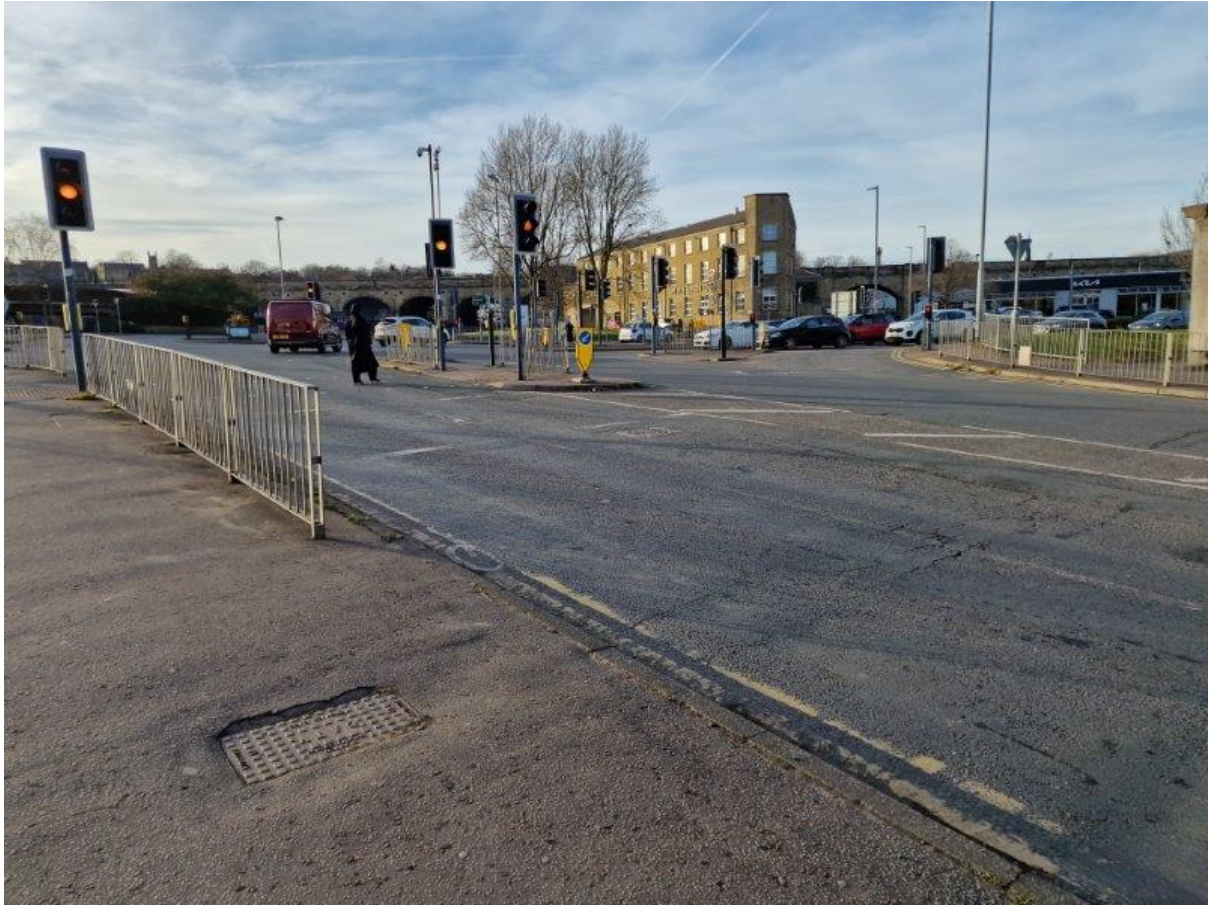
Lower Fitzwilliam Street/ Southgate junction (west side at the lights)

Yellow line and cyclist box marking faded. White lining faded general scarring and cracking to tarmac surface.

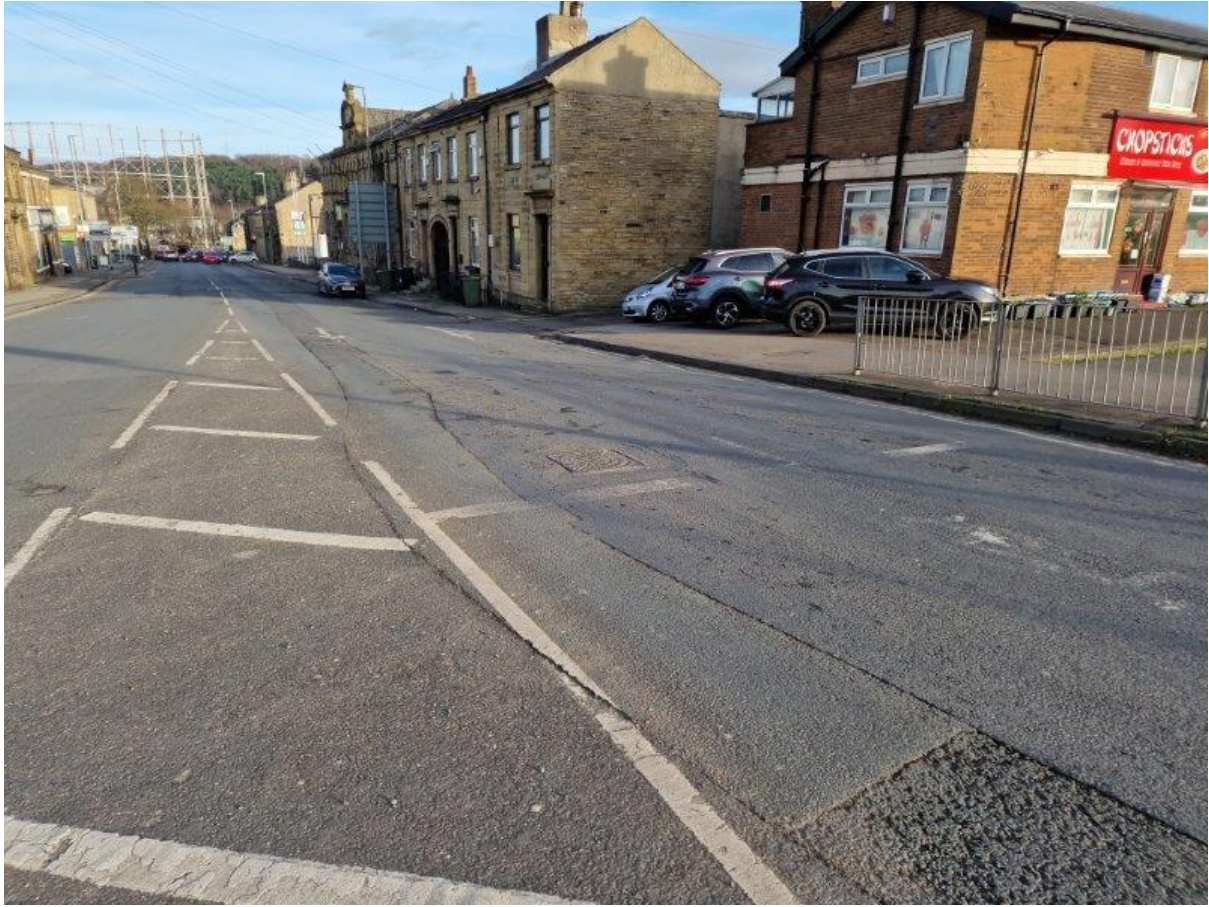
Lower Fitzwilliam Street/ Southgate junction (west side at the lights)

Yellow line and cyclist box marking faded. White lining faded general scarring and cracking to tarmac surface. Road showing signs of wear.

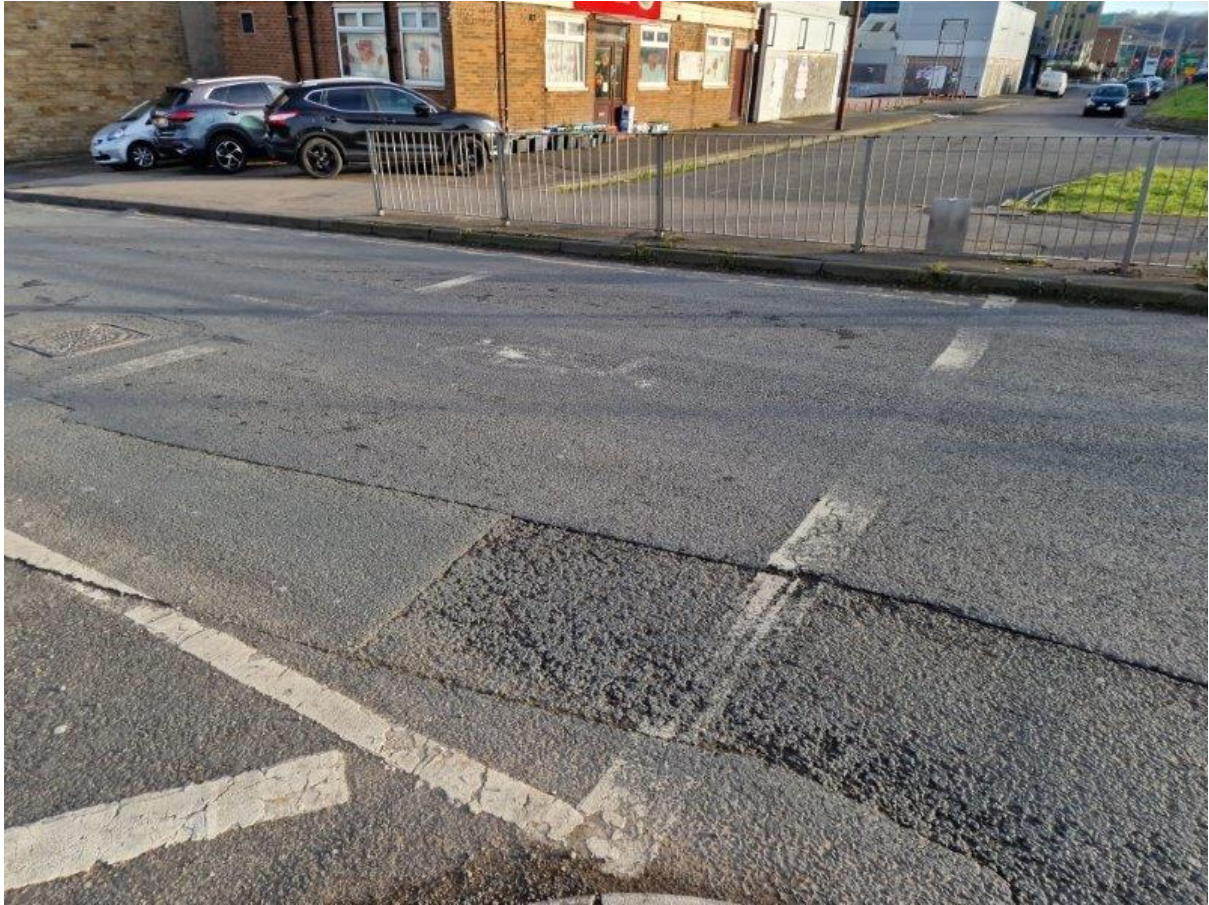
Lower Fitzwilliam Street/ Southgate junction (west side at the lights)

Cyclist box marking faded. White lining faded general scarring and cracking to tarmac surface. Road starting to deteriorate where previously resurfaced.

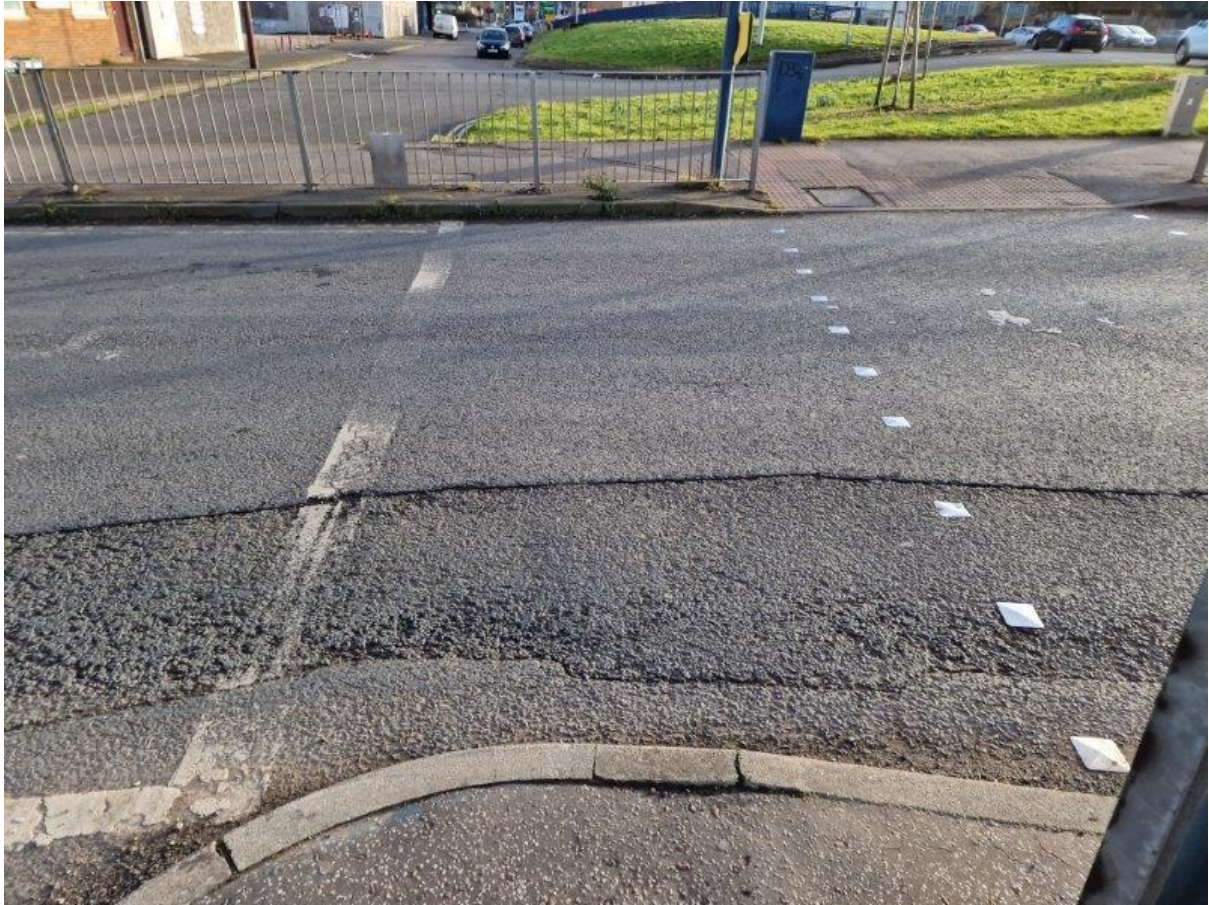
Lower Fitzwilliam Street/ Southgate junction (west side at the lights)

Cyclist box marking faded. White lining faded general scarring and cracking to tarmac surface. Road starting to deteriorate where previously resurfaced.

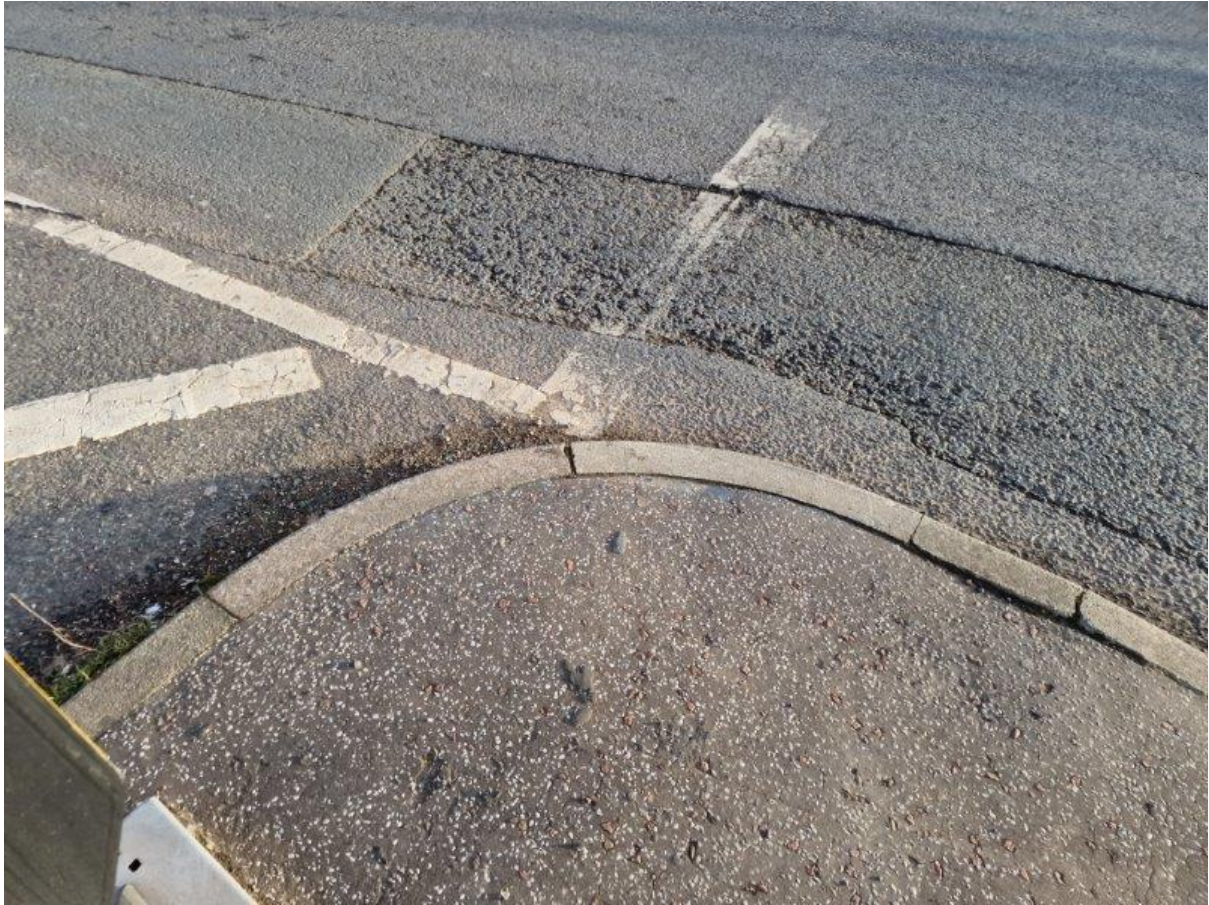
Lower Fitzwilliam Street/ Southgate junction (west side at the lights)

Path is eroding with cracks, and it has an uneven surface, the tarmac is worn and starting to break down. Minor kerb damage visible.

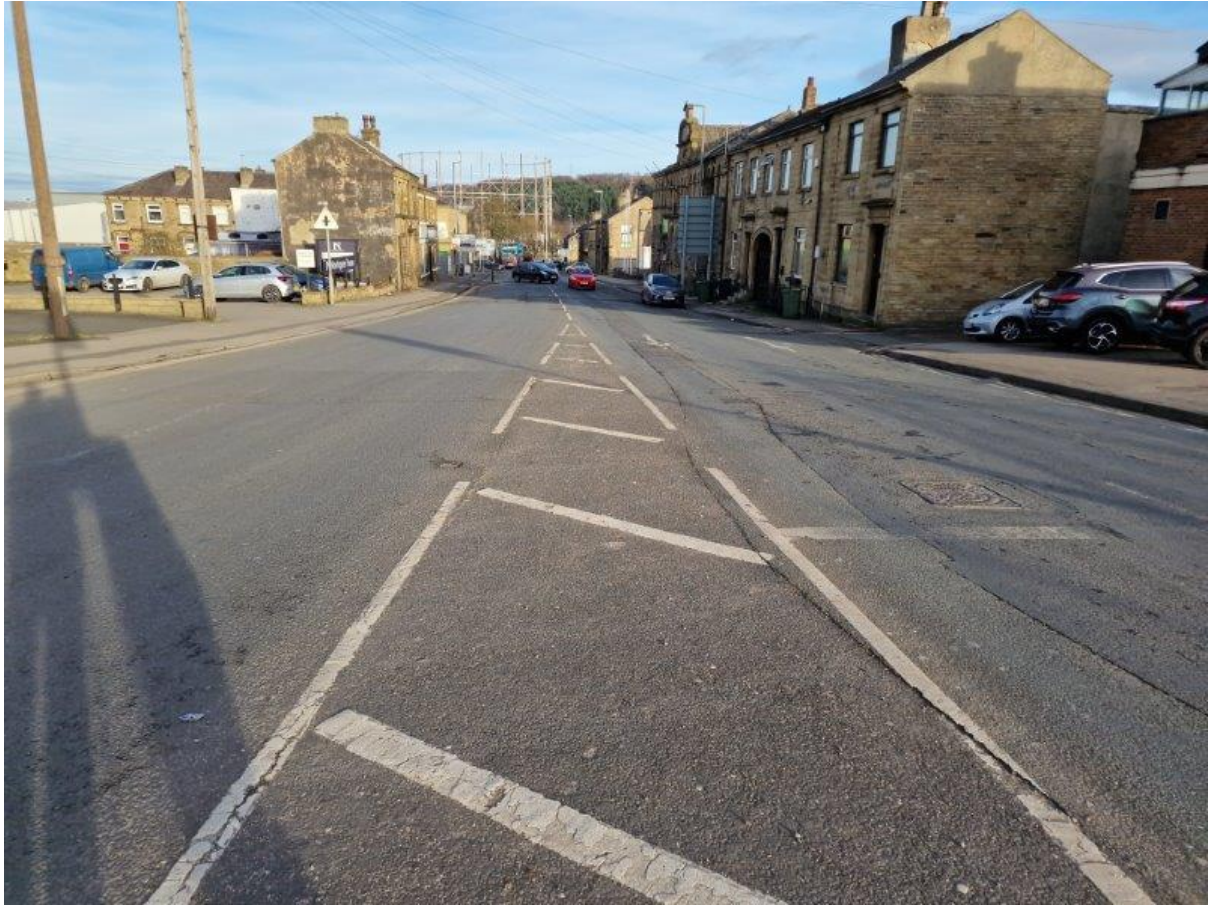
Lower Fitzwilliam Street/ Southgate junction (west side at the lights)

White lining faded general scarring and cracking to tarmac surface. Road starting to deteriorate where previously resurfaced/utilities works been carried out.

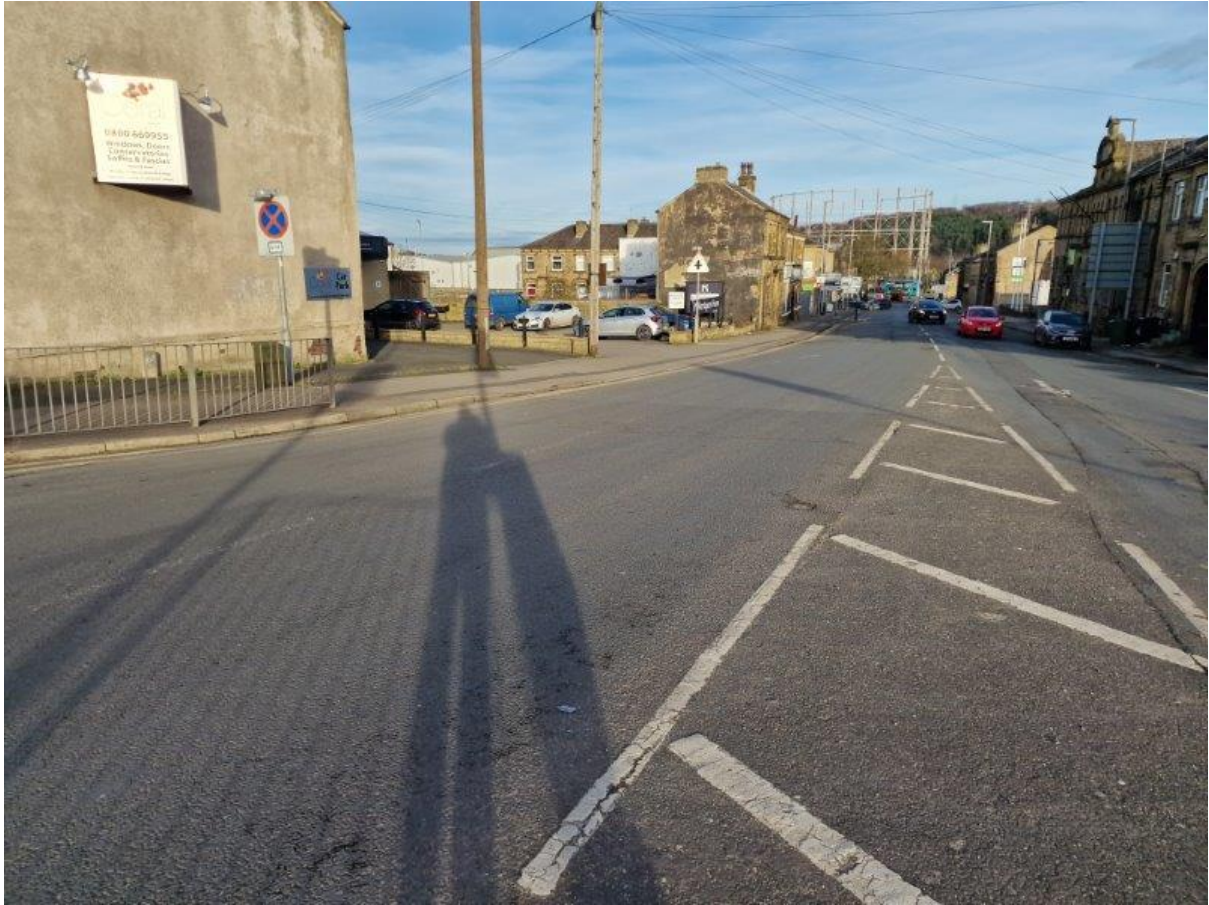
Lower Fitzwilliam Street/ Southgate junction (west side at the lights)

White lining faded general scarring and cracking to tarmac surface. Road starting to deteriorate where previously resurfaced.

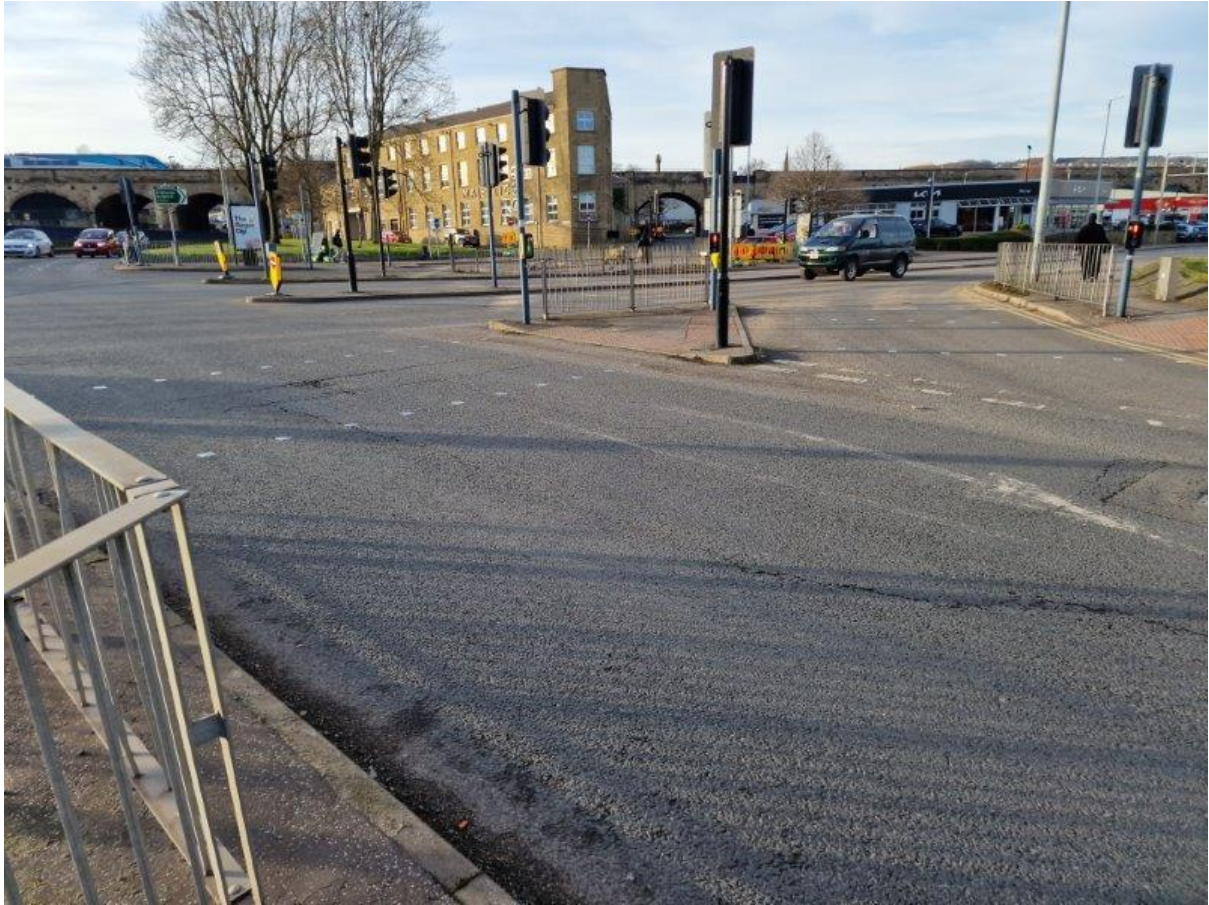
Lower Fitzwilliam Street/ Southgate junction (west side at the lights)

Tarmac has an uneven surface, the tarmac is worn and starting to break down in some areas.

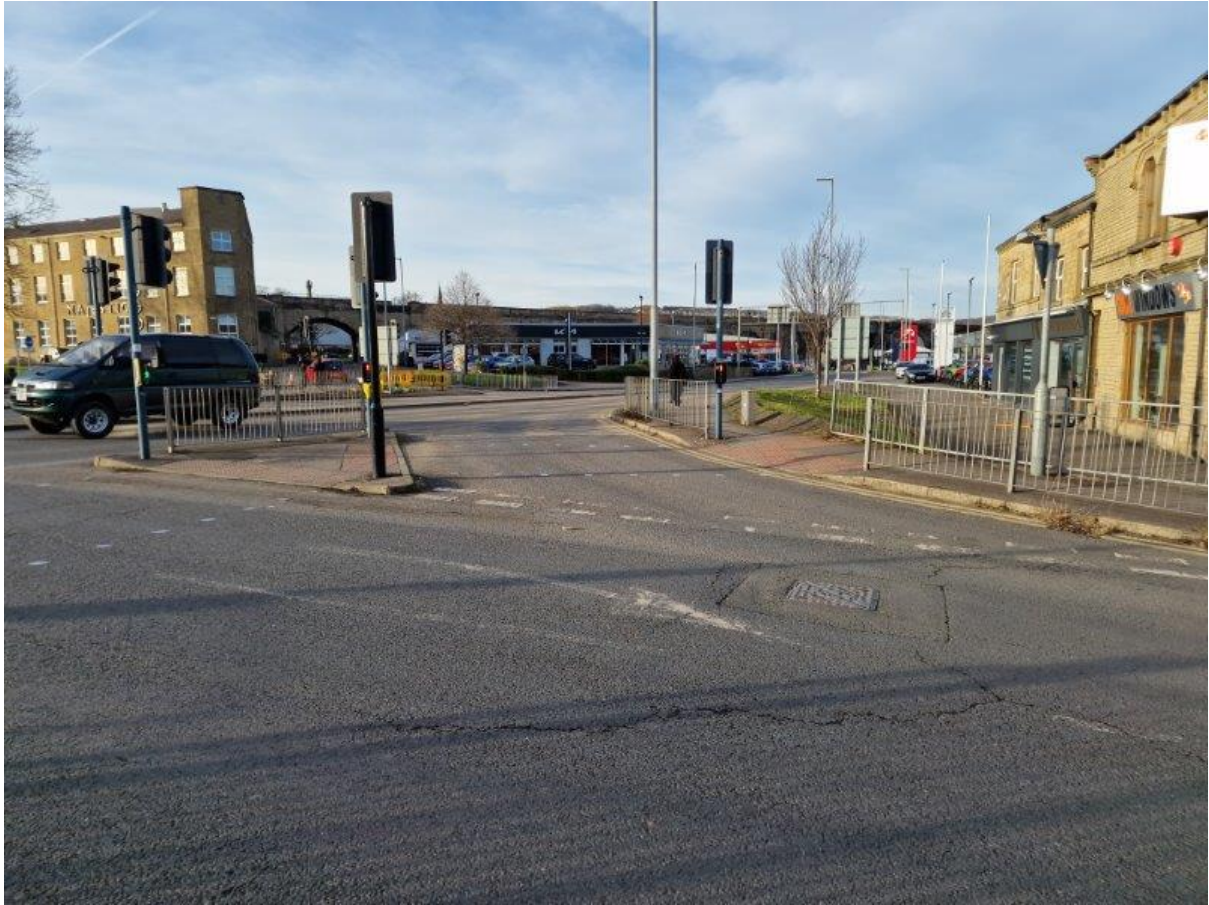
Lower Fitzwilliam Street/ Southgate junction (west side at the lights)

Tarmac has an uneven surface, the tarmac is worn and starting to break down in some areas.

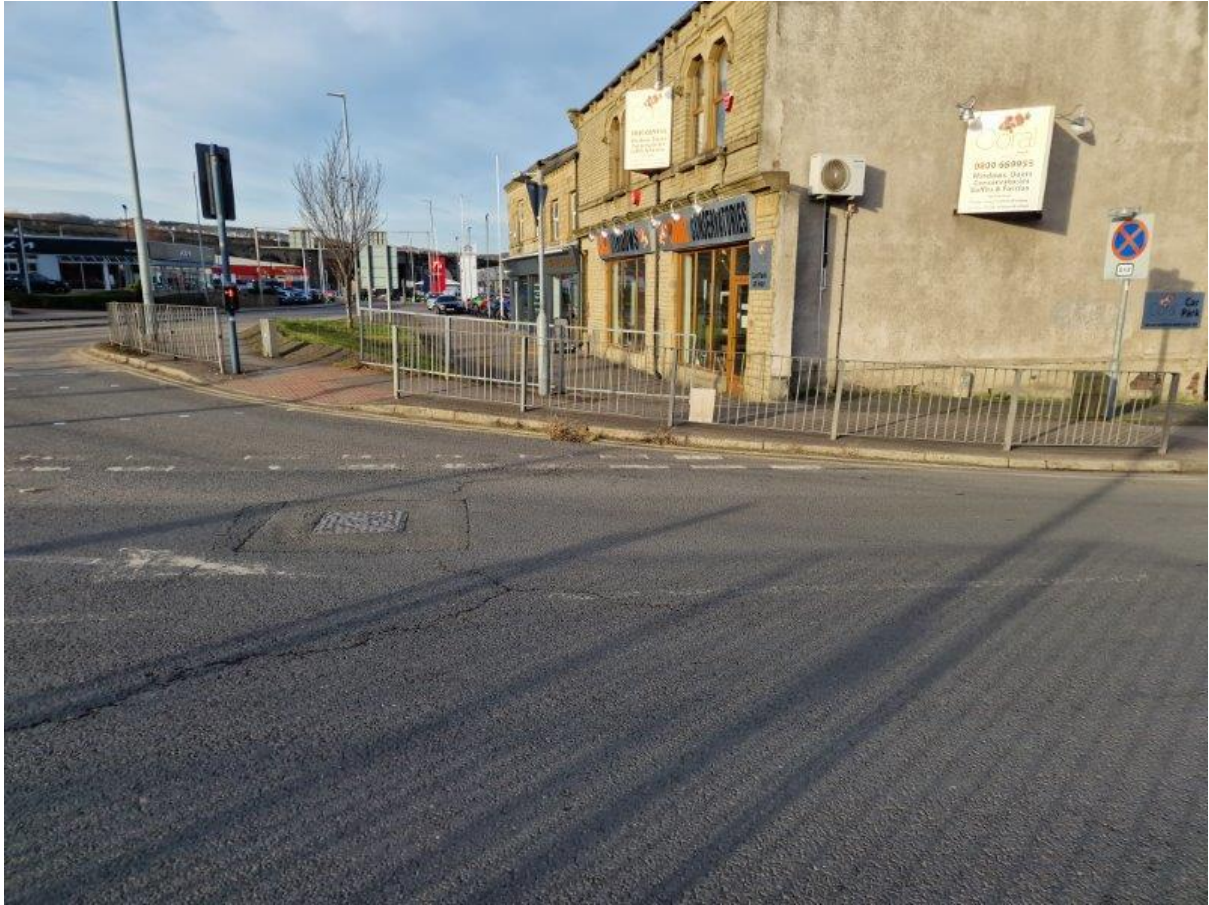
Lower Fitzwilliam Street/ Southgate junction (west side at the lights)

Tarmac has an uneven surface, the tarmac is worn and starting to break down in some areas.

Works around manhole have caused surface deterioration, cracking, and settlement visible.

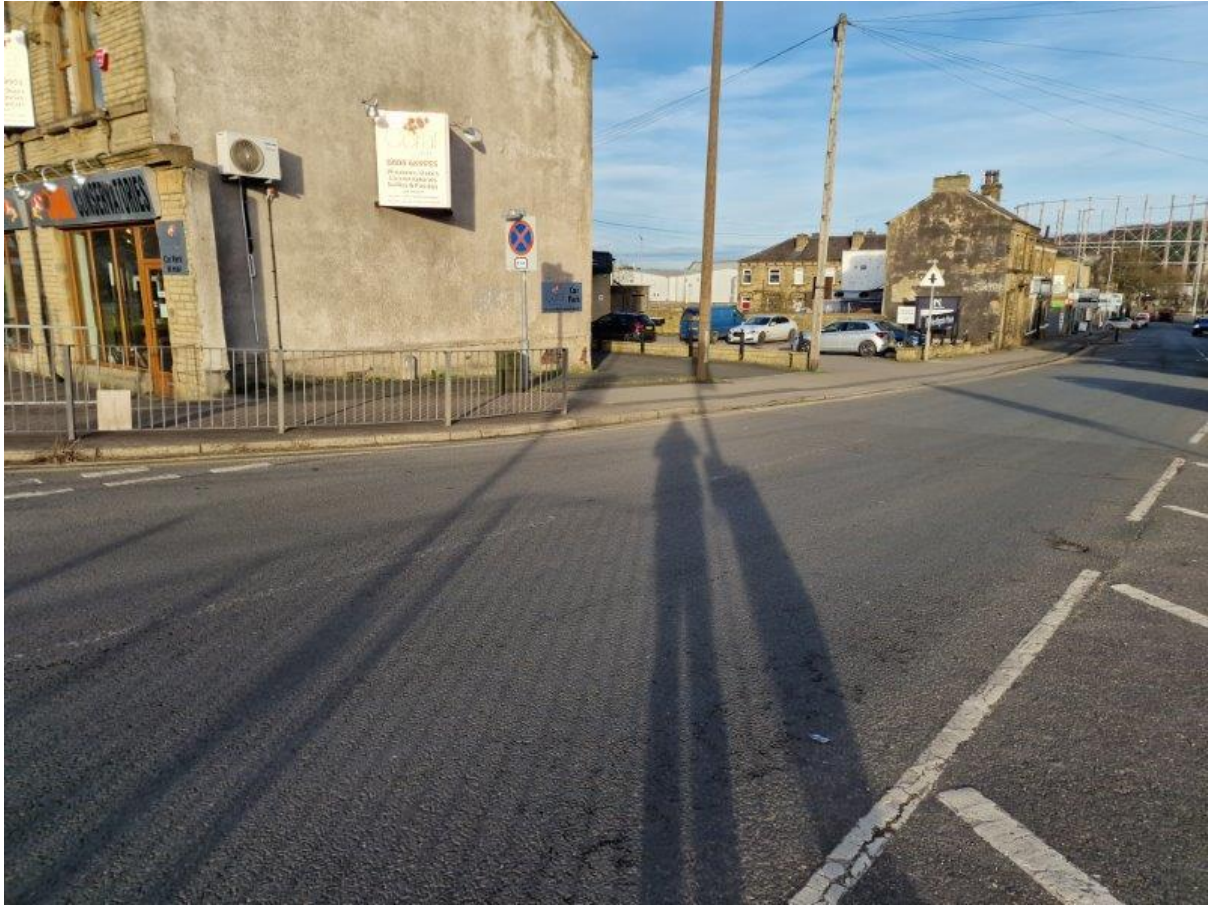
Lower Fitzwilliam Street/ Southgate junction (west side at the lights)

Tarmac has an uneven surface, the tarmac is worn and starting to break down in some areas.

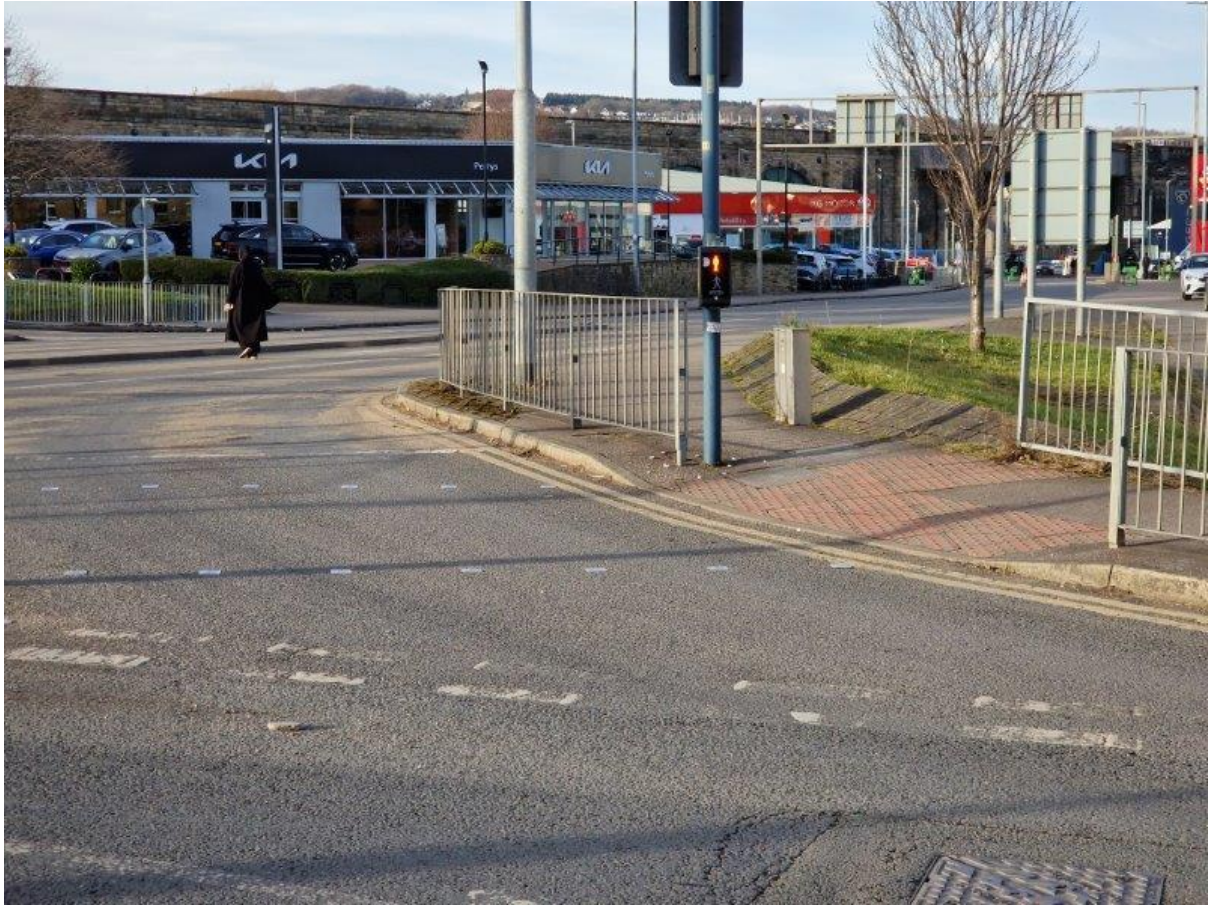
Lower Fitzwilliam Street/ Southgate junction (west side at the lights)

Tarmac has an uneven surface, the tarmac is worn and starting to break down in some areas. Works around manhole have caused surface deterioration, cracking, and settlement visible.

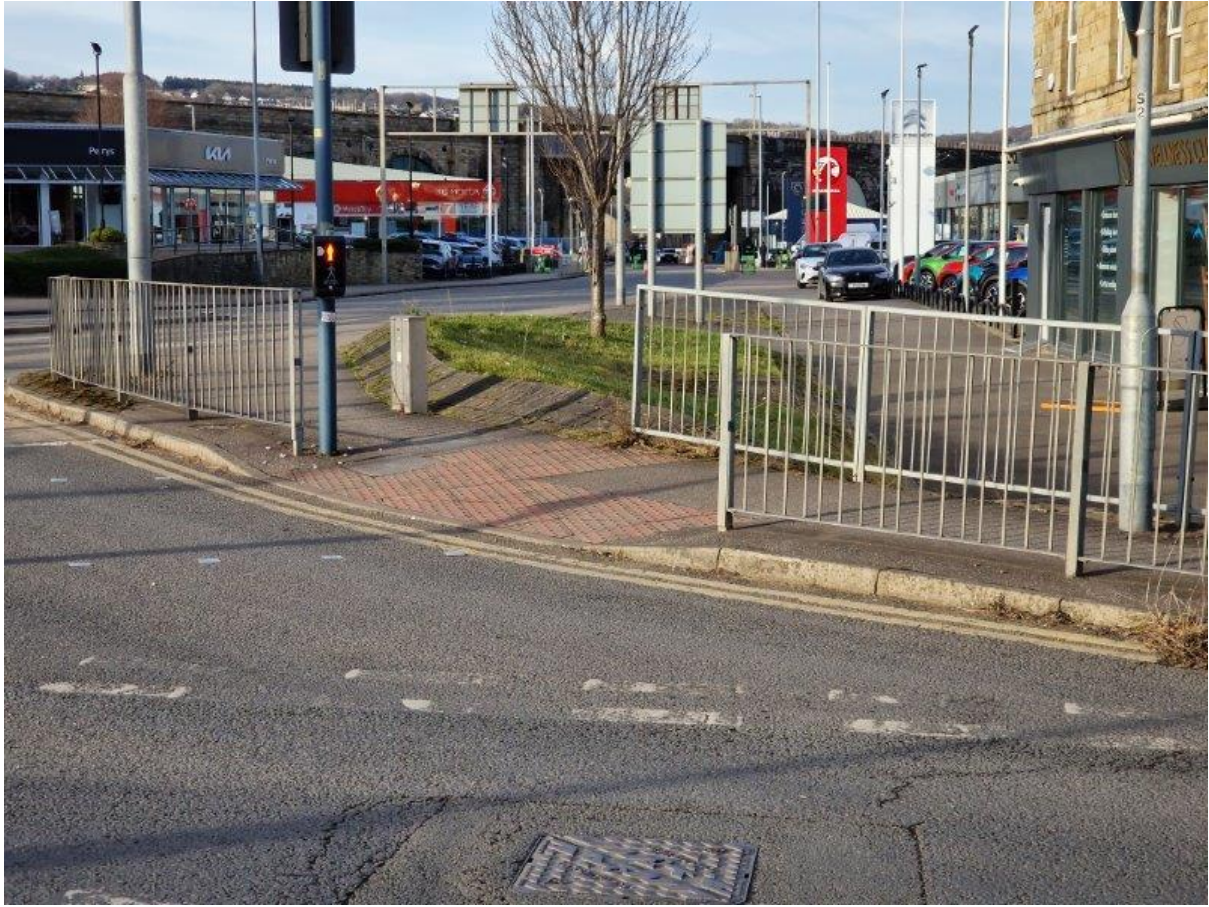
Lower Fitzwilliam Street/ Southgate junction (west side at the lights)

Tarmac has an uneven surface, the tarmac is worn and starting to break down in some areas. Works around manhole have caused surface deterioration, cracking, and settlement visible.

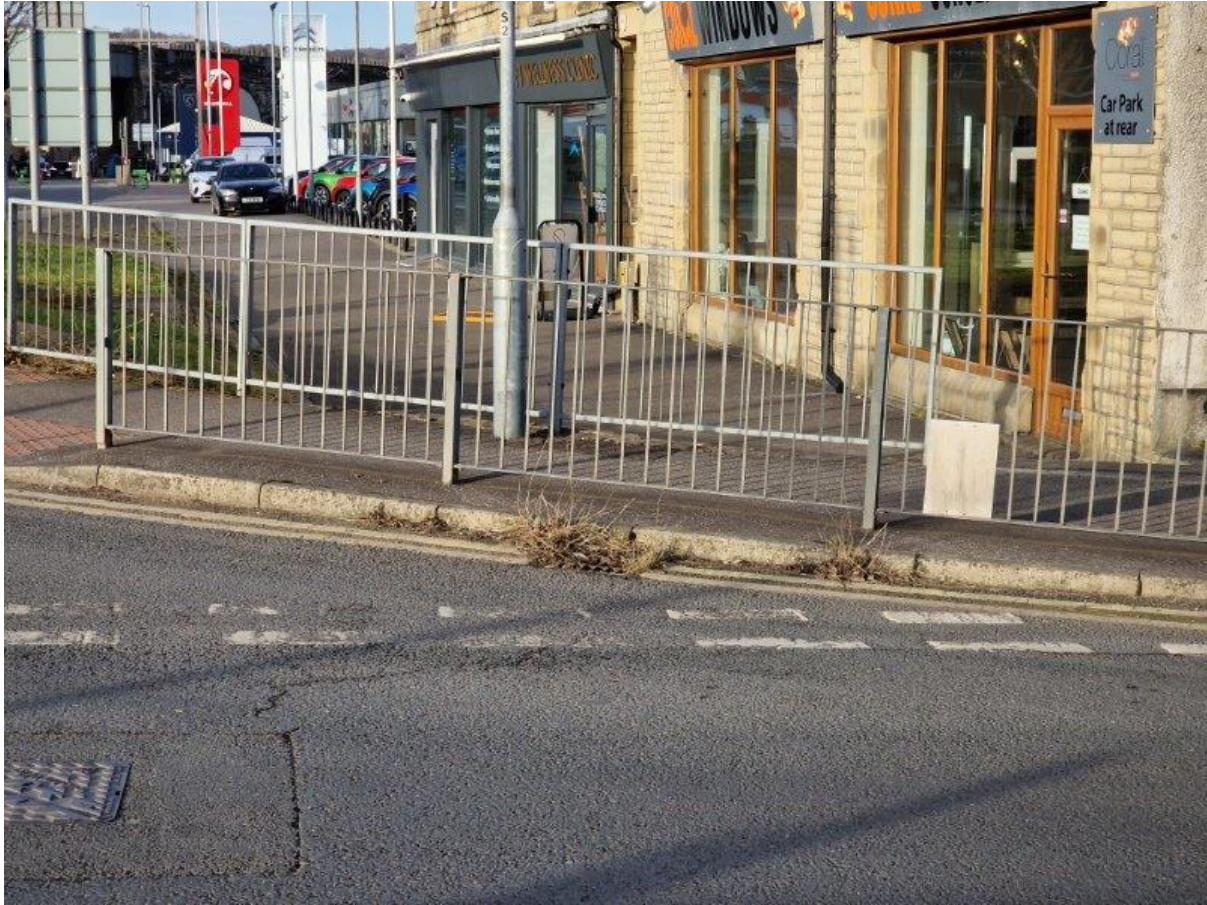
Lower Fitzwilliam Street/ Southgate junction (west side at the lights)

Tarmac has an uneven surface, the tarmac is worn and starting to break down in some areas. Works around manhole have caused surface deterioration, cracking, and settlement visible. Vegetation growing from kerb edges.

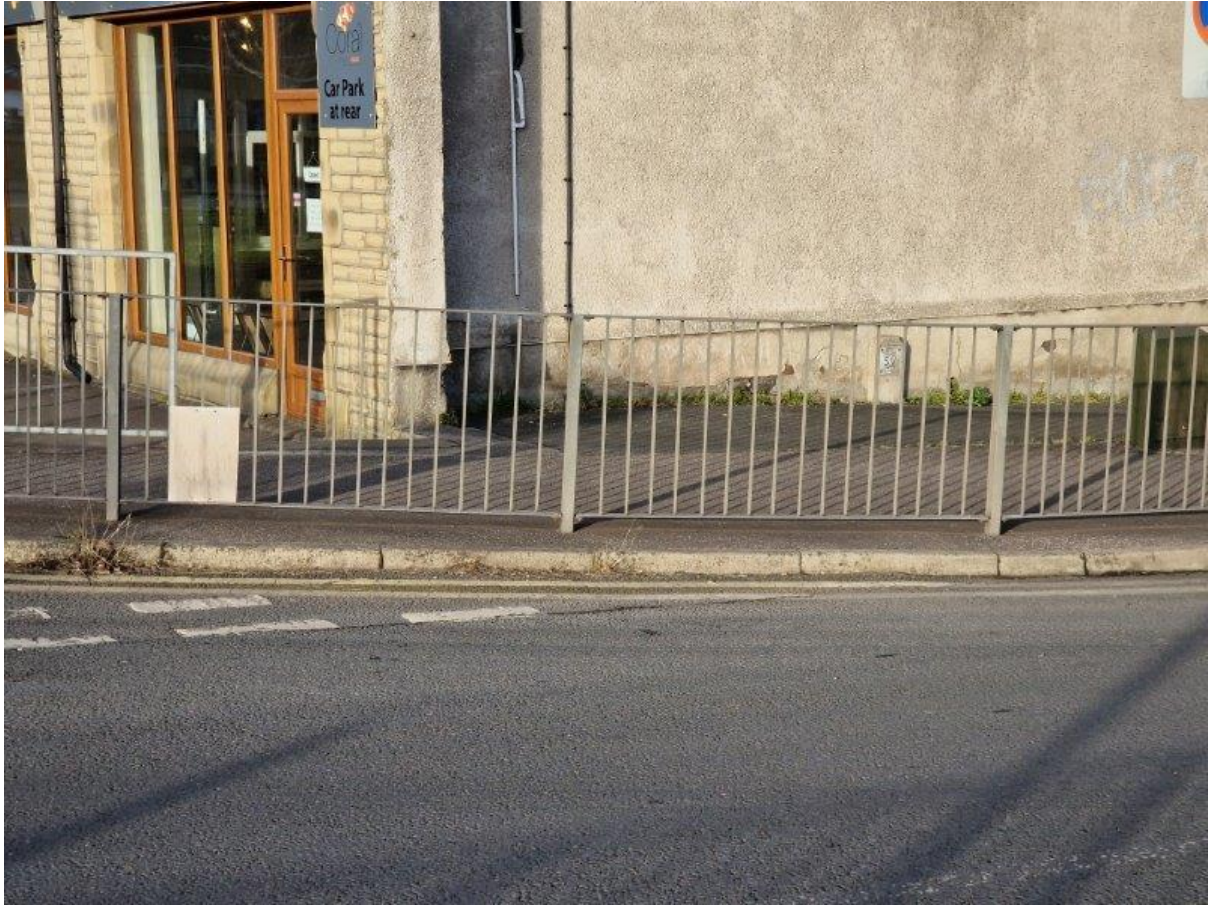
Lower Fitzwilliam Street/ Southgate junction (west side at the lights)

Tarmac has an uneven surface, the tarmac is worn and starting to break down in some areas. Works around manhole have caused surface deterioration, cracking, and settlement visible. Vegetation growing from kerb edges.

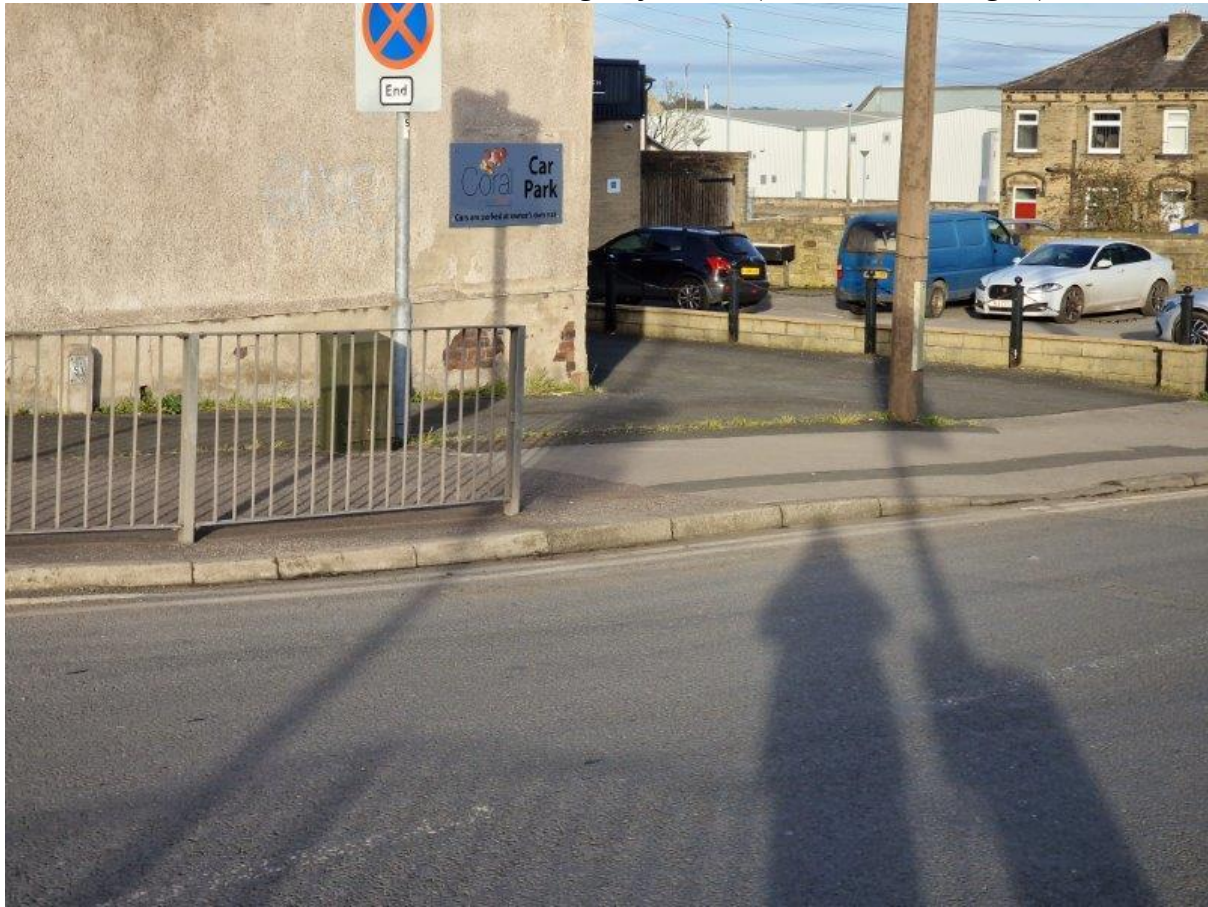
Lower Fitzwilliam Street/ Southgate junction (west side at the lights)

Tarmac has an uneven surface, the tarmac is worn and starting to break down in some areas. Works around manhole have caused surface deterioration, cracking, and settlement visible.

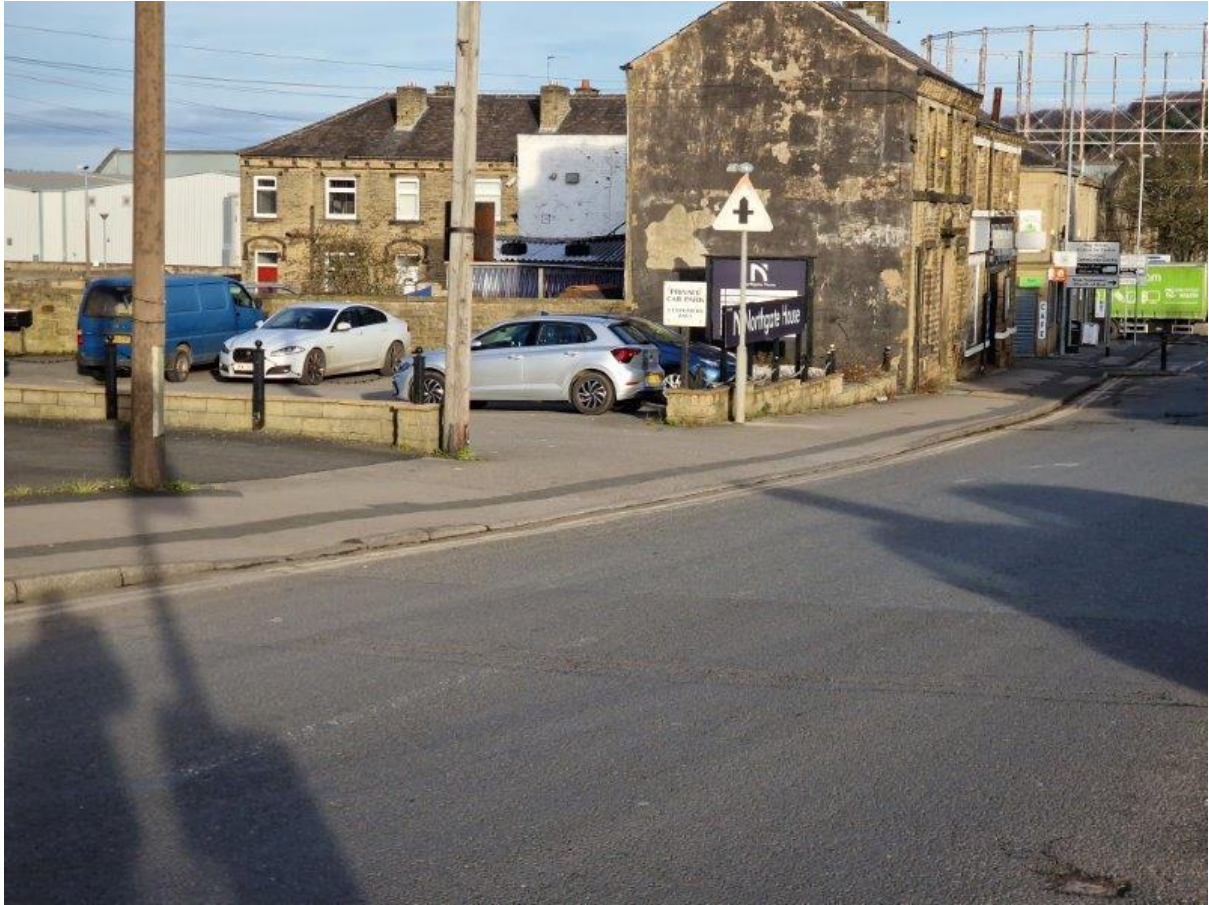
Lower Fitzwilliam Street/ Southgate junction (west side at the lights)

Tarmac has an uneven surface, the tarmac is worn and starting to break down in some areas. Works around manhole have caused surface deterioration, cracking, and settlement visible.

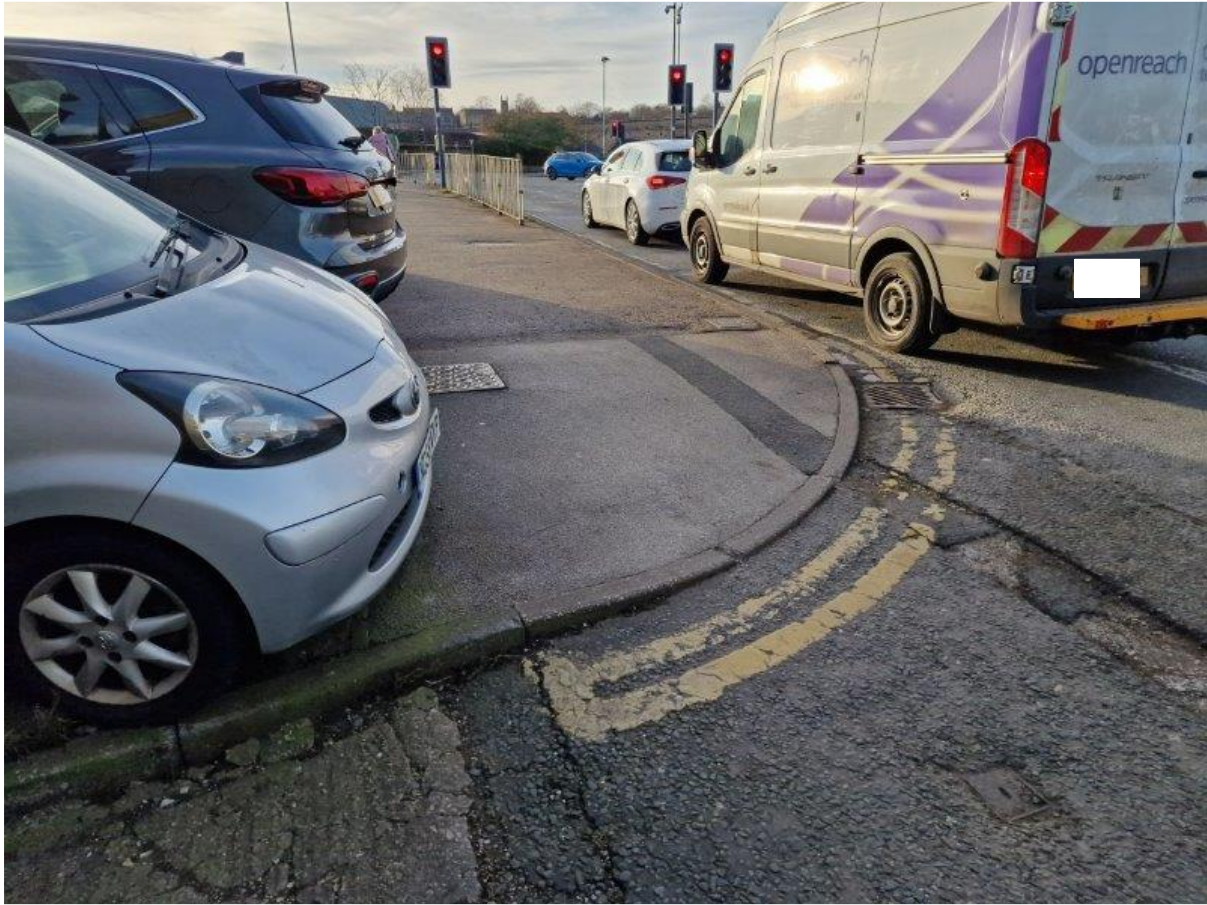
Lower Fitzwilliam Street 22m from lights

Surface damage and scarring to footpath and carriageway from utilities works. Yellow and white lining faded.
