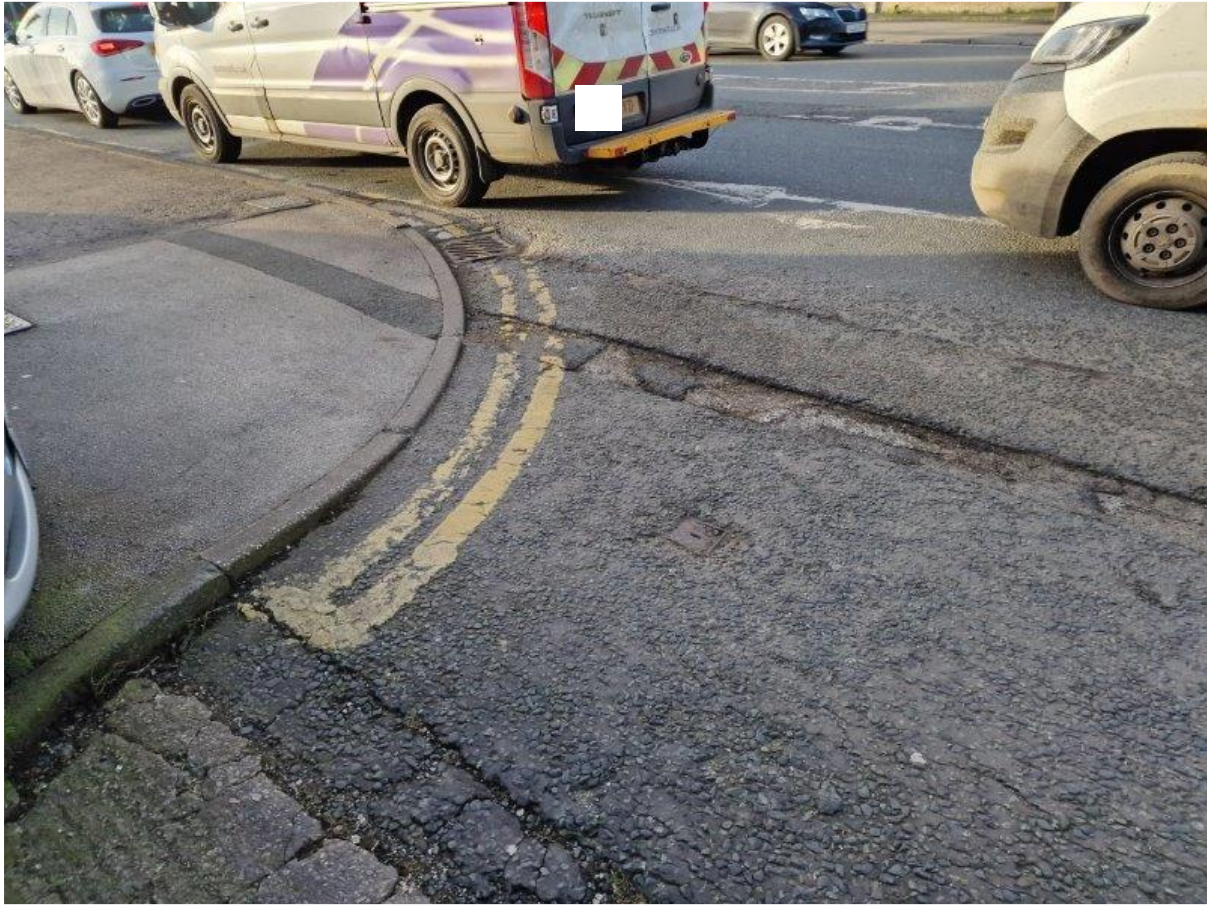
Lower Fitzwilliam Street 22m from lights

Surface damage and scarring to footpath and carriageway from utilities works. Yellow and white lining faded.
