Gas Membrane Installation
Validation Report
JP Marsden Construction Ltd
Town End Road
Holmfirth
HD9 1AH

Appendix 1 – Site Survey Sheets

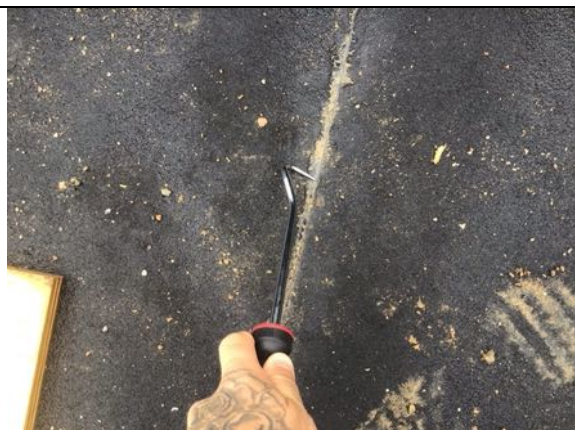
Probe testing welded membrane lap joints

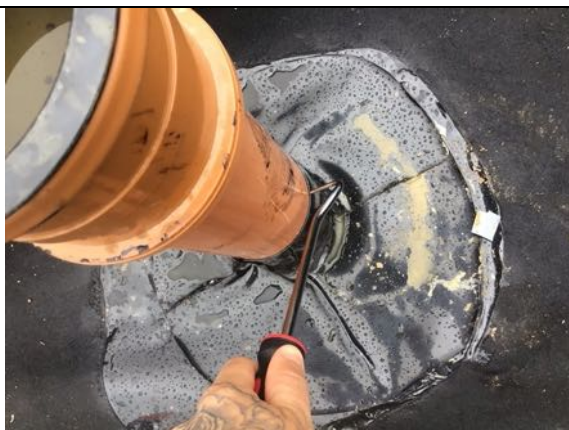
Probe testing pipe penetration

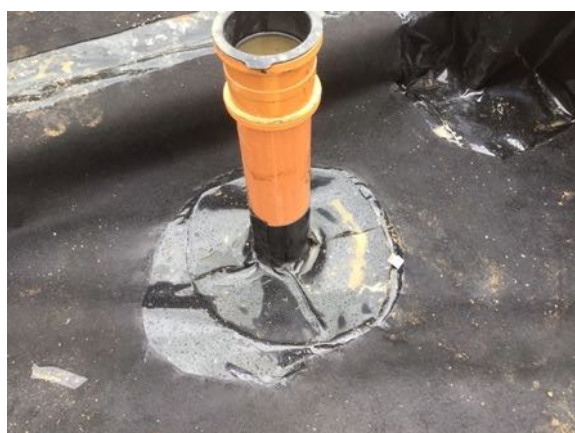
Sealed pipe penetration using Juta Titan tank and heat applied

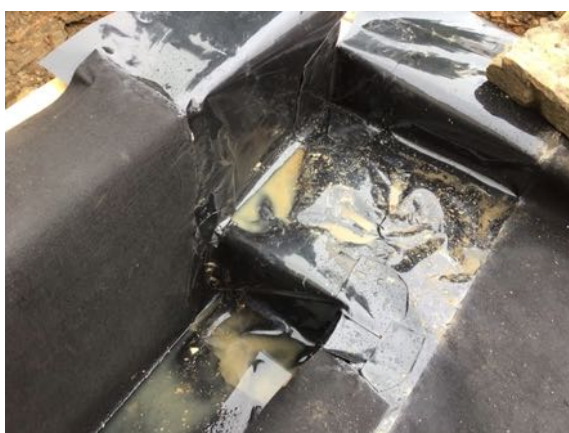
Corner detailing sealed using Juta Titan tank and heat applied

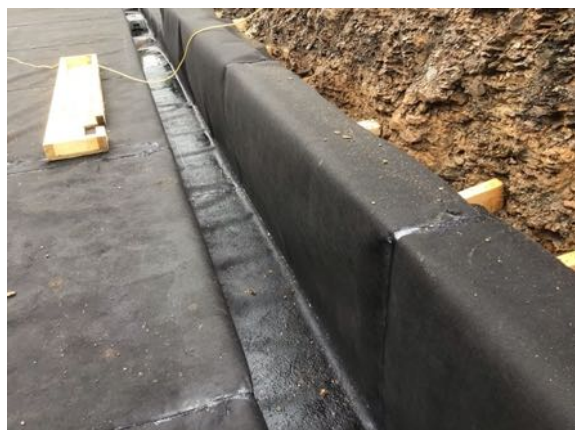
Membrane extended over the perimeter edge shuttering

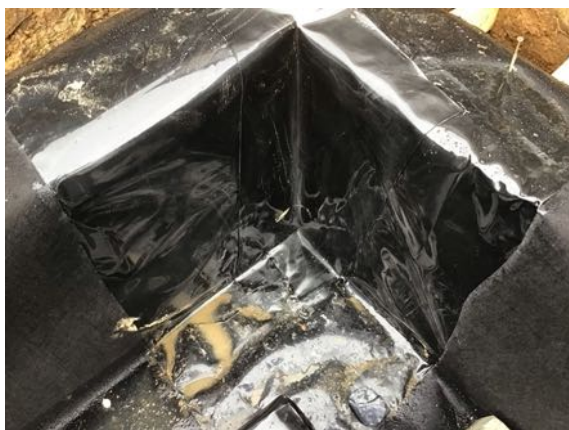
Corner detail sealed using Juta Titan tank and heat applied

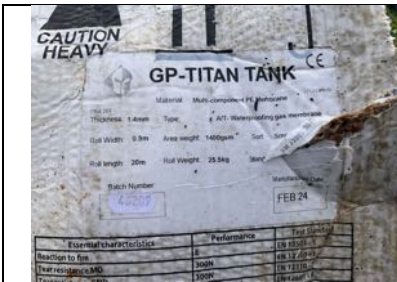
Evidence of the Juta TitanTank membrane used on this project.

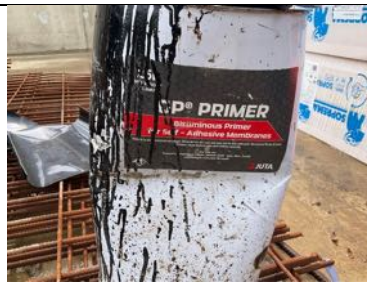
Evidence of the Juta GP Primer used on this project.

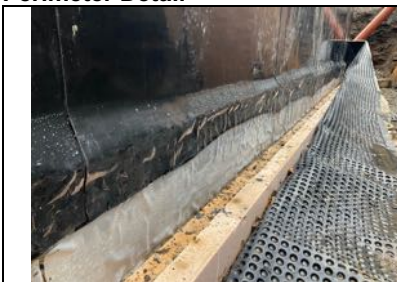
Juta TitanTank membrane sealed to the existing Juta TitanBond gas barrier.

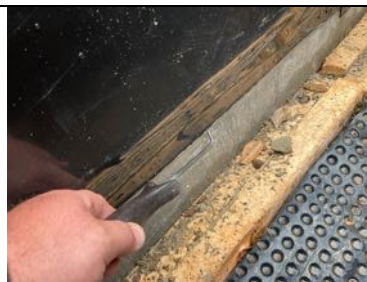
Pick & probe testing along termination to existing Juta TitanBond gas barrier.

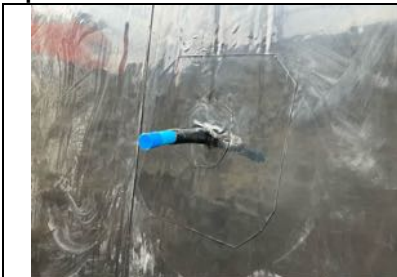
25mm Water Pipe sealed using Juta TitanTank.

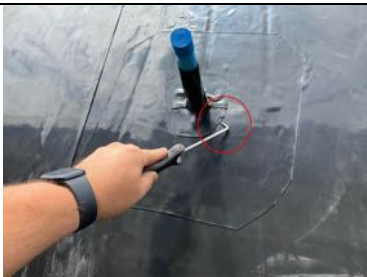
Pick testing to the sealed water pipe.

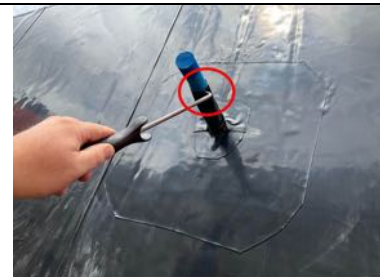
Pick & probe testing upon the sealed 25mm water pipe entry.

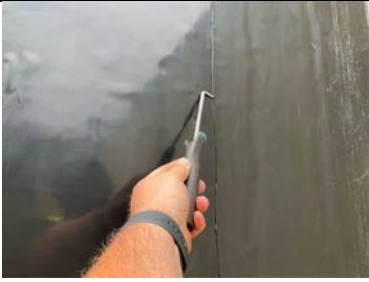
<p>3x small areas along lap joints that required additional heat and pressure applied.</p>	<p>No Action Required all Defects rectified at time of inspection</p>
--	---

Pick testing along adherence between adjacent sheets of Juta TitanTank.

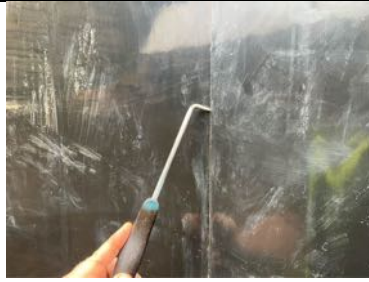
Pick & probe testing to all lapped joints.

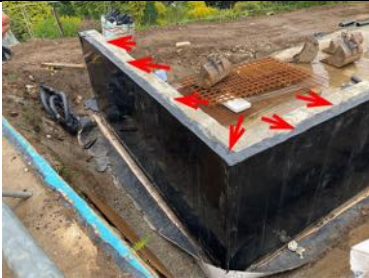
Evidence of Juta GP Primer applied to the retaining wall.

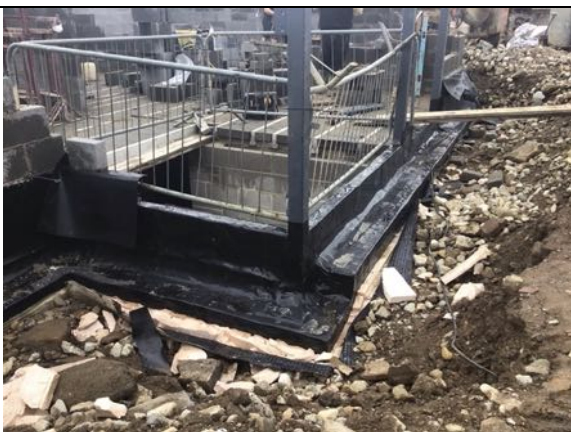
Perimeter retaining wall tanking detail

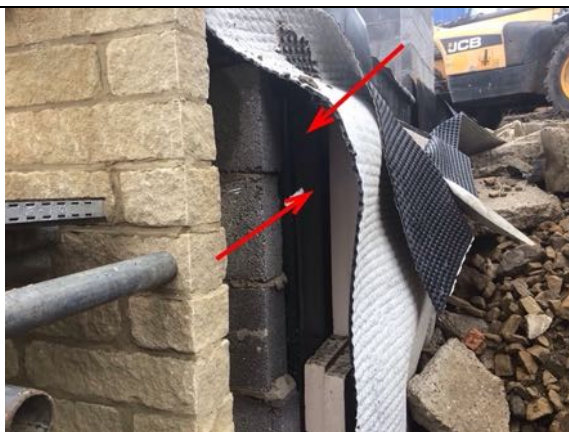
Existing previously installed tanking

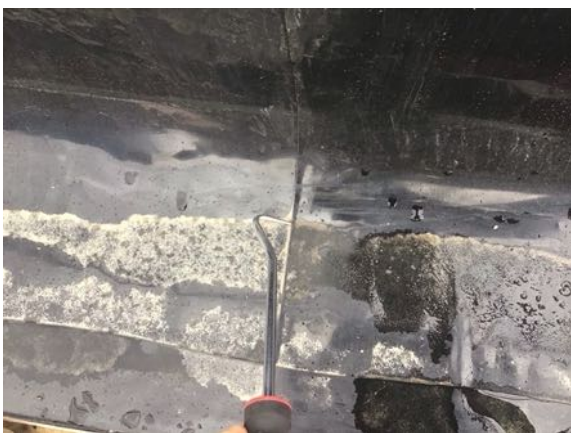
Probe testing joints

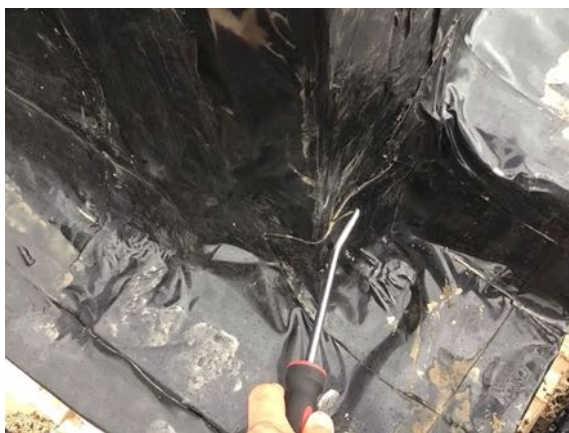
Probe testing corner detailing

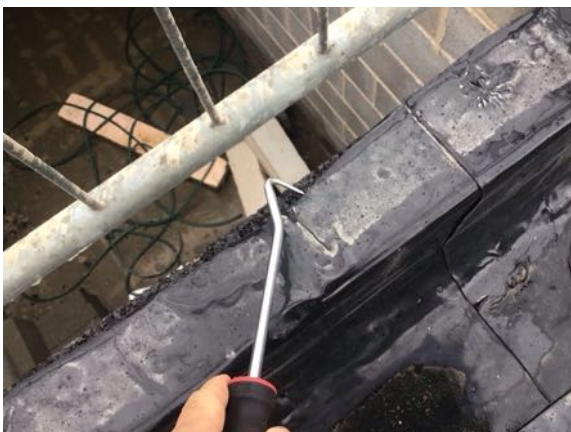
Probe testing seal to pre primed brickwork

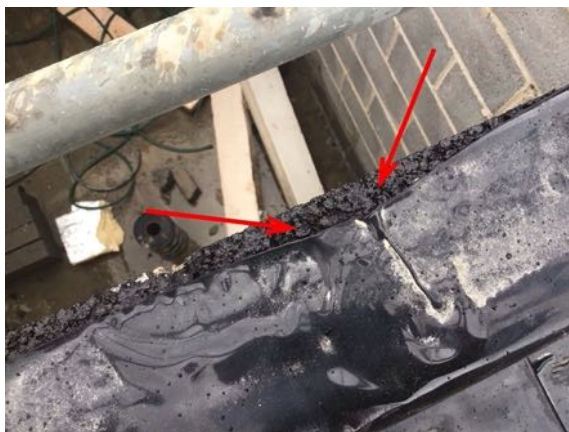
Primer applied

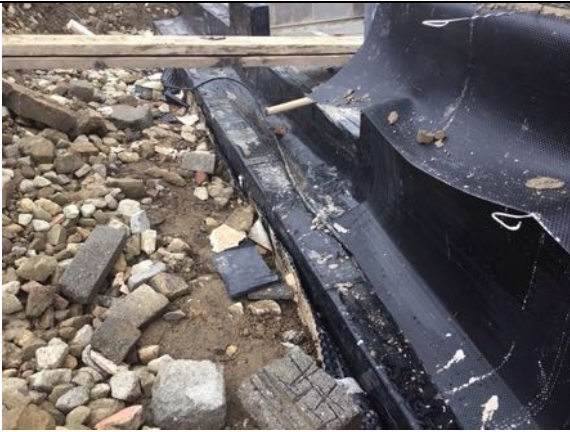
Perimeter retaining wall tanking detail

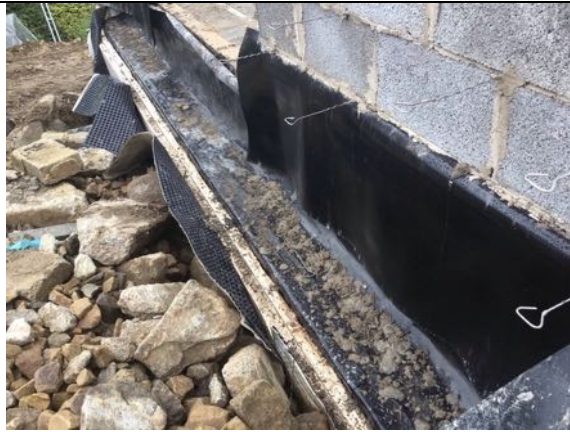
Perimeter retaining wall tanking detail

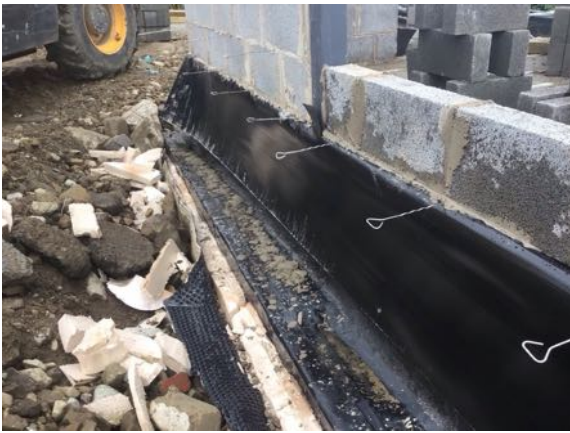
Perimeter retaining wall tanking detail
