18th August 2023

Ref C593/01/ATS

Ref: Shallow Mining Investigation on land at Thorncliffe Farm Shop, Westfield Lane, Emley Moor.

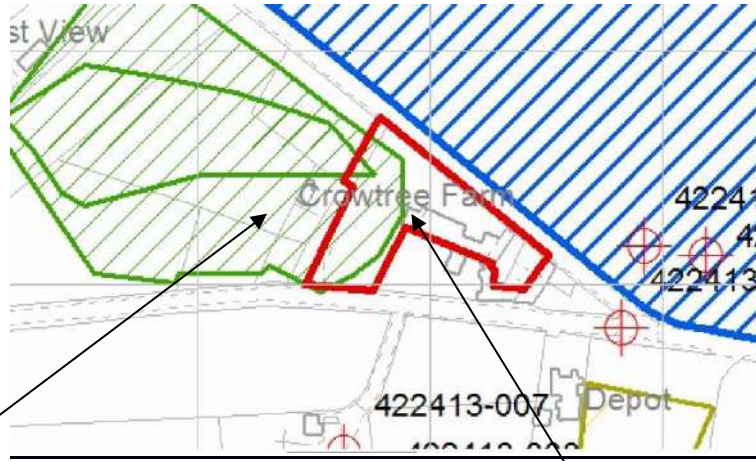
Within the above referenced CMRA, the summary of findings drawing, provided by the CA, indicates the presence of a historical area of unlicensed opencasting immediately adjacent to the western boundary of the new build, see below;

Area of Unlicensed opencast site

Location of proposed new building

However, in consideration of the fact that historical unlicensed opencasting is shown immediately adjacent to the western boundary of the new build, it is recommended that a watching brief is maintained during the development work, and that all surfaces exposed during construction of the foundations or areas external to the new build, are examined by a suitably qualified person, for evidence of such activity. If evidence of backfilled opencast is encountered within influencing distance of the foundations, work should immediately cease and the Coal Authority notified and the advice of geotechnical specialists sought.

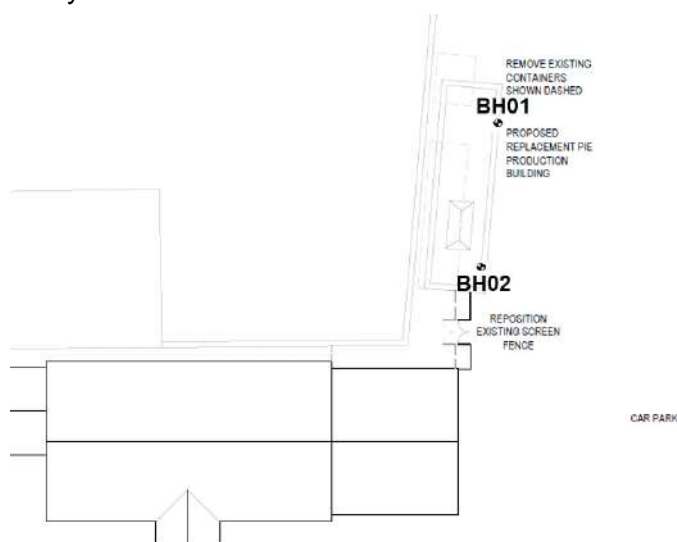
The locations of the exploratory holes are shown below.
