ARBORICULTURAL REPORT

& Impact Assessment

***The Priory,
Whitechapel Road,
Cleckheaton,
BD19 6HQ***

Reference: *AWA6460*

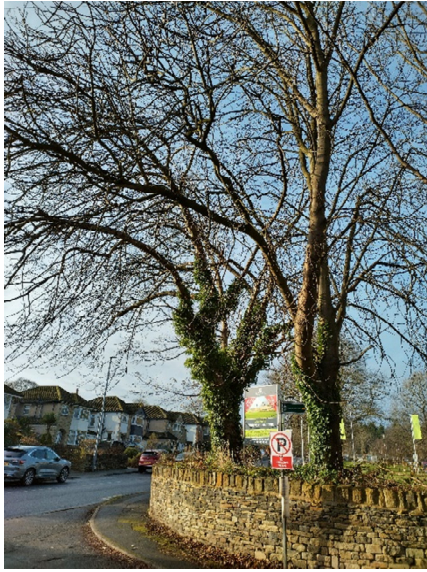
Photo 1: T1 and T2 from east.

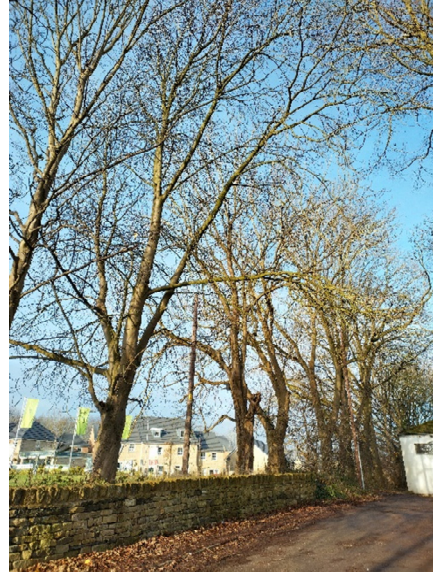
Photo 2: T4 – T12 from the southeast.

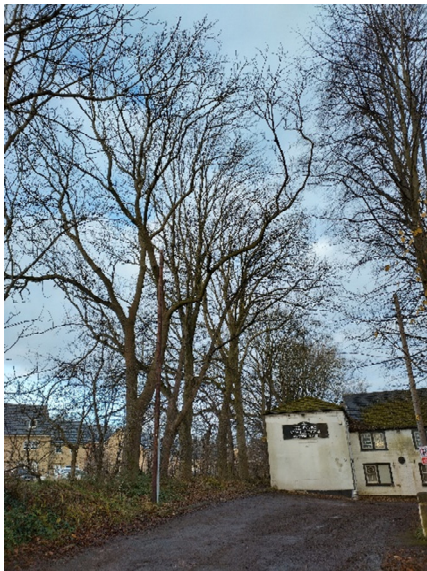
Photo 3: T10 – T17 from southeast.

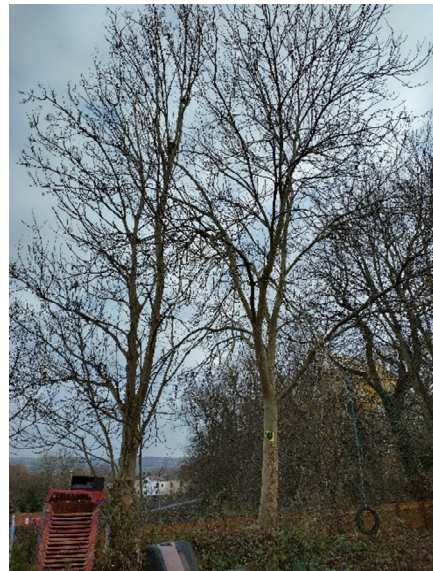
Photo 4: T22 and T23 from west.

4.2.3 T22 requires removal to facilitate the proposed new gardens, and T23 and T26 require removal to facilitate the extension of the car park. T22, T23 and T26 are all Ash trees which are in fair condition with limited prospects. T22 in particular has a long section of bark damage which is exposing the heartwood and is beginning to decay, significantly limiting its long-term prospects. All three trees have low amenity value and are retention category 'C', and are also likely to have further limited prospects due to Ash Dieback Disease. Due to the low value of the trees to be removed the removals will have only a negligible negative arboricultural impact, and the removals can easily be mitigated for with replacement planting.

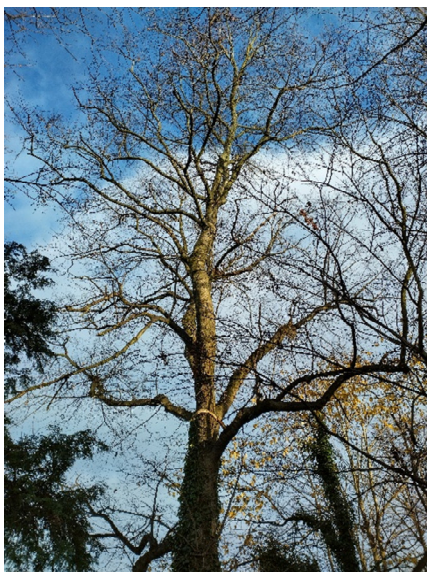
- 3.2.7 Most of the trees are early-mature to mature trees.
- 3.2.8 The sites most significant tree is Lime T27. T27 is not actually within the pub boundary itself, but directly adjacent within the graveyard of the church, with the crown of T27 hanging into site. T27 is large, mature Lime within a prominent position of the churchyard with high amenity value. T27 is in good condition, with good long-term prospects and as such is a retention category 'A' tree.

Photo 5: T27 from south.

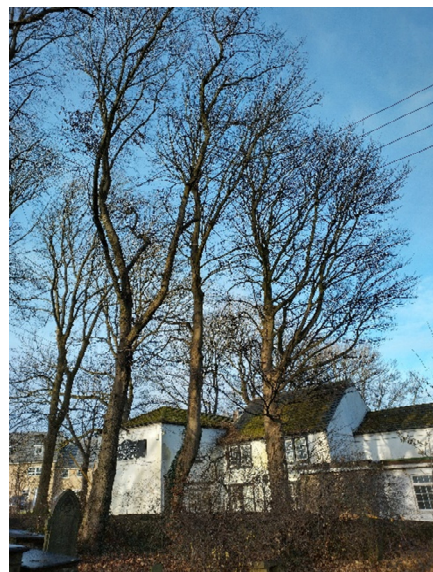
- 3.2.9 Other notable trees are the 10 retention category 'B' trees on site. These include Horse Chestnuts T2 and T4, Sycamores T15, T31, T33 and T34 and Limes T35, T36, T38 and T39. Horse Chestnuts T2 and T4 and Sycamore T15 are all situated on the western boundary of the site, where as Sycamores T31, T33 and T34 and Limes T35, T36 and T39 are all situated within the adjacent church graveyard with crowns overhanging into site itself. All of these trees are in good condition with good long-term prospects and have moderate amenity value.

Photo 6: T32 – T34 from southeast.

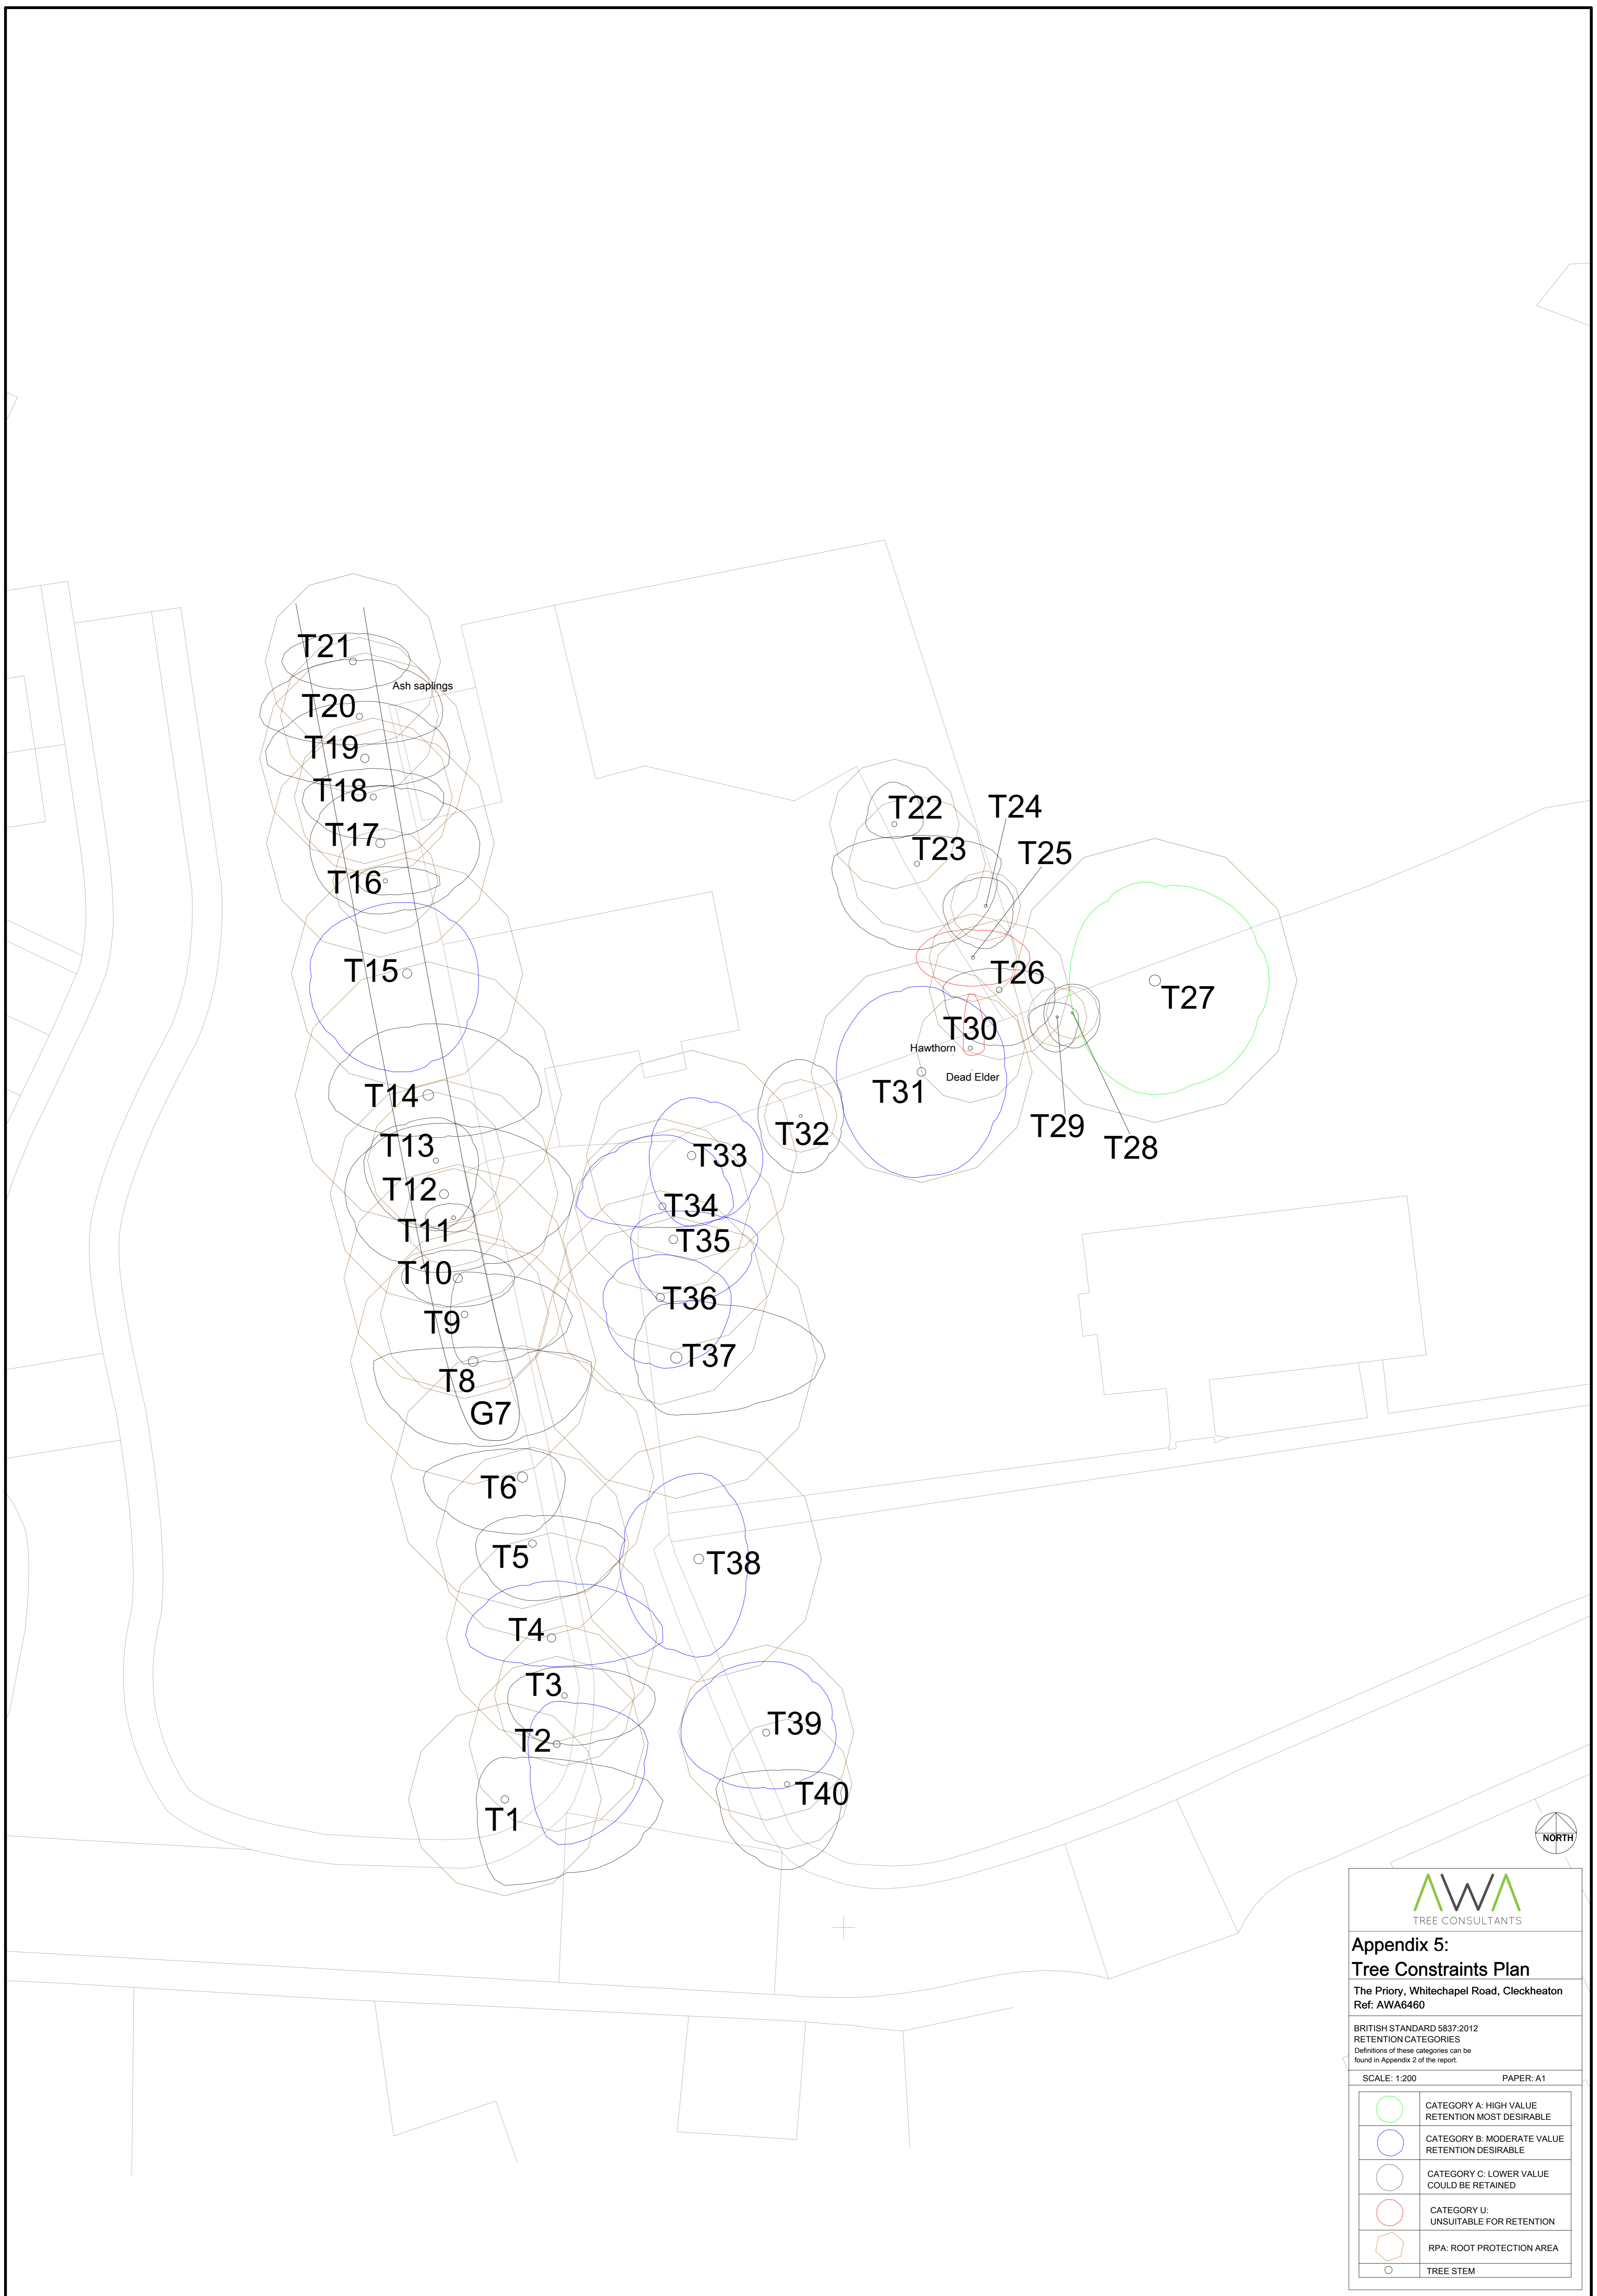
**Appendix 5:
Tree Constraints Plan**

- 3.2.1 The tree survey revealed 40 items of woody vegetation, comprised of 39 individual trees and 1 tree group.
- 3.2.2 Of the surveyed trees: 2 trees are retention category 'U', 1 tree is retention category 'A', 10 trees are retention category 'B' and 27 trees, tree groups and hedges are retention category 'C' (explanatory details regarding the retention categories are included at Appendix 3).

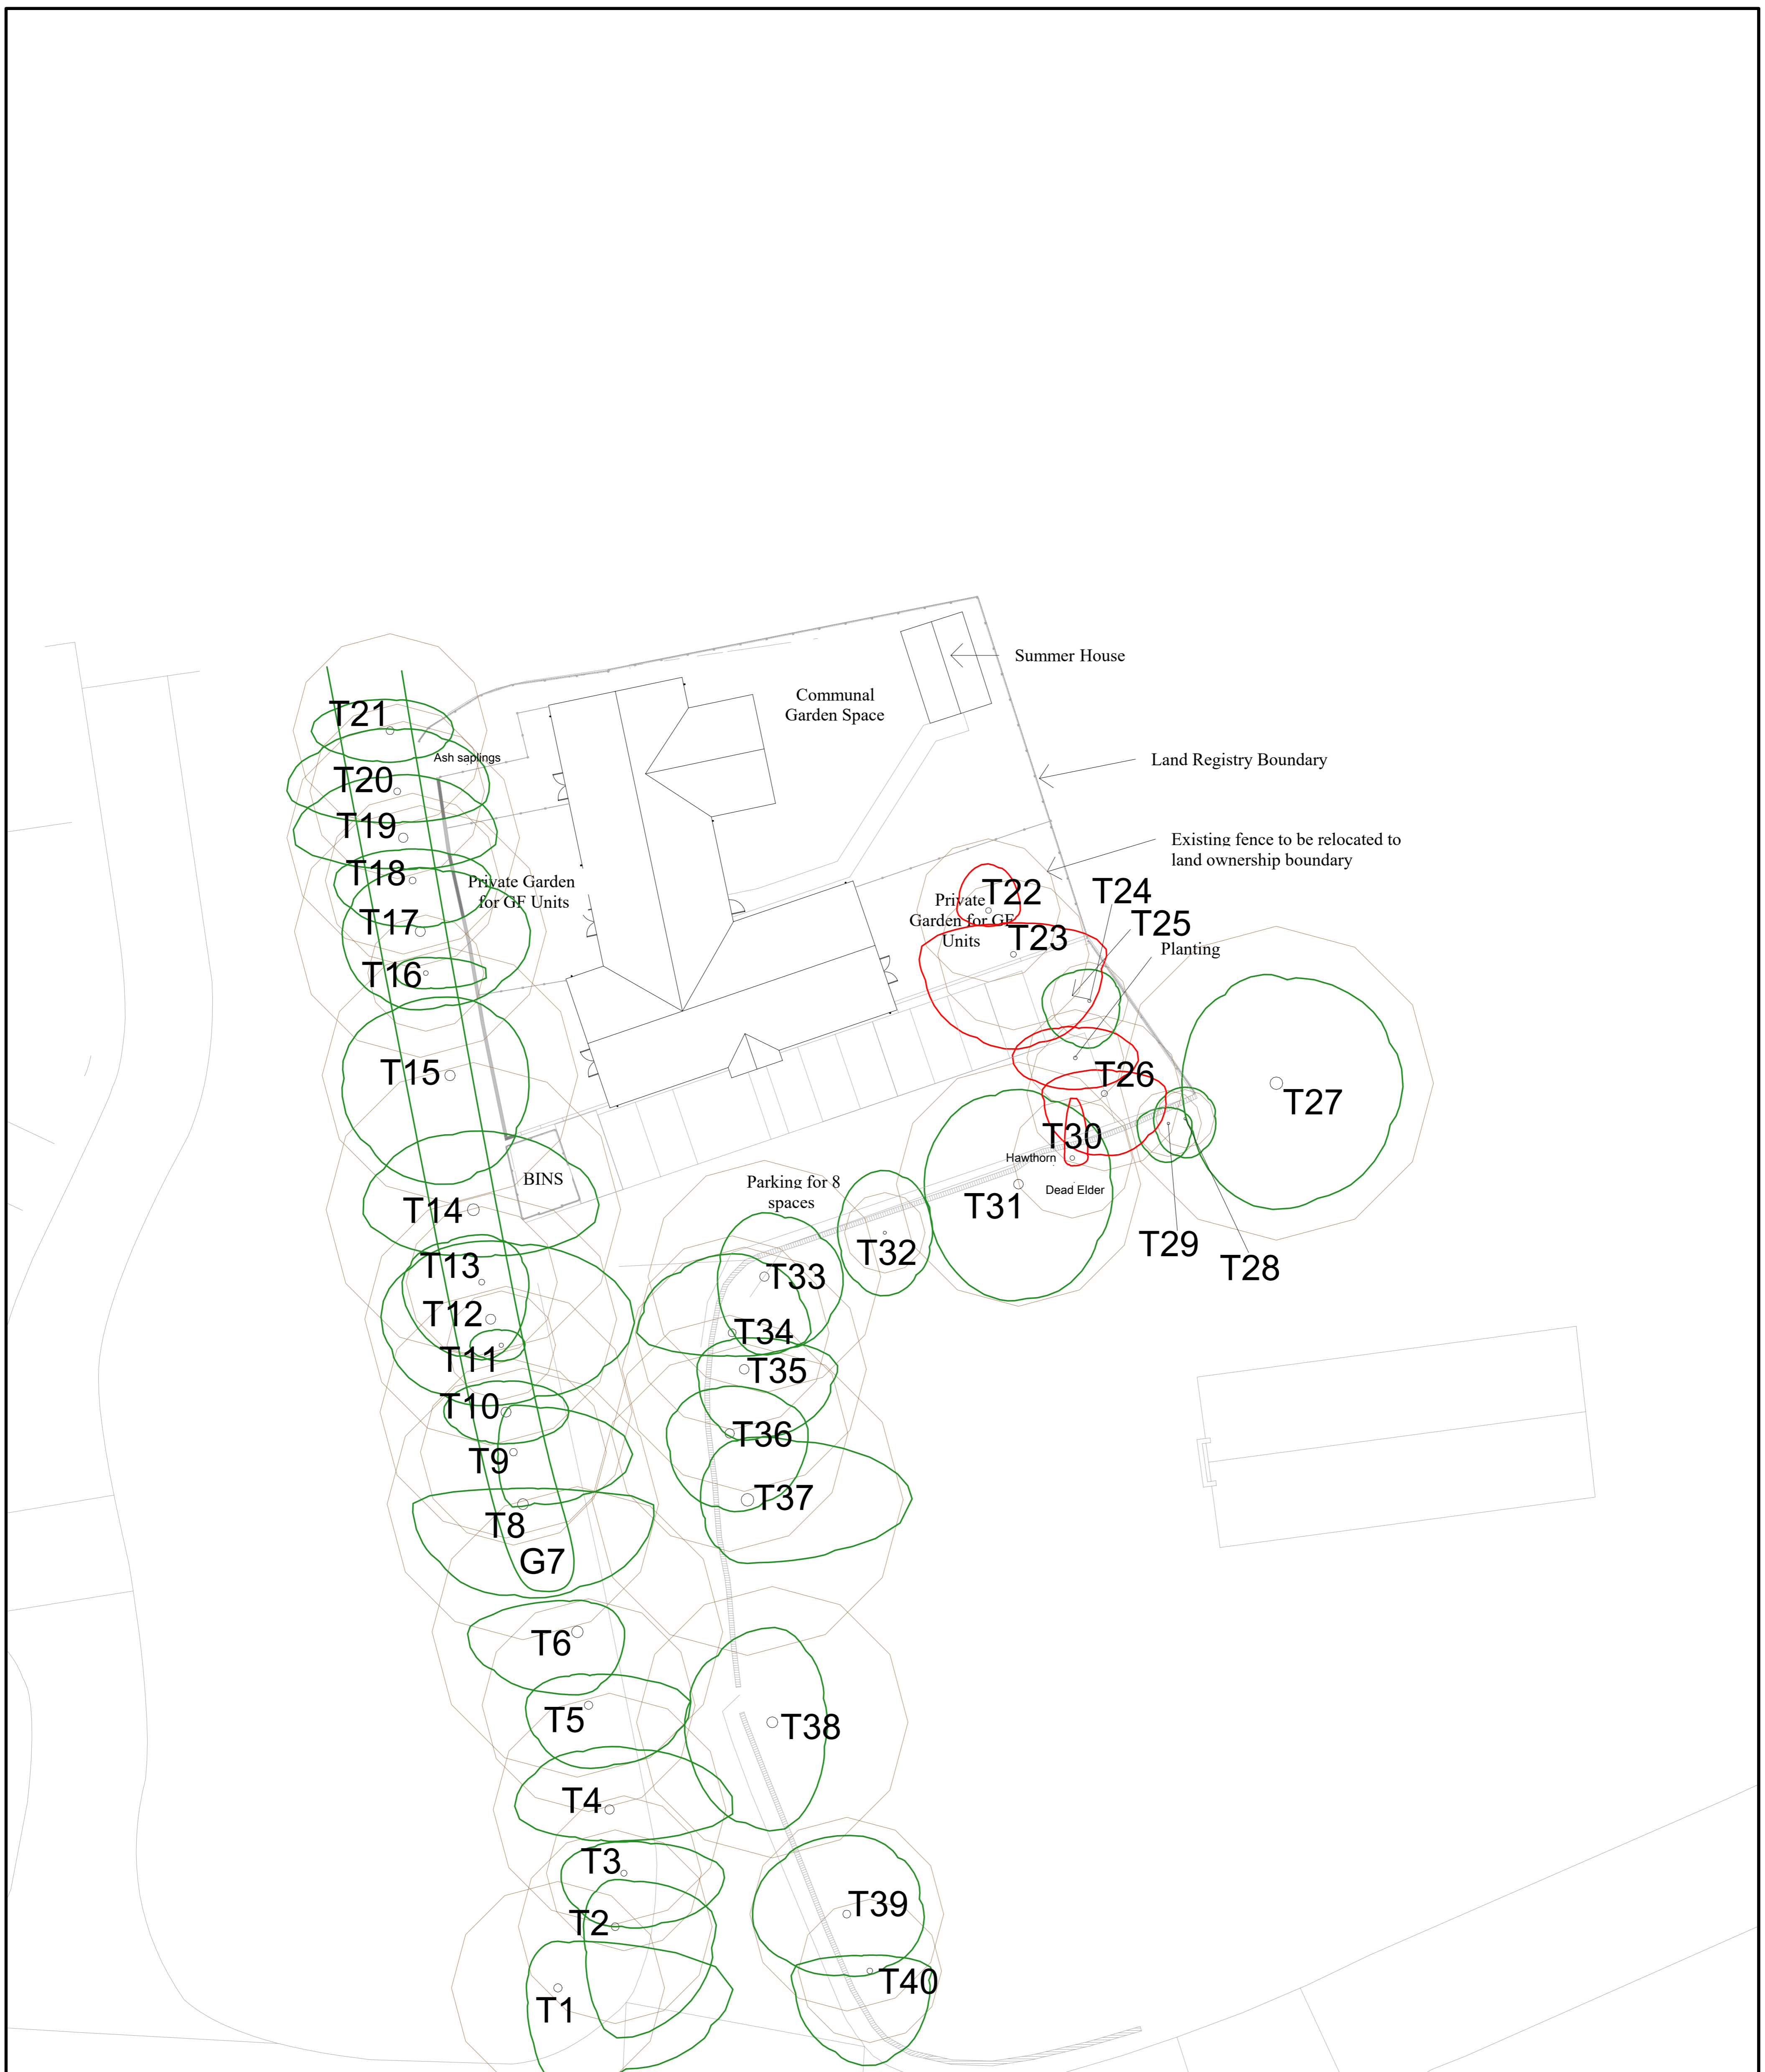
Appendix 6:
Tree Impacts Plan

4.2.1 From assessing the new development proposals, 3 trees will require removal to facilitate the development as they are situated in the footprint of the development or their retention and protection throughout the development is not suitable.

4.2.2 The trees that require removal to facilitate the development are T22, T23 and T26.
