## **STRUCTURAL CONDITION & DILAPIDATION REPORT**

**REF: MDL – 10813**

Retaining wall supporting the highway adjacent to:  
6, Garner Lane, Highburton, Huddersfield, HD8 0QX

To undertake a structural condition and dilapidation survey of the boundary retaining wall prior to construction works to build an extension to the property below the retaining wall.

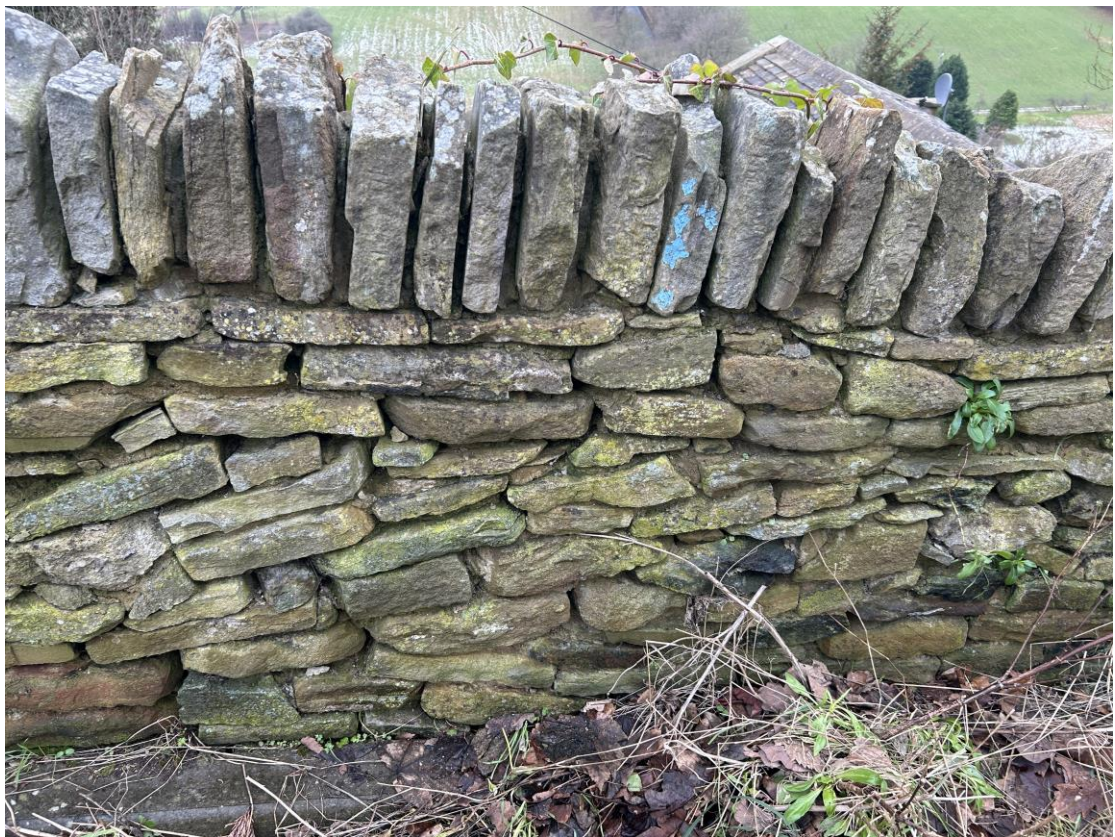
Photo 8

During our survey and inspection, other than some localised settlement of the stones (photos 8 & 9), there was no evidence of structural defect or distress noted to the retaining wall structure.
