Appendix A

Bank Lane – 07/02/25

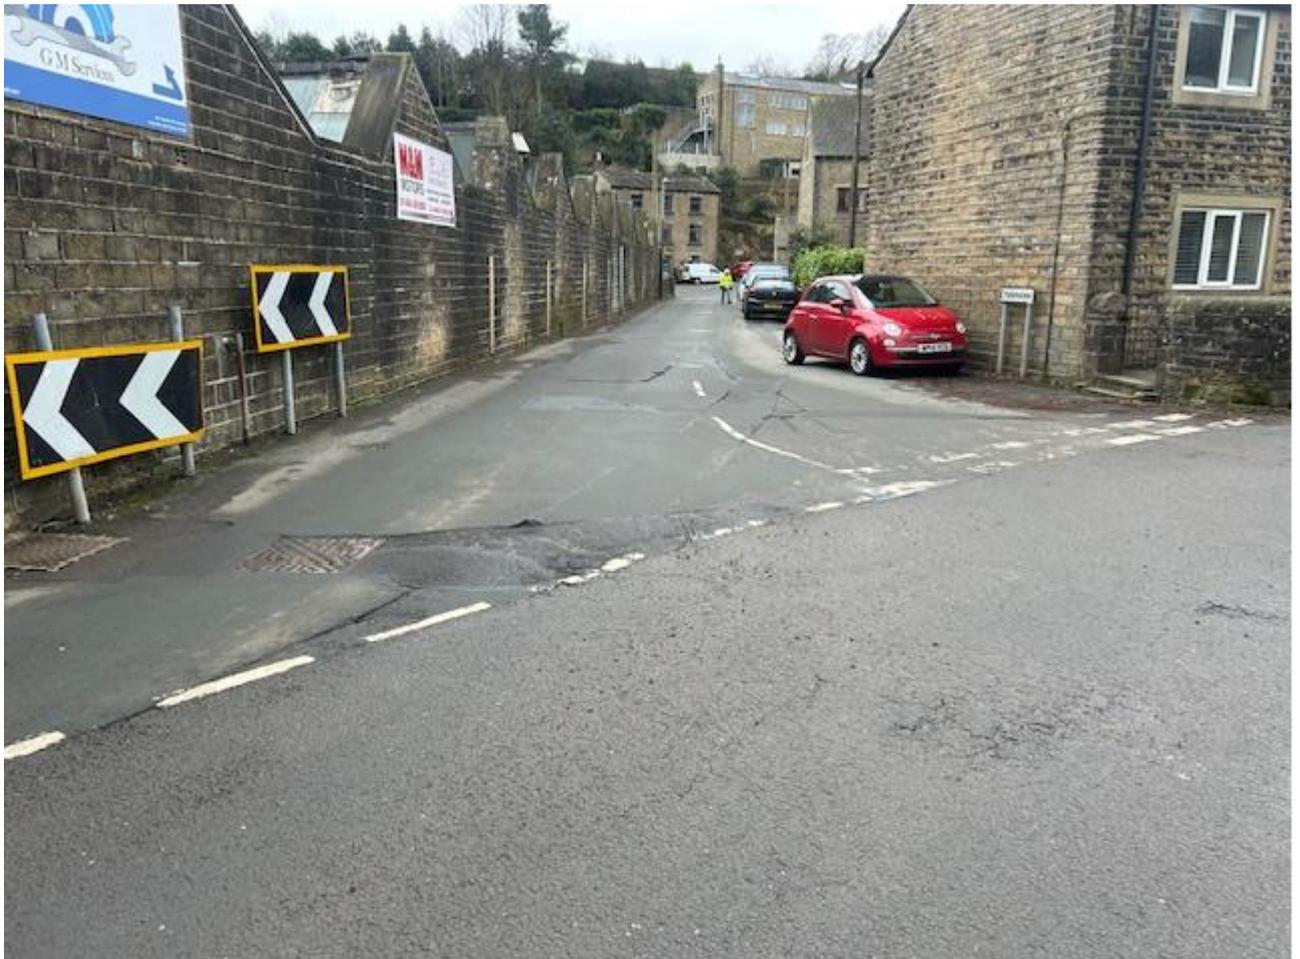
Chainage 0m.

Woodhead Road looking south at its junction with Bank Lane.

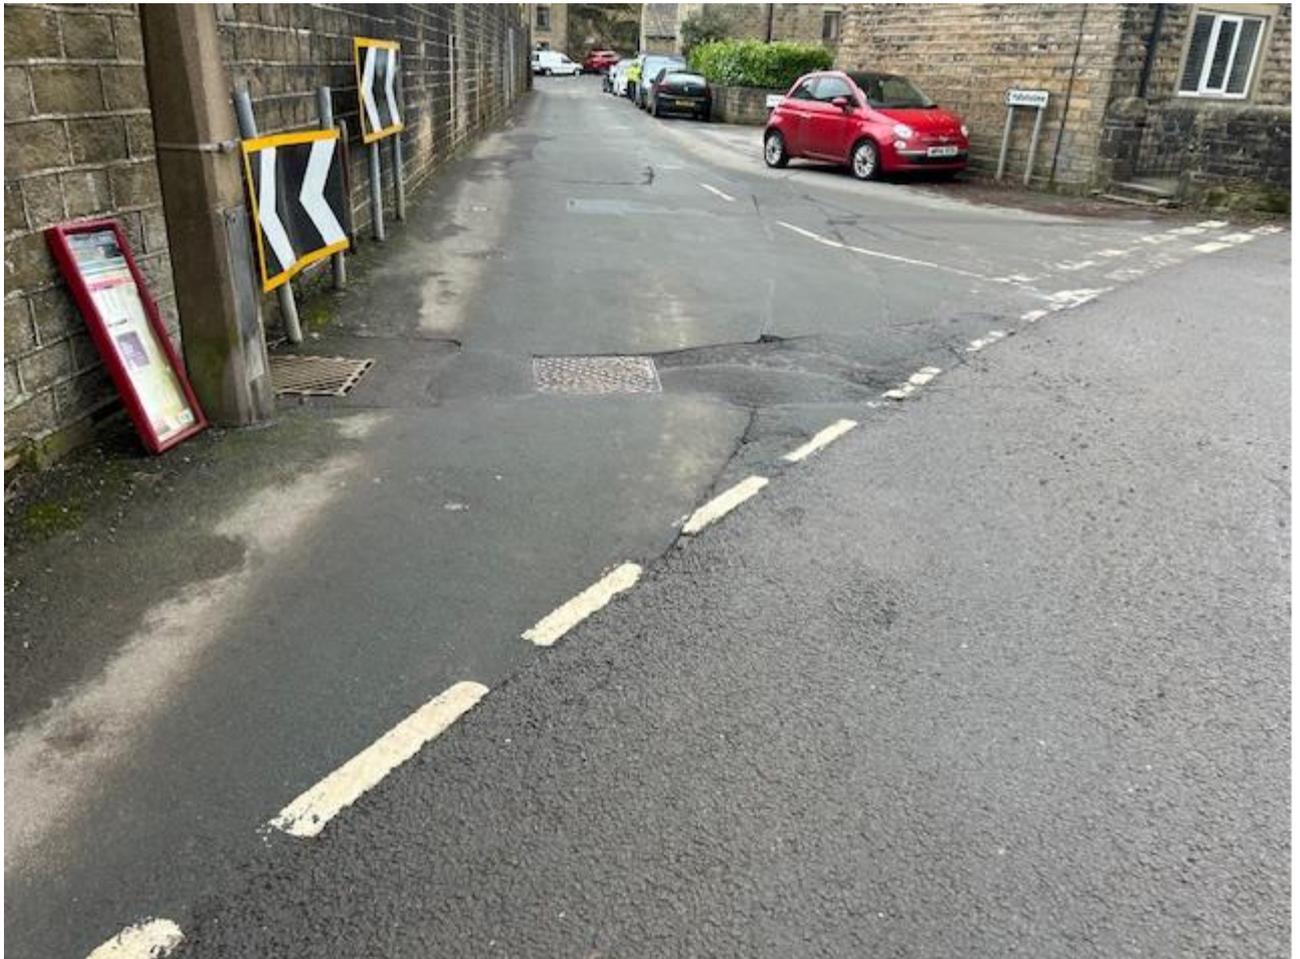
Chainage 0m

Comments – Woodhead Road showing early signs of surface course cracking.

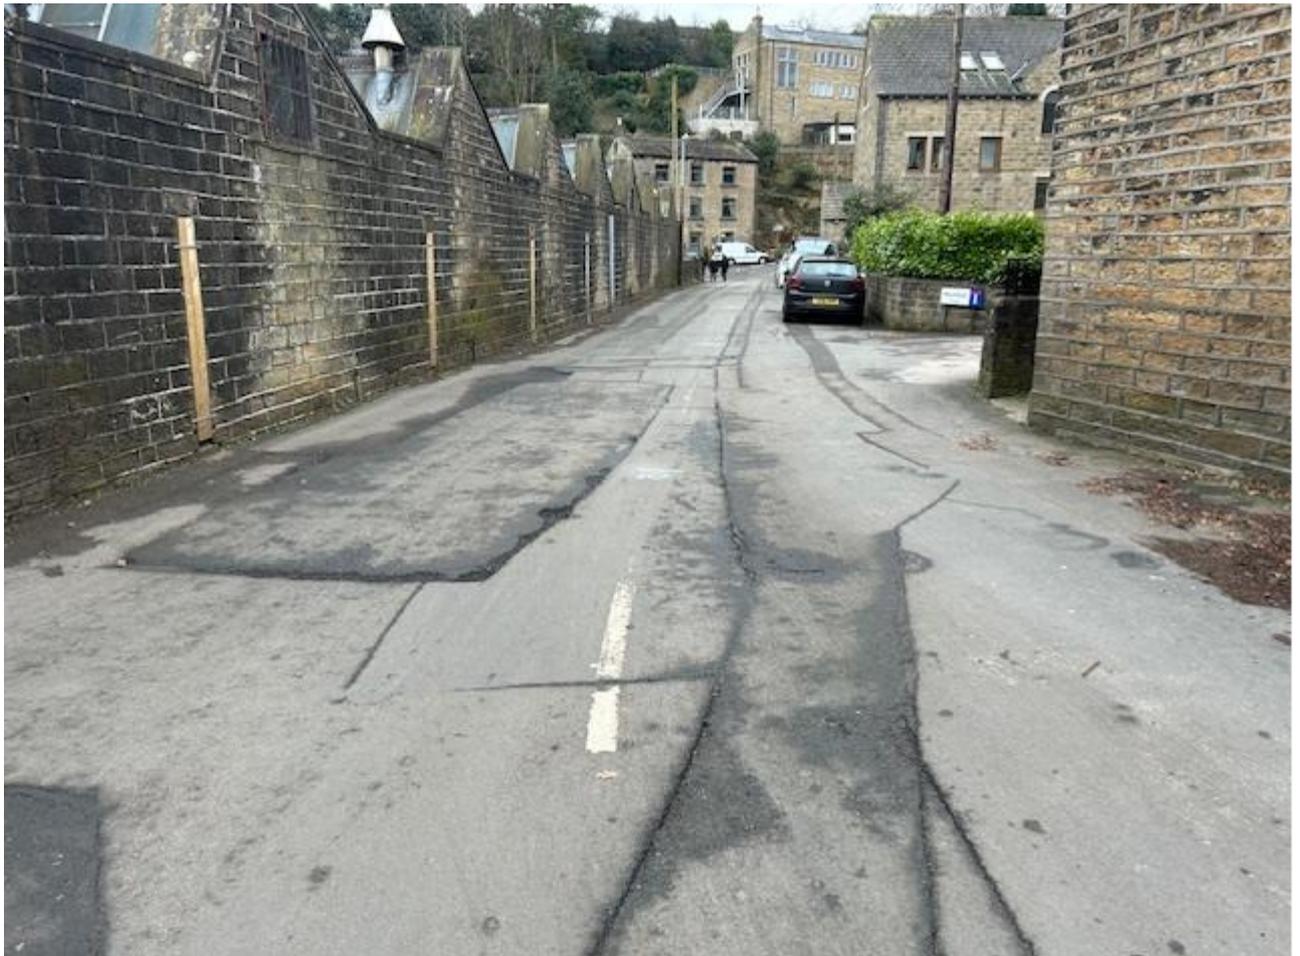
Chainage point 0m - 10m.

Comments – surface course generally intact with trench reinstatements. Inspection Cover (slight settlement) Road markings warn. **Focus point recommended.**

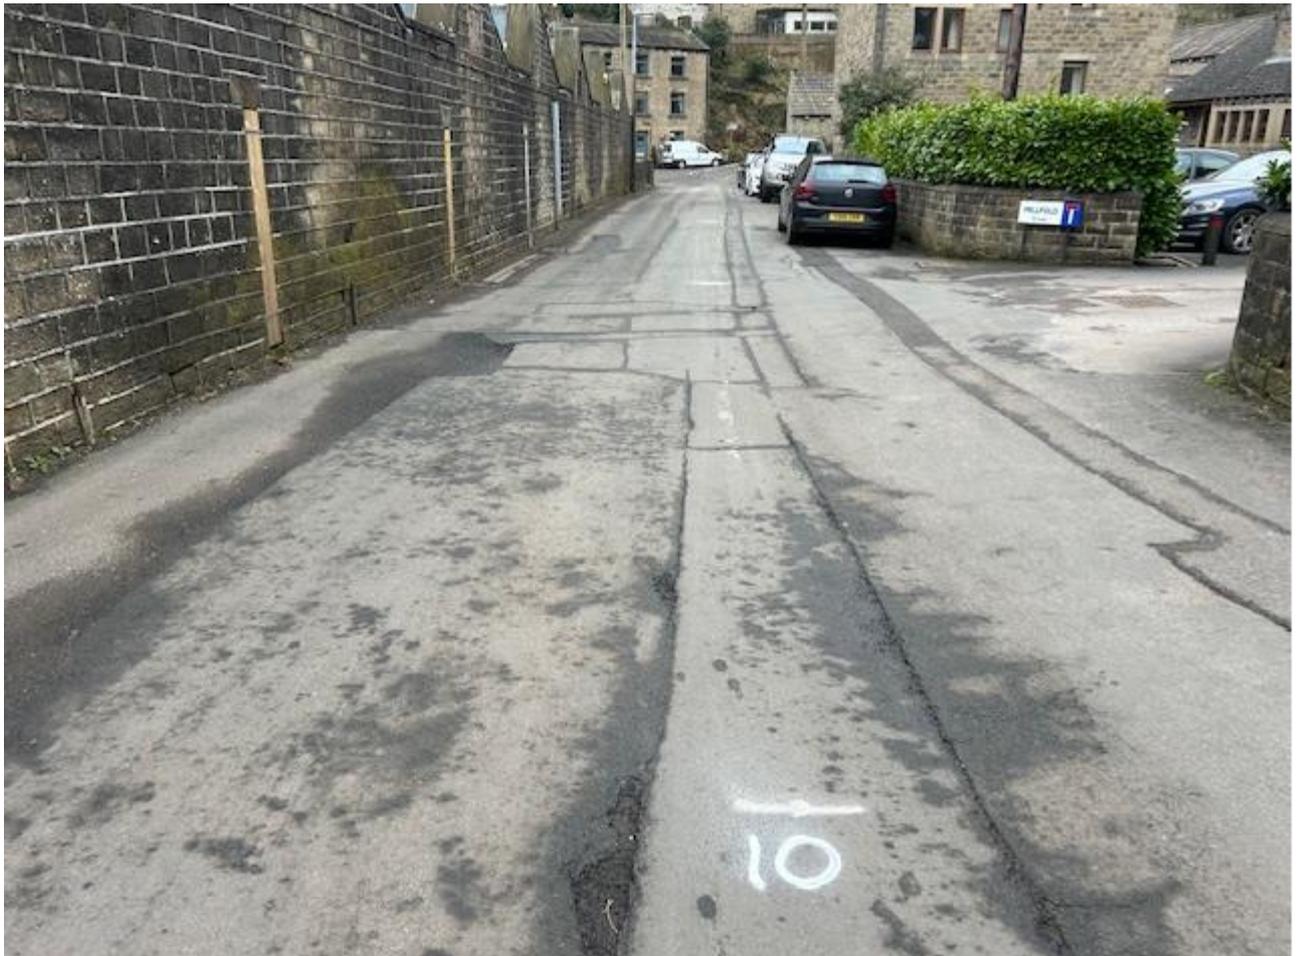
Chainage 10m

Comments - Patch reinstatement and signs of surface course joints degrading with no joint seal. Migration of surface course damage expected over winter period.

Centre line worn to a point where it is ineffective. **Focus point recommended.**

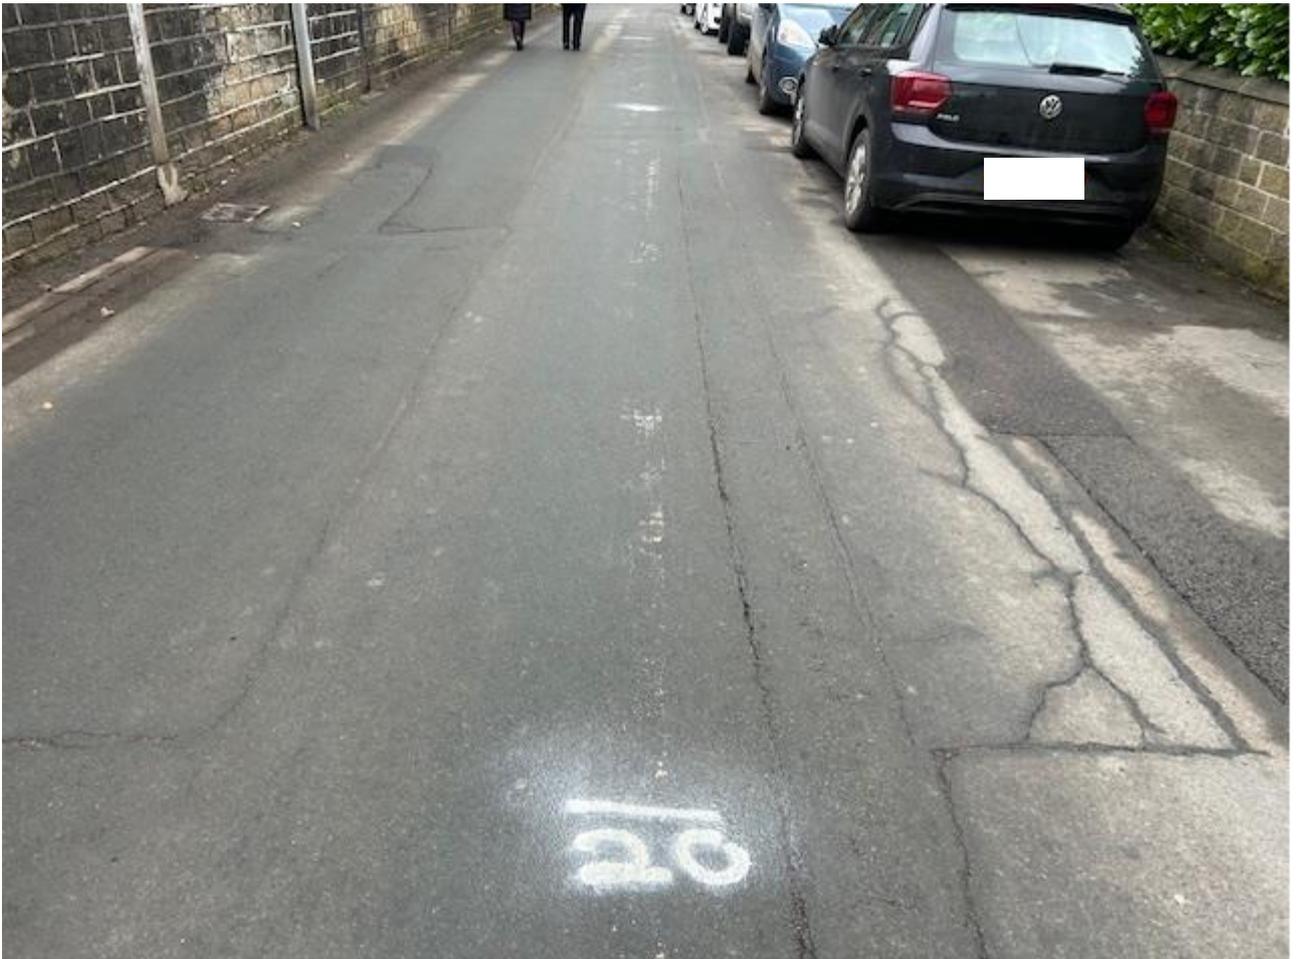
Chainage 20m

Comments – Patch reinstatement and signs of surface course joints degrading with no joint seal. Migration of surface course damage expected over winter period.

Centre line warn to a point where it is ineffective. **Focus point recommended.**

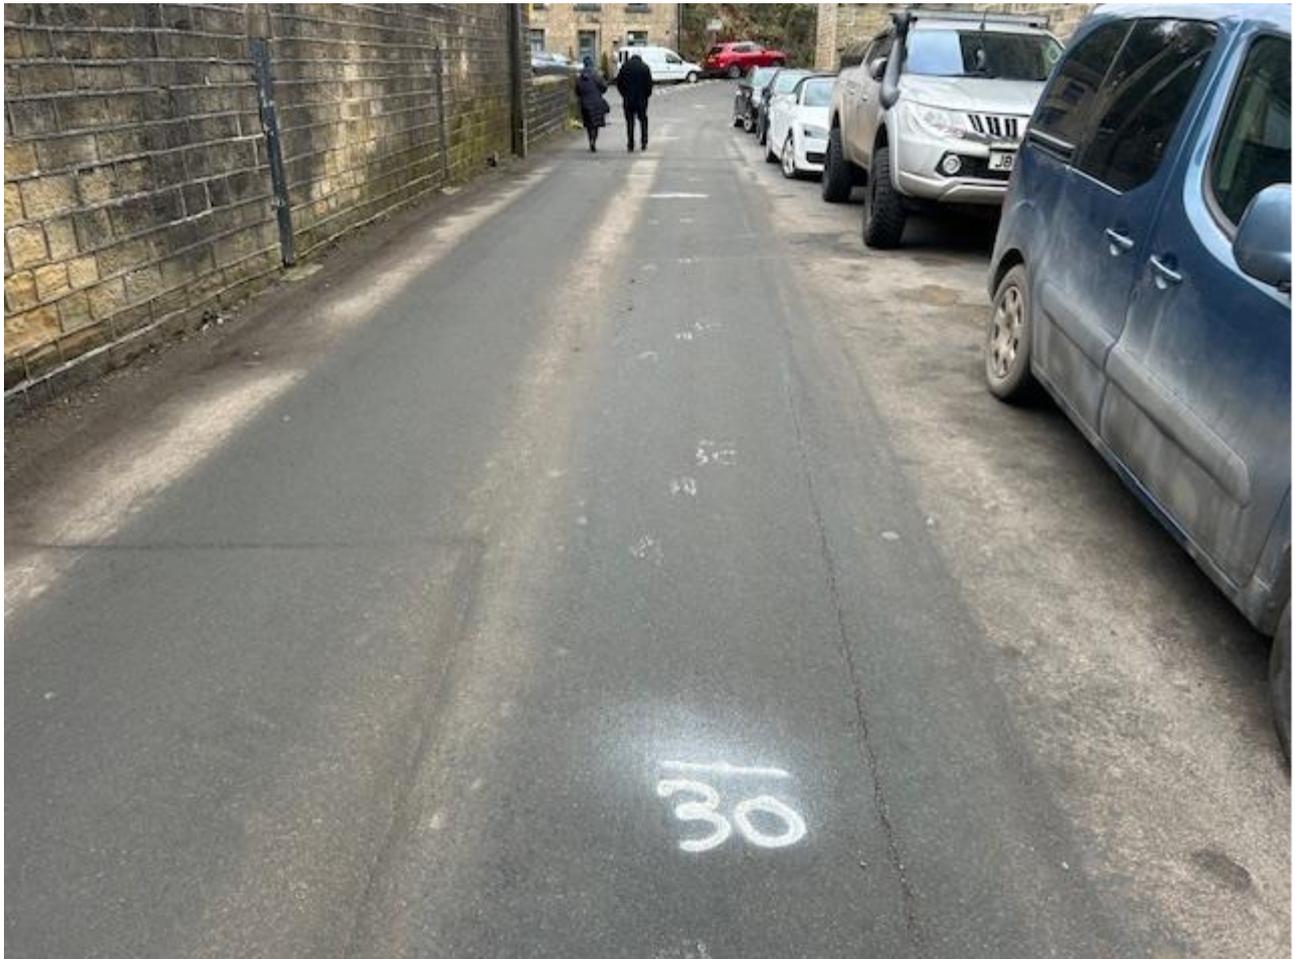
Chainage 30m

Comments – various degradation of surface course as a result of poor trench reinstatement resulting in some settlement and surface course cracking. This is expected to deteriorate prematurely should there be sub-zero temperatures. **Focus point recommended.**

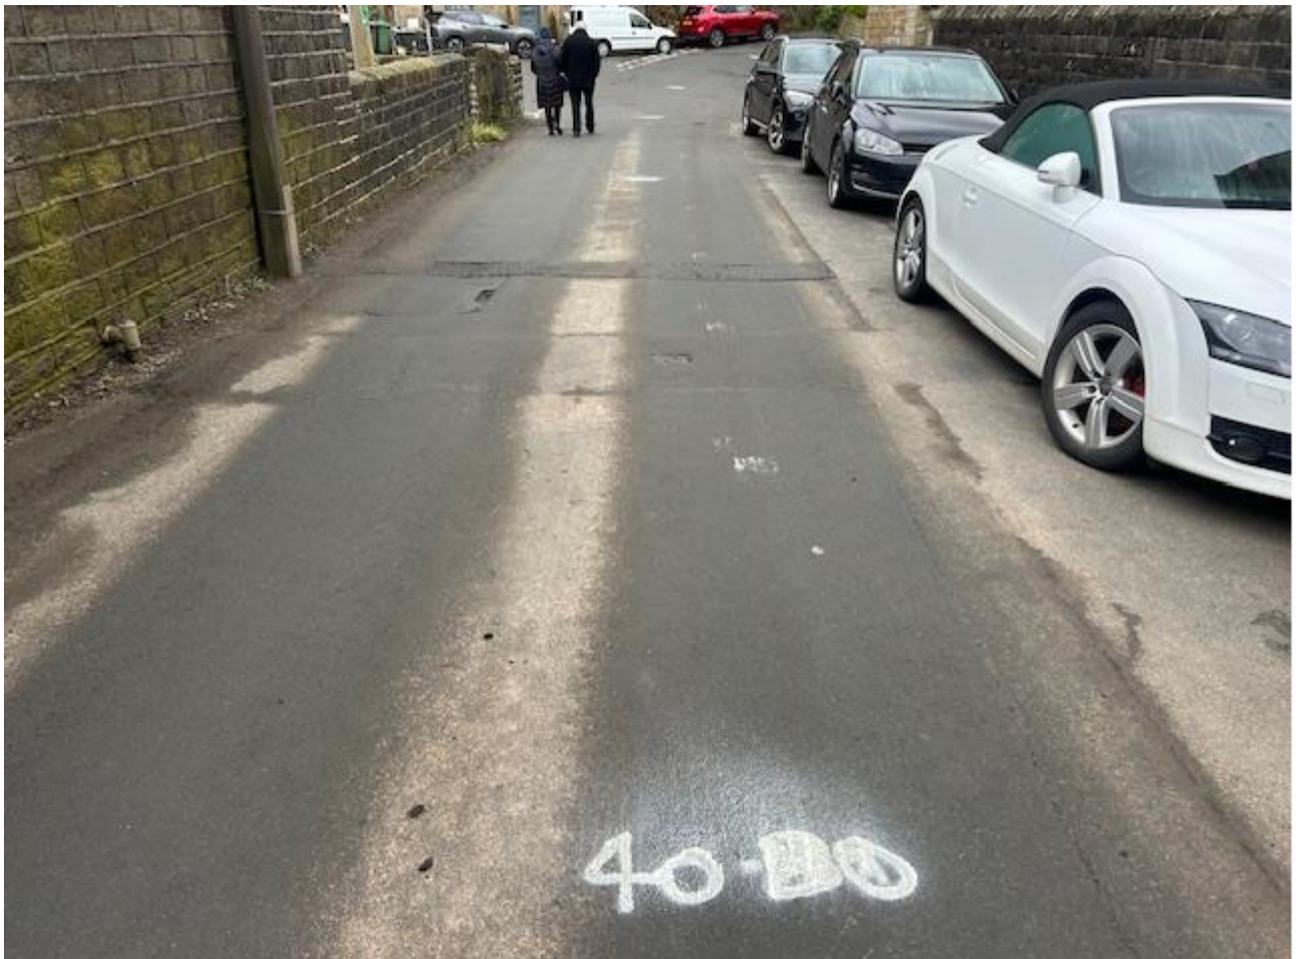
Chainage 40m

Comments – Trench reinstatement in surface course, no joint seal.

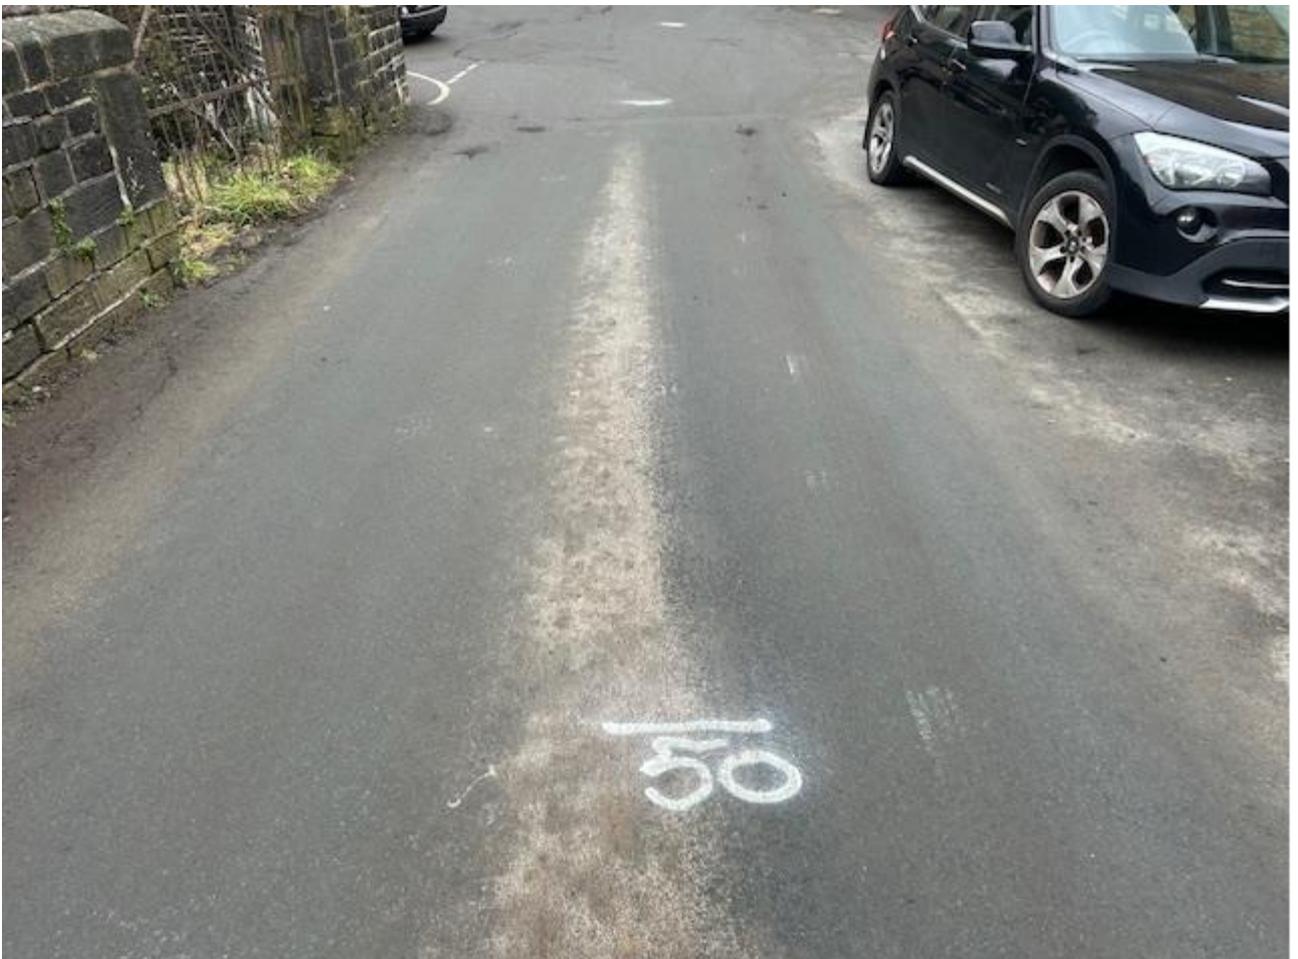
Chainage 50m

Comments – trench reinstatement in reasonable condition at Ch 46m

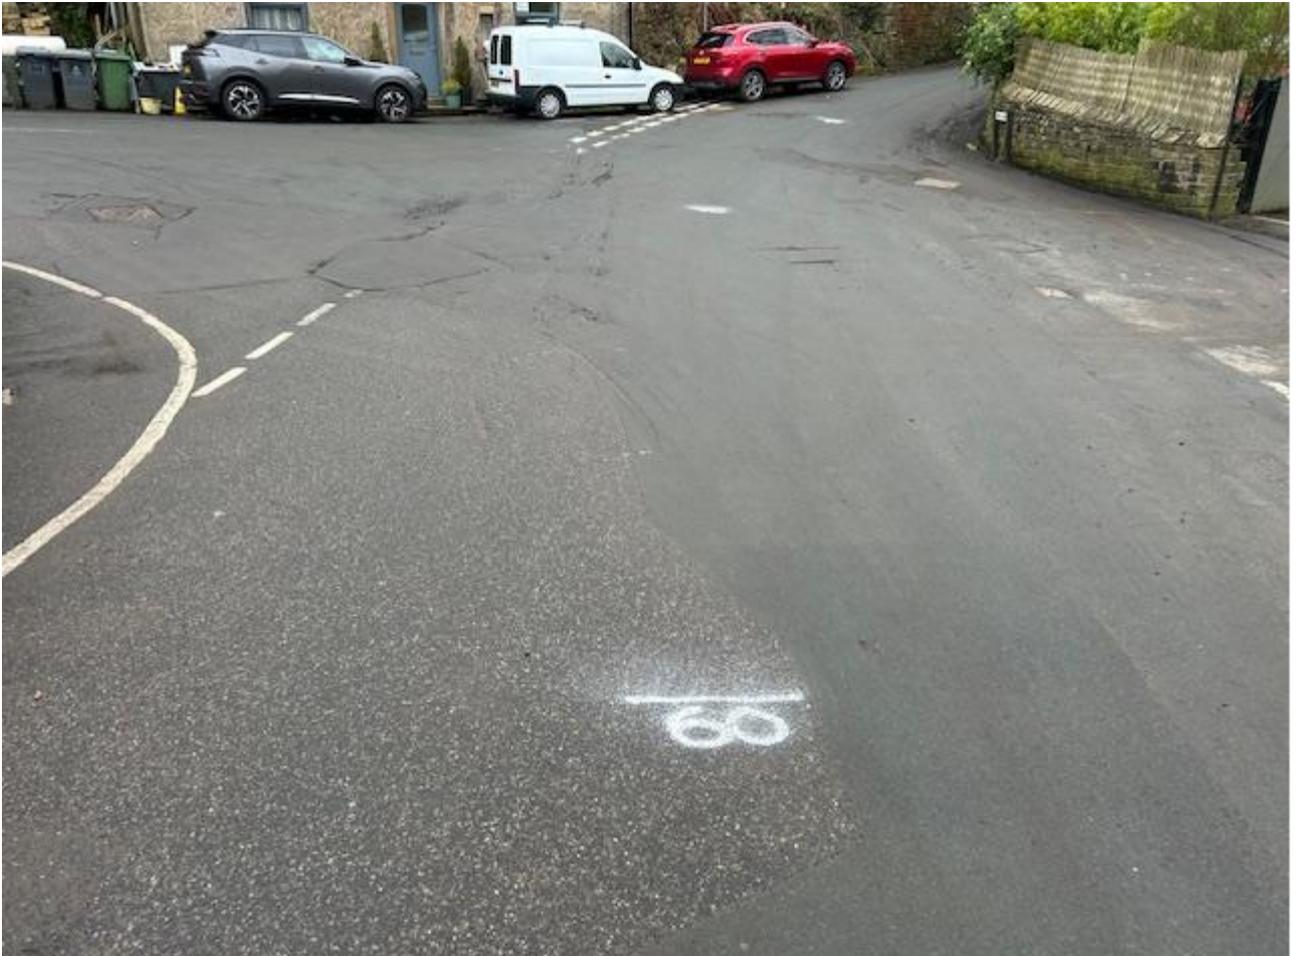
Chainage 60m

Comments – surface course acceptable

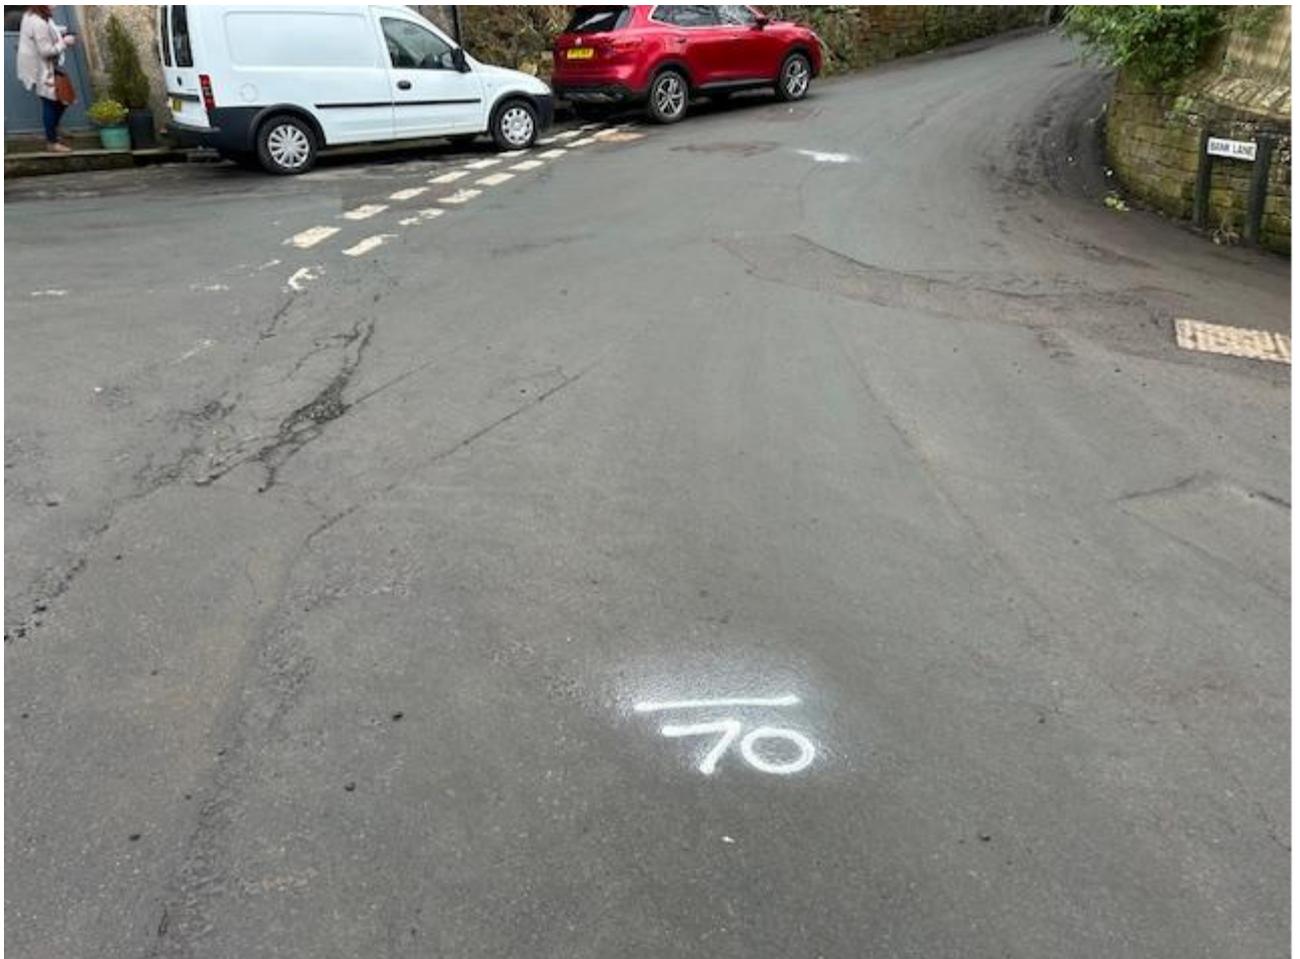
Chainage 70m

Comments – surface course observed to made up of two different specifications. Joints appear to be watertight.

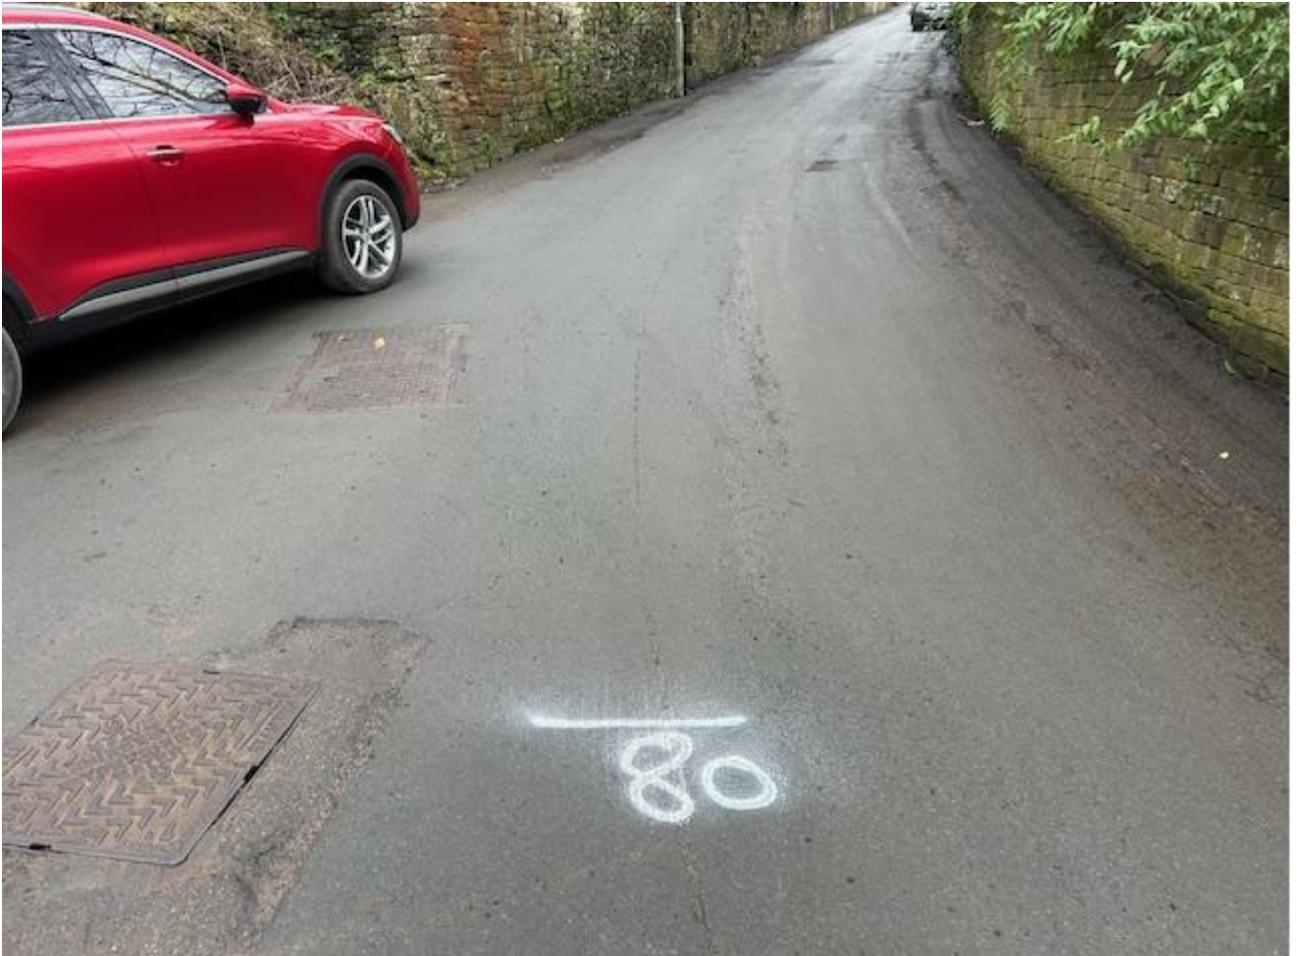
Chainage 80m

Comments – evidence of trench reinstatement and surface course deterioration adjacent to give way markings onto Smithy Lane. Surface course will degrade throughout winter period.
Focus point recommended.
