## Appendix D

### Laithe Bank Drive – 07/02/25

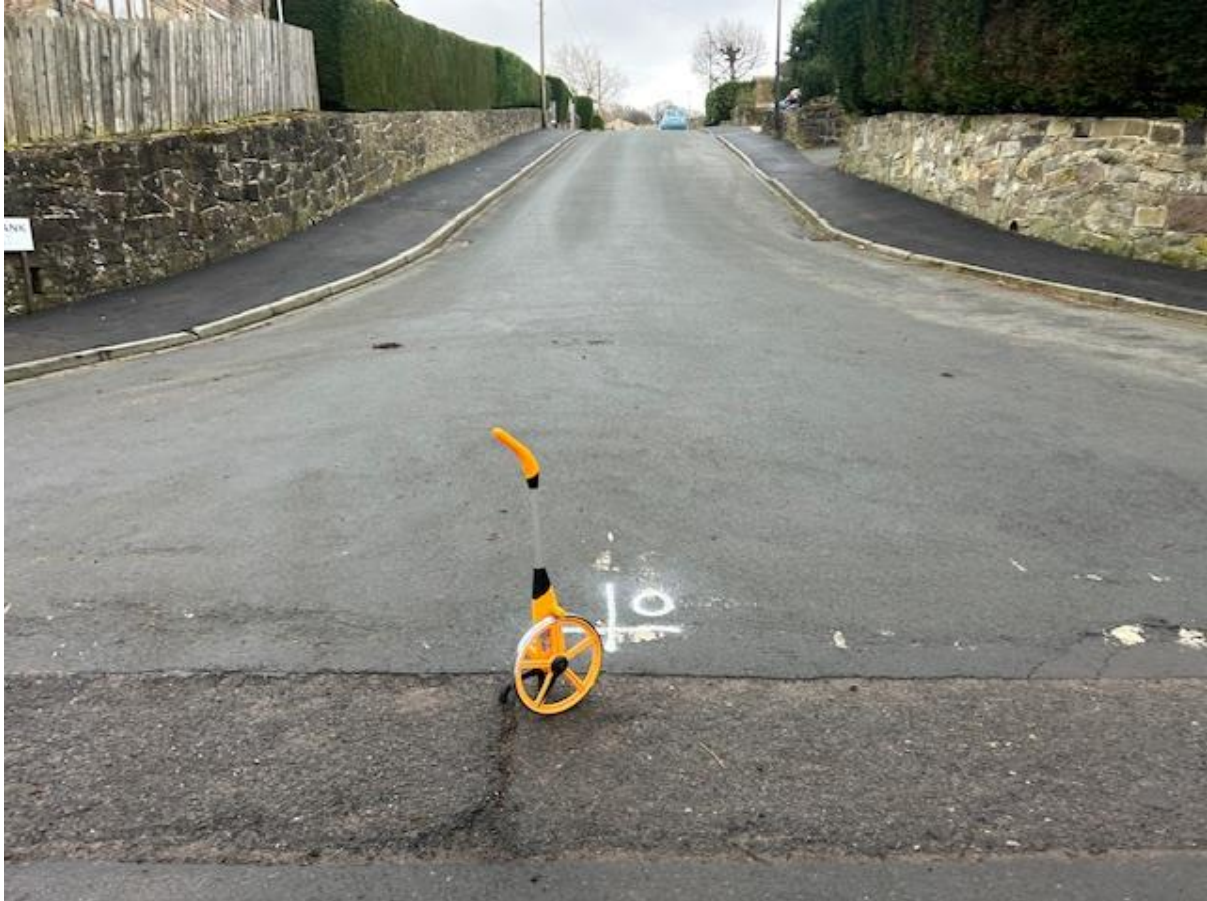
Chainage 0m

Comments – Prior to zero chainage, poor trench reinstatement. Give way marking worn.

**Focus point to monitor due to construction traffic using this junction when fully loaded.**

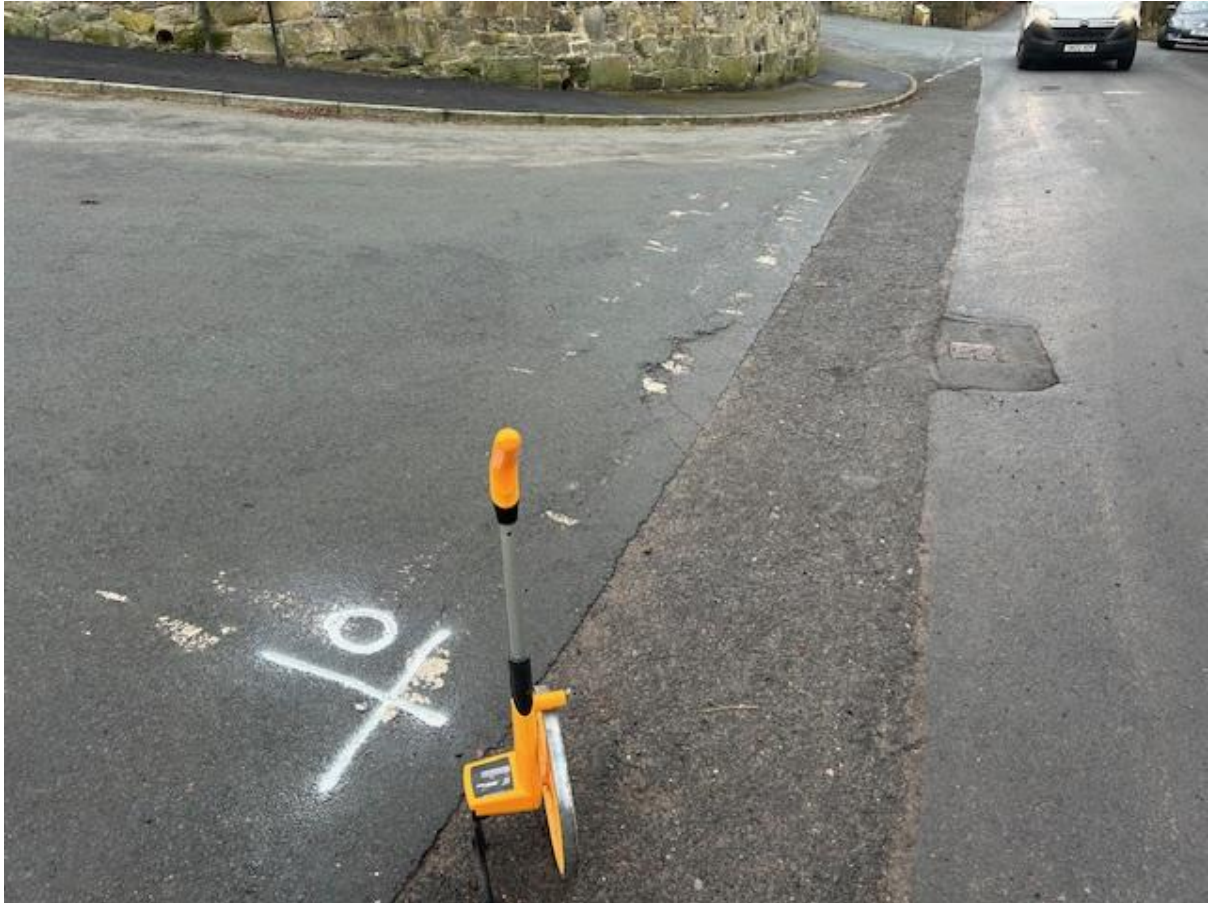
Chainage 0m

Comments – as above.

**Focus point to monitor as main route for construction traffic.**

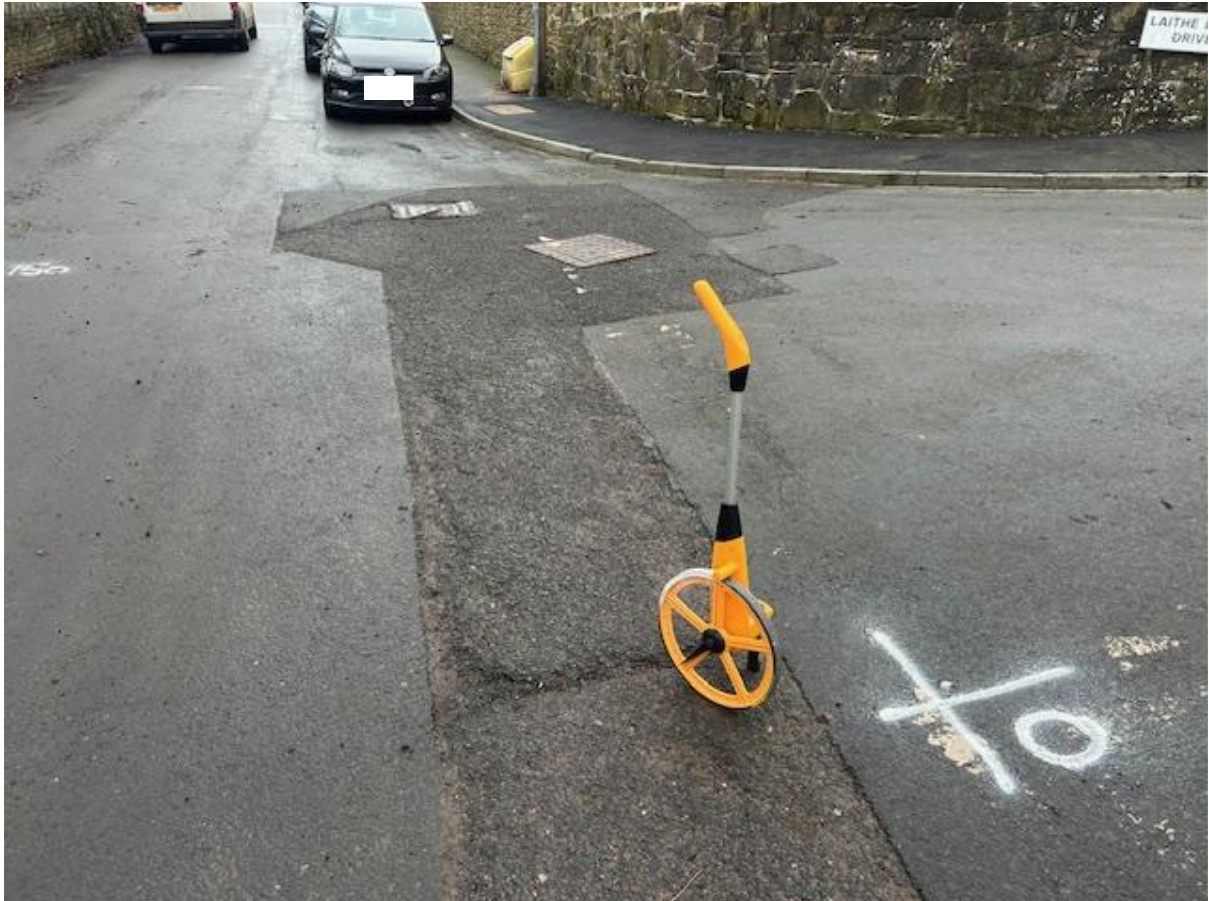
Chainage 0m

Comments – as above.

**Focus point to monitor as main route for construction traffic.**

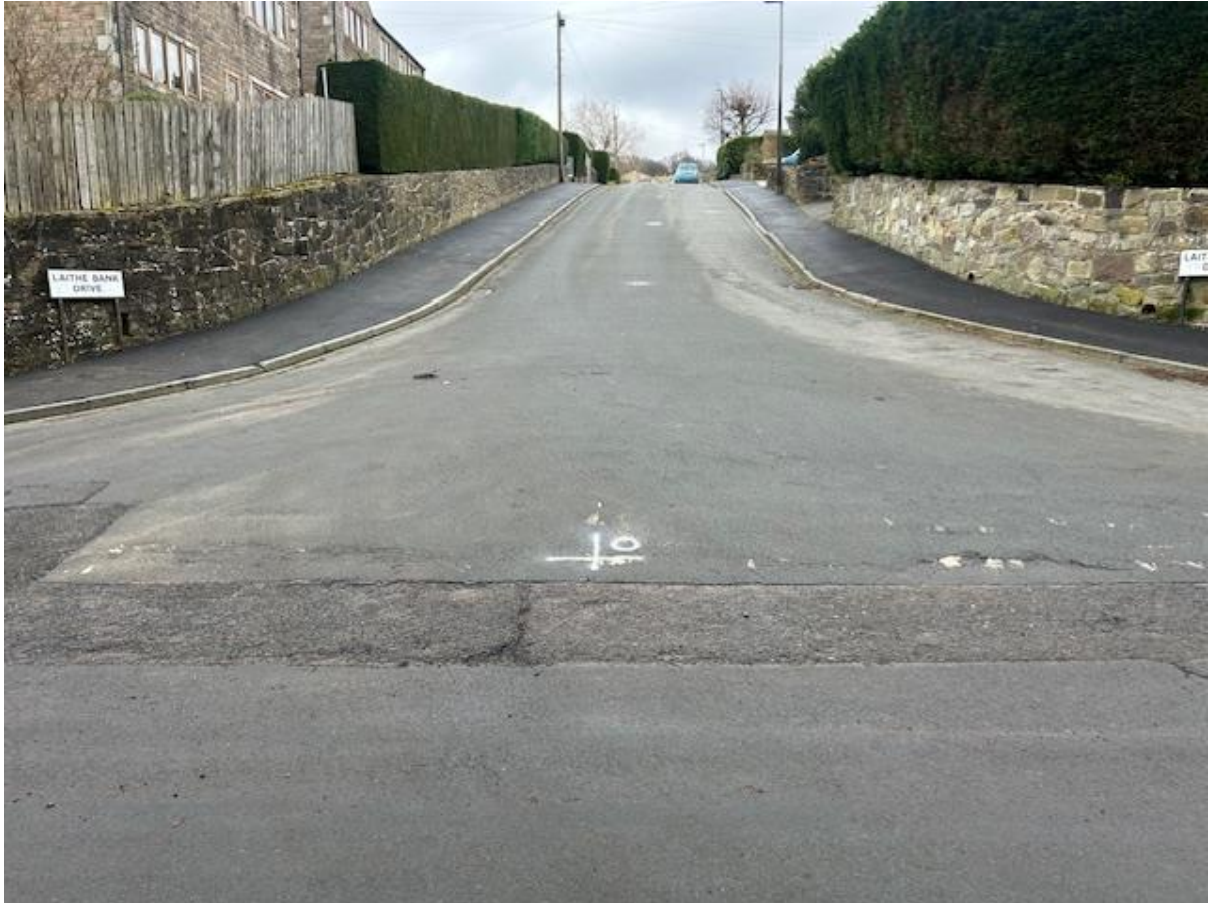
Chainage 0m

Comments – as above.

**Focus point to monitor as main route for construction traffic.**

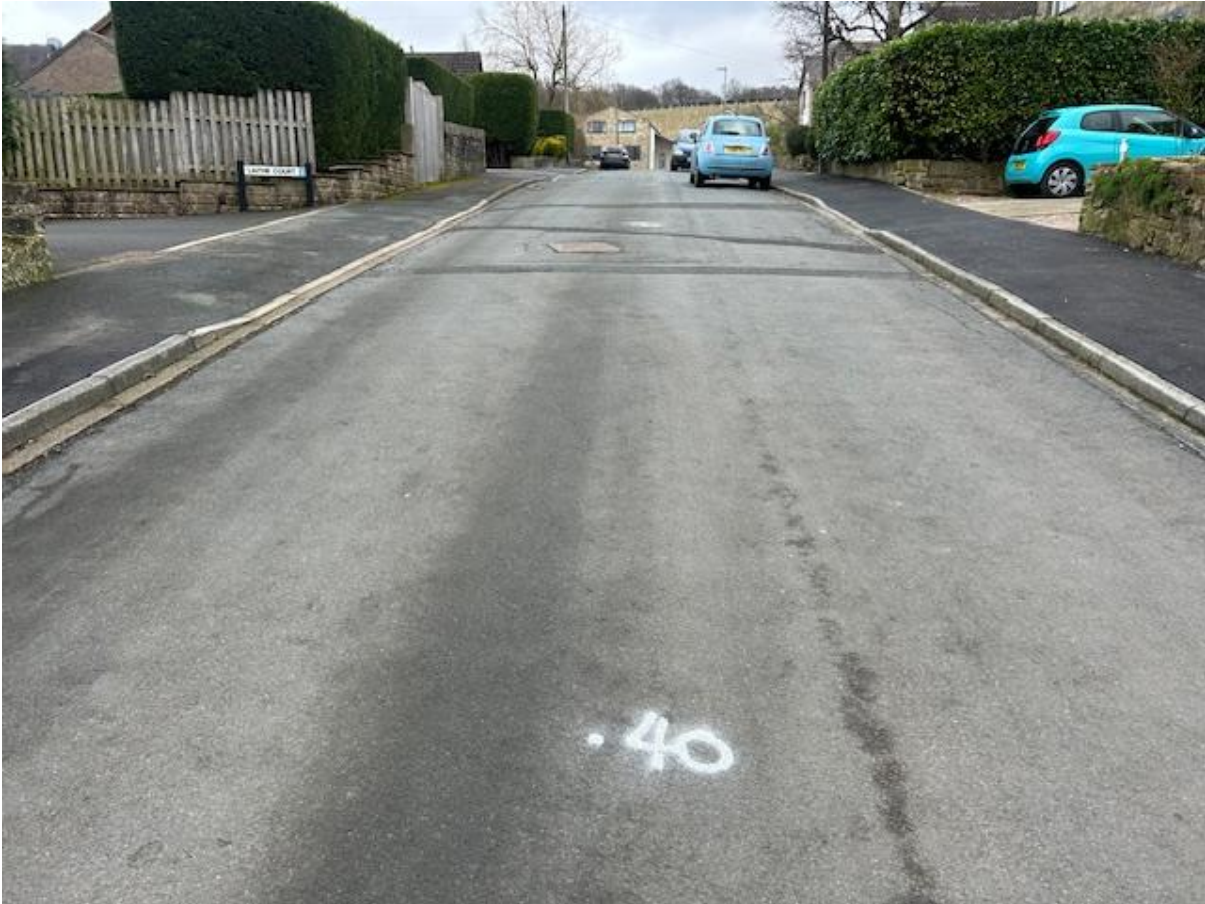
Chainage 40m

Comments – trench reinstatements crossing carriageway at Ch 38m and 39m. Surface course of reinstatements appears to be different specification with some element of settlement. Surface course surrounding Manhole cover at Ch 49 showing signs of settlement and tensile cracking. **Focus Point to monitor.**

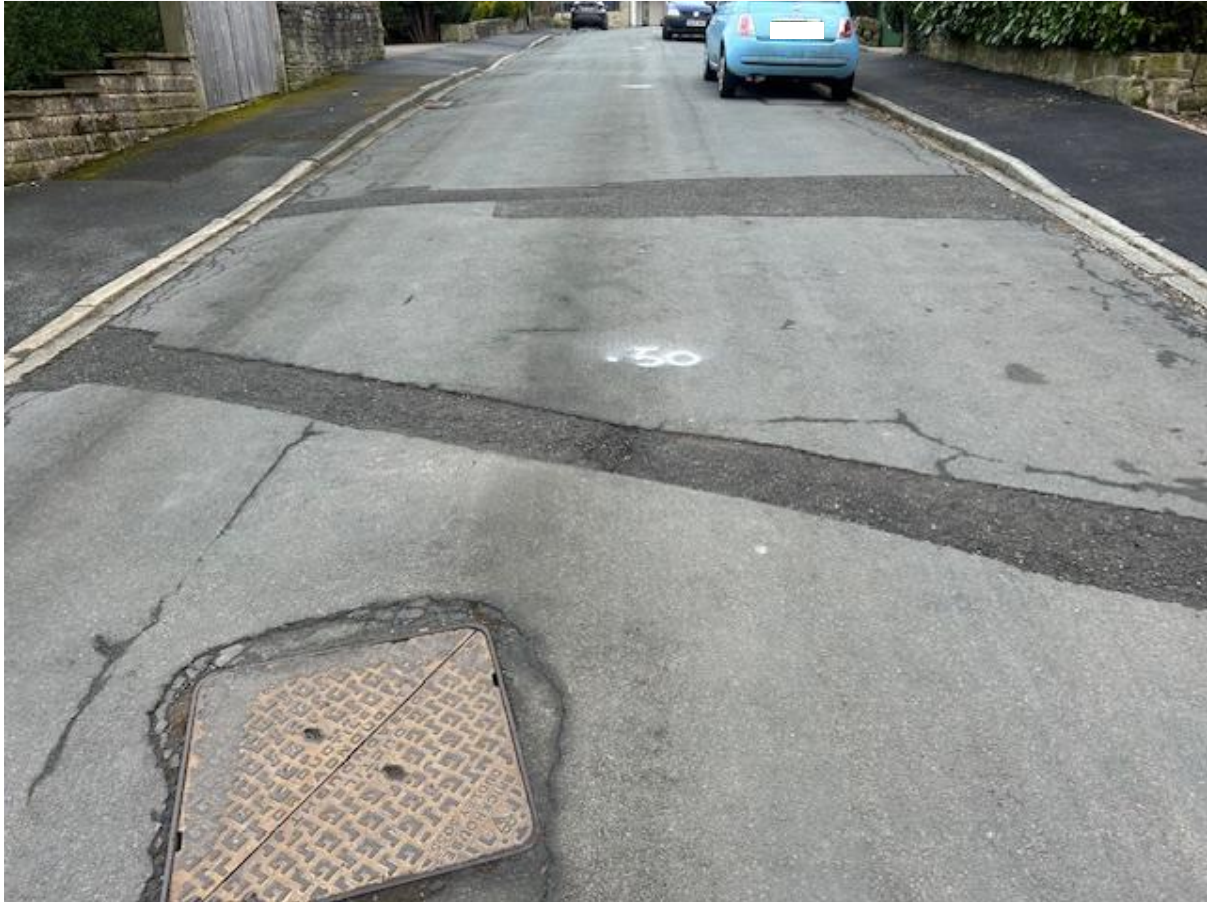
Chainage 50m

Comments – Ch 49 showing more detail of tensile cracking of surface course surrounding manhole and trench crossing carriageway. Tensile cracking along both side of carriageway adjacent to drainage channel. **Focus point to monitor.**

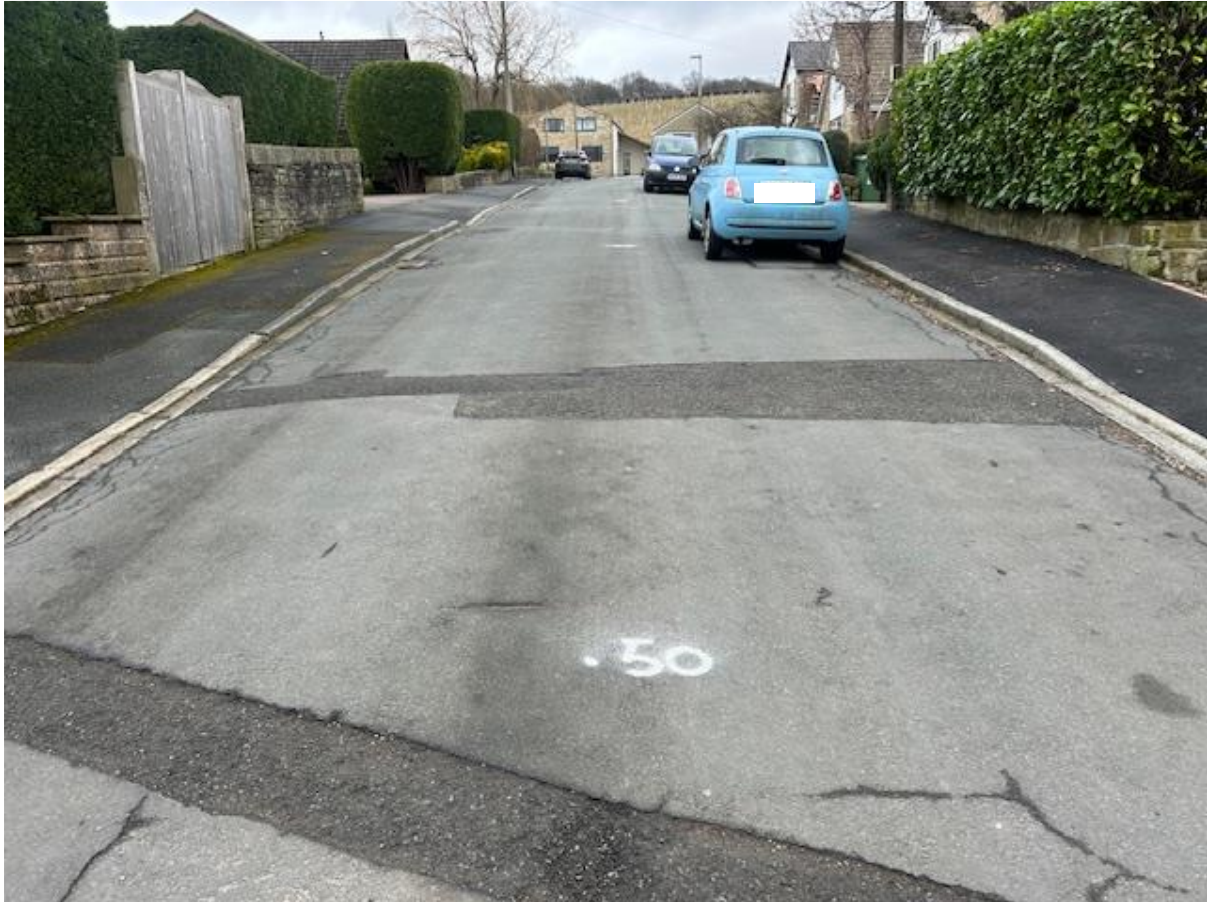
Chainage 50m

Comments – as above.

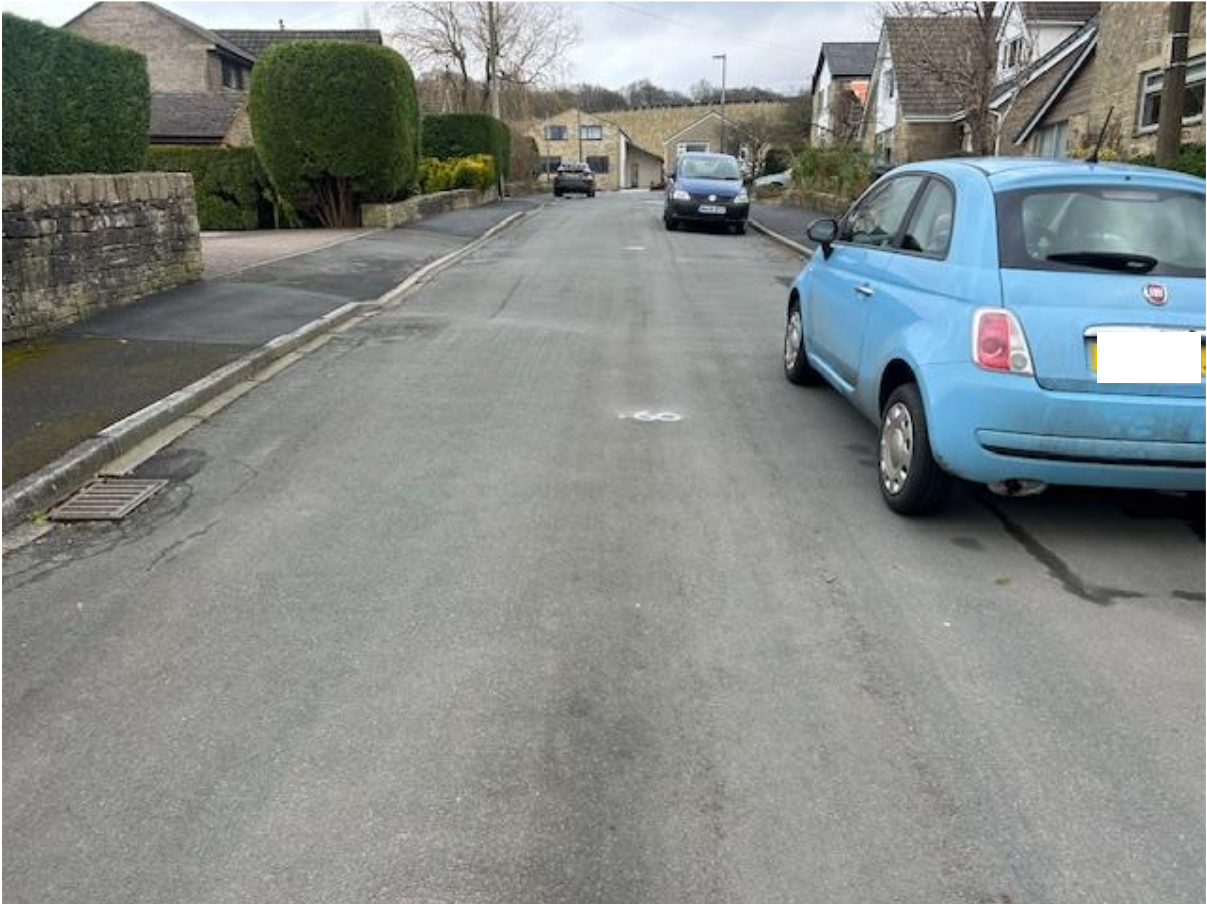
Chainage 55m

Comments – Drainage channel and surround surface course adjacent to road gully suffering from settlement. **Focus point to monitor.**

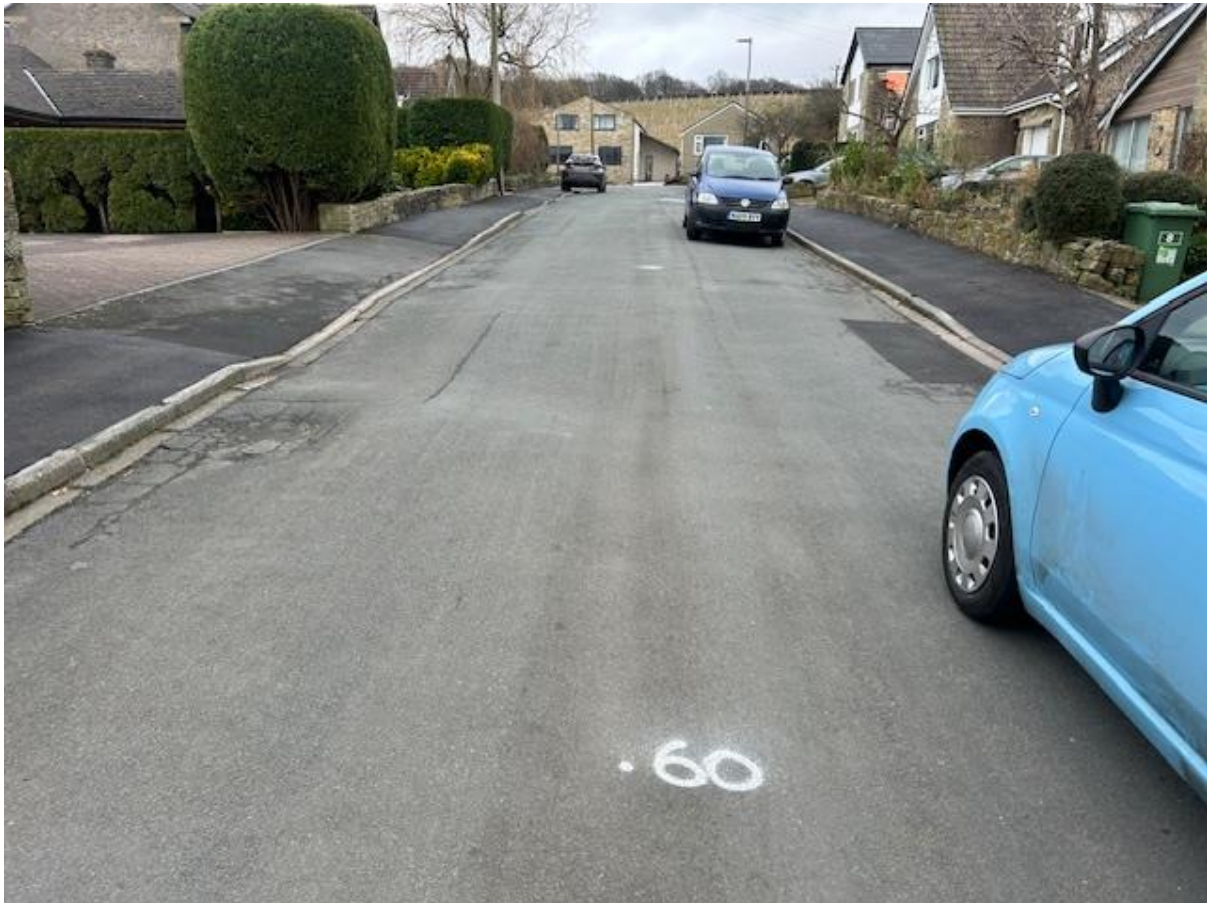
Chainage 60m

Comments – Uneven carriageway as a result of settlement on left hand side. Surface course suffering from tensile cracks. **Focus Point to monitor.**

Recent patch repair on right hand side of carriageway.

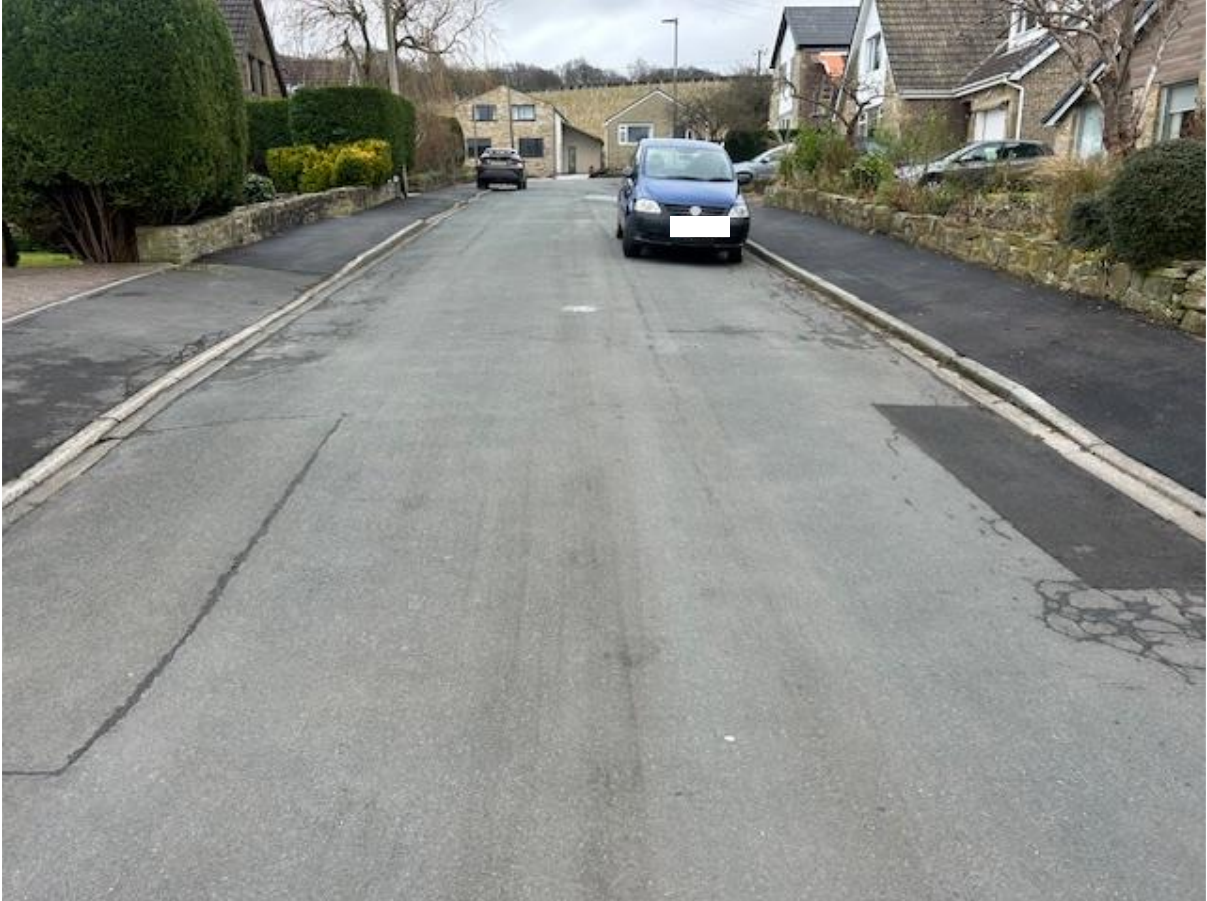
Chainage 65 m

Comments – as above

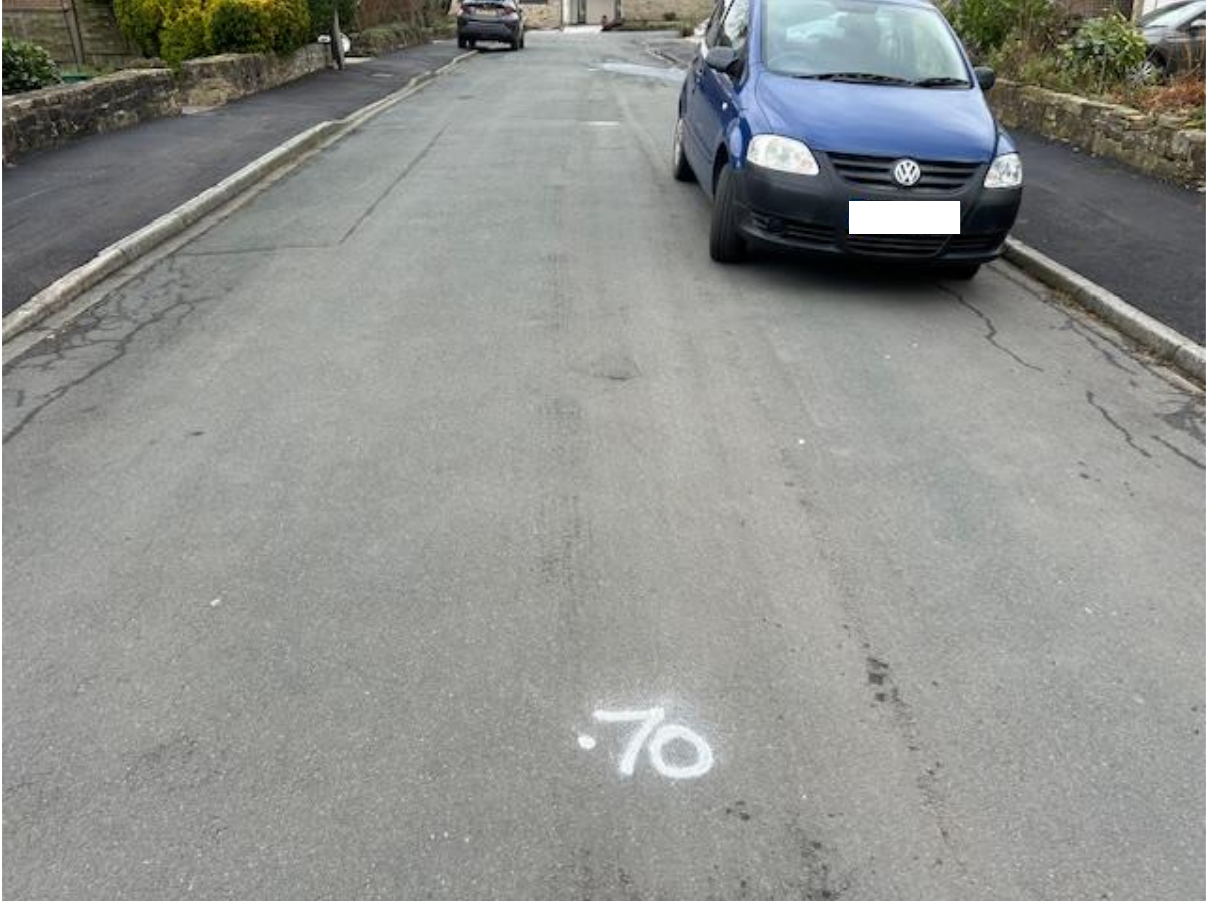
Chainage 70m

Comments – Surface course both sides of carriageway suffering from tensile crack.  
**Focus point to monitor.**

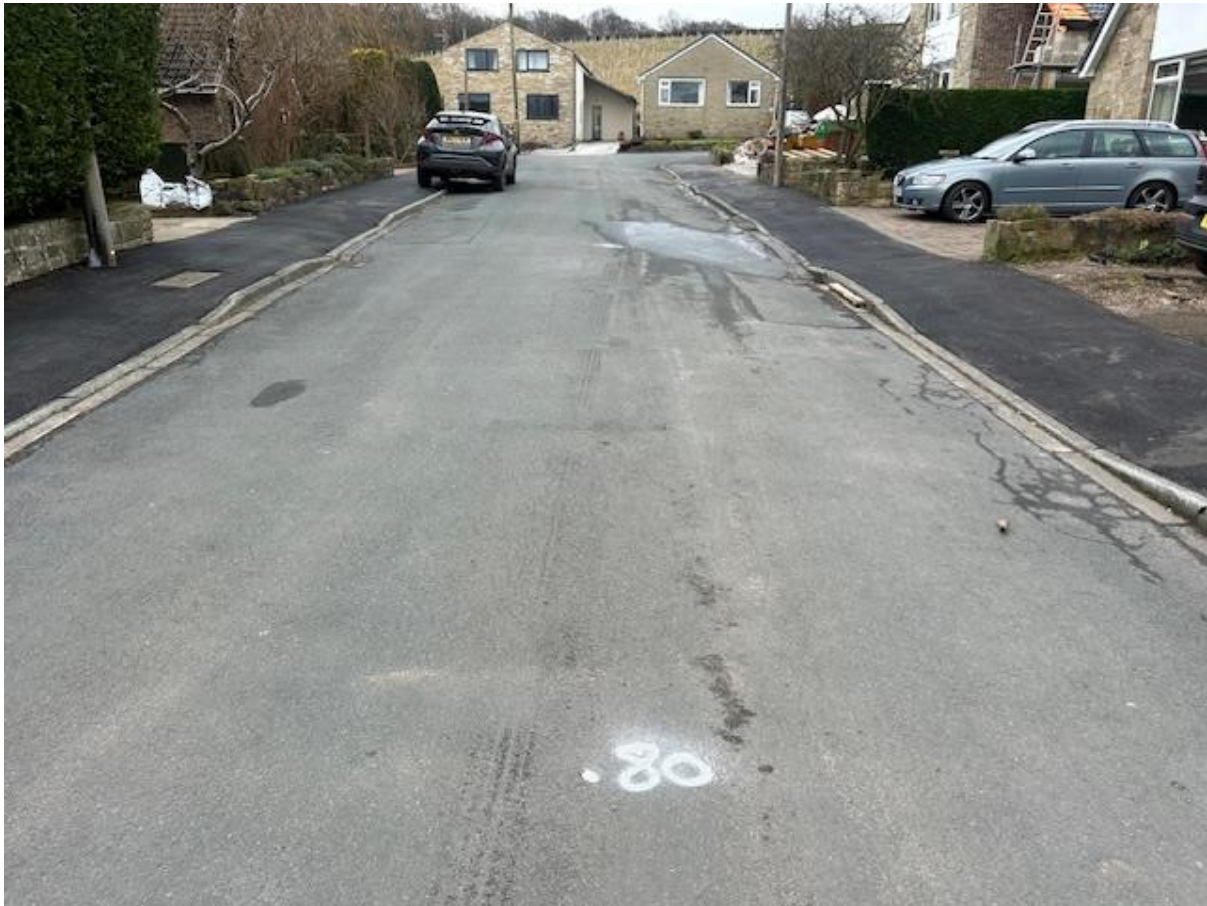
Chainage 80m

Comments – Tensile cracks along right-hand side of carriageway.

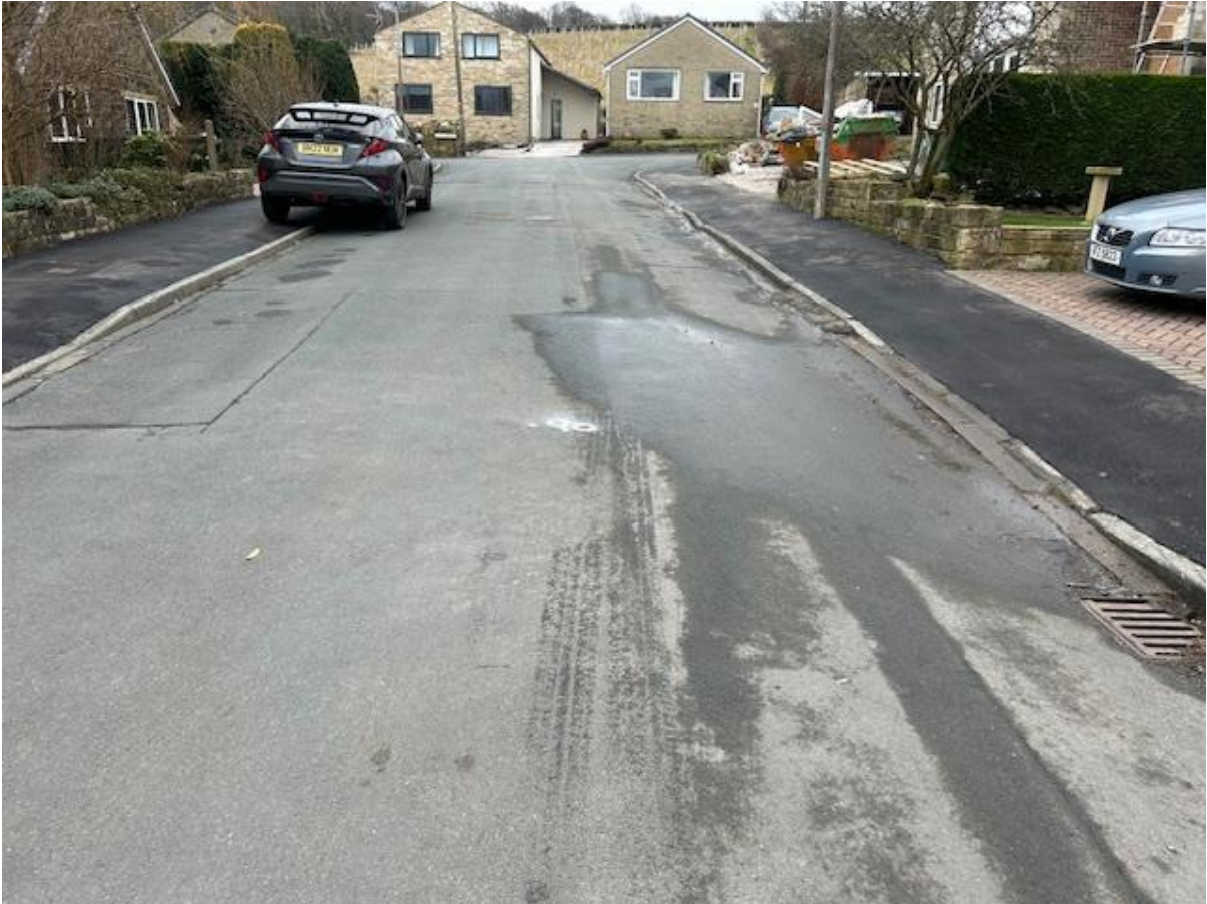
Chainage 85m

Comments – patchwork repair along left hand side of carriageway Ch 90m onwards.

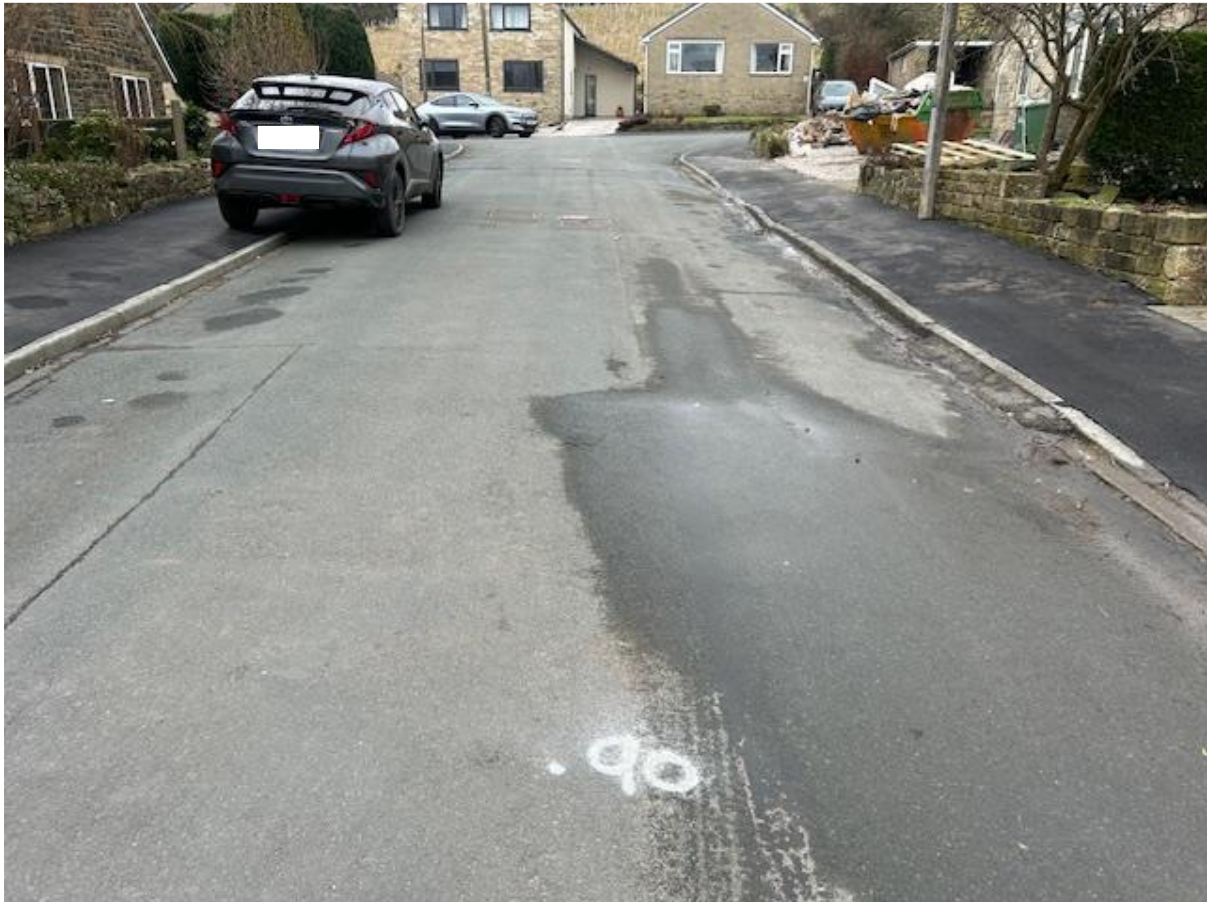
Chainage 90m

Comments – as above. Poor alignment of kerbs / drainage channel along right-hand side of carriageway. **Requires attention by Kirklees Highways. Focus point to monitor.**

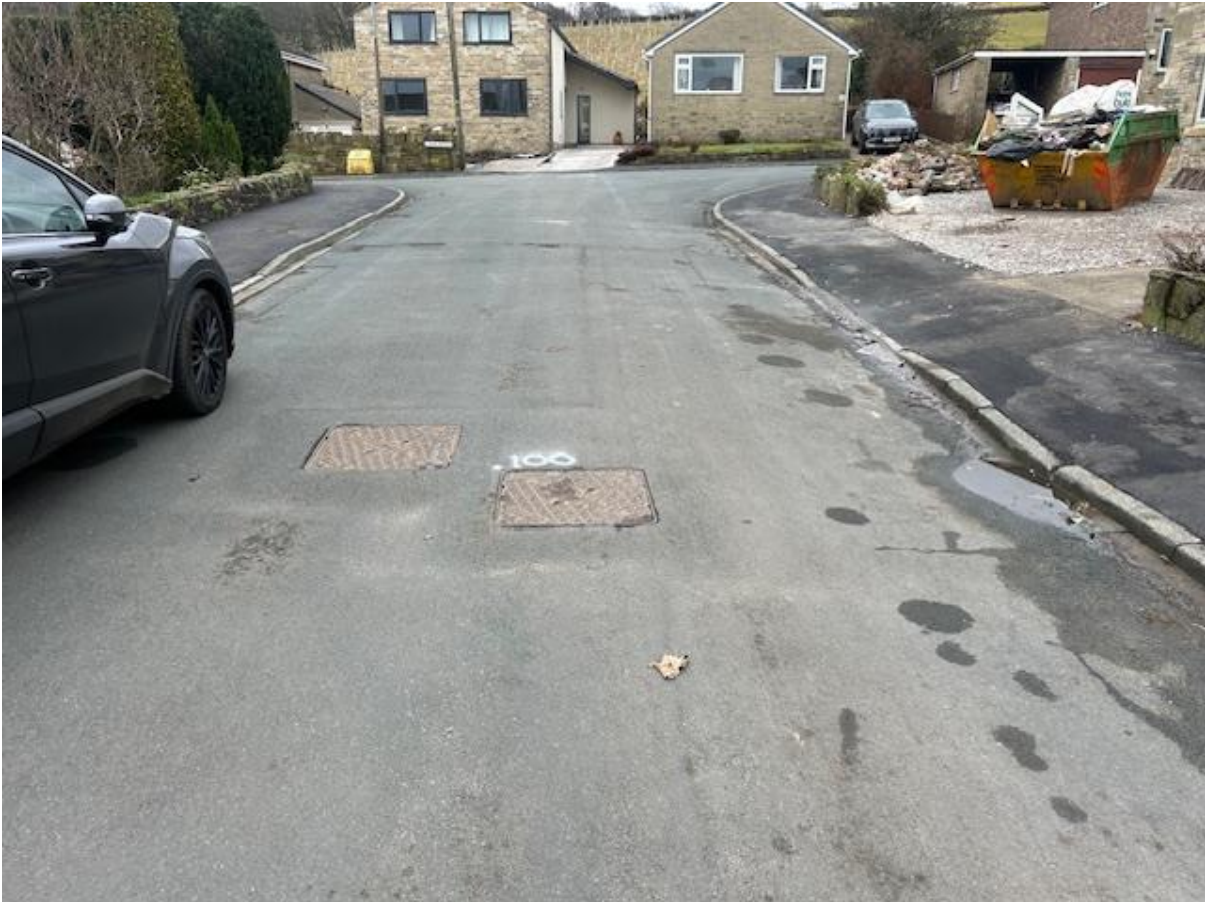
Chainage 100m

Comments – Drainage channel and surface course uneven as a result of premature settlement. **Requires attention by Kirklees Highways. Focus point to monitor.**

Some minor settlement around manhole chambers as this may lead to tensile cracks appearing over the next 12 months. **Focus point to monitor.**

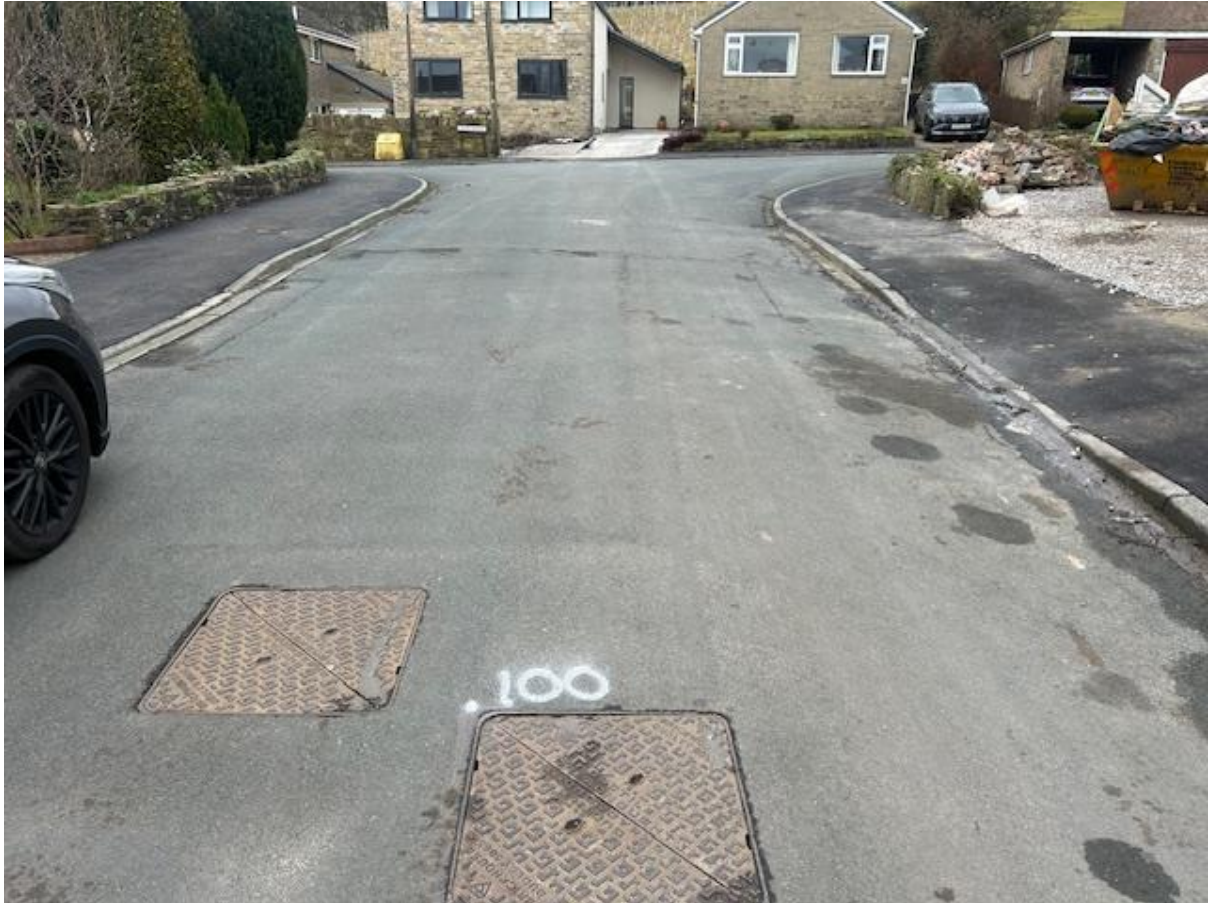
Chainage 100m

Comments – as above. Evidence of water weeping out of drainage channel on right hand side of carriageway / kerb line due to building works . Possible leak from water supply?  
**Requires Kirklees Building Control / Highways attention. Focus Point to monitor.**

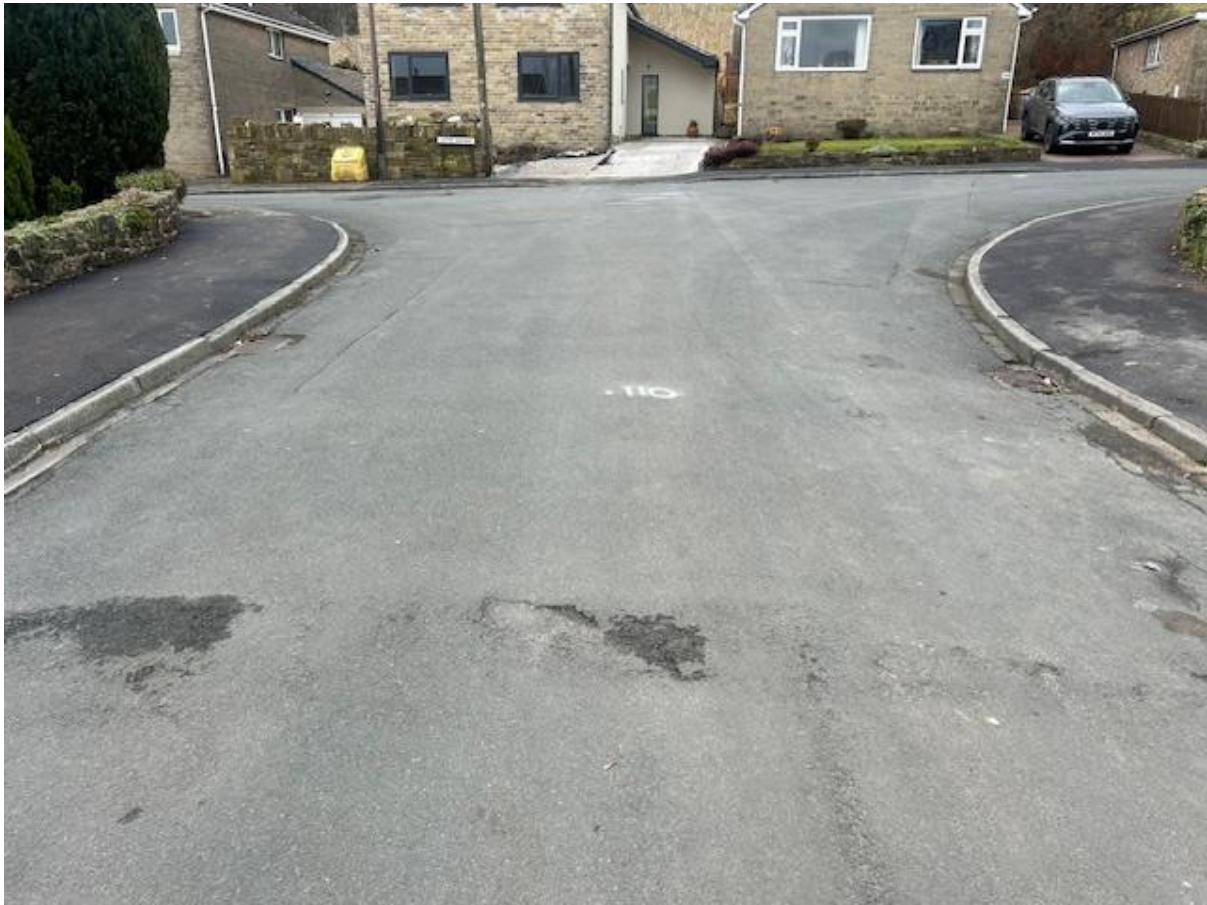
Chainage 105m

Comments – some minor degradation of surface course. Drainage channel / kerbs on right hand side of carriageway uneven. **Require Kirklees Highways attention. Focus point to monitor.**

Drainage channel and kerbs of left-hand side also uneven...**require Kirklees Highways attention. Focus point.**

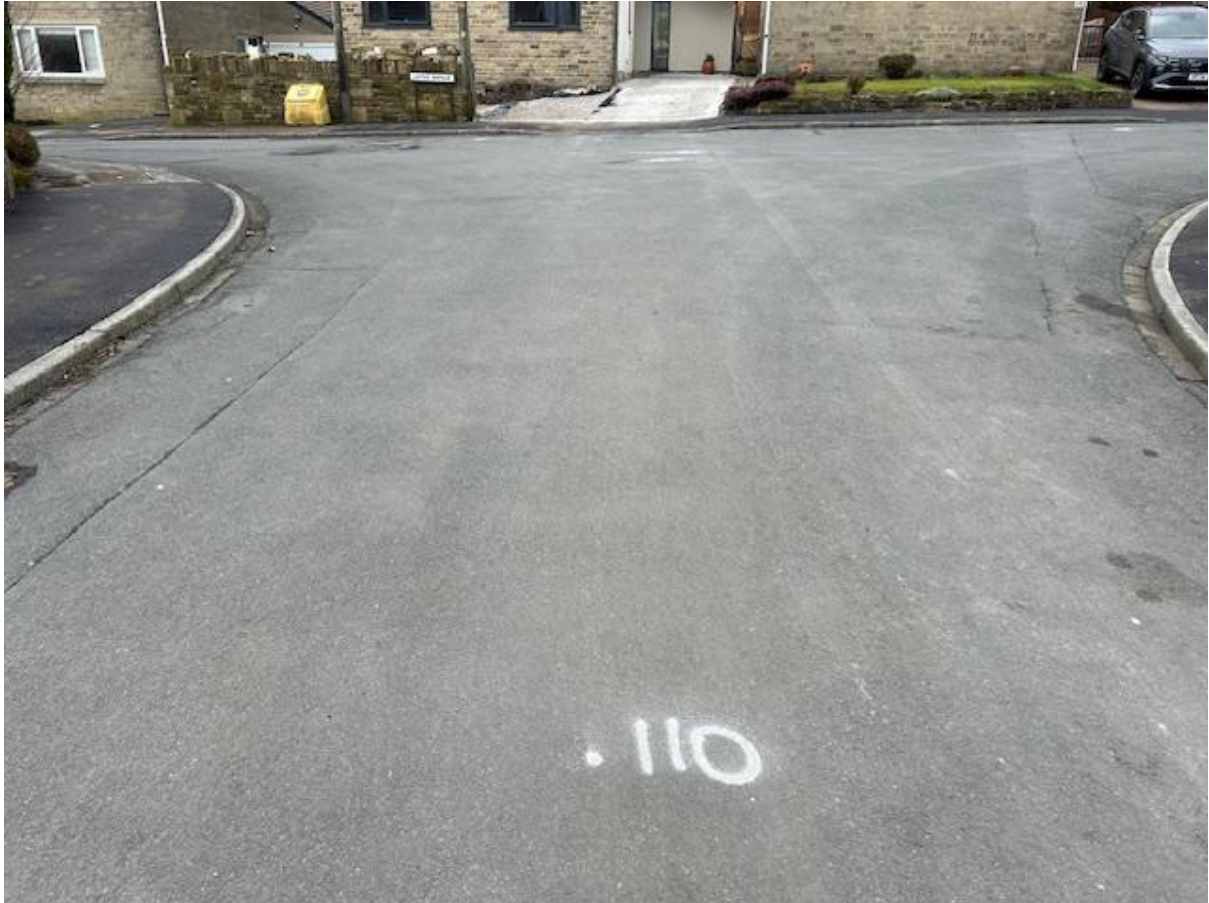
Chainage 110m

Comments – patchwork repair on left hand side of carriageway.
