Appendix E

Bankfield Drive - 07/02/25

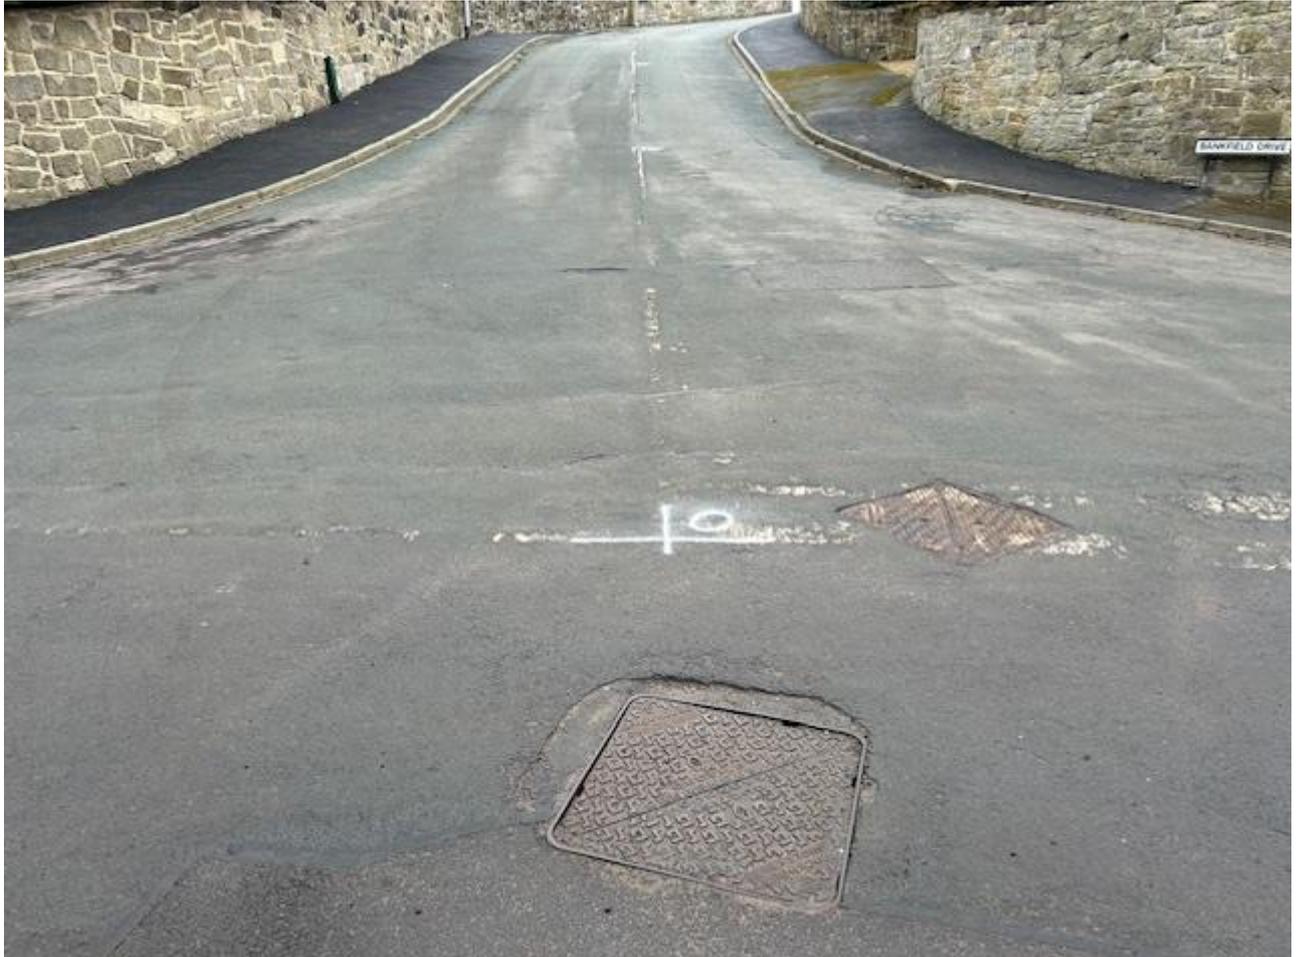
Chainage 0m

Comments – Manhole Ironwork slightly sunk.
Focus Point.

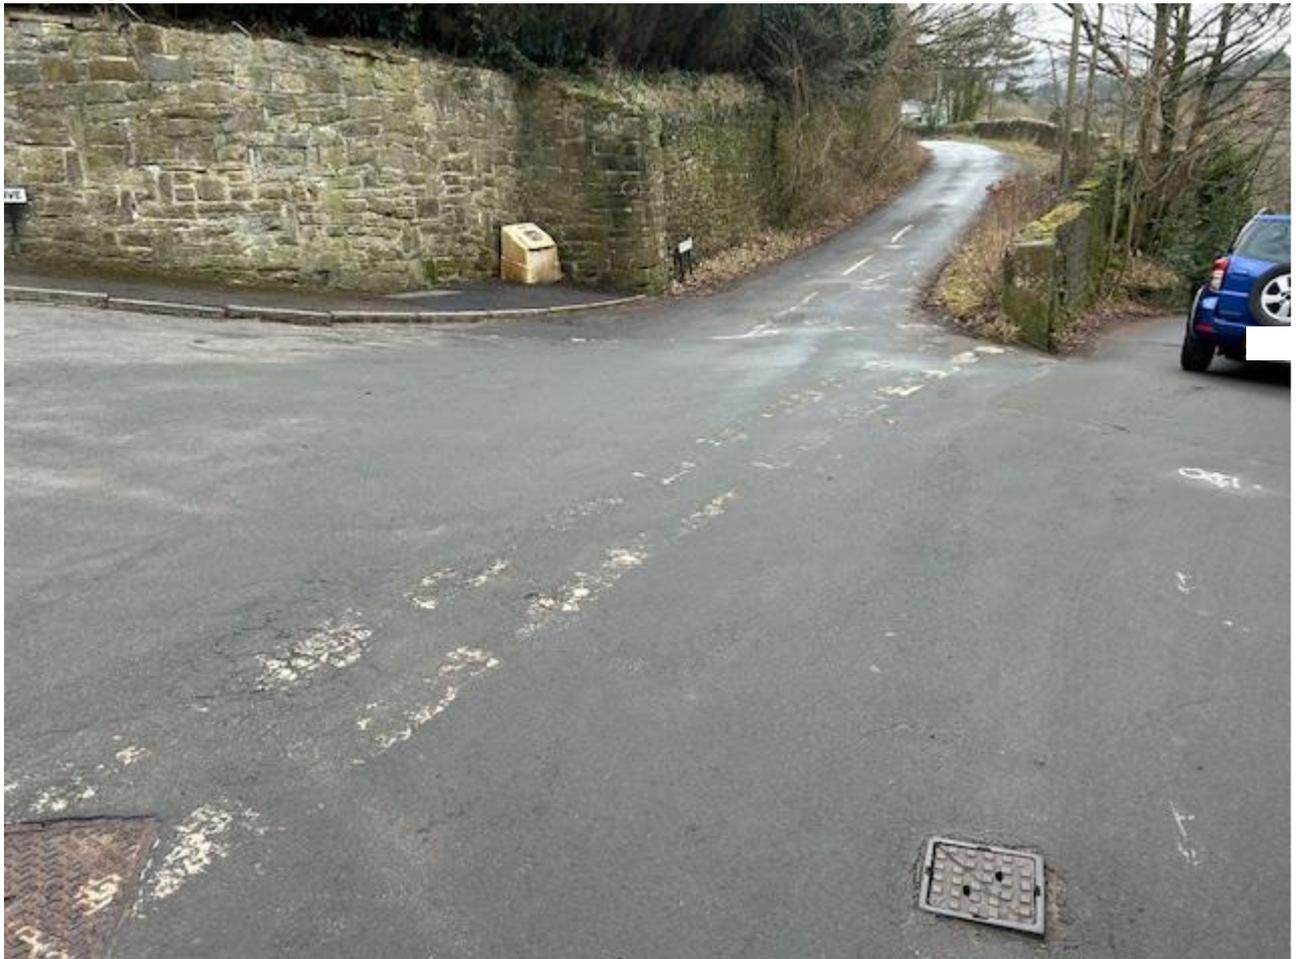
Chainage 0m

Comments – give way markings severley warn.

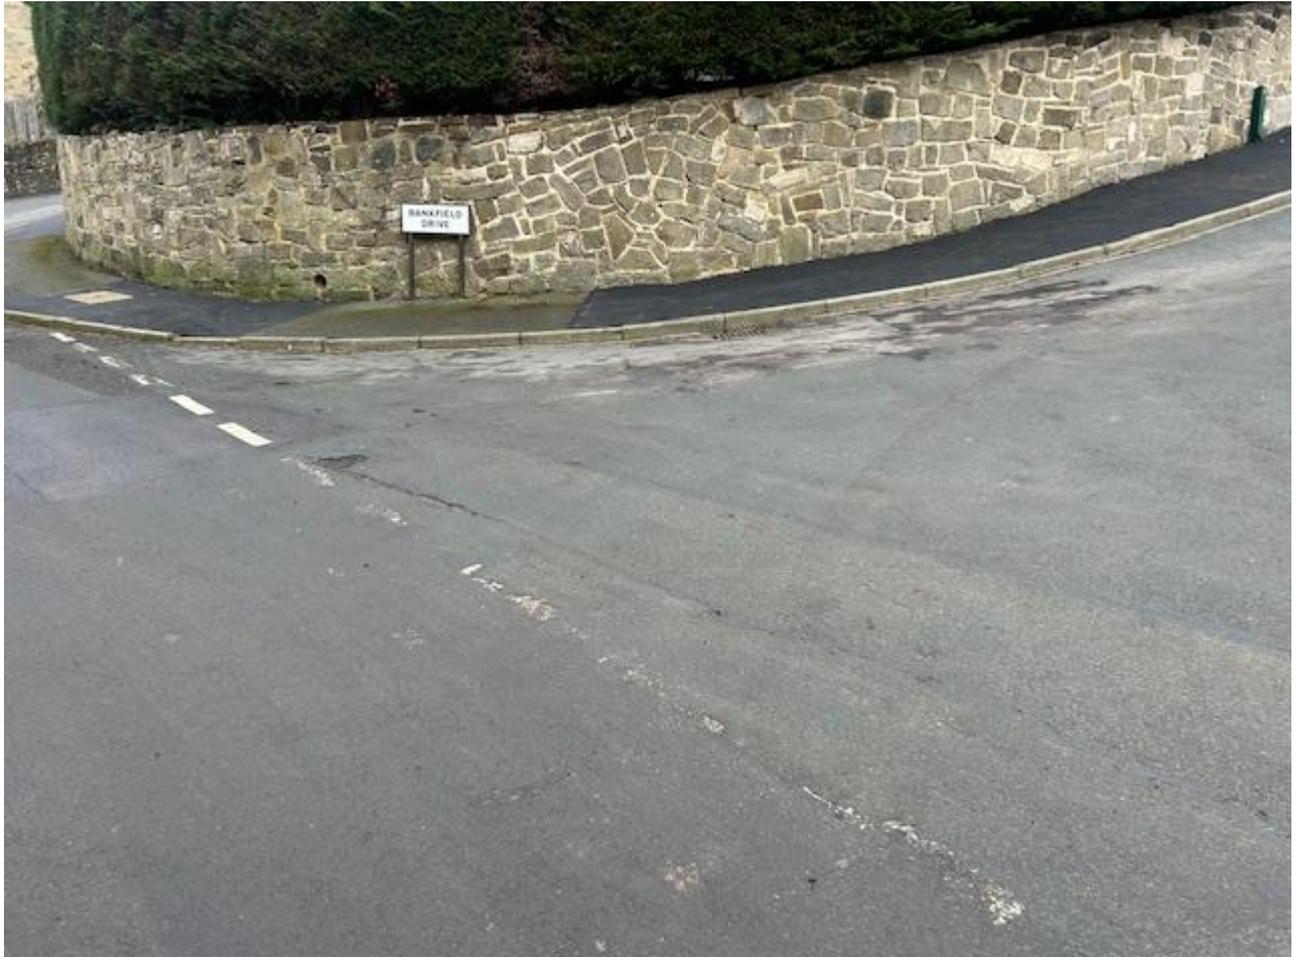
Chainage 0m

Comments – line marking severely worn. Localised area where surface course starting to break up.
Focus point.

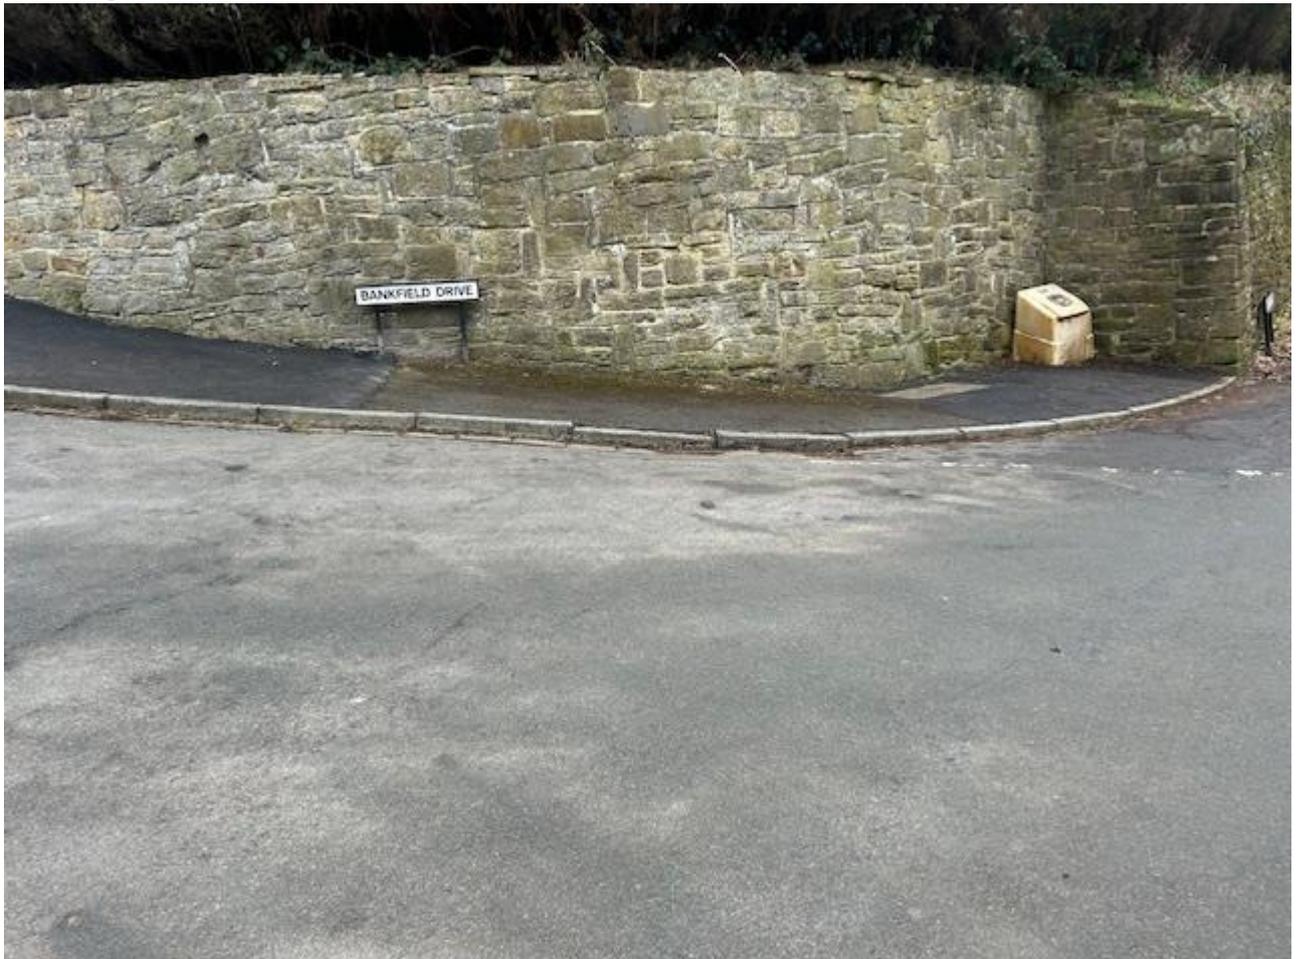
Chainage 0m

Comments – radius kerbs uneven.

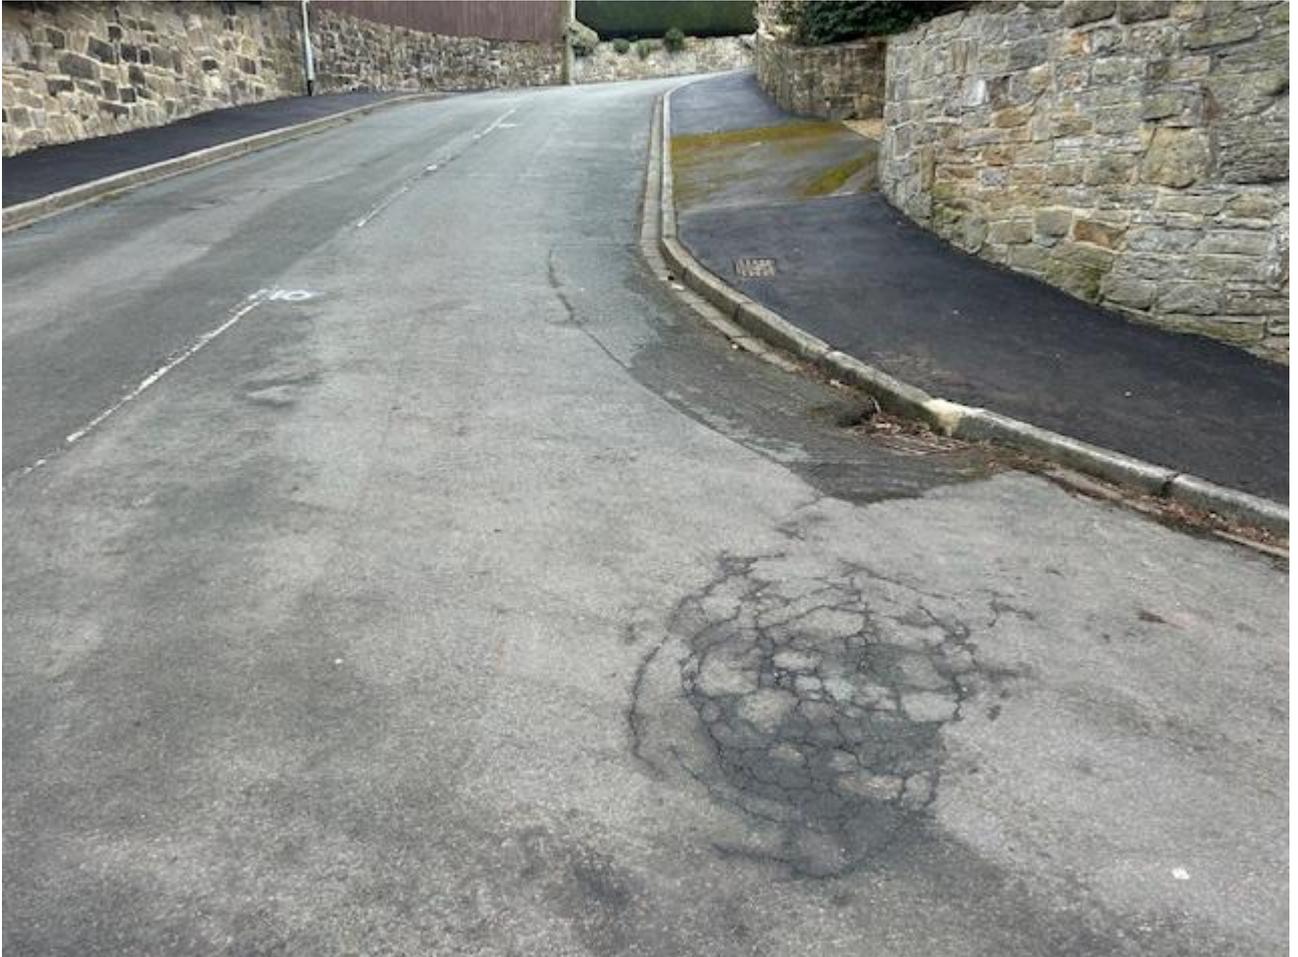
Chainage 5m

Comments – road surface sunk causing surface course to crack. Kerb line uneven adjacent to sunken gully. Trench reinstatement along right hand side of carriageway generally ok but joint not sealed leading to potential premature degradation. Centre line warn.

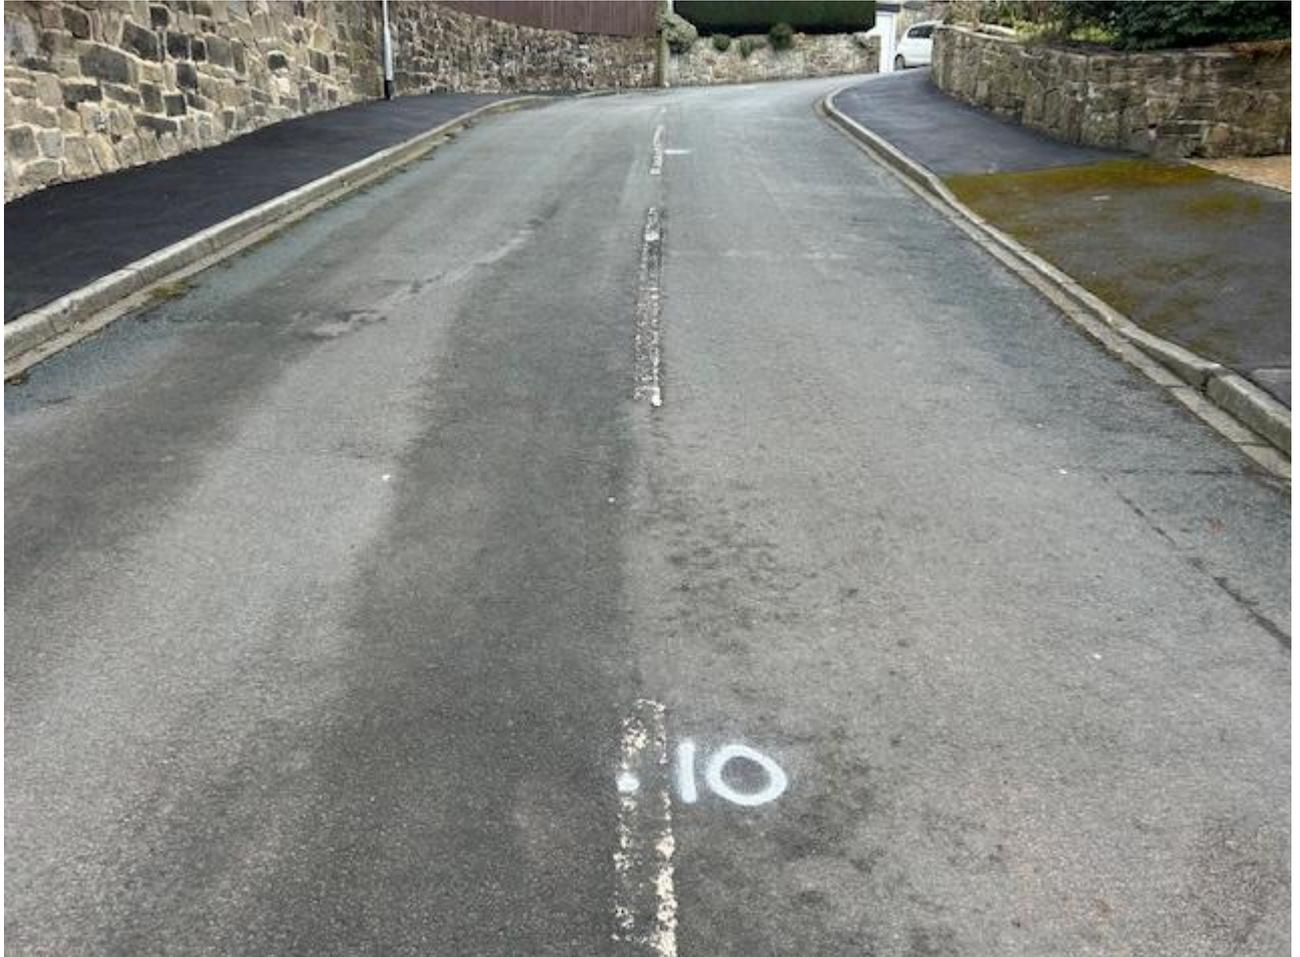
Chainage 10m

Comments – Centre line warn

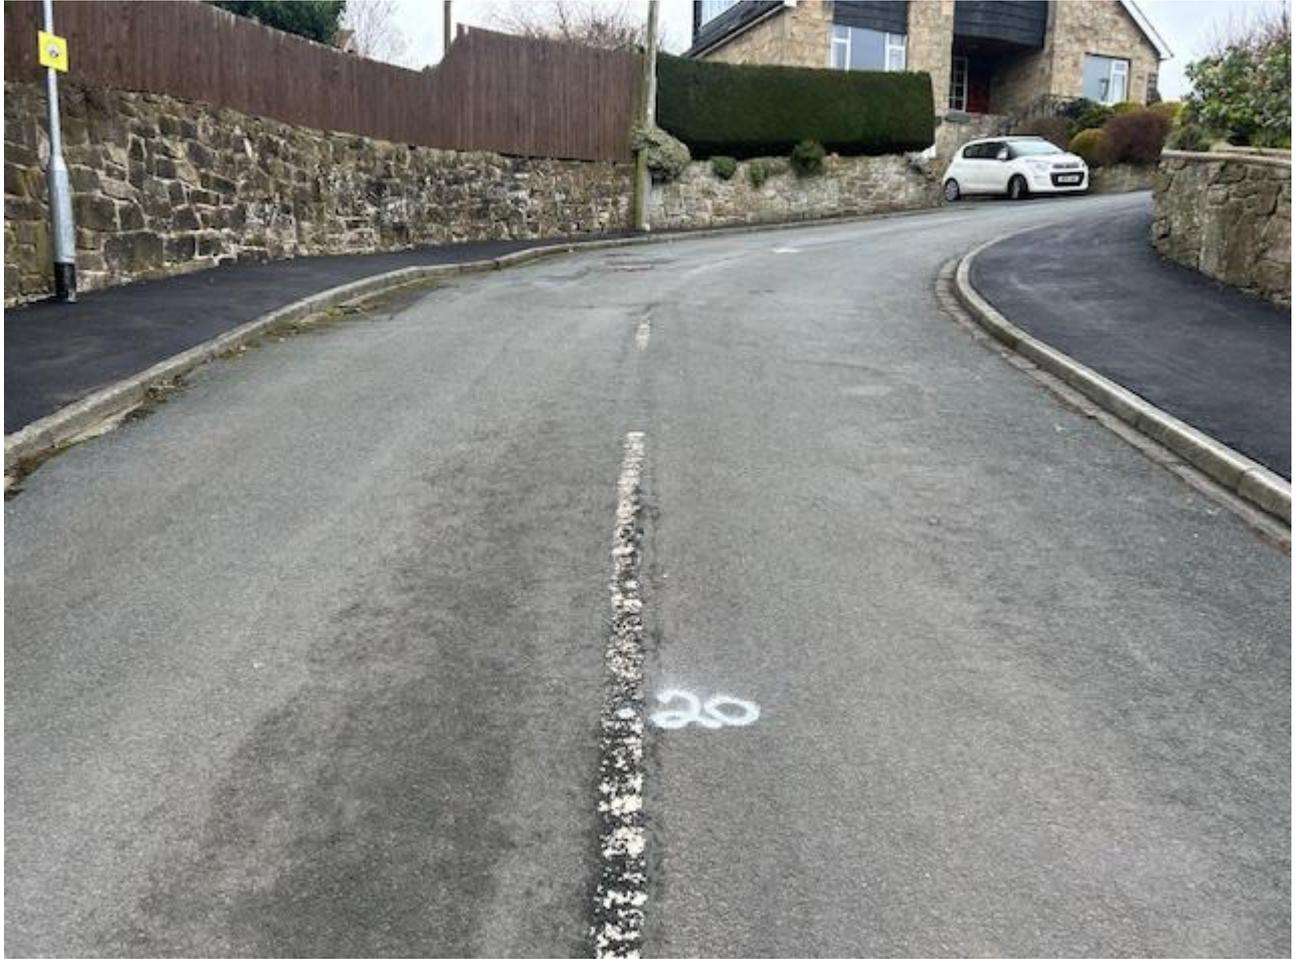
Chainage 20m

Comments – Centre line warn. Surface course up against left hand drainage channel degraded.

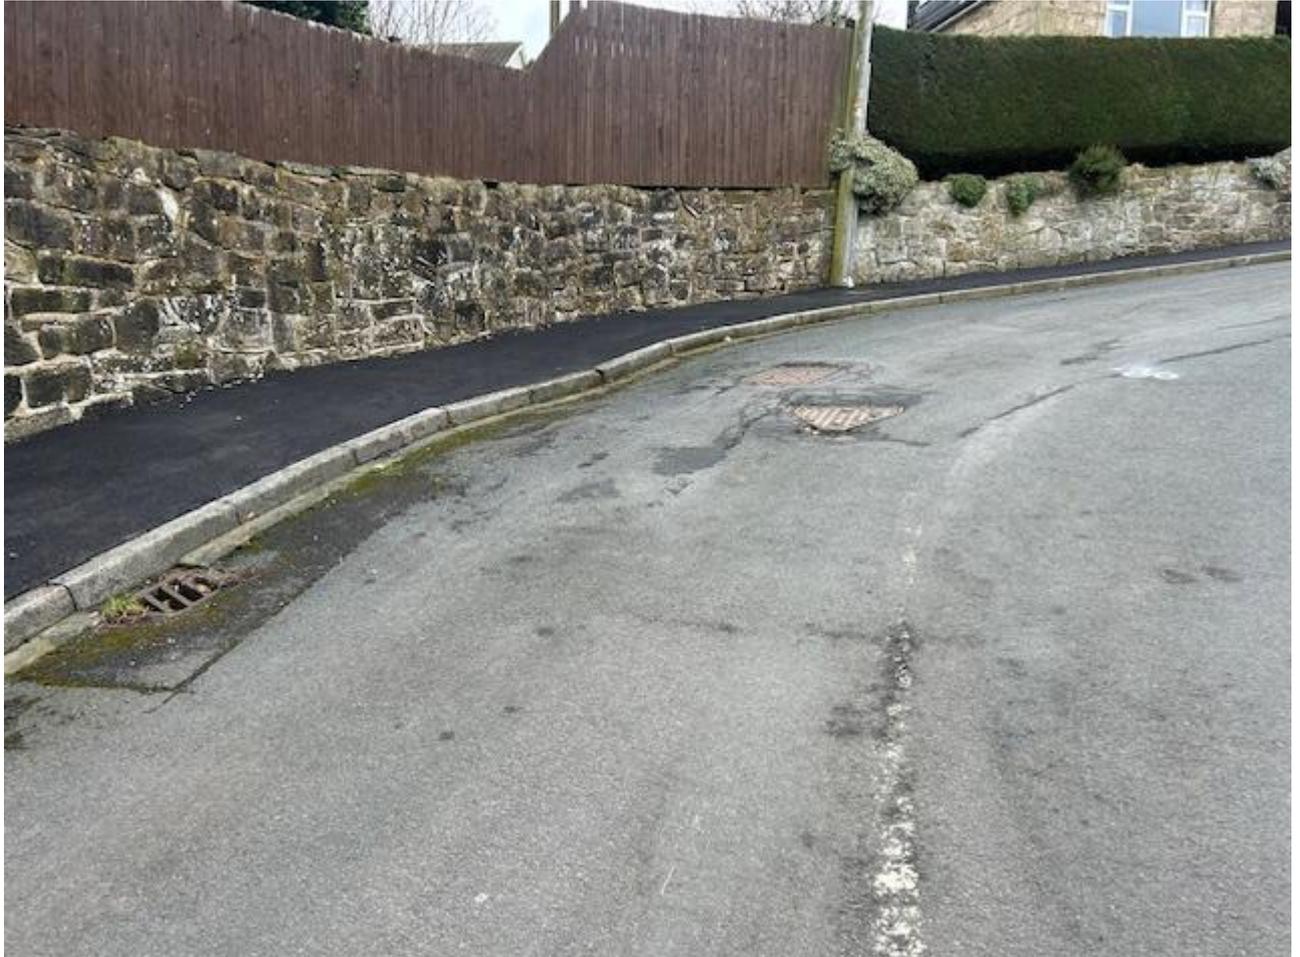
Chainage 25m

Comments – Centre line warn. Patchrepair around gully appears to be ok. Carrigeway / kerb settlement at chainage 29m

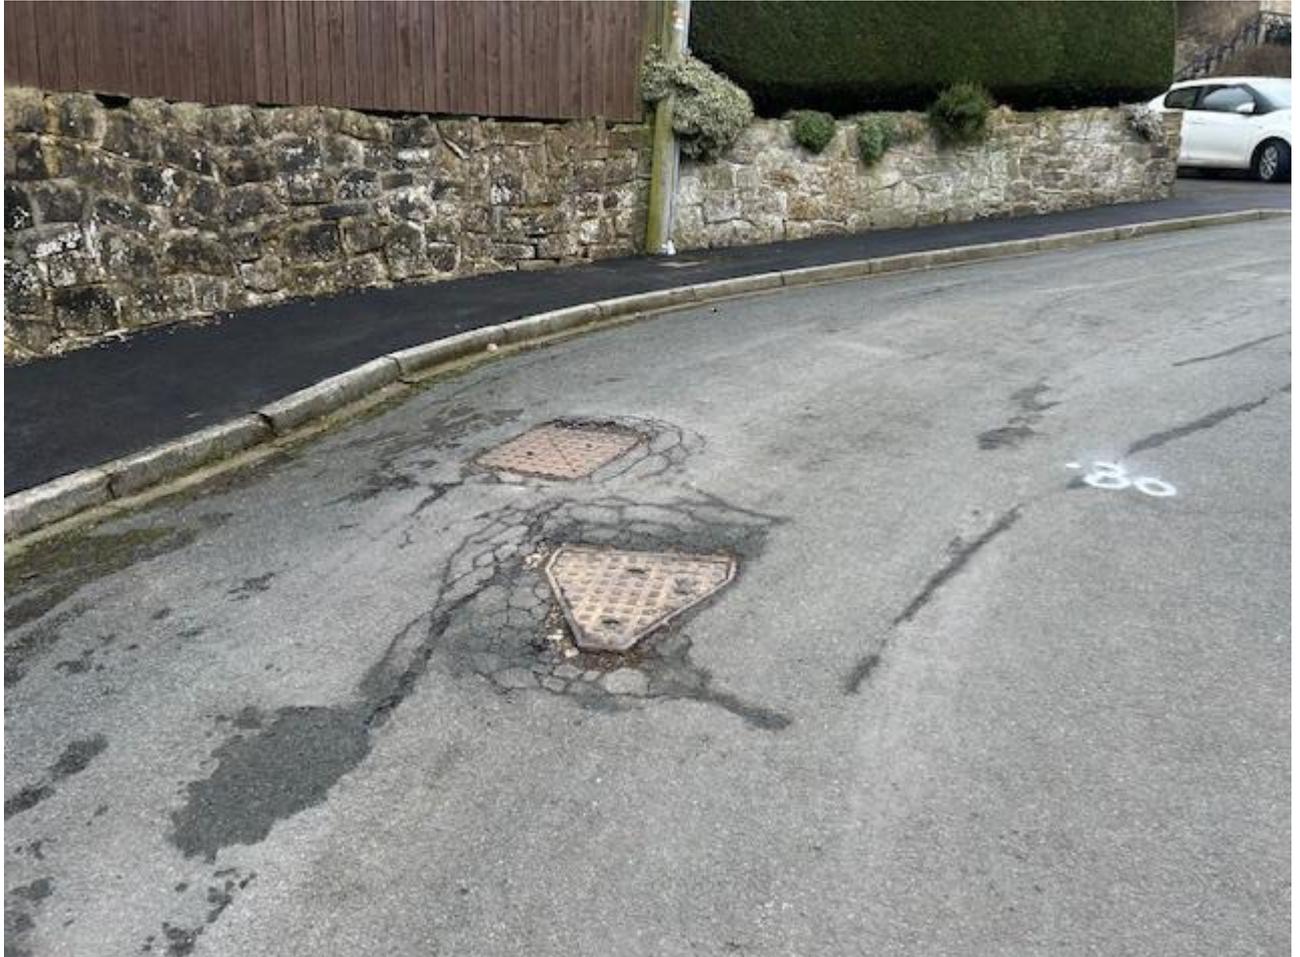
Chainage 30m

Comments – Kerb line and carriage way affected due to settlement. Iron work uneven due to similar problems with structural integrity of subbase. Requires attention. Focus point for monitoring.

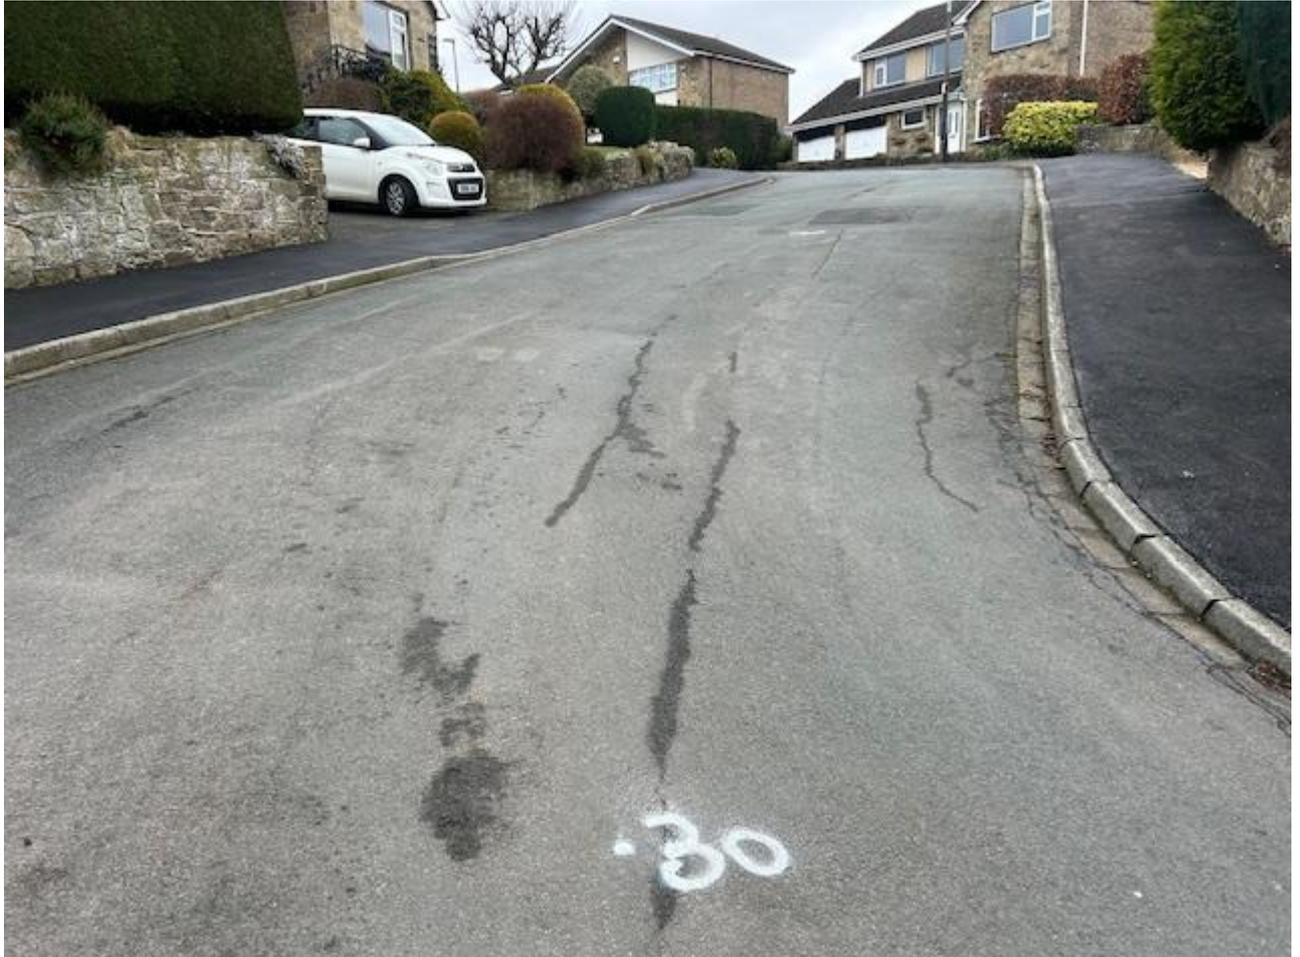
Chainage 30m

Comments – some evidence of surface course cracking.

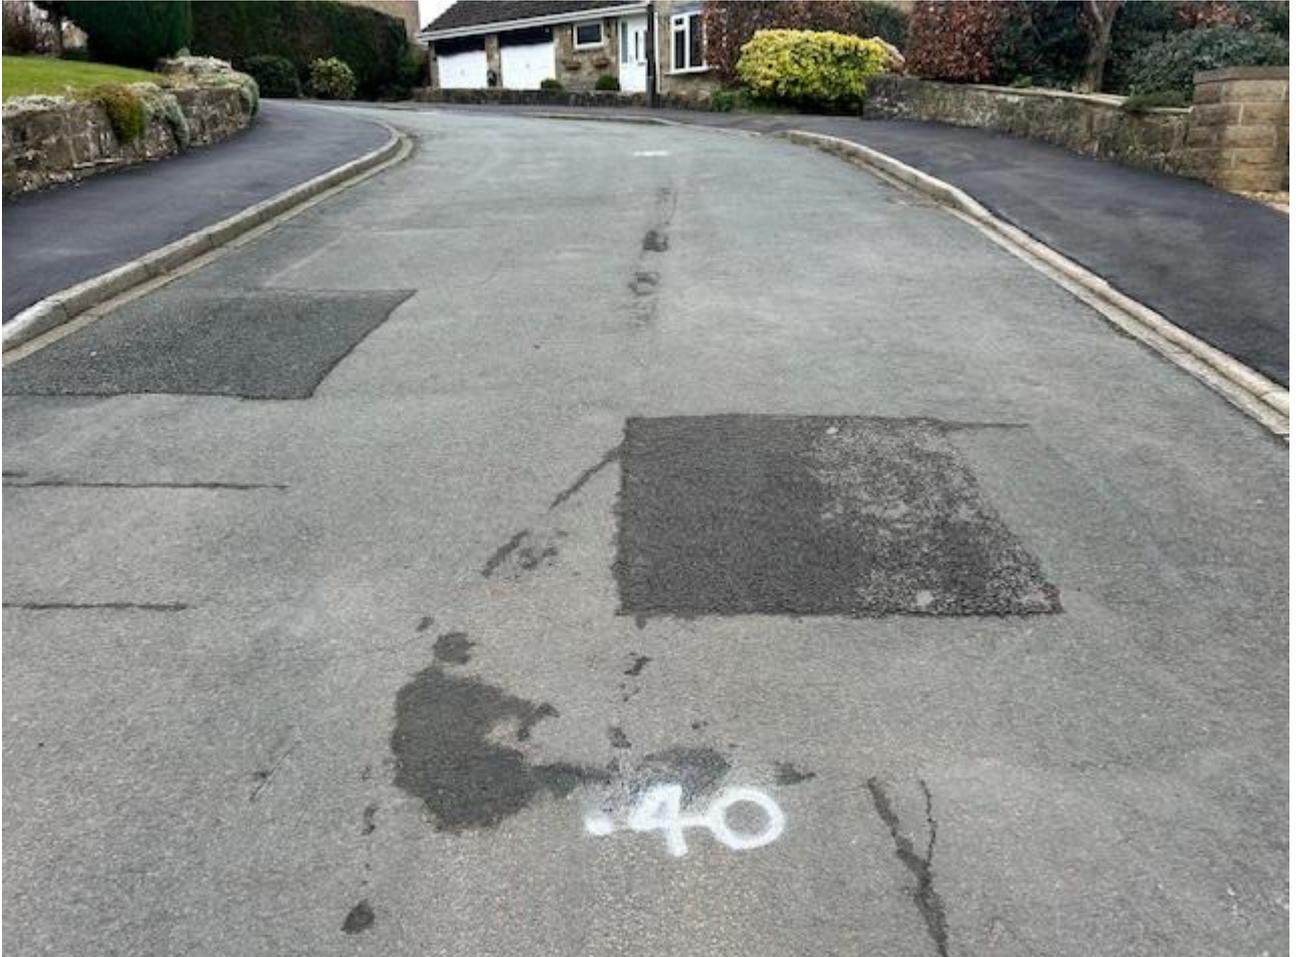
Chainage 40m

Comments – Patch repairs with no joint seal. Surface course cracks starting to develop.

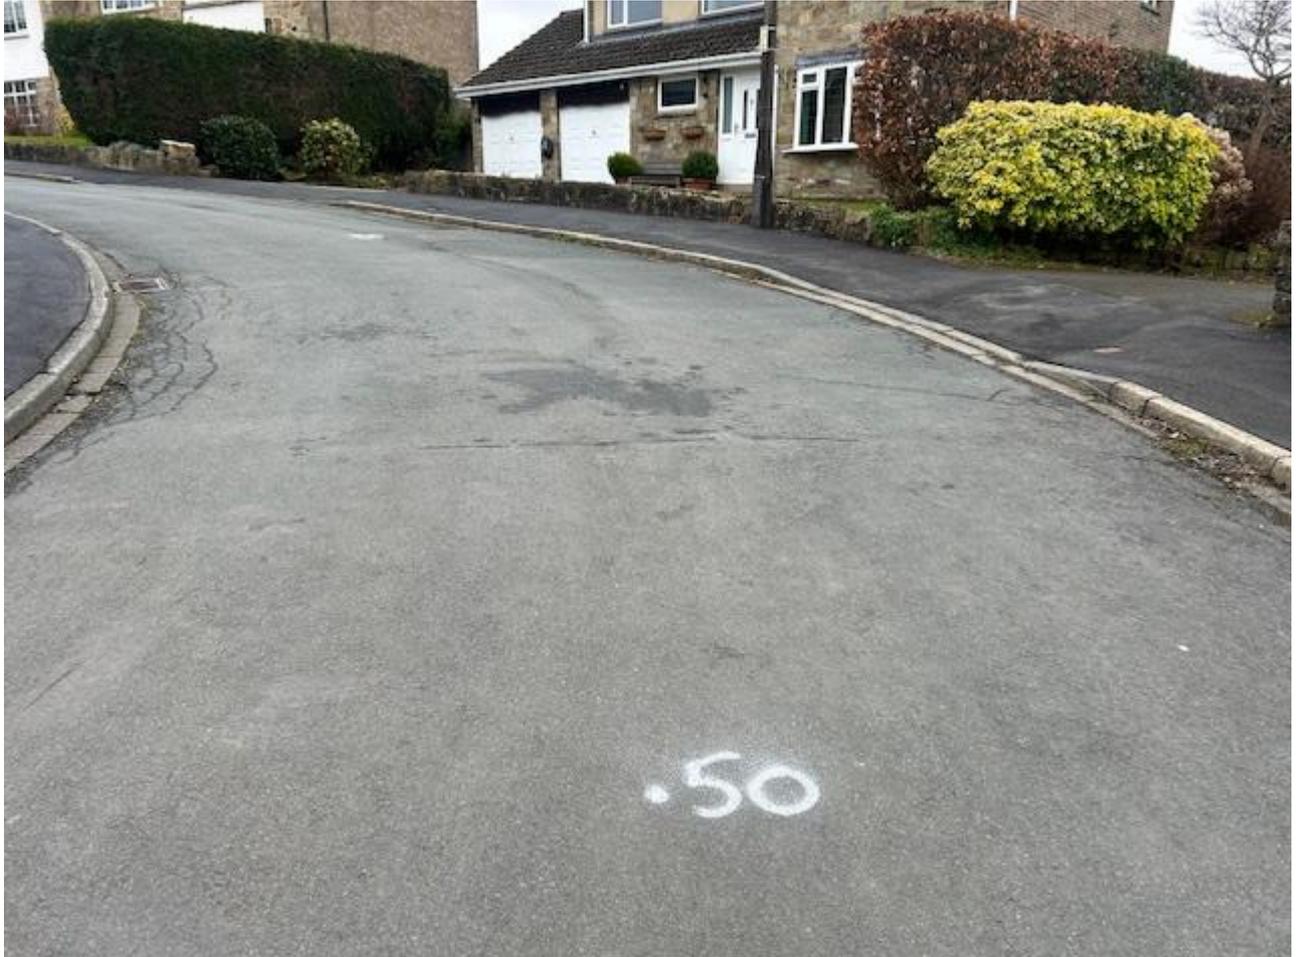
Chainage 50m

Comments – surface course tensile cracks starting to develop along left-hand side of carriageway due to settlement.

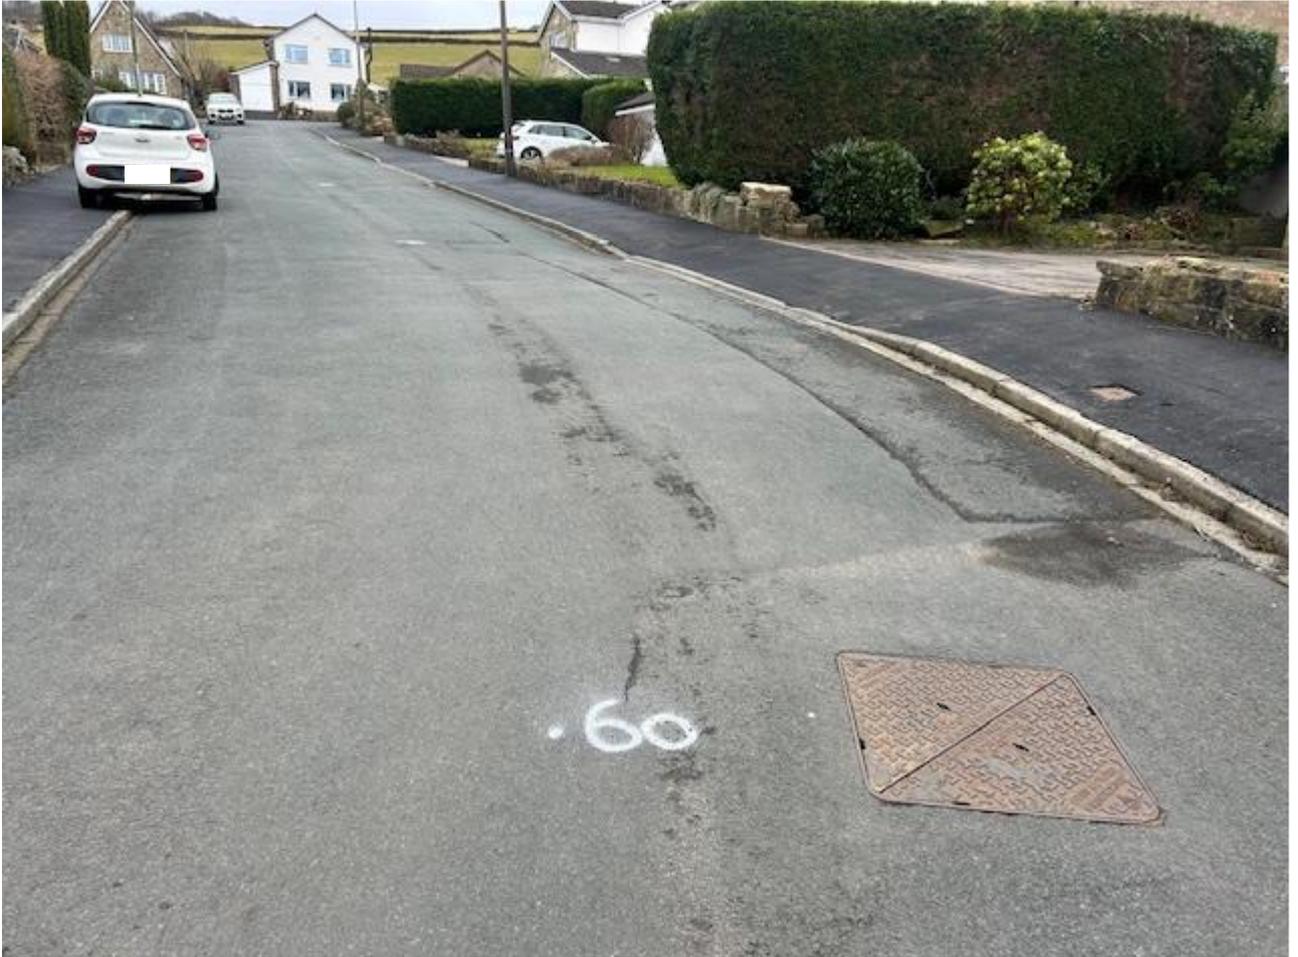
Chainage 60m

Comment – Patch repair along right hand side of carriageway, no joint seal.

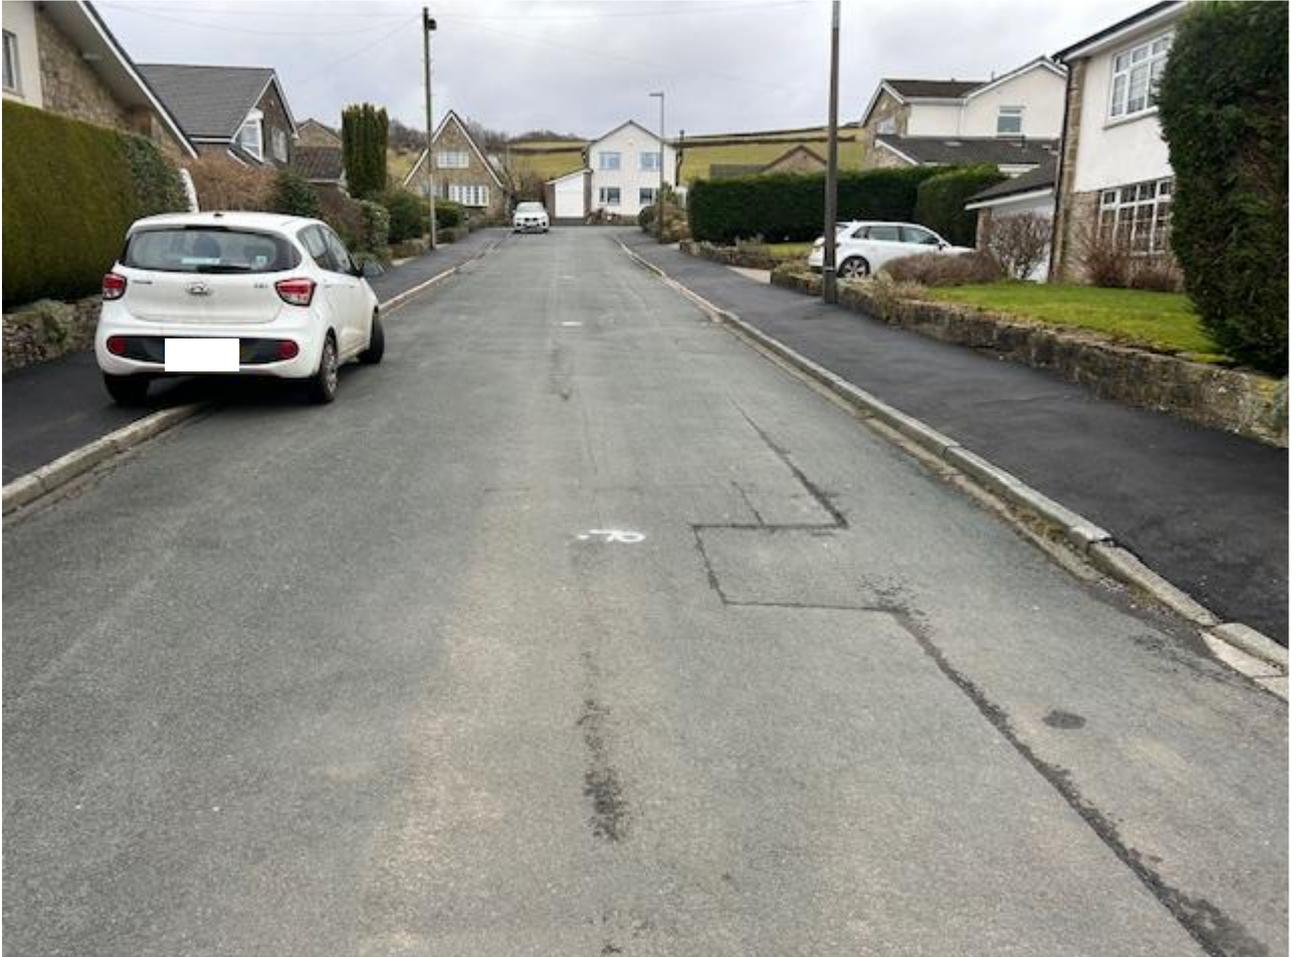
Chainage 65m

Comments - Drop kerb on right hand side of carriageway uneven, patch repair reinstatement continues. No joint seal.

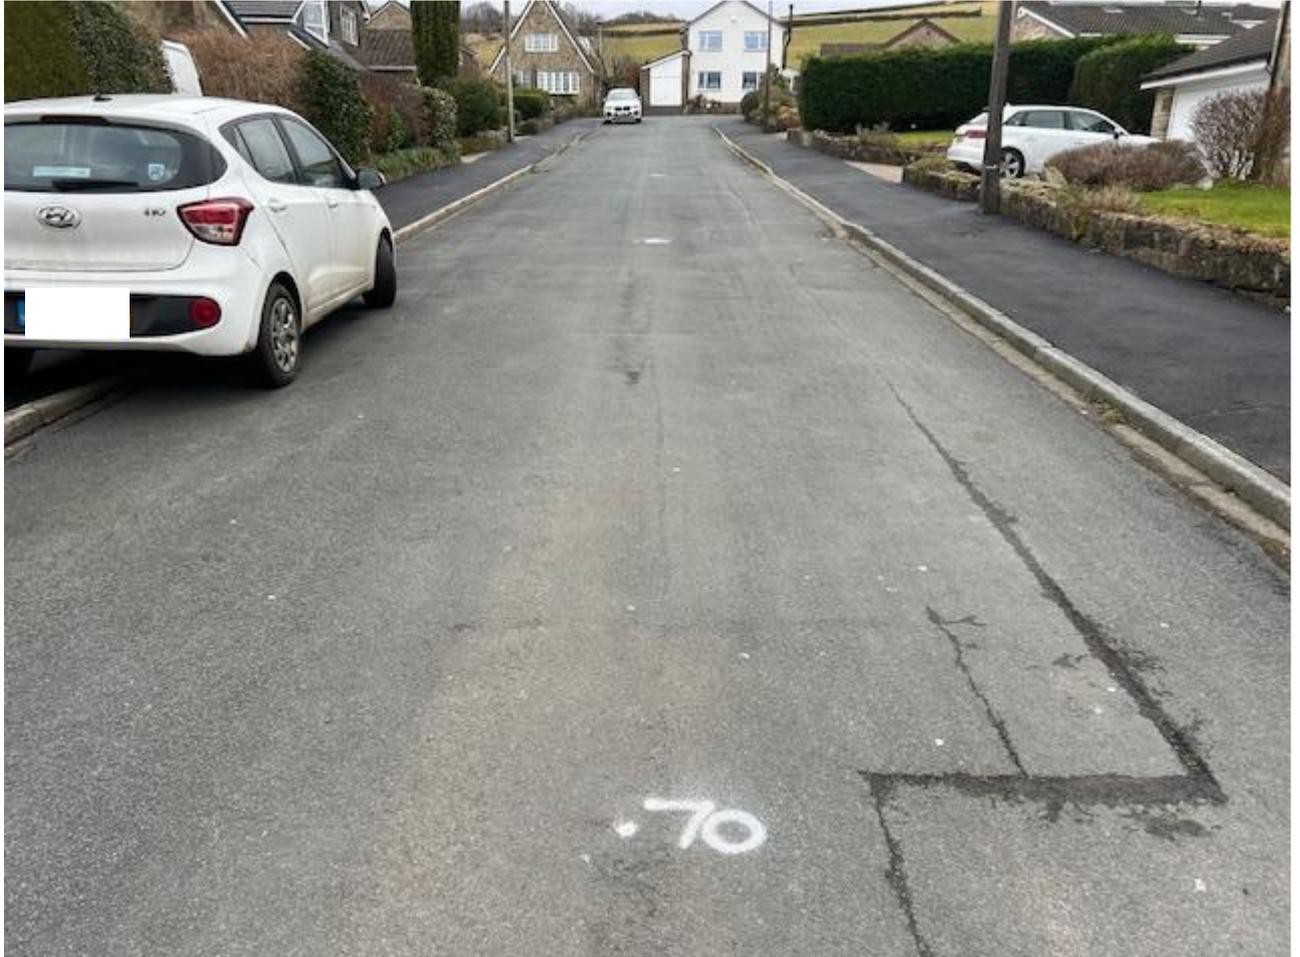
Chainage 70m

Comments – as previous.

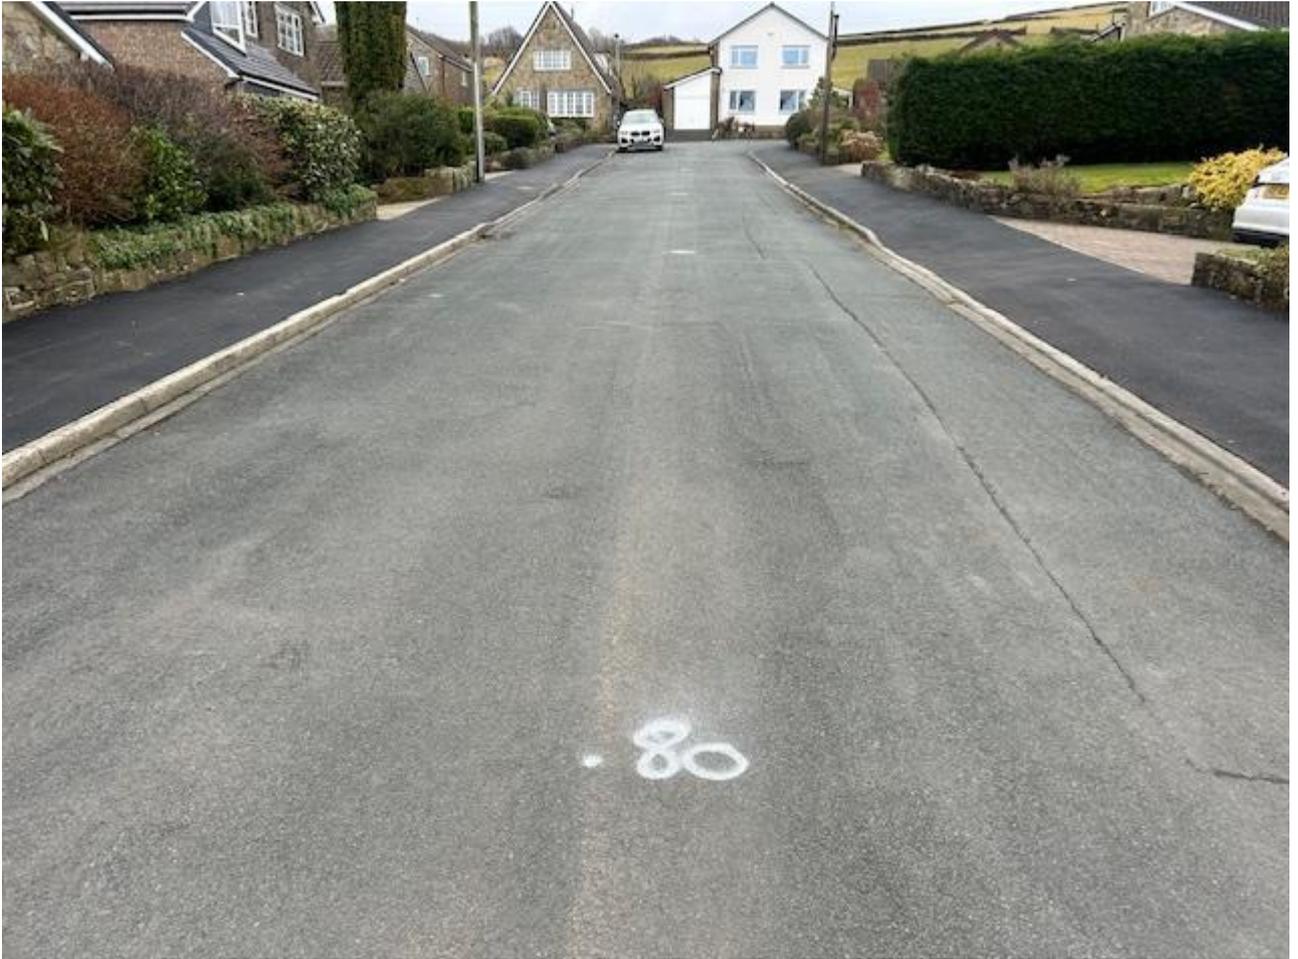
Chainage 80m

Comments – patch repair without sealed joint along right handside of carriageway.

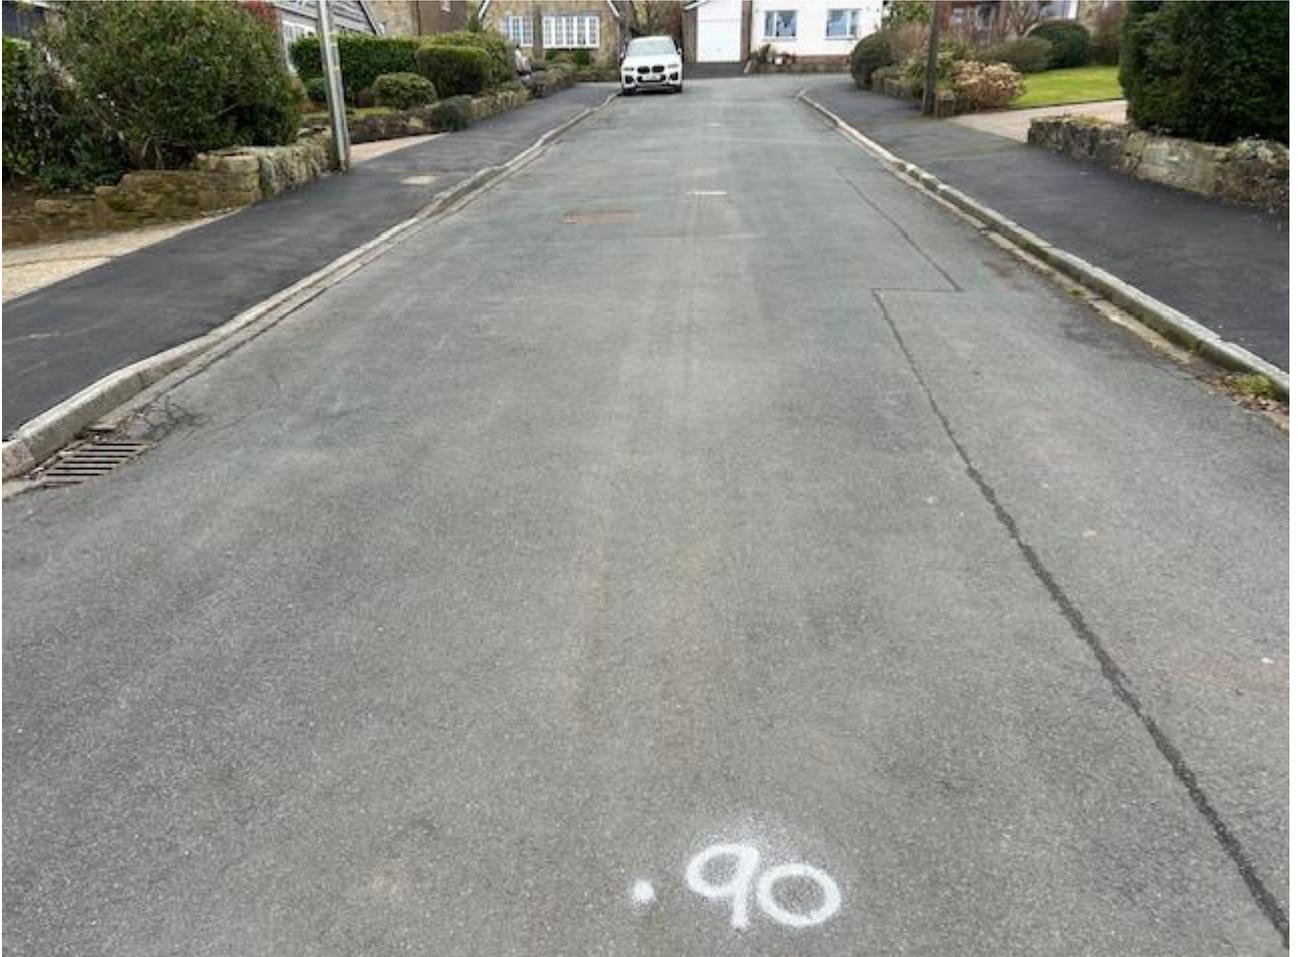
Chainage 90m

Comments – patch repair continues along right hand side of carriageway. Sunken road gully and drainage channel on left

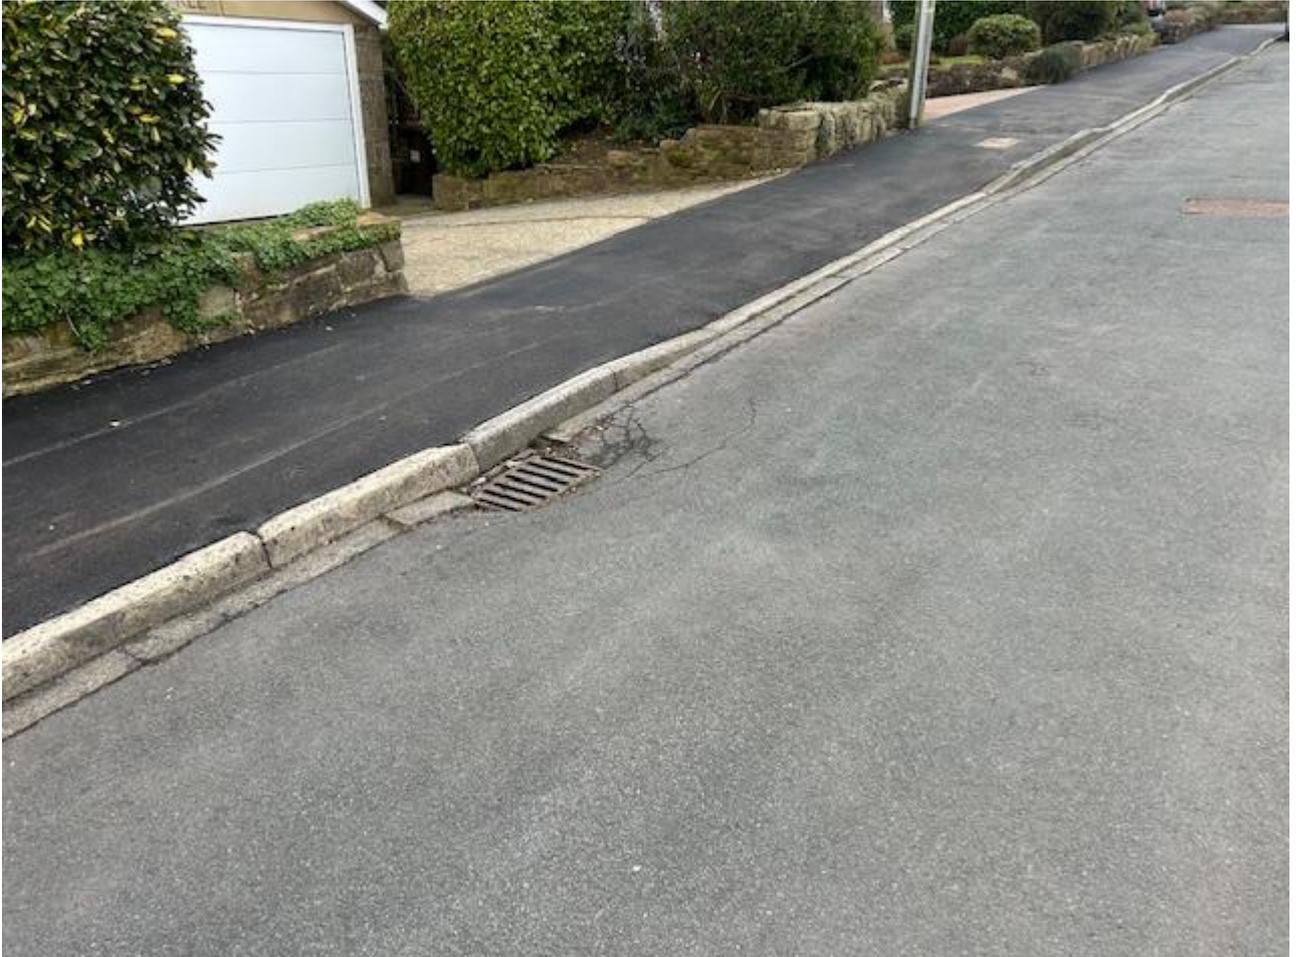
Chainage 94m

Comments – sunken gully in more detail plus some evidence of tensile cracks in surface course.
