Appendix E

Bankfield Drive - 07/02/25

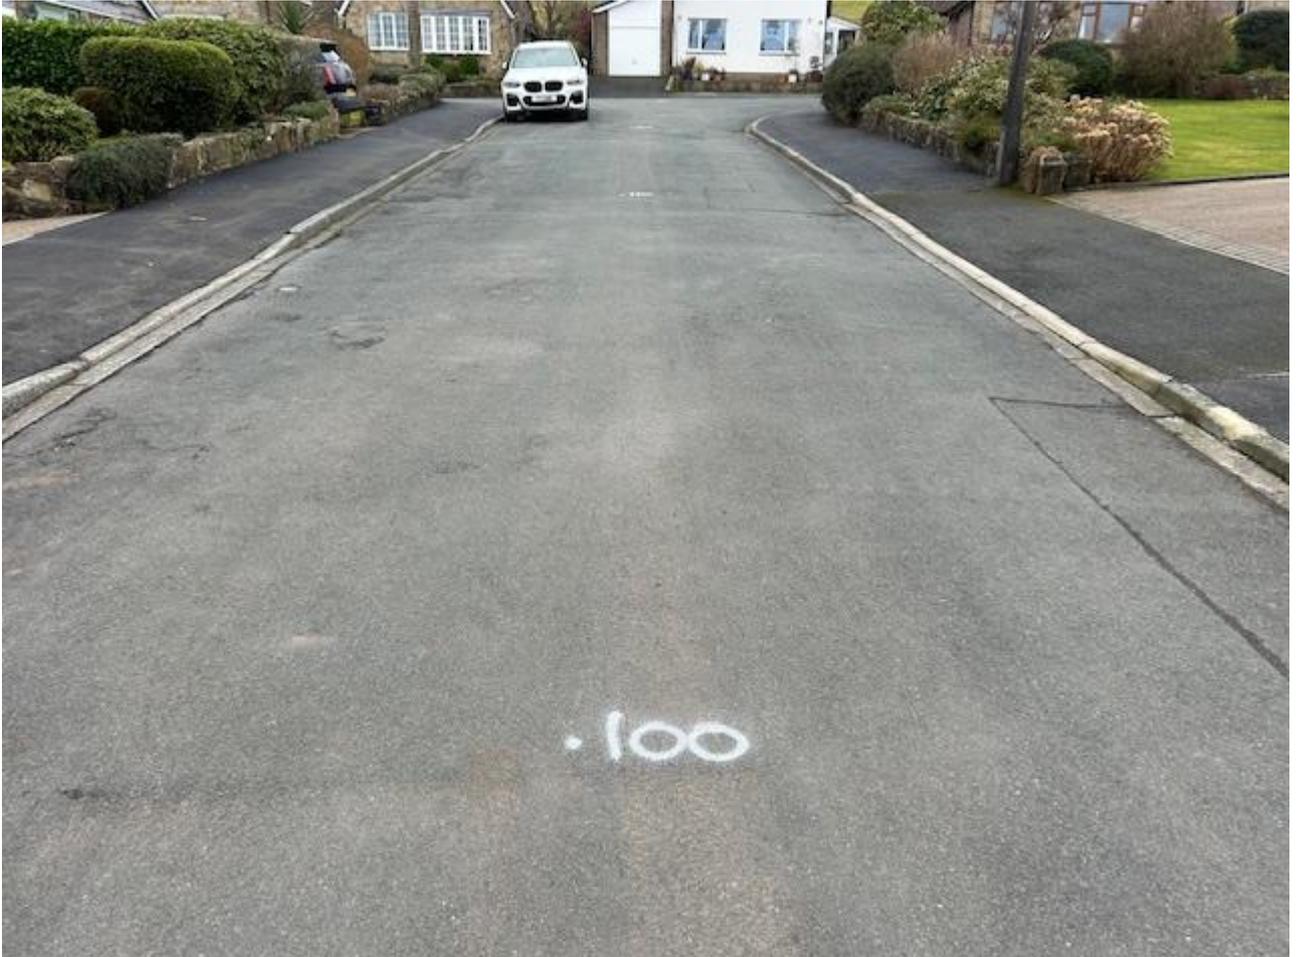
Chainage 100m

Comments – patch repiारे along right hand side of carriageway, no joint seal.

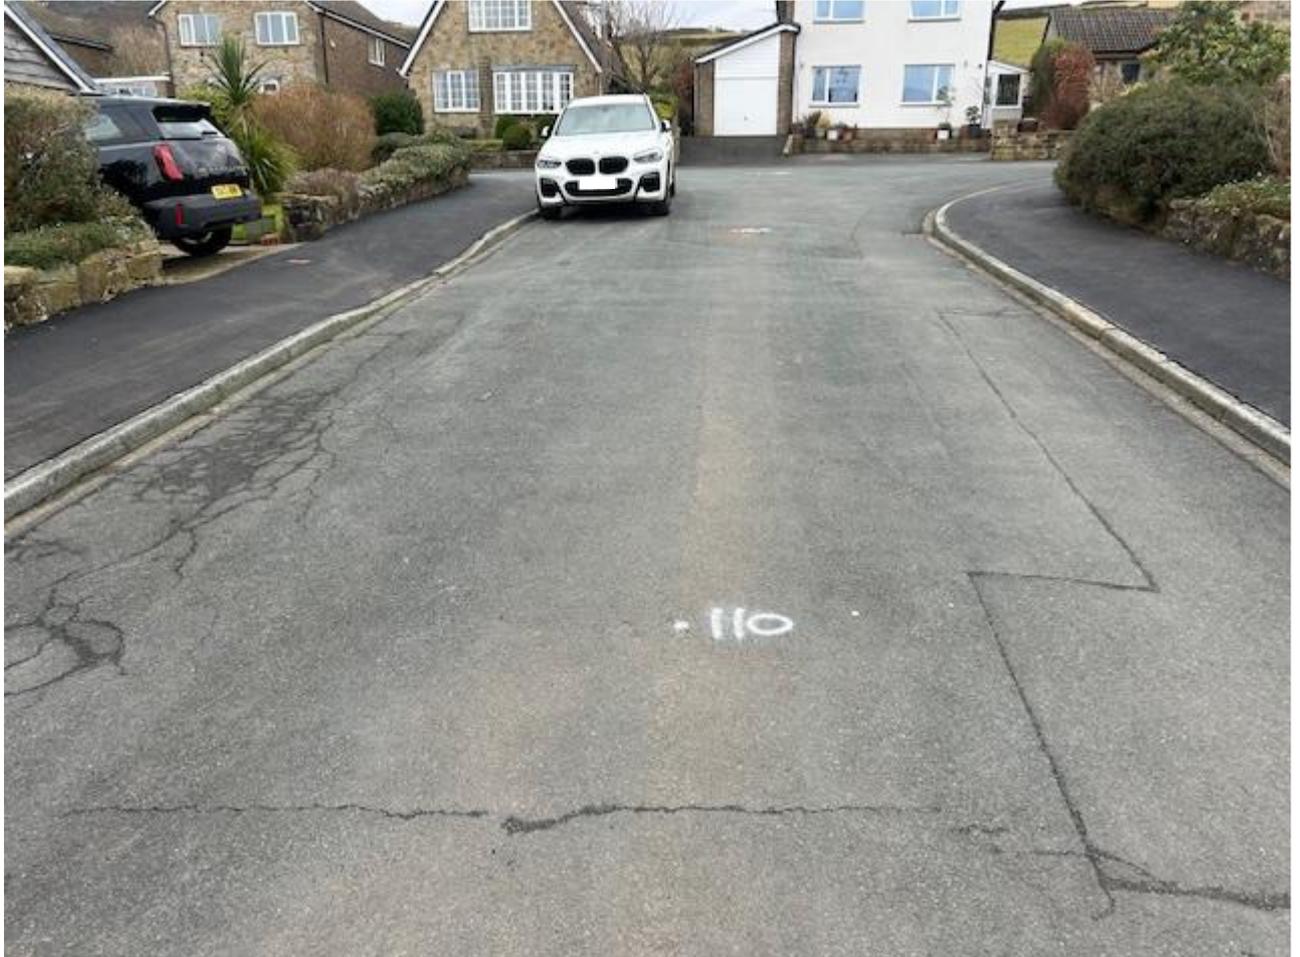
Chainage 110m

Comments – surface couse tensile cracks along left hand side of carriageway due to premature settlement. Evidence of transverse crack across carriageway. Patch repair along right hand side with no joint seal.

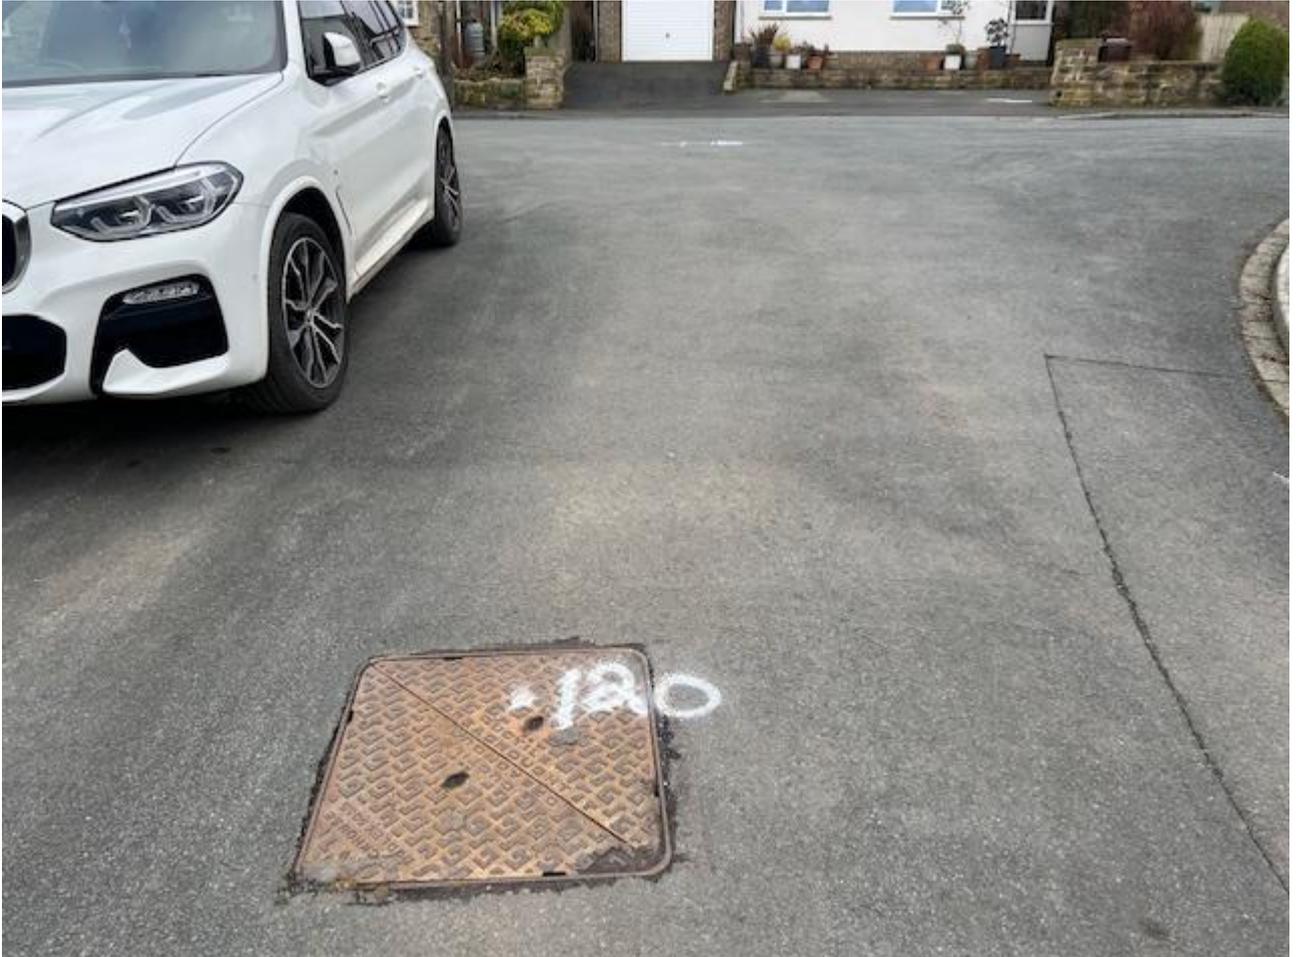
Chainage 120m

Comments – Patch repair on right hand side, no joint seal.
