STRUCTURAL ASSESSMENT OF
THE EXISTING BARN ADJACENT
TO

33 GAWTHORPE LANE
HUDDERSFIELD
HD5 0NY

DATED: FEBRUARY 2025

SUBMITTED BY NORTHERN DESIGN PARTNERSHIP
THE CHAPEL, MILLMOOR ROAD
MELTHAM, HOLMFIRTH HD9 5JU
TEL: 01484 854848
EMAIL: paul.briggs@northerndesignpartnership.co.uk

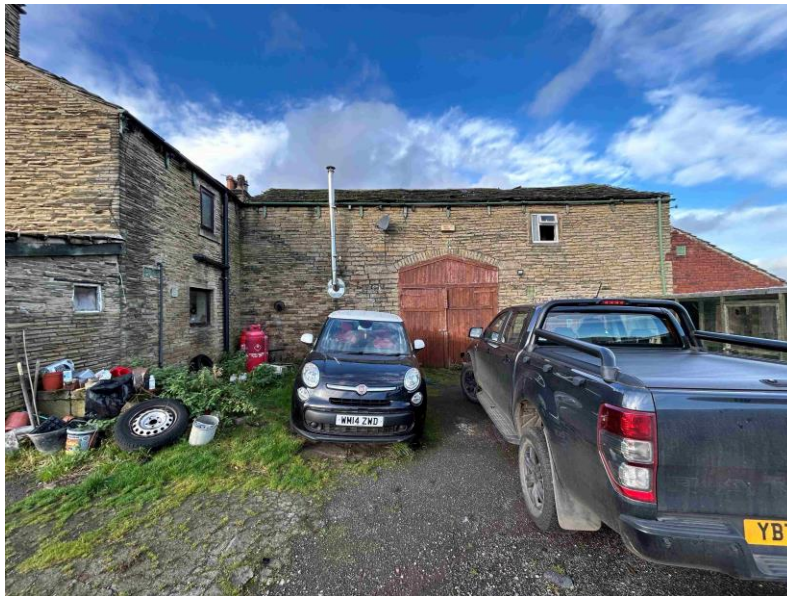
1.02 – The main barn is constructed of stone walls, with a stone slate roof, see photographs 1 and 2. The barn has a 'lean to' element to the North which is constructed of red brick with a stone slate roof, see photograph 3.

Photograph 1 – Barn East Elevation

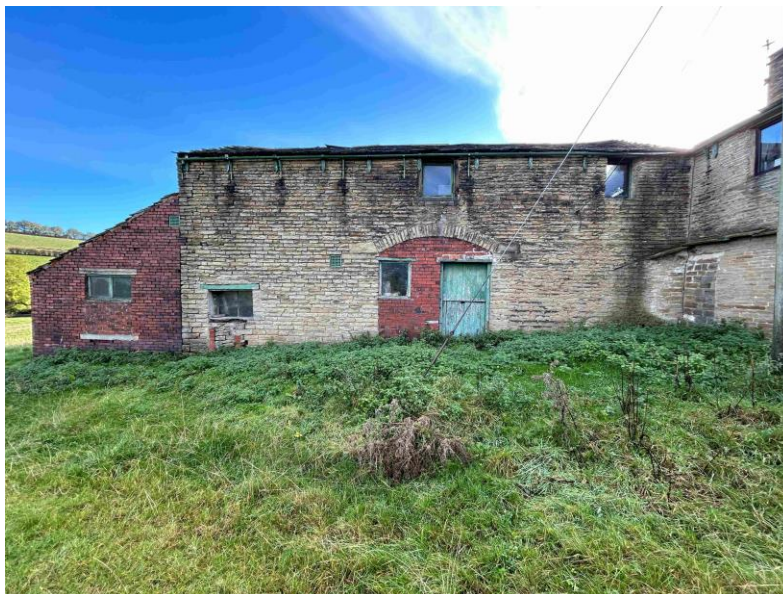
Photograph 2 – Barn West Elevation

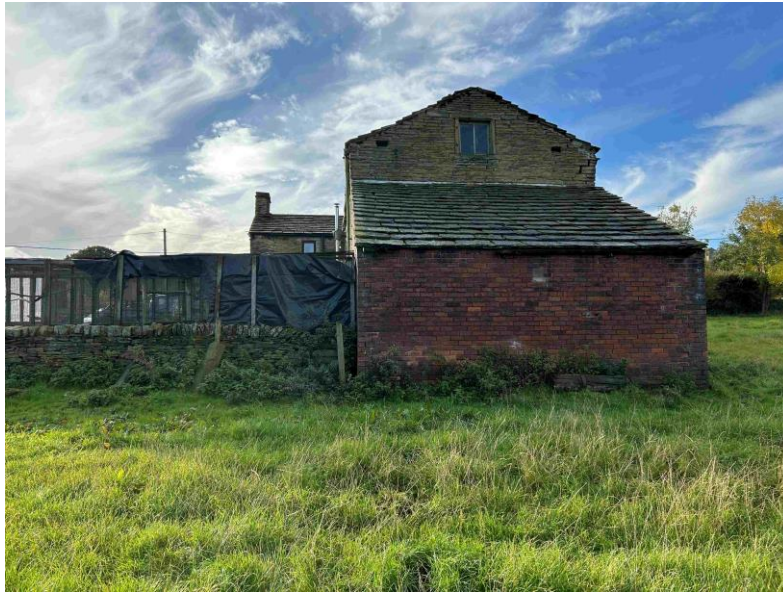
Photograph 3 – North 'lean to' section

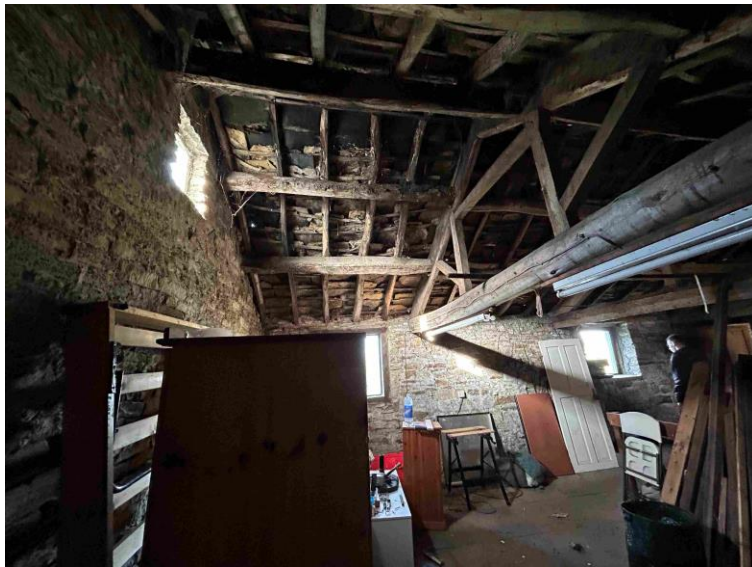
The roof to the main barn is of traditional construction and made up of 4 main timber trusses, with purlins and rafters. See Photographs 4 and 5. The roof timbers are generally in good order. Some localised strengthening and support maybe required, but this will not be significant. Some rafters may need replacing but on the whole the roof structure is suitable for the proposed conversion. As part of the conversion works, the roof slates will need carefully removing, the roof felted and battened and the roof slates re-laid. The roof in the lean to section is again traditional, with timbers purlins and rafters, all in good order. See Photograph 6.

Photograph 4 – Main Roof Structure

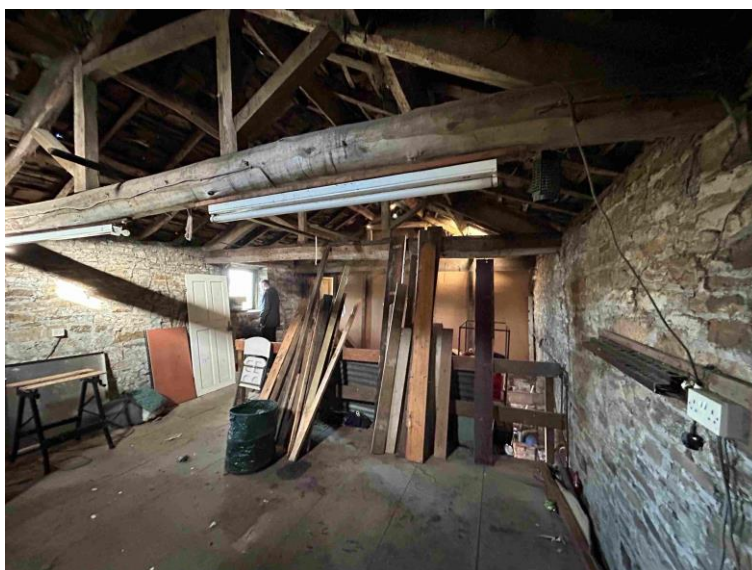
Photograph 5 – Main Roof Structure

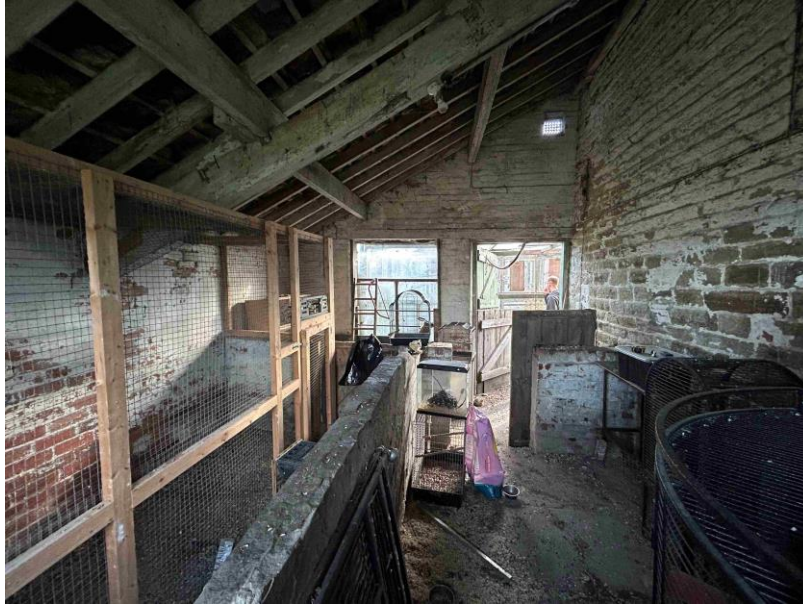
Photograph 6 – ‘Lean To’ Roof Structure

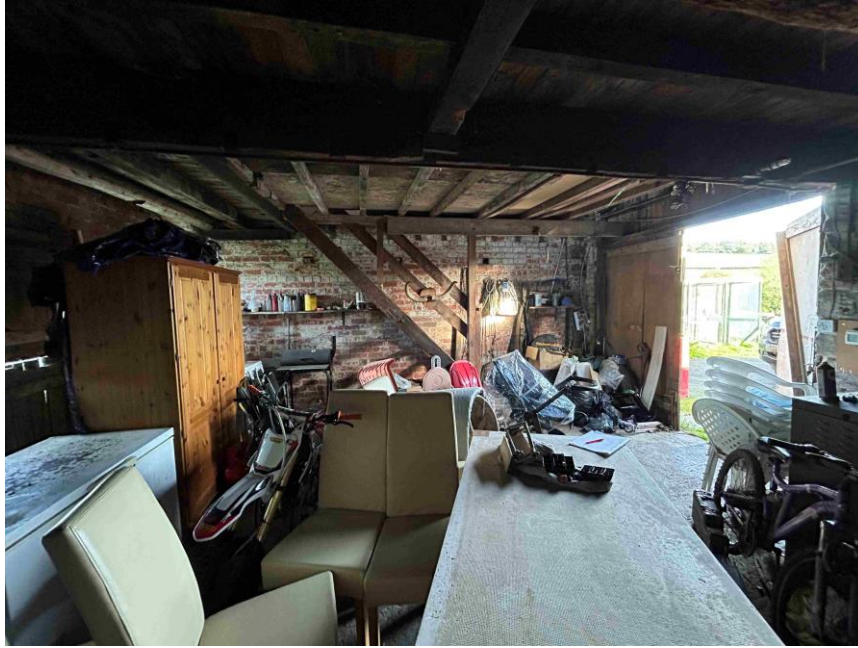
The ground floors are concrete. These show no signs of structural movement. The first floor is a timber joist structure, see Photograph 7. The joists are in good order. It's likely that the floors will be replaced to ensure current damp proofing and insulation levels can be achieved.

Photograph 7 – First Floor Structure in Main Barn.
