STRUCTURAL APPRAISAL REPORT

REF: MDL – 8474

Barns at Barley Fields Farm
Oxford Road
Gomersal
Cleckheaton
BD19 4HA

We have been instructed to undertake an appraisal of the structural condition of 2No. barns with a view to their future conversion into habitable dwellings under 'Class Q' planning guidelines.

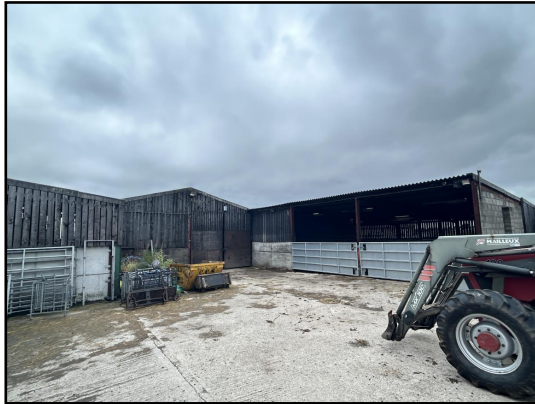
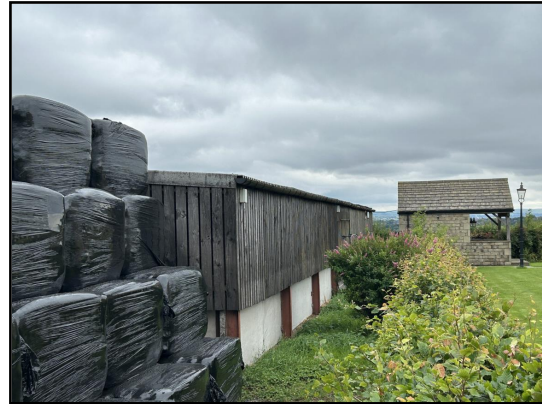
Main Barn – Steel Portal Framed Shed

The main barn building comprises of an extended individual single bay steel portal frame structure being approximately 31m long by 21m wide.

The portal frame bays are at approximate 4.5m centres and the steel stanchions measured as 178x102x19 UB sections with the rafters also measuring 178x102x19 UB sections. The height to eaves measured 4.0m, with a height to the apex of the roof approximately 5.1m high.

Inspection of the main structural members confirmed that they were free from defect, with no evidence of distress, buckling or excessive deflection of the steelwork.

Very minor surface corrosion was noted to the steelwork; however, no delamination of the steelwork was in evidence therefore we do not consider this to be a structural concern.

The main bolt fixings between the stanchion columns and roof rafters were all in a serviceable condition, with no structural defects noted.

The barns have substantial 140mm thick external blockwork walls up to a maximum height of 2.0m above ground level. Timber slatted panels feature above the block work, thus letting light into the inner barn area. The timber slats are supported on 100x75 timber eaves beams and cladding rails.

The walls are all vertically plumb, with no structural movement or cracking defects being noted to the external masonry walls of the barn.

The roof of the barn has a corrugated cement board covering supported on timber purlins spanning between the main steel frames. The timber purlins were measured to be approximately 175mm by 75mm sections at approximately 1.2m centres.

Since it is proposed to replace the current roof covering, which weighs approximately 17 kg/m². it is our advice and recommendation that the roof covering is replaced with a more modern insulated composite panel roof covering.

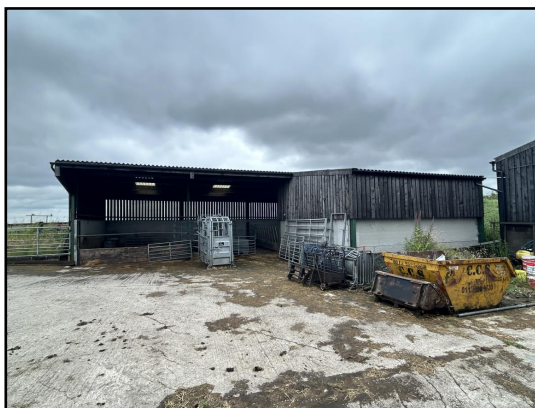
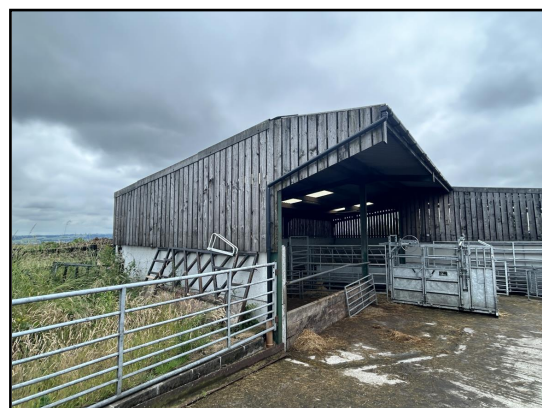
Small Barn – Steel Portal Framed Shed

The small barn building comprises of an 'L' shaped individual single bay steel portal frame structure being approximately 15.0m long by 12.0m wide.

The portal frame bays are at approximate 5.0m centres and the steel stanchions measured as 178x102x19 UB sections with the rafters also

measuring 178x102x19 UB sections. The height to eaves measured 3.3m, with a height to the apex of the roof approximately 4.2m high.

Inspection of the main structural members confirmed that they were free from defect, with no evidence of distress, buckling or excessive deflection of the steelwork.

Very minor surface corrosion was noted to the steelwork; however, no delamination of the steelwork was in evidence therefore we do not consider this to be a structural concern.

The main bolt fixings between the stanchion columns and roof rafters were all in a serviceable condition, with no structural defects noted.

The barns have substantial reinforced concrete panels forming the external walls up to a height of 1.8m above ground level. Timber slatted panels feature above the block work, thus letting light into the inner barn area. The timber slats are supported on 100x75 timber eaves beams and cladding rails.

The walls are all vertically plumb, with no structural movement or cracking defects being noted to the external concrete walls of the barn.

The roof of the barn has a corrugated cement board covering supported on timber purlins spanning between the main steel frames. The timber purlins were measured to be approximately 200mm by 75mm sections at approximately 0.8m centres.

Since it is proposed to replace the current roof covering, which weighs approximately 17 kg/m². it is our advice and recommendation that the roof covering is replaced with a more modern insulated composite panel roof covering. The proposed loading is very similar to the existing roof covering, and such a nominal increase does not warrant any structural concern.
