## STRUCTURAL CONDITION REPORT The George Hotel, Huddersfield

Client: GMI Construction  
Project Name: The George Hotel, Huddersfield  
Report Title: Block A – Condition Report  
Report Author: James Hendry  
Document ref: 00.24363 -ACE-ZZ-ZZ-T-S-0003  
Date: Apr'25

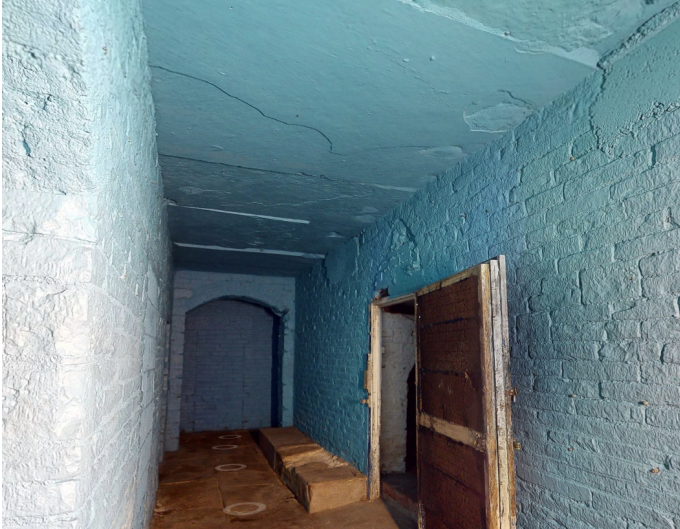
Location	Notes	Photo
B.01	<p>Stone paving flags spanning between masonry walls observed in several areas.</p> <p>Concrete basement slab present, with isolated areas surfaced in stone paving flags.</p> <p>Heavy paint coating noted on masonry walls and soffit, which may be obstructing a full visual assessment of their condition.</p>

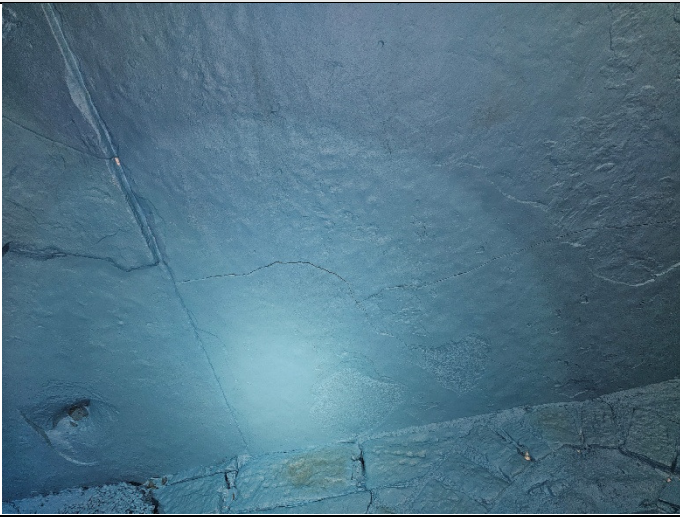
Location	Notes	Photo	
B.02	Possible shear crack visible in soffit of stone slab.

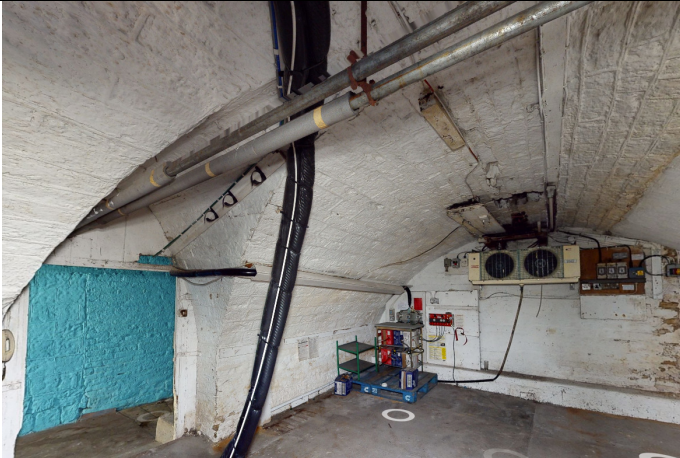
B.03	<p>The vaulted masonry basement appears to be in generally reasonable condition, with no visible signs of longitudinal cracking or structural movement.</p> <p>Numerous service installations are suspended from the soffit.</p>

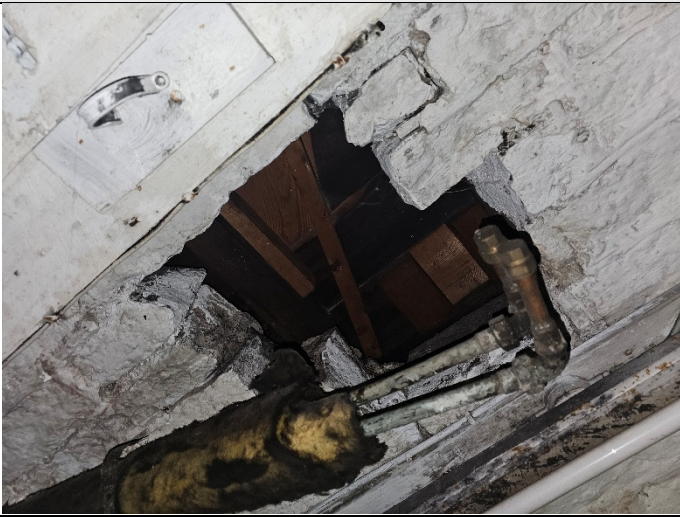
Location	Notes	Photo	
B.04	<p>A service hole is present within the vaulted masonry structure. It is likely that the masonry thickens toward the base of the vault.</p> <p>Timber floor construction observed at ground floor level above.</p>

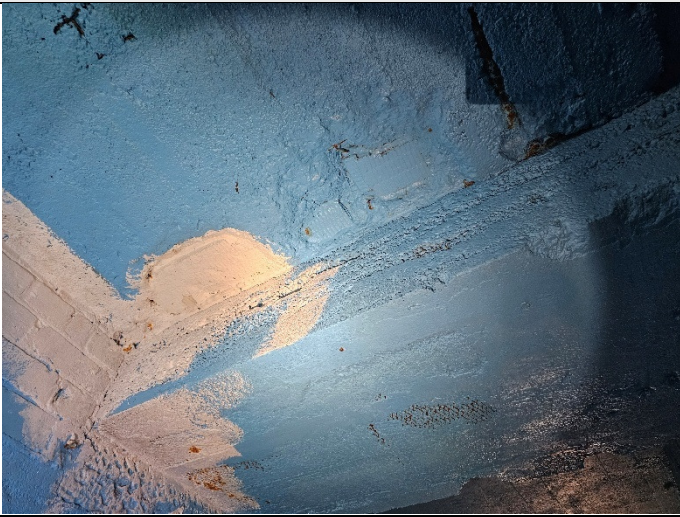
Location	Notes	Photo	
B.06	Signs of damp and lack of cover to concrete reinforcement.

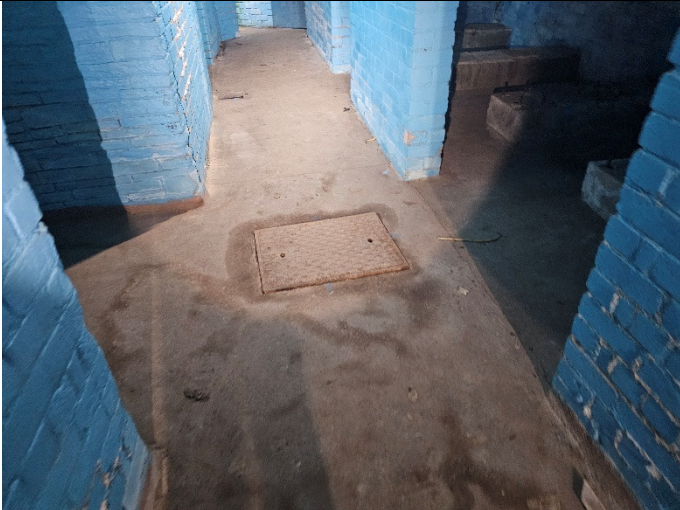
B.07	Existing manhole in basement beneath Block A – further investigation required.

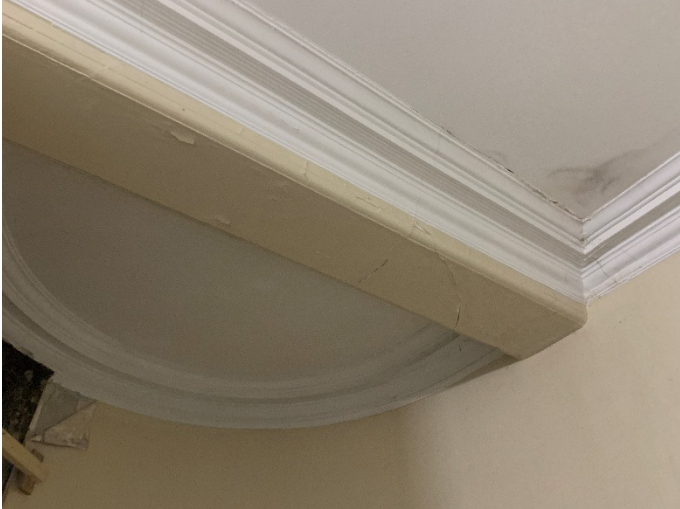
Location	Notes	Photo
G.01	Downstand structure supporting external wall above noted; further investigation required to confirm construction and condition.

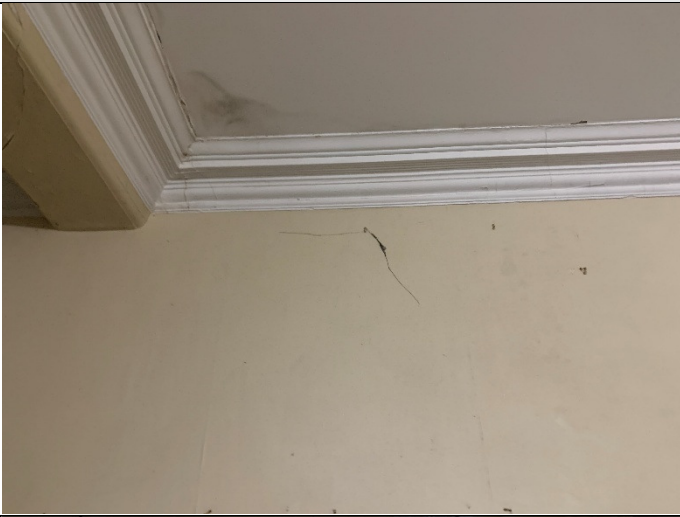
Location	Notes	Photo	
G.02	Crack noted in wall finishes.

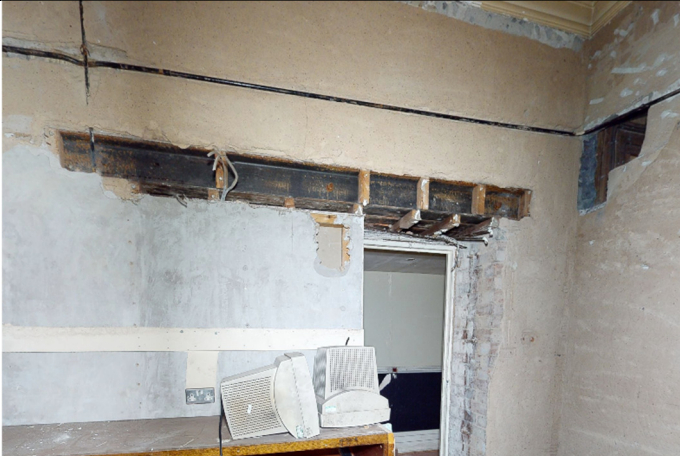
G.03	Exposed steel beams supporting wall above, condition appears to be acceptable.  Infill stud wall suggests the opening was potentially wider.

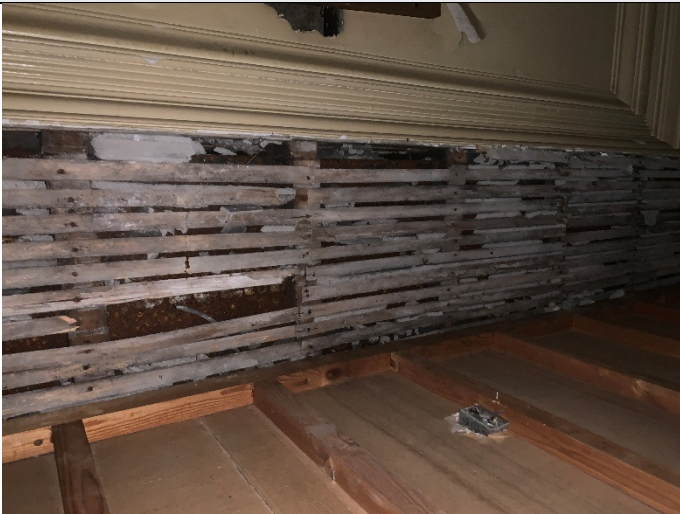
Location	Notes	Photo	
G.04	Exposed ceiling laths visible.  Support structure above to be investigated.

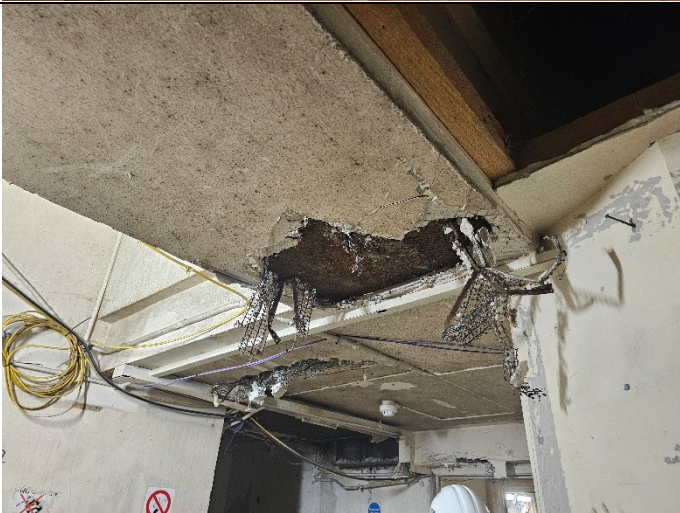
A photograph showing a close-up view of a ceiling structure. The top layer of plaster or paint has been removed, revealing a series of parallel wooden laths. The laths appear aged and somewhat uneven in color. Below the laths, there are wooden beams and a section of the floor or another ceiling layer.
G.05	Exposed beams supporting walls above. Surface corrosion visible. Condition of support beams to be inspected.

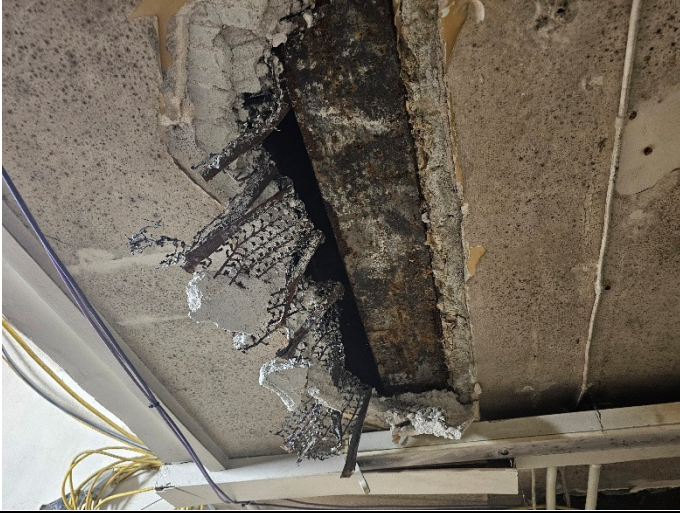
Location	Notes	Photo
G.06	As above.

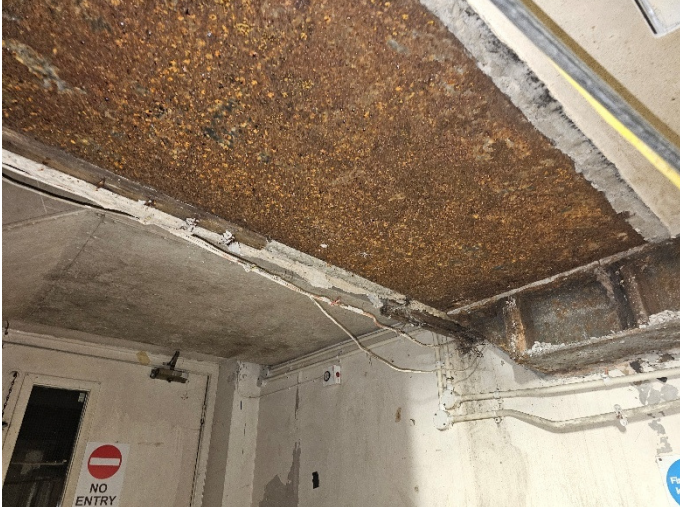
G.07	Exposed beams are likely supporting rear wall of central staircase. Surface corrosion visible. Condition of support beams to be inspected.

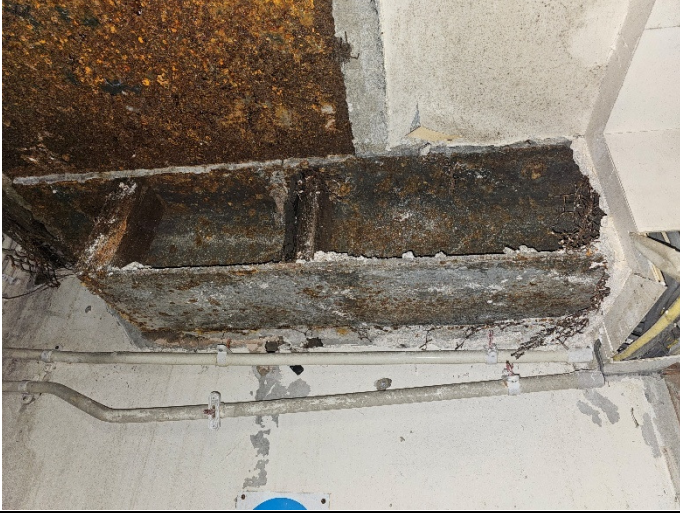
Location	Notes	Photo	
G.08	Exposed beam supporting walls above. Surface corrosion visible. Condition of support beam to be inspected further.

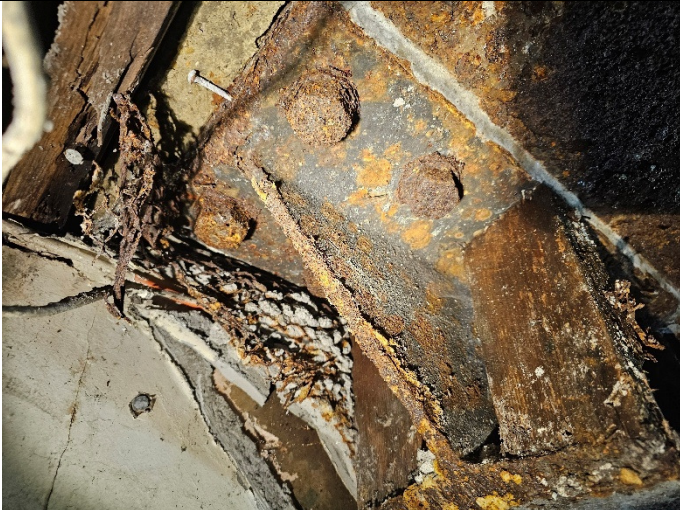
G.09	Structural connection showing signs of deterioration.

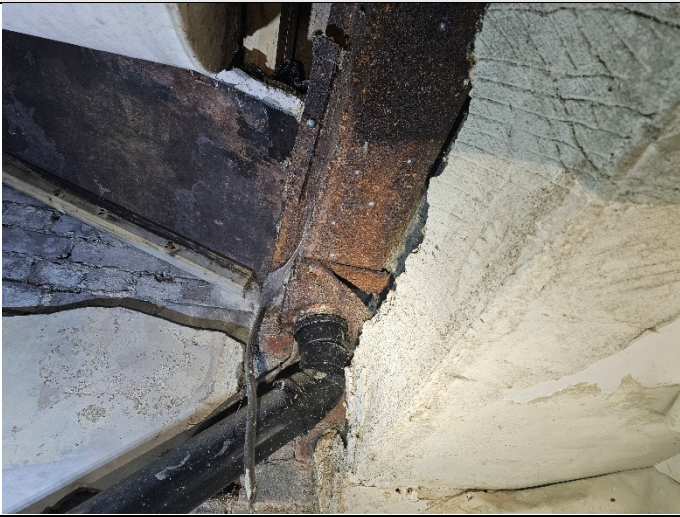
Location	Notes	Photo	
G.10	Gutter to rear of central staircase. Surface corrosion visible.

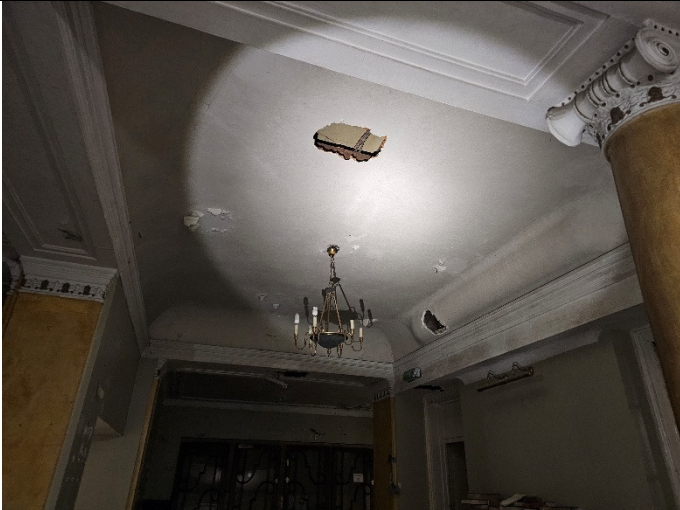
G.11	Hole in ceiling revealing soffit of stone slabs above at first floor level.  Full extents of stone slabs at first floor level to be determined.

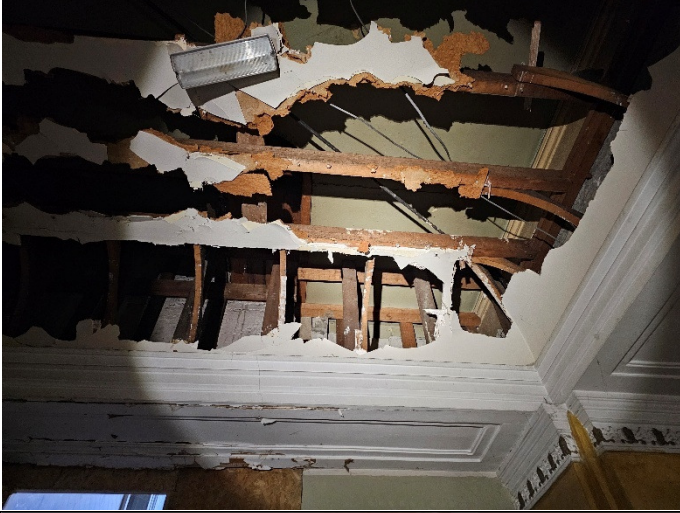
Location	Notes	Photo	
G.12	Modern plaster ceiling removed to expose extent of stone slabs at first floor level.  As above.

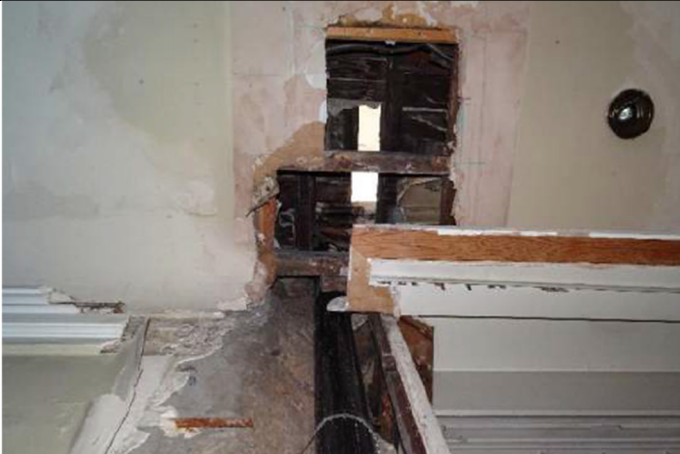
G.13	Hole in first floor structure.

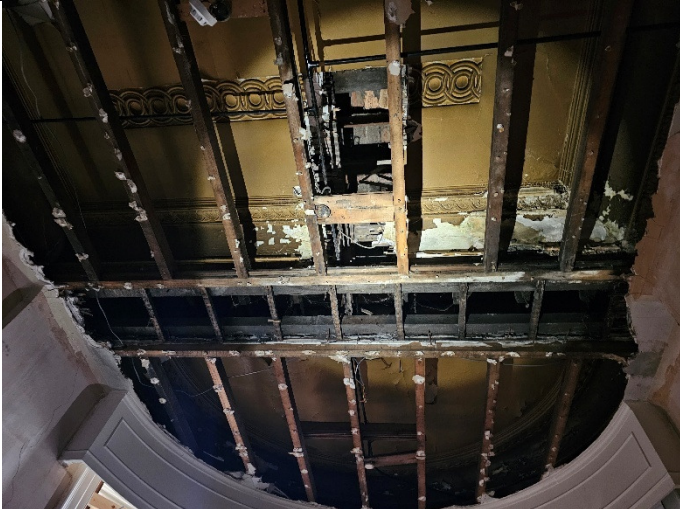
Location	Notes	Photo
1.01	Modern plaster ceiling removed, and original ceiling and timber joists exposed.

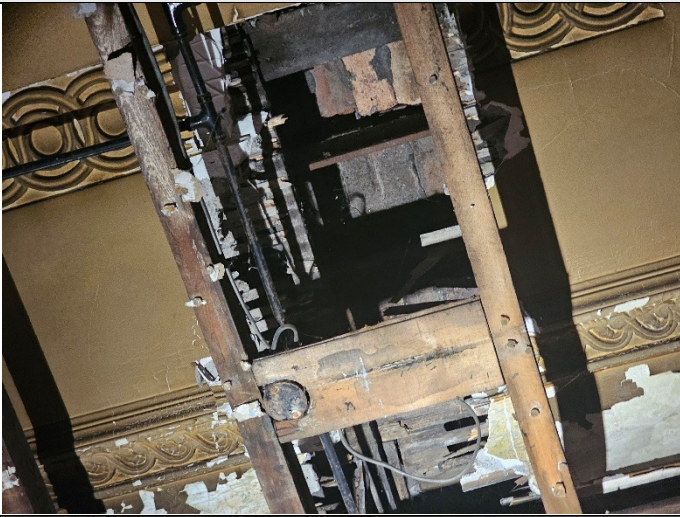
Location	Notes	Photo	
1.02	Steel plate and bricks noted within ceiling. Suspect this is a section of infill floor above local to the later steel staircase. To be investigated further.

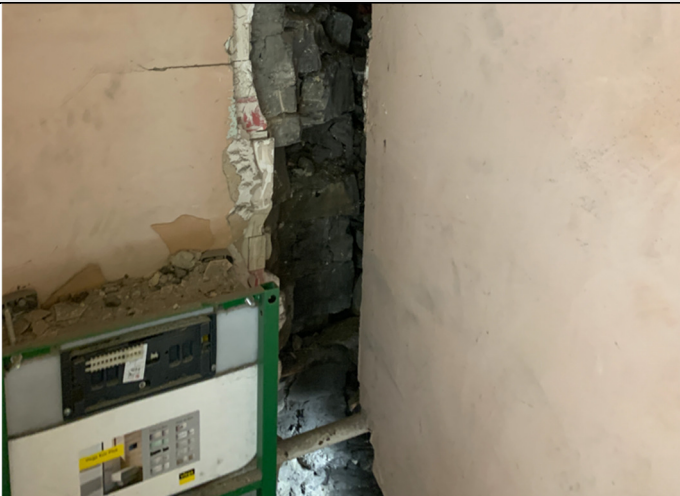
Location	Notes	Photo	
1.04	Plaster finishes removed; it appears that the internal wall is not bonded to the external wall.

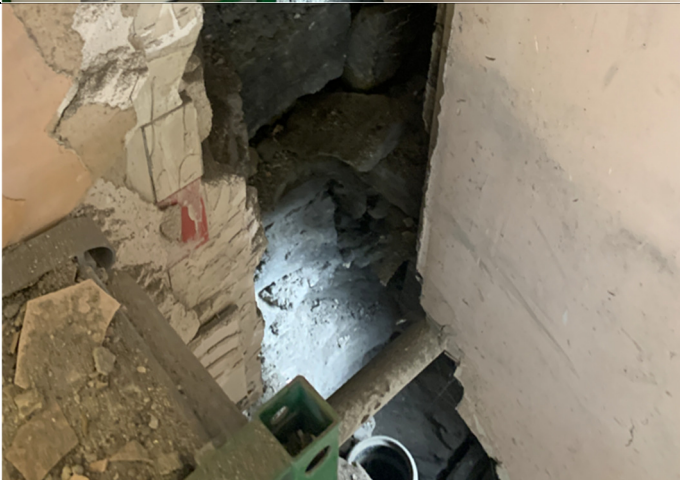
A photograph showing a wall repair site. On the left, there is a white and green control panel with various switches and a digital display. To the right of the panel, there is a vertical gap between the internal wall and the external wall, revealing a dark, textured surface. The surrounding walls are light-colored and appear to be in the process of being repaired or finished.
1.05	As above.

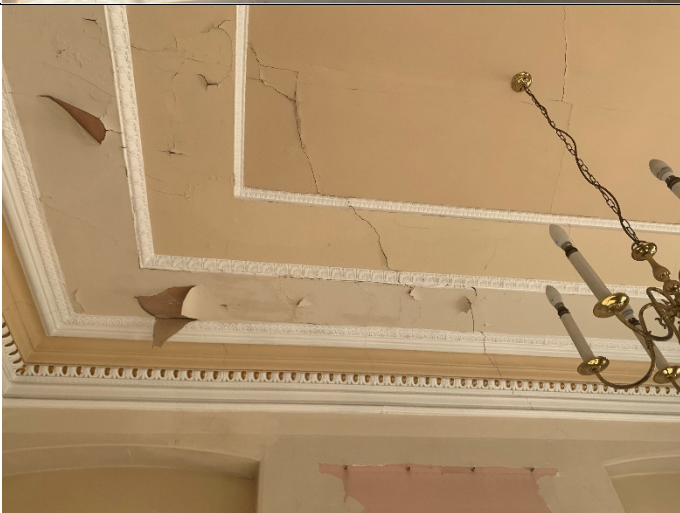
A wide-angle photograph of a room with yellow walls and a white ceiling. A chandelier hangs from the ceiling. A doorway is visible on the right side of the room. The floor is light-colored and appears to be made of stone or tile. There is a large window on the left side of the room, and a piece of pink paper is taped to the wall.
1.07	Cracks in lath and plaster ceiling to be investigated. Possible that the laths are coming away from the timber joists due to rusting nails etc.

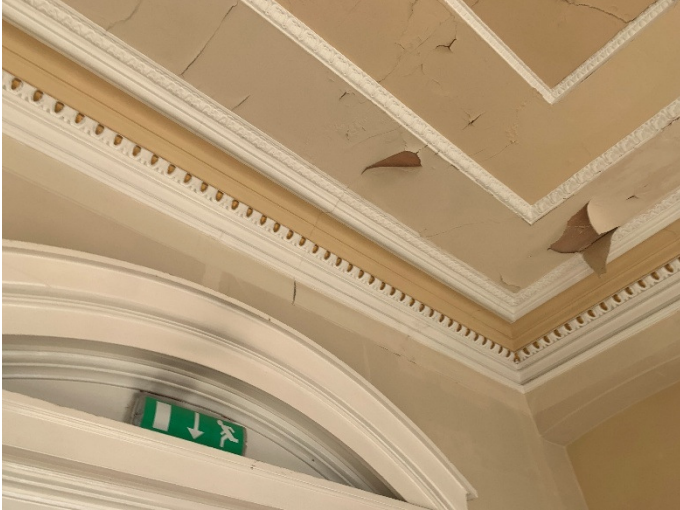
Location	Notes	Photo
1.08	As above.  Cracks noted in coving.

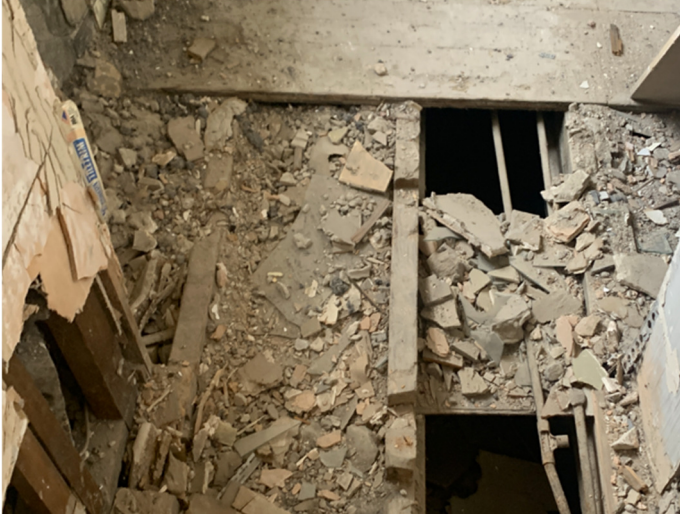
1.09	Notches noted in timber floor joists to allow for services. Pugging and pugging boards visible and have been removed in areas.

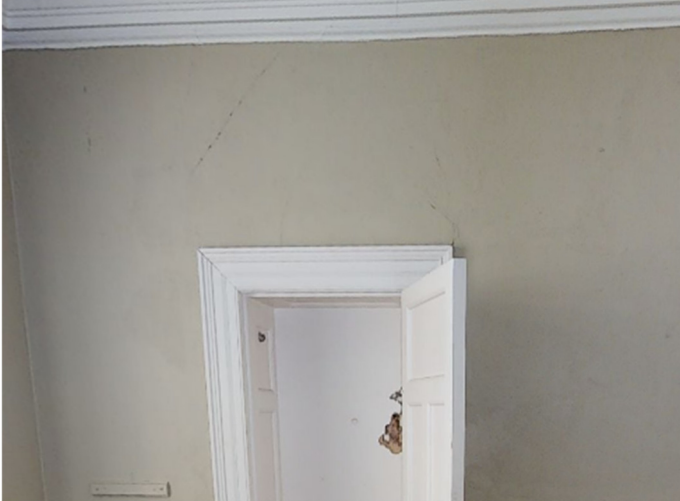
Location	Notes	Photo
2.01	Cracks in wall above door opening.

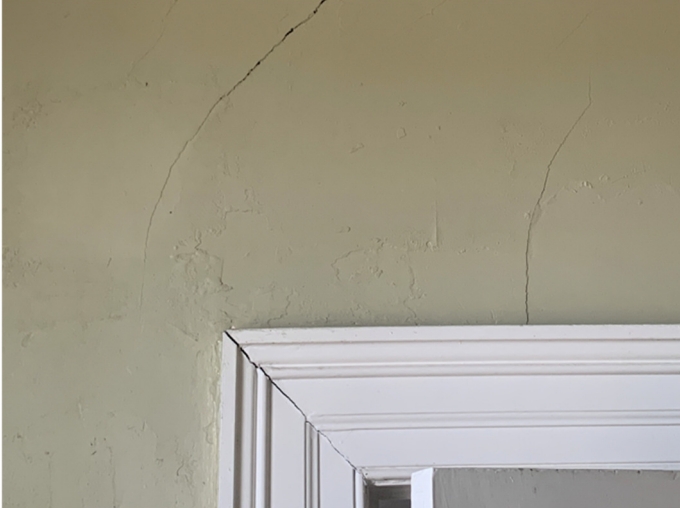
Location	Notes	Photo
2.02	Gaps in the architrave and cracks in wall suggest signs of movement. To be investigated further.

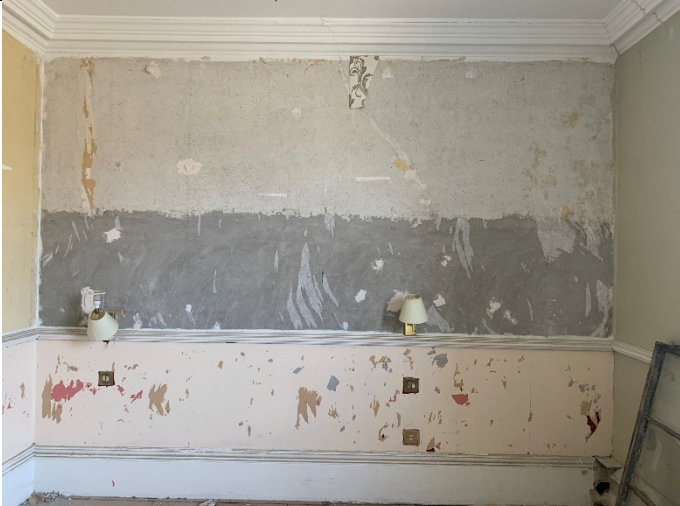
2.03	Cracks in wall and ceiling coving.

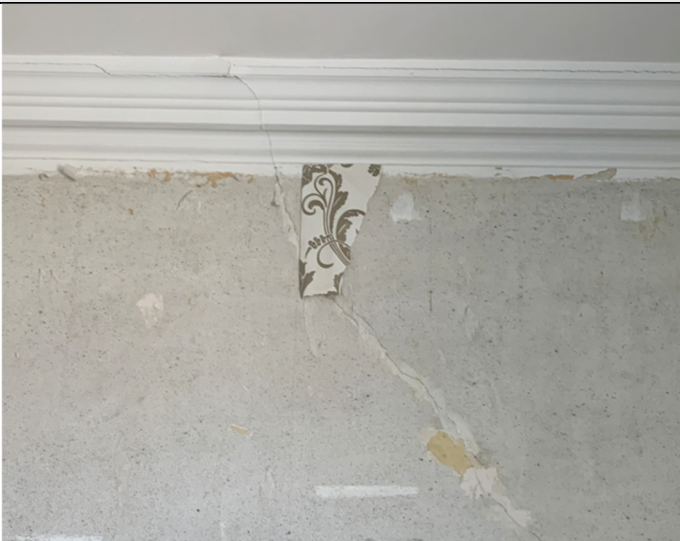
Location	Notes	Photo	
2.04	Closer view of crack in wall from image above.

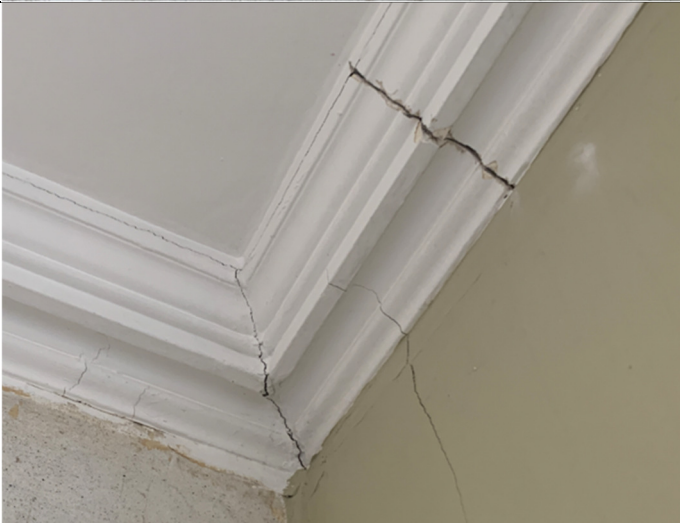
A close-up photograph showing a vertical crack in a wall. The wall is covered in decorative wallpaper with a floral pattern. The crack runs through the wallpaper and into the underlying plaster. A small white object is visible on the wall near the crack.
2.05	Closer view of crack in coving from image above.

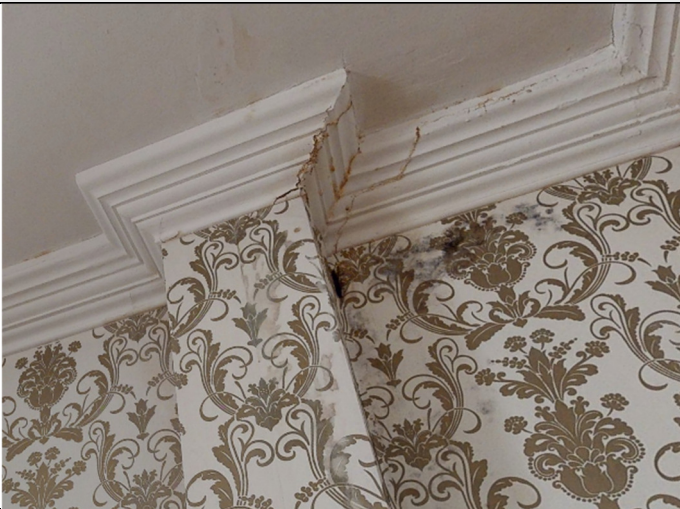
Location	Notes	Photo	
2.06	Cracks and water damage in coving.

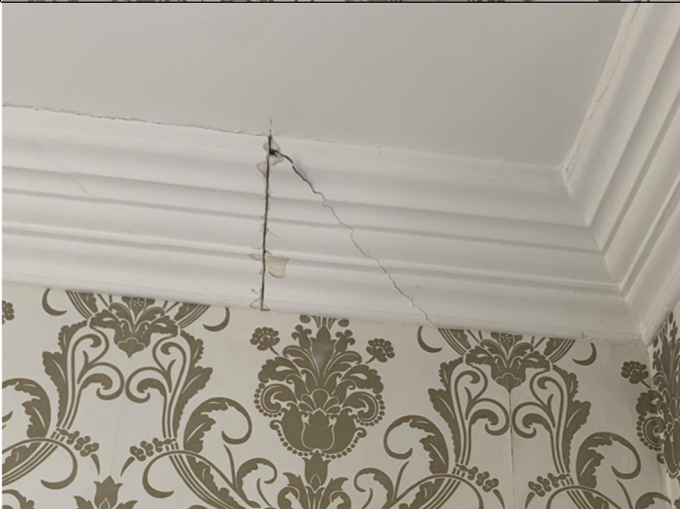
2.07	Cracks in coving.

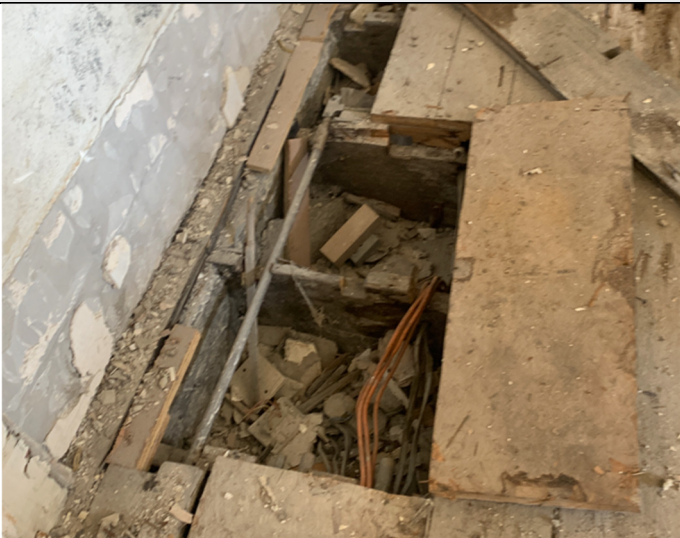
Location	Notes	Photo	
2.08	Severe notches in timber joists noted.

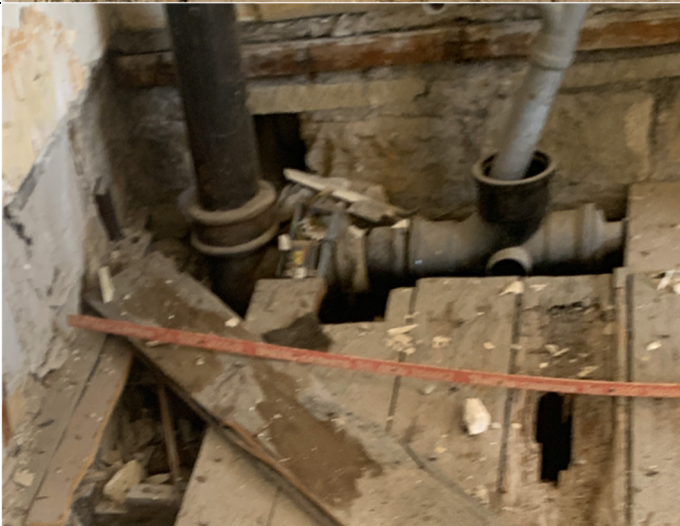
A photograph showing a cross-section of a timber joist that has been severely damaged by notching. The joist is surrounded by other wooden debris and a metal pipe is visible nearby.
2.09	Debris and removed floorboards around existing plumbing.

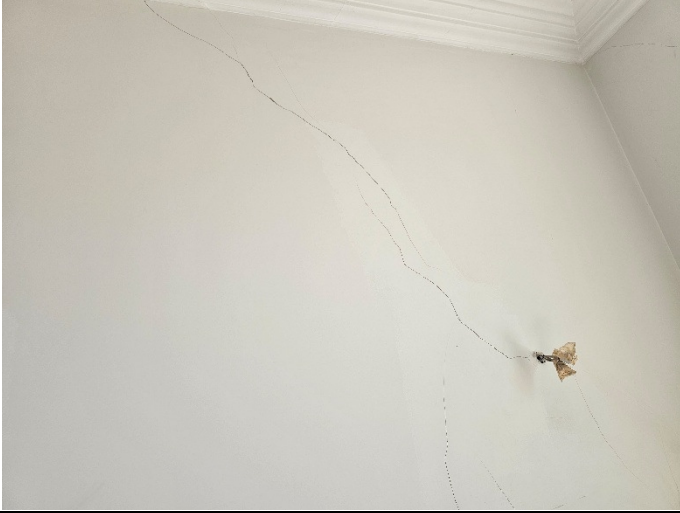
Location	Notes	Photo	
2.10	Diagonal crack noted in both sides of the wall above the signing room suggest sagging in timber support beam.

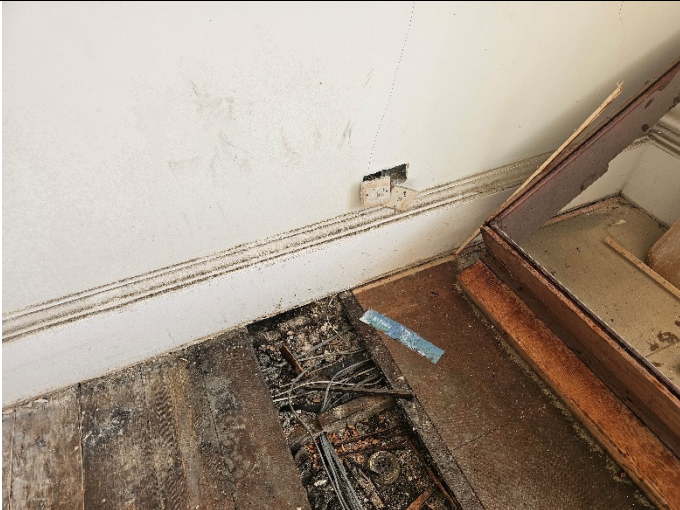
2.11	Existing floorboards removed. Pugging visible.

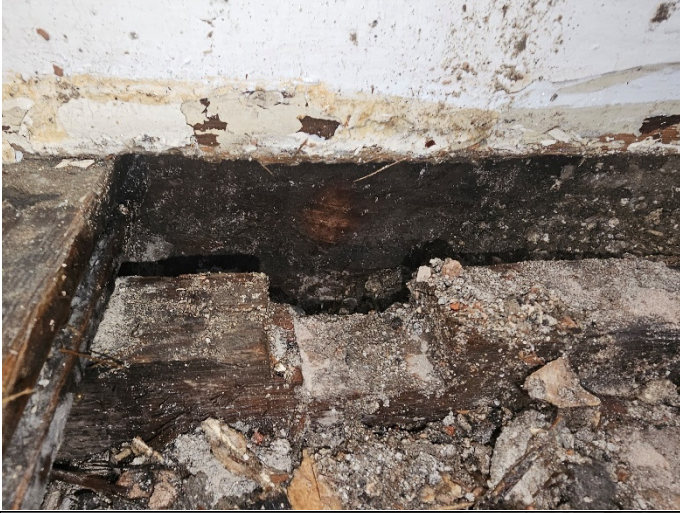
Location	Notes	Photo	
2.12	Photo of timber support beam supporting the wall above the signing room. Further investigation required to determine geometry and overall condition, including end bearings.

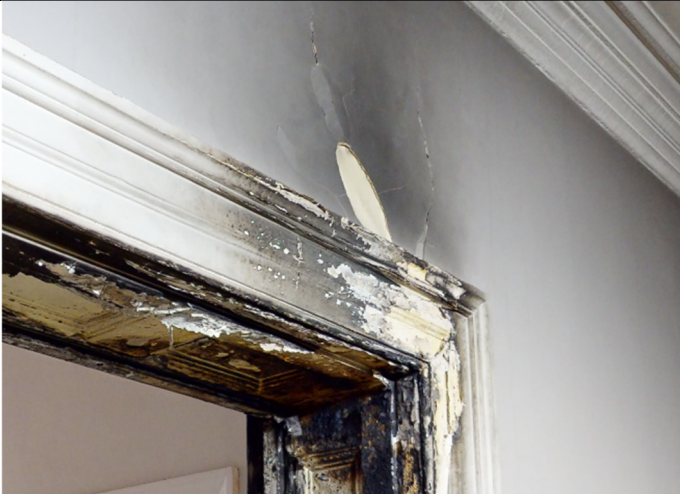
2.13	Fire damage to door frame and wall above. Crack in wall finish.

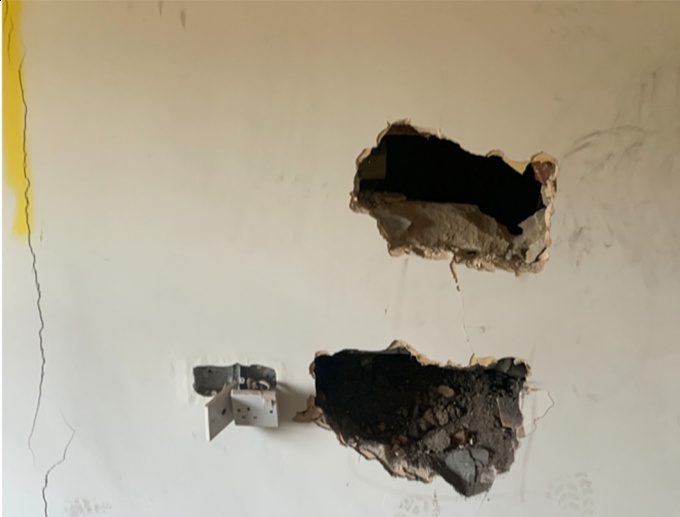
Location	Notes	Photo
3.01	Vertical crack and holes noted in wall.

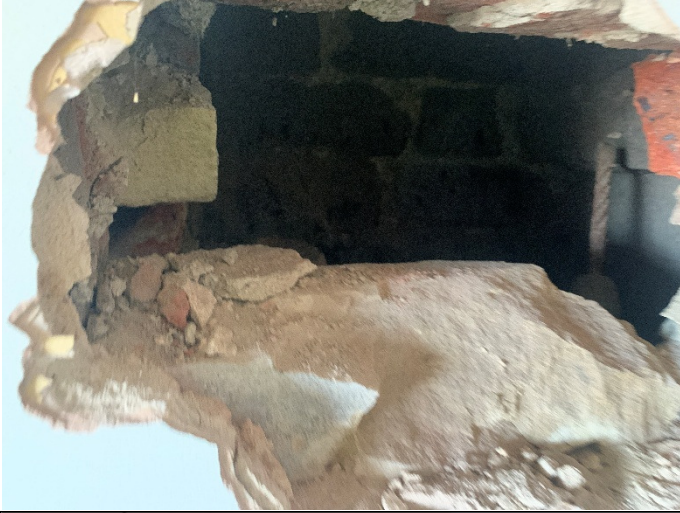
Location	Notes	Photo	
3.02	Closer view of void behind wall from image above.

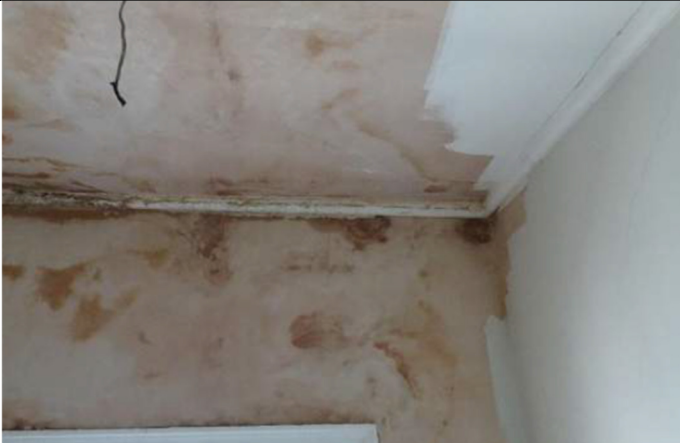
3.03	Signs of water damage to wall and ceiling.

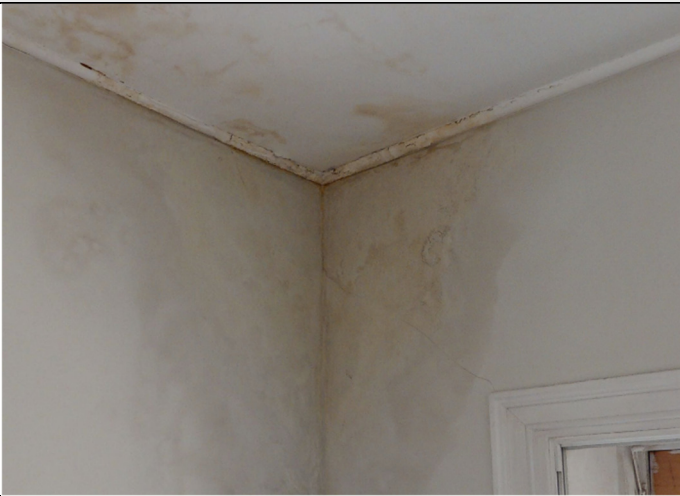
Location	Notes	Photo	
3.04	Signs of water ingress in corner of room.

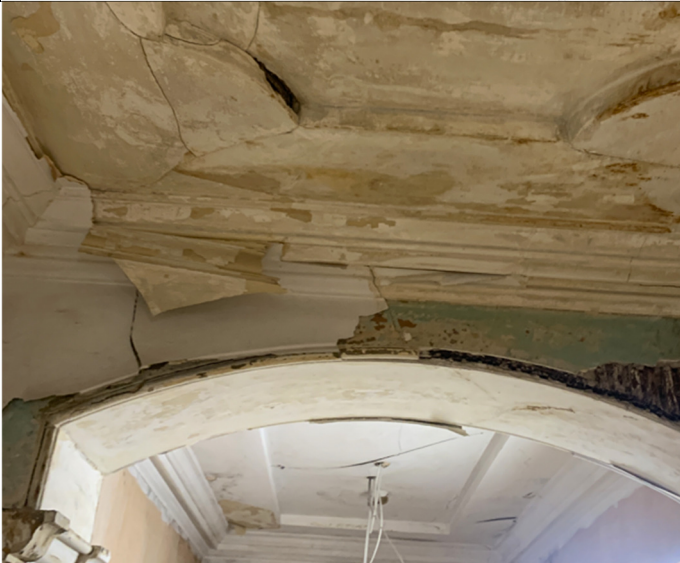
3.05	Ceiling plaster cracking and falling away.

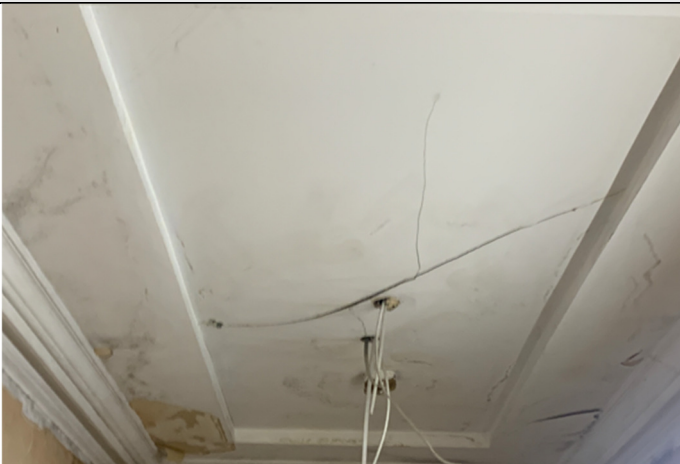
Location	Notes	Photo	
3.06	Large cracks in ceiling plaster finishes.

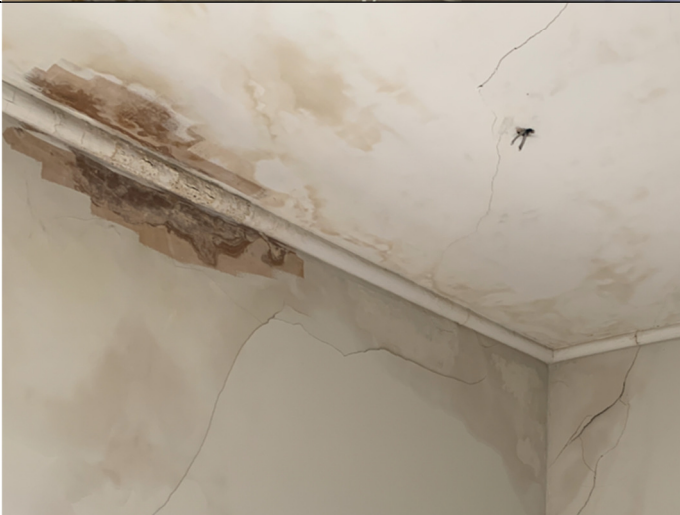
3.07	Water damage and cracks in corner of room.

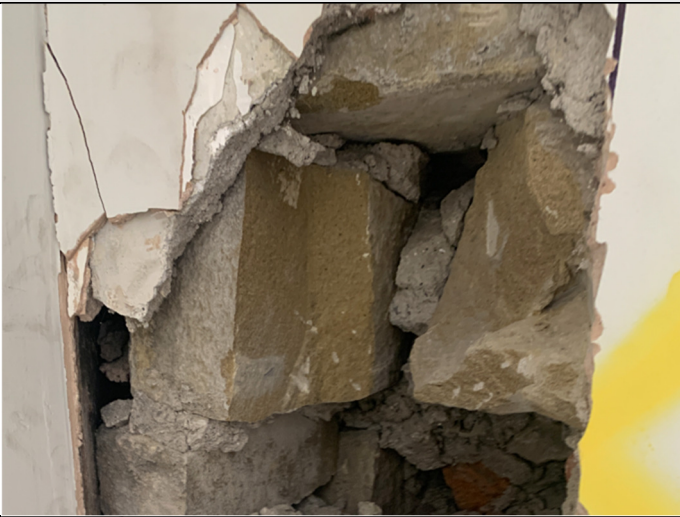
Location	Notes	Photo	
3.08	Void and debris revealed behind removed plaster.

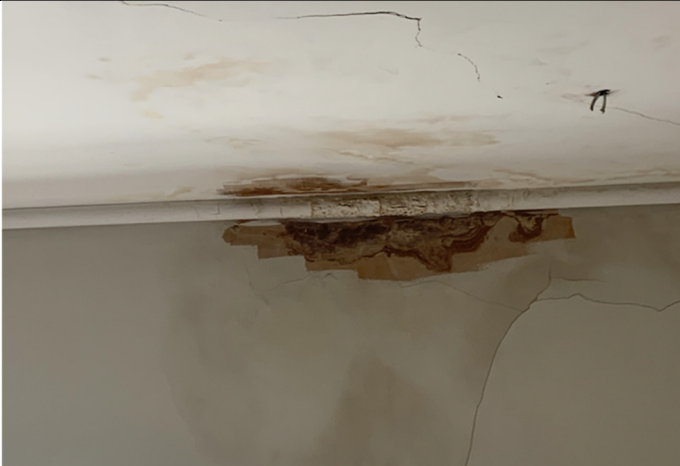
3.09	Water damage and cracks to wall and ceiling.

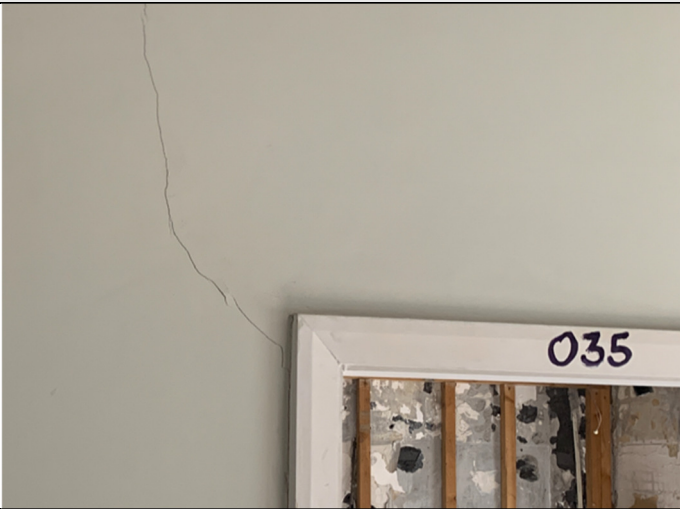
Location	Notes	Photo	
3.10	Crack forming from corner of door frame.

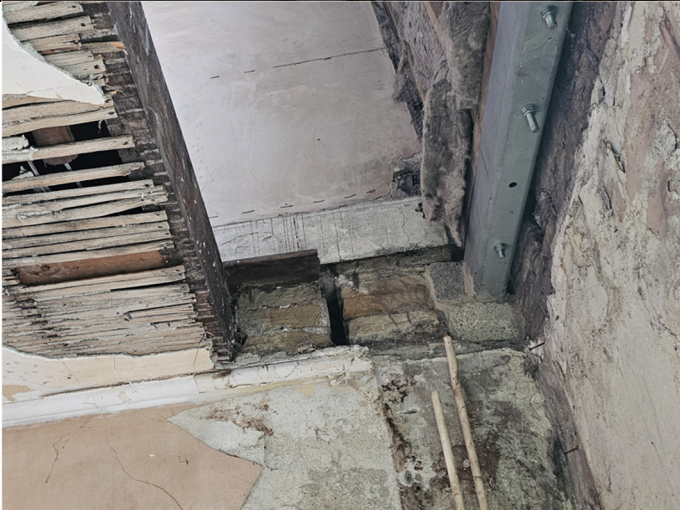
3.11	Large gap in fourth floor structure thought be part of the previous works.

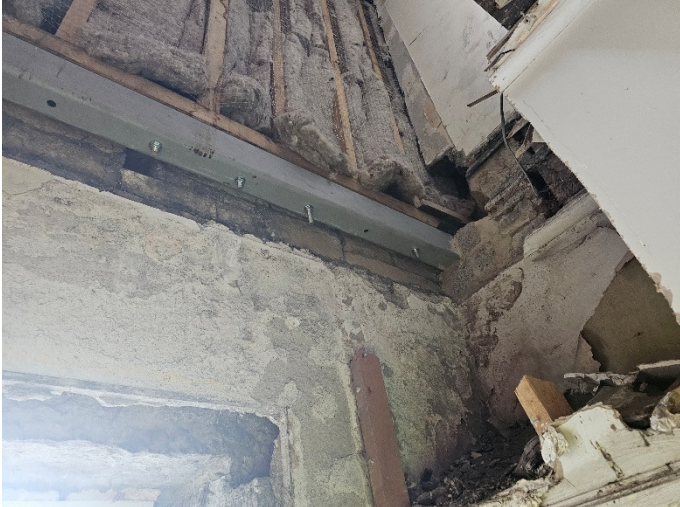
Location	Notes	Photo
3.12	As above.

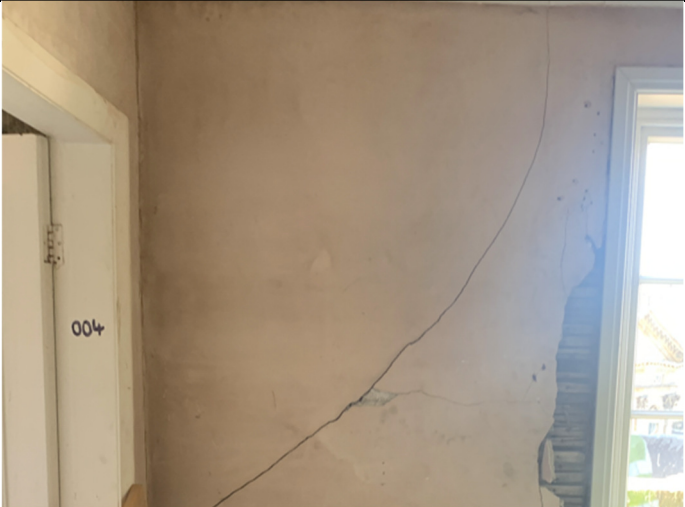
Location	Notes	Photo
4.01	Large crack in wall adjacent to window.

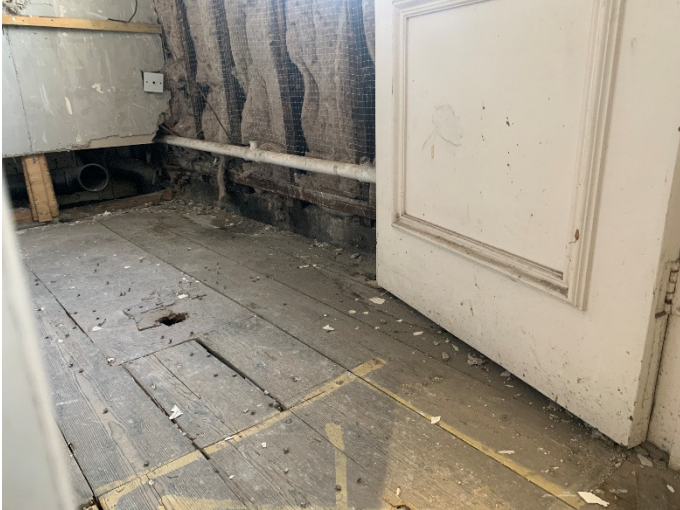
Location	Notes	Photo
4.02	Small nails visible in floorboards where boarding has been removed.

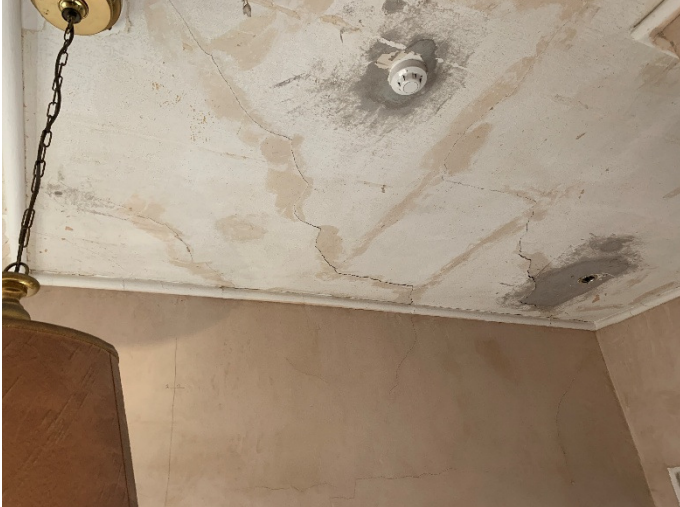
4.03	Cracks in ceiling.

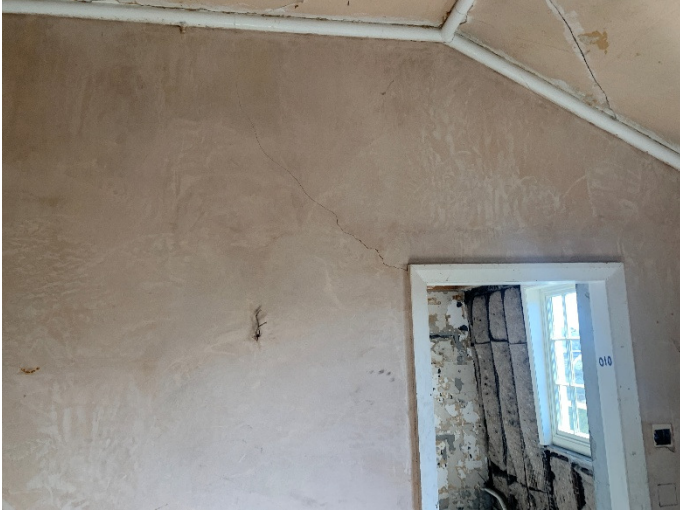
Location	Notes	Photo
4.04	Cracks in ceiling and wall finish starting from corner of door frame.

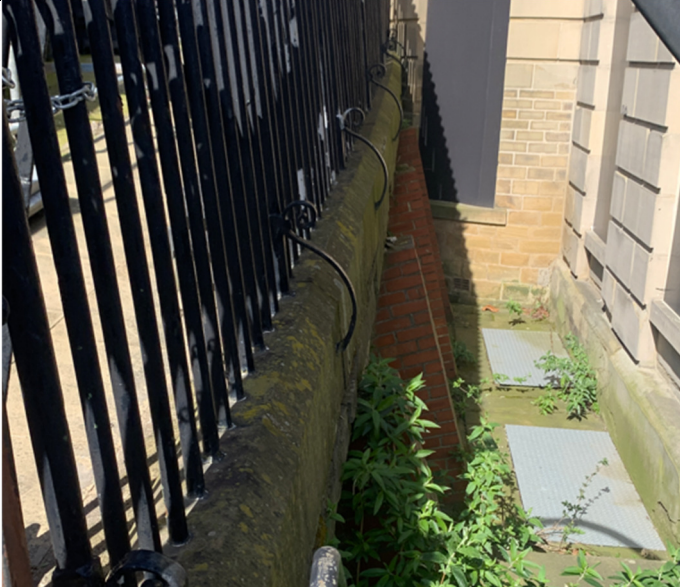
Location	Notes	Photo
<p>Car Park Historic Wall Adjacent to St George's Square.</p>	<p>External retaining wall observed to be in generally poor condition, with a noticeable lean towards Block A.</p> <p>Brickwork piers appear to have been retrospectively added to provide some degree of stabilisation.</p> <p>Foundation details are currently unknown.</p> <p>Vegetation growth noted at the base of the wall, which may be contributing to ongoing deterioration.</p>

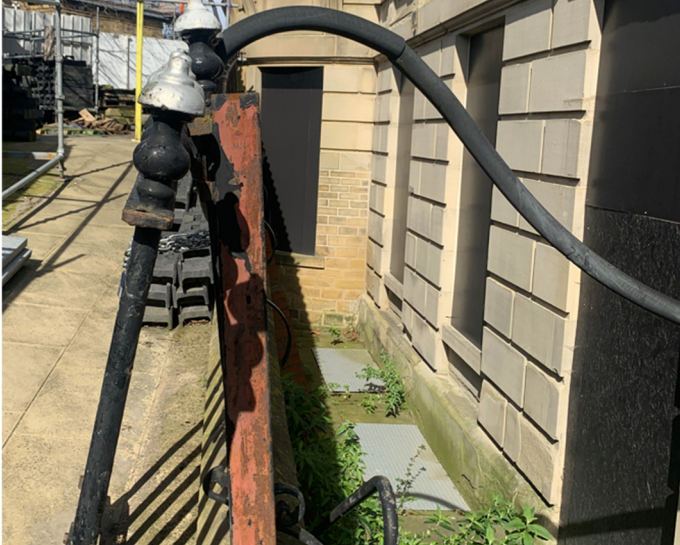
Location	Notes	Photo
As above.	<p>As above.</p> <p>Railing and stone coping are also in poor condition and appear to be coming away from the wall below.</p>

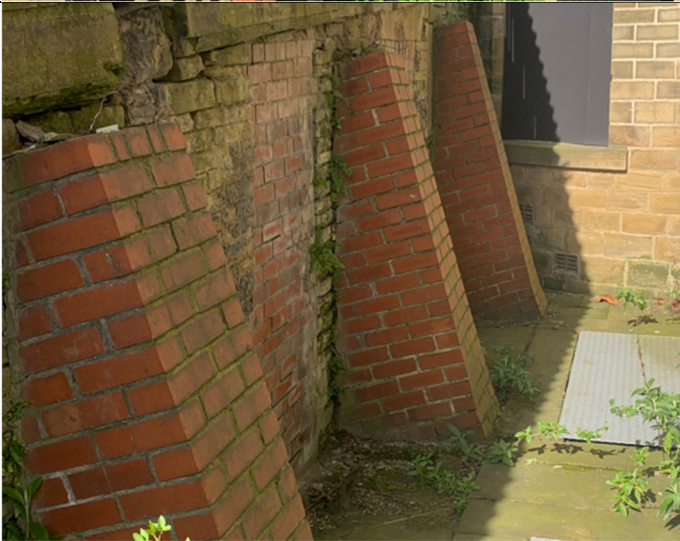
As Above.	<p>Closer view of brickwork buttress piers.</p>

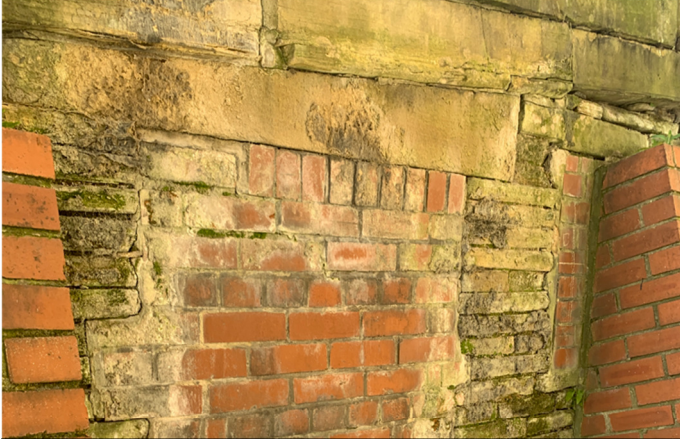
Location	Notes	Photo	
As Above.	Presence of a stone lintel and surrounding brickwork suggests that the former opening has been infilled. Further investigation is recommended to confirm whether voids remain beneath the ramp or if the area has been fully backfilled.
