STRUCTURAL REPORT The George Hotel, Huddersfield

Client: GMI Construction
Project Name: The George Hotel, Huddersfield
Report Title: Block A – Central Staircase Structural Condition Report B
Report Author: Tristram Hope / James Hendry
Document ref: 00.24363-ACE-ZZ-ZZ-T-S-0002
Date: Mar'25

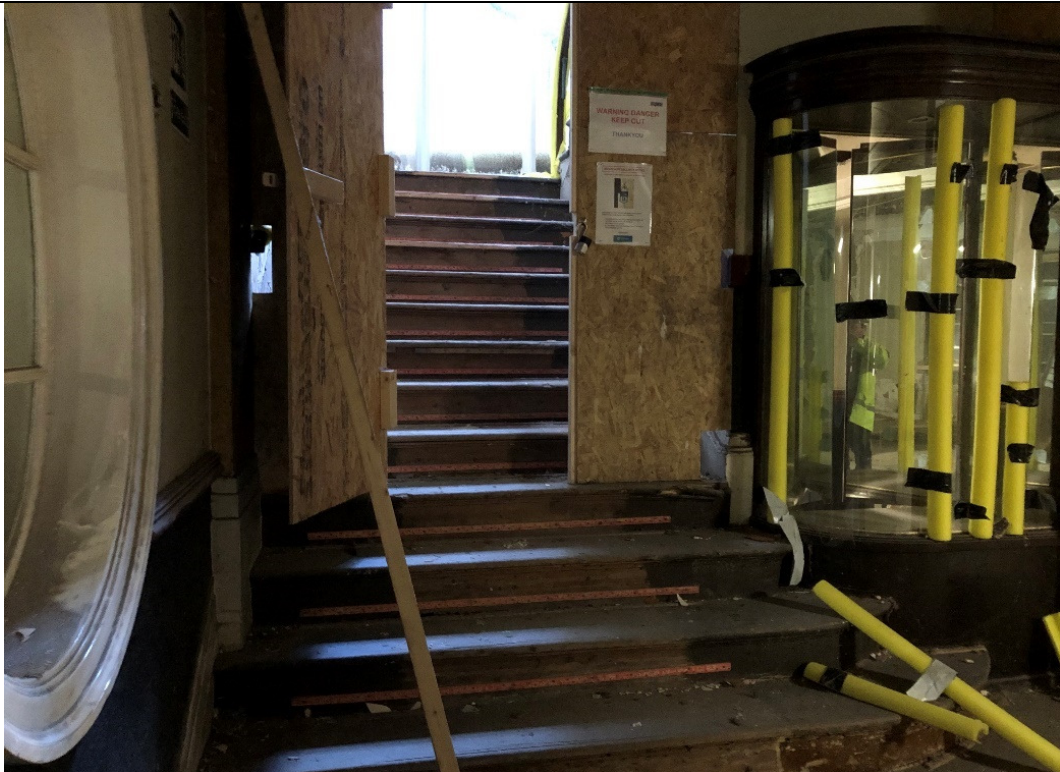
Photo 1

- 3.1.1. The stair is of the traditional stone cantilevering / stacking tread type from ground floor level up to level 2.0, after which it continues in timber. The first flight up from ground floor level appears to have been amended and overlain in timber to give a wider, more impressive appearance when seen from the entrance foyer. The original stone tread units and their supporting side wall can be seen still to be in place when the flight is viewed from below. (Photo 1).

Timber overlay over the widened first flight up from ground floor level, concealing the original stone tread unit stair flight below.

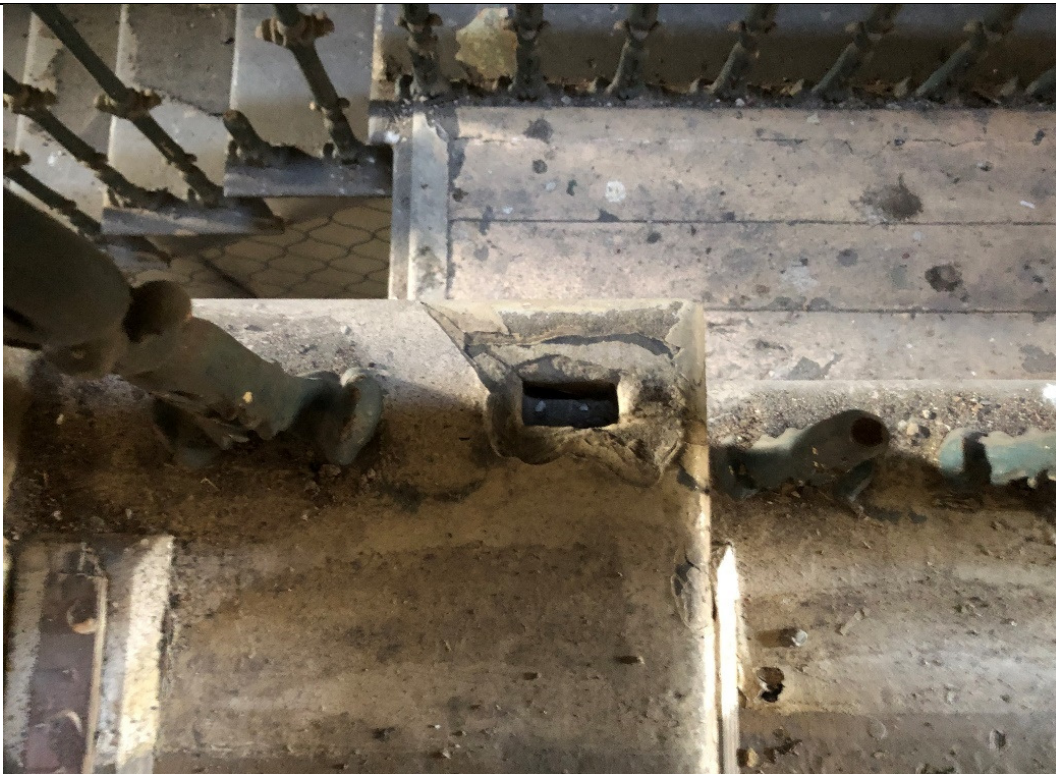
Photo 2

- 3.1.5. The outer (balustrade) ends of the tread units were inspected. A diagonal crack of long standing was noted in the top of the first tread unit in the flight up from level 1.0 to level 1.5, running from the end of the tread through one of the rectangular baluster sockets, towards the nosing. This is likely to have been caused when the previously-adjointing cast iron baluster was damaged. (Photo 2).

Diagonal crack, running through one of the baluster sockets in the top of the first tread unit in the flight up from level 1.0 to level 1.5.

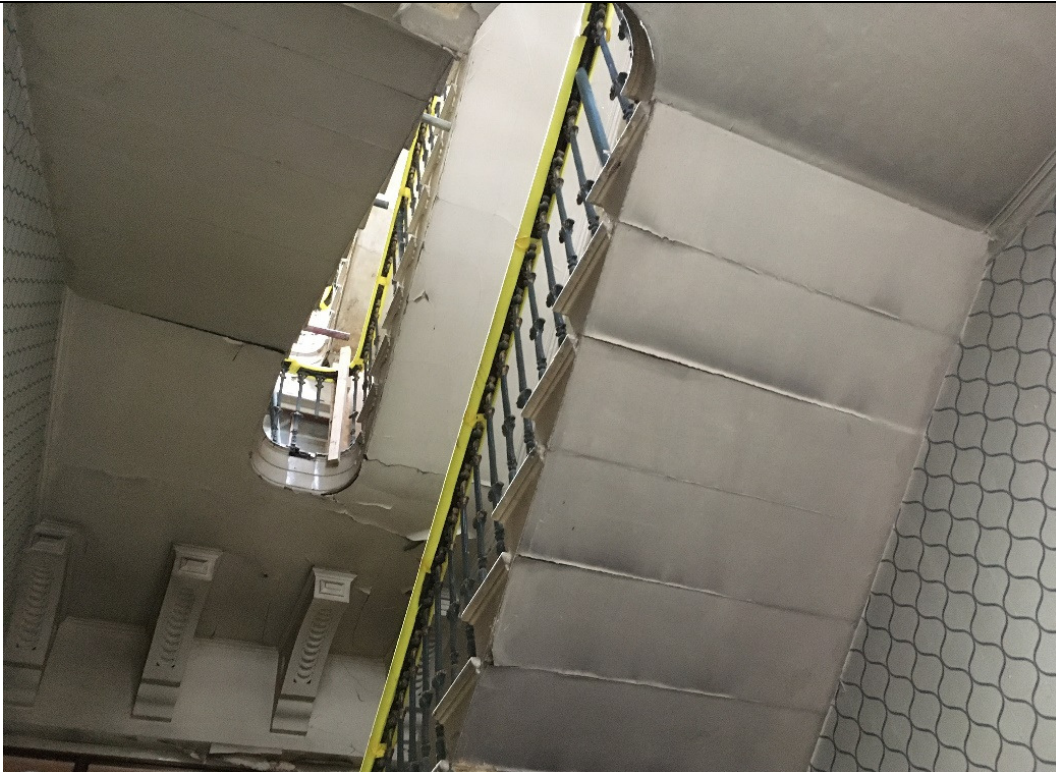
Photo 3

- 3.1.6. The thick build-up of paint to the soffit of the stone tread units was noted to have split and peeled along the tread joint lines, indicating that small amounts of movement have occurred between adjacent stone tread units. Notwithstanding this, where it could be inspected, the bedding mortar between the individual tread units appeared to have remained in place, and to be in satisfactory condition. (Photo 3).

Splitting and peeling of painted soffit finishes along the joint lines between individual stone tread units, indicating that minor movements have occurred.

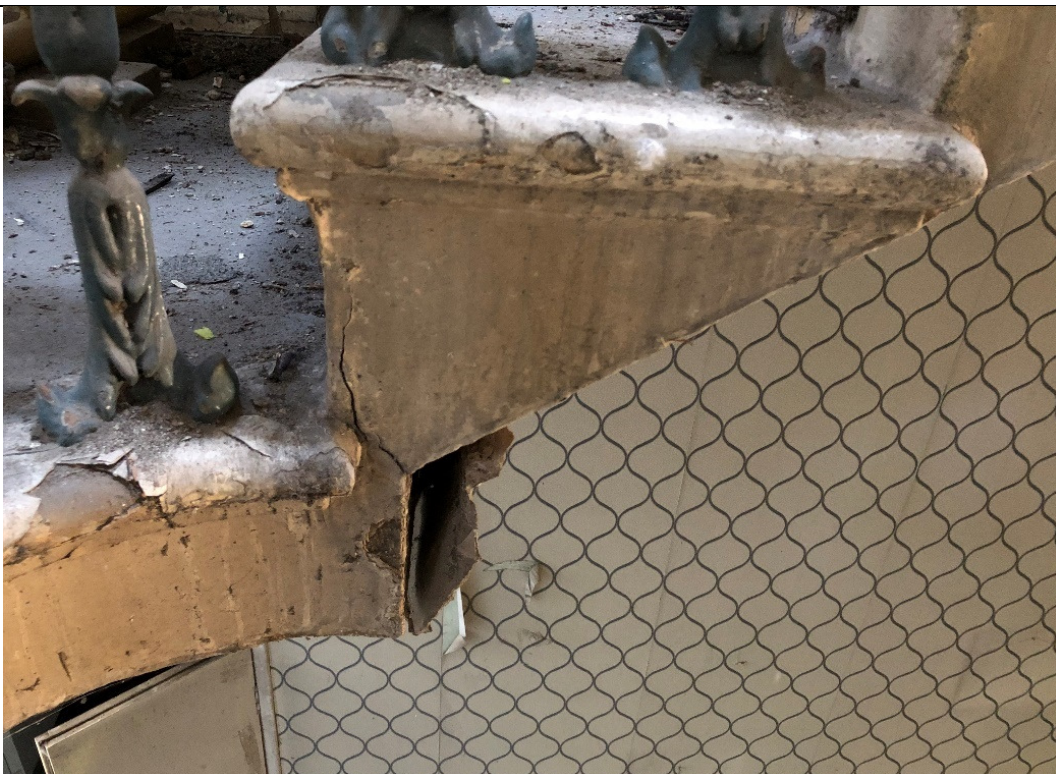
Photo 4

- 3.1.7. A near-vertical crack is visible in the riser face of the first tread unit up from stone slab cross-landing at level 1.0, set back approx. 10mm from the riser face, as well as slight separation of the rebate joint between the bottom tread and the supporting edge of the landing. (Photo 4).

Half-height near-vertical crack, approx. 10mm back from the riser face of the first tread unit in the flight up from level 1.5 to level 2.0.

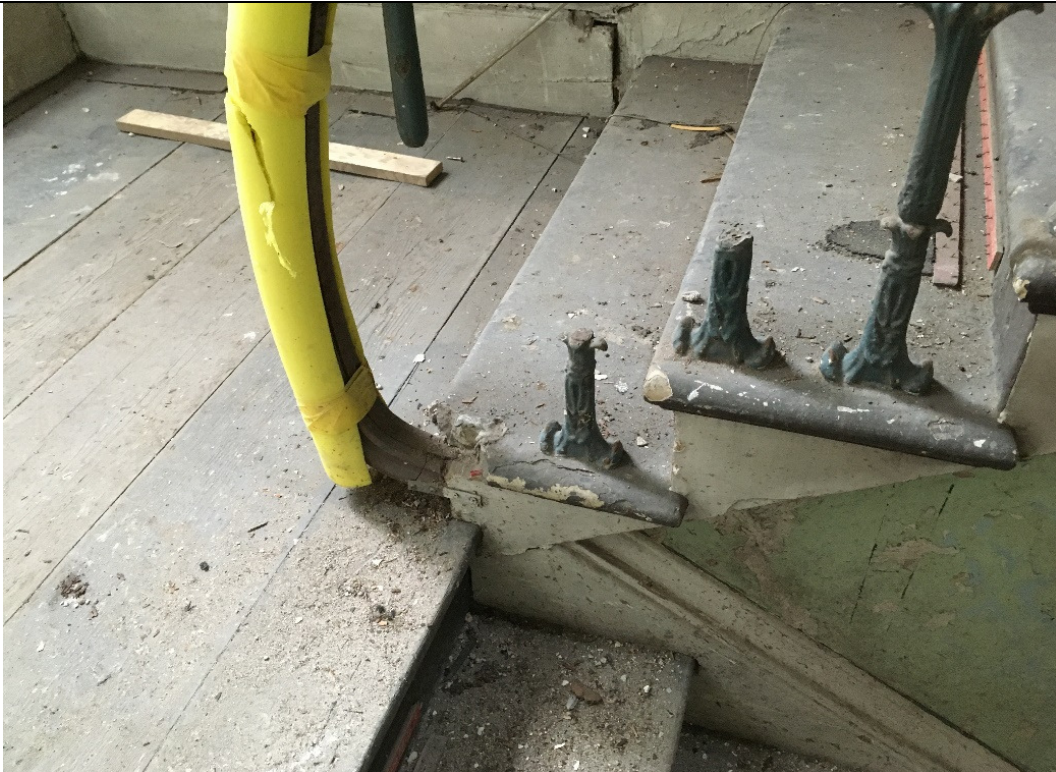
Photo 5

- 3.1.9. Several areas of impact damage were noted in the balustrade, where the balusters have been either partially broken off, or are missing altogether. The top corner of the lowest tread in the flight up from level 0.5 to level 1.0 was noted to have been cracked off beyond the corner baluster pocket. (Photo 5).

Example of damage to the (modified) cast iron balustrade to the flight up from the landing at level 0.5 to level 1.0.

- 4.3.1. As noted above, the existing balustrade does not comply with current regulations. In order to comply, remedial works would be needed to close any gaps through the balustrade to less than 100mm, and to increase the heights from the string line and floors to the handrail to 0.9m and 1.1m respectively.

- 4.3.2. It is envisaged that this could best be achieved by repairing and retaining the existing cast iron balustrade as part of the visible heritage fabric, and by installing a second balustrade in parallel with the original, comprising laminated glass panels of sufficient strength and height to meet the regulatory requirements.

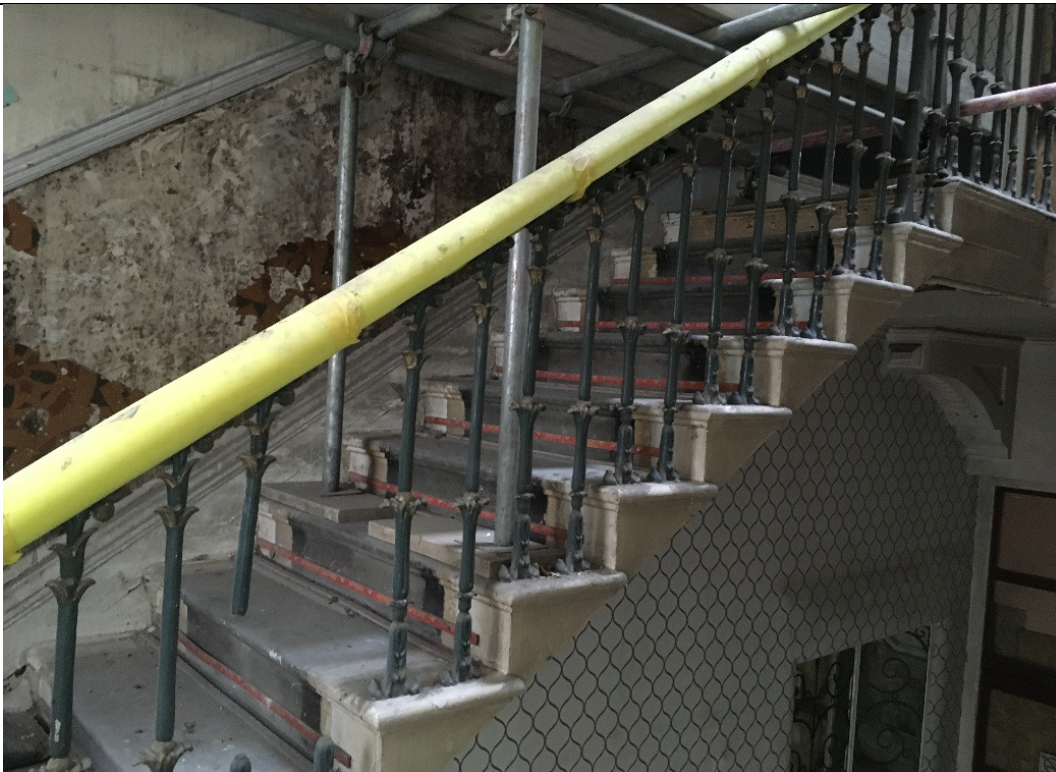
Photo 6

- 3.2.1. Temporary scaffolding was noted to have been installed directly onto the flight from the level 1.5 half-landing, to provide support the floors and stair above level 2.0. The scaffolding bears onto and is carried by a single stone tread unit towards the middle of the flight, without any corresponding temporary support below. (Photo 6).

- 3.2.2. CROSS Safety Report 1147 draws attention to the possible risks of applying direct localised load onto individual stone tread units (or onto stone landing slabs), which could cause them to fracture. It also draws attention to the possible risk of fracturing due to upward jacking forces being inadvertently applied to the underside of the tread units and landing slabs.

- 3.2.3. The transfer of temporary support loading from the upper stair flights and landings is dependent at least in part on the stone tread units and landings below. This is an undesirable and potentially unsafe situation. It would be preferable for any temporary support or working access scaffolding to be independent of the treads and landings, and for the load to be transferred independently down to foundation level.

Temporary scaffold support to second floor, bearing onto the middle stone tread unit of the flight from level 1.5 to level 2.0, with no corresponding support below.

- 3.2.4. It appears possible that this could be achieved by locating any vertical supporting structure within the stair void between the flights and landings. Putlogs or other horizontal supports could then span between the central vertical support and the flank walls, clear of the stair flights and landings.
