## STRUCTURAL REPORT

Client: GMI Construction  
Project Name: The George Hotel, Huddersfield  
Report Title: Block A – Central Staircase Structural Condition Report A  
Inspection Dates: 4<sup>th</sup> August & 11<sup>th</sup> September 2023

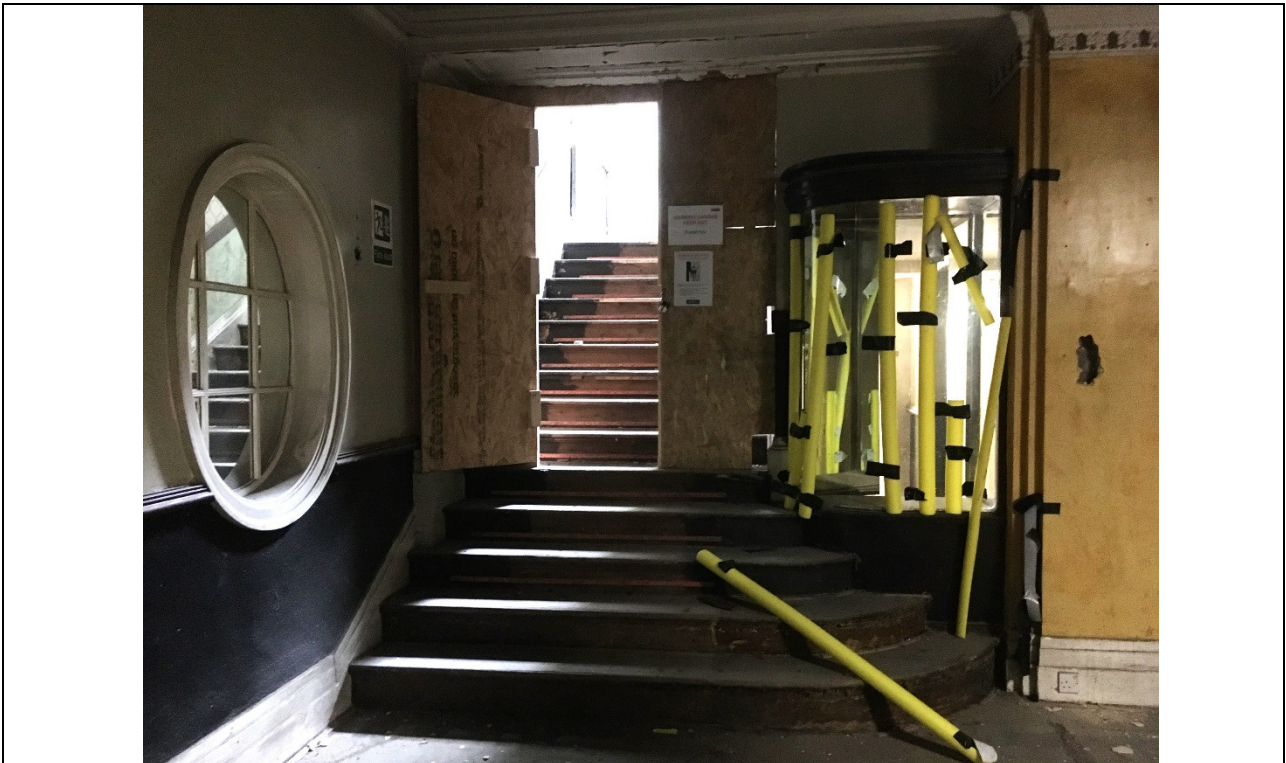
Photo A1.1

- 4.4. The ground floor (Level 00) floor adjacent to the stair foot appears to be of terrazzo-covered stone slab construction.
- 4.5. The ground floor to first floor lower stair flight comprises a 14-riser run in timber, which appears to be in fair condition, though with some abrasion wear to the treads. The existing arrangement appears to be a modification of the original stair, which is thought to have been of stone construction. (See Photo A1.1).

Foot of the main staircase, as seen from the Level 00 (Ground Floor) entrance lobby. The stair locally is in formed in timber and is thought to be a modification from the original.

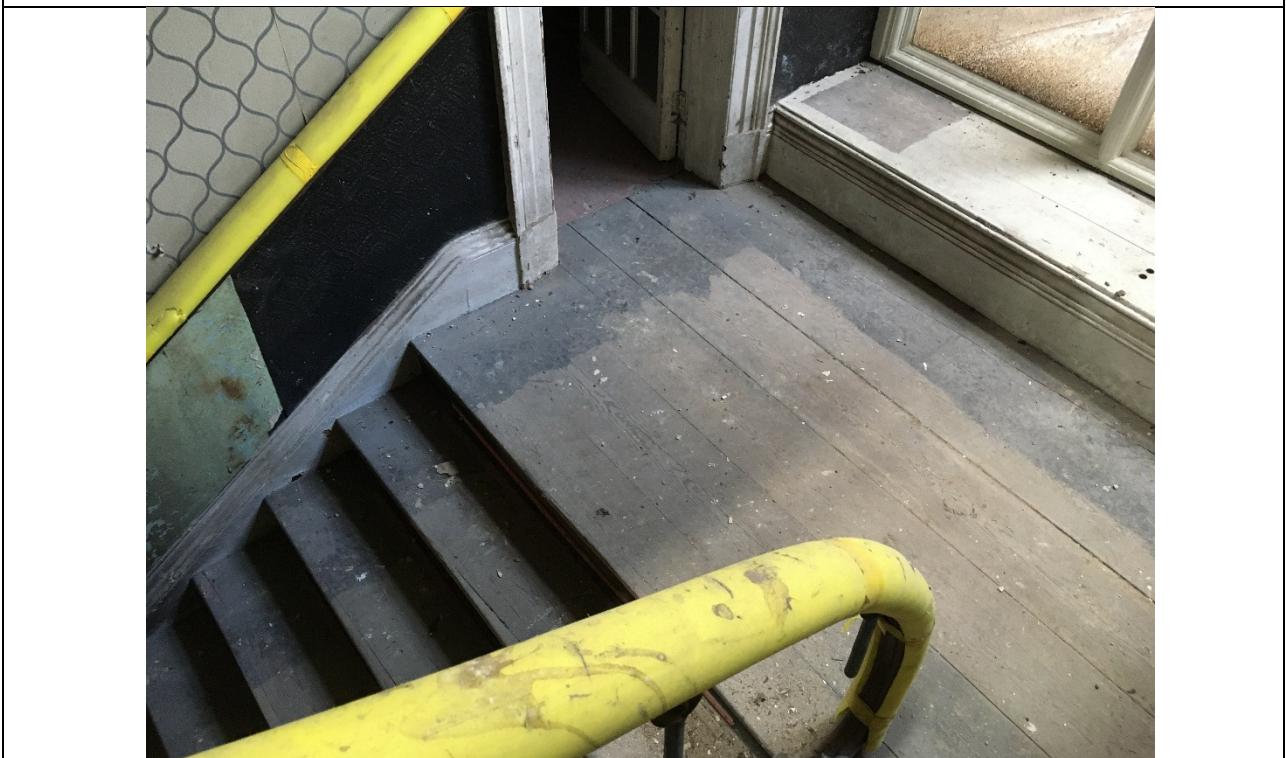
Photo A1.2

- 4.6. The half-landing between ground floor and first floor levels is in timber and appears to be in fair condition with no visible signs of decay. (See Photo A1.2).

The Level 00 to 01 half-landing is boarded in timber and appears to be in fair condition.

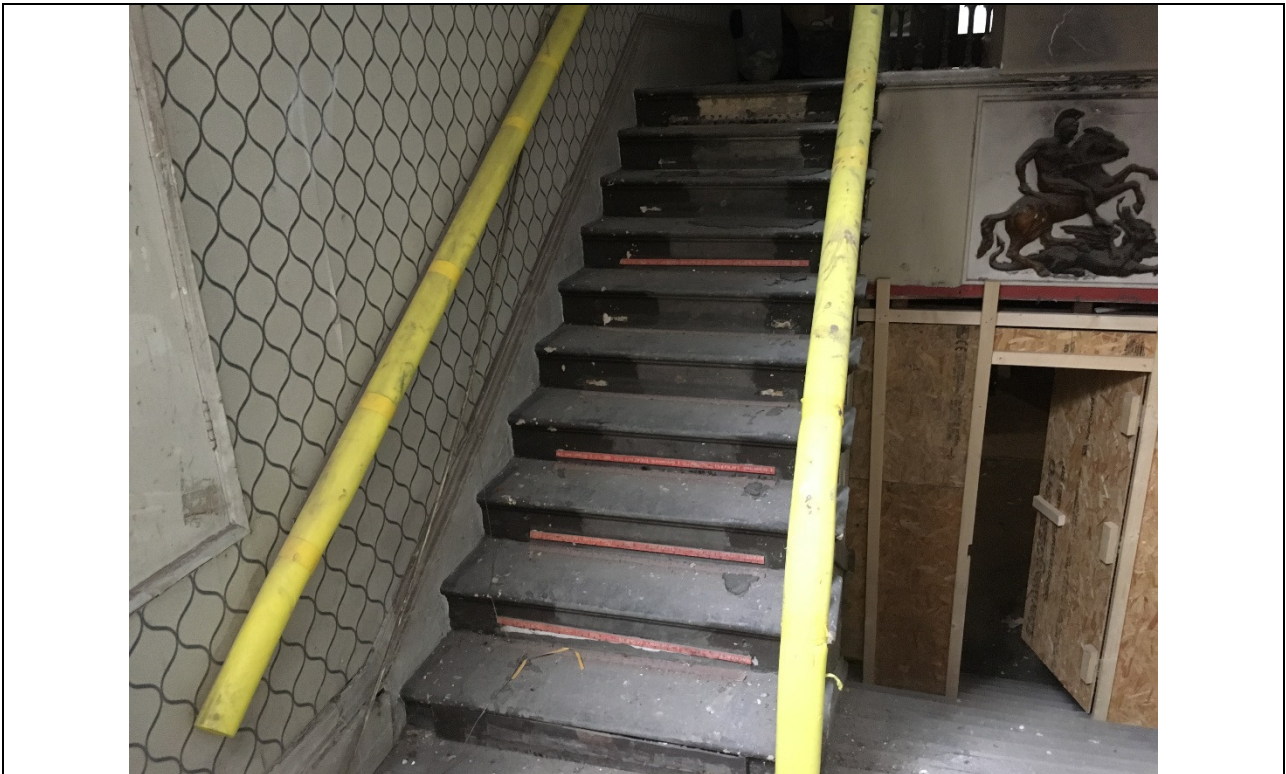
Photo A1.3

- 4.7. The ground floor to first floor upper stair flight comprises 10 cantilevering stone treads, which appear to be in fair condition. (See Photo A1.3).

View of the Level 00 to 01 upper stair flight, which is of cantilevering segmental stone tread construction and appears to be in fair condition.

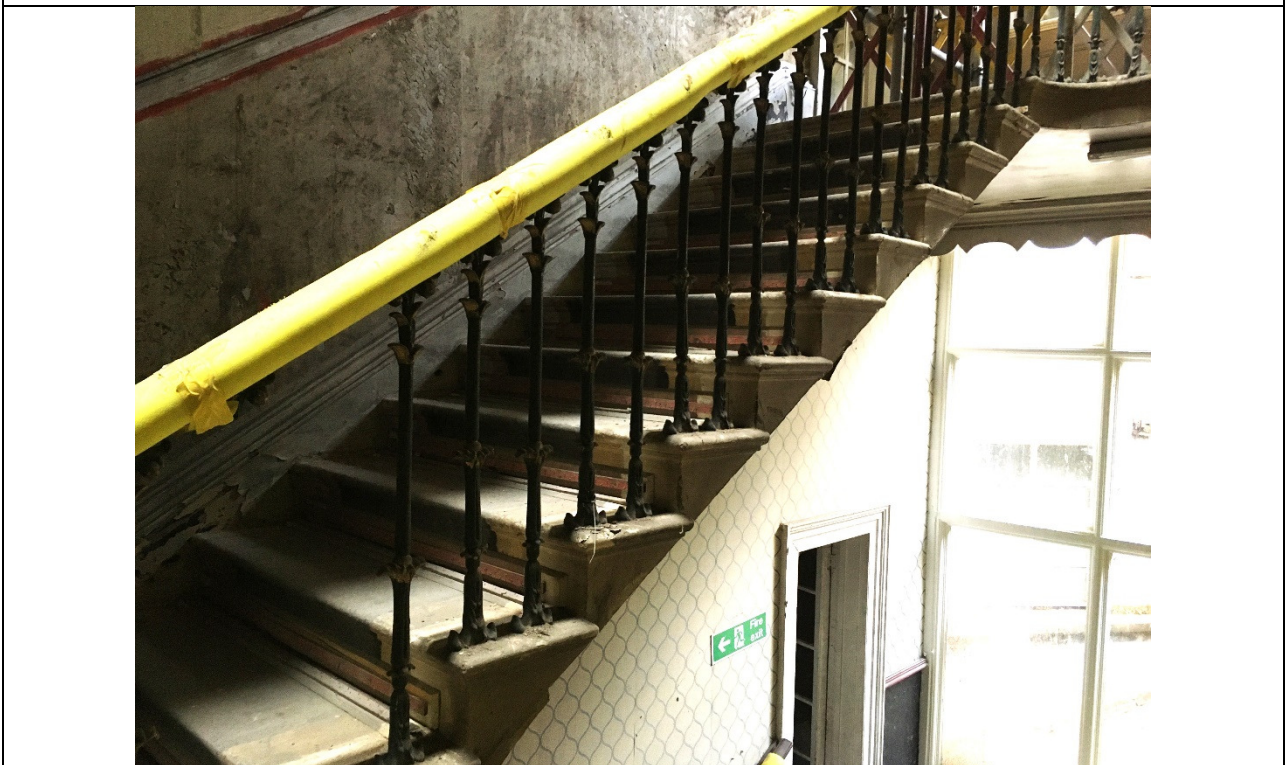
Photo A1.4

- 4.8. **The first floor (Level 01) structure adjacent to the stair appears to be of stone slab construction.**
- 4.9. **The first floor to second floor lower stair flight comprises 14 cantilevering stone treads, which appear to be in fair condition. (See Photo A1.4).**

The Level 01 to 02 lower stair flight is of cantilevering segmental stone construction and appears to be in fair condition. NB – Broken ornate cast iron balusters locally.

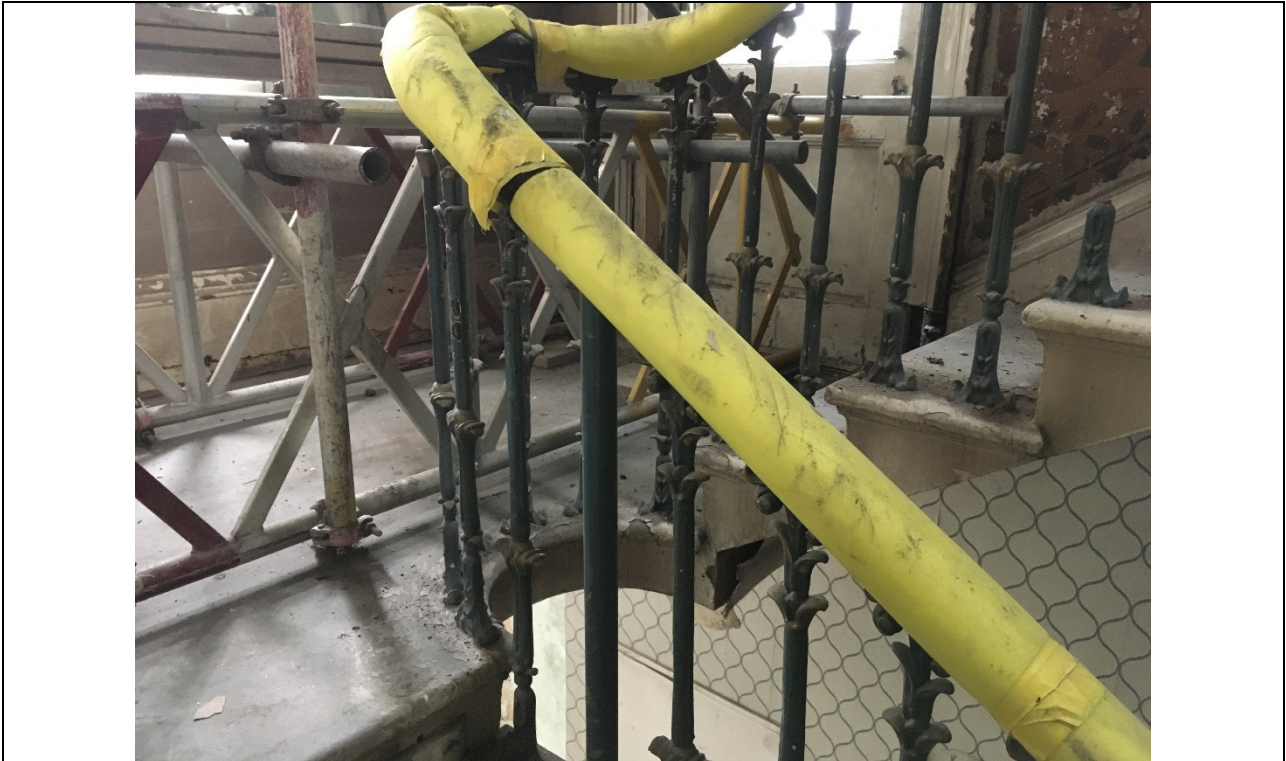
Photo A1.5

- 4.10. **The half-landing between first floor and second floor levels is of stone construction and appears to be in sound condition. The half-landing currently carries the scaffolding that supports the half-landing between second and third floor levels, and the stair flights above. (See Photo A1.5).**

Level 01 to 02 half-landing is of stone construction and appears to be in sound condition. NB lattice scaffold truss support to the Level 02 to 03 and 03 to 04 half-landings above.

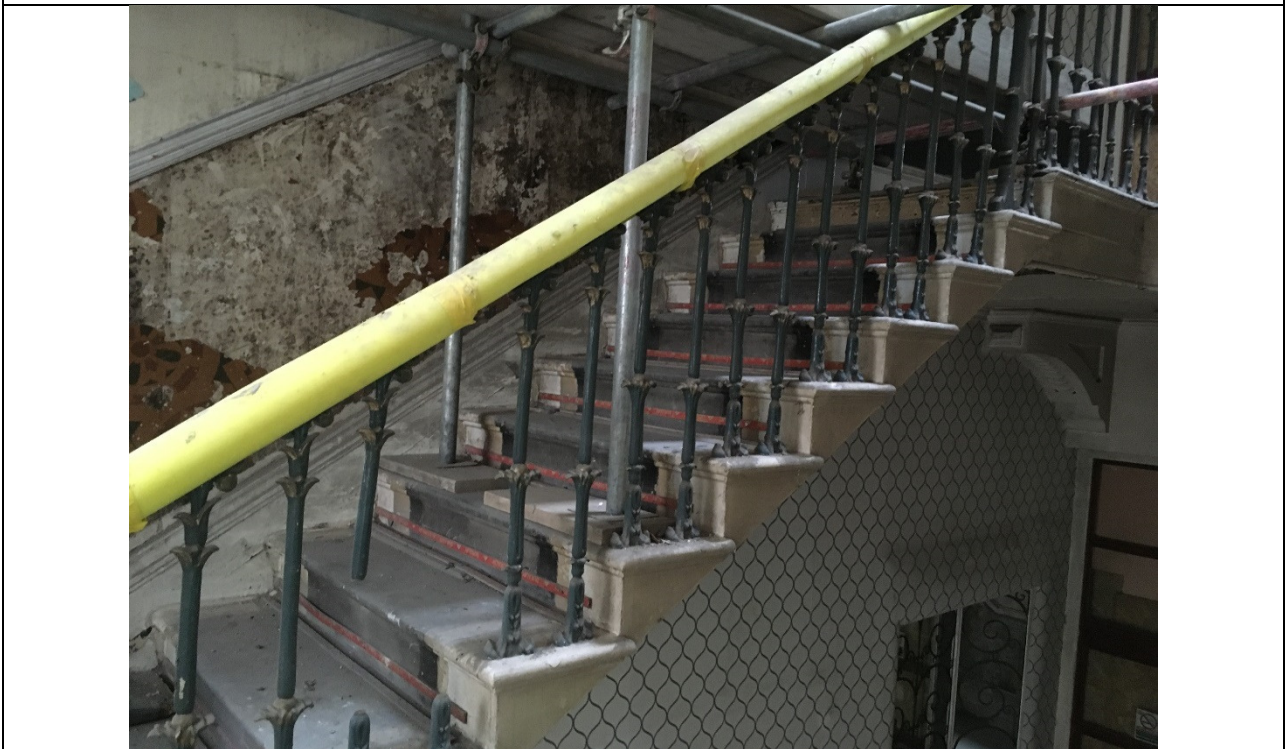
Photo A1.6

- 4.11. **The first floor to second floor upper stair flight** comprises 11 cantilevering stone treads, which appear to be in fair condition. (See Photo A1.6).

The Level 01 to 02 upper stair flight is of cantilevering segmental stone tread construction and appears to be in sound condition. NB – Broken ornate cast iron balusters locally.

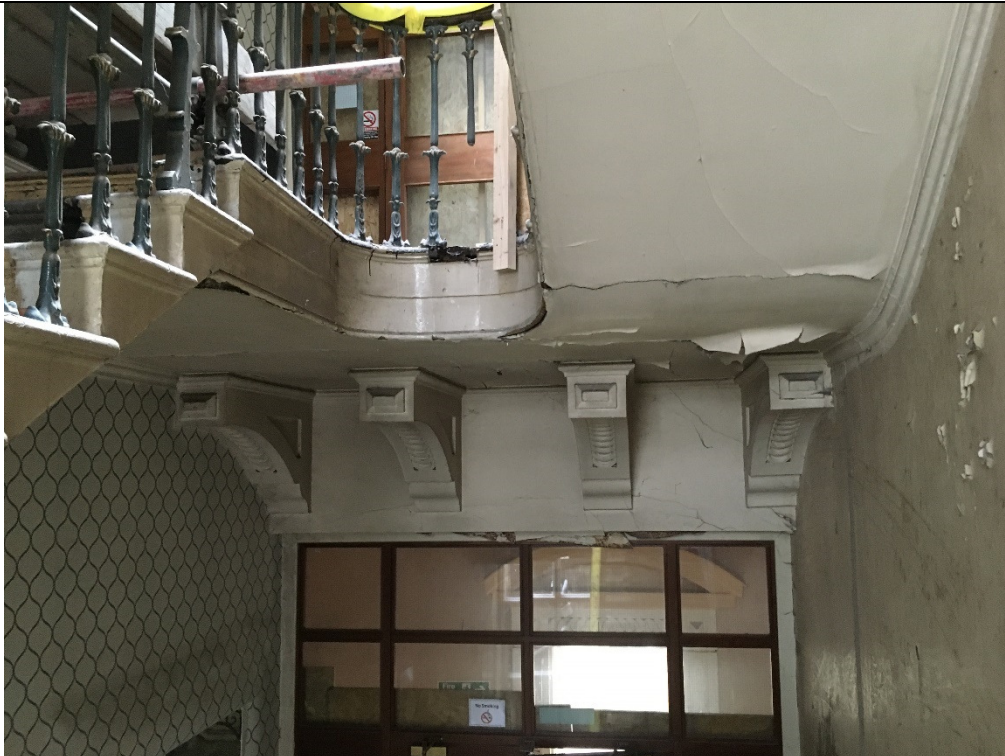
Photo A1.7

- 4.12. The second floor (Level 02) structure is of timber construction.
- 4.13. The decorative lath and plaster ceiling to the underside of the second floor staircase entrance appears to have become de-bonded, with gaps and cracks being visible. Replacement of the plasterwork appears to be necessary. (See Photo A1.7).

Underside of the stair at Level 02 has suffered from water ingress, resulting in the separation of the lath and plaster ceiling from the stair flight above. Repairs to the ceiling are needed.

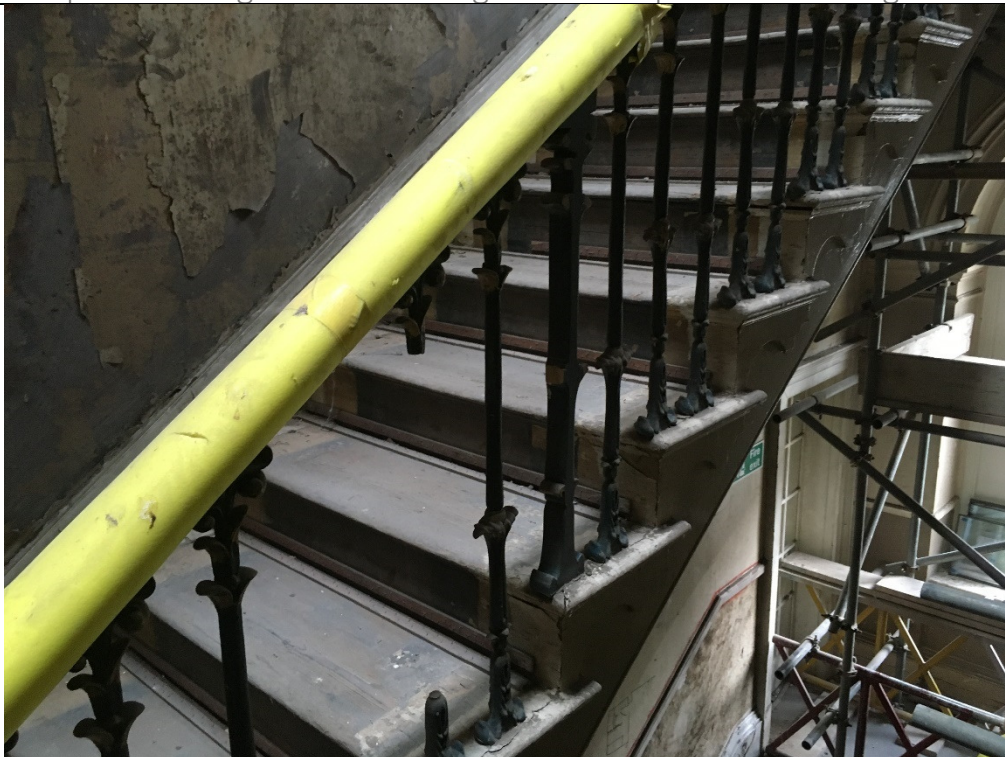
Photo A1.8

- 4.14. The second floor to third floor lower flight is in timber and comprises 13 risers. (See Photo A1.8).
- 4.15. The lath and plaster ceiling to the underside of the second floor to third floor lower flight has cracked at approx. mid-span and appears to be separating from the stair above. Repairs to the plasterwork will be required. (See Photo A1.9).

Level 02 to 03 lower flight is of timber construction. The treads show signs of abrasion wear and will need local repairs. NB – Broken ornate cast iron balusters and makeshift timber replacement.

- 5.8. Some abrasion wear to the timber stair treads was noted, as well as other peripheral damage to decorative timber edgings and mouldings. To mitigate any trip hazard, it is suggested that all timber treads with wear to a depth of 5mm or greater should be removed and replaced with new.

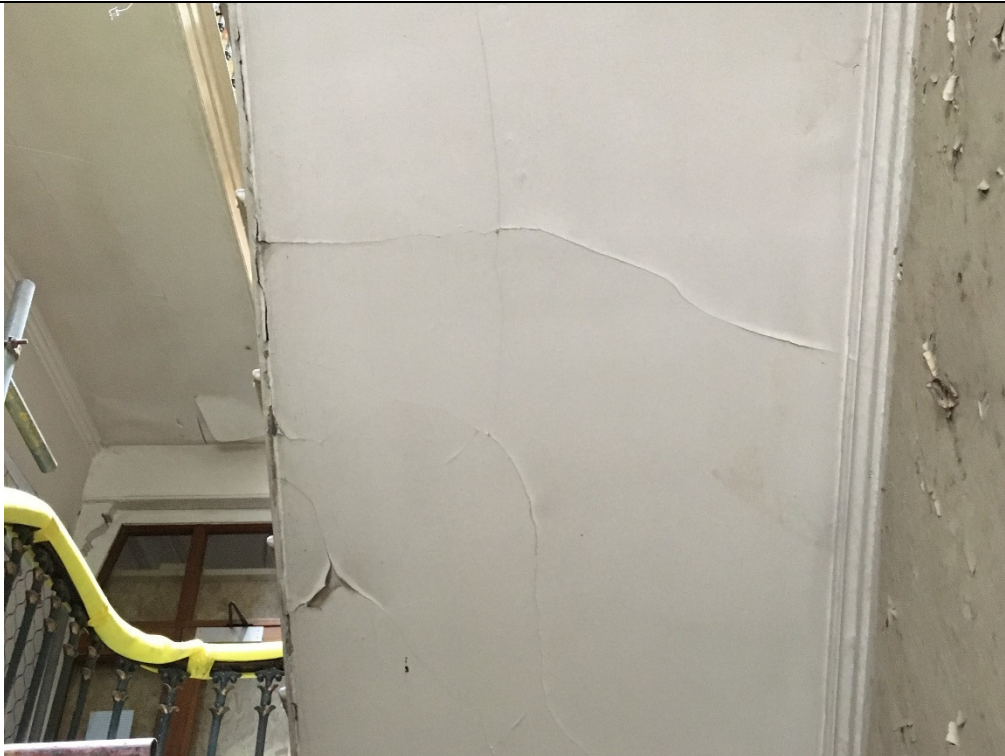
Photo A1.9

The ceiling to the underside of the Level 02 to 03 lower stair flight is showing signs of cracking and separation from the timber structure above. Local repairs needed.

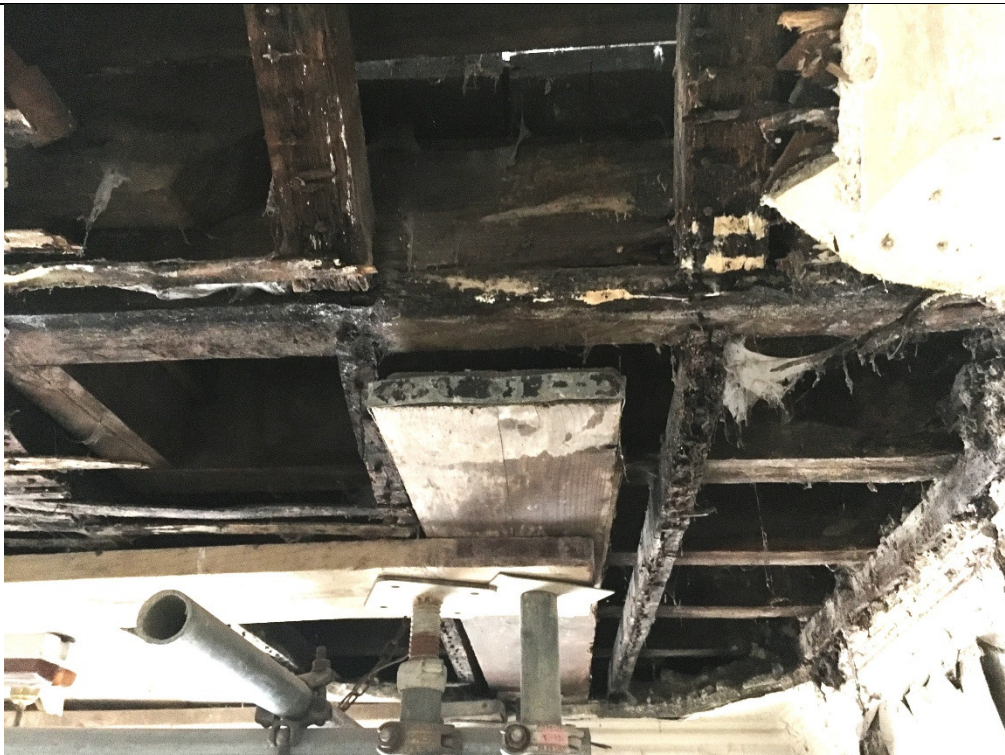
Photo A1.10

- 4.16. The half-landing between second and third floor levels is of timber construction and appears to be badly decayed. The junction between the eastern end of the half-landing and the stair is in very poor condition, with signs of both wet and dry rot being visible. Major repairs will be needed, and it is suggested that the complete removal and replacement of the half-landing should be anticipated. (See Photo A1.10).

Severely decayed timber structure of the Level 02 to 03 half-landing, as seen from below. Signs of dry rot and wet rot were noted. Removal and replacement of the half-landing is anticipated.

- 6.7. Incrementally remove the existing support scaffold down to the underside of the Level 02 to 03 half-landing.
- 6.8. Remove and replace Level 02 to 03 upper stair flight and the Level 02 to 03 half-landing in their entirety.

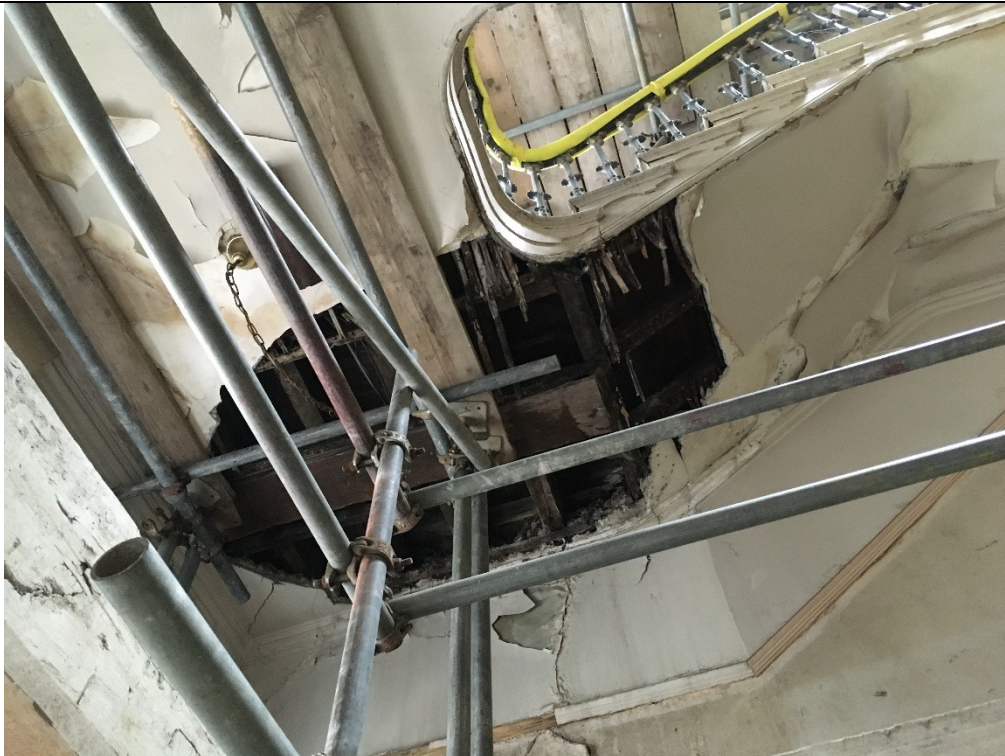
Photo A1.11

- 4.17. The second floor to third floor upper stair flight is in timber, comprising 5 risers. The flight comprises inner and outer string members, with two intermediate ceiling bearers, all of

which are very badly decayed. Removal and replacement of the complete flight will be required. (See Photo A1.11).

View of the underside of the Level 02 to 03 half-landing, showing extent of loss of the decorative plaster ceiling, and damage to the Level 02 to 03 upper flight, which will require replacement.

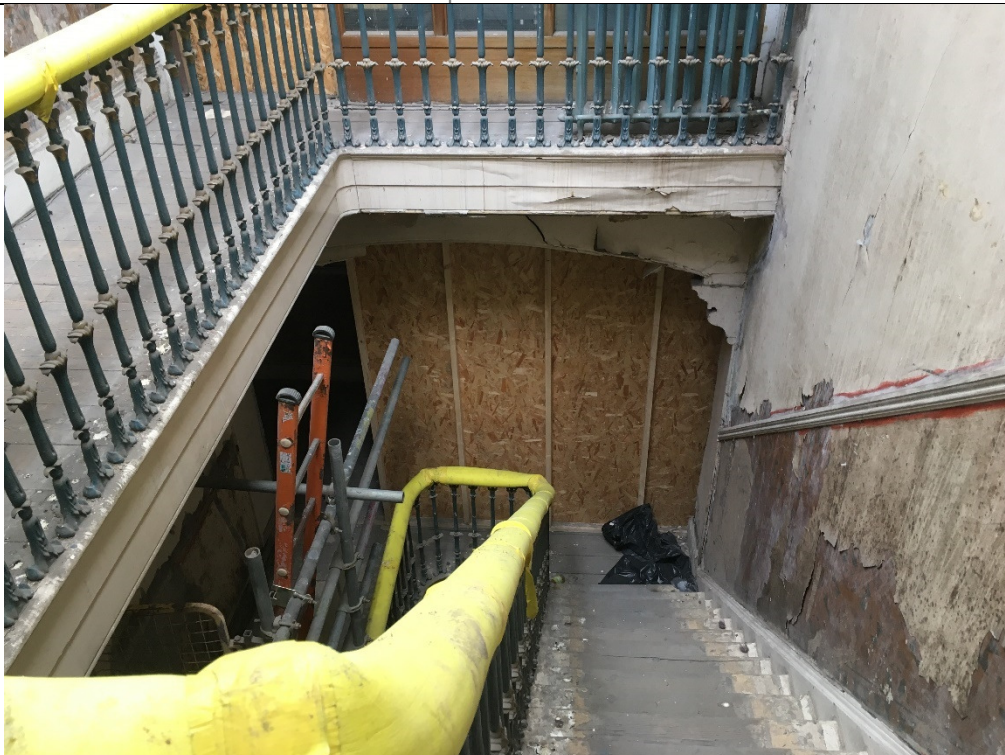
Photo A1.12

- 4.18. The third floor (Level 03) structure is of timber construction.
- 4.19. The third floor to fourth floor main flight is timber and comprises 17 risers. The flight feels firm to walk on, with very little perceptible deflection or vibration being noted. The flight appears to be in fair condition. (See Photo A1.12).

The Level 03 to 04 main stair flight (photo bottom RHS) is in timber and appears to be in fair condition, though the treads are showing signs of abrasion wear and will require repairs locally..

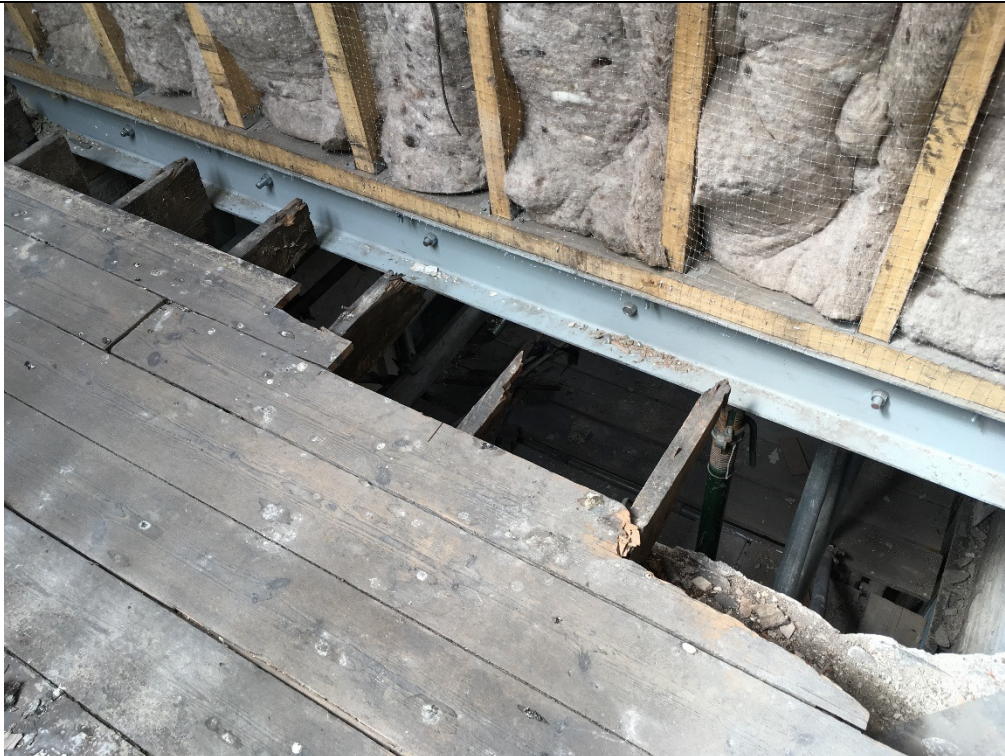
Photo A1.13

- 4.20. The half-landing at fourth floor level is of timber construction and is in very poor condition where it meets the external (north) wall. (See Photo A1.13).

Level 04 half-landing, showing the joist ends completely rotted away. NB The joists do not reach as far as the grey-painted steel 203 x 133 x 25 UKB support beam, which has been installed recently.

- 6.5. Remove and replace the Level 04 half-landing in its entirety, ensuring full bearing onto the existing 203 x 133 x 25 UKB bearer beam.
- 6.6. Repair the Level 04 side landing as necessary, replacing the floor boards where damaged or missing.

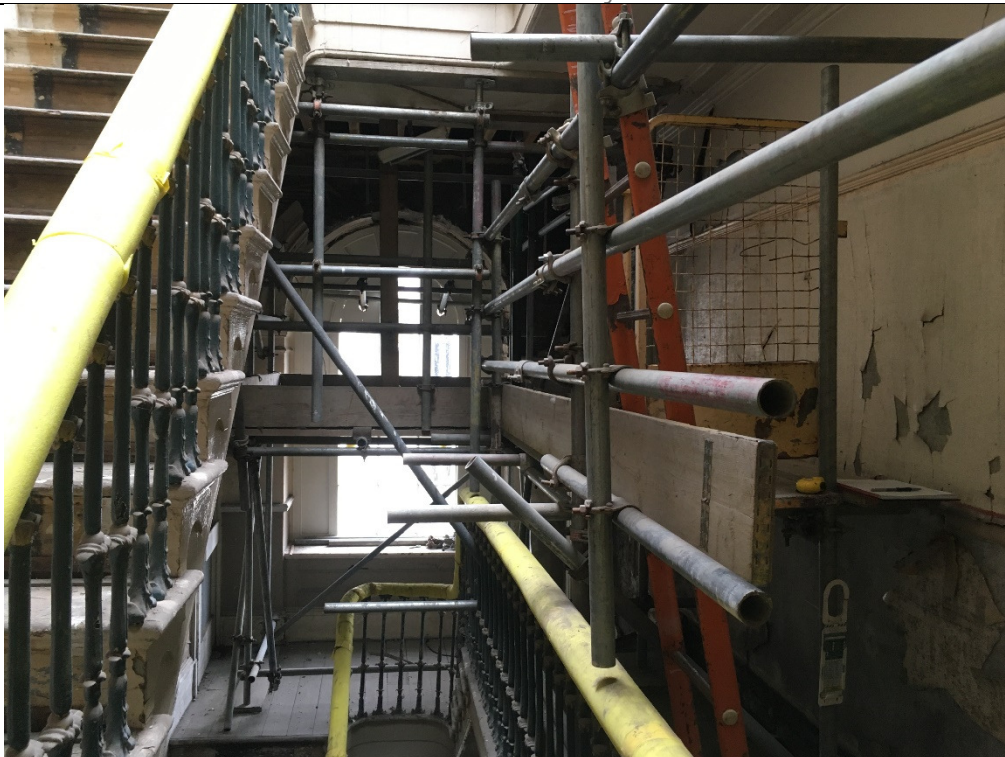
Photo A1.14

- 4.21. The northern (external wall) ends of the floor joists have rotted away. A steel 203 x 133 UKB bearer beam has been installed, which spans across beneath the flank walls has been installed but the decayed ends of the joists stop short of the beam, which therefore currently does nothing to support the half-landing. The half-landing is currently being supported by scaffolding from below. (See Photo A1.14).

The Level 04 half-landing and side landing are supported by scaffolding from below. The scaffolding bears onto the Level 02 to 03 half landing and upper stair flight, which is decayed.

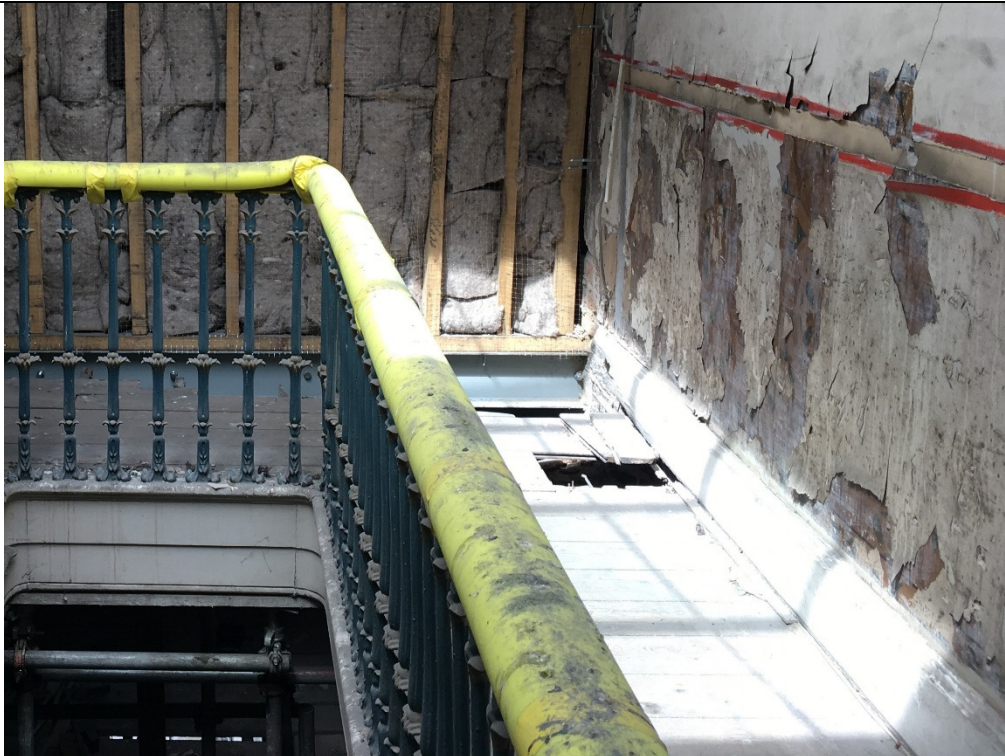
Photo A1.15

- 4.22. The fourth floor stair-side landing is of timber construction and appears to be in fair condition. (See Photo A1.15).
- 4.23. The fourth floor (Level 04) structure adjacent to the stairs is of timber construction and comprises a narrow landing that spans across the width of the stairwell.

The Level 04 side landing is generally in fair condition. The north-eastern end abuts the Level 04 half-landing, which is badly decayed. NB missing floor boards and 203x133x25 UKB support beam.

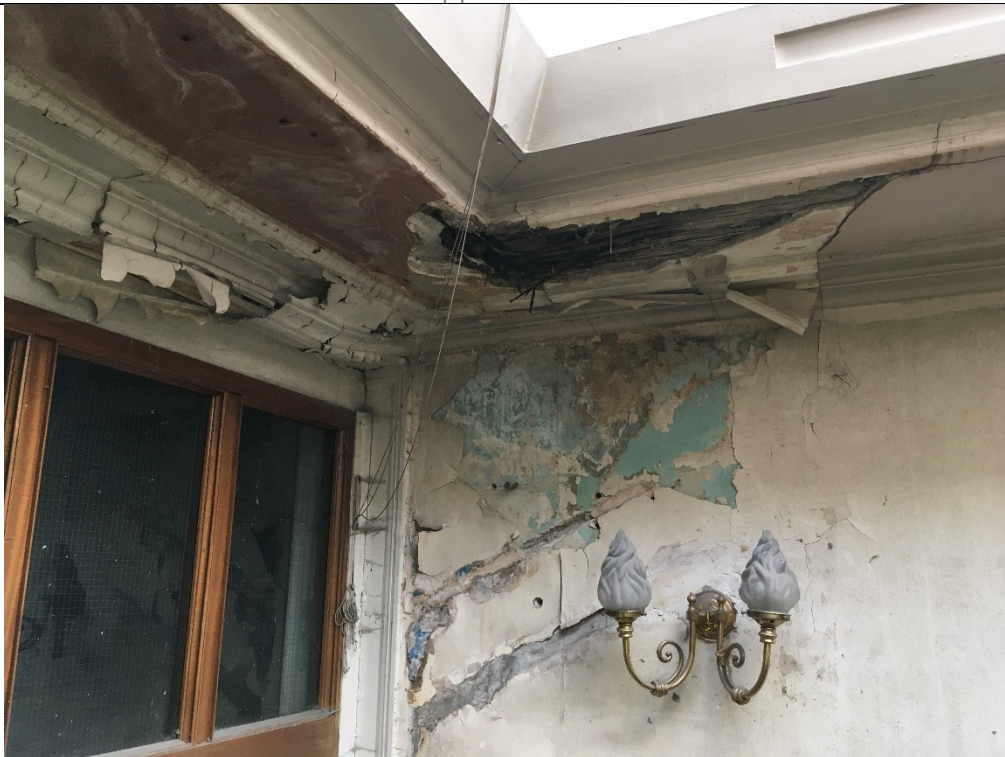
Photo A1.16

- 4.24. The roof to the stairwell has a central, glazed lantern light, set upon a timber upstand. The gutters and roof finishes around the lantern light upstand appear to have failed, and the resulting water ingress overtime has resulted in serious damage to the decorative plasterwork, decay of the backing laths and wet rot in the roof joists. (See Photo A1.16).

- 5.5. The main damage to the timber stair areas is due to rainwater ingress, chiefly at roof level, though there may also have been some leakage through poorly sealed windows to the external (north) wall. This appears to have been ongoing for some considerable time, given the evident age and extent of some of the damage.

Ceiling to the south-west corner of the stairwell roof. Rainwater ingress over a prolonged period has led to decay of the backing laths and local collapse of the plasterwork. Local repairs are needed.

- 5.6. It is therefore essential that any further rainwater ingress should be prevented by removing the existing finishes to the stairwell roof, repairing any decayed timberwork to the roof deck, valleys and lantern light upstand, adjusting the roof profile as necessary to ensure effective falls to drainage points, and providing a new, high performance waterproofing system over the stairwell roof area.

- 6.1. The following remedial work is anticipated:
- 6.2. Remove all flashings and roof finishes to the stairwell roof area, and repair any decayed timberwork to the roof deck, valleys and lantern light upstand.

- 6.3. Adjust the roof profile as necessary to ensure effective falls to drainage points.
- 6.4. Provide new high-performance waterproofing system over the stairwell roof area.

- 6.11. Apply fungicidal timber treatment to all exposed timberwork, including within ceiling voids wherever possible.
- 6.12. Remove and replace the plaster finishes to the underside of the stairwell roof and lantern light upstand area.

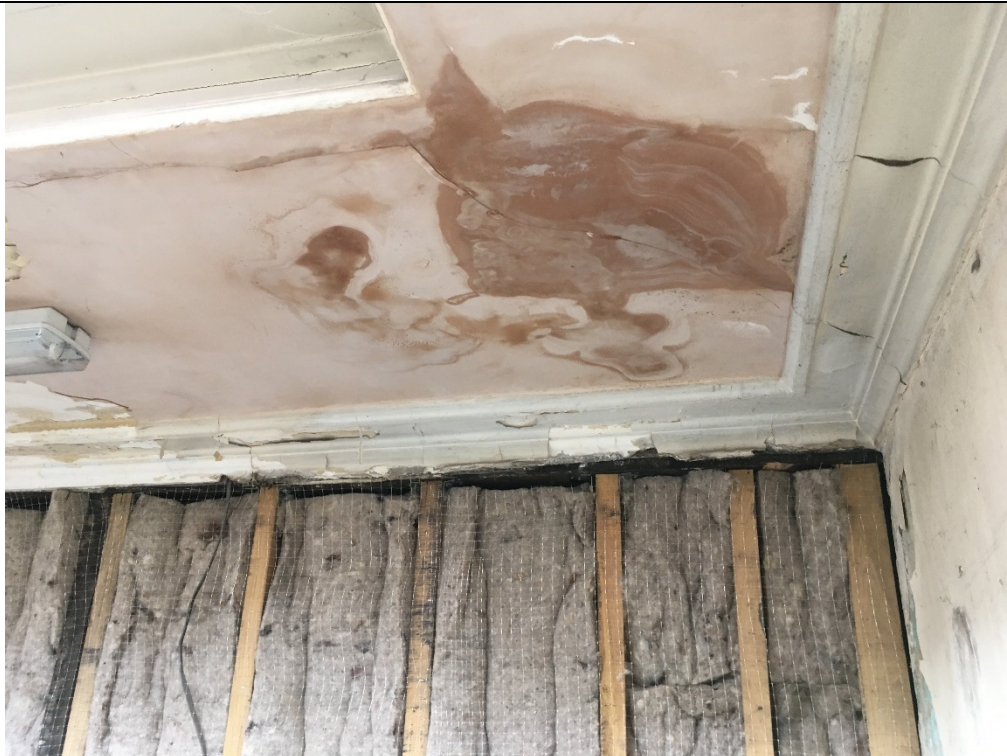
Photo A1.17

- 4.25. Similar damage has occurred to the north-east, north-west and south-west corners of the stairwell roof as a whole. (See Photo A1.17).
- 4.26. The staircase features an ornate cast iron balustrade and hardwood handrail. (See Photo A1.18).

Damage to recently replaced ceiling plasterwork below roof level, caused by water ingress. General repairs are needed to the ceiling in this area.

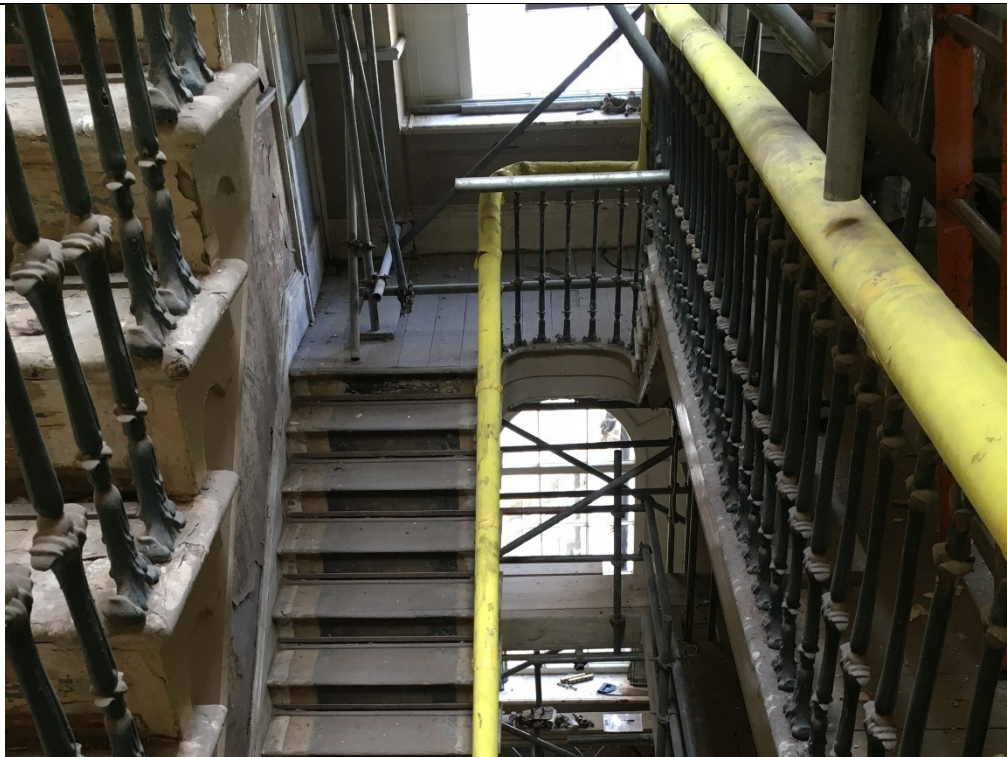
Photo A1.18

The staircase features an ornate cast-iron balustrade, with a hardwood handrail (shown protected by yellow foam sheathing) NB - Variation in alignment of the stair flights and landings from level to level.

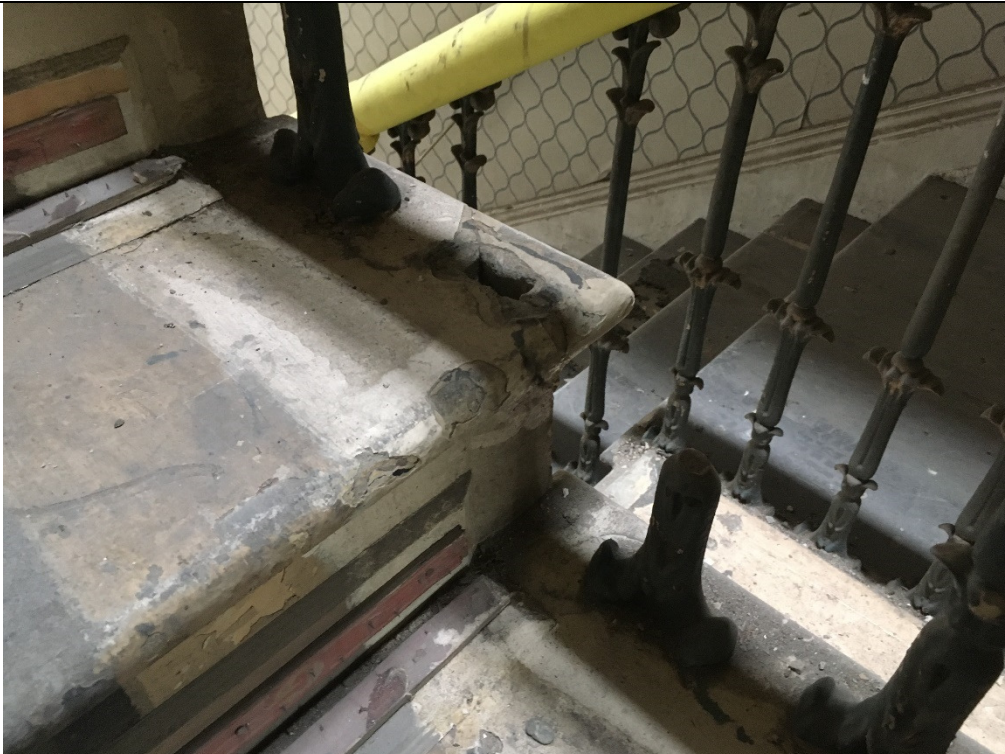
Photo A1.19

Baluster foot socket in the inner end of a cantilevering stone tread unit. The cast iron balusters have rectangular ends that fit into the sockets.

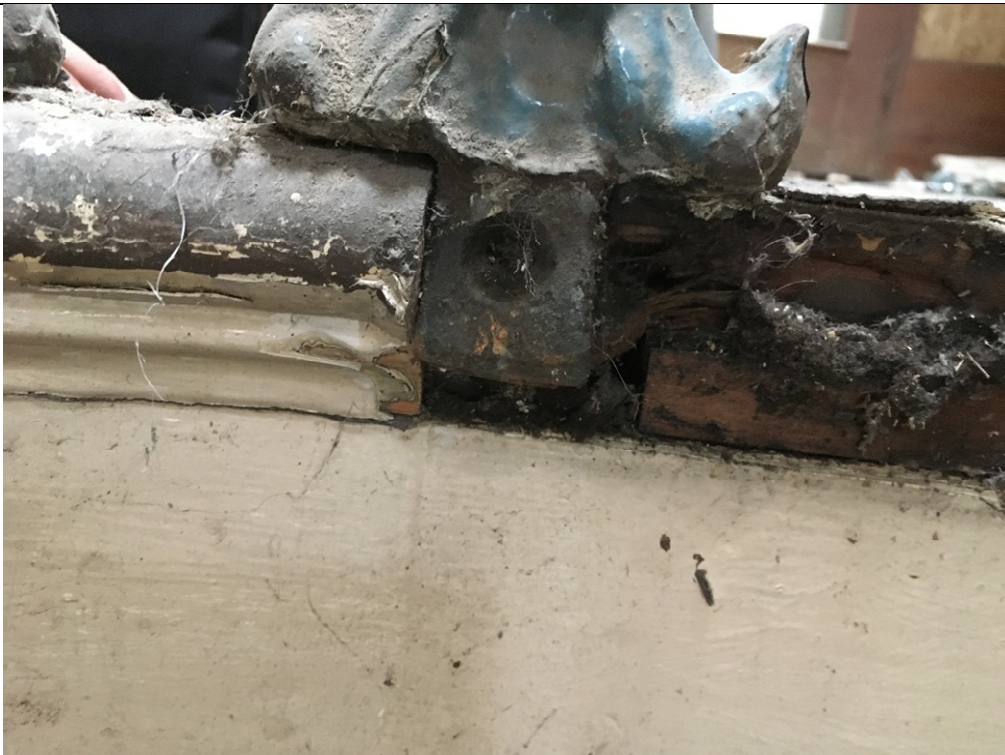
Photo A1.20

Rectangular bottom end of cast iron baluster, showing countersunk hole for wood screw to fasten the baluster to the timber stair string member behind. The screw is missing in this location.

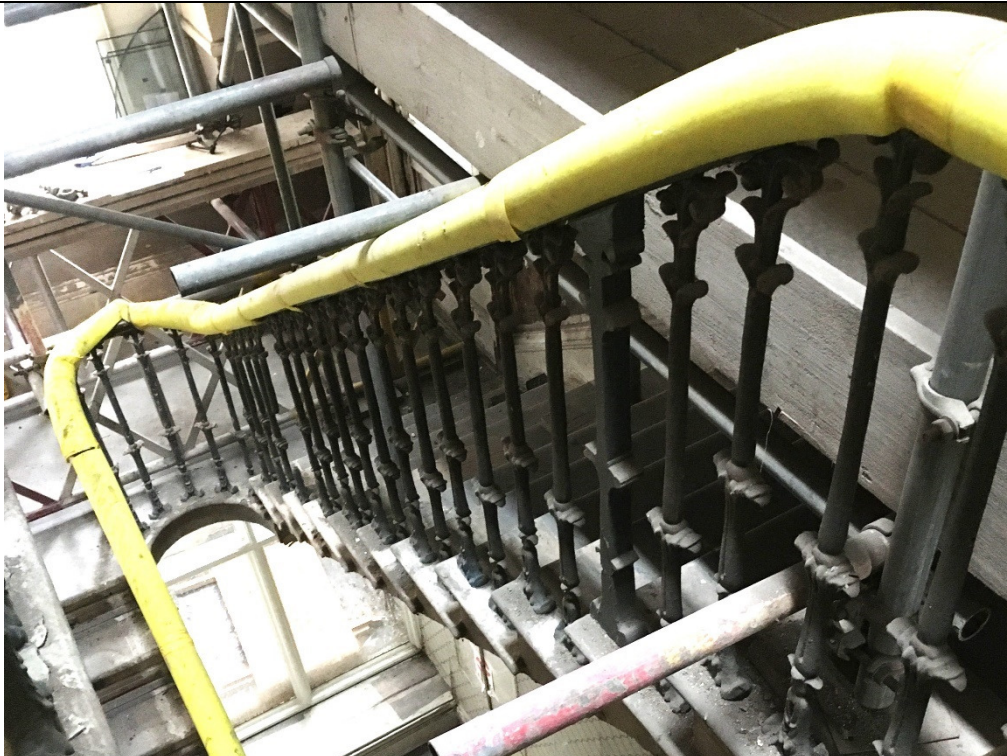
Photo A1.21

- 4.29. The balusters have been broken and removed in several locations. In some instances, makeshift timber replacements have been fitted to fill the gaps. (See Photo A1.21).

- 5.13. The balustrade to the main staircase is of ornate cast-iron, with a hardwood handrail. Several balusters (approx. 20) have been broken and lost and will need to be replaced. Some have already been replaced by makeshift timber balusters, roughly cut to reflect the overall profile of the cast-iron balusters.

The ornate cast iron balustrade has been broken in places and the balusters removed. NB - Makeshift wooden balusters have been fitted in places – e.g. fifth baluster from the right.

- 6.15. Remove all broken cast iron balusters and replace all missing or broken ornate balusters with new replicas.
- 6.16. Install new upper handrail, newel post and anchor bracket arrangement to all levels of the staircase.

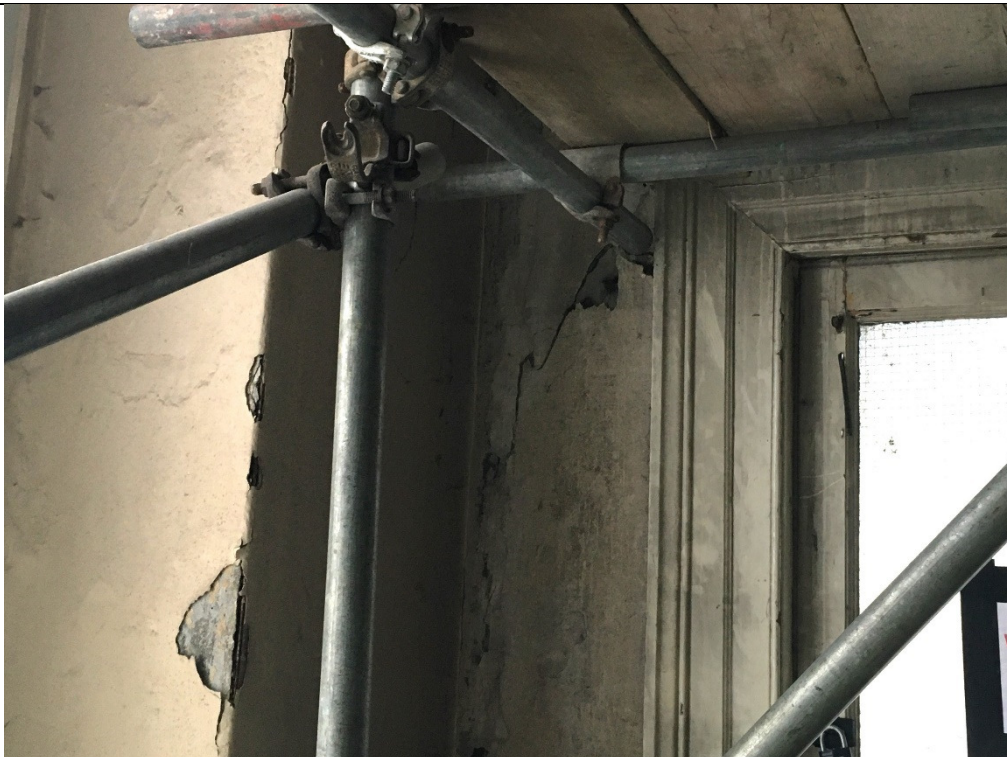
Photo A1.22

- 4.30. Diagonal cracking was noted in the staircase flank walls in several locations. The majority of the cracks indicate slight movements at points of high stress concentration, particularly adjacent to the emergency access door openings off the half-landings. The cracking will require repair, using stitching bars to restore the structural integrity of the walls locally. (See Photo A1.22).

- 5.3. The need to provide fire escape access has resulted in additional door openings being formed through the stairwell flank walls. It is probable that the formation of these additional openings has led to stress concentrations in the flank walls, the result of which being the cracking that is evident.

Diagonal cracking in the staircase east flank wall adjacent to the half-landing emergency access door. Local stitching / masonry repairs needed to restore structural integrity locally.

- 5.4. Stitch repairs using proprietary embedded helical bar (HeliFix Helibar, bonded using HeliBond mortar, or similar products), or block-bonded replacement of the masonry across the cracks is proposed. This would help to restore the structural integrity of the flank walls locally.

- 6.13. Repair cracking generally throughout the height of the stairwell flank walls and make good to the plasterwork that has been disturbed.
- 6.14. Replace timber floorboards and treads generally where in excess of 5mm of abrasive wear is present.
