**Carlinghow Motor Care
27 Ings Road
Batley
WF17 8LT**

**LYONS CMC
COAL MINING & GEOTECHNICAL
CONSULTANCY**

Date: 4th July 2025
Your ref: (WF17 8LP)
My Ref: SI 00405

**COAL MINING RISK INTERPRETATION REPORT – FOLLOWING THE SITE
INVESTIGATION FOR PROPOSED COMMERCIAL DEVELOPMENT AT LAND TO THE
REAR OF 588-594 BRADFORD ROAD, BATLEY WF17 8LP**

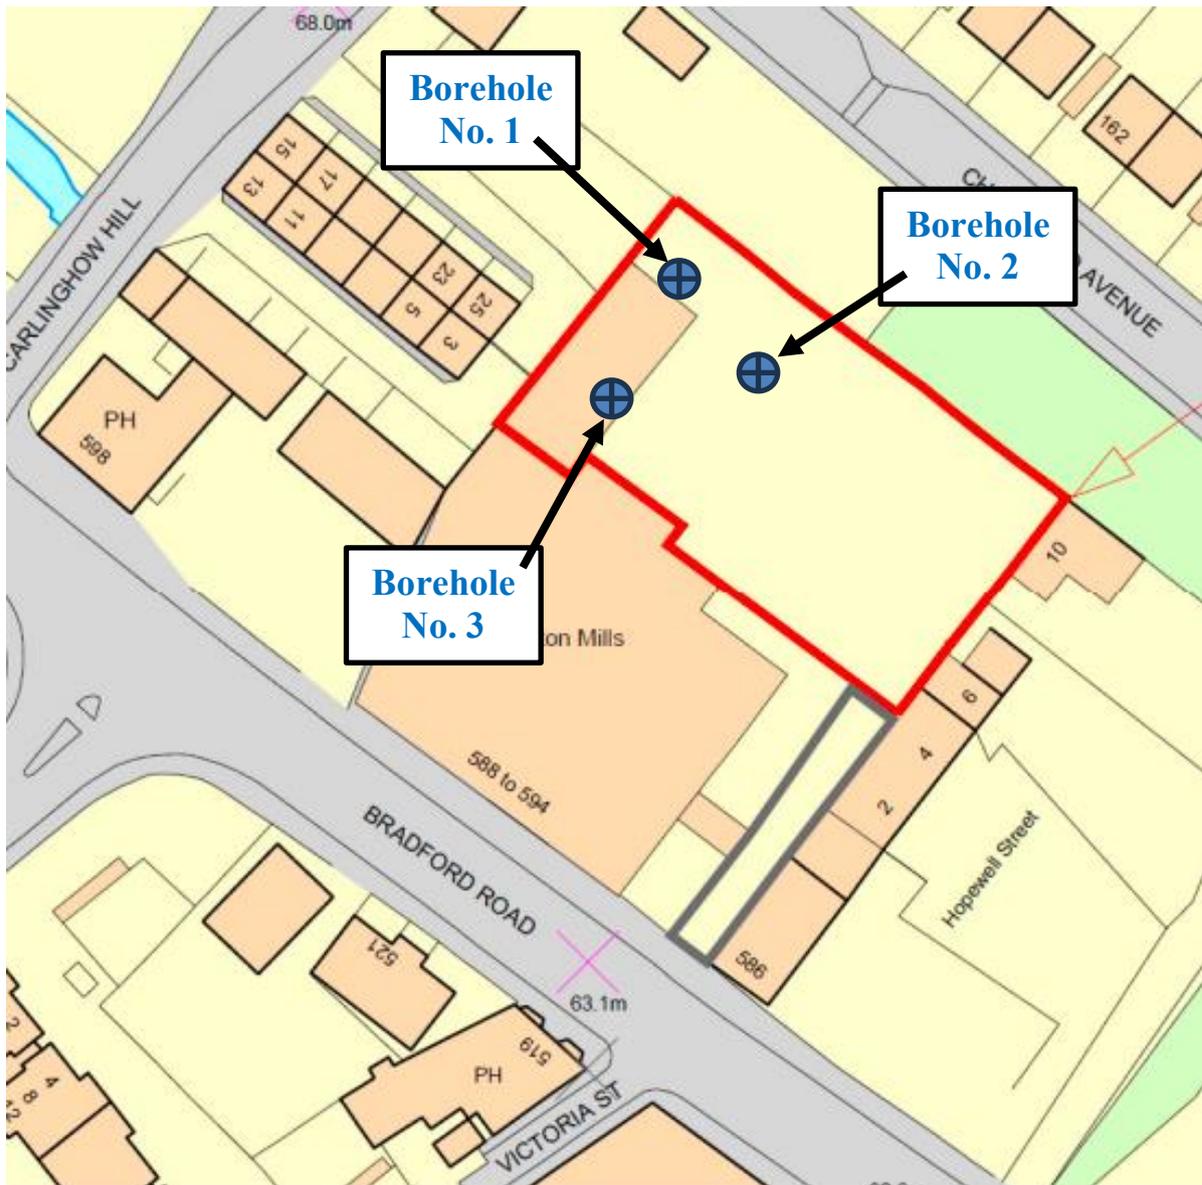
5.2 Borehole Location Plan No. 00405/B

Borehole No. 1 proved 0.3m of made ground followed by soft light brown sandstone to 0.8m deep and a thin 0.1m section of **coal** to 0.9m deep. Grey light brown mudstones followed by grey sandstone was then proved to 20m deep with no signs of any other coal seam.

Borehole No. 2 proved 0.5m of made ground followed by light brown/yellow clay to 1.1m deep and a thin 0.1m section of **coal** to 1.2m deep. Grey light brown mudstones followed by grey sandstone was then proved to 20m deep with no signs of any other coal seam.

Borehole No. 3 proved 1.5m of made ground followed by light brown/yellow clay to 1.8m deep (no coal). Grey light brown mudstones followed by grey sandstone was then proved to 20m deep with no signs of any coal seam.

No signs of underground shallow workings or unstable ground were encountered at any of the three borehole locations and no fugitive gases were detected at any point during the drilling operations.
