## **Project**

**Project Name:** FJ00401962 - Old EPI Building  
**Project Description:** CCTV Survey  
**Project Number:** FJ00401962  
**Project Status:** Complete  
**Project Date:** 14/03/2025

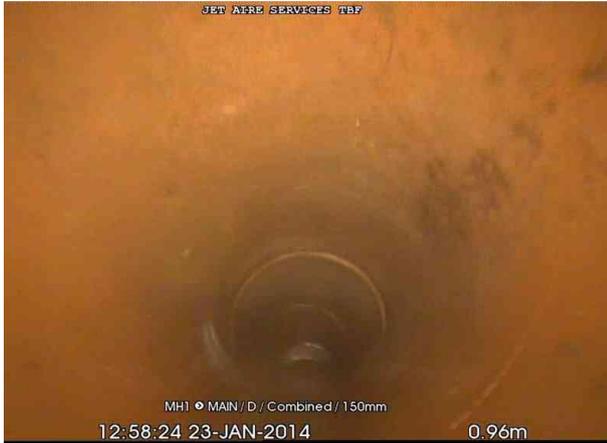
41341.jpg, 00:00:11, 0.96 m  
Crack, circumferential from 4 o'clock to 6 o'clock

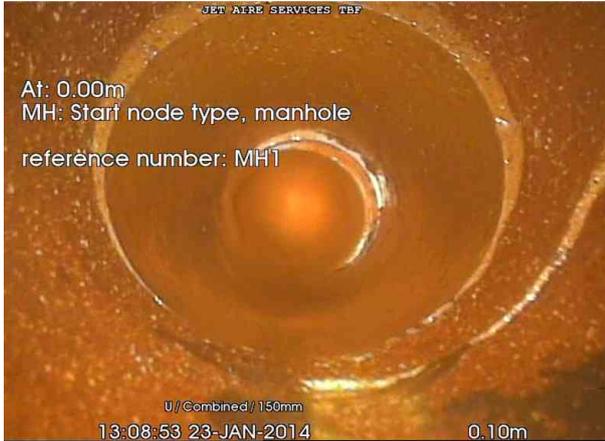
2128.jpg, 00:00:09, 0.10 m  
Fracture, circumferential from 2 o'clock to 6 o'clock

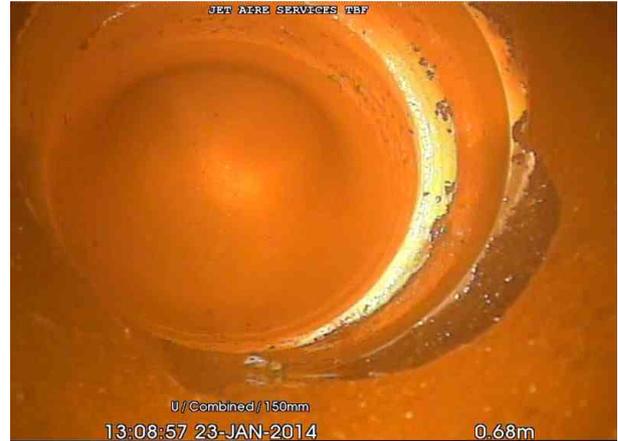
Section	PLR	Grade	Description
2	LINE AX	5	Hole in drain or sewer at joint from 3 o'clock to 6 o'clock
5	MH4X	3	Fracture, longitudinal at 11 o'clock
6	MH4X	3	Fracture, longitudinal at 12 o'clock

9504.jpg, 00:00:13, 0.68 m  
Hole in drain or sewer at joint from 3 o'clock to 6 o'clock

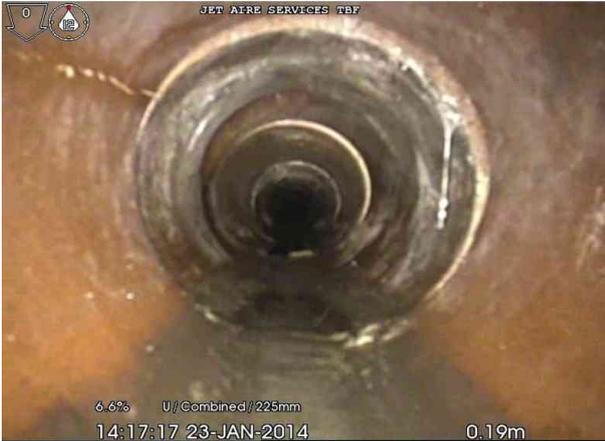
13469.jpg, 00:00:12, 0.19 m  
Fracture, longitudinal at 11 o'clock

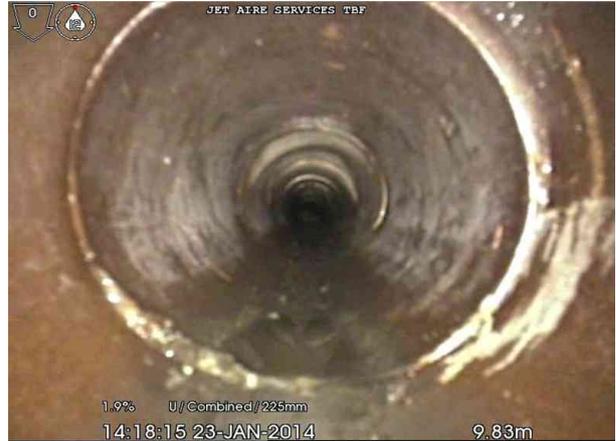
44294.jpg, 00:01:10, 9.83 m  
Crack, longitudinal at 3 o'clock

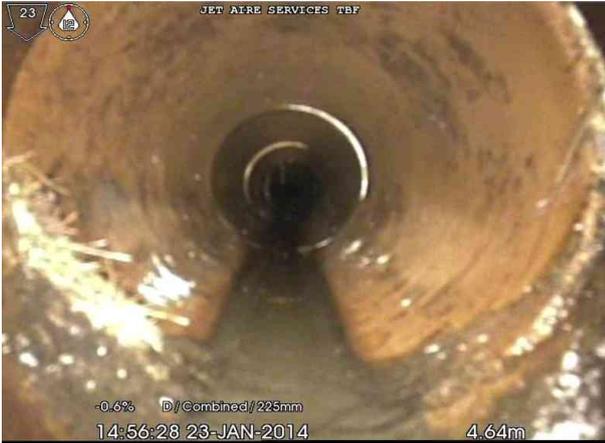
50388.jpg, 00:00:44, 4.64 m  
Roots, mass at joint, 5% cross-sectional area loss

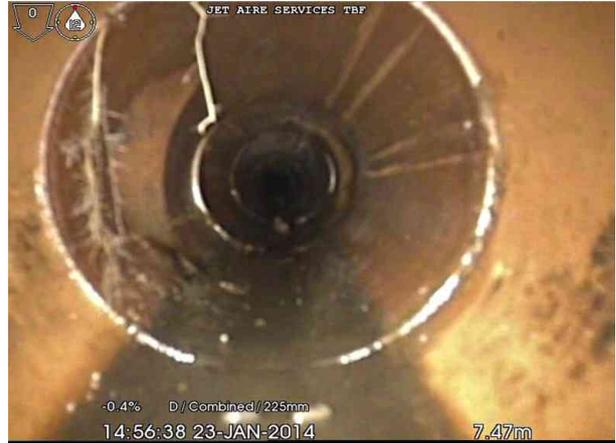
6822.jpg, 00:00:54, 7.47 m  
Roots, fine at joint

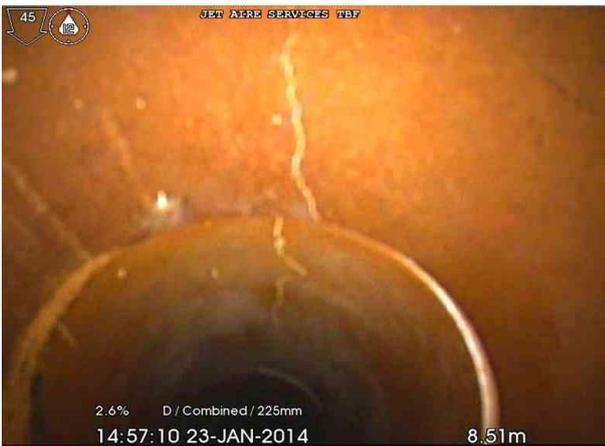
9028.jpg, 00:01:25, 8.51 m  
Fracture, longitudinal at 12 o'clock

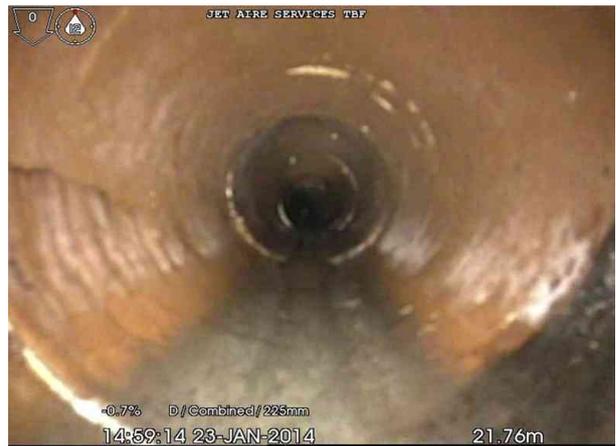
63511.jpg, 00:03:30, 21.76 m  
Crack, longitudinal at 9 o'clock

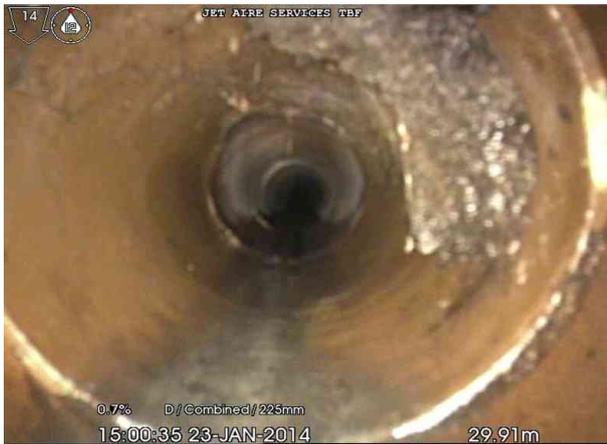
63552.jpg, 00:04:51, 29.91 m  
Attached deposits, encrustation from 12 o'clock to 4 o'clock,  
10% cross-sectional area loss, Around Connection

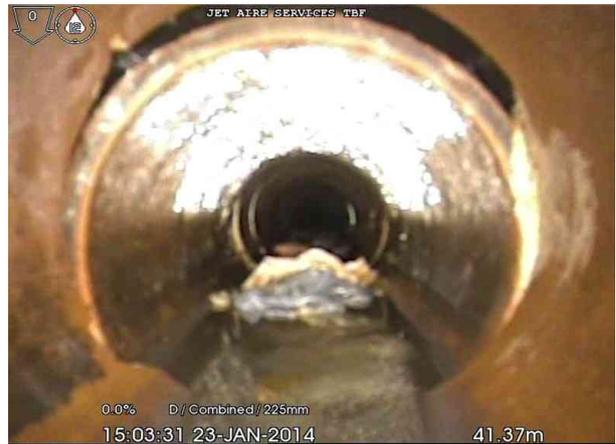
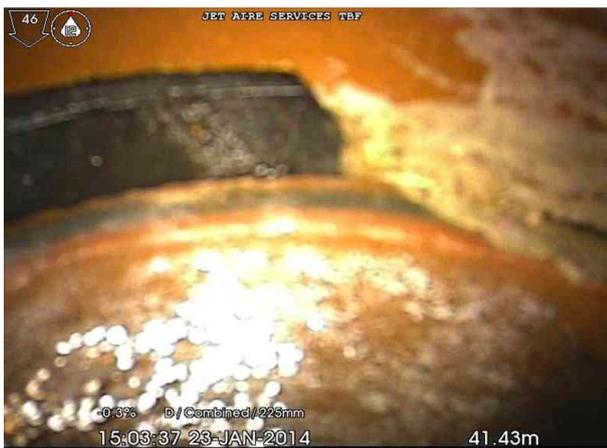
32681.jpg, 00:06:44, 41.37 m  
Joint displaced, large

52760.jpg, 00:06:44, 41.37 m  
Joint displaced, large
