# Arboricultural Safety Assessment

**WC-391.1b**

19, Hightown View, Liversedge WF15 8BY

<b>Report type:</b>	Arboricultural Safety Assessment
<b>Report reference:</b>	WC-391.1
<b>Revision:</b>	b
<b>Client:</b>	Thomas Chamberlain
<b>Site address</b>	19, Hightown View, Liversedge WF15 8BY
<b>OS Grid reference:</b>	SE 18484 24435
<b>Report prepared by:</b>	Jack Delaney MICFor MArborA
<b>Date:</b>	29 <sup>th</sup> April 2025

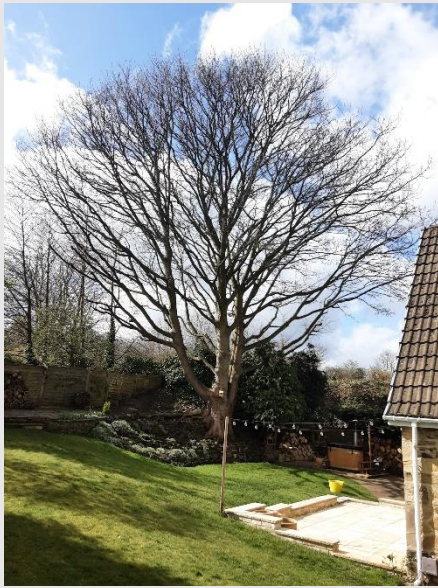
3.3.1. T001 is a mature sycamore *Acer pseudoplatanus*, which bifurcates between 1 m and 3 m into multiple co-dominant stems. The angles of these branch unions are all greater than 25°, which suggests that they do not contain included bark.

3.3.2. Deadwood which is less than 100 mm in diameter was identified throughout the crown of T001, which is considered typical of the species type at full maturity.

- the RoH presented by T001 - in terms of the deadwood within the crown - was determined to be less than 1/1,000,000; and,
- the RoH presented by T001 - in terms of the potential for catastrophic failure of the main stem or root plate - was determined to be less than 1/1,000,000.

*Plate 1: T001 (viewed from the south)*

4.1.1. Since the RoH posed by T001 has been deemed to be broadly acceptable, no further work to the tree is recommended for risk mitigation.

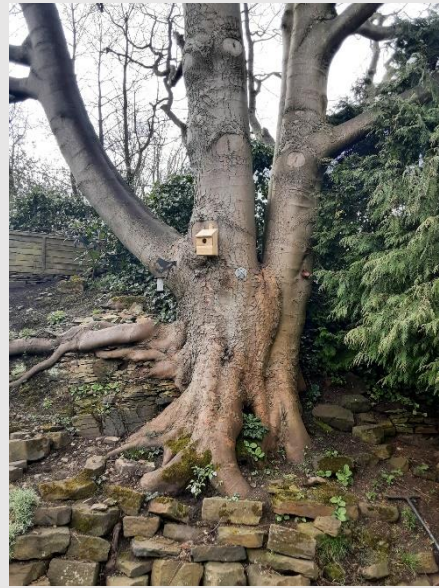
*Plate 2: Base and lower main stem of T001 (viewed from the east)*

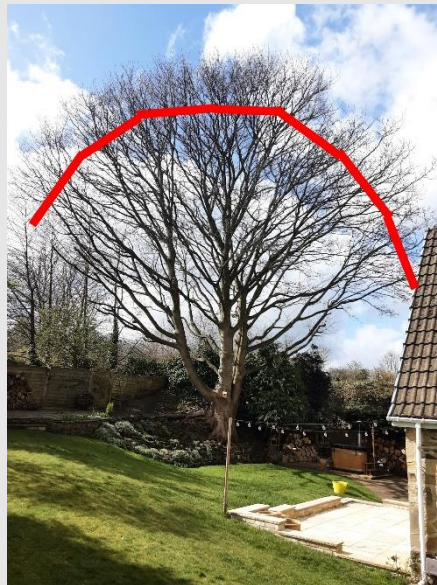
*Plate 3: Approximate extent of proposed 3 m reduction*

4.2.2. The 5 m crown lift and crown clean which was previously granted by Kirklees Council under Application Number: 2021/92079 is still considered unworthwhile, as the lowest branches are already close to this height. Alternatively, it is proposed that a 3 m crown reduction is carried out.

- 4.2.4. The crown of T001 should be reduced in proportion to its existing shape, so as to avoid altering the balance of the tree as a whole. The pruning cuts should not exceed 100 mm.
- 4.2.5. Due to its potentially negative effects, the crown reduction of T001 should not be carried out in addition to other pruning operations (e.g. thinning), which would add to the amount of wounding and leaf loss.
