## **STRUCTURAL APPRAISAL REPORT**

**REF: MDL – 9683**

Bradley Hall Farm  
Lower Quarry Road  
Bradley  
Huddersfield  
HD2 1FN

We have been instructed to undertake a structural appraisal report of Bradley Hall Farm with a view to its conversion into habitable accommodation with workshop units.

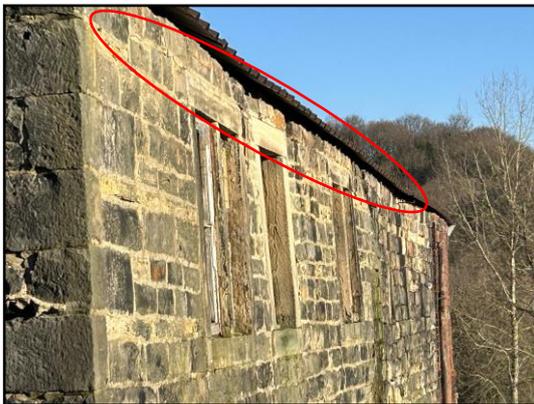
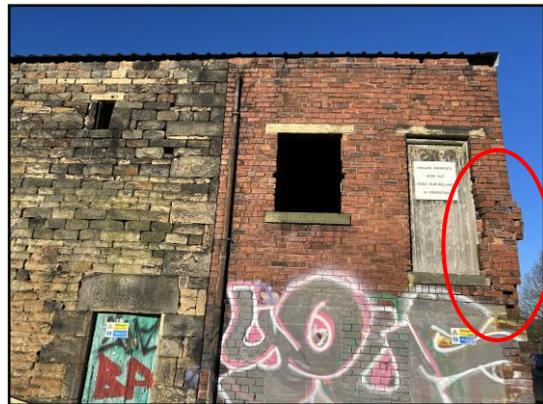
Minor lateral movement was noted the top two courses of stonework on the front elevation and minor realignment repairs will be needed during the renovation and re-roofing of the property.

The brick work on the front right hand corner has previously been impacted, with displacement of the individual bricks noted adjacent to the first floor door opening. Simple realignment repairs will be required to this minor structural defect.

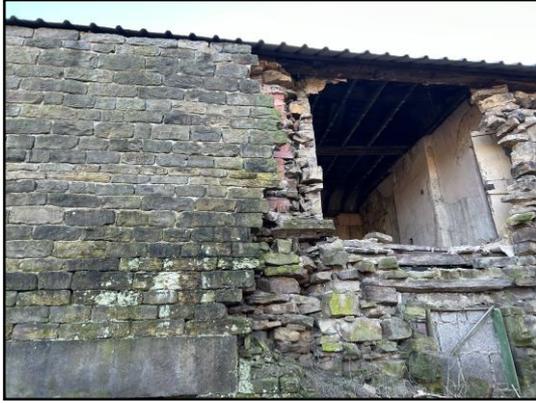
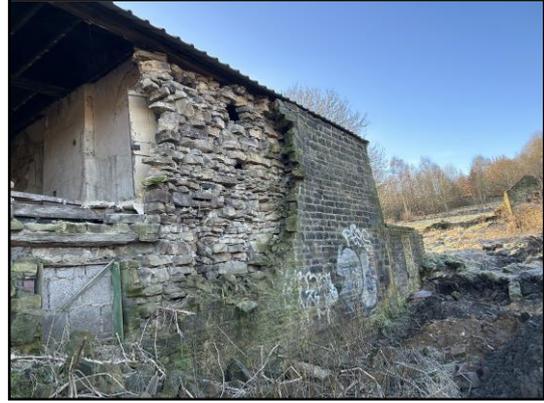
Partial collapse of the rear elevation has occurred to the central section of this wall. Remedial repairs in the form of localised building, approximately 30m<sup>2</sup> of walling, to the rear elevation will be required.

This will include the reformation of the original window and door openings to this elevation and the replacement of defective timber window lintels.

We consider that these proposed remedial rebuilding repairs to be a necessary structural intervention to ensure the long term stability of the rear elevation of the barn.

More modern remedial repairs in the form of corner strapping onto the internal walls will also be required during the rebuilding works.

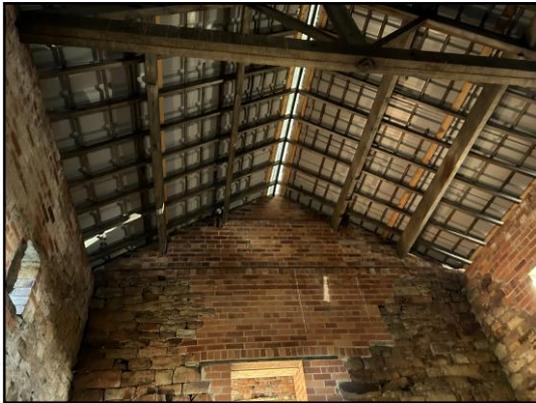
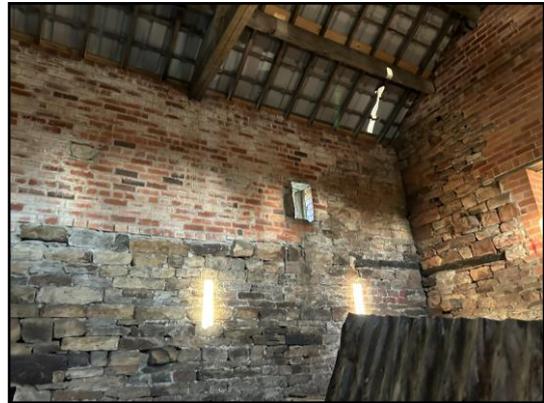
Internally, previous rebuilding repairs were noted to the inner skin of masonry to small sections of the barn walls. The previous repair works comprise of brickwork infilling and these appear to have been undertaken to a good standard and they are well tied and bonded into the original stonework coursings.

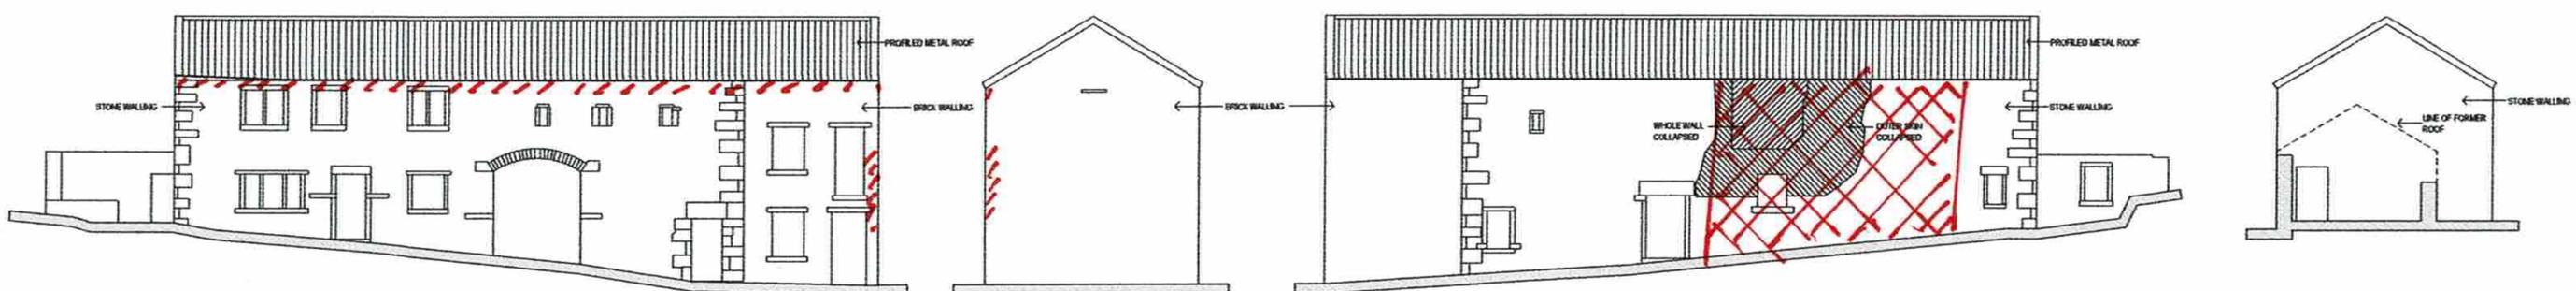
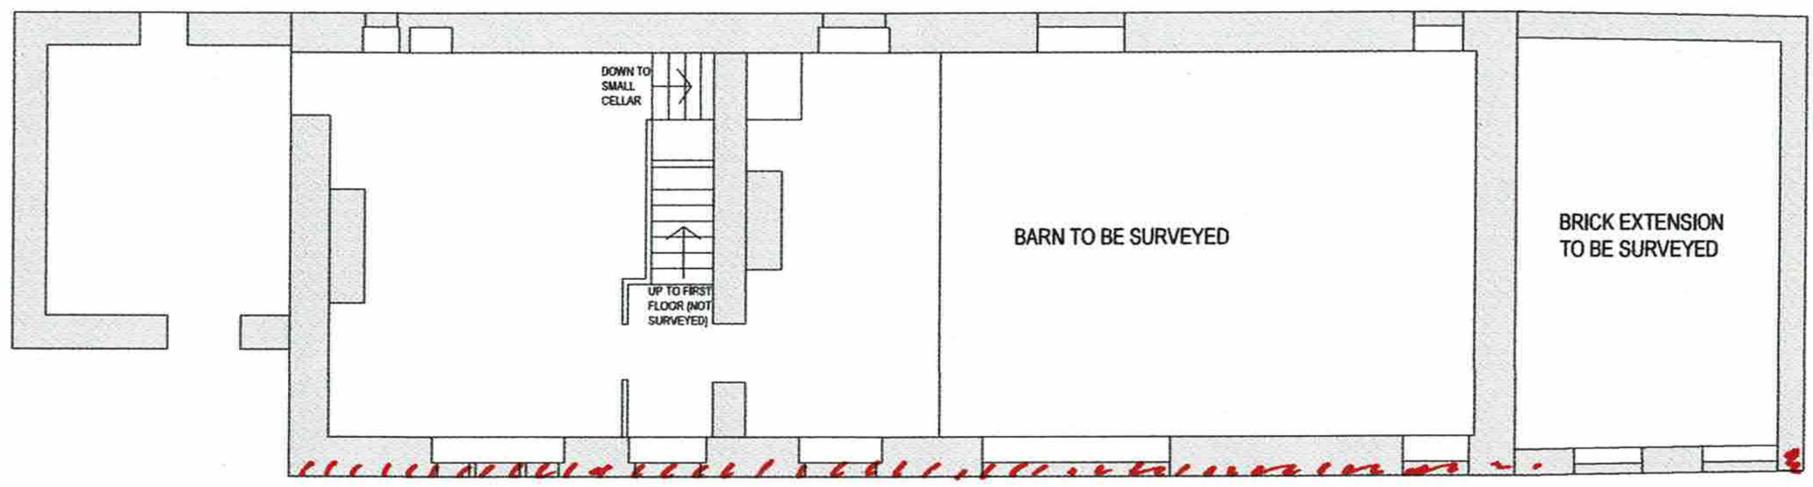
Bradley Hall Farm  
Structural Remedial Works  
MDL - 9683 - SK01

The locations of these proposed remedial works are highlighted on the sketch MDL-9683-SK01.
