STRUCTURAL APPRAISAL REPORT

REF: MDL – 9683

Bradley Hall Farm
Lower Quarry Road
Bradley
Huddersfield
HD2 1FN

We have been instructed to undertake a structural appraisal report of Bradley Hall Farm with a view to its conversion into habitable accommodation with workshop units.

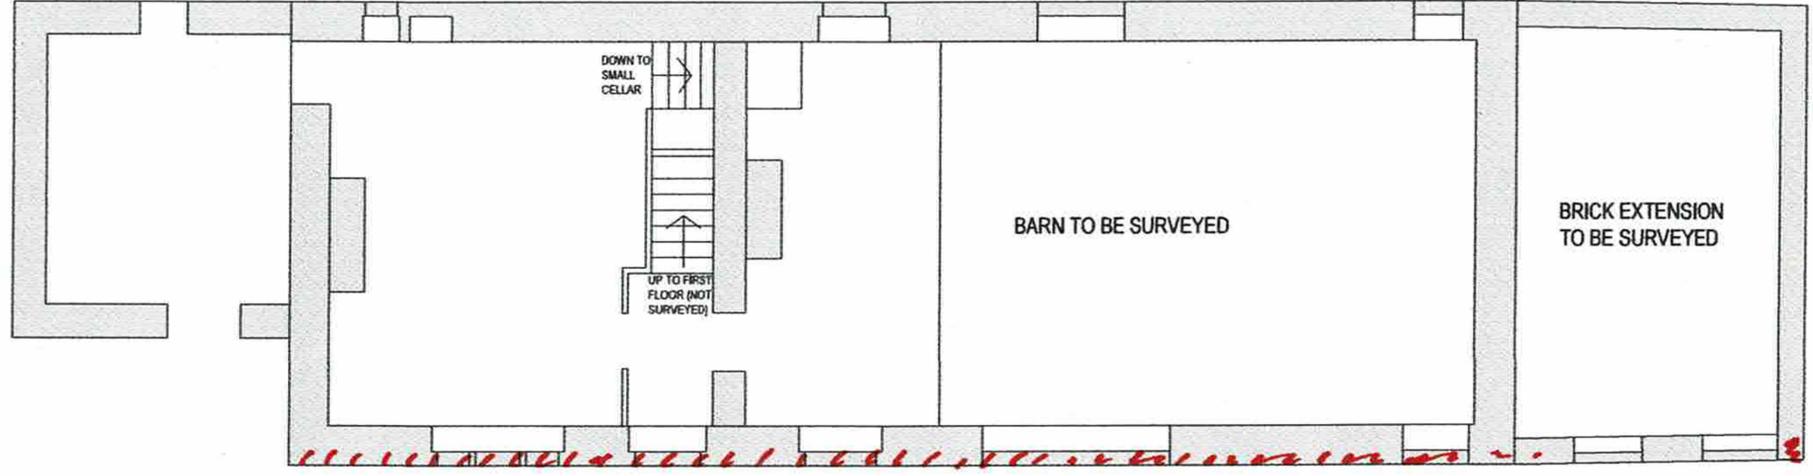
Bradley Hall Farm
Structural Remedial Works
MDL - 9683 - SK01

The locations of these proposed remedial works are highlighted on the sketch MDL-9683-SK01.
