Re: Development at Gynn Lane, Honley for Vivly Homes

Further to your recent planning comments dated July 25 and our meeting with the local residents further site investigation work has been undertaken to determine if there was any existing land drainage associated with the former off site tank/ mill pond on the third party land.

Haigh Huddleston & Associates

Site Photographs

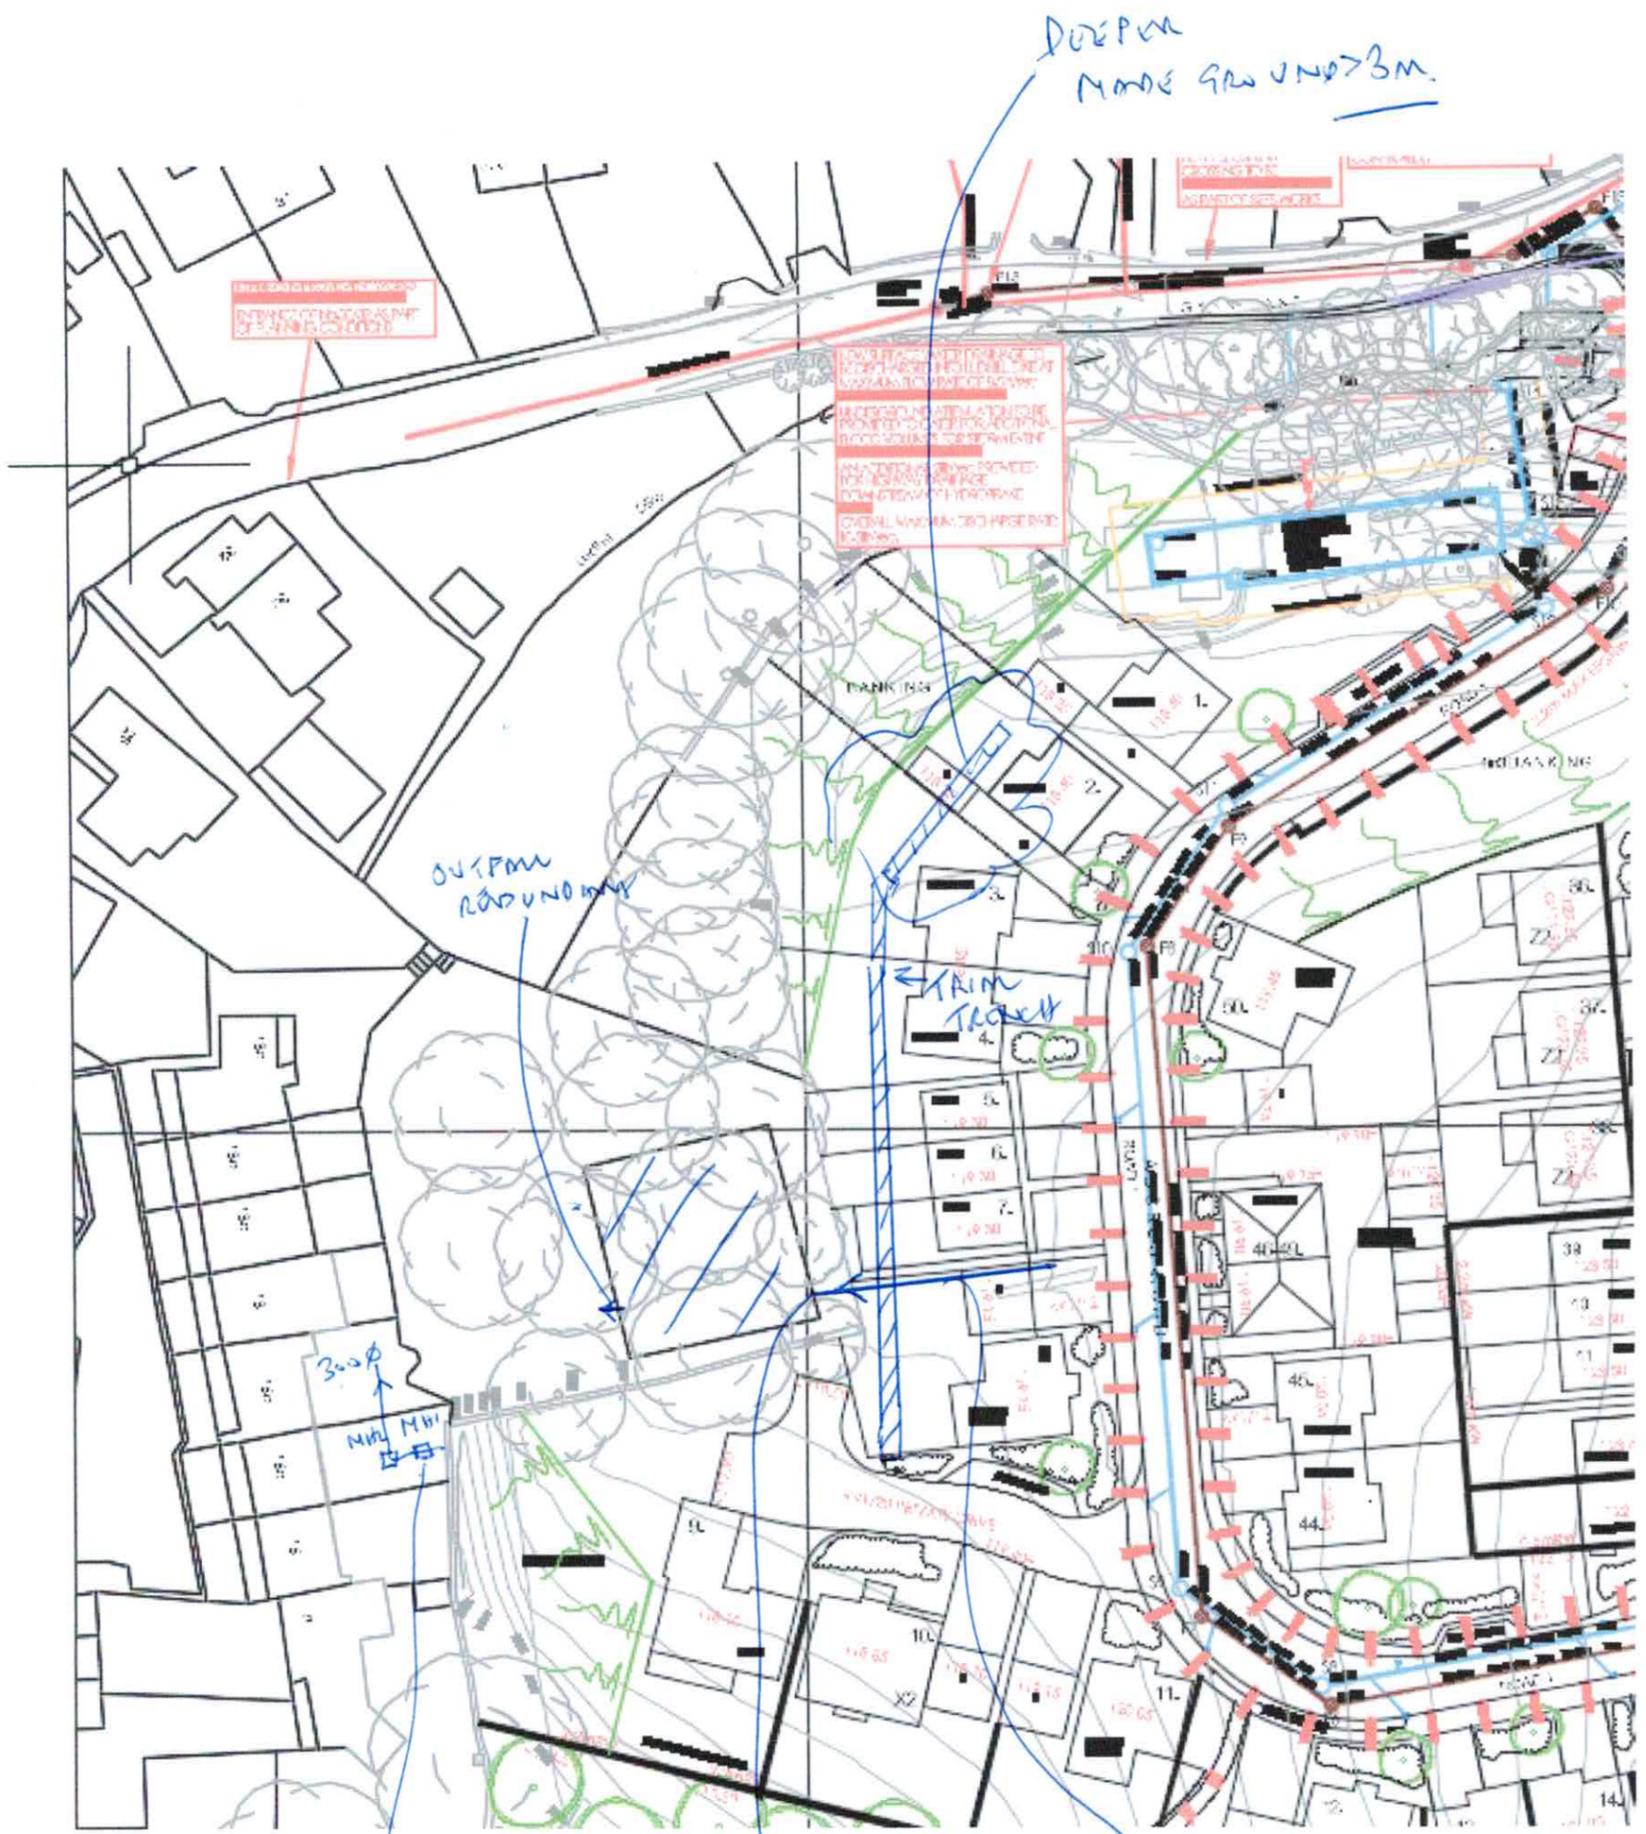
Location Plan

CASCADIC
MANHOLE
FLOW FROM MINE ADIT.

150M CAST IRON
PIPEWORK ENTERING
FORMER MILL POND
NOW REDUNDANT

EXTENT OF TRIAL TRENCH
NO EVIDENCE OF ANY OTHER
PIPEWORK OR DRAINAGE FEATURES

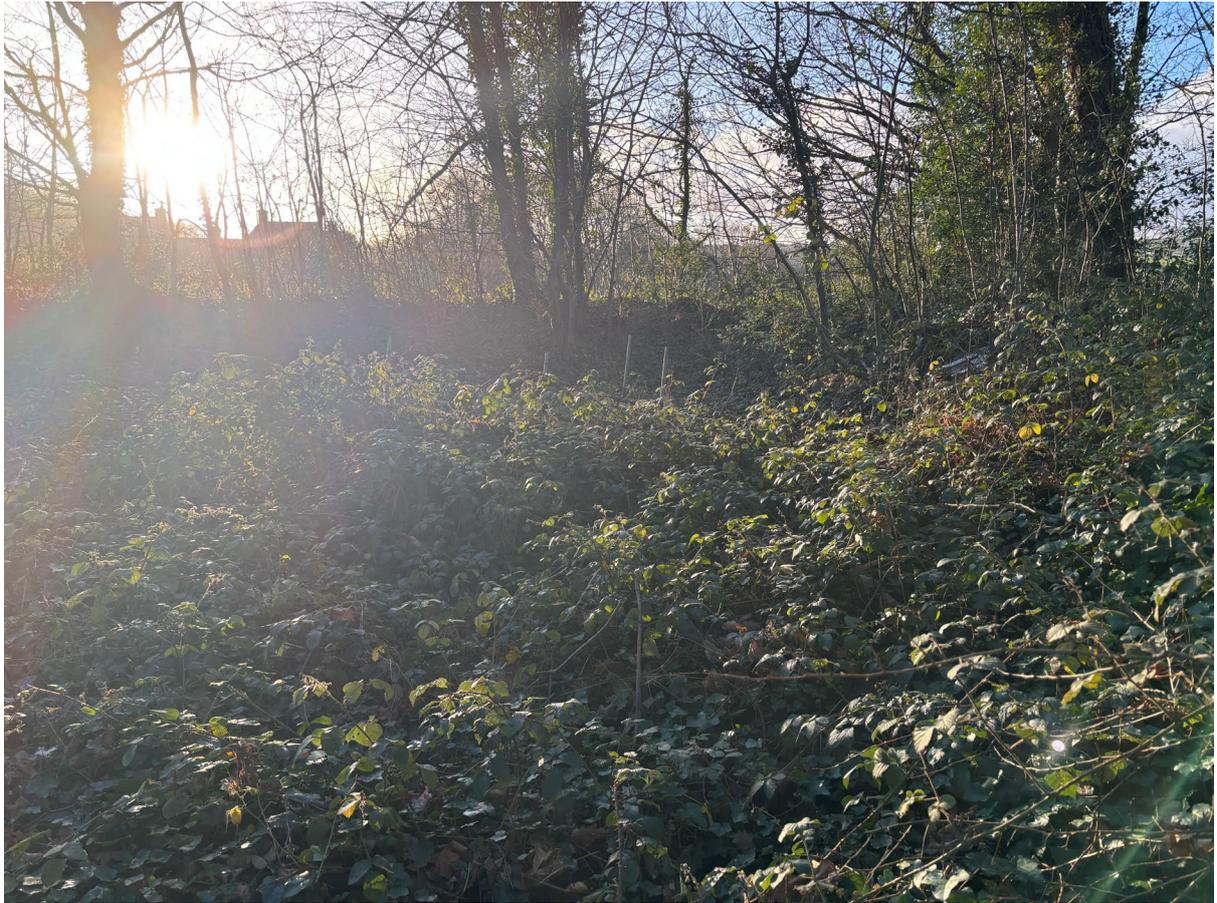
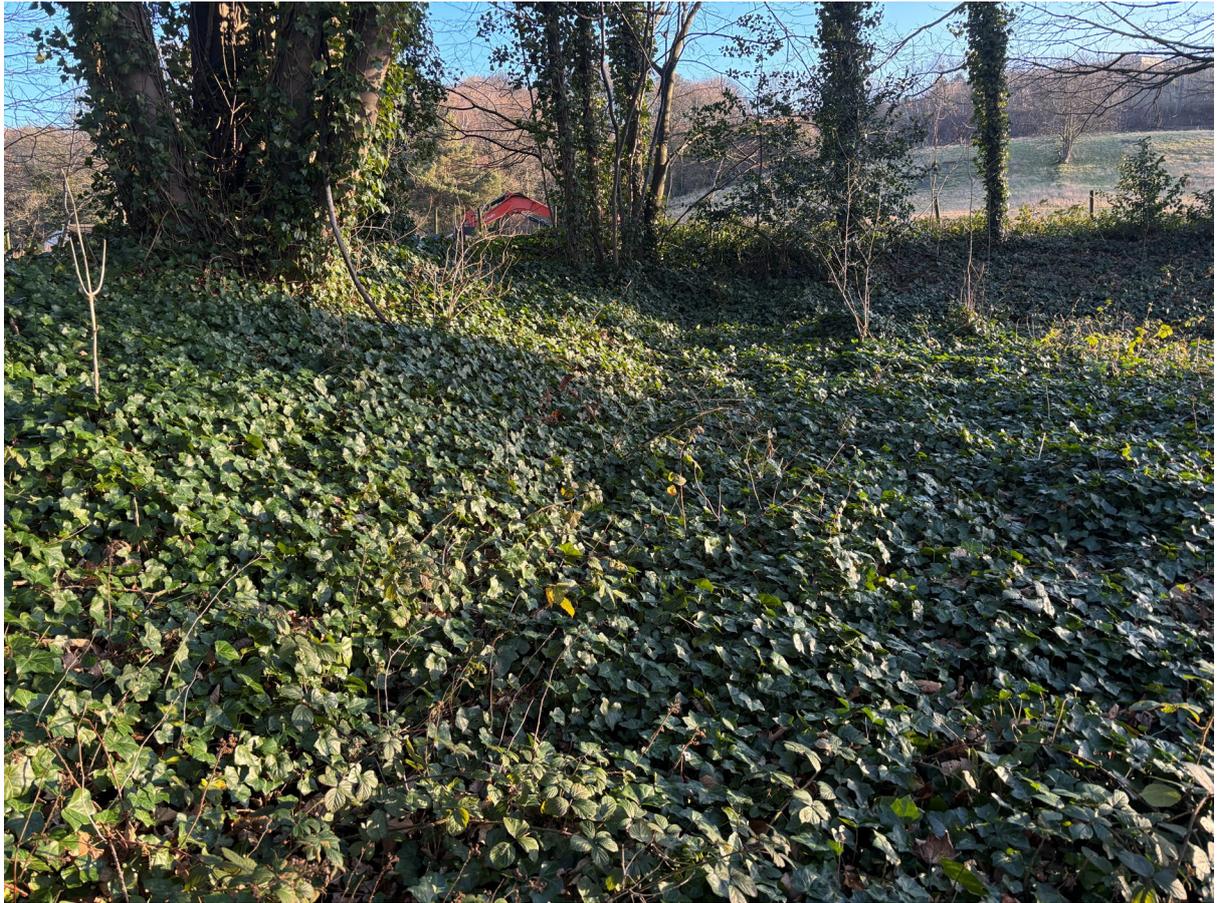
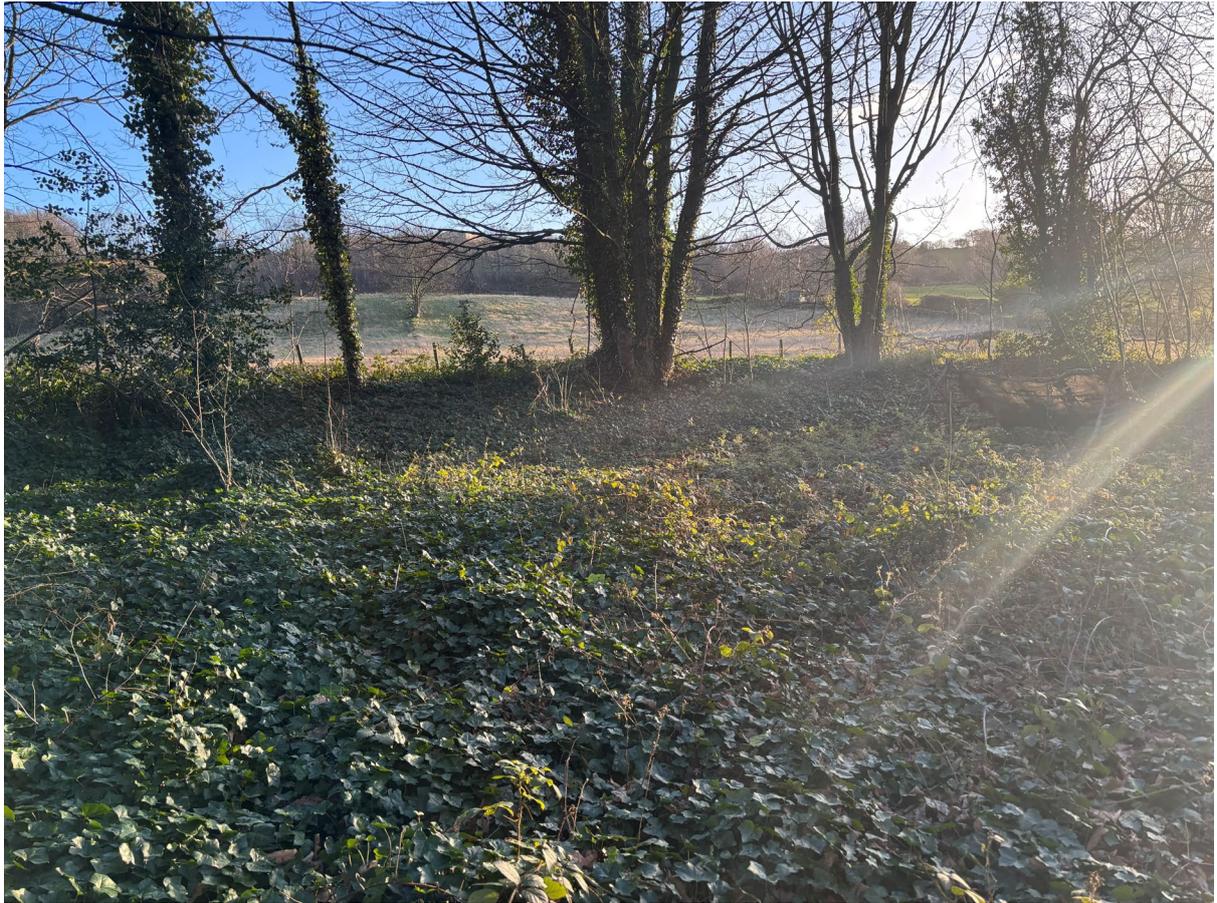
A second days investigation was undertaken to determine if there was a buried tank below the off-site shallow dry mill pond. The area at the pond was dry even following the recent heavy rainfall and it is evident that no significant surface water flow enters this area at present time.

Figure 1 Dry Mill Pond

Figure 2 Dry Mill Pond

Figure 3 Dry Mill Pond

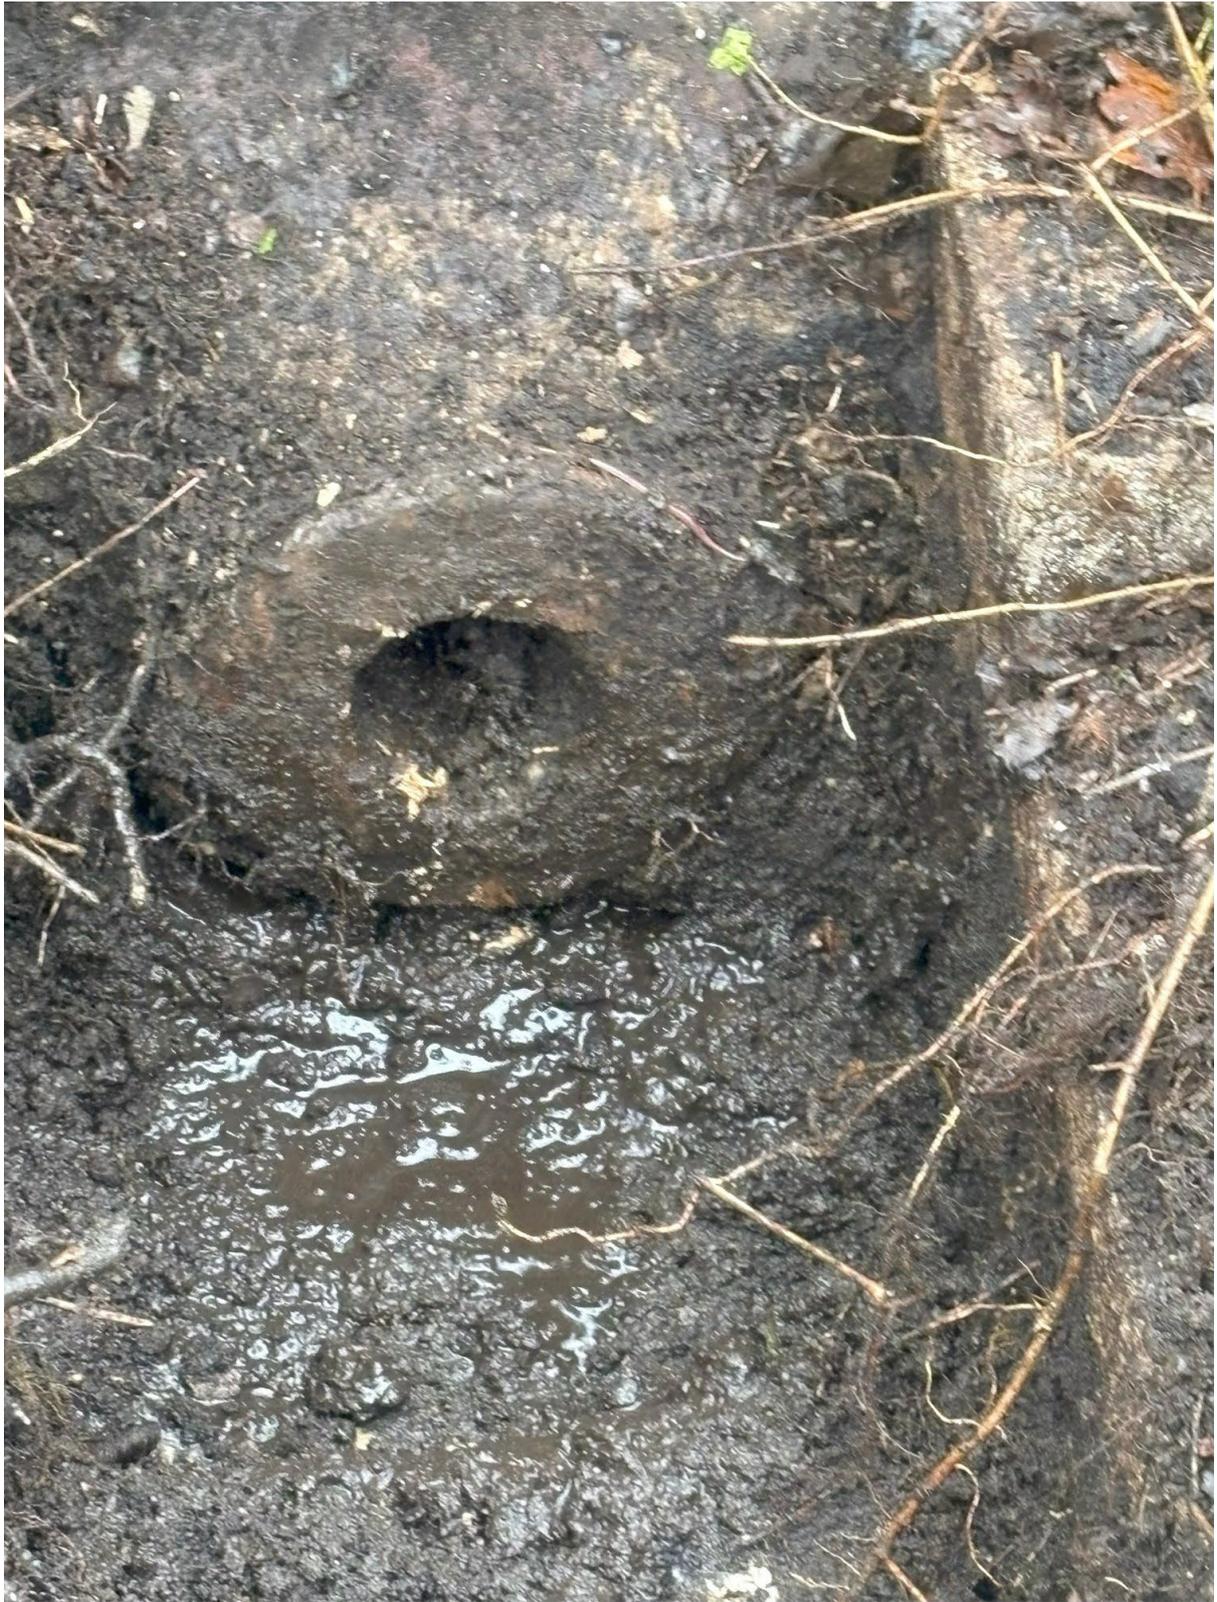
The area is heavily overgrown with ivy however a concrete base was proved. A small section was broken out and proved clay strata underlying. Further investigations revealed an 100mm outfall and a 150mm inlet from the shallow cast iron pipework. The inlet has previously had a concrete bung prevented entering the pond area. We would conclude that the cast iron pipework is now redundant and can be removed from the development area when exposed.

Figure 4 100mm outfall from mill pond

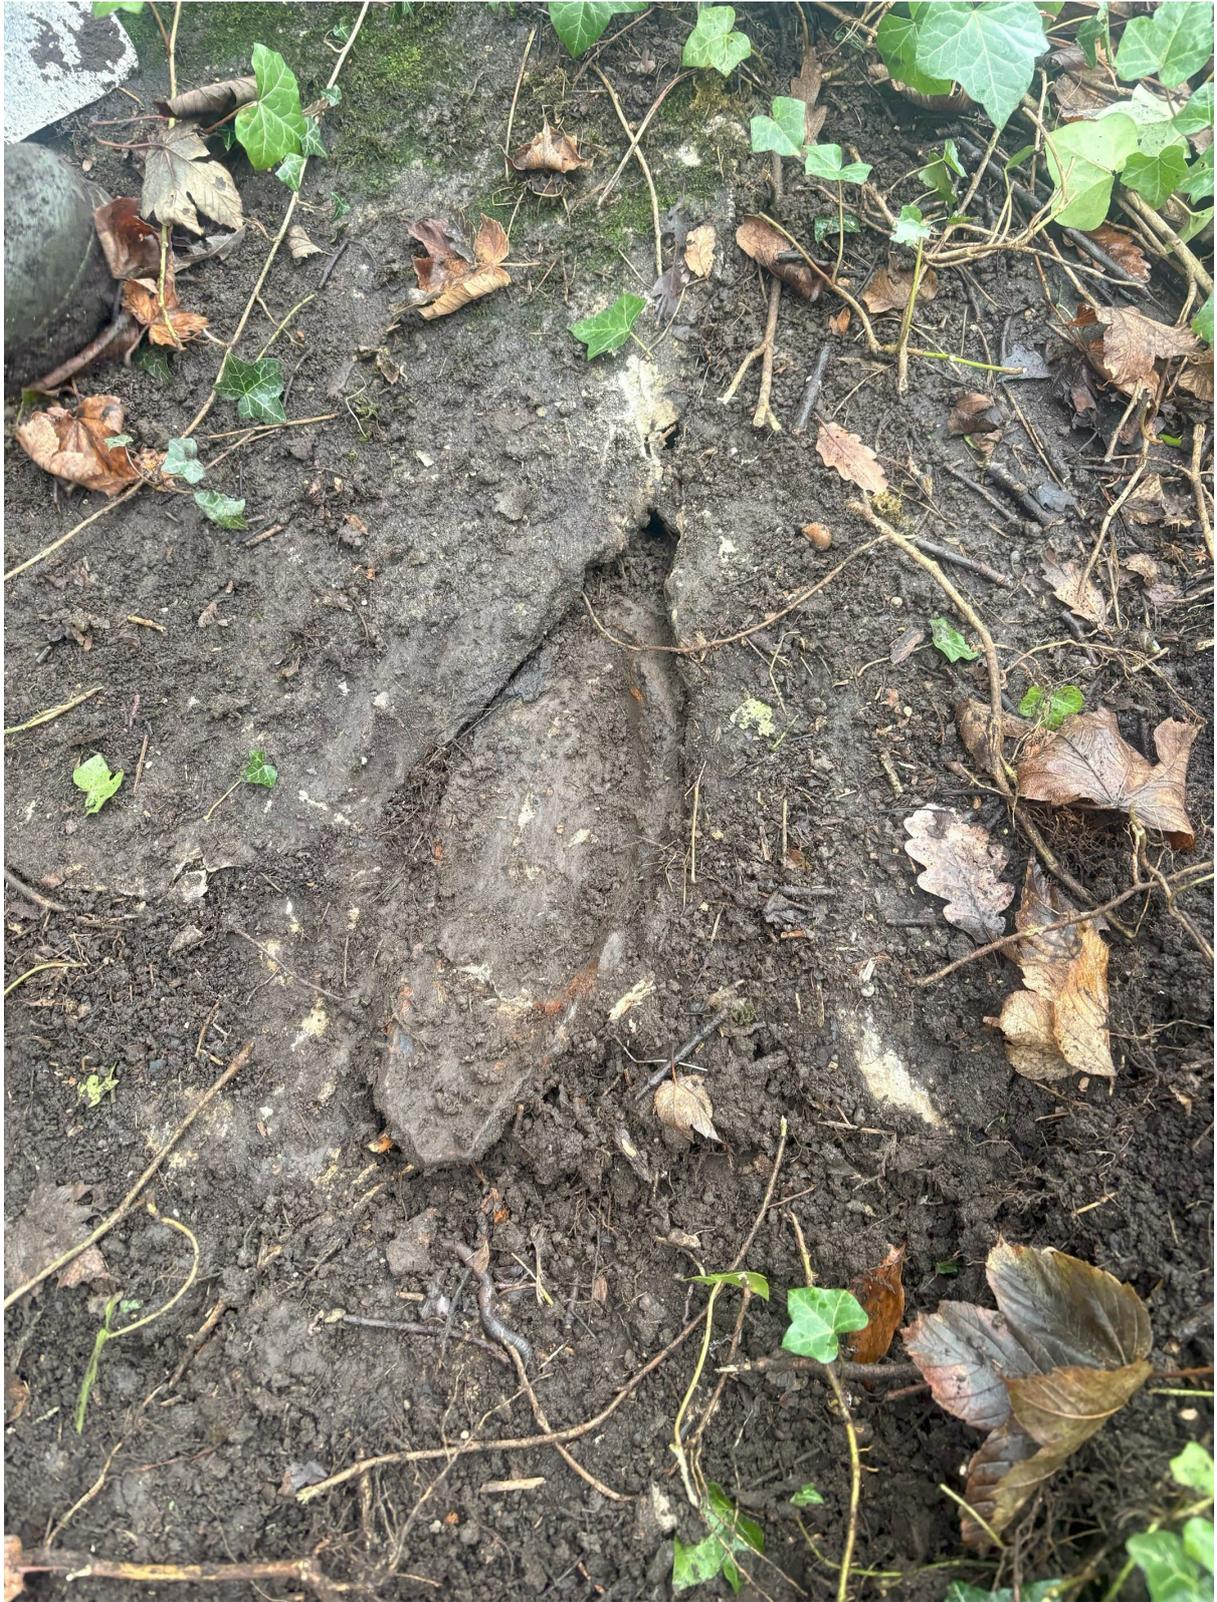
Figure 5 Inlet from cast iron pipe with concrete plug

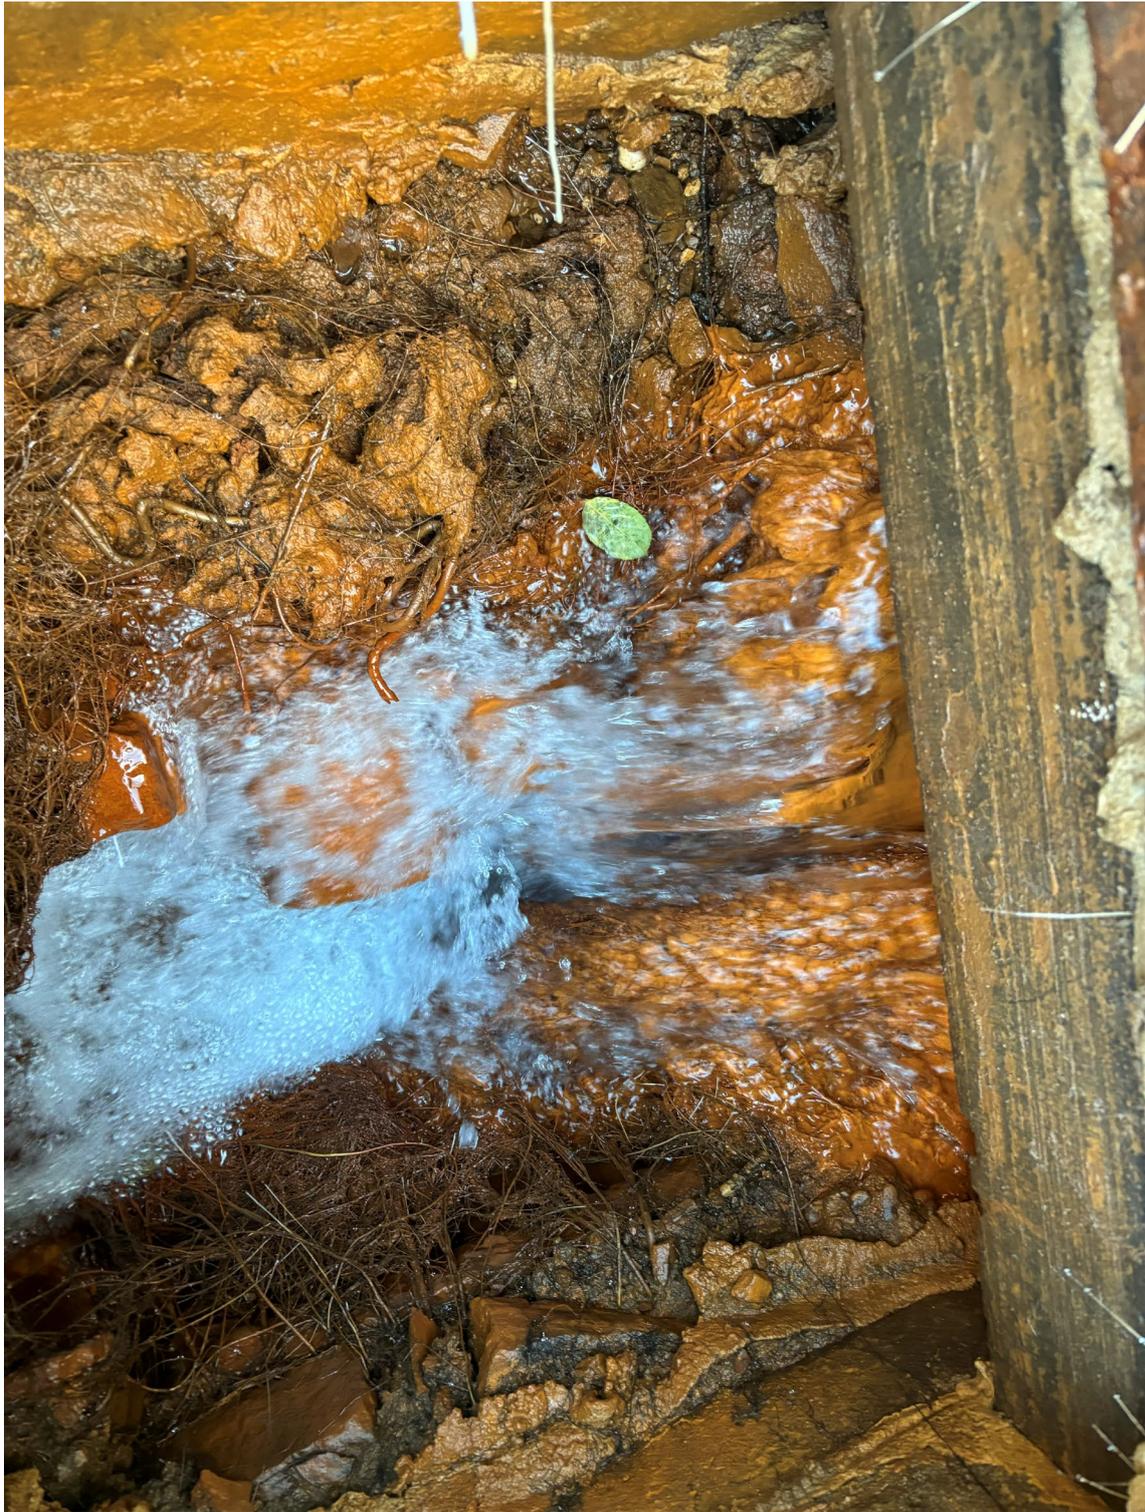
The system was relatively shallow and entered the first manhole via an earth cascade before turning 90° in the second manhole with a 300mm dia clay pipe. At the time of our visit the flow was consistent with slight iron staining within each manhole. The source of the flow is likely to be from the mine adit previously identified on site in the Lithos investigation.

Figure 6 Inflow to upstream MH No. 16a

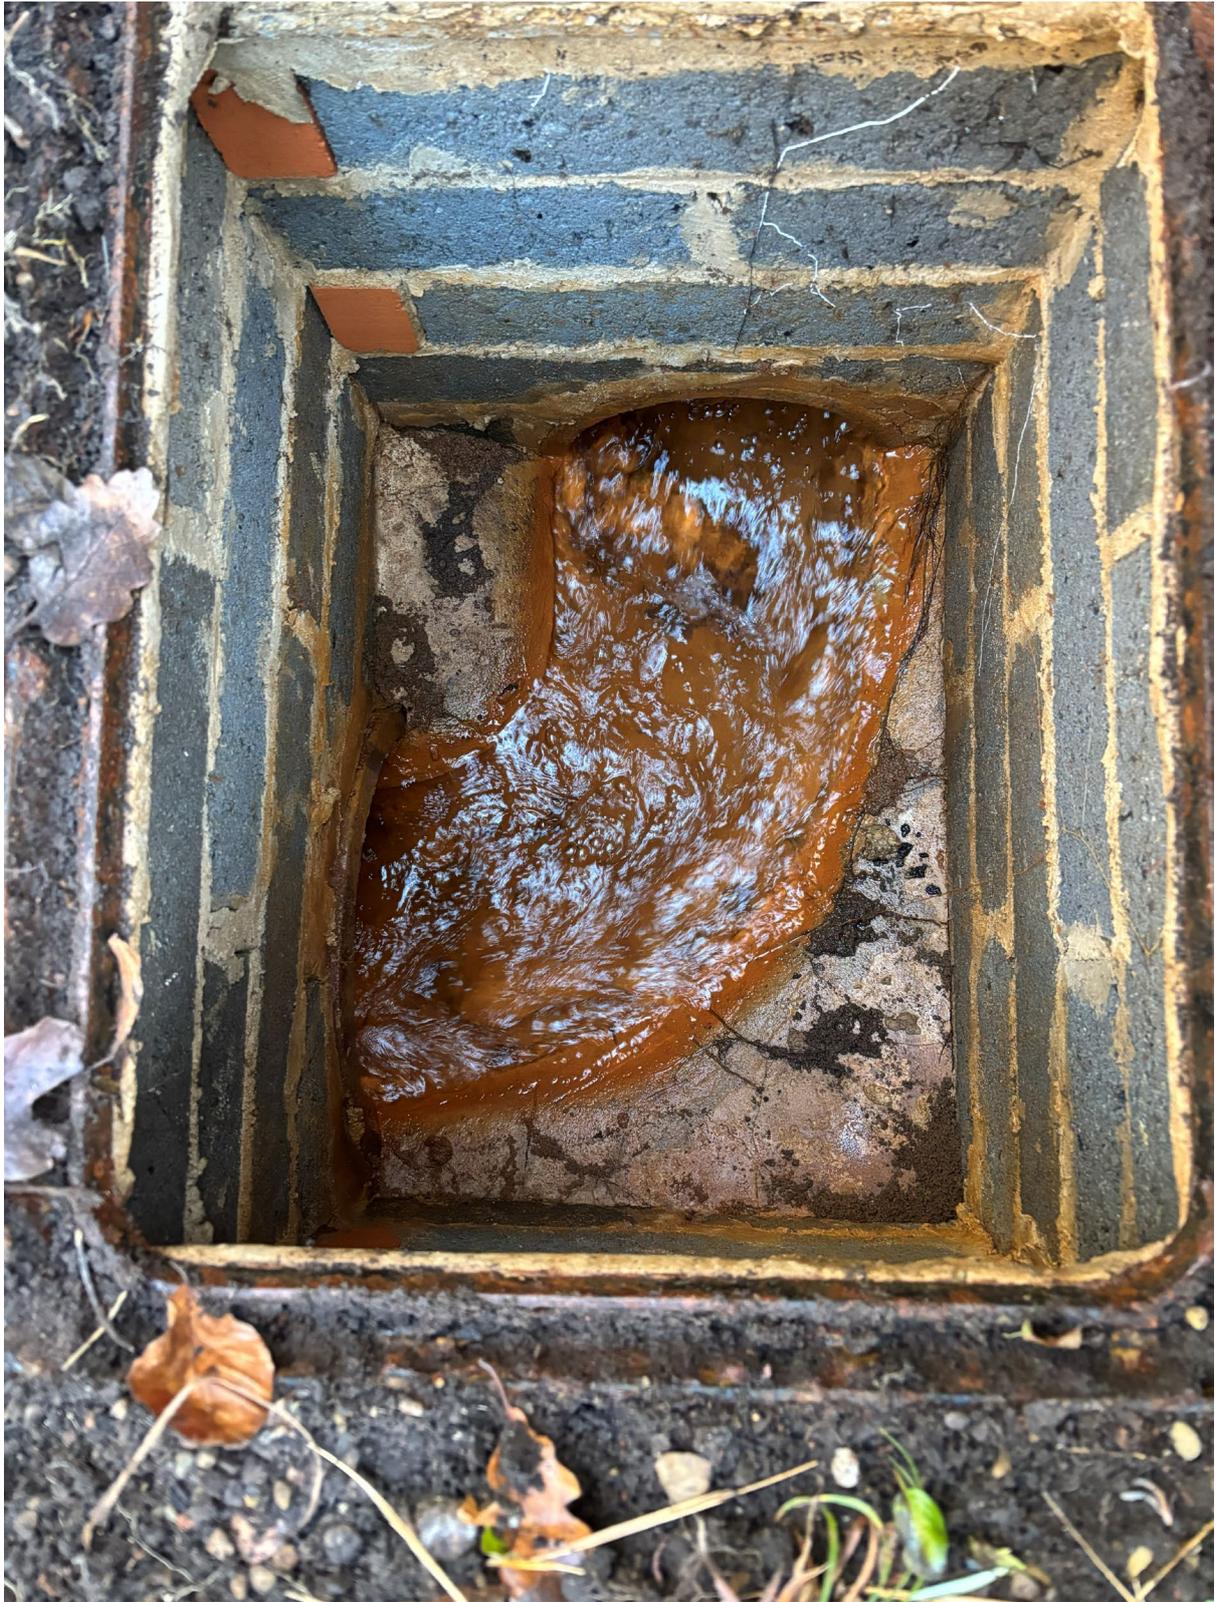
Figure 7 300mm 90deg bend House 16a

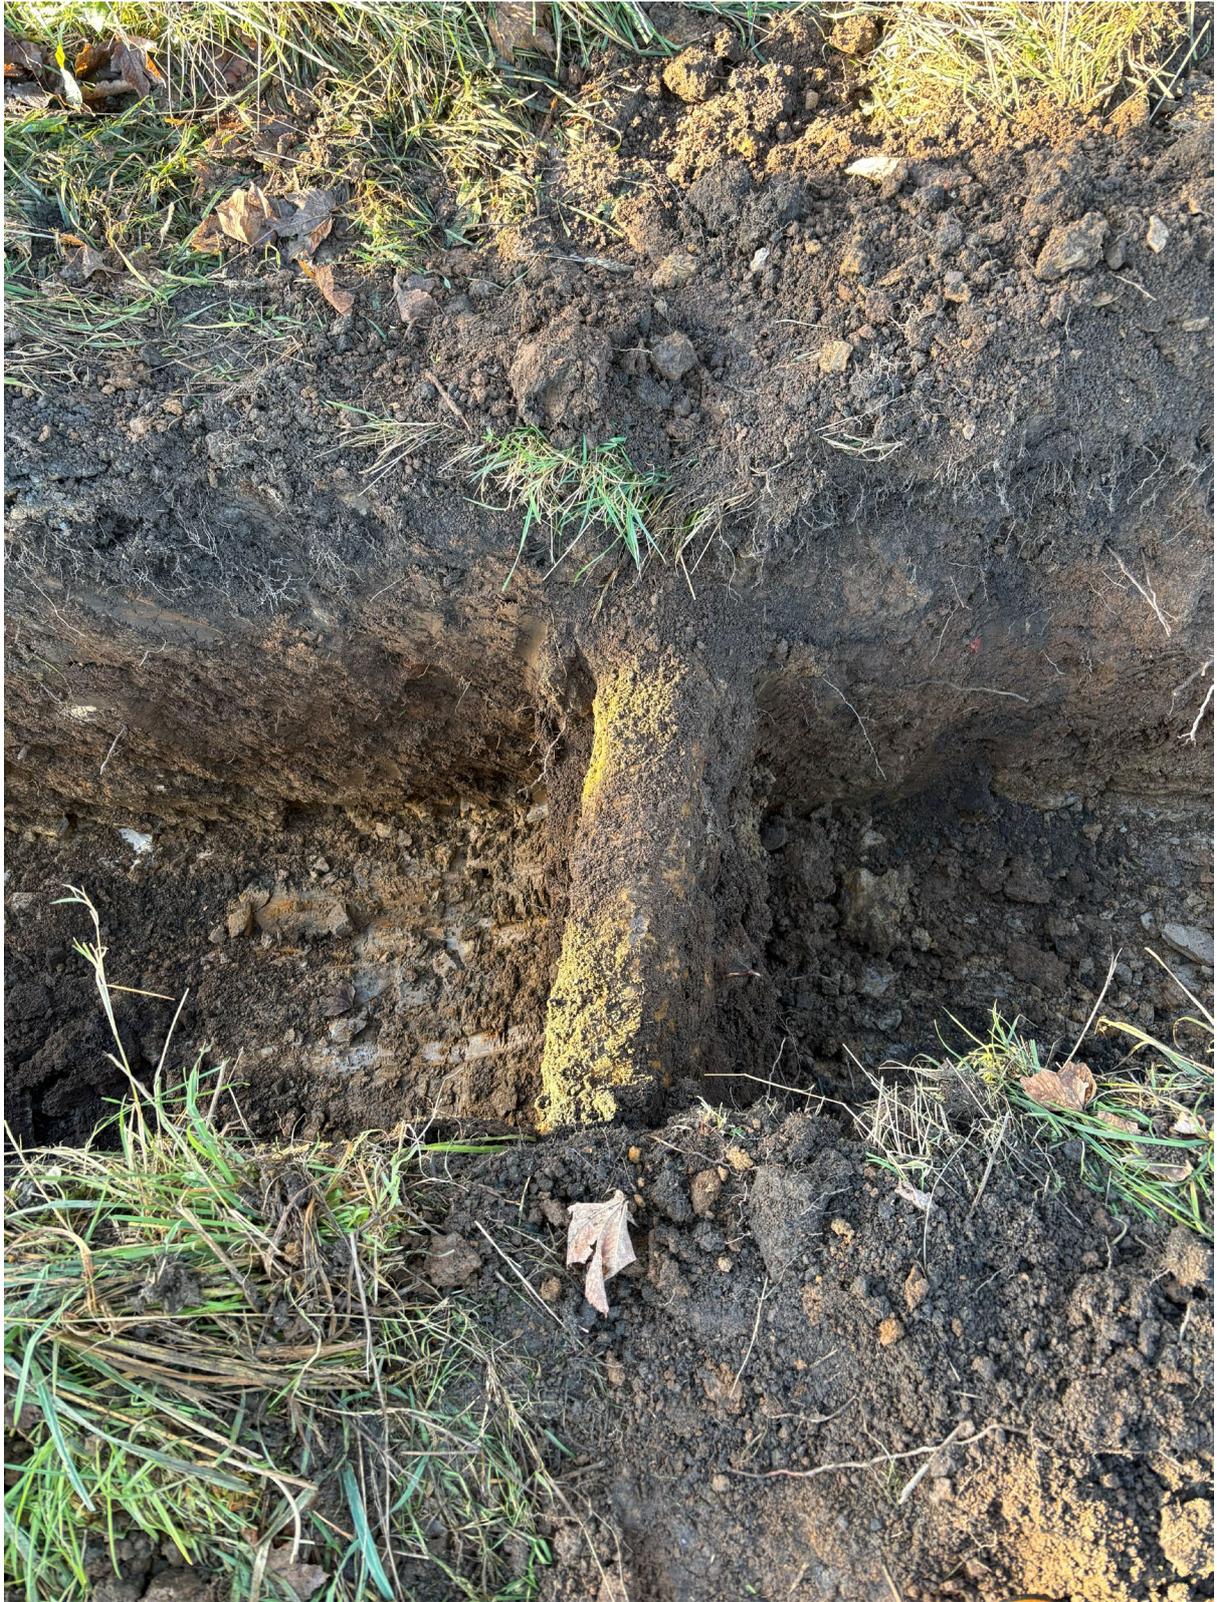
Figure 8 Cast Iron Pipe encountered within trial trench
